LIMITED EVALUATION OF A RELATIVE GPS DATALINK BETWEEN TWO C-12C AIRCRAFT (PROJECT "LOST WINGMAN")

FINAL TECHNICAL INFORMATION MEMORANDUM

AIR FORCE FLIGHT TEST CENTER
EDWARDS AIR FORCE BASE, CALIFORNIA
AIR FORCE MATERIAL COMMAND
UNITED STATES AIR FORCE

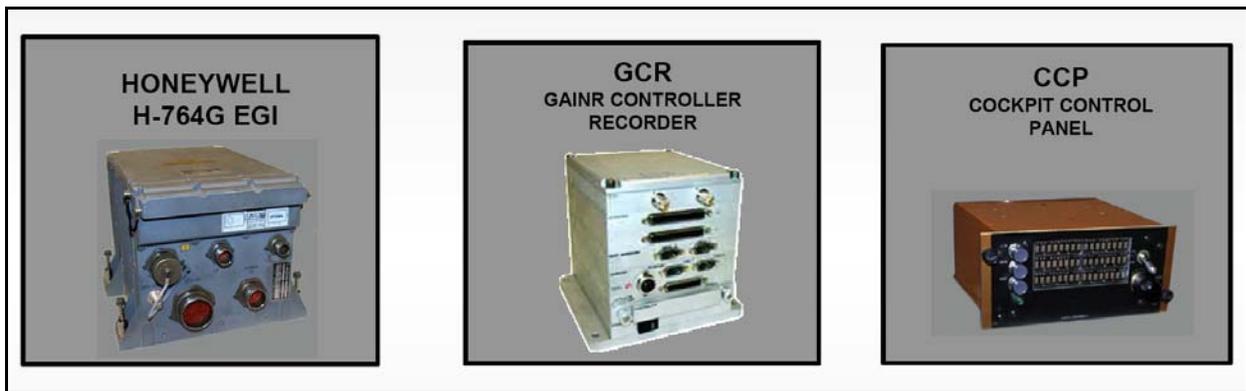
Figure A-3: Components of the GPS Aided Inertial Reference System

The test support hardware consisted of two truth sources supplied by 412th Test Wing, Range Support Division Edwards AFB (412 TW/ENR). A GPS Aided Inertial Reference (GAINR) system was the truth source on C-12C #73-1215 and a GAINR-Lite system (i.e., no Embedded GPS INS) was the truth source on C-12C #70-00158. According to Reference 5, the GAINR-II accuracy was identified at 1 foot accuracy. With two GAINR sources used for truth source relative GPS solution, the accuracy was 2 feet. Figure A-3 illustrates the three components of the GAINR system and figure A-4 illustrates the GAINR-Lite system used during the test program.

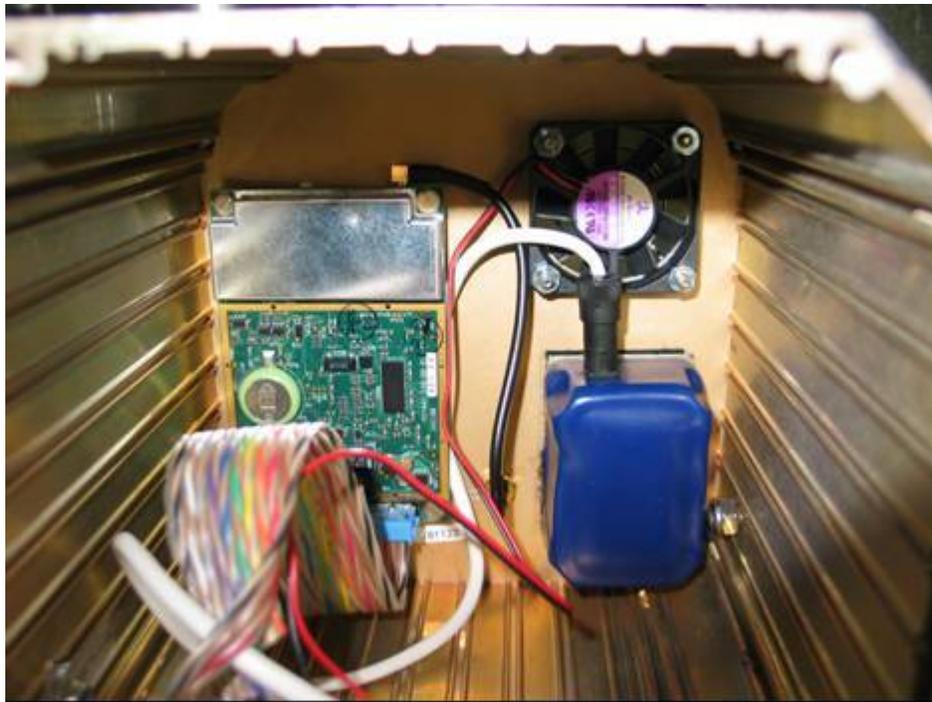
**Javad GPS Receiver Card (left) and MEMS IMU (lower right)
mounted inside Lost Wingman SUT**
