Data from Channel-Change Monitoring at Selected Sites in Maricopa County, Arizona, 1997-2002

Open-File Report 2004–1230

By Christie M. O'Day

Prepared in cooperation with the
FLOOD CONTROL DISTRICT OF MARICOPA COUNTY

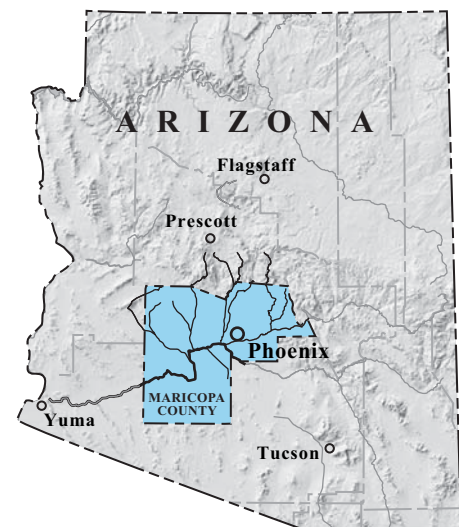
Figure 1. Locations of study area and streamflow-gaging stations associated with channel-change monitoring sites, Maricopa County, Arizona.

In the pilot part of this study, Capesius and Lehman (2002) reported on channel change for 10 sites on 7 perennial and ephemeral streams using historical cross-section data and data collected during 1996–97. The data-collection network has been revised for longer term monitoring and data analysis, and now consists of 11 sites on 10 streams ([fig. 1](#)).

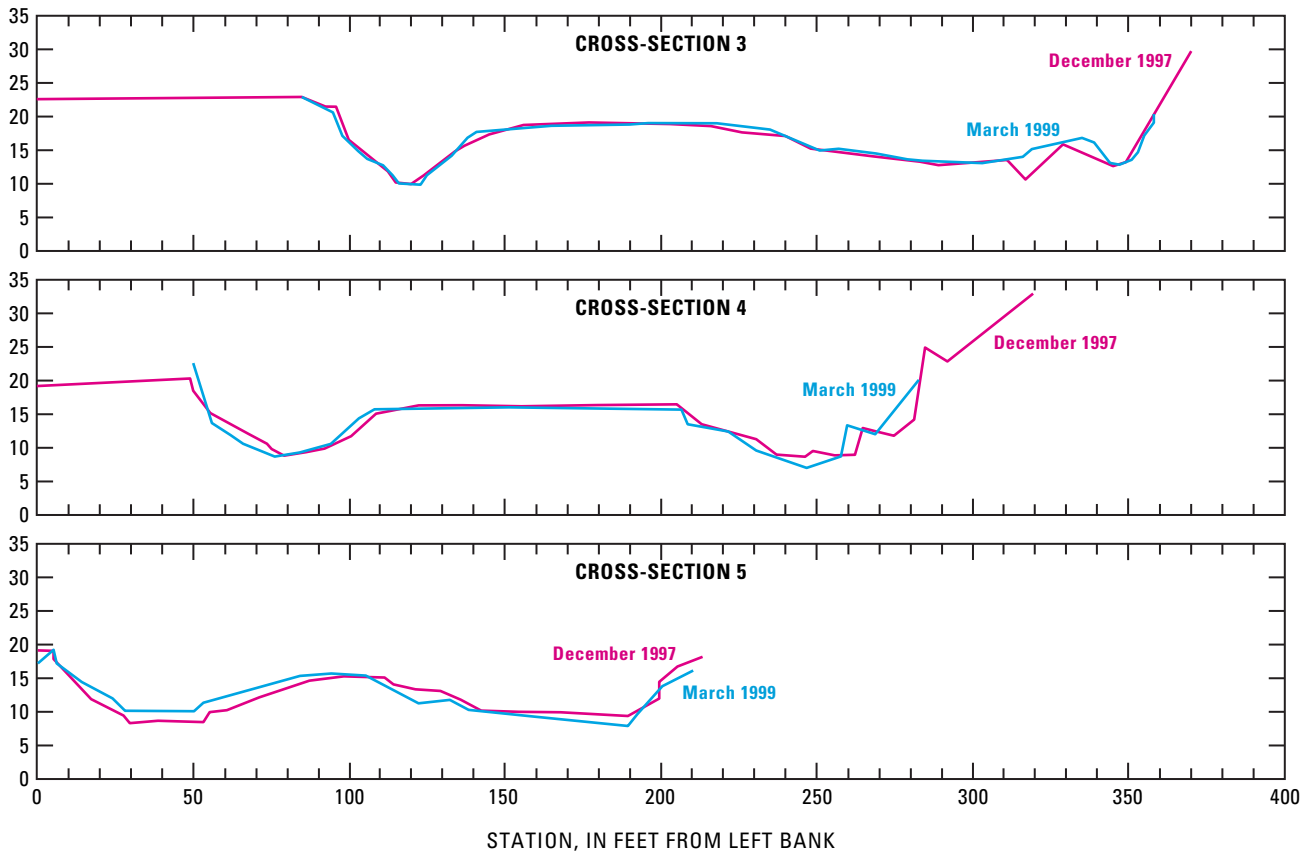
Figure 8. Channel-change cross sections from surveys at New River at New River, Arizona, 1997–99.
