## **Dust Abatement Methods for Lines- of-Communication and Base Camps in Temperate Climates**

John F. Rushing, Vernon M. Moore, Jeb S. Tingle,  
Quint Mason, and Tim McCaffrey

October 2005

Final report

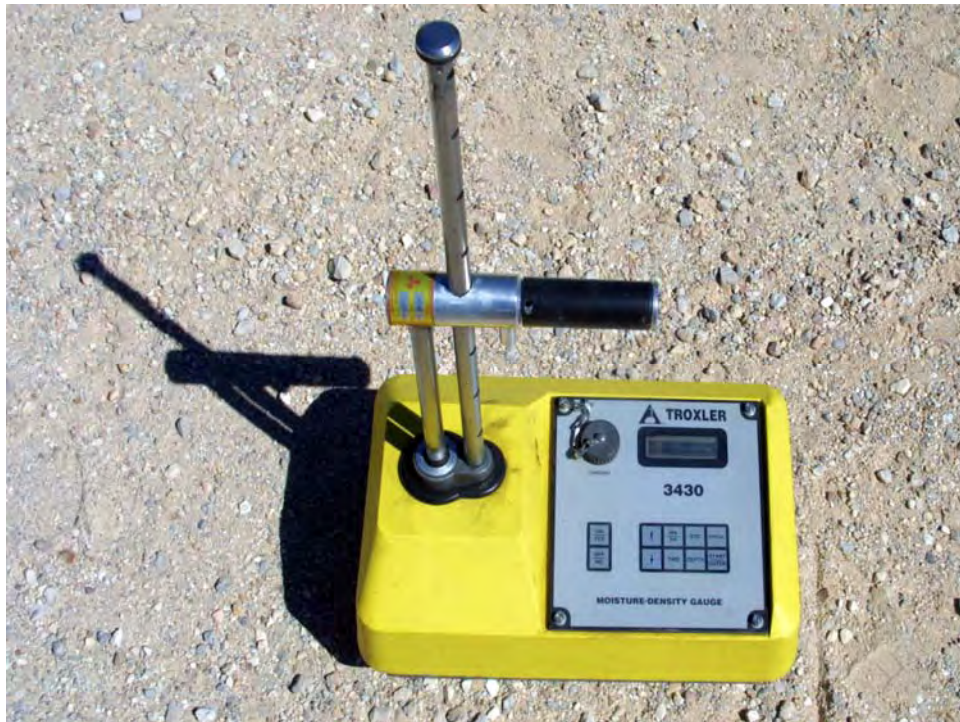
Photo 1. Troxler 3430 nuclear density gauge

A Troxler® 3430 nuclear gauge was used to collect density and moisture data in the center of each test section prior to construction and after each evaluation period (Photo 1). The gauge contains two radioactive sources: Cesium-137 for density measurement and Americium-241:Beryllium for determining moisture content. Density measurements were taken in the 6-in. direct transmission mode after creating a hole in the section using a drill rod according to ASTM D2922. Moisture contents were obtained using procedures outlined in ASTM D3017.

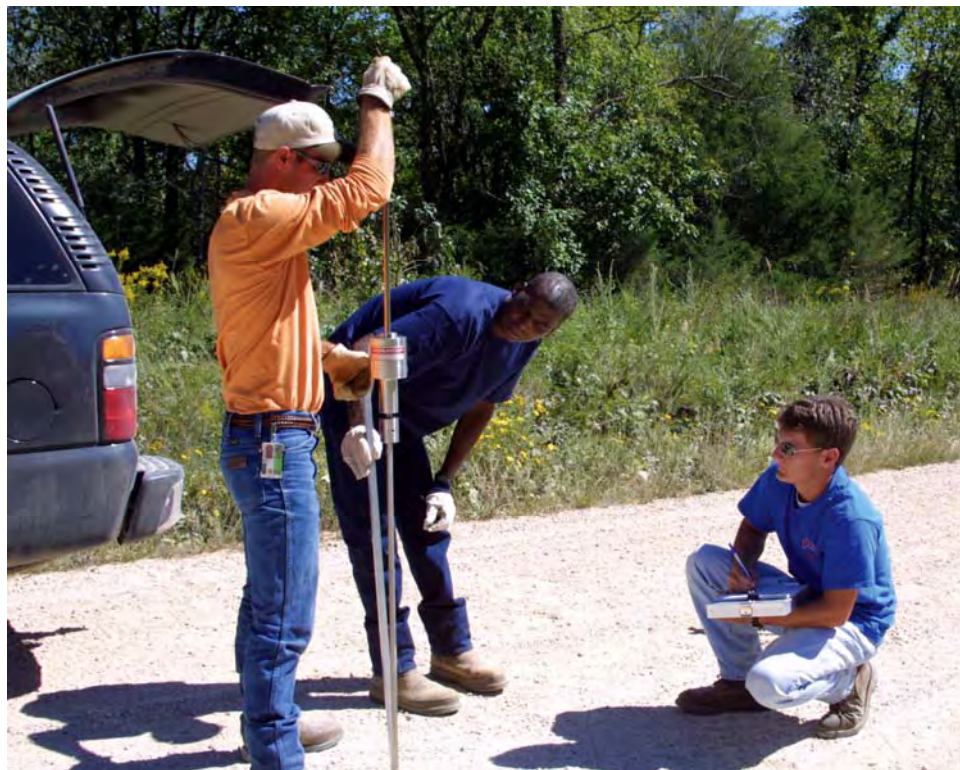
Photo 2. Dynamic cone penetrometer

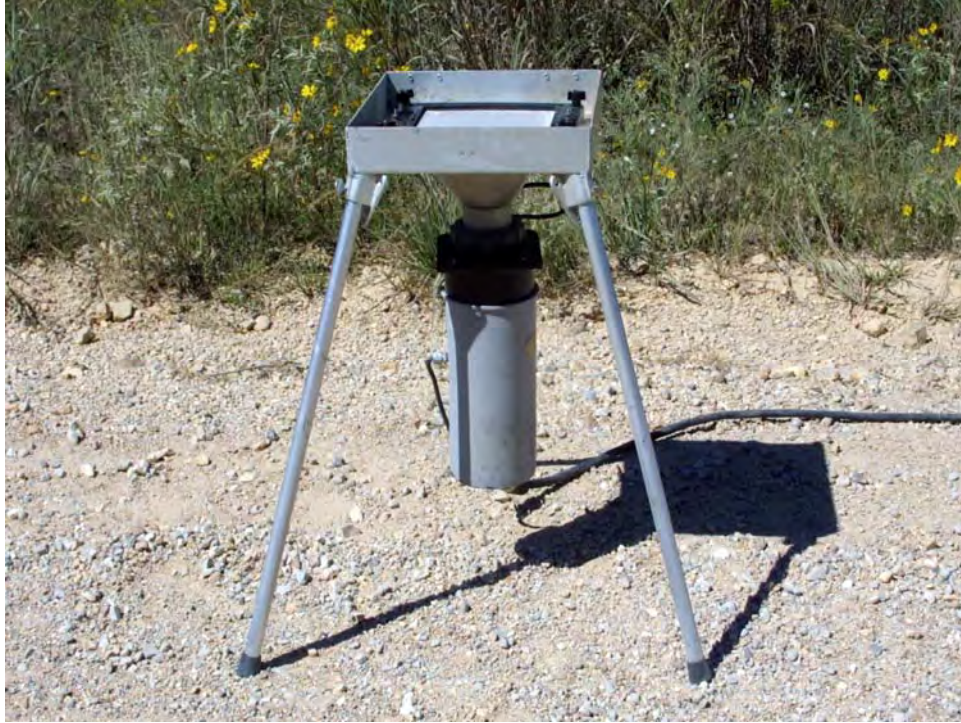
Photo 3. Stationary dust collection system

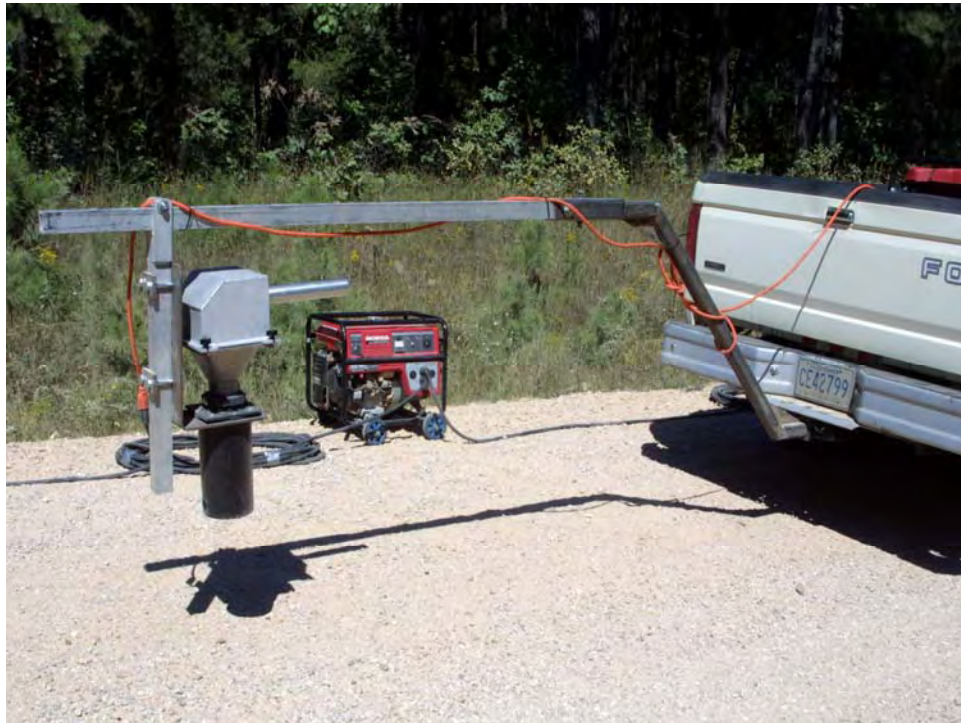
Photo 4. Mobile dust collection system

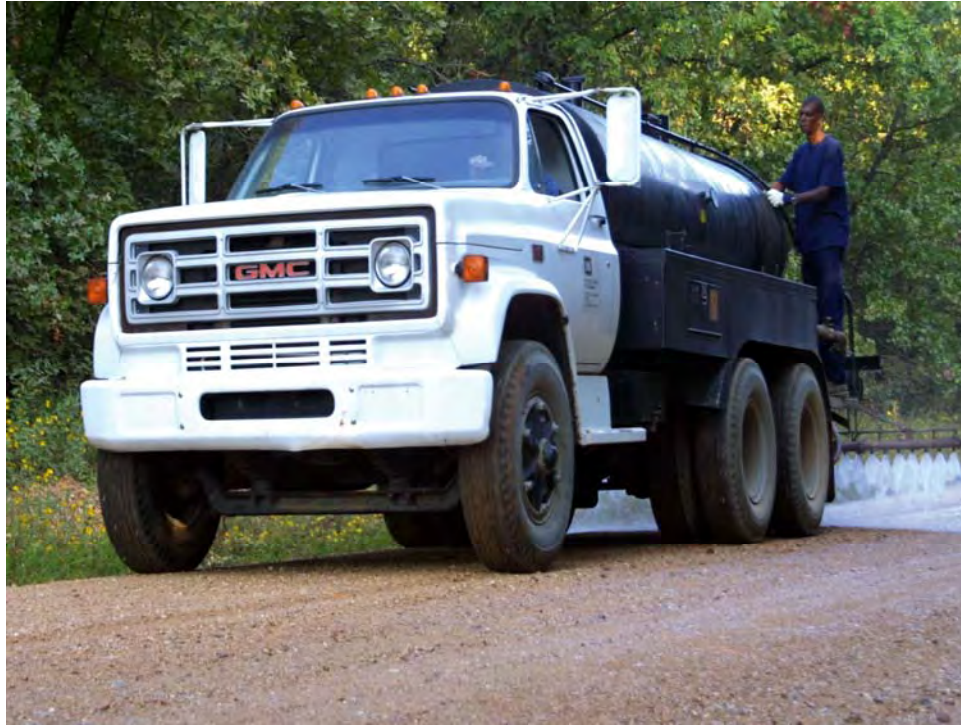
Photo 5. Etnyre asphalt emulsion distributor

- a. An Etnyre asphalt emulsion distributor was effective for spraying each of the dust palliatives. It provided a controlled application rate with even distribution. However, using the polymer emulsions in the equipment may cause maintenance problems if the polymers begin to harden in the tank or within the distribution pipes and valves.
- b. A TEREX soil reclaimer/stabilizer provided excellent mixing for incorporating the dust palliatives in the respective road section. It also provided precise control over the tilling depth.
- c. A 12-ton vibratory compactor was unable to achieve the original density of the road sections with only three coverages. Compactors with greater

- c. A distribution system comparable to the asphalt emulsion distributor is recommended for applying dust palliatives. The system must be capable of holding significant volumes of fluid and evenly dispersing the fluid via fan-type spray nozzles. Mechanical pumps must be able to generate pressures capable of providing even dispersion across the road. Minimum pump pressures will be dictated by the size and type of spray nozzle used and should be adjusted to meet the manufacturer's recommendations. The distribution system should be able to regulate the volumetric output of the fluids for application rate control. Minimum flow rates of 100 gal/min are recommended for treating large areas.

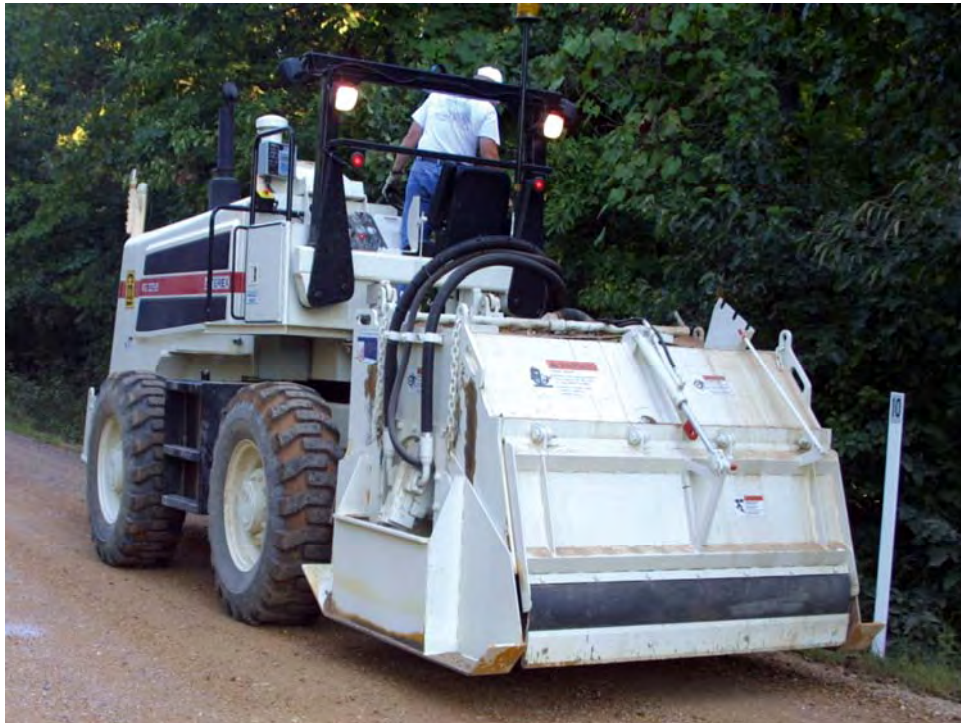
Photo 6. TEREX soil reclaimer/stabilizer

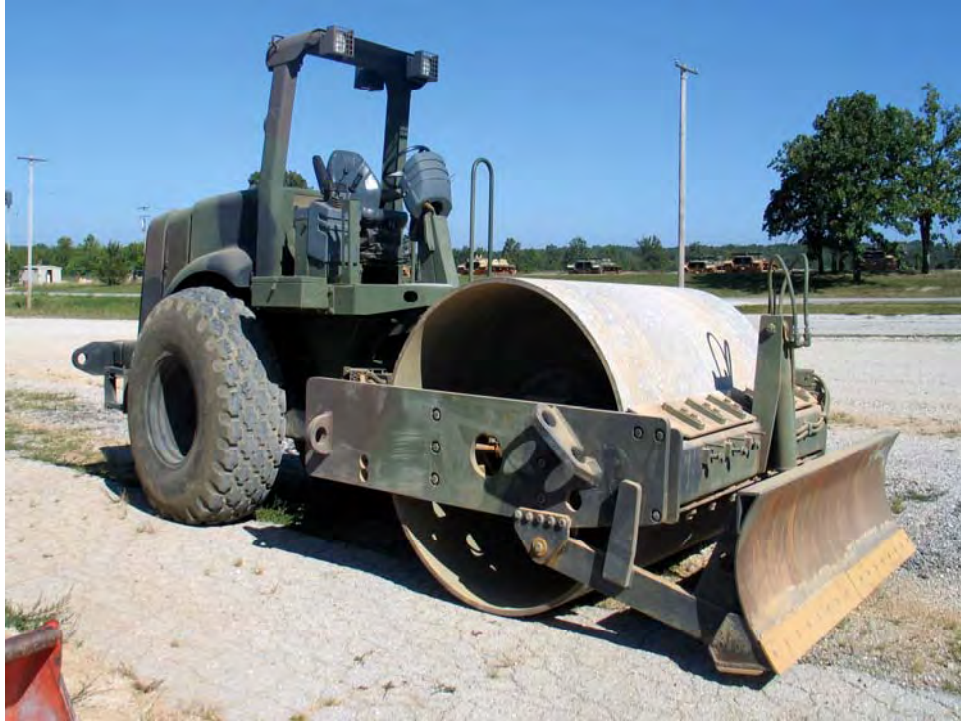
Photo 7. Caterpillar 12-ton vibratory roller

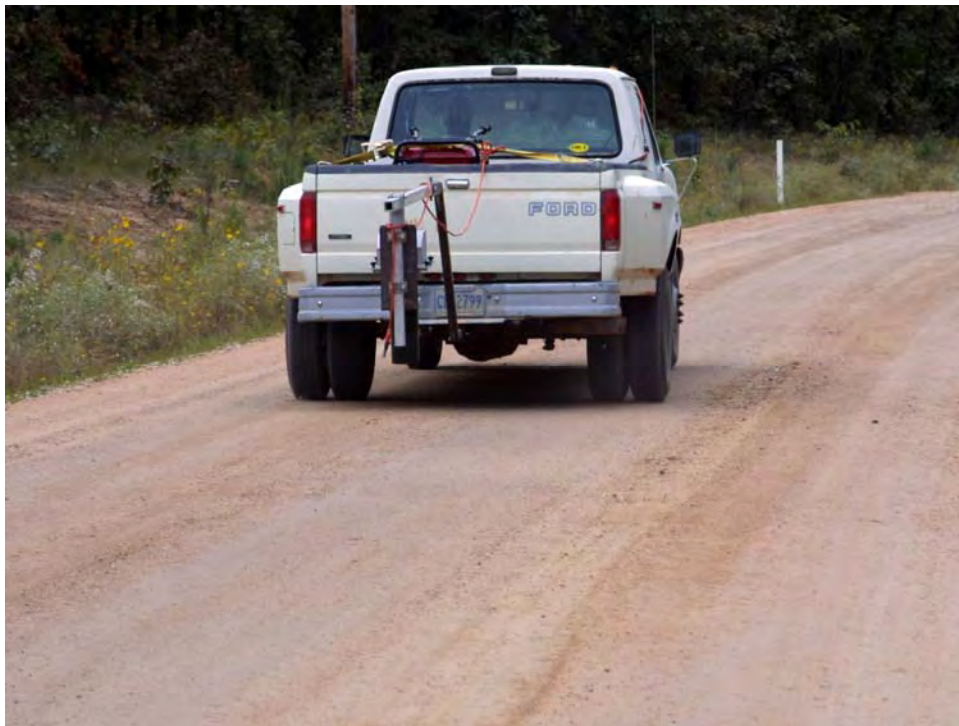
Photo 10. Section 1 after treating with Envirotac II® (0.8 gsy admix)

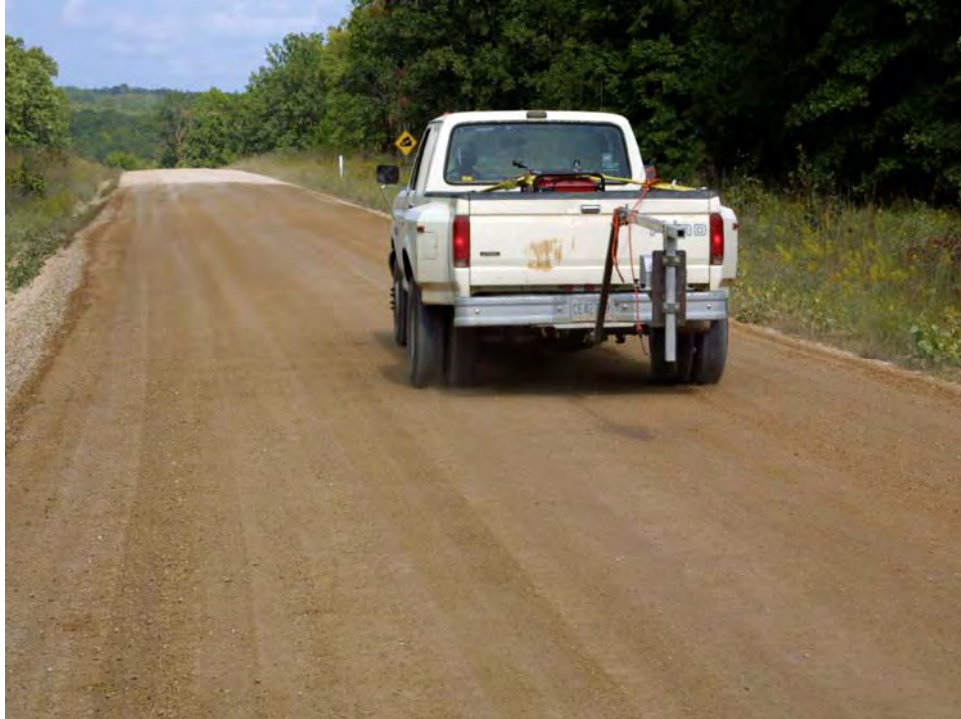
Photo 11. Section 5 after treating with Surtac® (0.8 gsy admix)

The fifth section used the same construction method to place Surtac®. The section was prewet with 0.4 gsy of water and then sprayed with 0.4 gsy of a 3:1 water:Surtac® solution. The section was tilled to a depth of 2 in. using three passes of the TEREX. The ends of the section were smoothed using the Kubota tractor, and the section was compacted with three coverages of the 12-ton vibratory roller. A final 0.4 gsy of a 3:1 solution of water and Surtac® was applied to the road topically to provide a sealed wearing surface. The section had a smooth, tight final surface with polished wheel paths and loose gravel covering less than 5 percent (Photo 11).

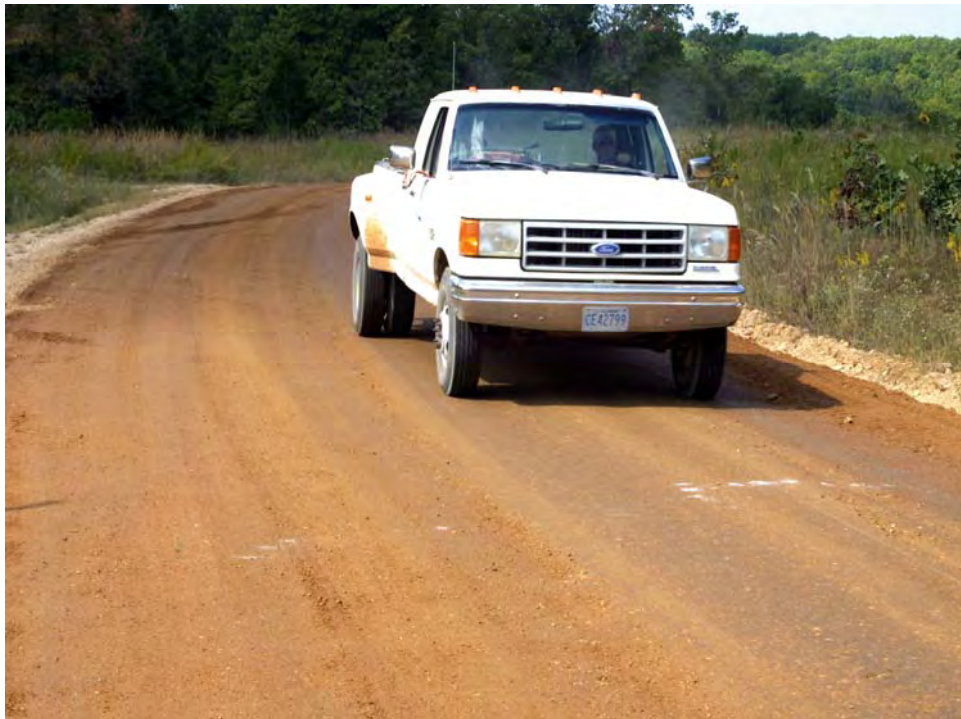
Photo 12. Section 6 after treating with calcium chloride (0.8 gsy admix)

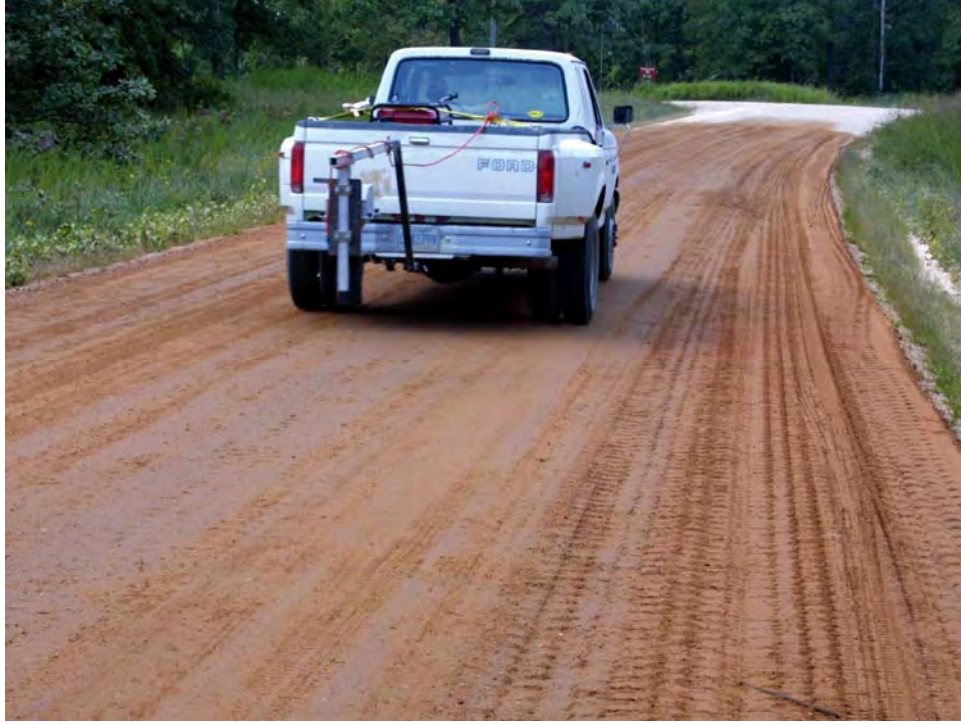
Photo 13. Section 7 after treating with Durasoil® (0.8 gsy admix)

The seventh section was treated with Durasoil®. The section was prewet with 0.4 gsy of water and then sprayed with 0.4 gsy of Durasoil®. The section was tilled to a depth of 2 in. using three passes of the TEREX. The ends of the section were smoothed using the Kubota tractor, and the section was compacted with three coverages of the 12-ton vibratory roller. A final 0.4 gsy of the Durasoil® was applied to the road topically to increase the effectiveness of dust abatement at the surface. The section had a smooth surface with polished wheel paths that were slightly rutted. Loose aggregate covered approximately 2 percent of the surface area at the northeast end. The Durasoil® caused the soil to appear much darker than the surrounding material (Photo 13).

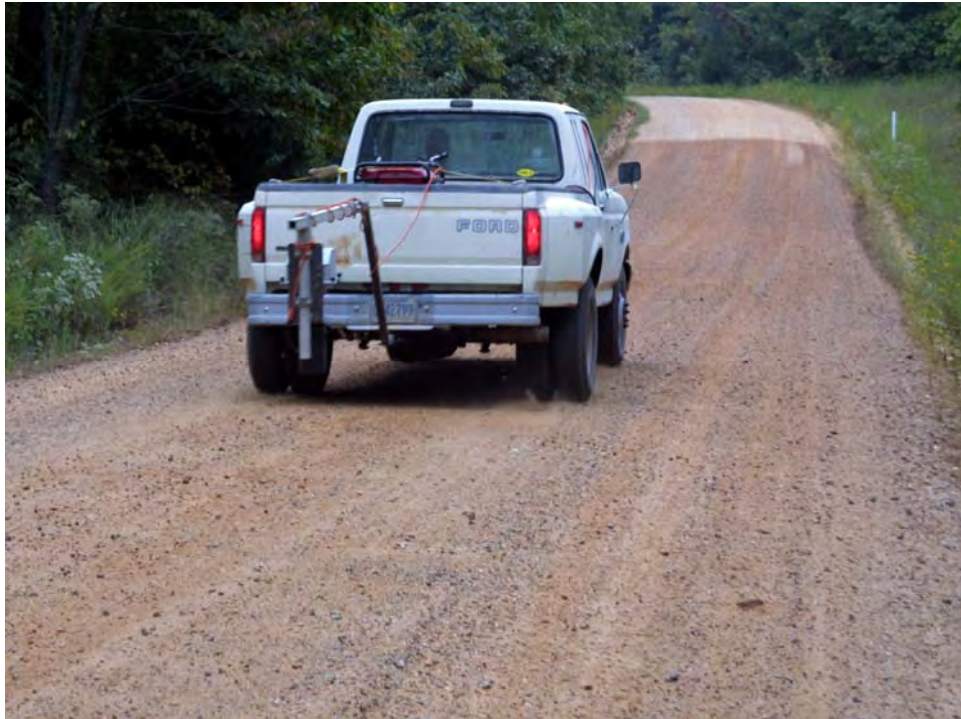
Photo 14. Section 13 after topical application of calcium chloride (0.4 gsy)

Sections 13 through 17 were designed to test the effect of application procedures on dust palliative performance. They were each constructed using topical applications of 0.4 gsy after an initial prewet with 0.4 gsy of water. Two polymer emulsions, one calcium chloride solution, and one synthetic fluid were chosen for these sections, along with one section treated with only water for comparison. Section 13 was first prewet with 0.4 gsy of water and then sprayed with 0.4 gsy of a 38 percent by weight solution of calcium chloride. The section had a rough surface with potholes and scattered loose aggregate covering the entire area. The calcium chloride produced a significant color change to the section and provided visual evidence of its location (Photo 14).

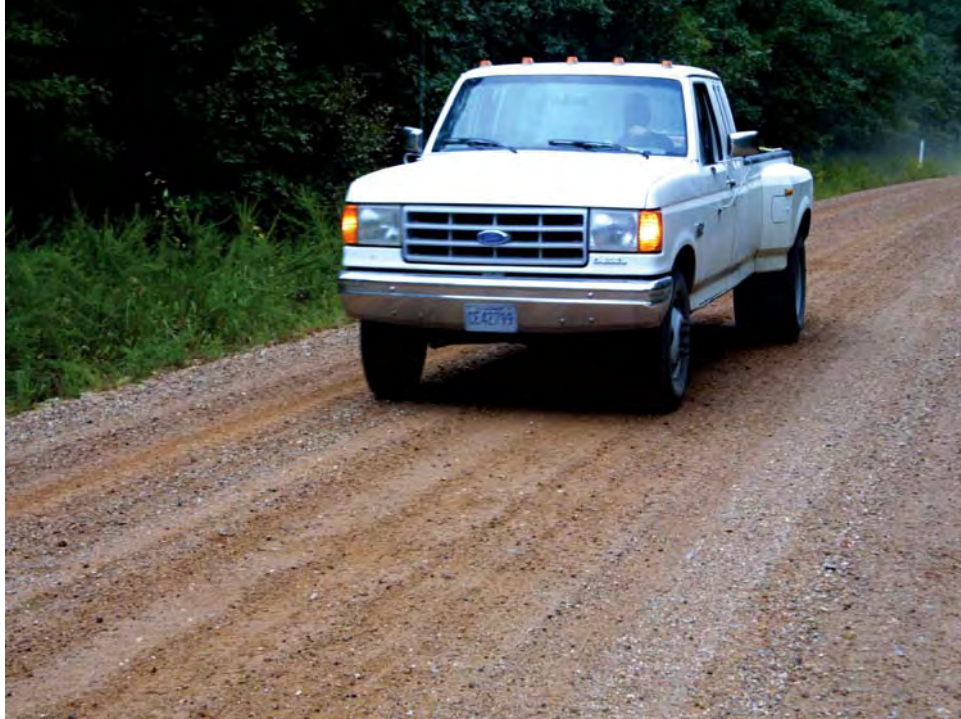
Photo 15. Section 14 after topical application of Durasoil® (0.4 gsy)

Section 14 was treated with a topical application of Durasoil®. It was first prewet with 0.4 gsy of water and then sprayed with 0.4 gsy of Durasoil®. The section had some densification in the wheel paths and scattered loose gravel over 60 to 70 percent of the surface. The Durasoil® produced a significant color change to the section and provided visual evidence of its location (Photo 15).

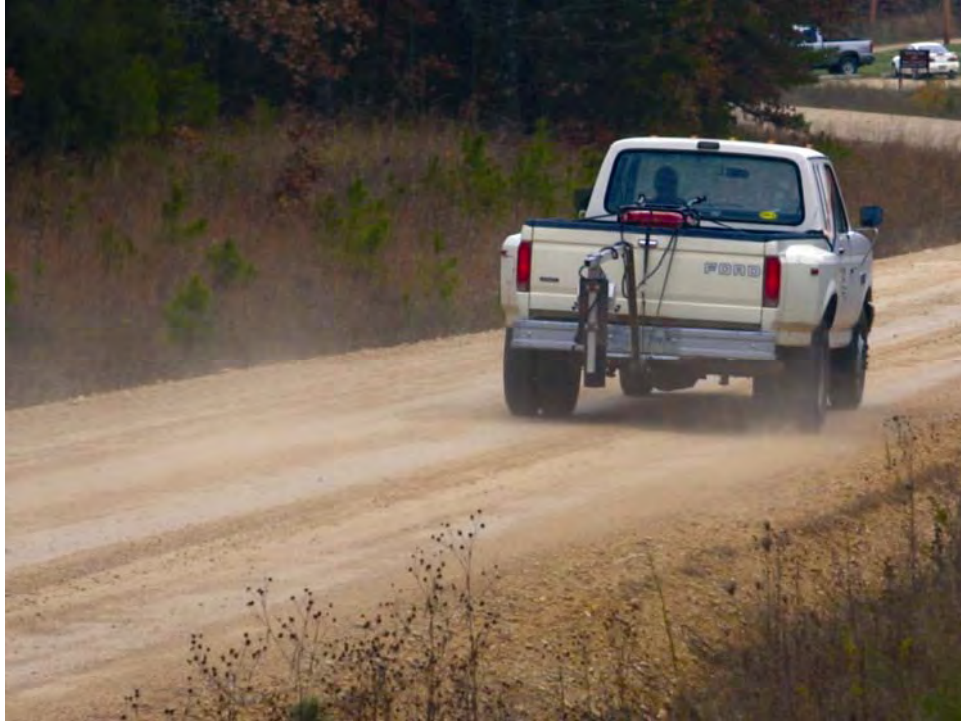
Photo 19. Light dust produced on section 3 (M10 + 50® 0.8 gsy admix) during 30-day evaluation

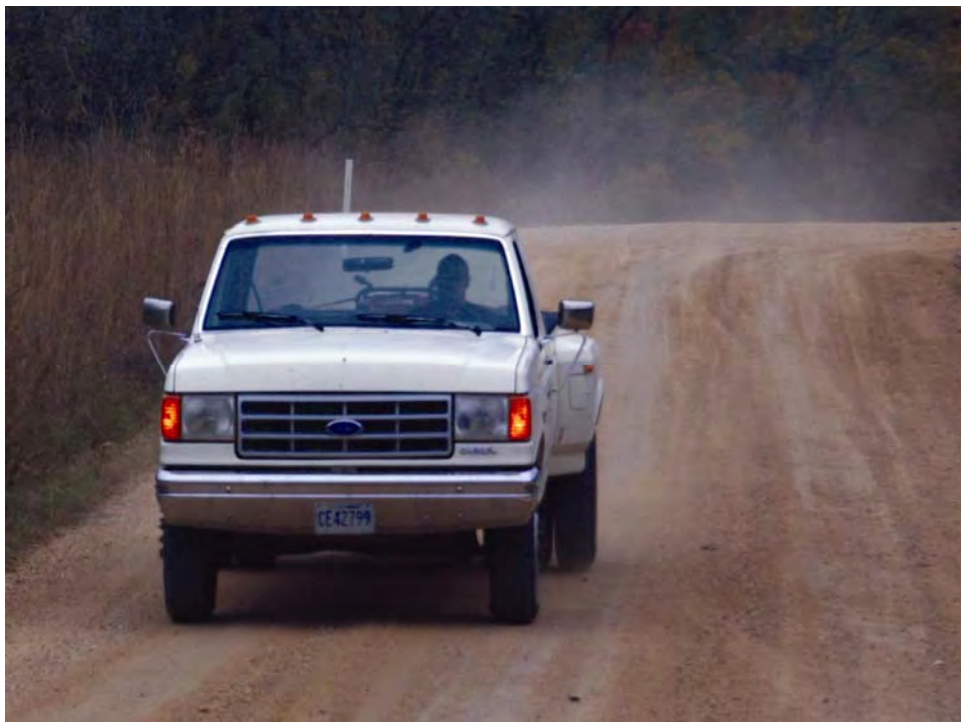
Photo 20. Light dust produced on section 4 (Soil Sement® 0.8 gsy admix) during 30-day evaluation

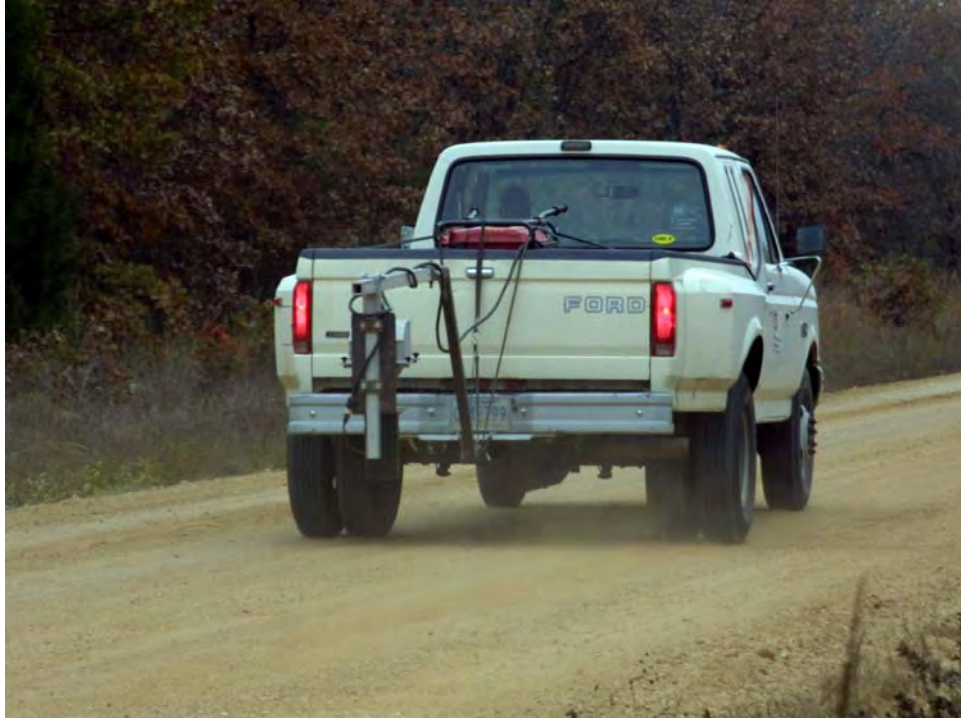
Photo 21. Excellent dust reduction on section 5 (Surtac® 0.8 gsy admix) during 30-day evaluation

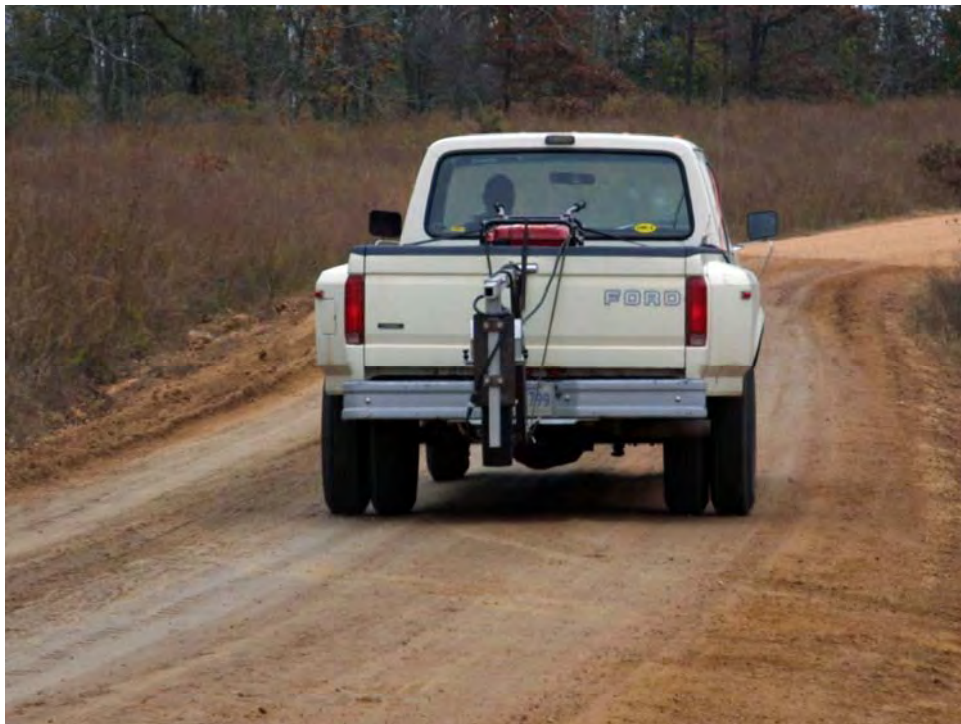
Photo 22. Absence of dust on section 6 (calcium chloride 0.8 gsy admix) during 30-day evaluation

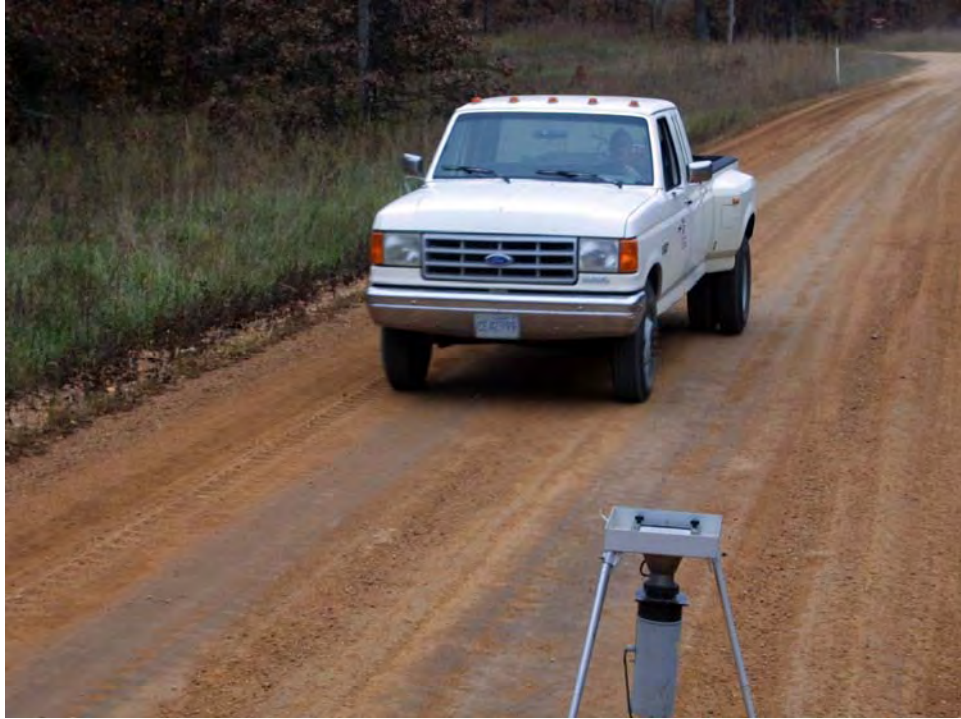
Photo 23. Absence of dust on section 7 (Durasoil® 0.8 gsy admix) during 30-day evaluation

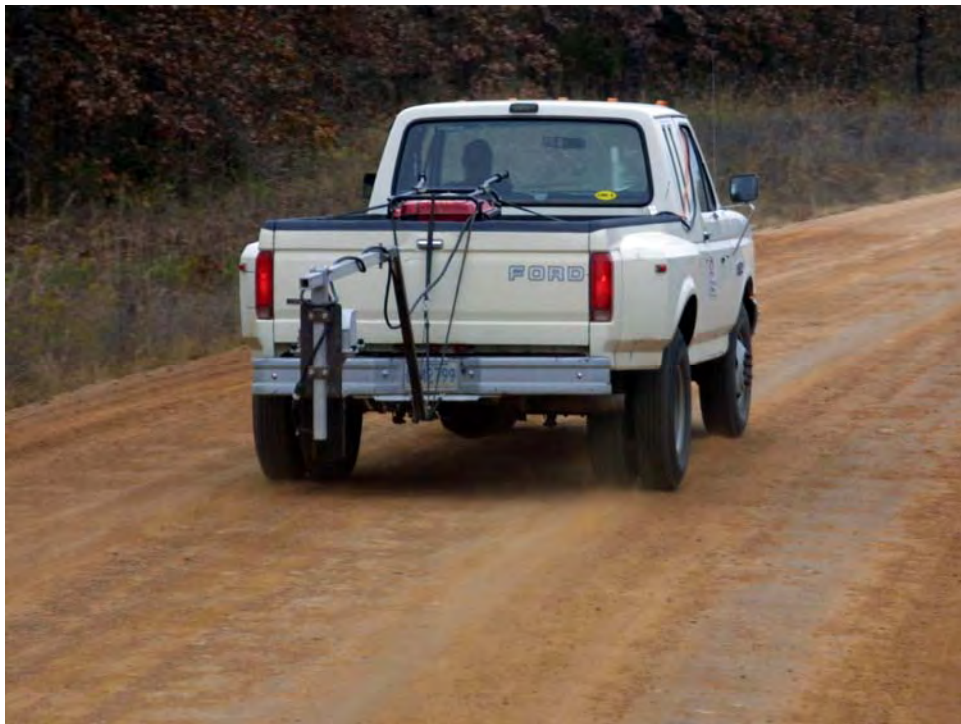
Photo 24. Absence of dust on section 8 (Envirokleen® 0.8 gsy admix) during 30-day evaluation

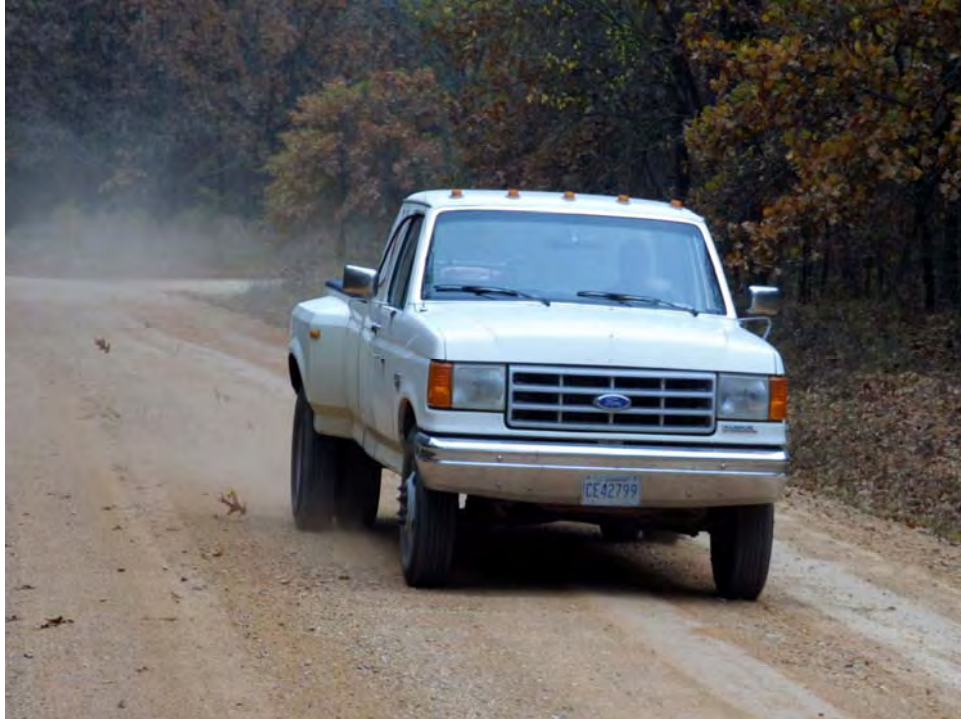
Photo 25. Dust generated on section 10 (Soiltac® 0.4 gsy admix) during 30-day evaluation

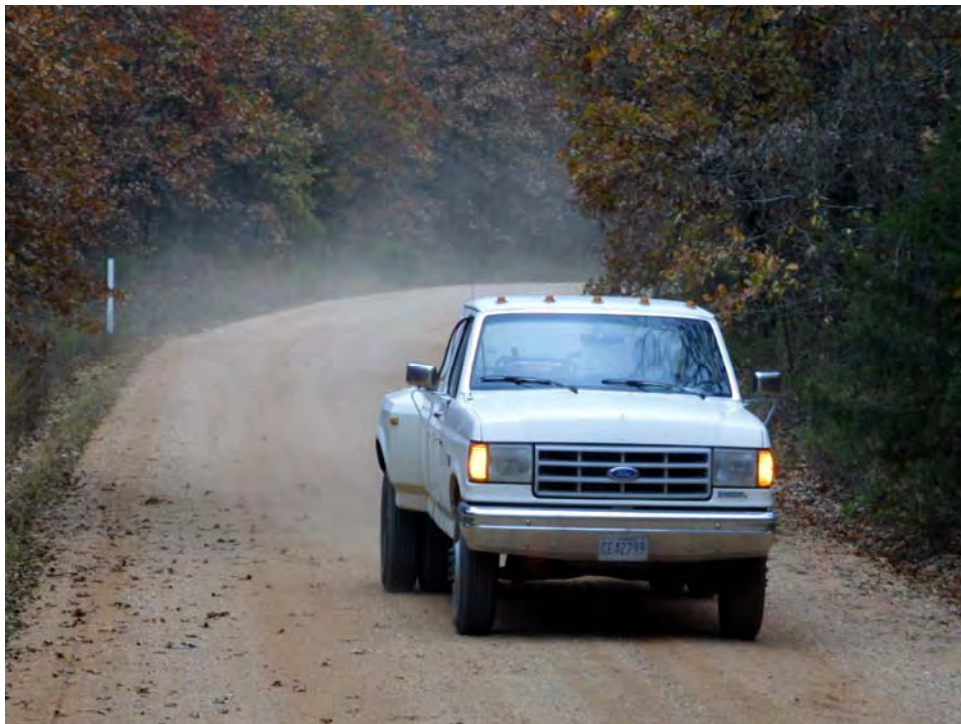
Photo 26. Dust generated on section 11 (Envirotac II® 0.4 gsy admix) during 30-day evaluation

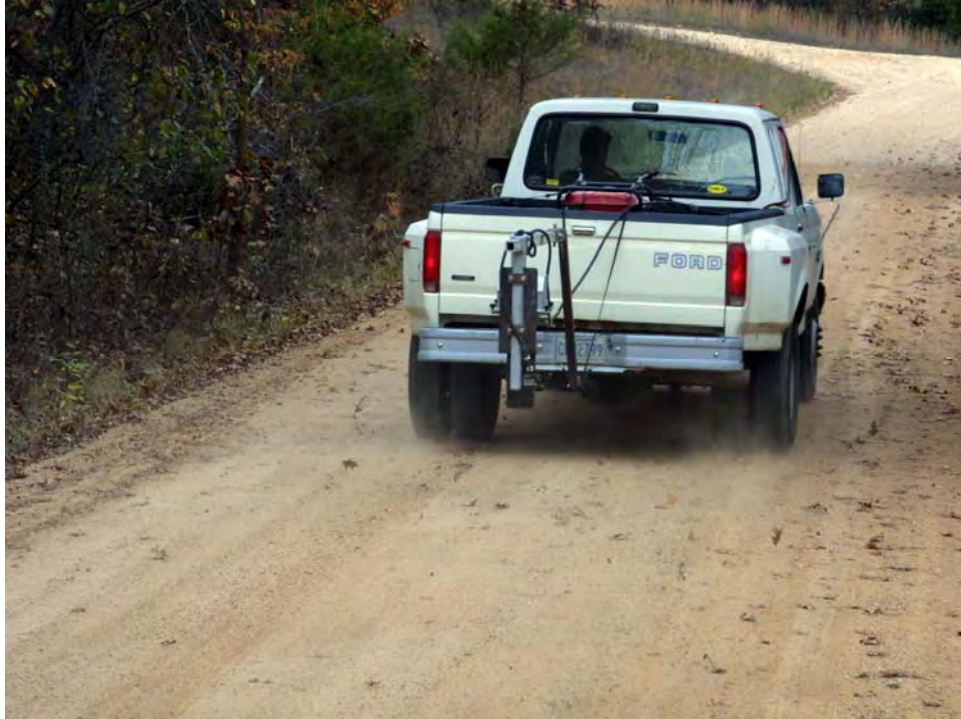
Photo 27. Dust generated on section 12 (Surtac® 0.4 gsy admix) during 30-day evaluation

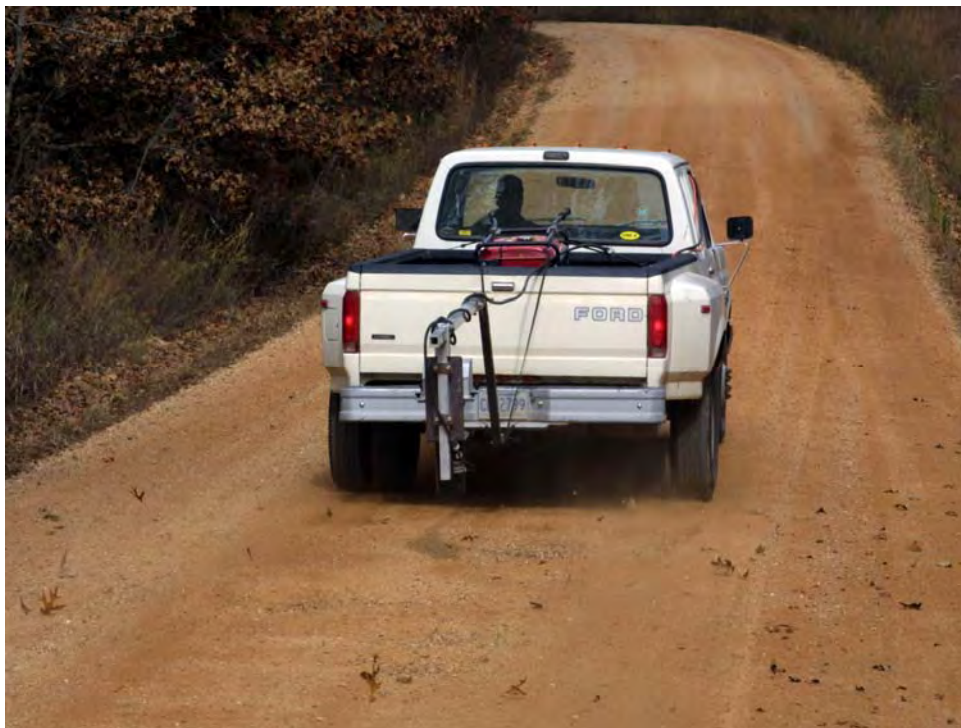
Photo 28. Dust generated on section 13 (Calcium Chloride 0.4 gsy topical) during 30-day evaluation

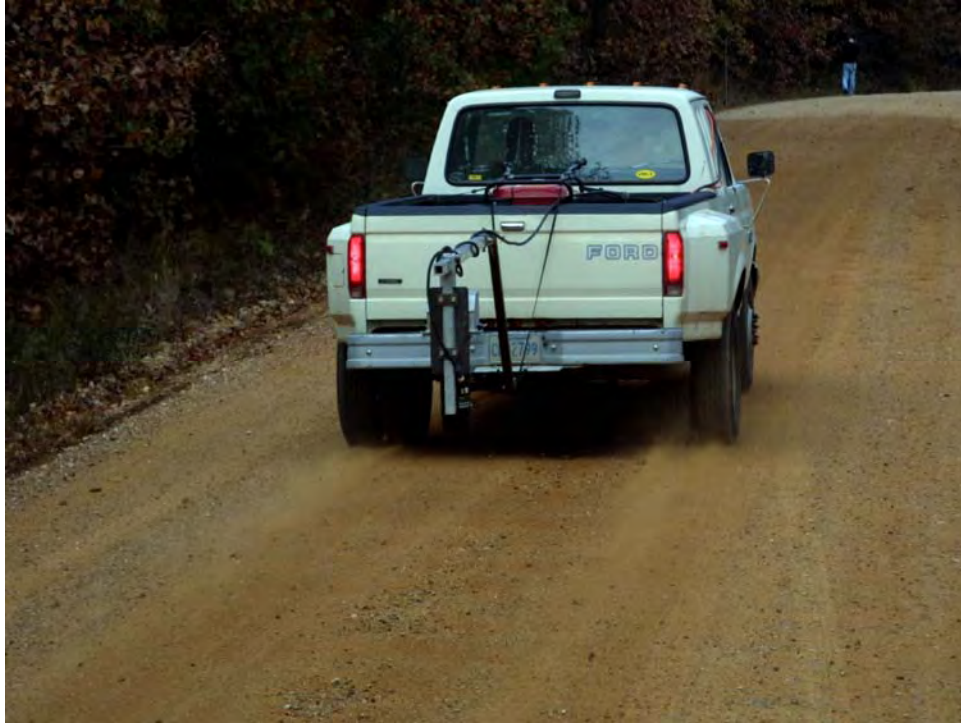
Photo 29. Dust generated on section 14 (Durasoil® 0.4 gsy topical) during 30-day evaluation

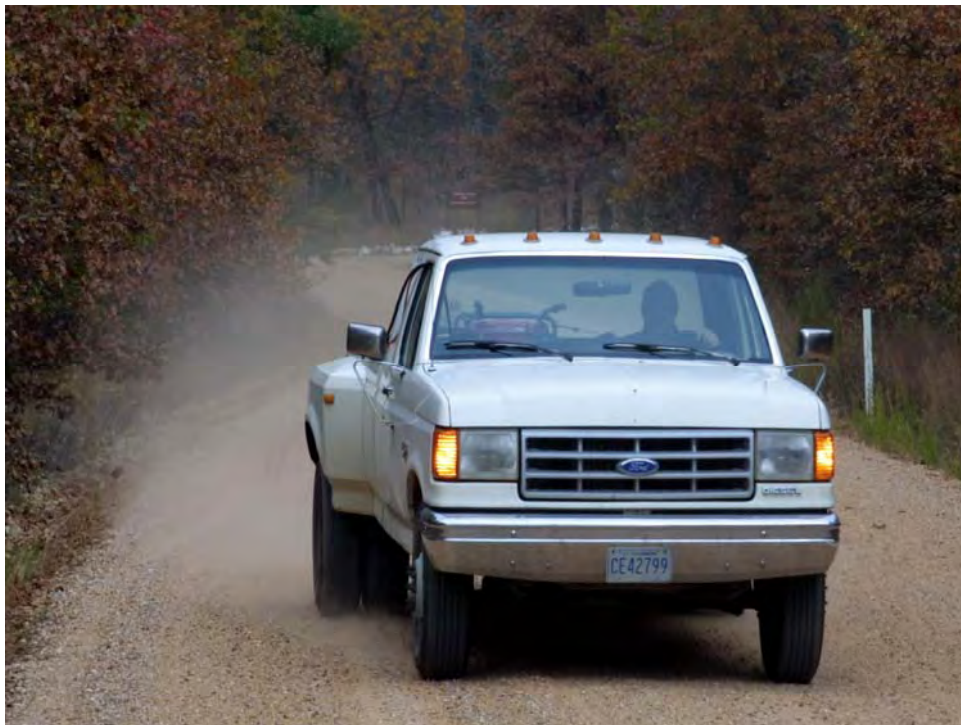
Photo 30. Dust generated on section 15 (Envirotac II® 0.4 gsy topical) during 30-day evaluation

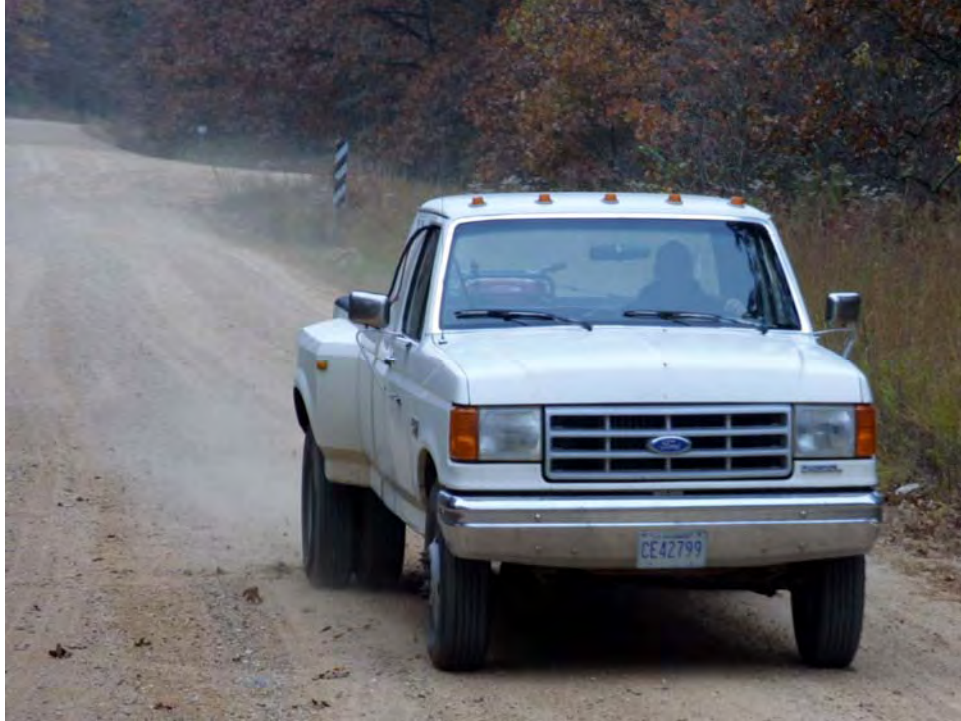
Photo 31. Dust generated on section 16 (water 0.4 gsy topical) during 30-day evaluation

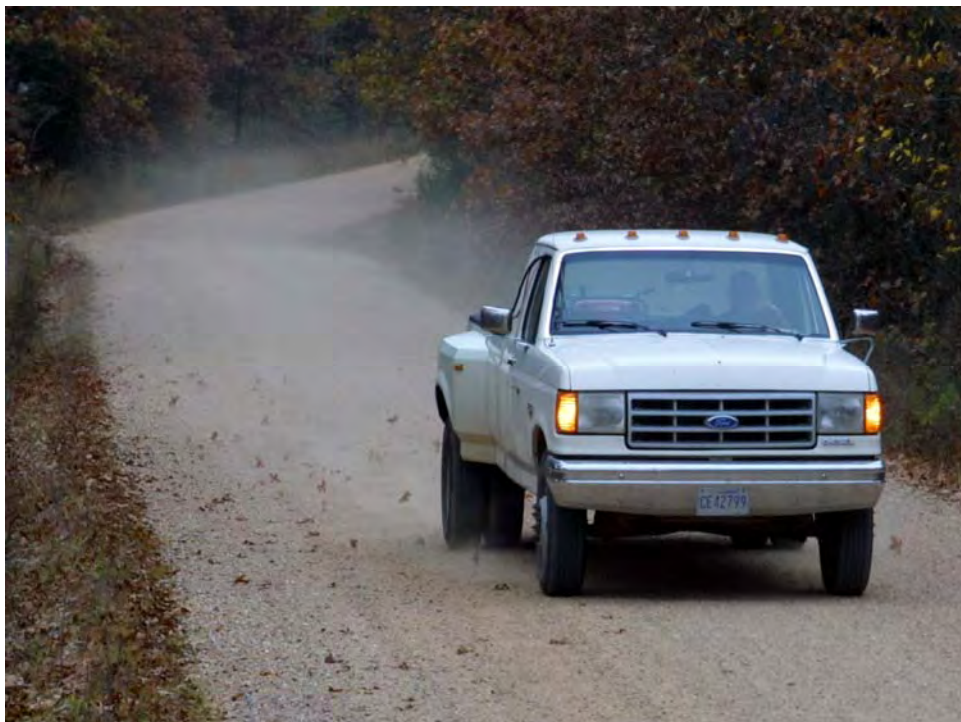
Photo 32. Dust generated on section 17 (Soiltac® 0.4 gsy topical) during 30-day evaluation

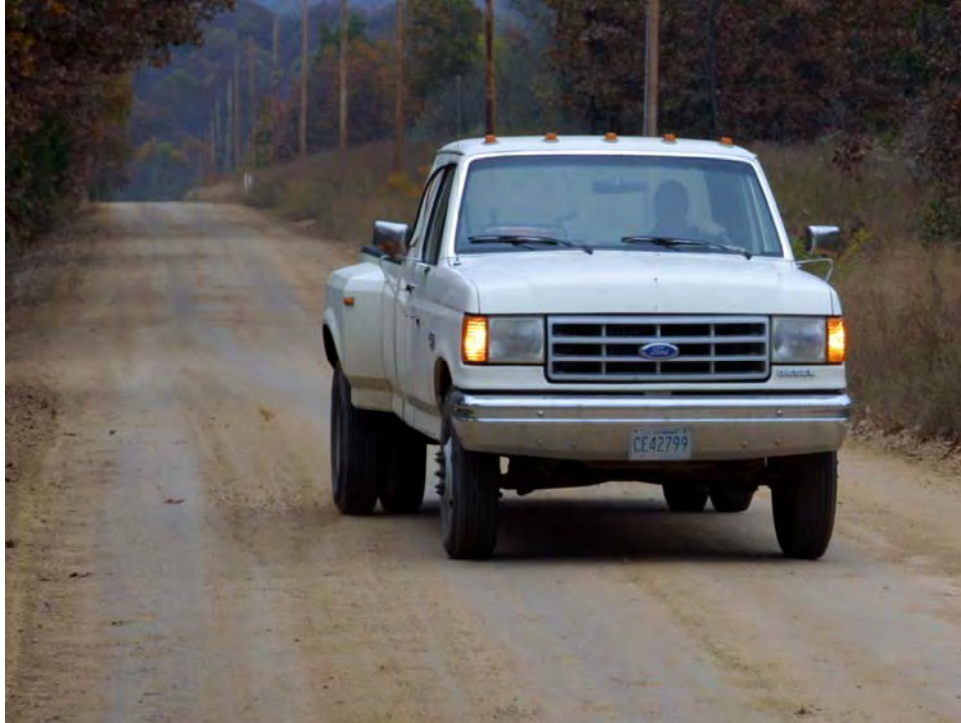
Photo 33. Dust generated on section 18 during 30-day evaluation

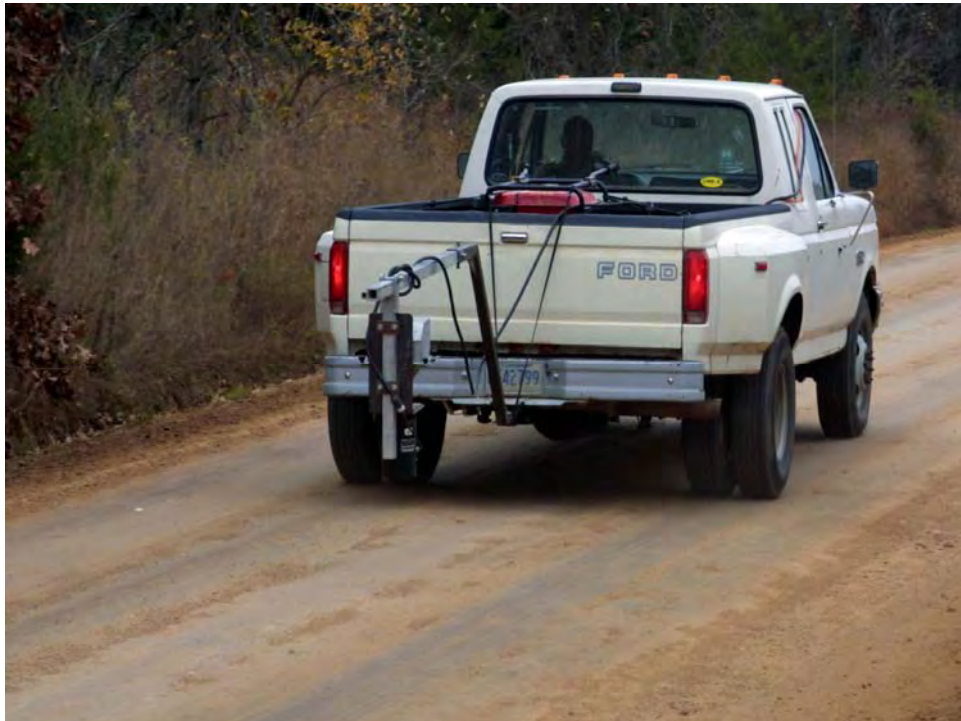
Photo 34. Dust generated on section 19 (Durasoil® 0.8 gsy topical) during 30-day evaluation

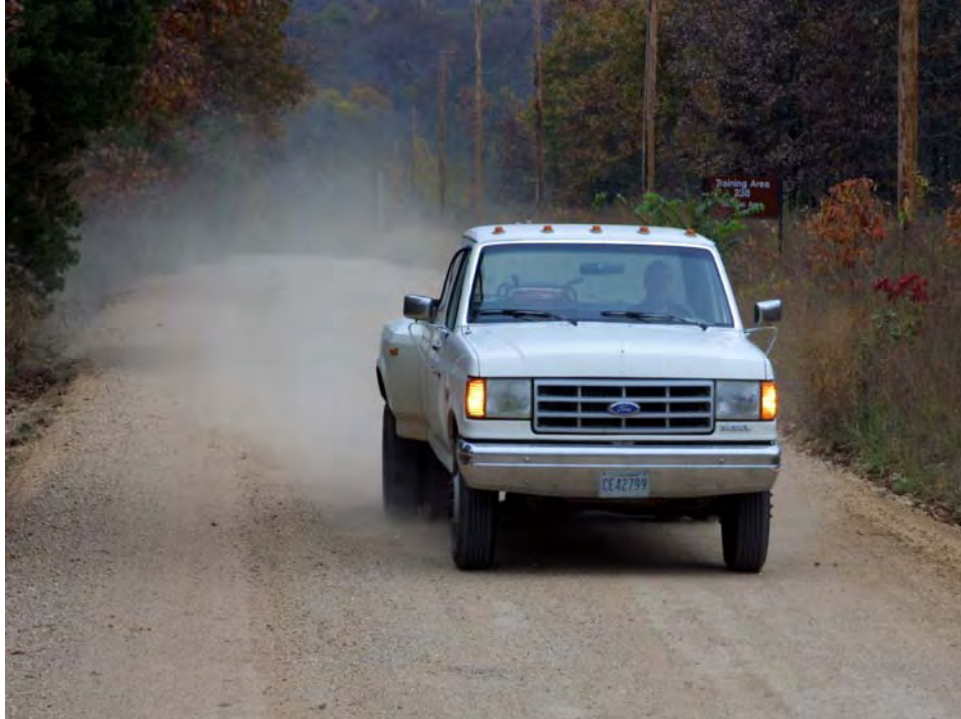
Photo 35. Dust generated on section 20 (Envirotac II® 0.8 gsy topical) during 30-day evaluation
