## **Dust Abatement Methods for Lines- of-Communication and Base Camps in Temperate Climates**

John F. Rushing, Vernon M. Moore, Jeb S. Tingle,  
Quint Mason, and Tim McCaffrey

October 2005

Final report

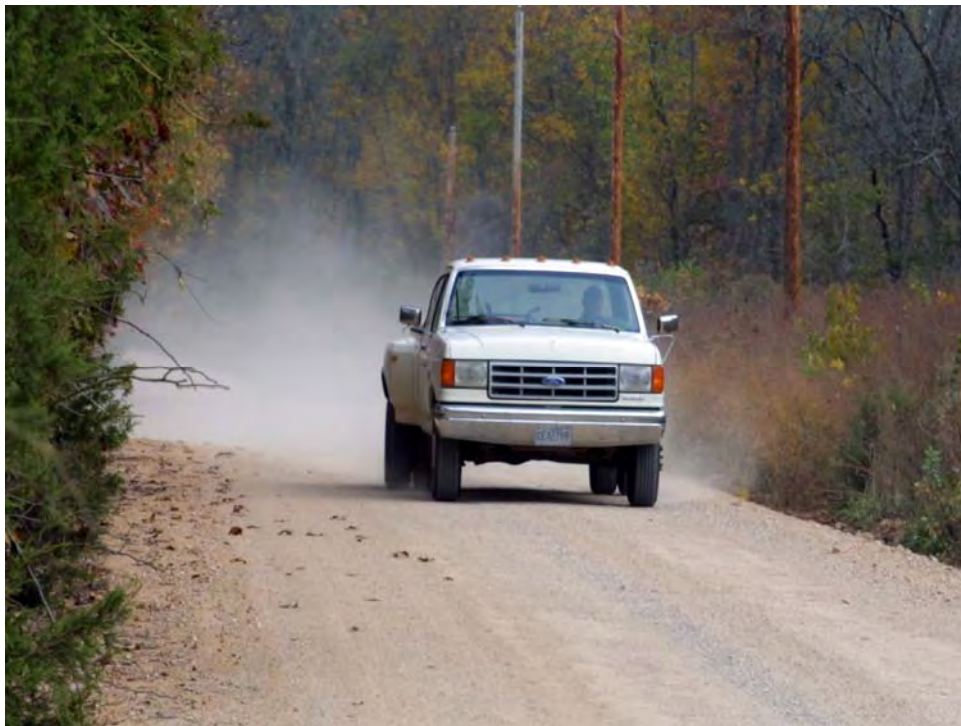
Photo 36. Dust generated on section 24 (water 0.8 gsy topical) during 30-day evaluation

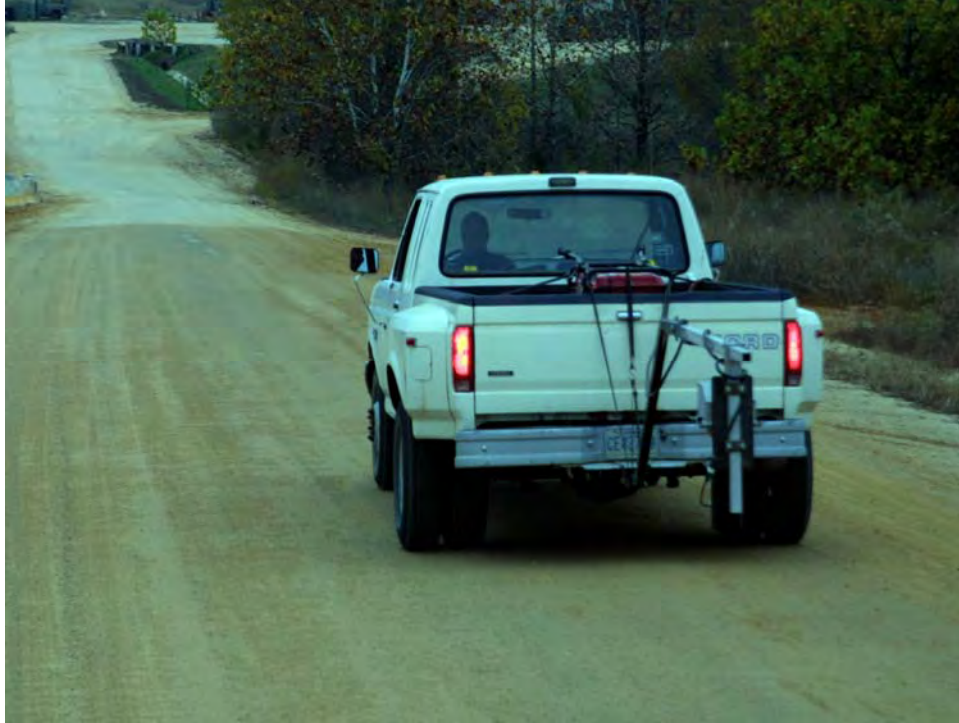
Photo 37. Dust generated on section 21 (calcium chloride 0.4 gsy topical) during 30-day evaluation

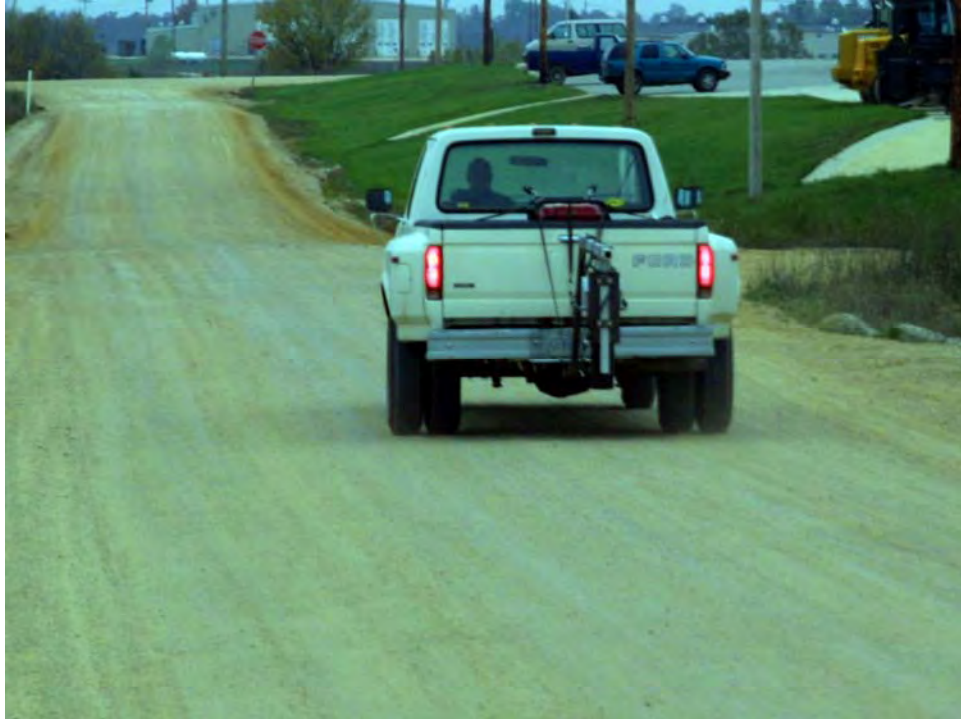
Photo 39. Dust generated on section 23 (Surtac® 0.4 gsy topical) during 30-day evaluation

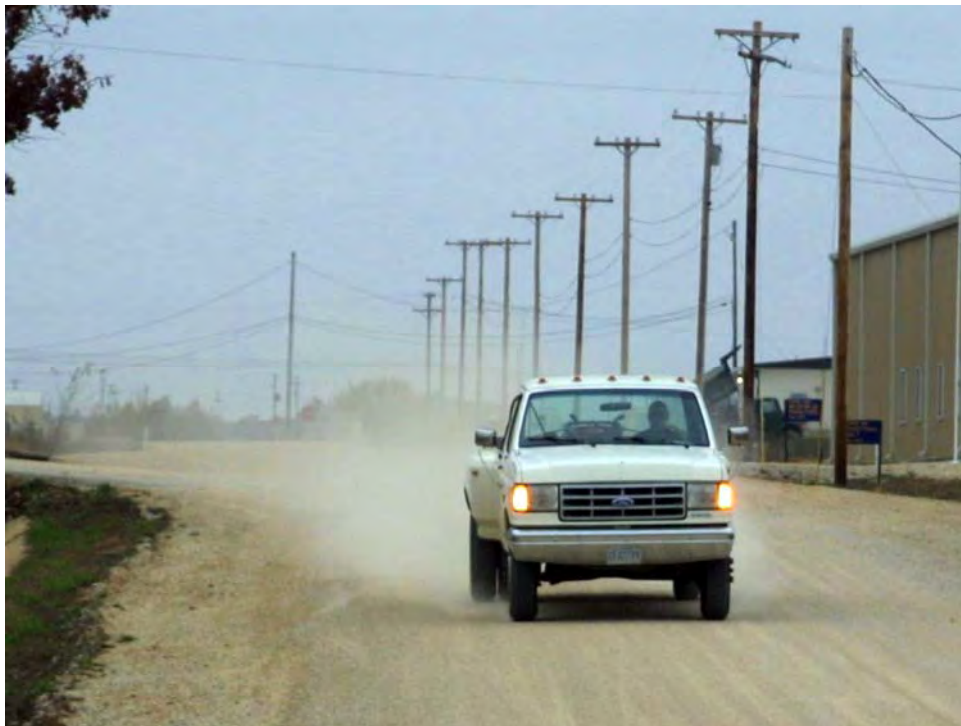
Photo 40. Dust generated on section 25 (Envirotac II® 0.4 gsy topical) during 30-day evaluation

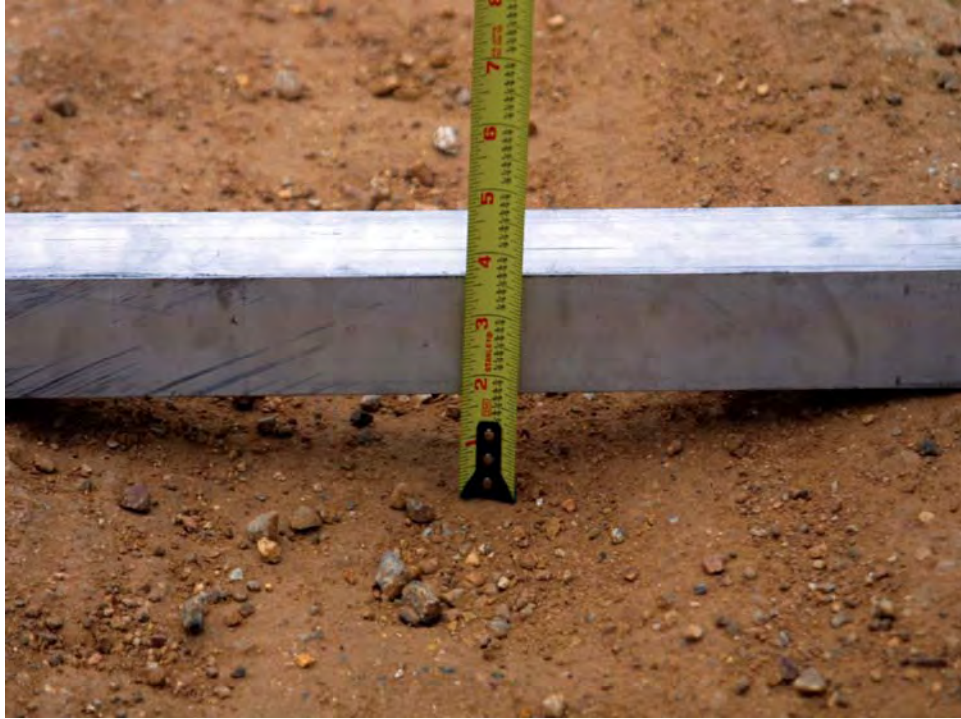
Photo 41. Rutting and dislodged aggregate in surface of section 1

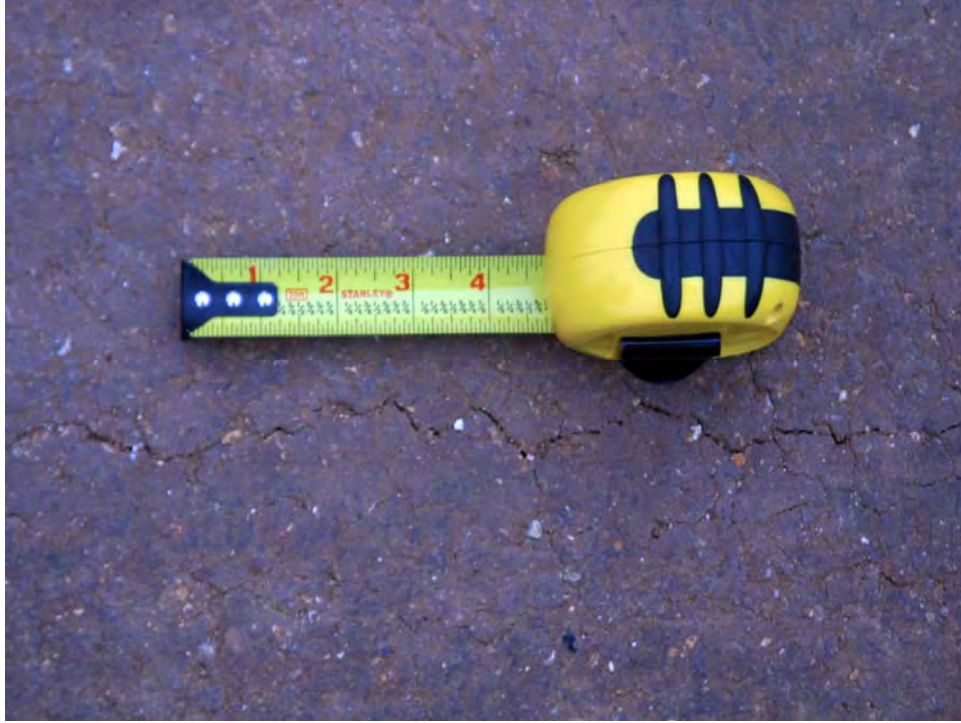
Photo 43. Longitudinal cracking in surface of section 2

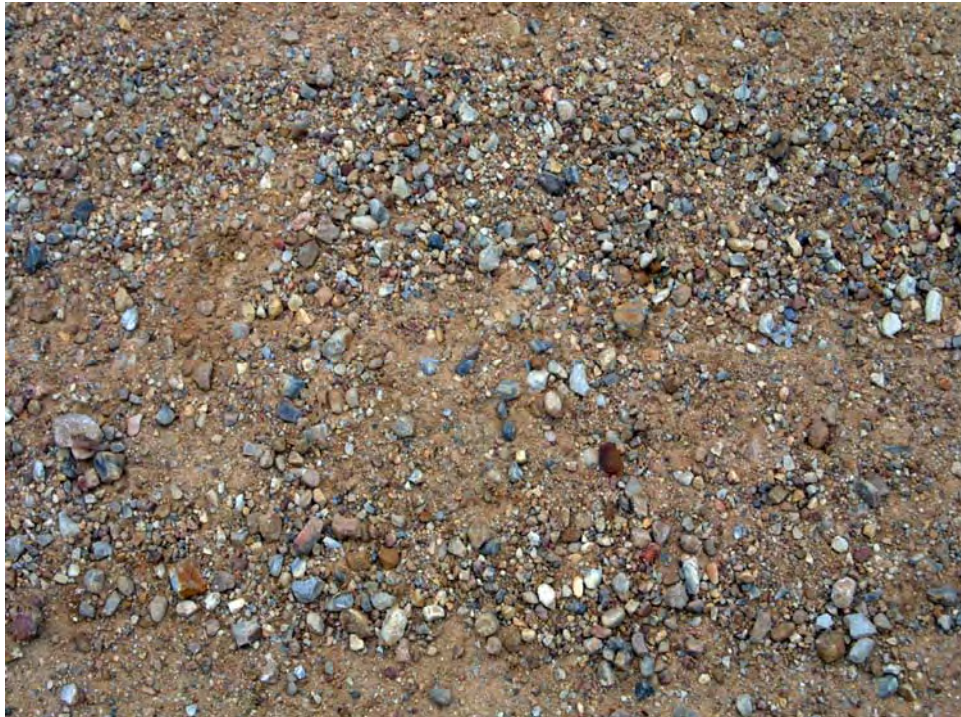
Photo 44. Aggregate raveling on surface of section 11

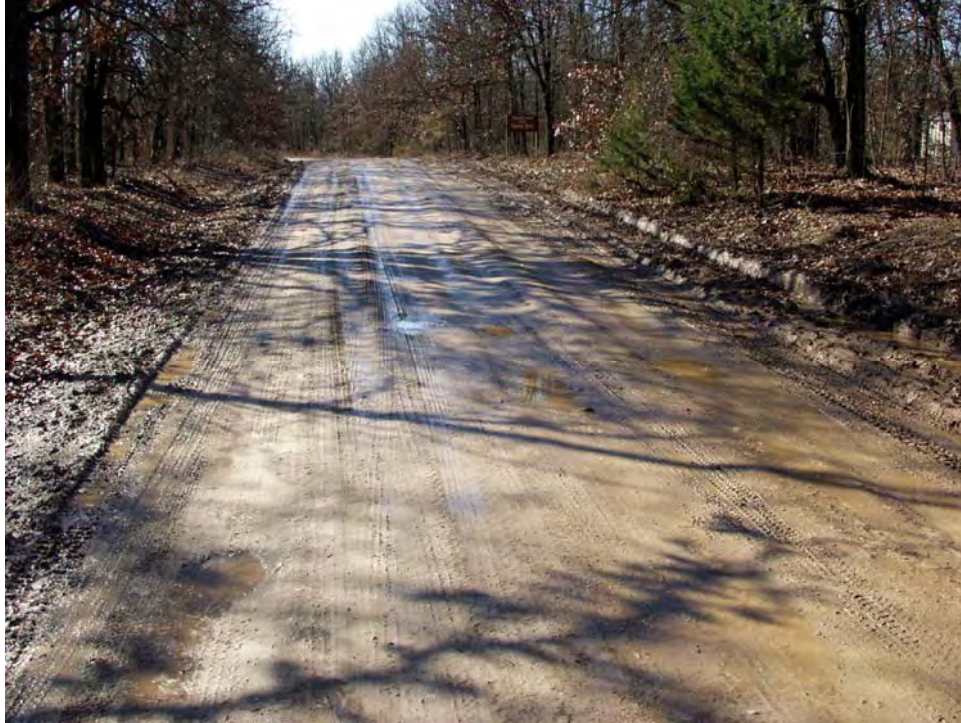
Photo 61. Section 9 (water 0.8 gsy admix) - medium improper cross section

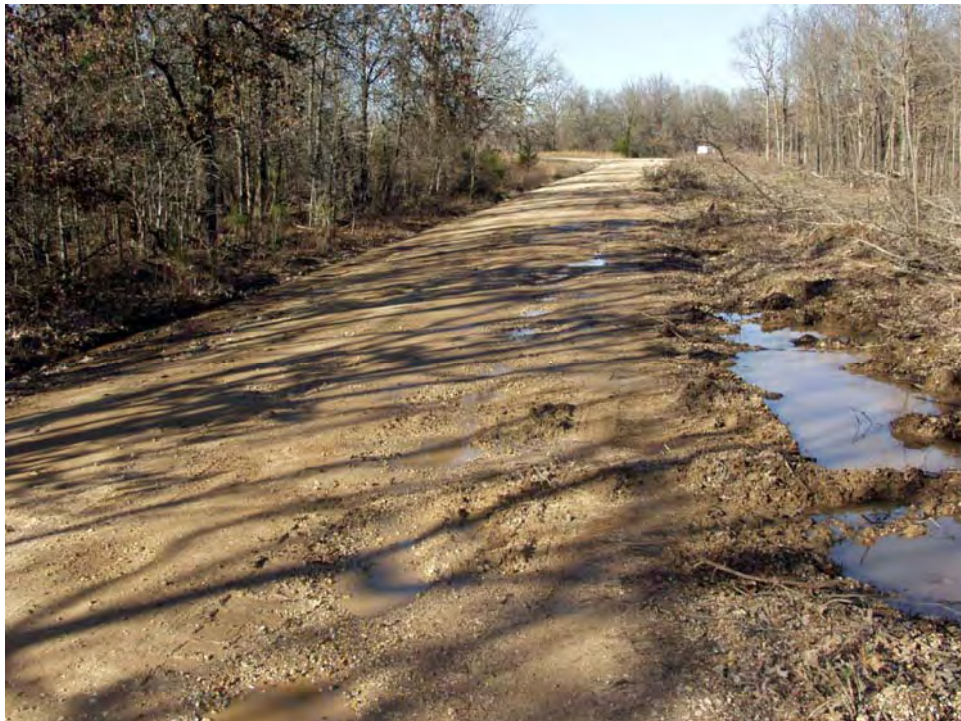
Photo 62. Section 12 (Surtac® 0.4 gsy admix) - inadequate roadside drainage

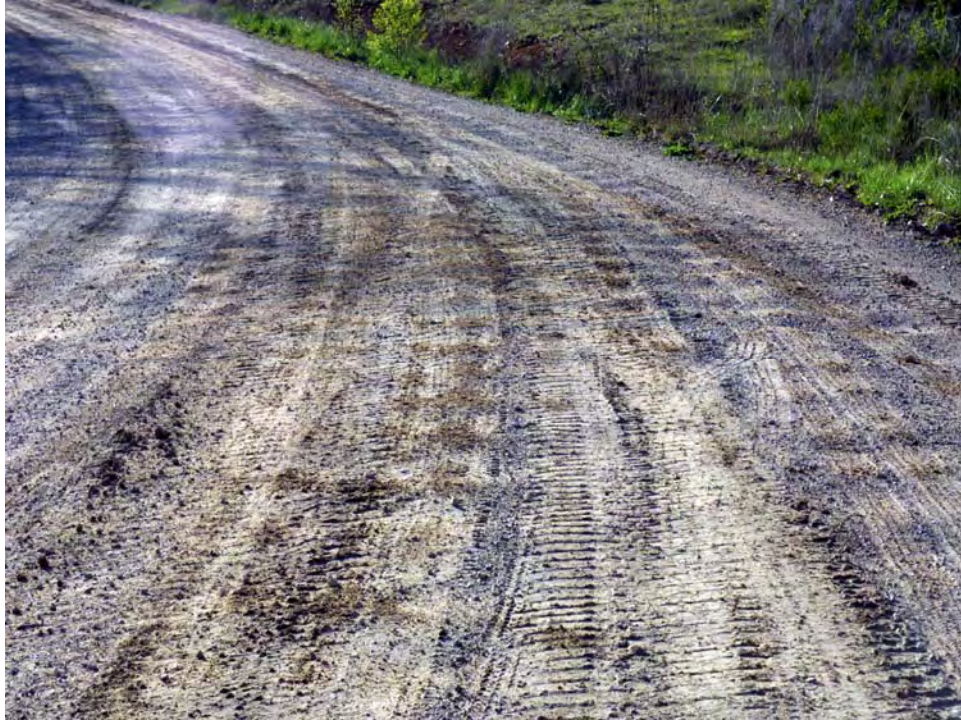
Photo 63. Corrugations along curve in untreated area of road

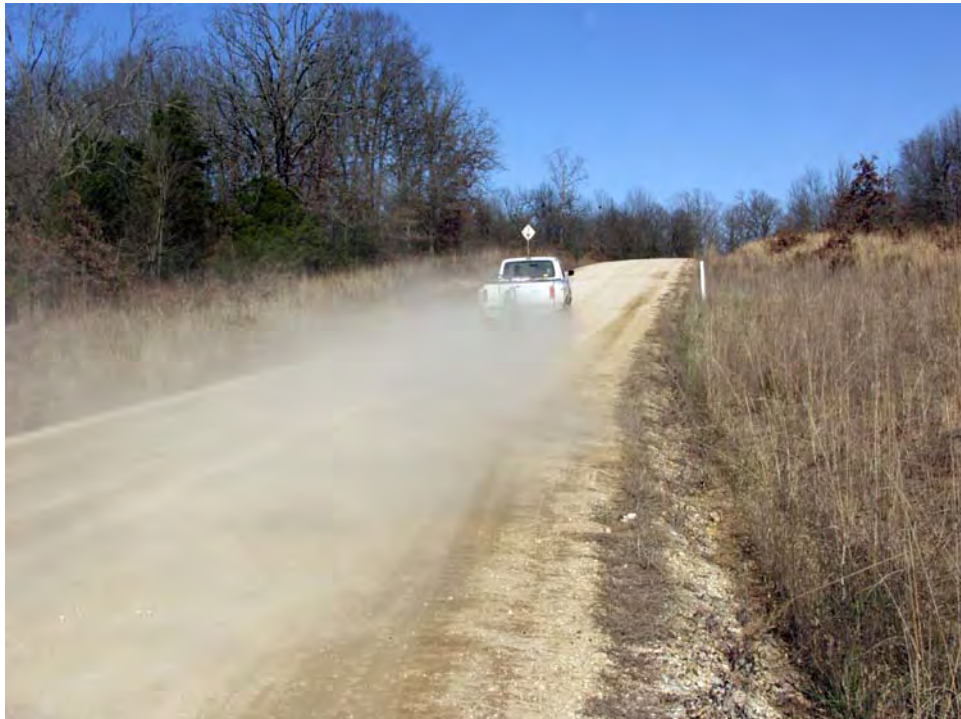
Photo 64. Section 4 (Soil~Sement® 0.8 gsy admix) – medium dust

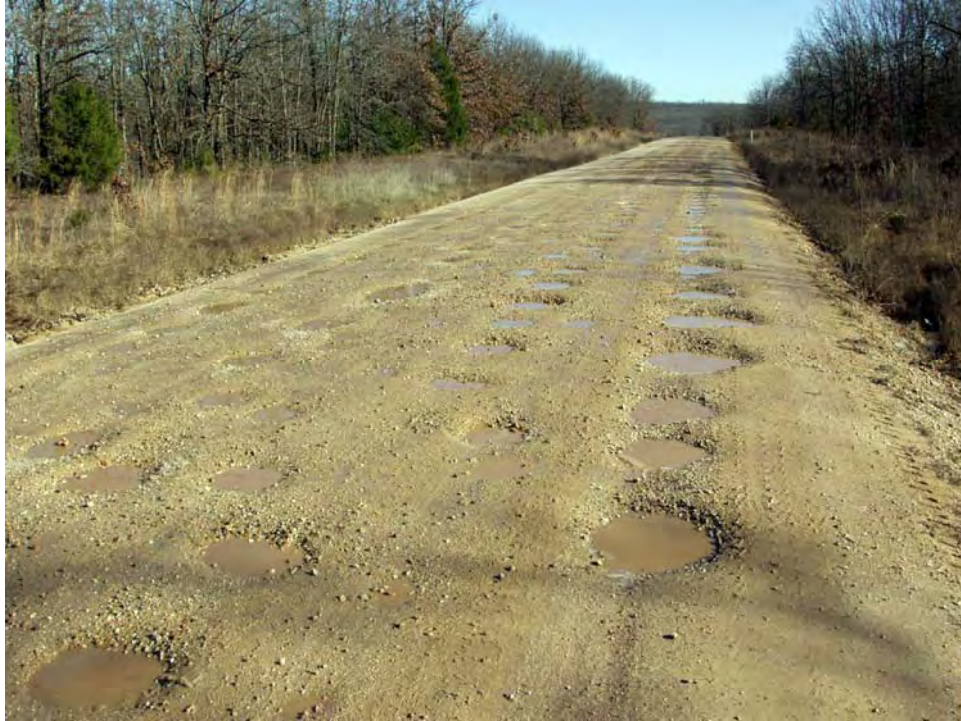
Photo 65. Section 5 (Surtac® 0.8 gsy admix) - low and medium potholes

- j. Frequent exposure to precipitation is detrimental to the performance of Surtac®. The product did not provide moisture resistance and produced an enhanced deterioration rate of the road surface when placed with the admix procedure.

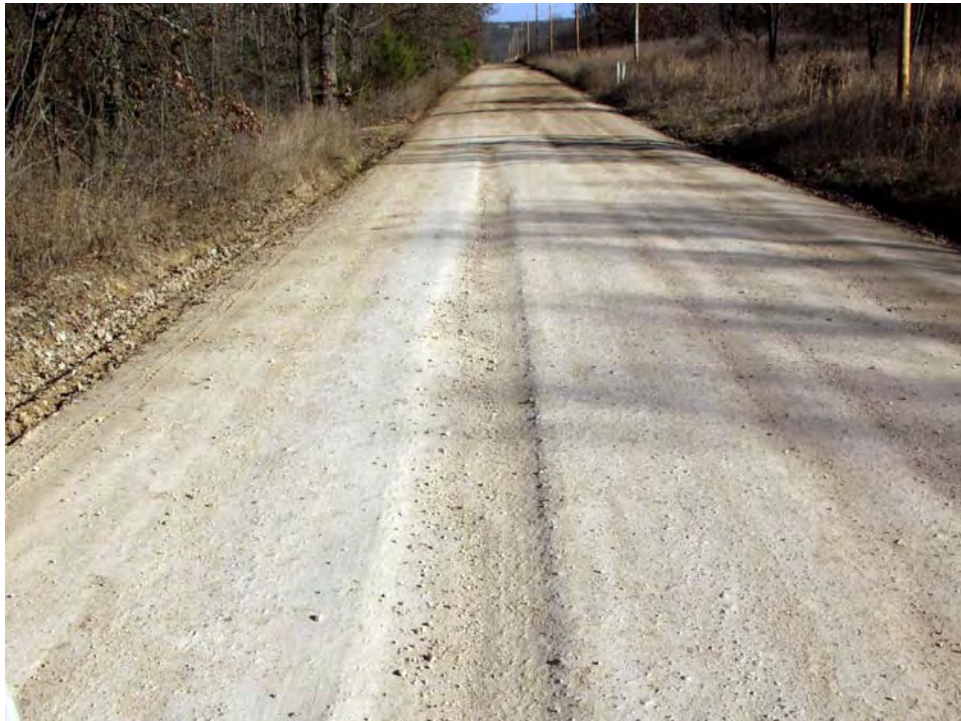
Photo 66. Section 1 (Envirotac II® 0.8 gsy admix) - low rutting
