D Y N A M I C C O R R O S I O N T E S T I N G
" C O P P E R L O K " C O A T I N G S Y S T E M

April 1985

U.S. DEPARTMENT OF TRANSPORTATION
MARITIME ADMINISTRATION

IN COOPERATION WITH
AVONDALE SHIPYARDS; NEW ORLEANS, LOUISIANA

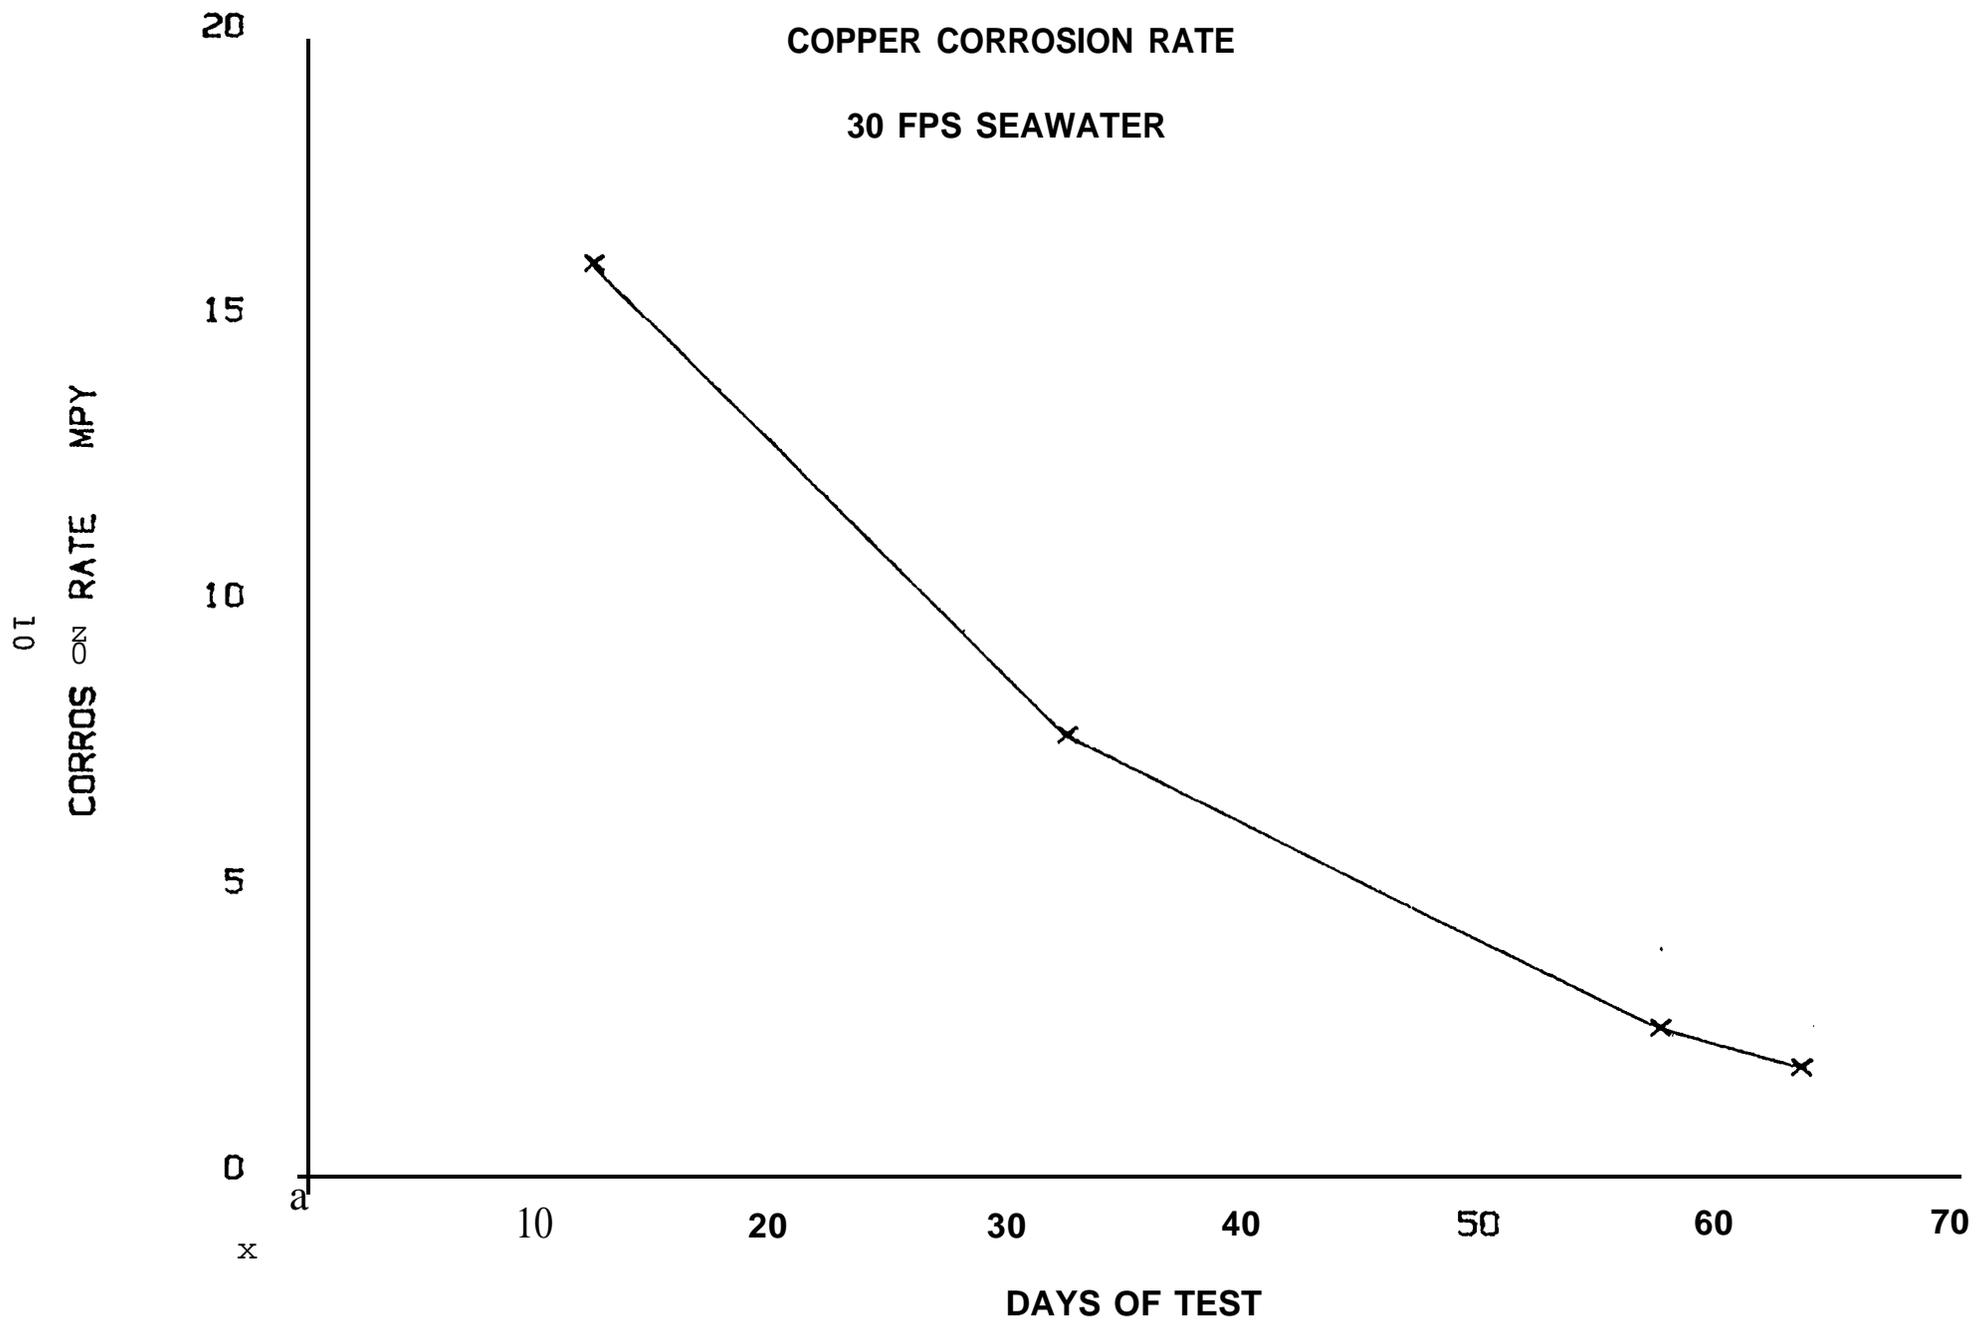
Figure 6.

Figure 6 shows corrosion rates determined at different times during the test run. These rates are calculated from polarization resistance measurements as described in Appendix I. All plotted values are the average of two successive polarization resistance measurements. The initial value, ten days into the test run, is 16 mils/year. The final value, after 63 days' exposure, is 1.69 mils/year.

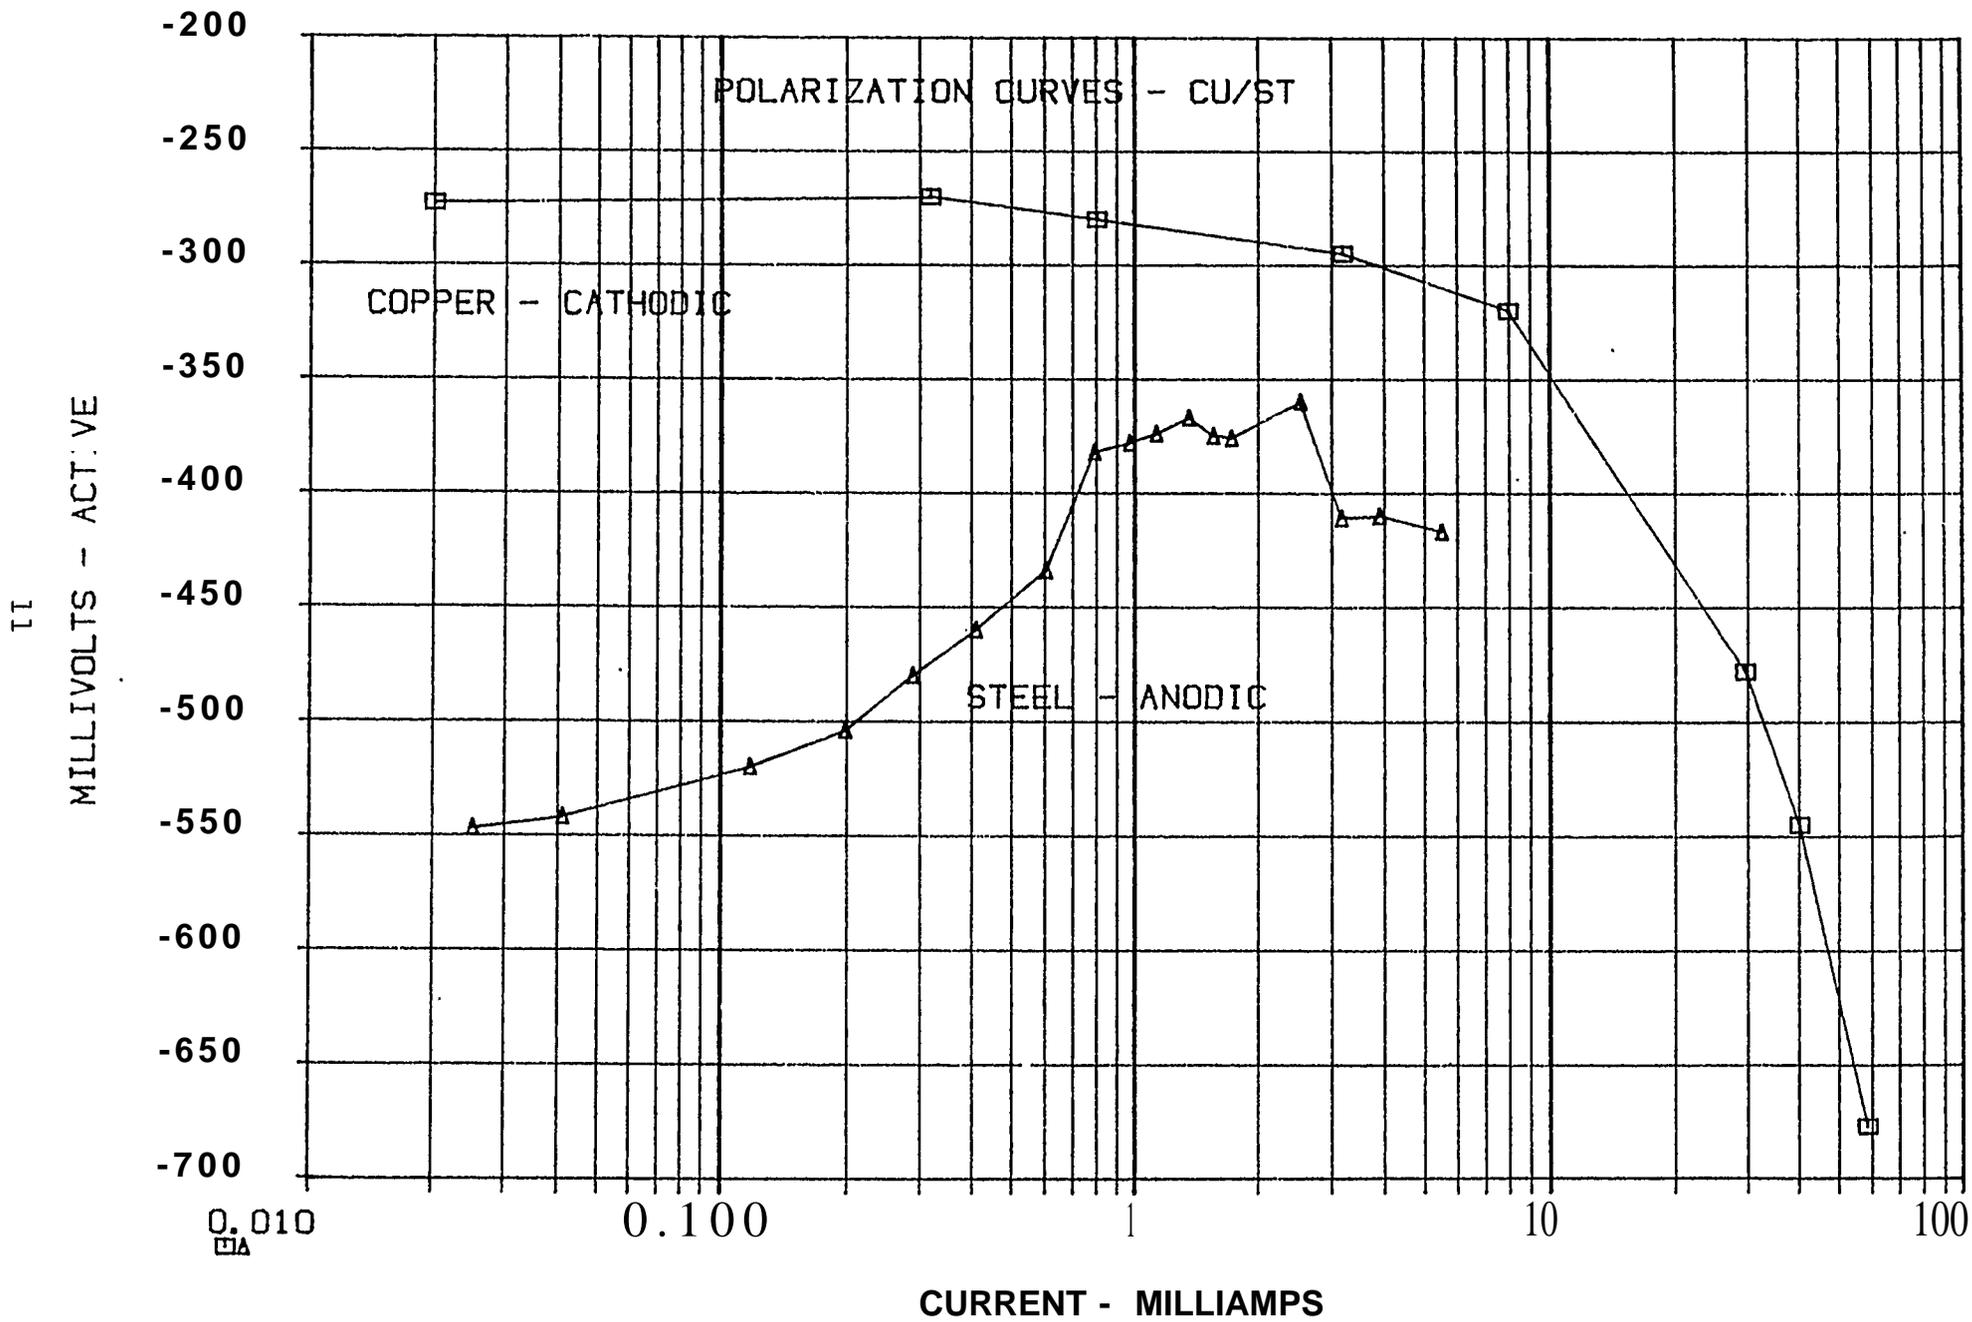
Figure 7.

In order to evaluate this possibility, we conducted further tests to determine the anodic polarization characteristics of the steel substrate at the holiday and the cathodic polarization characteristics of the copper alloy coating. Figure 7 shows the plots of the anodic polarization curve for the steel at the 1/2-inch holiday and the cathodic polarization curve for the copper alloy coating of one of the test panels. The cathodic curve for the copper alloy is typical. The anodic curve for the steel shows an unusual behavior, becoming unstable at values about 1.5 milliamps (1.1 amps/sqft). Supplementary measurements showed that the resistance of the exposed metal to its environment also became unstable above this range, indicating surface film breakdown.
