**EFFECTS OF FREQUENCY AND ENVIRONMENT ON FATIGUE BEHAVIOR
OF AN OXIDE-OXIDE CERAMIC MATRIX COMPOSITE AT 1200°C**

THESIS

AFIT/GAE/ENY/06-J05

AIR FORCE INSTITUTE OF TECHNOLOGY

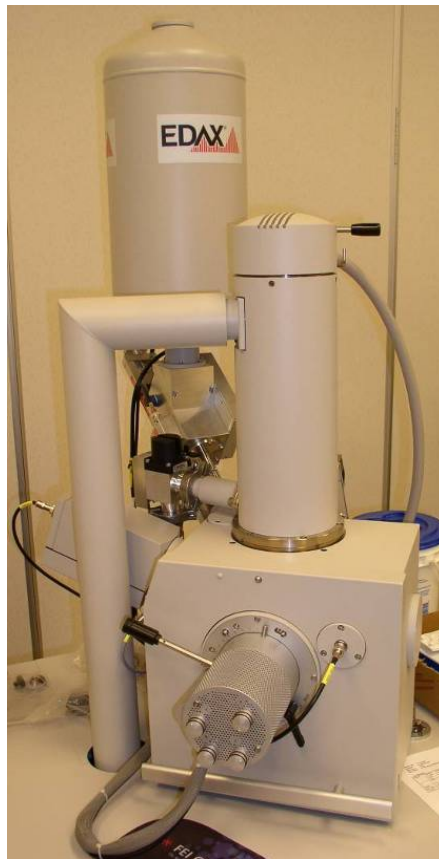
Figure 13. SEM and EDAX equipment.

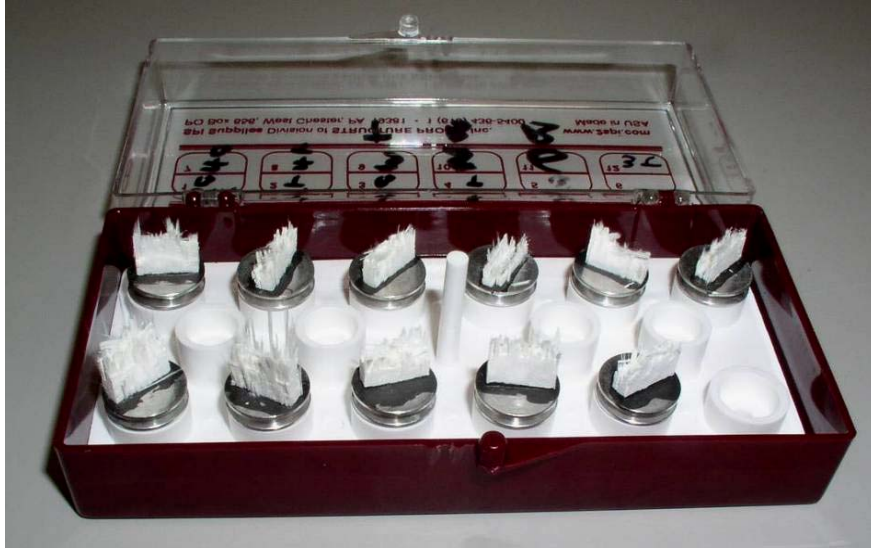
Figure 14. Uncoated N720/A specimens prepared for SEM observation.

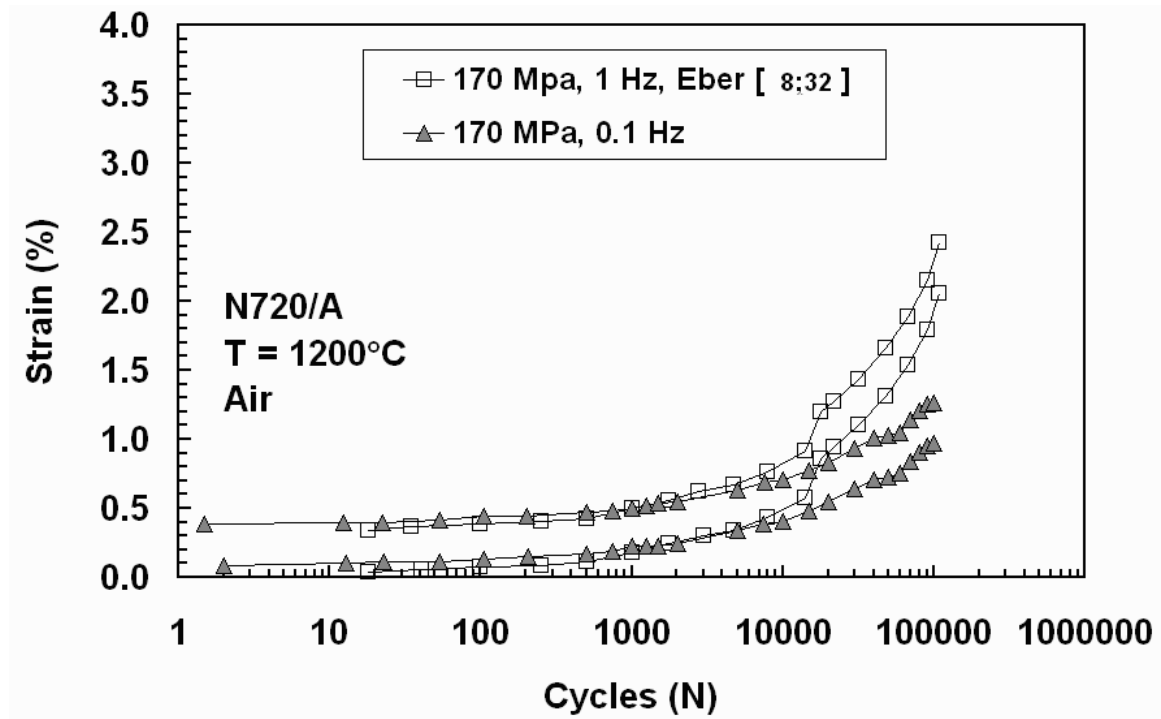
Figure 17. Maximum and minimum strain versus cycle number for fatigue of N720/A in air at 1200°C with maximum stress level of 170 MPa. Data from reference [8:32] is also included.

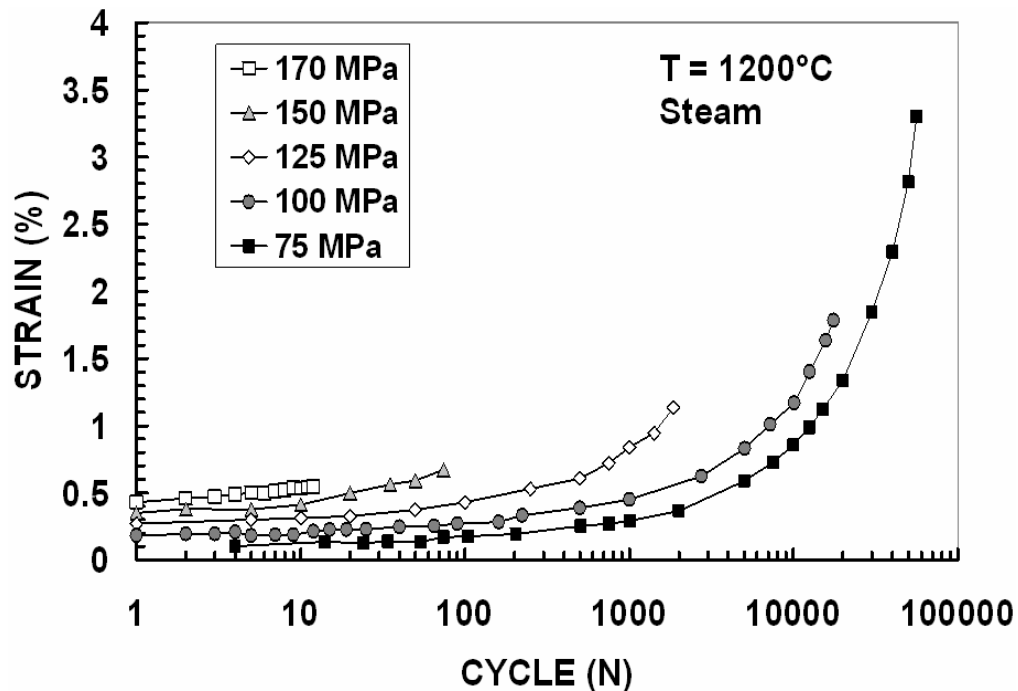
Figure 19. Maximum strain as a function of cycle number for N720/A specimens subjected to fatigue testing in steam at 1200°C with the frequency of 0.1 Hz and maximum stresses of 170, 150, 125, 100, and 75 MPa.

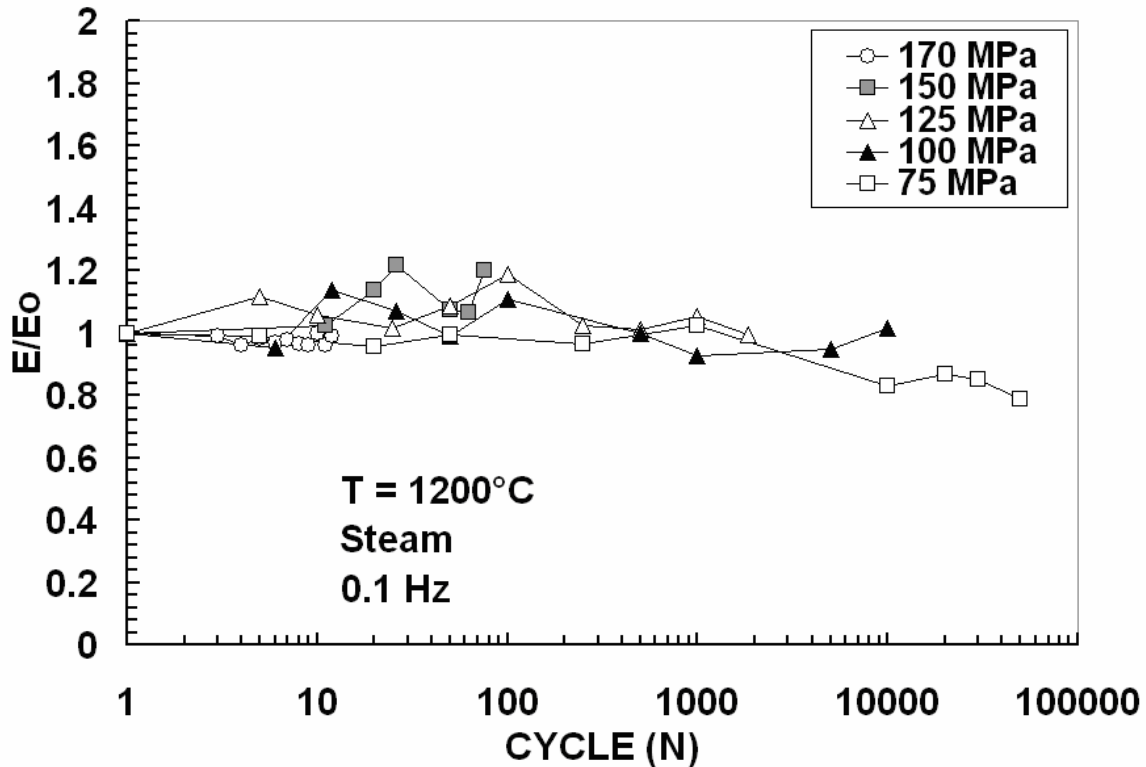
Figure 20. Normalized stiffness as a function of cycle number for N720/A specimens subjected to fatigue testing in steam at 1200°C with the frequency of 0.1 Hz and maximum stresses of 170, 150, 125, 100, and 75 MPa.

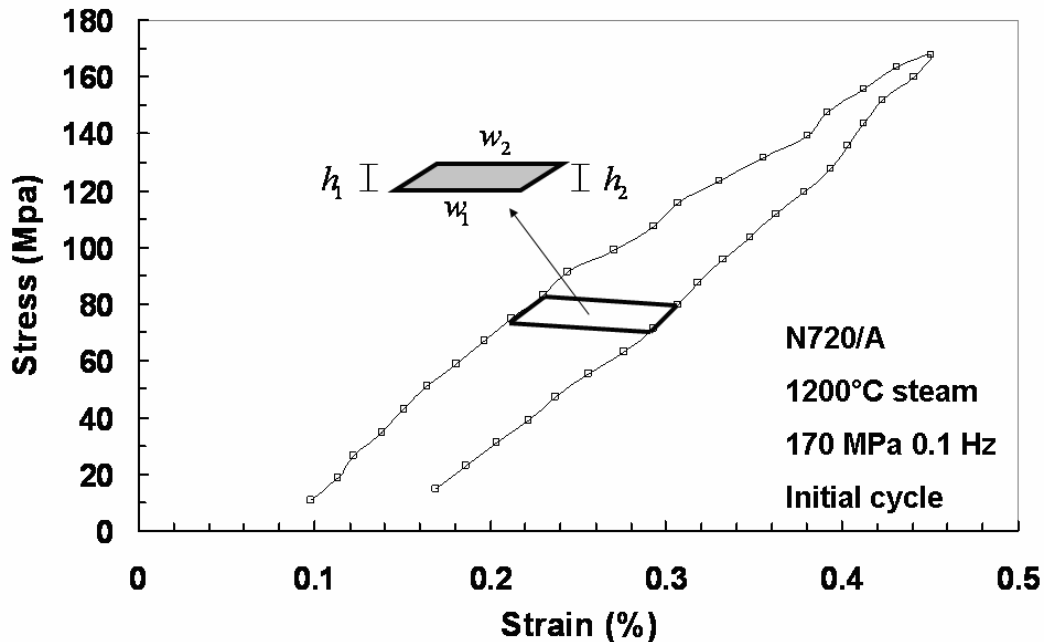
Figure 21. Illustration of typical quadrilateral used in hysteresis energy density calculations, including hysteresis loop for the initial cycle of the specimen tested in steam at 1200°C with the frequency of 0.1 Hz and maximum stress of 170 MPa.

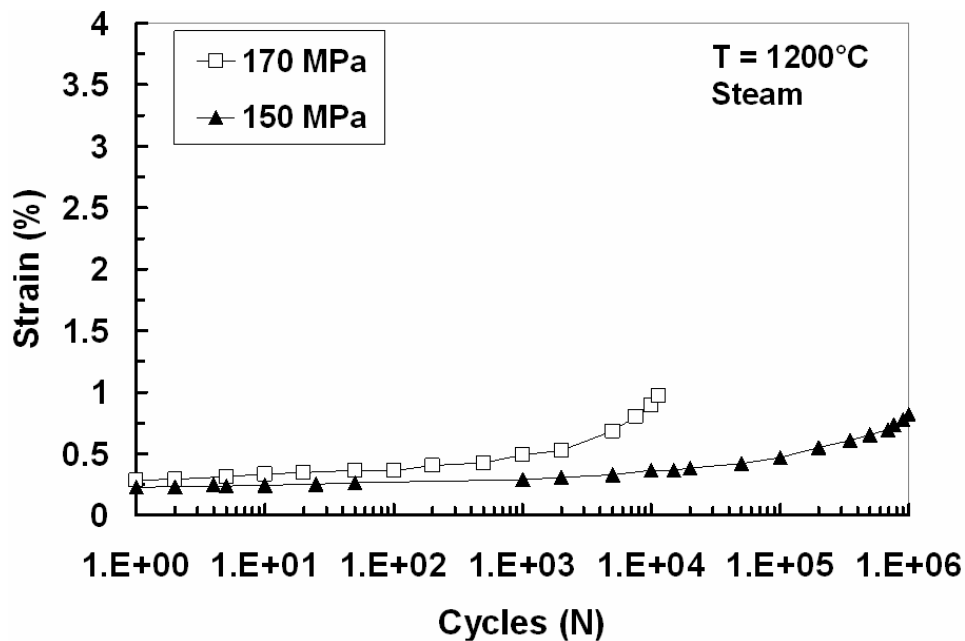
Figure 23. Maximum strain as a function of cycle number for N720/A specimens subjected to fatigue testing in steam at 1200°C with the frequency of 10 Hz and maximum stresses of 170 and 150 MPa.

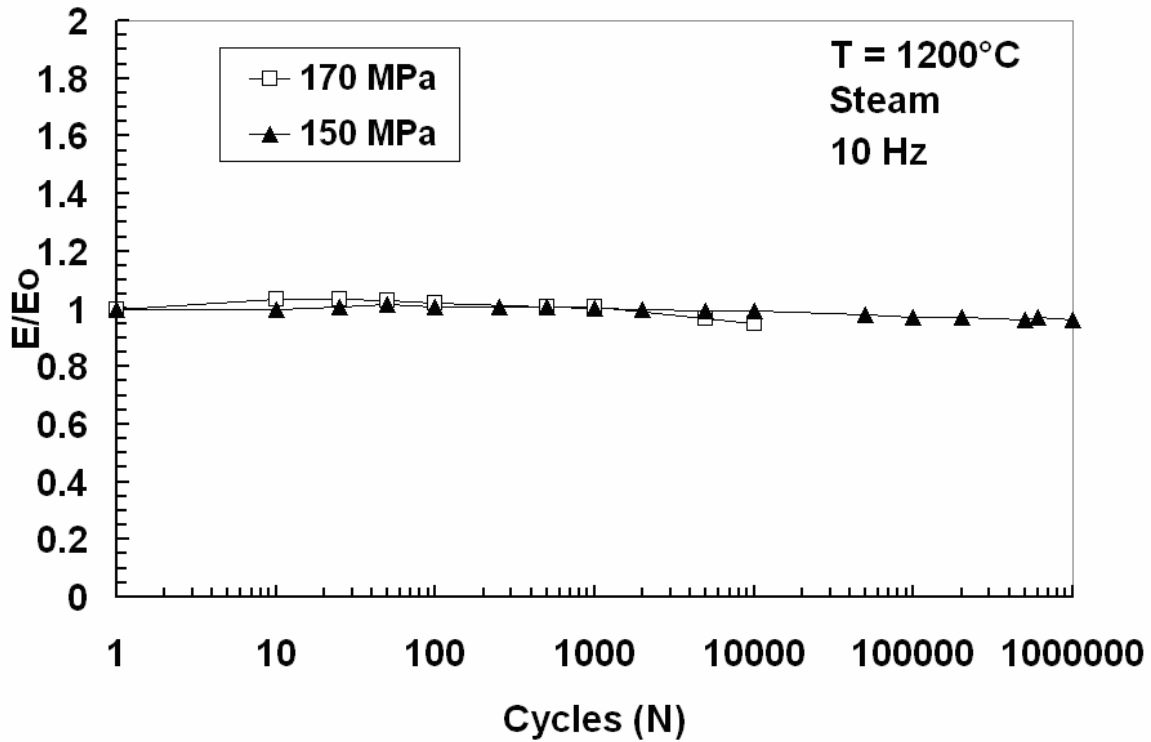
Figure 24. Normalized stiffness as a function of cycle number for N720/A specimens subjected to fatigue testing in steam at 1200°C with the frequency of 10 Hz and maximum stresses of 170 and 150 MPa.

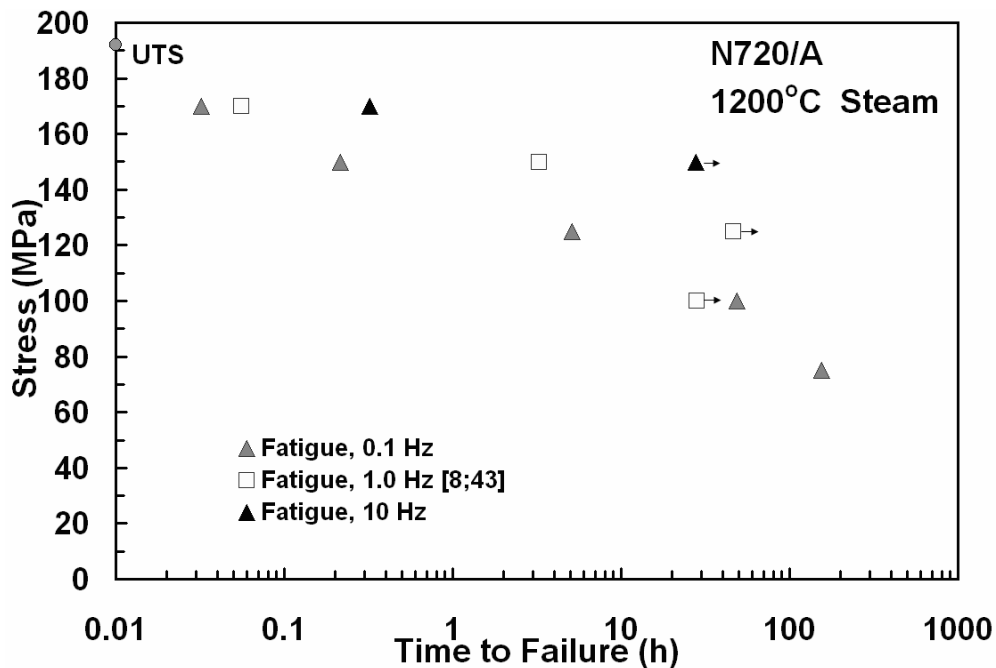
Figure 25. Times to failure for N720/A specimens subjected to fatigue in steam at 1200°C. Data from reference [8:43] is also included.

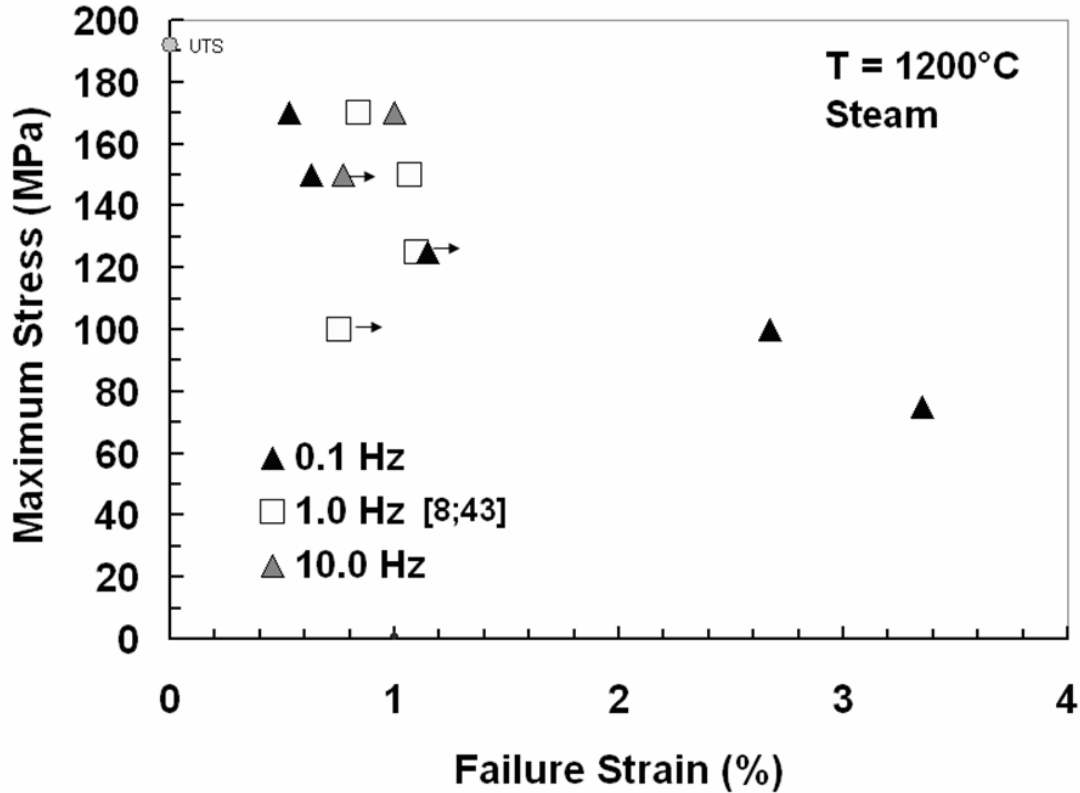
Figure 26. Maximum stress versus failure strain for N720/A specimens tested in fatigue at 1200°C in steam environment. Strains for specimens that achieved run-out are denoted by an arrow. Run-out strains are equivalent to the maximum strain at run-out. Note that no run-outs were achieved for the frequency of 0.1 Hz. Data from reference [8:43] is included.

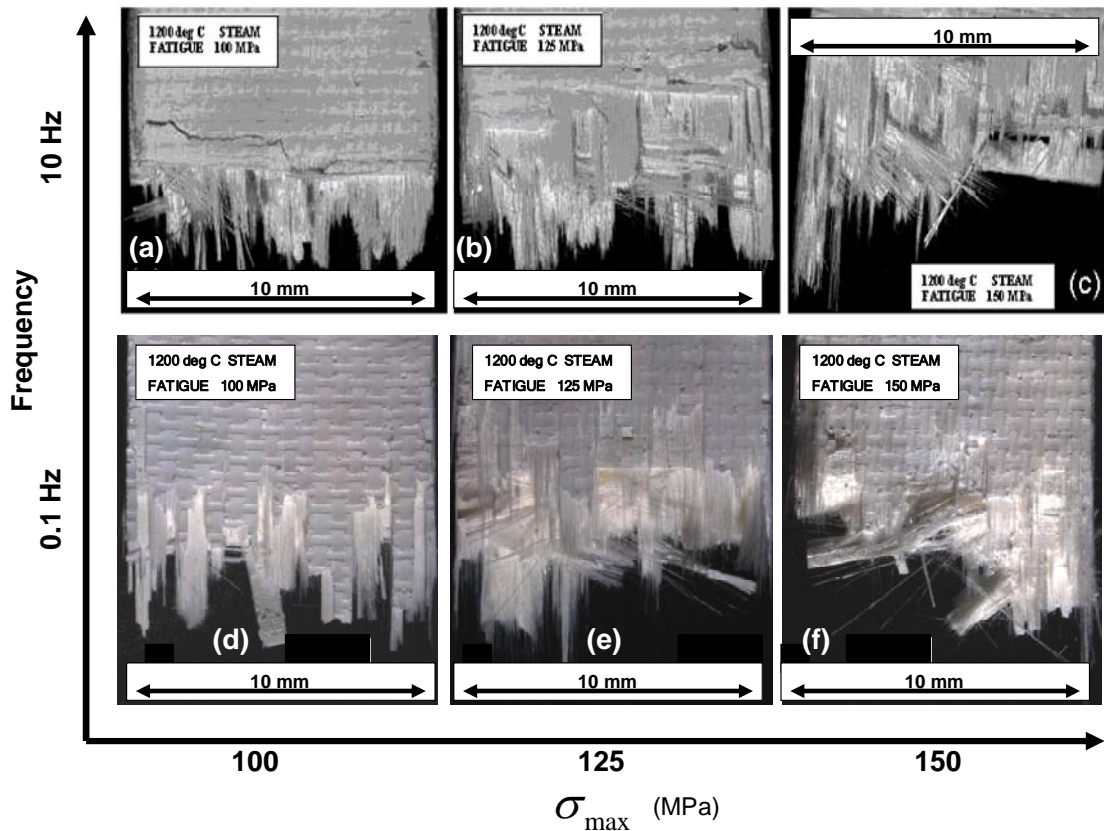
Figure 28. Fracture surfaces of Nextel 720/A specimens tested in fatigue at 1200°C in steam environment at maximum stresses of: (a,d) 100 MPa, (b,e) 125 MPa, and (c,f) 150 MPa, and frequencies of: (a,b,c) 10 Hz, and (d,e,f) 0.1 Hz. Specimens tested at 1.0 Hz exhibit higher degrees of fiber pull-out than those tested at the frequency of 0.1 Hz. Micrographs (a,b,c) are from reference [8].

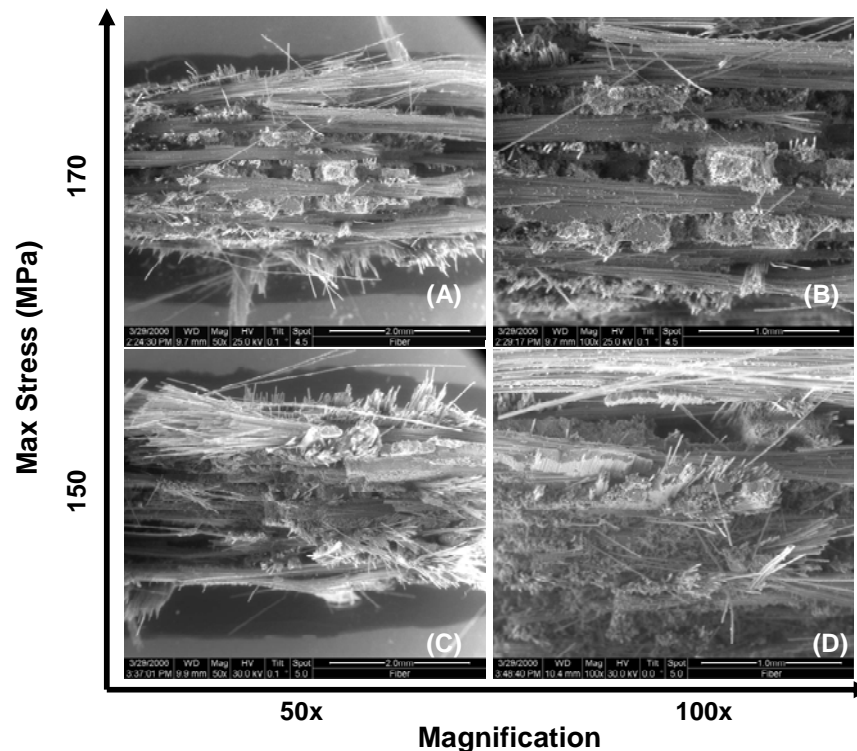
Figure 33. Fracture surfaces of Nextel 720/A specimens tested in fatigue at 1200°C in steam environment (frequency = 0.1 Hz) at maximum stresses of: (a,b) 170 MPa, and (c,d) 150 MPa. All micrographs exhibit both areas of coordinated fracture and fiber pull-out.

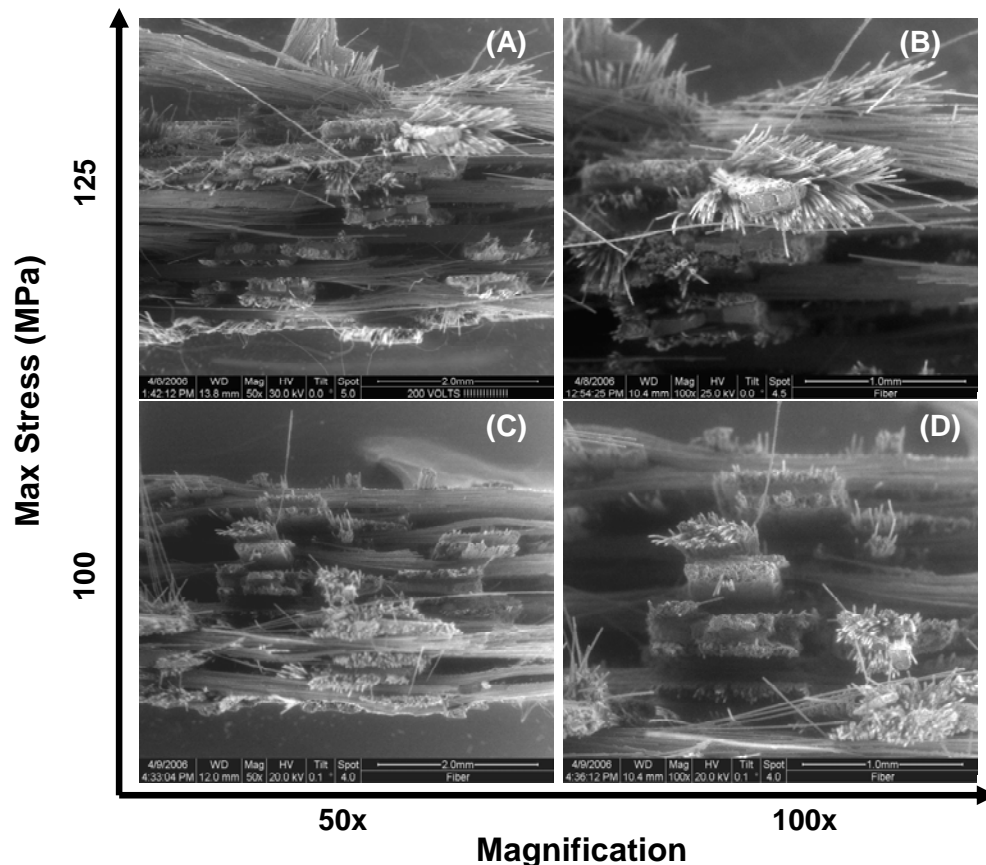
Figure 34. Fracture surfaces of Nextel 720/A specimens tested in fatigue at 1200°C in steam environment (frequency = 0.1 Hz) at maximum stresses of: (a,b) 125 MPa, (c,d) 100 MPa. All micrographs exhibit both areas of coordinated fracture and fiber pull-out.

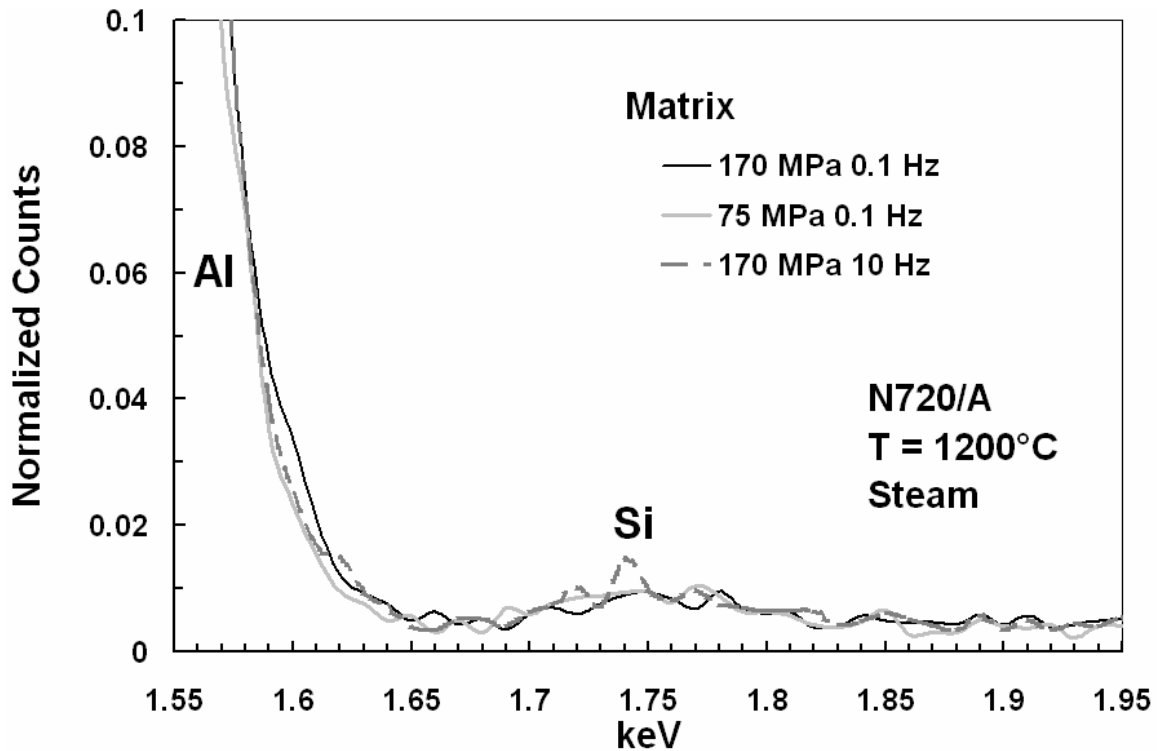
Figure 43. EDS spectra of matrix from three N720/A specimens tested in fatigue at 1200°C in steam environment with maximum stresses and frequencies of: 170 MPa and 0.1 Hz, 75 MPa and 0.1 Hz, and 170 MPa and 10 Hz.

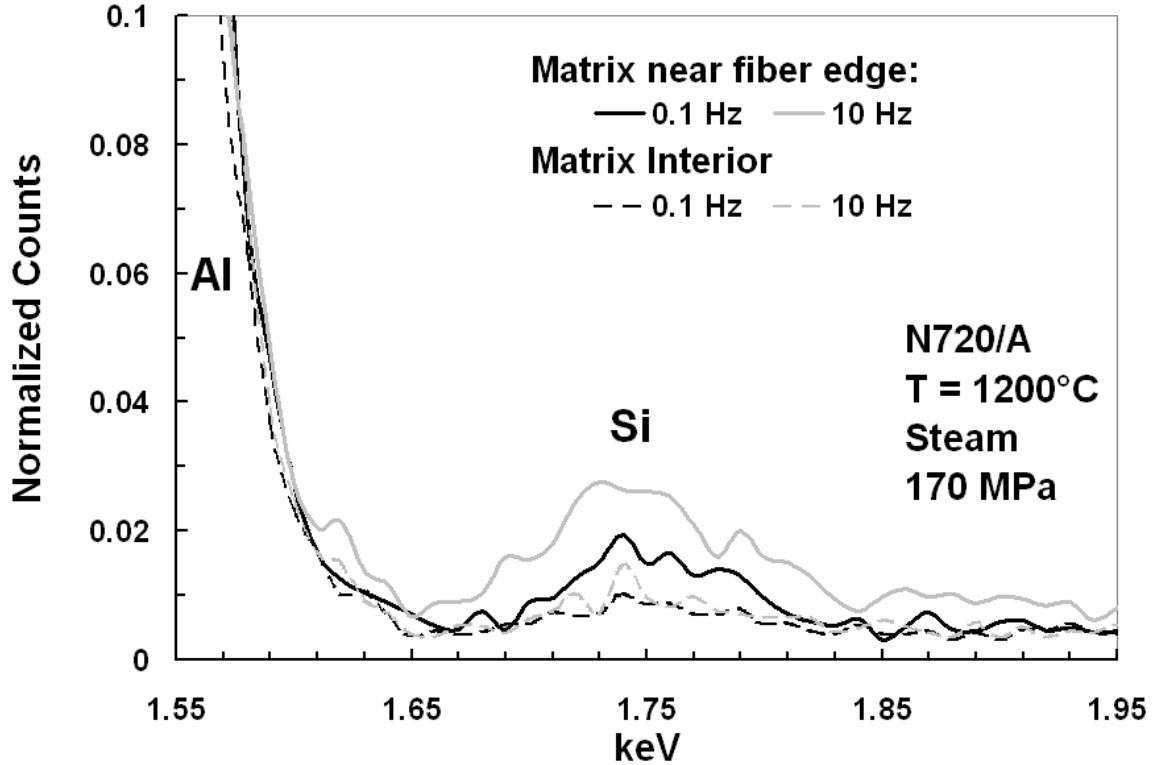
Figure 44. EDS spectra of matrix near fiber edge from two N720/A specimens tested in fatigue at 1200°C in steam environment with maximum stress 170 MPa and frequencies of 0.1 Hz and 10 Hz.

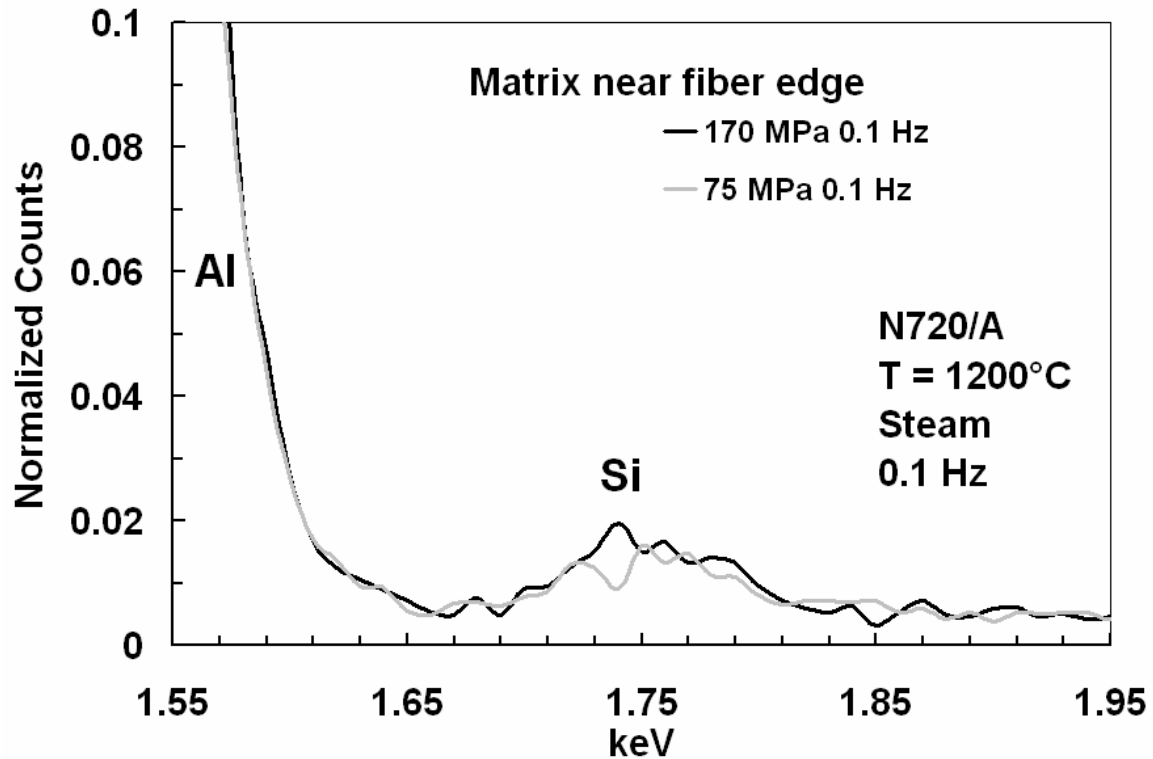
Figure 45. EDS spectra of matrix near fiber edge from two N720/A specimens tested in fatigue at 1200°C in steam environment with the frequency of 0.1 Hz and maximum stresses of 170 MPa and 75 MPa.
