Development and Calibration of a Frangible Leg Instrumented for Compression and Bending

Weapons Systems Division
Defence Science and Technology Organisation

DSTO-TR-1829

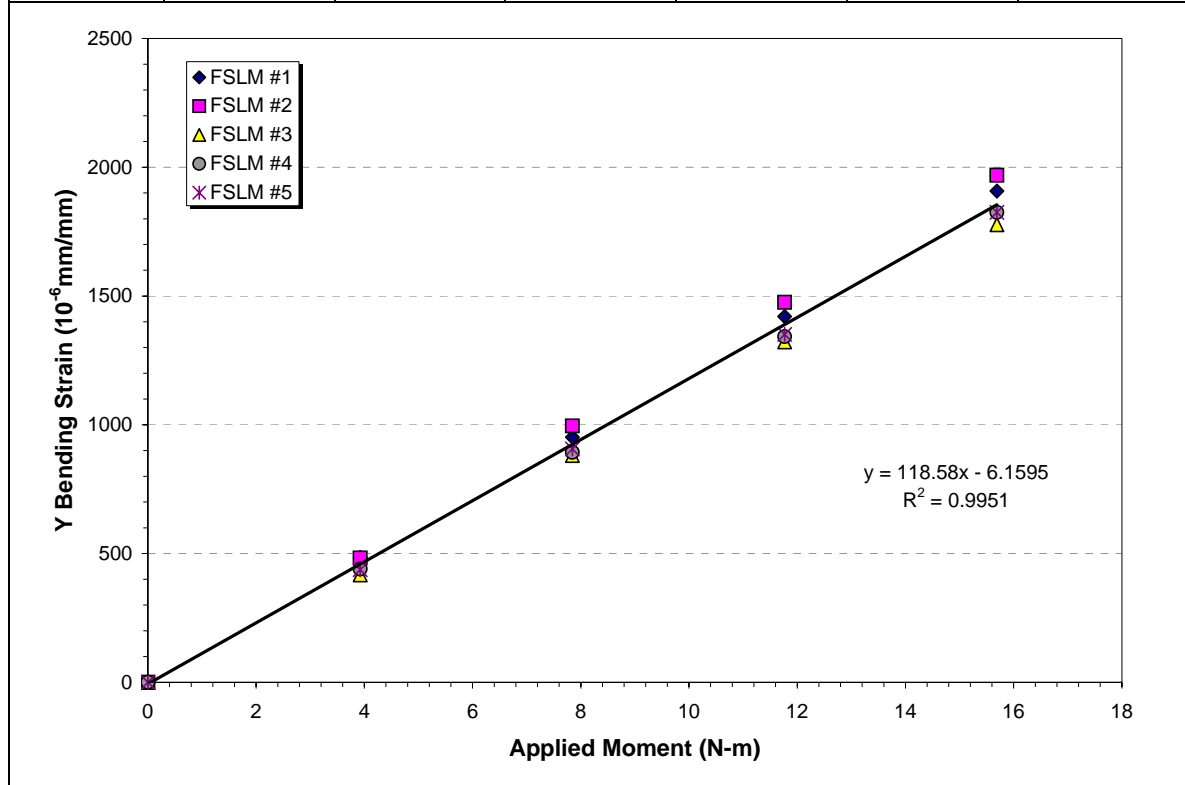
Once again, the correction tightened the data, resulting in a standard deviation between 4.1% and 6.6% from leg to leg for a given applied moment. The slope and offset of the linear fit for each leg is listed in the table below. The average slope was 118.58 Nm/microstrain with an average offset of -6.159 Nm. The standard deviation for the slope was 4.1%.

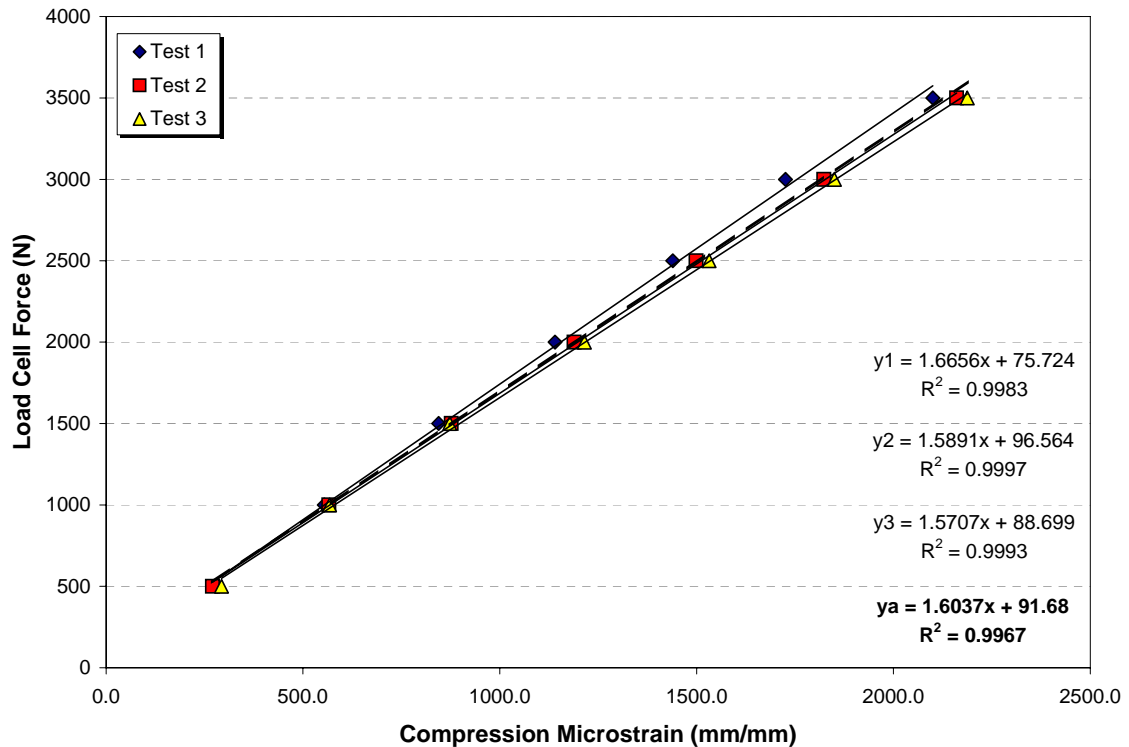
Compression strain calibration derived from the Inside and Outside gauges, C2IOA, for leg 1.

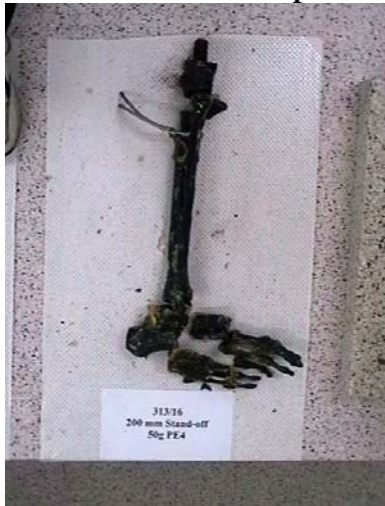
Debridement and Inspection of the FSLM Bones

The gelatine was stripped from the FSLM to expose multiple fractures to the metatarsal and tarsal bones, including a fracture forward of the talus. The calcaneus was not fractured and the talus had not been crushed. The fibula was intact while the tibia was broken at its proximal end, near the end of the metal pin insertion. This break does not correlate with the results from similar experiments with cadavers [5]. It is therefore considered to be an artefact of the mounting method used to attach the leg to the test fixture and would likely not occur in a real life accident.

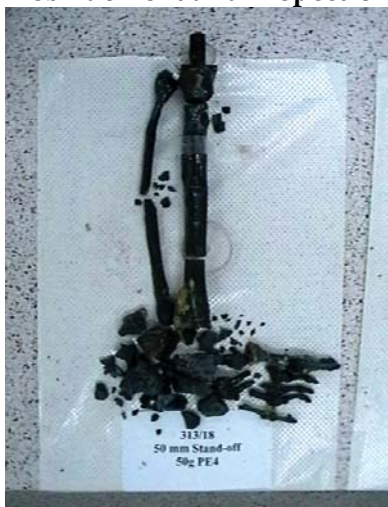
Debridement and Inspection of the FSLM Bones

Debridement of the gelatine from the FSLM clearly showed a mid-fibula fracture and a 1/3rd distal fracture of the tibia. The tibia also fractured at the proximal end through the metal pin attachment, an artefact of the mounting technique. All foot bones, with exception of the phalanges, suffered extensive comminution. These bones were avulsed during the traumatic amputation process. Soot and dust coated the bone fragments that had been recovered from the blast chamber as well as the distal end of the long bones. The calcaneus and talus were shattered into numerous small pieces.

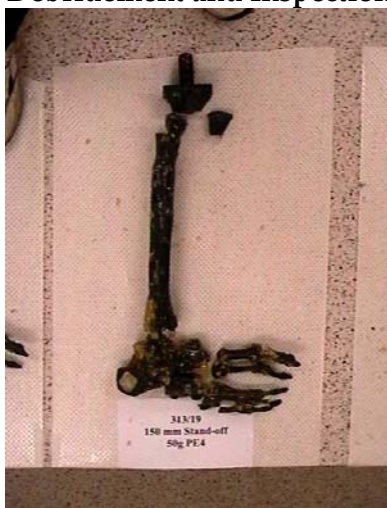
Debridement and Inspection of the FSLM Bones

Upon debridement of the gelatine from the FSLM, the fibula was found to be intact. The tibia had a transverse fracture above the level of the built-in load cell. There were no apparent fractures to the distal end of the tibia and fibula although there was a dislocation of the talus from the long bones. The metatarsals and tarsals suffered limited fractures and dislocations. There were no fractures of the calcaneus and talus. The bone group of the mid-foot (sub-talar group) suffered multiple dislocations.
