*Monitoring Completed Navigation Projects Program*

## **Greenville Bridge Reach, Bendway Weirs**

Final report

**Abstract:** Greenville Bridge Reach is located on the Mississippi River from river mile 542 to mile 530. The Greenville reach affects tows navigating through the Highway 82 Bridge located at mile 531 approximately 12 miles downbound of Greenville, MS.

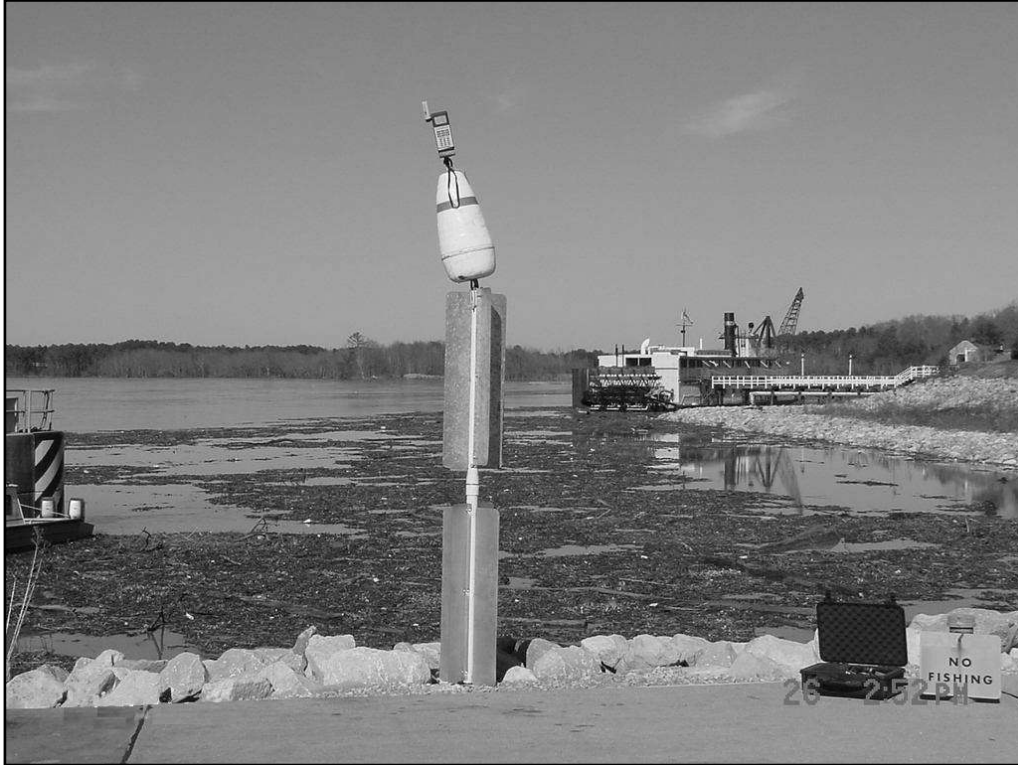
Figure 3. Float with two sections configured to draft 8 ft (after Winkler and Wooley 2002).

A float was designed to accept a GPS unit mounted near its top to reduce any interference to the signals from the GPS satellites. The float was constructed in 4-ft sections so the depth of the float could be adjusted to either a 4-ft or 8-ft draft by screwing the two sections together (Figure 3). The float was constructed of 3-in.-diam PVC pipe attached to a 12-in.-diam high density Styrofoam buoy. Four sheet metal fins were mounted to the PVC pipe to increase the effective area of the float. The 6-in. sheet metal fins increased the resistance of the float, ensuring that the float would

move at the speed of the current. The metal fins also increased the weight of the float to make it stand vertical in the water column (Figure 4).

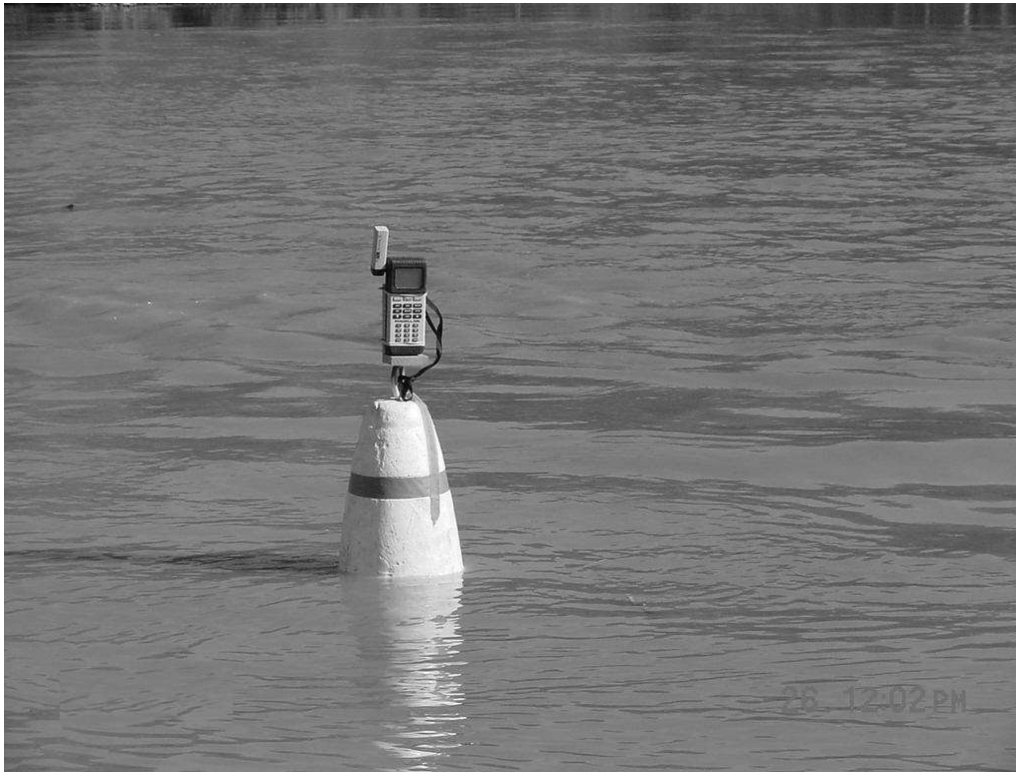
Figure 4. Float with GPS receiver mounted on top standing vertical in the water (after Winkler and Wooley 2002).

The GPS receiver was mounted near the top of the buoy to minimize any interference with the GPS antenna. Mounting the GPS receiver to the buoy also minimized the risk of losing the receiver if the bottom section of the float was snagged on an underwater object and broke free. A two-man crew per boat was required to drop, track, and retrieve the float. The boat operator positioned the boat at the drop site, while the second crewmember turned on the GPS receiver and placed the float over the side. Two floats were used but a separate boat tracked each float. Experience with floats in large rivers has shown that floats dropped close together sometimes will separate by moving apart or one moving at a different speed making it difficult or impossible for one boat to keep track of two floats. Also, for safety reasons and protection of the floats, it was better to have two boats dropping floats in case one boat stalled at a critical time. The tracking boat stayed close enough to the float in case it needed to be retrieved due to tow traffic without interfering with the currents affecting the float.

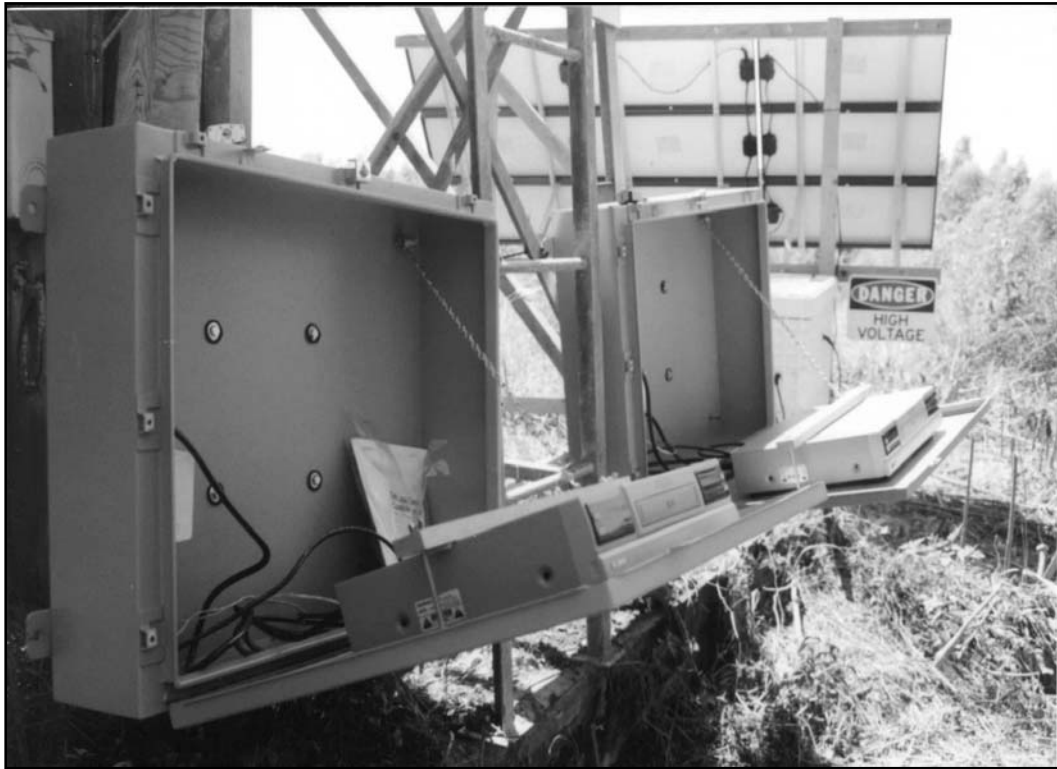
Figure 5. Time-lapse recorder and open enclosure (after Winkler et al. 2003).

A basic time-lapse video system consists of a time-lapse video recorder and video camera. A Sony Time Lapse Video Cassette Recorder model SVT-S3100 was installed at the site to record tows moving through the reach (Winkler et al. 2003). The recorder was programmed for a daily start and stop time and time-lapse interval. The recorder had a battery backup for the recorder clock and programming in the event of a power failure. Due to the systems being located on the highway bridge and being exposed to the weather, the recorders were installed in a weatherproof case. A standard electrical box was modified to house the time-lapse recorder and other components of the system (Figure 5). It should be noted that in Figure 5 the box is open, but when closed the recorder is actually horizontal in the box.

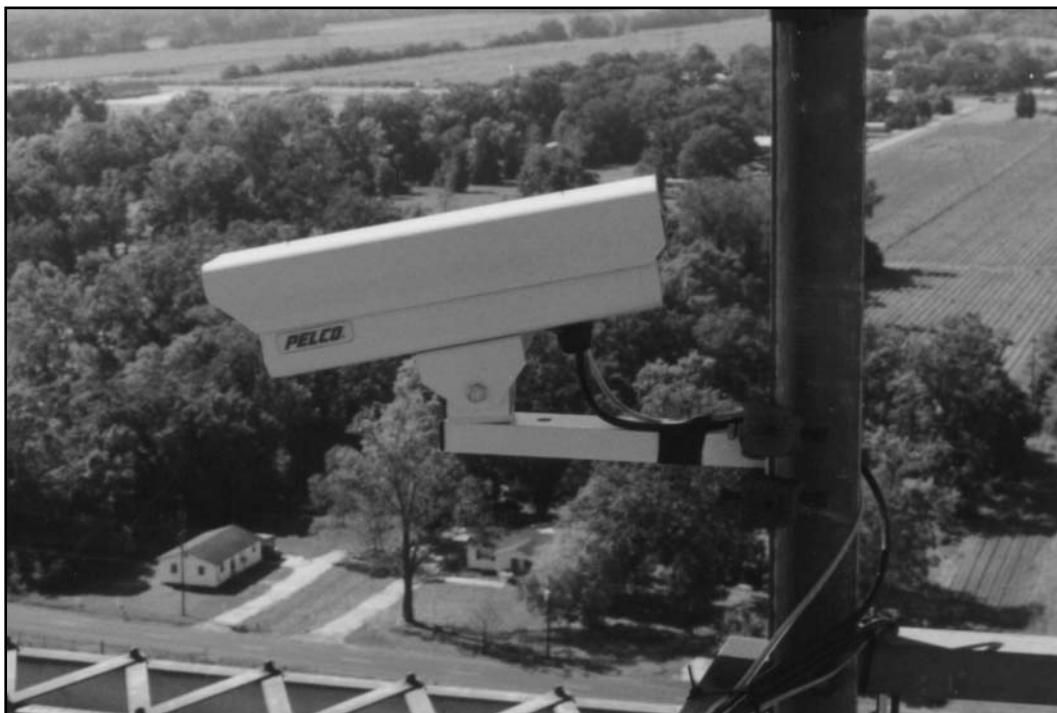
Figure 6. Video camera in weatherproof case (after Winkler et al. 2003).

A high quality camera was selected to provide clear, crisp pictures for analyses. A Sony Color Video Camera model SSC-CX34/34P was selected for the project. The SSC-CX34/34P camera is compact, lightweight and has a 12-power zoom lens with automatic iris. A camera without a zoom lens could have been used but the zoom lens allowed better compositions of the target area without repositioning the camera. The automatic iris was essential for adjusting the iris to changing light conditions in the field. The camera was mounted in a weatherproof camera case with a mount that allowed some rotation for aligning/positioning the camera (Figure 6). In extreme weather conditions, the camera case could be outfitted with heat strips and/or a fan to control the temperature inside the case. The SSC-CX34/34P camera operated on 24-volt alternating current and, therefore, required a transformer that was installed in the recorder box.
