Effects of Environment on Creep Behavior of Two Oxide-Oxide
Ceramic Matrix Composites at 1200°C

THESIS

AFIT/GAE/ENY/06-S05 GAE 06S

AIR FORCE INSTITUTE OF TECHNOLOGY

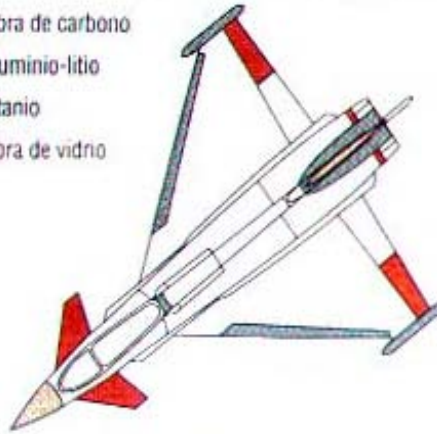
El consorcio EADS-CASA ha construido el Eurofighter usando los últimos avances tecnológicos en ingeniería.

- Fibra de carbono
- ▒ Aluminio-litio
- Titanio
- ▒ Fibra de vidrio

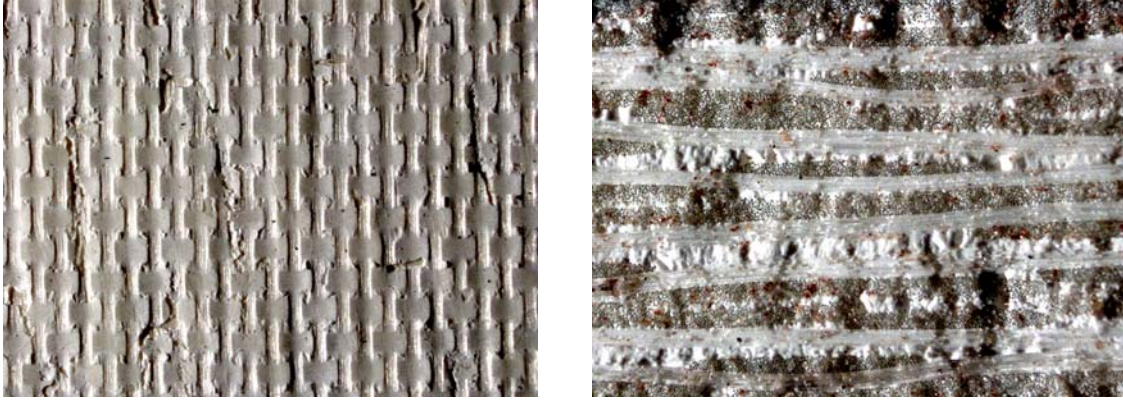
Figure 6 show the surface microstructure of the as received N720/AS material. 0⁰/90⁰ layers are clearly observable as well as micro- cracks in the matrix that are formed during the manufacturing process.

Figure 6. Surface Microstructure of as received Material N720/AS

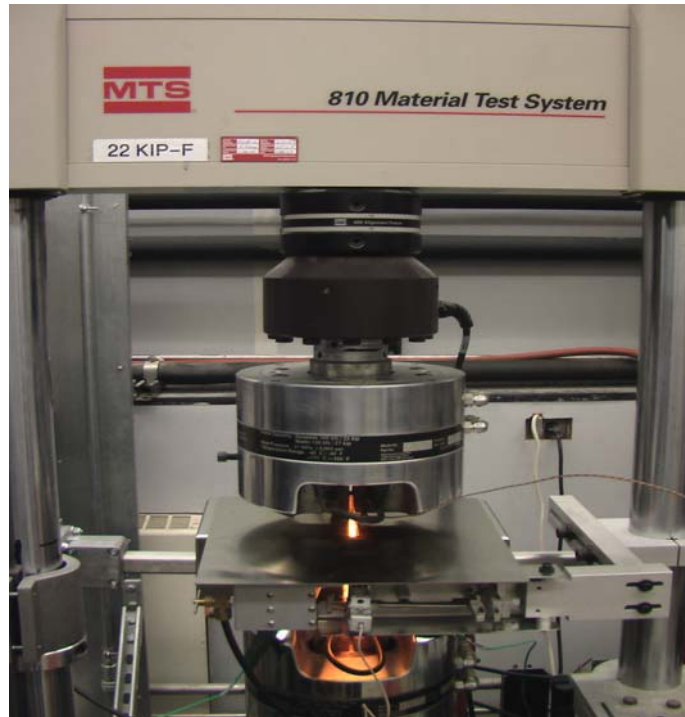
For the mechanical testing of the specimens two MTS (Material Test Systems) Corporations servo hydraulic machines (model 810) were used as seen in figure 9. One of those had a load capacity of 5.5 kip and on that machine the testing in air and steam environment was conducted while the other had a load capacity of 22 kip and the testing in argon environment was conducted.

Figure 9. MTS hydraulic testing machine

In order to secure the specimens in their place a grip force of about 8Mpa was used in the first machine whereas the later required a grip force of about 3 Mpa. The grips were MTS's model 647 water cooled hydraulic wedge with a surfalloy surface used to prevent slipping. For the water cooling a Neslab model HX-75 chiller was used, for circulating through the grips cold water in order to maintain a safe temperature.

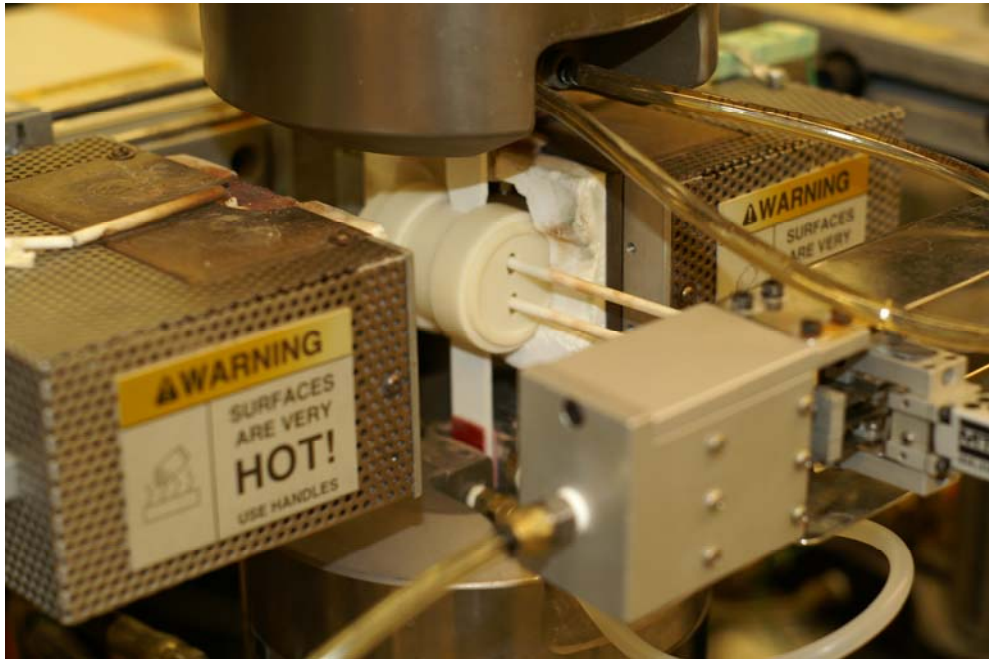
in order to enclose the specimen. Inside each chamber silicon carbide heating elements were positioned at the top and the bottom in order to achieve the required temperatures. Alumina pieces were fitted inside each one, leaving enough room just for the specimen in order to prevent heat loss. To achieve temperature monitor and control an S-type thermocouple was placed inside each chamber connected to the other end with a MTS model 409.83B temperature controller as seen in figure 11.

Figure 11. Amteco Hot-Rail Furnace

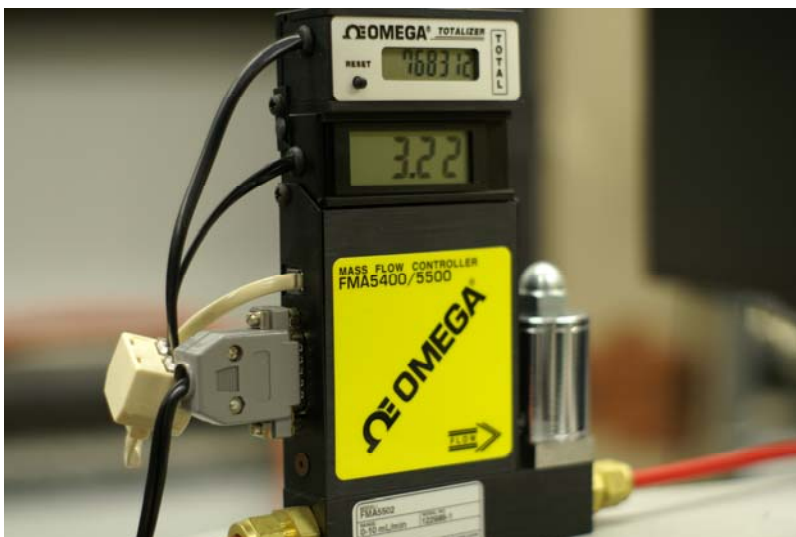
Figure 13. Omega Mass Flow Controller

The argon environment was created by using a high pressurized tank filled with high purity argon and an Omega Mass Flow Controller which was used in order to control the amount of argon that would flow into the susceptor. For the specific tests the flow was 41mL/min.

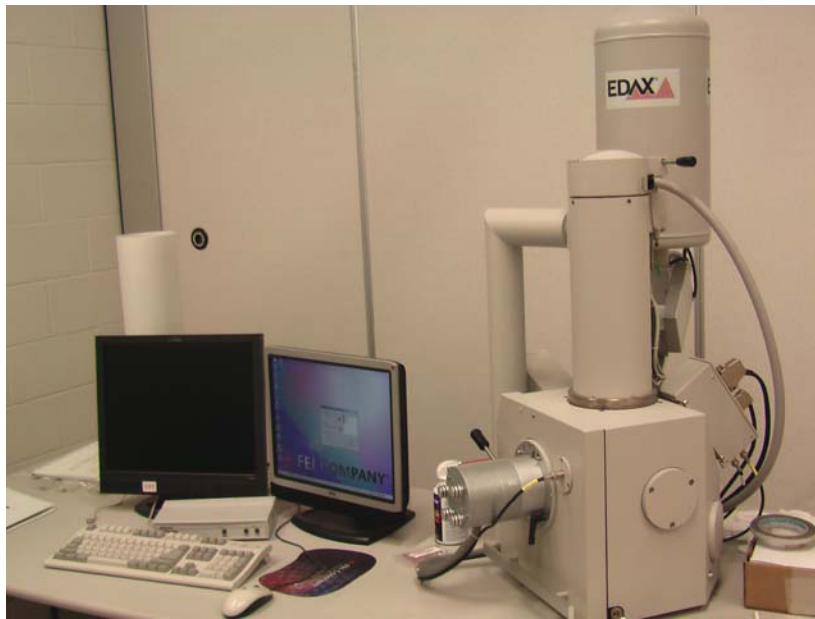
For higher magnification images a FEI FP 2011/11 Quanta 200 HV Scanning Electron Microscope which is shown in figure 16 was used.

Figure 16. FEI FP 2011/11 Quanta 200 HV Scanning Electron Microscope

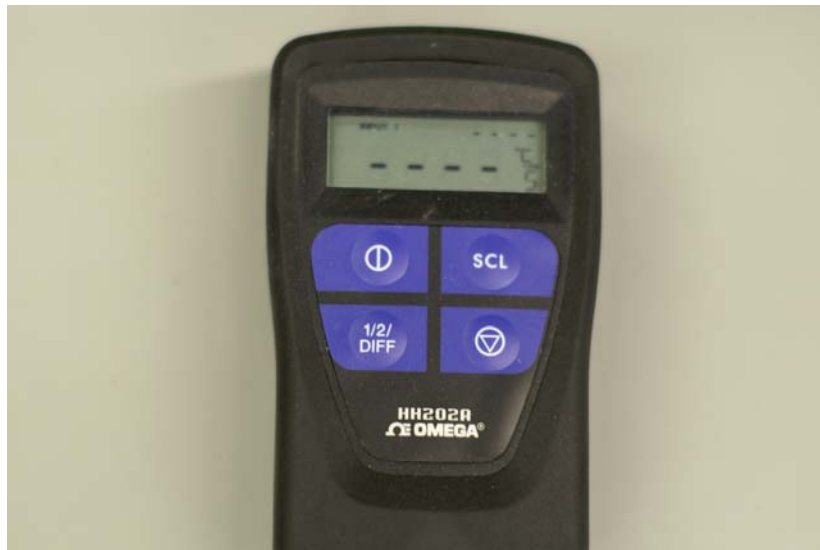
Figure 17. Omega Engineering OMNI CAL -8A-110 temperature sensor

The specimen was then gripped at the machine and each thermocouple was connected to an Omega Engineering OMNI CAL -8A-110 temperature sensor in order to monitor the temperature at the surface of the specimen. Closely monitoring the sensors, the furnace temperature was raised slowly until the required temperature was achieved. Then the furnace temperature was recorded.

After that the temperature setting for the furnace was calibrated in order to achieve exactly 1200° C at the surface of the specimen regardless the environment. For this to happen a specimen was prepared with two thermocouples bonded at each side of the cross sectional area with Zircon alumina cement.

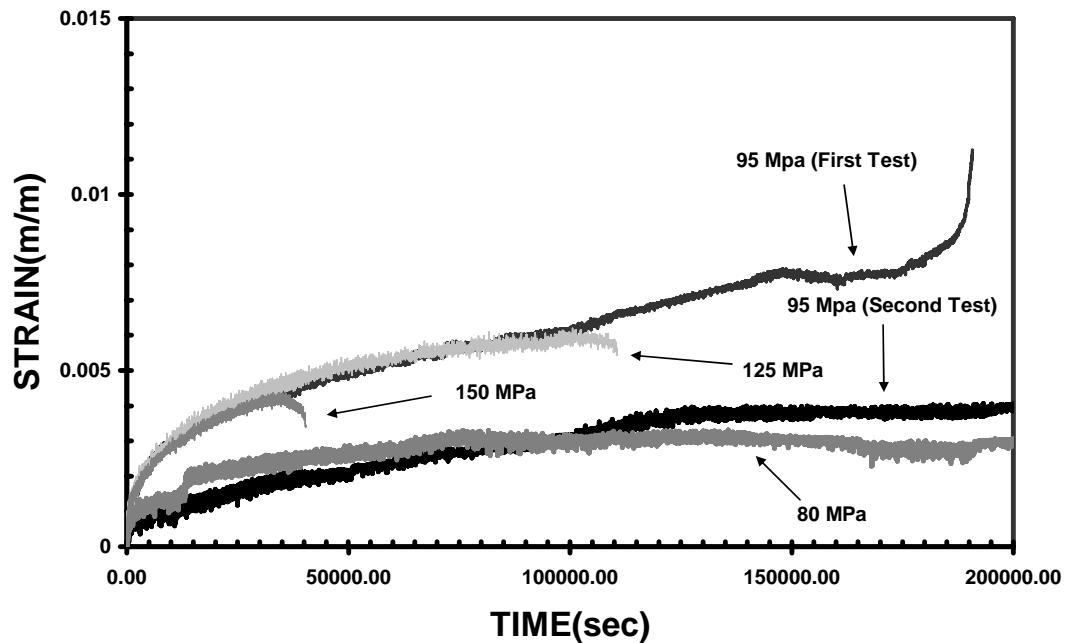
Figure 19 shows strain vs. time for all specimens. In figure 20 the time scale is truncated in order to show clearly the strain curves. It should be noted that all the

specimens exhibited both primary and secondary creep while specimen A95-2 had tertiary creep as well.

Figure 19. Creep Strain vs Time for N720/AS in air 1200°C

Figure 20. Creep Strain vs Time for N720/AS in air 1200°C (Time Truncated)

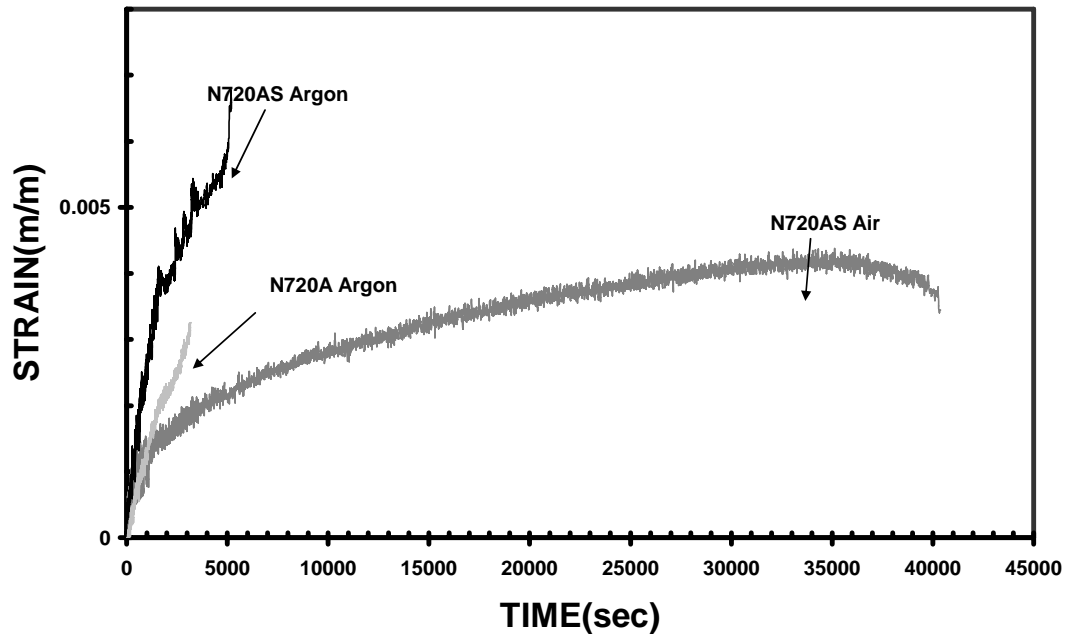
Figure 28 depicts a comparison of creep strain and time to rupture for all the specimens tested at 150 MPa. The specimen S150 is not listed as it failed during ramp-up. The results for the argon environments were as expected, but what seems weird is the rupture time for the specimen in air. As argon is an inert gas what was expected was the specimen in air to have worst performance than the one in argon. The fact that as described earlier the MTS machine that was used for the tests in air had a big offset, although the whole process and temperature was inspected thoroughly both before and after the test, raises questions about the credibility of the result in air.

Figure 28. Creep Strain vs Time at 150 MPa in all environments at 1200°C

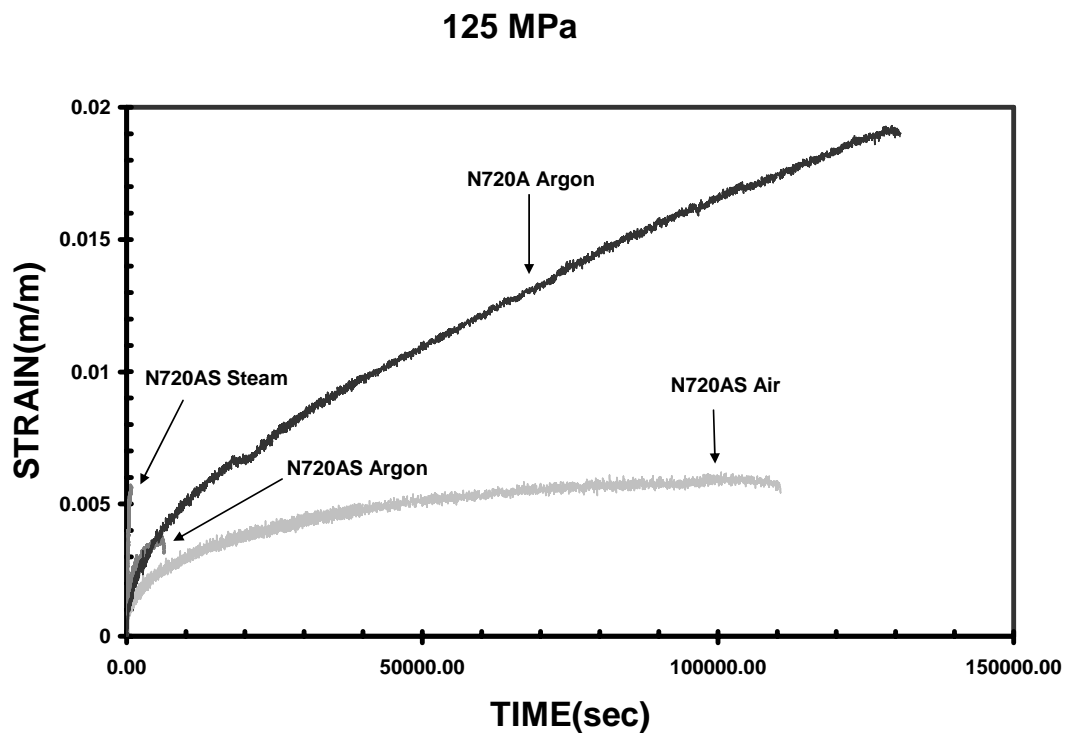
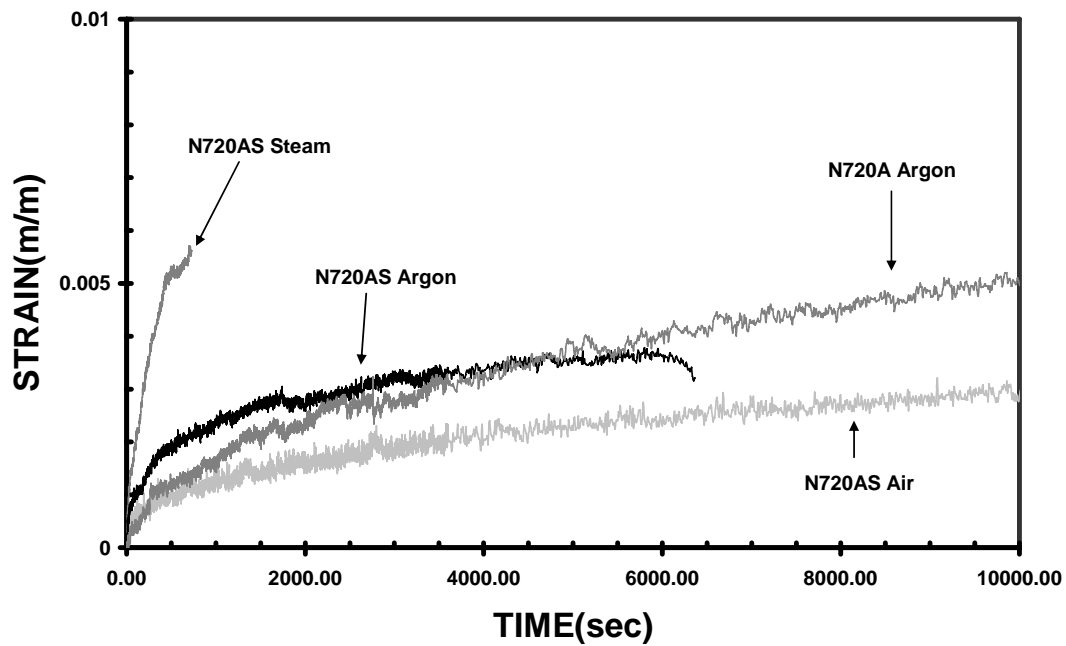
Figures 29 and 30 demonstrate the specimens tested at 125MPa. It is clear here that N720A material performed far better than the N720AS specimens. It should be noted that although N720AS in argon failed early until its fracture, the accumulated strain had the same curvature as the N720A.

Figure 29. Creep Strain vs Time at 125 MPa in all environments at 1200°C

Figure 30. Creep Strain vs Time at 125 MPa in all environments at 1200⁰(Time Truncated)

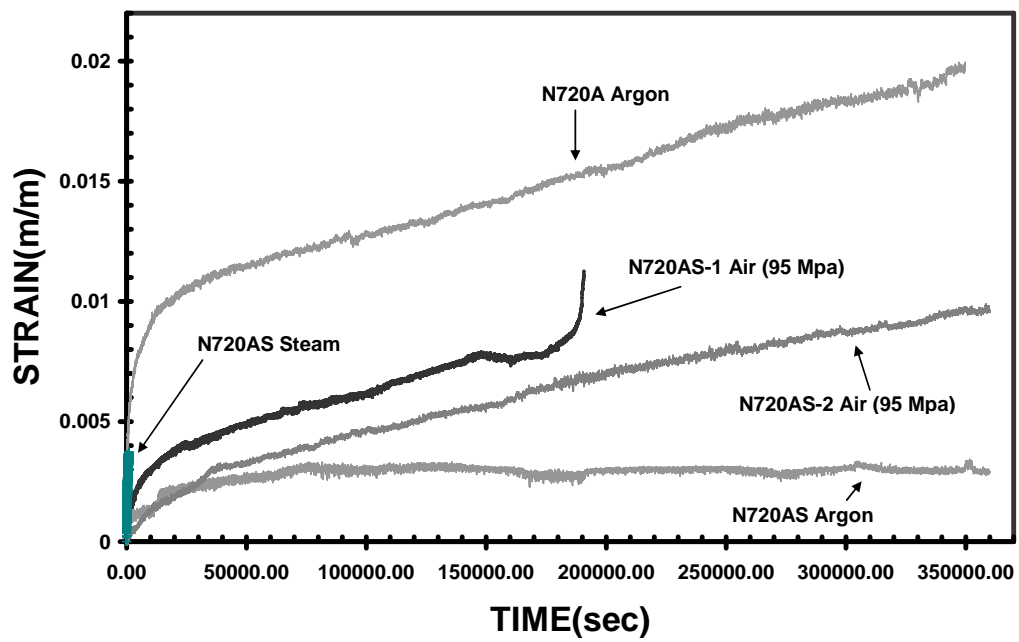
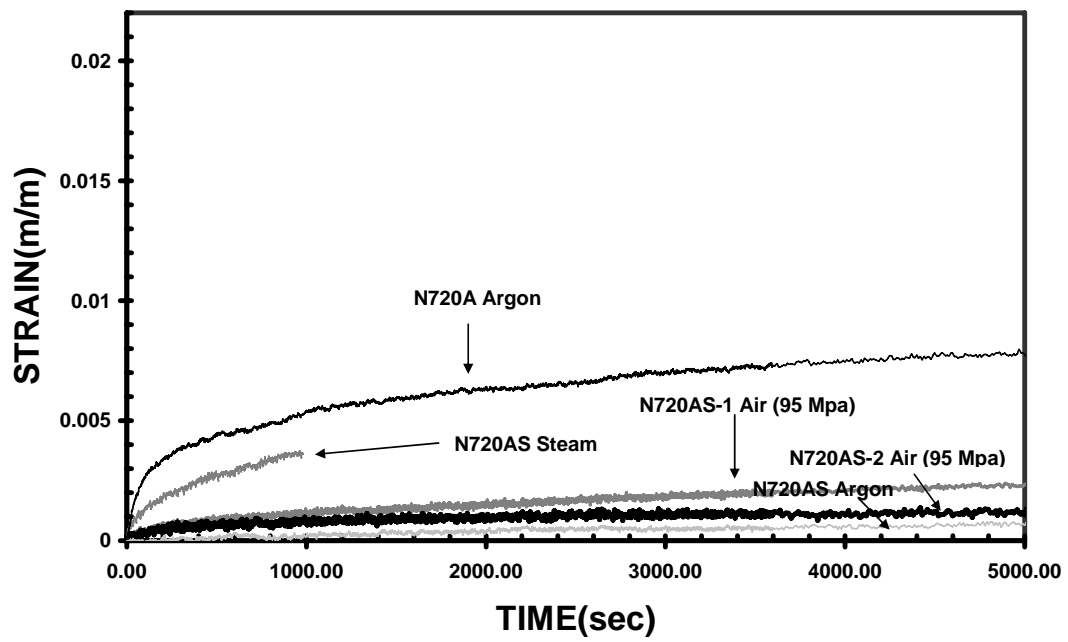
At 100MPa it can be also be observed that N720A material had the highest creep strain as it was also observed at 125Mpa, where it also easily observable that the specimen in steam environment failed much earlier than the others. The early failure in steam environment is depicted also at figures 31 and 32.

Figure 31. Creep Strain vs Time at 100 MPa in all environments at 1200°C

Figure 32 . Creep Strain vs Time at 100 MPa in all environments at 1200⁰C(Time Truncated)

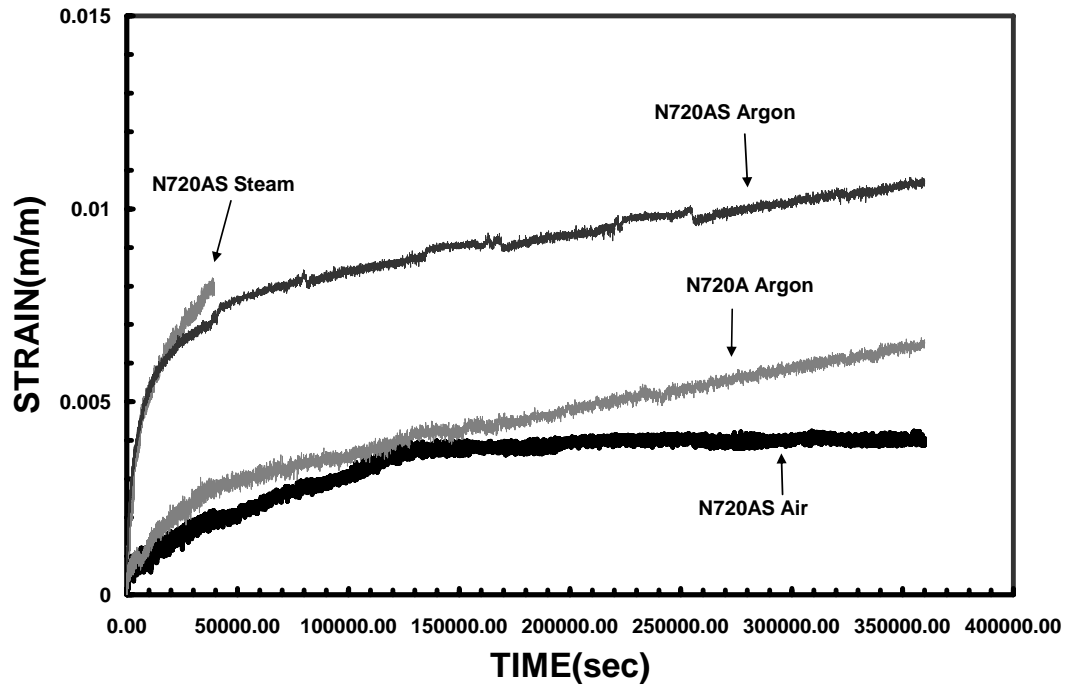
Figure 33. Creep Strain vs Time at 80 MPa in all environments at 1200°

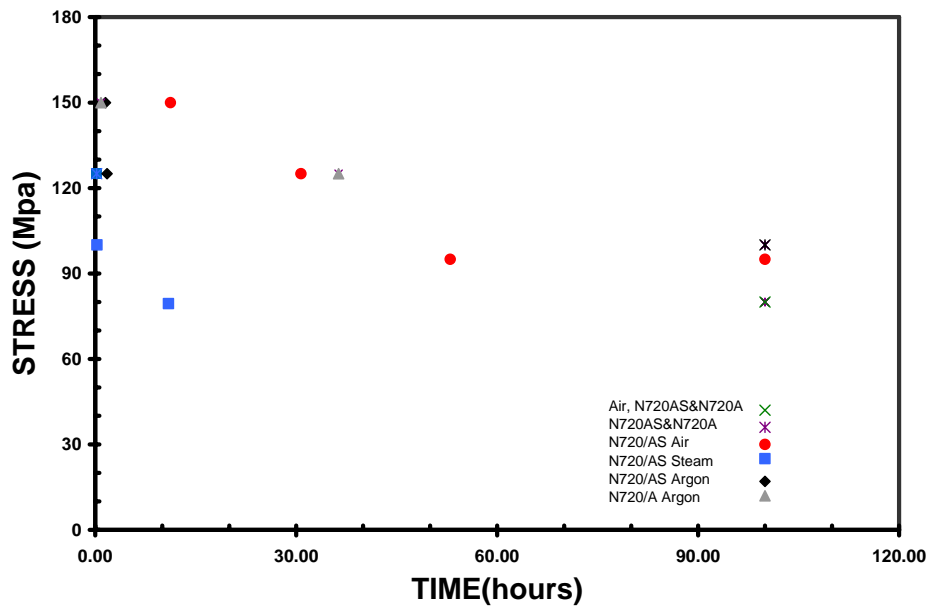
Figure 34. Applied stress vs time to failure summary
