AFRL-ML-WP-TP-2006-420

**STRUCTURAL HEALTH
MONITORING OF AN AIRCRAFT
PANEL USING CONTINUOUS AE
SENSOR (PREPRINT)**

APRIL 2006

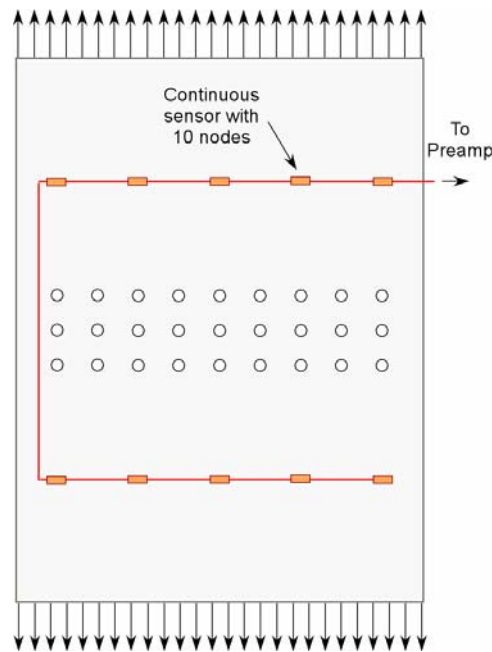
Figure 1. Continuous sensor for monitoring multiple damage sites.

fatigue crack growth from multiple holes in the specimen shown in Figure 1. In this case, since the source to sensor distances for the potential crack growth sites are reasonably small, it is expected that the sensitivity of such a system would be high. A structural health monitoring system based on the continuous sensor is described in reference 6. The objective of the present work was originally set to monitor fatigue crack growth in 7075-T6 lap joints using continuous sensors. Subsequently it was suggested that 2024-T3 aluminum lap joints be monitored for fatigue cracks around rivet holes. The AE signals from fatigue crack growth in aluminum typically are of very small amplitude. This small amplitude combined with the presence of various sources of noise signals present in the environment pose unique challenge in the structural health monitoring application. However, if these problems are overcome, the acoustic emission technique has the ability to quantify the crack growth rate and directly assess the damage criticality in real time.

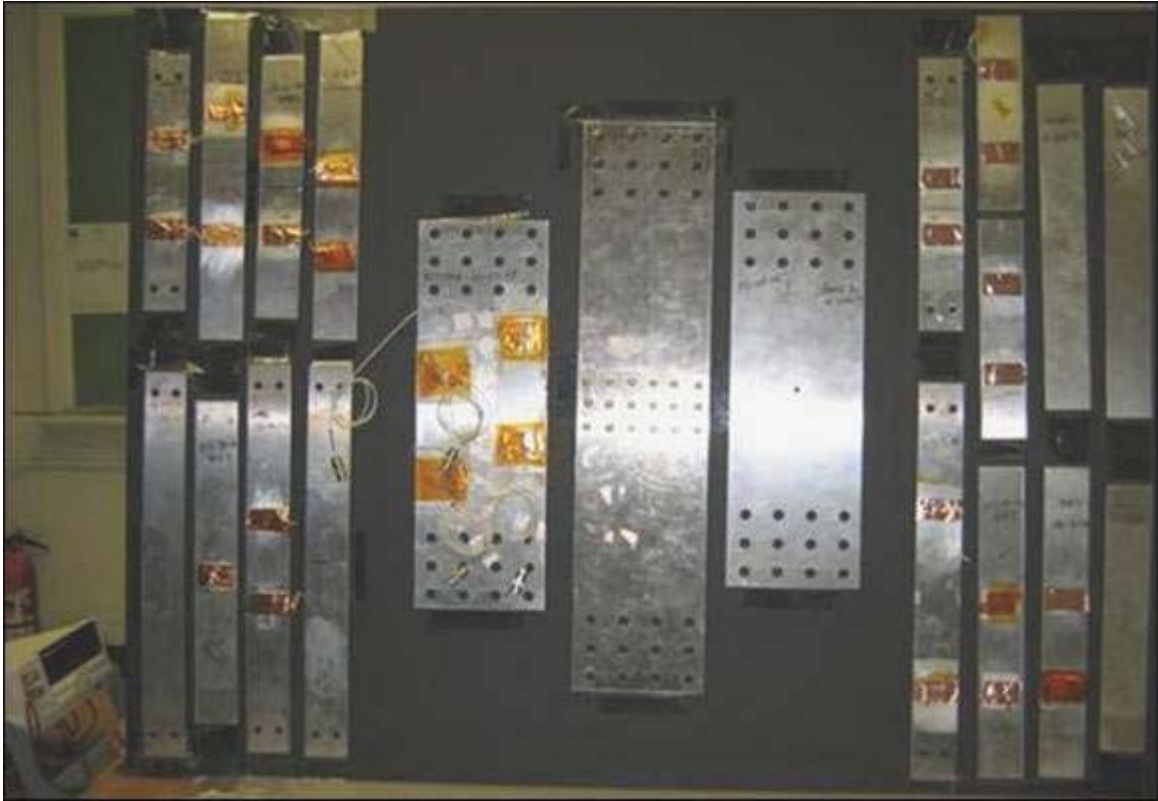
Figure 3. Part of the total number of specimens that were fabricated, precracked, and tested for developing the structural health monitoring technique.

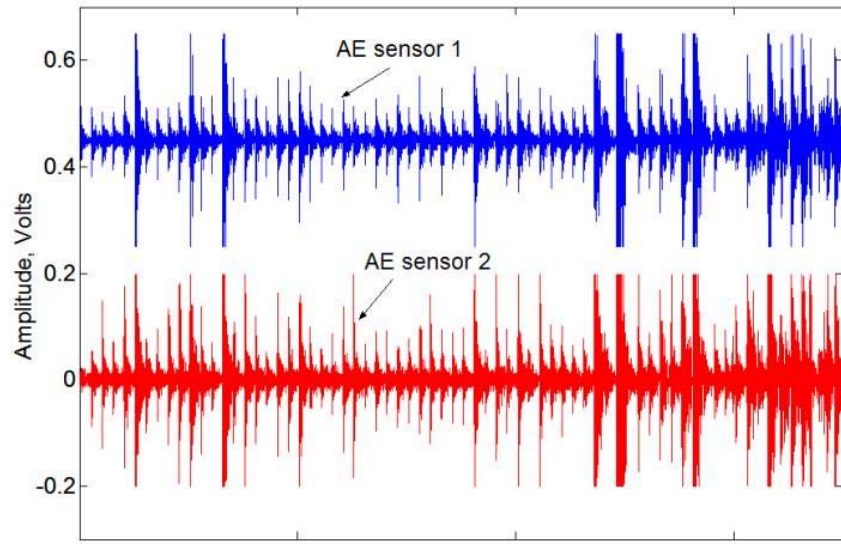
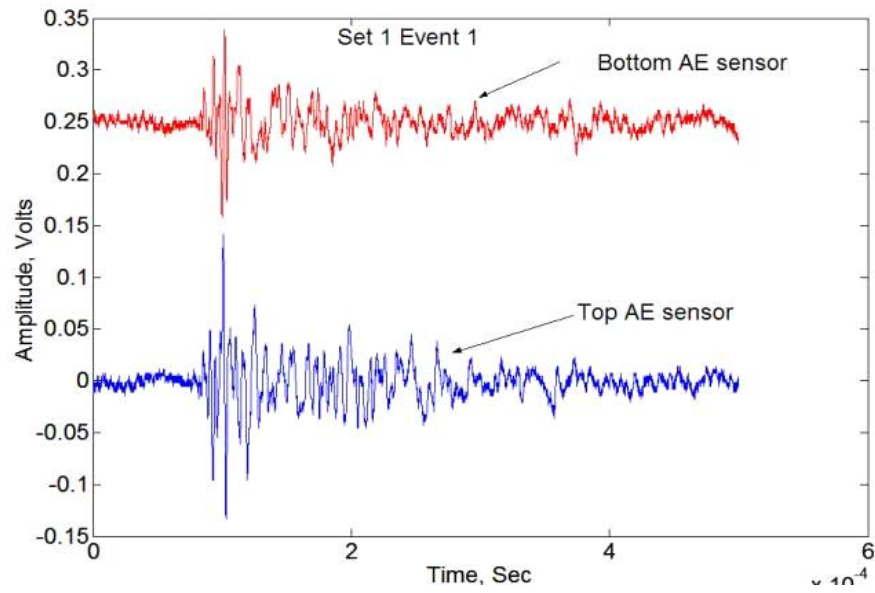
Figure 5. Acoustic emission signals from fatigue crack in 2-inch wide coupon specimen. (a) Sequence of 50 AE events, and (b) One of the events in the sequence

Figure 5(a) shows a sequence of about 50 acoustic emission events sensed by two 150 kHz resonant frequency sensors attached to a two-inch coupon, during fatigue crack propagation. In Figure 5(b) one of the individual events is shown. The source of each of these signals could be determined from the time difference in the AE signals sensed by the two sensors. In one of these specimens, the average crack growth rates and the average acoustic emission energy per cycle were measured.

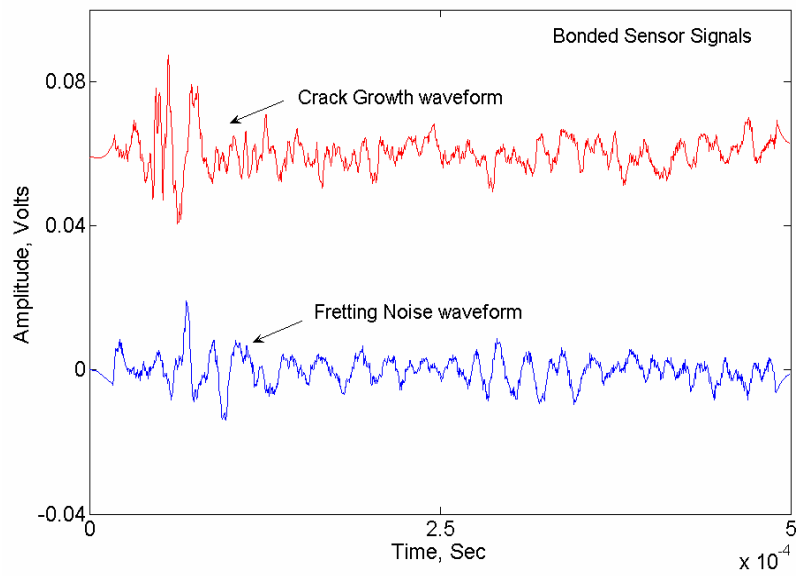
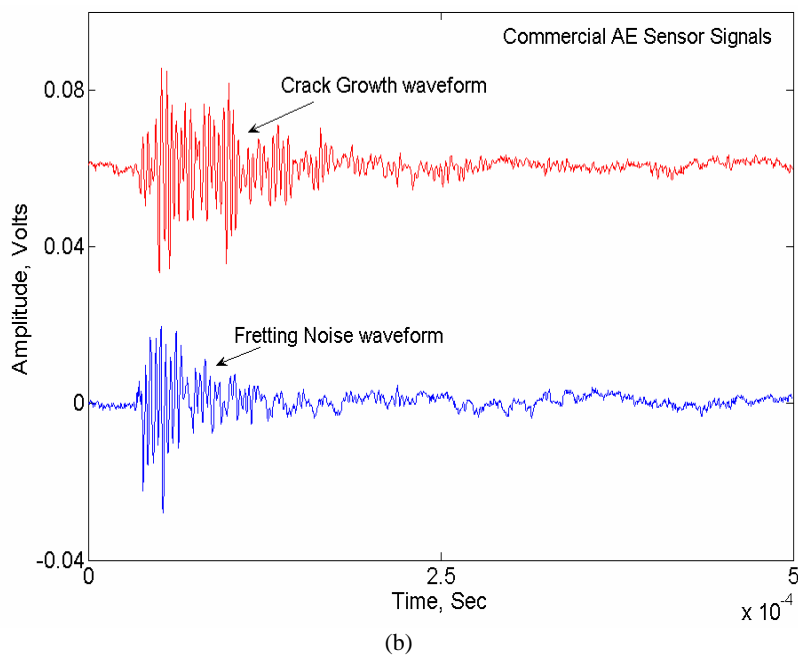
Figure 7. Comparison of AE waveforms related to crack growth and fretting related noise from the two types of sensors (a) Bonded sensor, and (b) 300 kHz commercial sensor.

As mentioned earlier, the susceptibility of the AE technology to various types of noise signals is of great concern. In the current study two types of noise signals were present. The first one is the RF noise due to various sources. In general, it is possible to identify the RF noise from the frequency content, which is generally far above the typical AE signals which are in the frequency band of 100 kHz to 500 kHz and can be eliminated through suitable low pass filtering. The second type of noise is the fretting noise generated through friction between two surfaces moving relative to one another. In the present tests, such noise signals are generated at the grips in the coupon specimens and the lap area in the case of lap joints. The crack growth related AE signals sensed by the bonded sensor have distinctive high frequency components at the leading edge as shown in the top trace of Figure 7(a). Fretting related noise signals do not have such high frequency leading edge and hence can be eliminated if wide band sensors are used. However, the conventional high sensitivity commercial sensor, Figure 7(b), is not able to distinguish between AE signals generated by fatigue crack growth and the fretting related noise because of the resonant frequency response of these sensors.

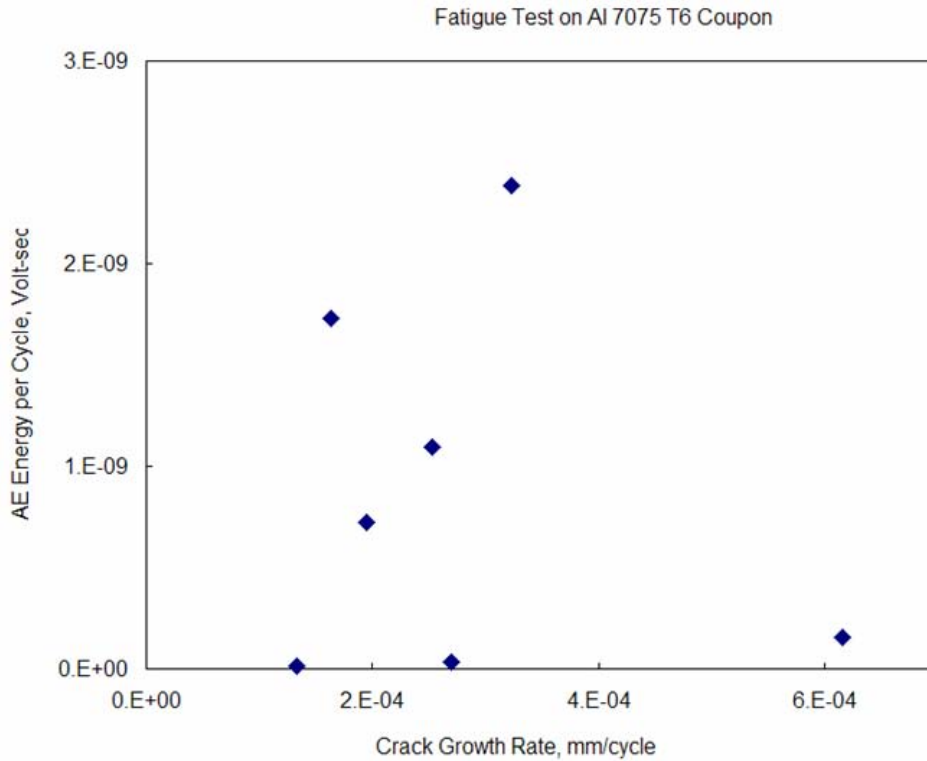
Figure 8. Acoustic emission energy per cycle as a function of fatigue crack growth rate for 2-inch wide coupon specimen.

The objective of acoustic emission monitoring is to estimate the rate of crack growth per cycle directly from the AE signals. For 2-inch wide coupon as well as the 6-inch wide panel specimen, the fatigue crack growth rates were measured initially using low power hand held magnifiers at intervals of several thousands of cycles and the average crack growth per cycle was determined. From the AE data collected during such intervals the average acoustic emission energy per cycle was also calculated. Figure 8 shows the variation of the acoustic emission energy per cycle measured

by the bonded sensor with the fatigue crack growth rate. Lack of good correlation for this plot could be attributed to poor resolution of the hand held magnifier for crack length measurement and the presence of some noise in the signals.

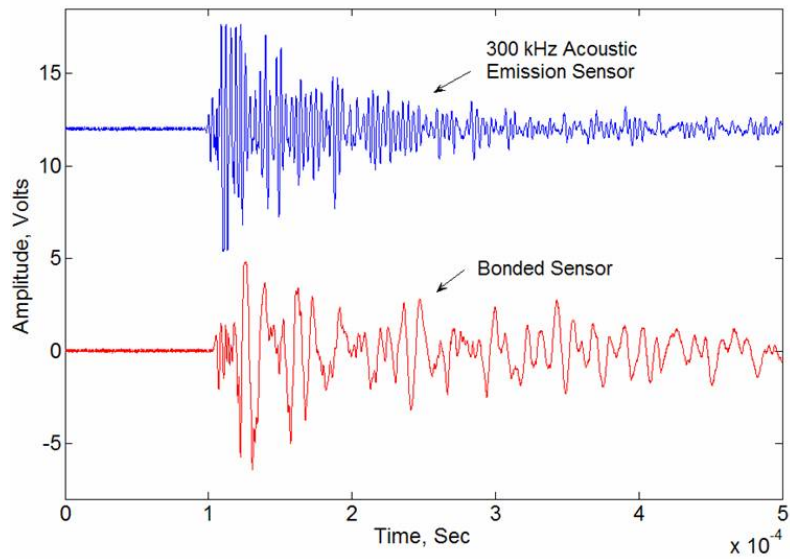
Figure 9. Simulated acoustic emission event showing comparison of responses of the resonant frequency sensor and the bonded continuous sensor

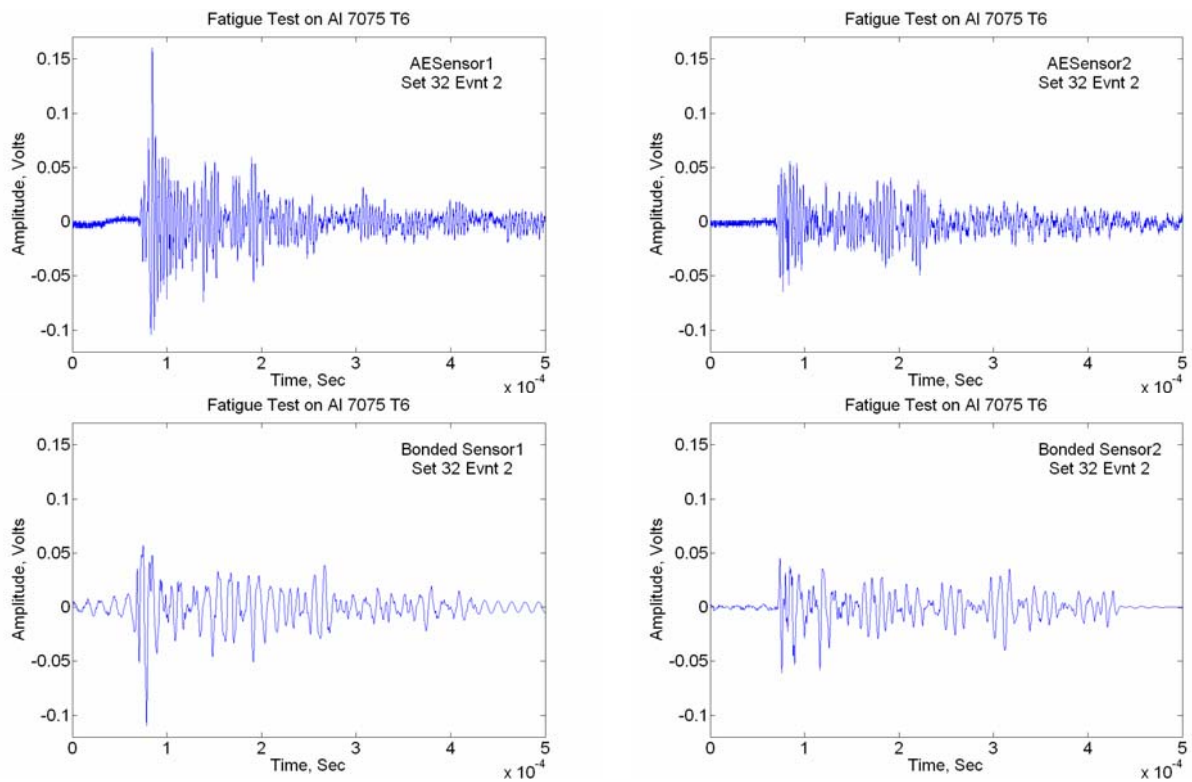
Figure 10. Waveforms corresponding to a crack growth event in 0.125" thick 7075-T6 panel with central crack

The 7075-T6 panel was instrumented with one continuous sensor 2.5 inches above the crack and another continuous sensor 1.5 inches below the crack. Both of these continuous sensors had two nodes each. 300kHz resonant frequency sensors were located at 2 inches above and below the crack. The response of the bonded continuous sensor and resonant frequency sensors corresponding to a simulated AE event are compared in Figure 9. The panel was loaded at a frequency of 5 Hz and the data reported were collected using the wide band preamplifier and oscilloscope mentioned earlier. The cycling was stopped periodically to measure the crack length using a 45X traveling microscope. The crack growth was monitored from an initial length of about 0.375 inch to a final length of nearly 3 inches. A set of waveforms from the two continuous sensors and the two resonant frequency sensors are shown in Figure 10. The waveforms from the continuous sensor contained high amplitude, low frequency components below 100 kHz. These waveforms for the continuous sensor were filtered with a 70 kHz to 500 kHz band pass filter before plotting in these figures. The origin of the signals could be ascertained from the time difference between the top and bottom sensor signals. Hence, it was possible to determine if the signals were from the fatigue crack at the center of the panel or from the fretting in the grip area. Two events whose sources were identified are plotted in Figure 13. The signals in the bottom row were from the bonded continuous sensor. The signal due to fatigue crack growth generally had short rise time and higher frequency content in the beginning, while the fretting related signals had longer rise time and smaller amplitude. However, it was not possible to discriminate between the crack growth related signals and fretting related signals from the resonant frequency sensor. For this panel almost all the signals recorded were from fatigue crack growth. The energy content in these waveforms was calculated and from the total energy recorded during the periodic stops of cycling, the AE energy per cycle was determined. Figure 14 shows the plot of the AE energy per cycle vs. the crack growth rate da/dN.

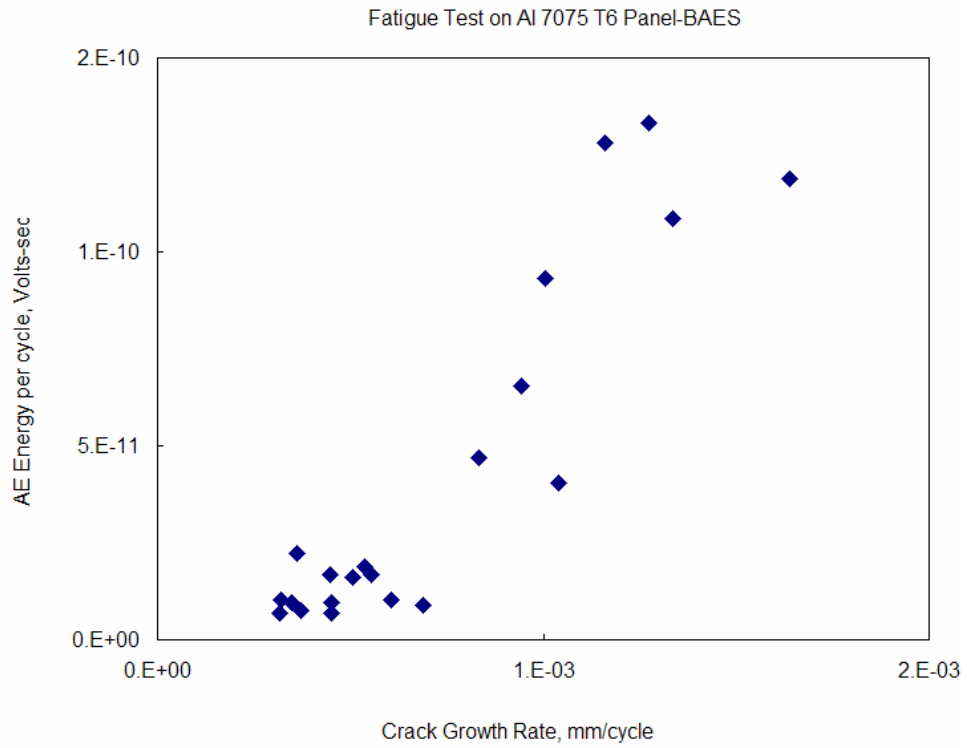
Figure 12. Relationship between the crack growth rate and the acoustic emission energy per cycle for 0.125 inch thick 7075-T6 panel.

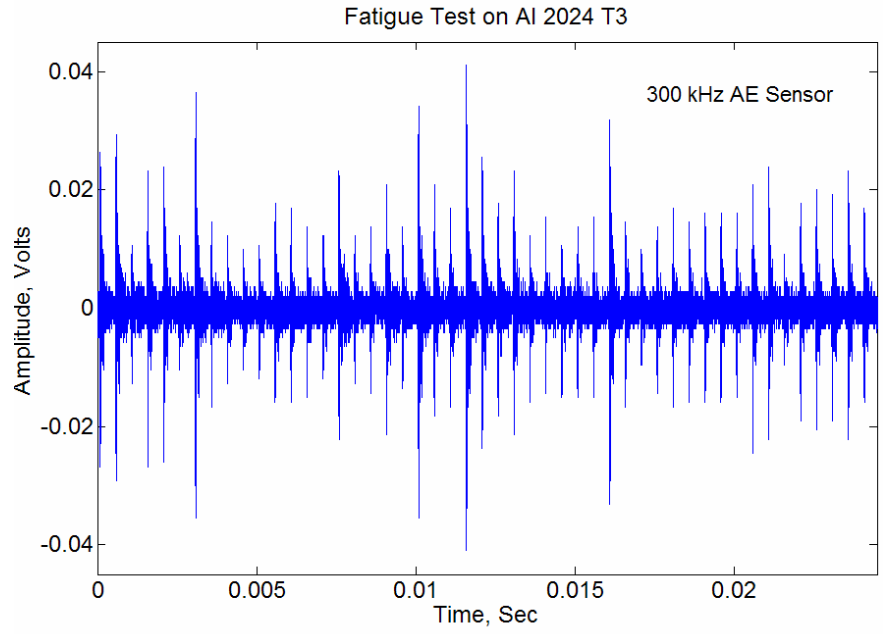
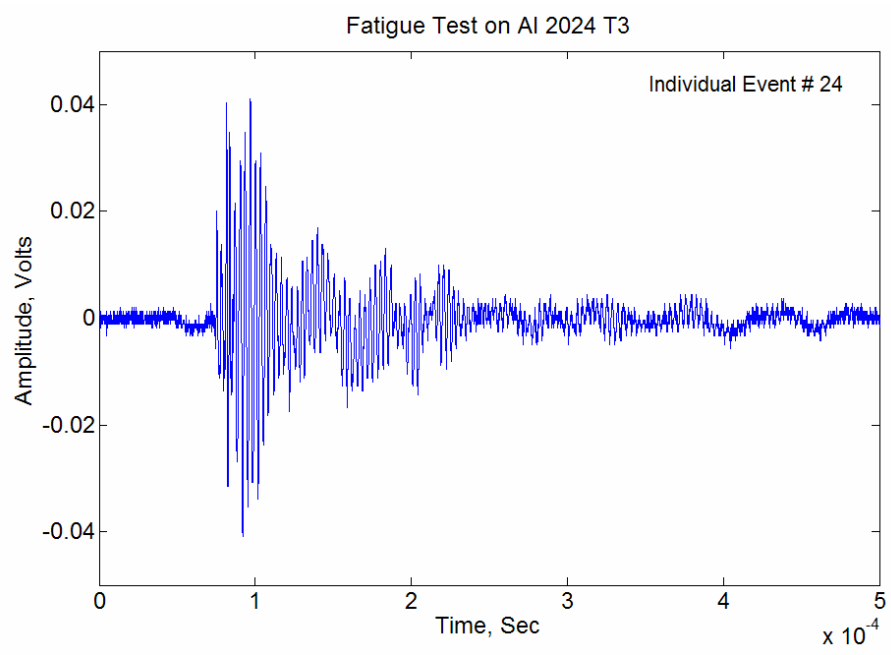
Figure 13. AE Signals from 300 kHz resonant frequency sensor due to fatigue crack growth in 2024-T3 Aluminum Panel; (a) Sequence of 49 AE events, and (b) One of the events in the sequence

A 2024-T3 panel was initially instrumented with two 300 kHz resonant frequency sensor to observe the fatigue crack growth related AE signals, this panel was cyclically loaded to grow the fatigue crack by about 0.25 inch. One sequence of AE signals from the fatigue crack growth is shown in Figure 13. Subsequently this panel was instrumented with continuous sensor and the fatigue crack growth was monitored. The acoustic emission signals from the 1 mm thick 2024-T3 panels shown in Figure 14 were smaller in amplitude compared to those observed in 7075-T6 panel. The plot of the AE energy per cycle vs. crack growth rate da/dN is shown in Figure 15.

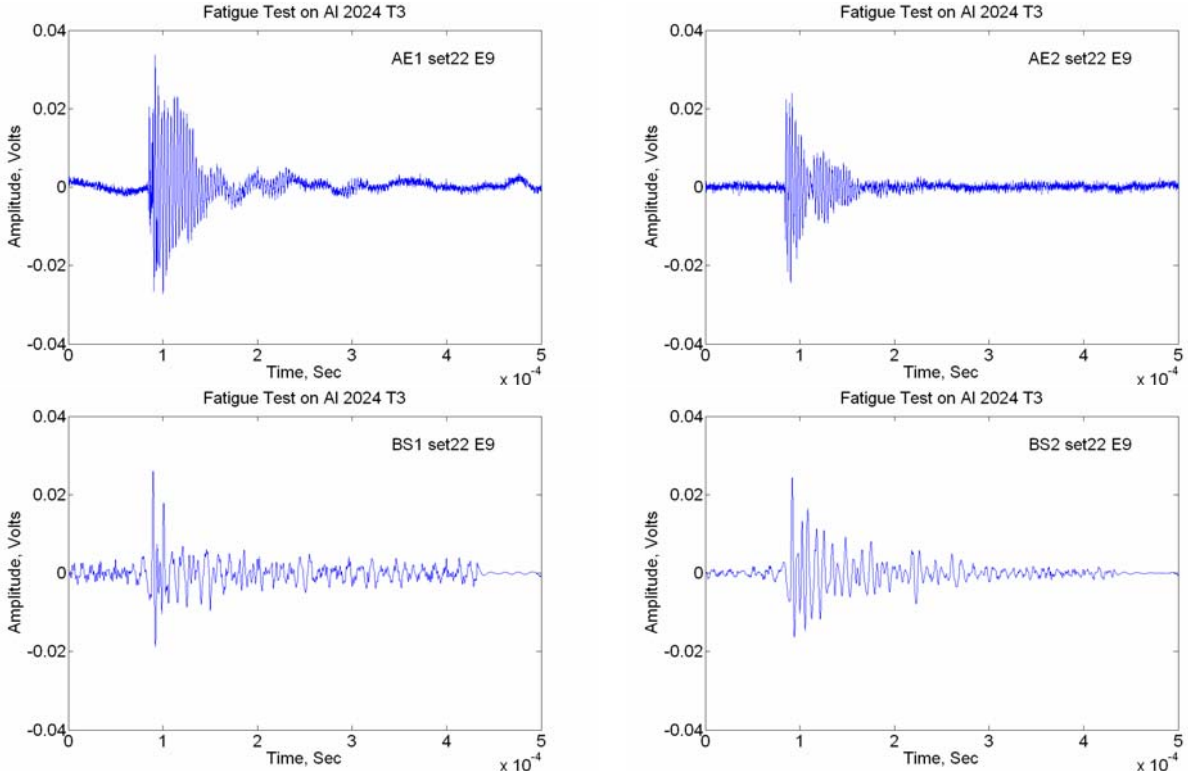
Figure 14. Waveforms corresponding to crack growth related event. The waveforms shown in the top are from 300 kHz resonant frequency sensors located above and below the central crack and the waveforms shown in the bottom are those due the corresponding bonded continuous sensors.

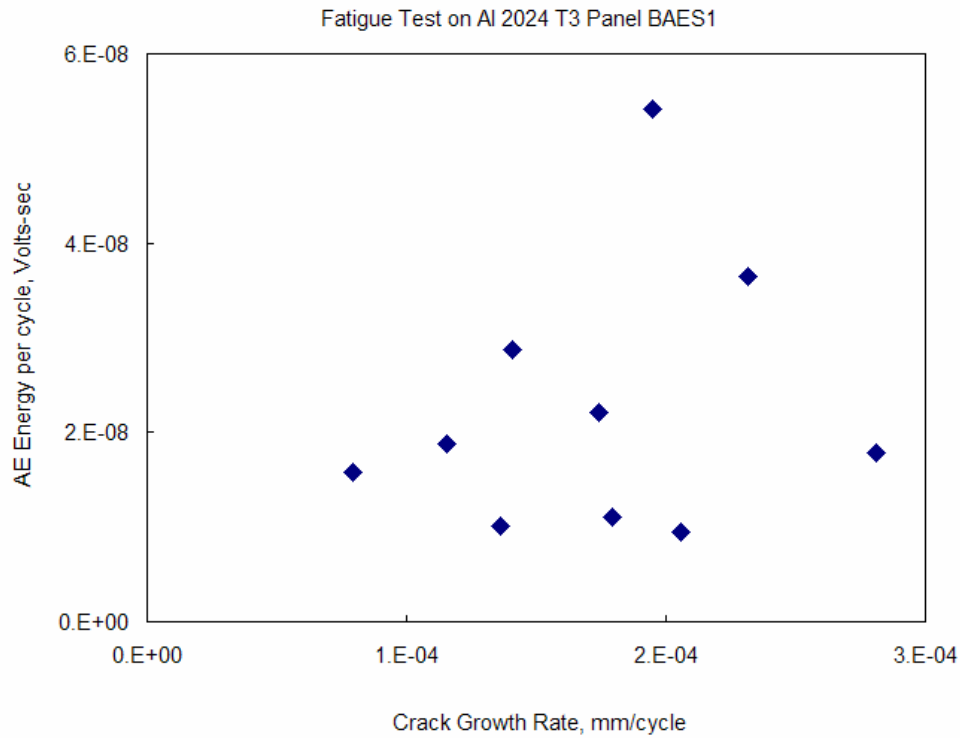
Figure 15. Plot of AE energy/cycle versus crack growth rate for 2024-T3 panel.

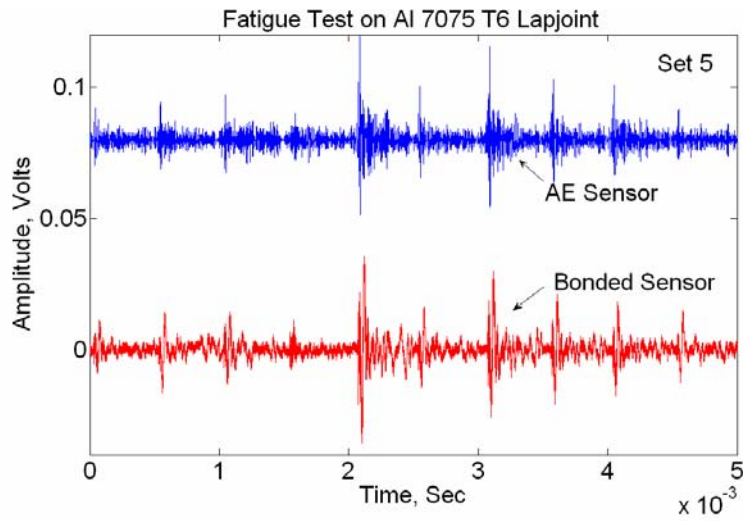
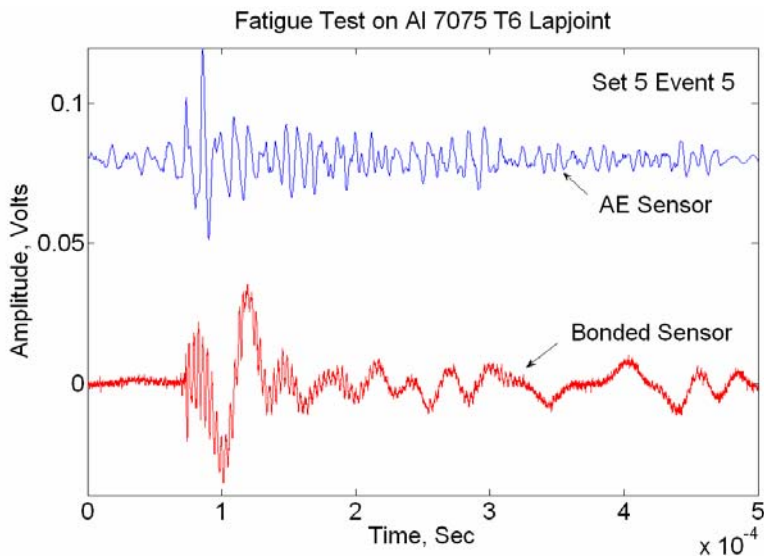
Figure 16. Acoustic emission signals recorded from the 7075-T6 lap joint; (a) a sequence of events recorded during the fatigue loading; (b) an event from this sequence magnified along the time axis.

The 7075-T6 lap joint was fabricated from a 1 mm thick plate. The specimen was fabricated with a pre-crack at the central bolt hole in the bottom row of the lower plate. It was instrumented with two continuous sensors with 3 nodes each, one in the top plate of the joint and the other in the bottom plate. In addition, two 300 kHz resonant frequency sensors were also located nearly at the same distance as the bonded continuous sensors in the two plates. The specimen was cycled at 1 to 3 Hz loading rate and acoustic emission waveforms were recorded using wideband voltage amplifier and digital oscilloscope. Representative waveforms from the crack growth are shown in Figure 16.

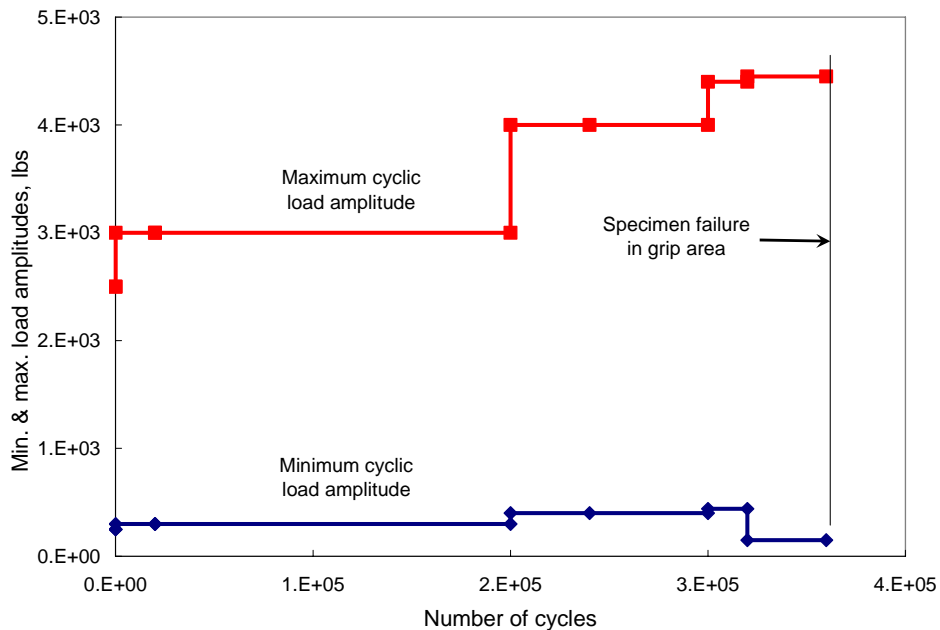
Figure 19. Minimum and maximum load amplitudes applied during the fatigue testing of lap joint from a KC-135 aircraft fuselage.

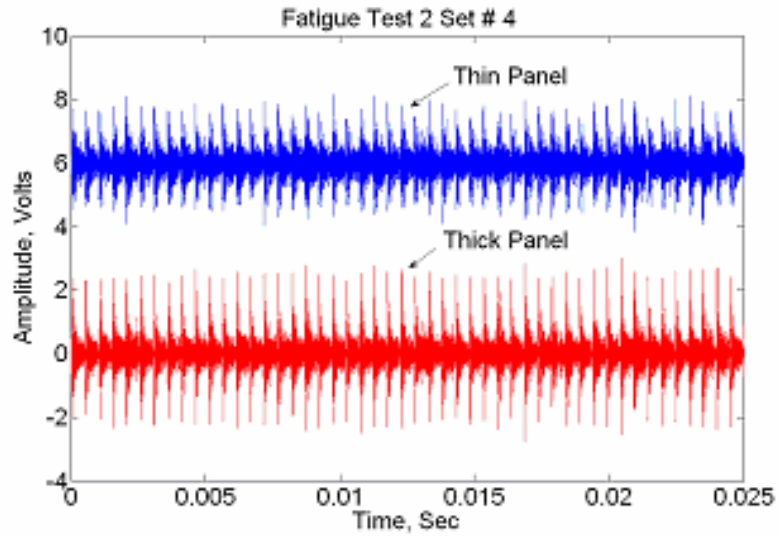
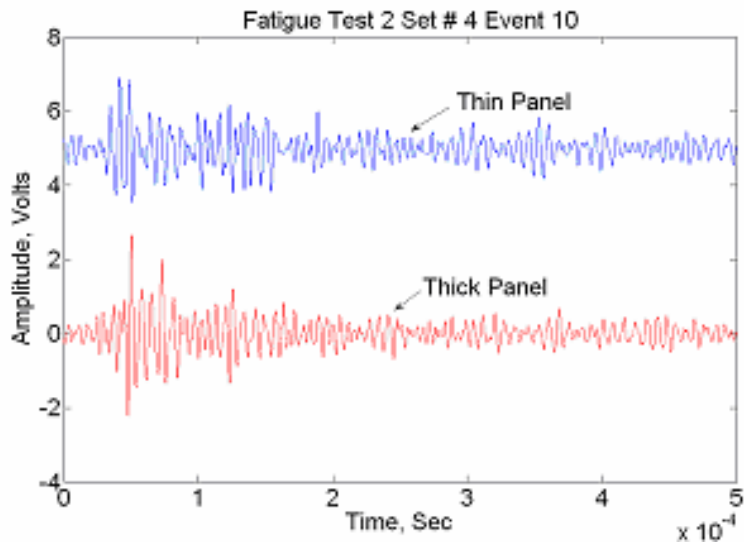
Figure 20. (a) A sequence of AE events recorded during the second segment of fatigue load and (b) one of these events magnified along the time axis.

each containing 50 events each collected during a small number of cycles at various stages of the fatigue loading are described here. The first of these sequences, recorded during the 2nd segment of fatigue loading is shown in Figure 20. A series of 50 events shown in the top of this Figure and the single event from this sequence that is magnified along the time axis shown in the bottom of the Figure. It may be observed that most of these events have relatively large rise time (larger than 15 microseconds) and large duration (above 300 microseconds). The second sequence shown in Figure 21 was recorded during the seventh segment of fatigue load during which the cyclic amplitude was the highest. However, during a short period of this segment, the cyclic frequency was increased from 10 Hz to 20 Hz. This increase in the frequency of fatigue load resulted in excessive vibration of the specimen and hence, the frequency was changed back to 10 Hz within a short time. The sequence shown in Figure 21 were recorded during this period when the cyclic frequency was at 20 Hz, and most of the signals during this period are believed to be due to fretting caused by the excessive vibration. Relatively long rise time and duration are seen in these events and hence they are similar to the events seen during the second sequence of fatigue load.

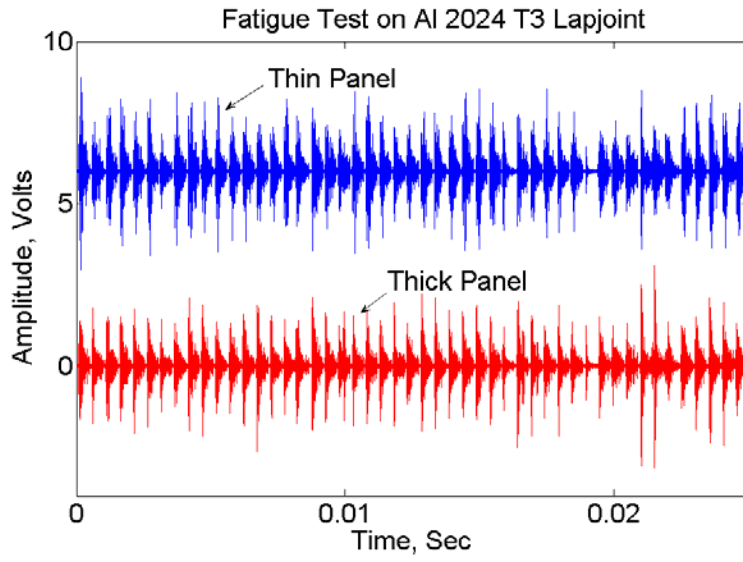
Figure 21. (a) A sequence of AE events recorded during the seventh segment of fatigue load during which the loading frequency was increased to 20 Hz resulting in excessive specimen vibration and (b) one of these events magnified along the time axis.

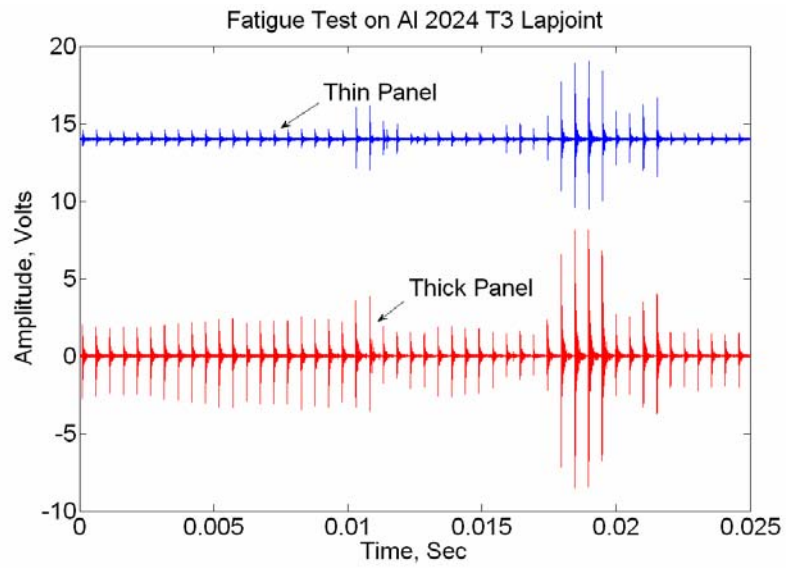
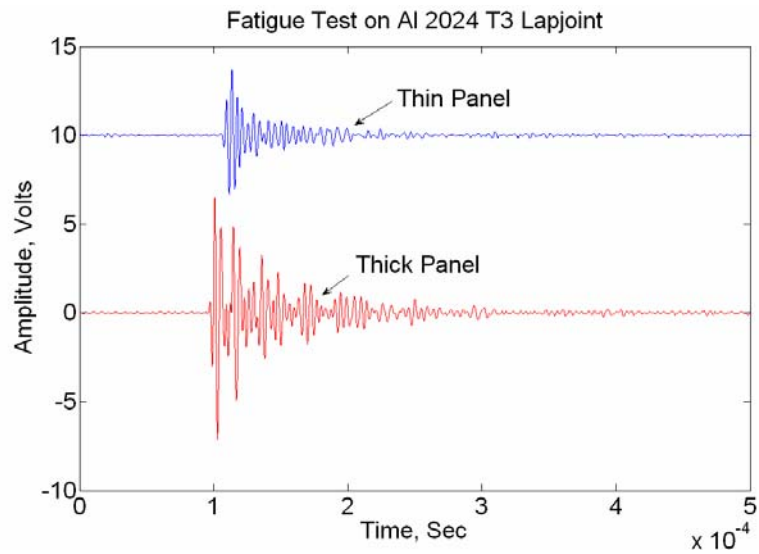
Figure 22. (a) A sequence of AE events recorded towards the end of the seventh segment of fatigue load and (b) one of these events magnified along the time axis.

The third sequence of events shown in Figure 22 was recorded towards the end of the seventh sequence of fatigue load. These events had predominantly short rise time, less than 7 microseconds and short duration, less than 150 microseconds. Further, most of these signals arrived at the bottom continuous sensor first and later at the top continuous sensor. The amplitude of the signals from the lower continuous sensor was larger than the top continuous sensor. The arrival time difference along with the short rise time and short duration of these events suggest the initiation and propagation of a crack near the bottom row of rivets in the lower half (thick panel) of the riveted joint. This hypothesis has to be confirmed by visual inspection or by other means.

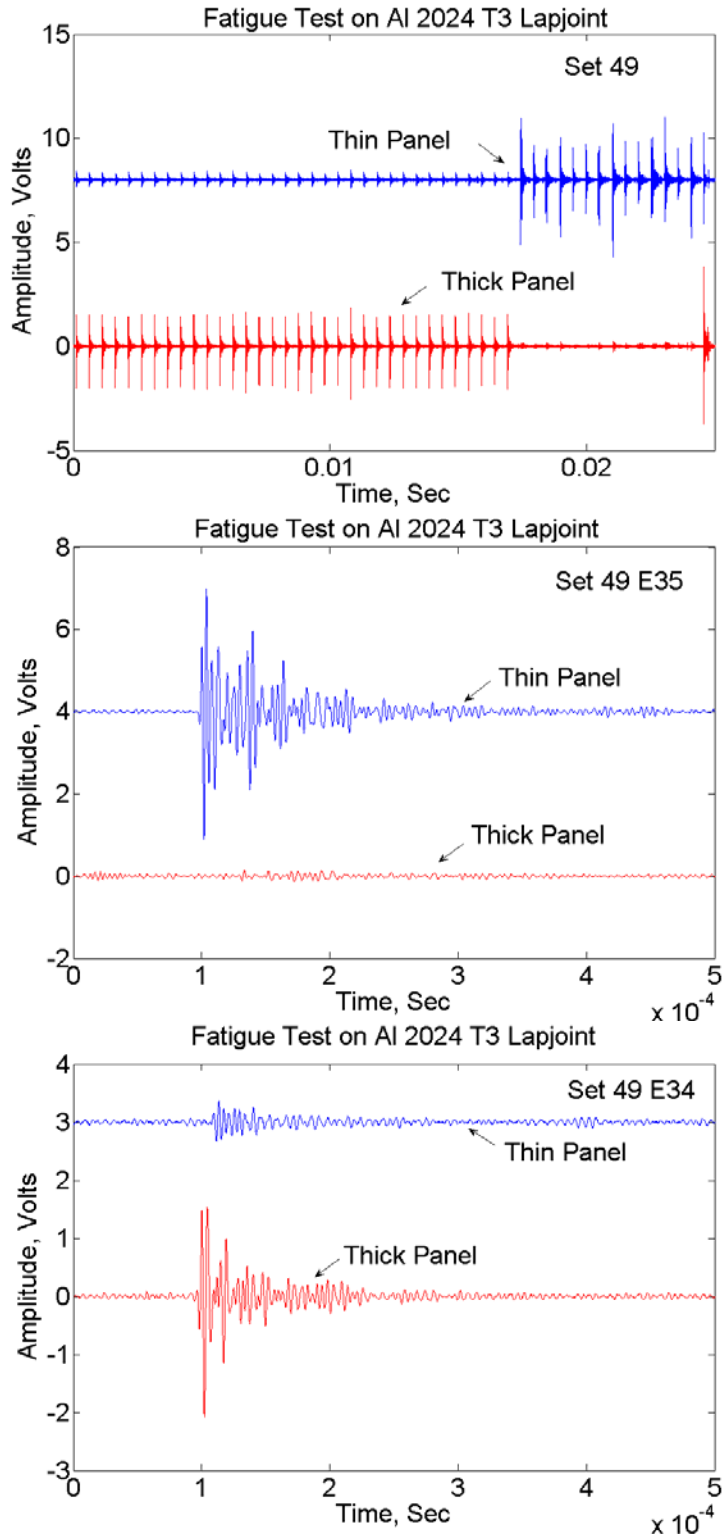
Figure 23. (a) A sequence of AE events recorded towards the end of the seventh segment of fatigue load and (b) one of these events magnified along the time axis for which the top continuous sensor received the emissions first; (c) one of the events for which the bottom continuous sensor received the signal first.

The fourth sequence shown in Figure 23 was recorded very near the failure of the specimen. This sequence of events also had predominantly short rise time and short duration events similar to the events shown in Figure 22. Such events, however, arrived at the top sensor first before reaching the bottom continuous sensor. The amplitude of the signals from the top continuous sensor was larger than the bottom continuous sensor. The arrival time difference along with these signal characteristics suggests the presence of a crack above the top continuous sensor in the thin panel. Since the final failure was caused by crack growth in the top grip area, the signals recorded does correlate with the crack growth in the grip area. This unexpected failure event in the grip region does emphasize the advantage of the acoustic emission technique in that one does not have to know the location of the potential failure location in the region that is being monitored to detect dangerous levels of crack growth rates.

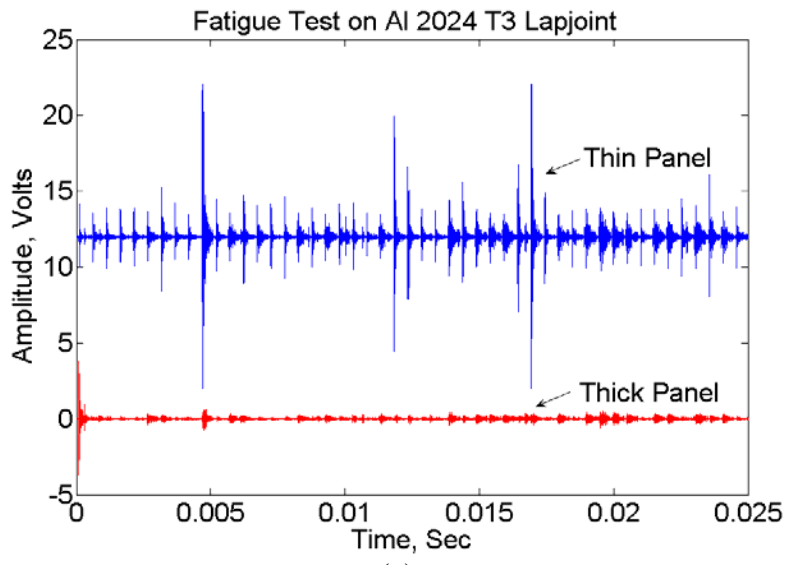
Figure 24. (a) A sequence of AE events recorded towards the end of the seventh segment of fatigue load and (b) one of these events magnified along the time axis.

Figure 24. (c) One of the events from the sequenced shown above which had very high energy indicating fast crack growth; (d) another event in this sequence with long rise time and long duration.
