NRL/MR/6180--06-8983

Final Report on Fire Performance of Shipboard Electronic Space Materials

14. ABSTRACT Compartment-scale tests were conducted to evaluate the fire performance of typical cables, false deck panels, and thermal/acoustic insulation panels found in electronic spaces (such as CIC) on DDG-51 class destroyers. Cable fires were ignited by combinations of simulated short circuits and external spray fires, and the progress of the fires was monitored. It was found that modern electronic space materials are remarkably resistant to ignition and tend to be self-extinguishing. Compartment temperatures were found to be survivable, but the atmosphere was seriously degraded due to production of smoke and toxic gases and to oxygen depletion.

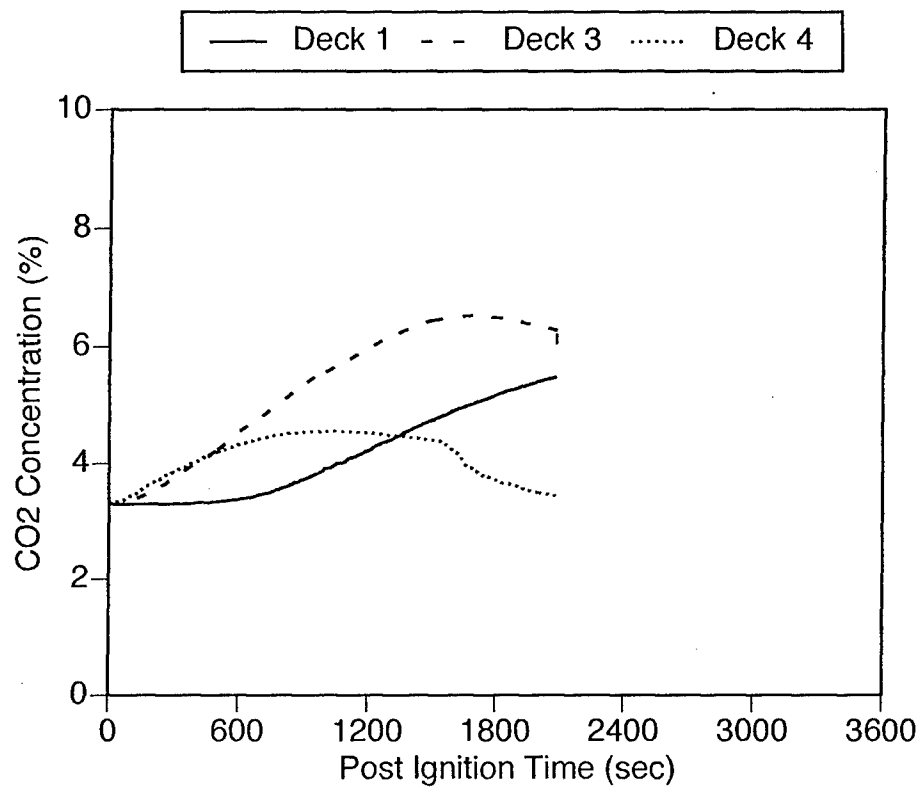
Figure 29. Comparison of CO₂ Concentrations for Group 1 Tests

After alignment of the cable ignition times at time zero, as discussed in the text, the carbon dioxide concentrations for the three Group 1 tests could be directly compared.

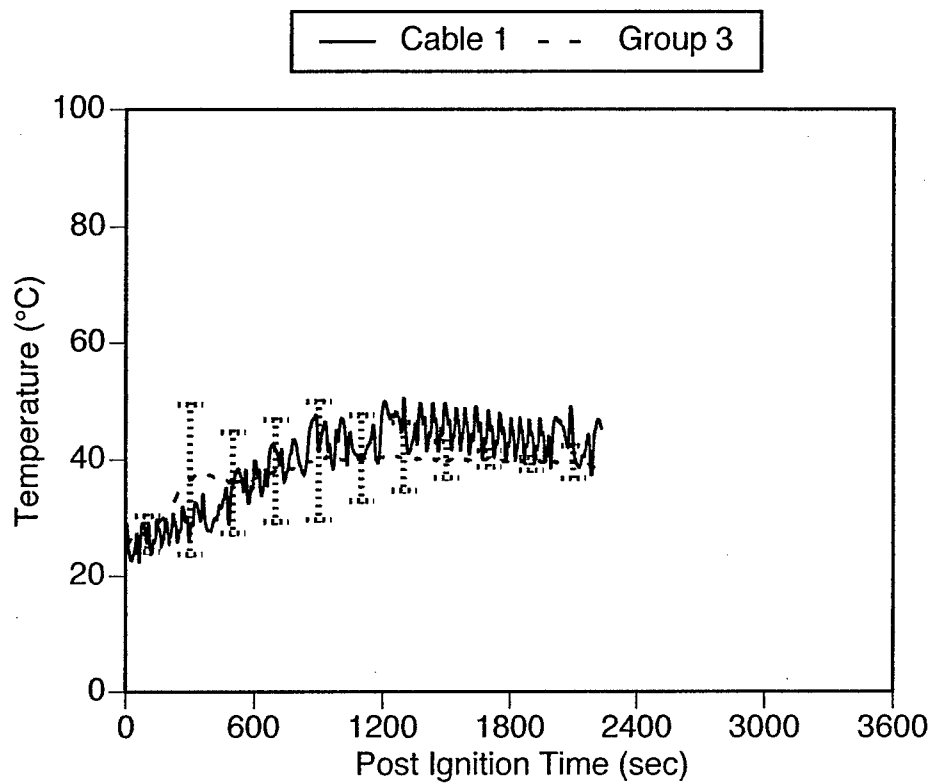
Figure 32. Above Deck Cable 1 and Group 3 Air Temperatures

The above deck air temperatures from the Cable 1 test are compared with those from the Group 3 tests. The dotted error bars represent one standard deviation for the Group 3 results; Cable 1 was a single test and, therefore, no errors could be calculated.
