**US Army Corps
of Engineers®**
Engineer Research and
Development Center

Unbonded Aggregate Surface Roads

December 2006

Final report

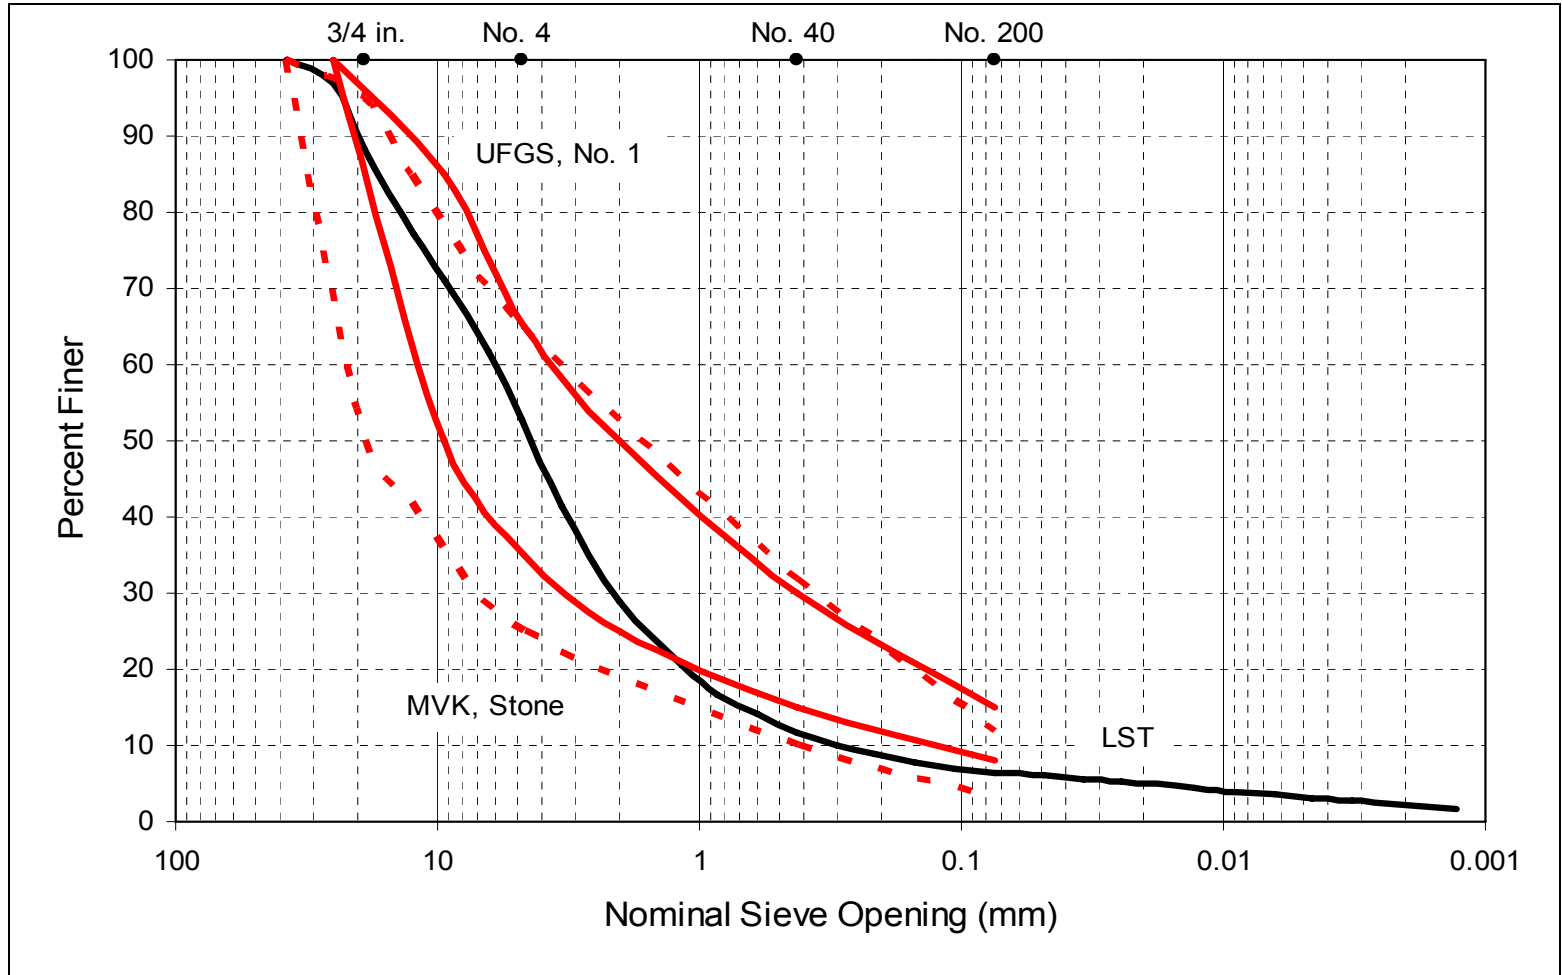
Figure 39. Comparison of as-received LST grading to USACE specifications

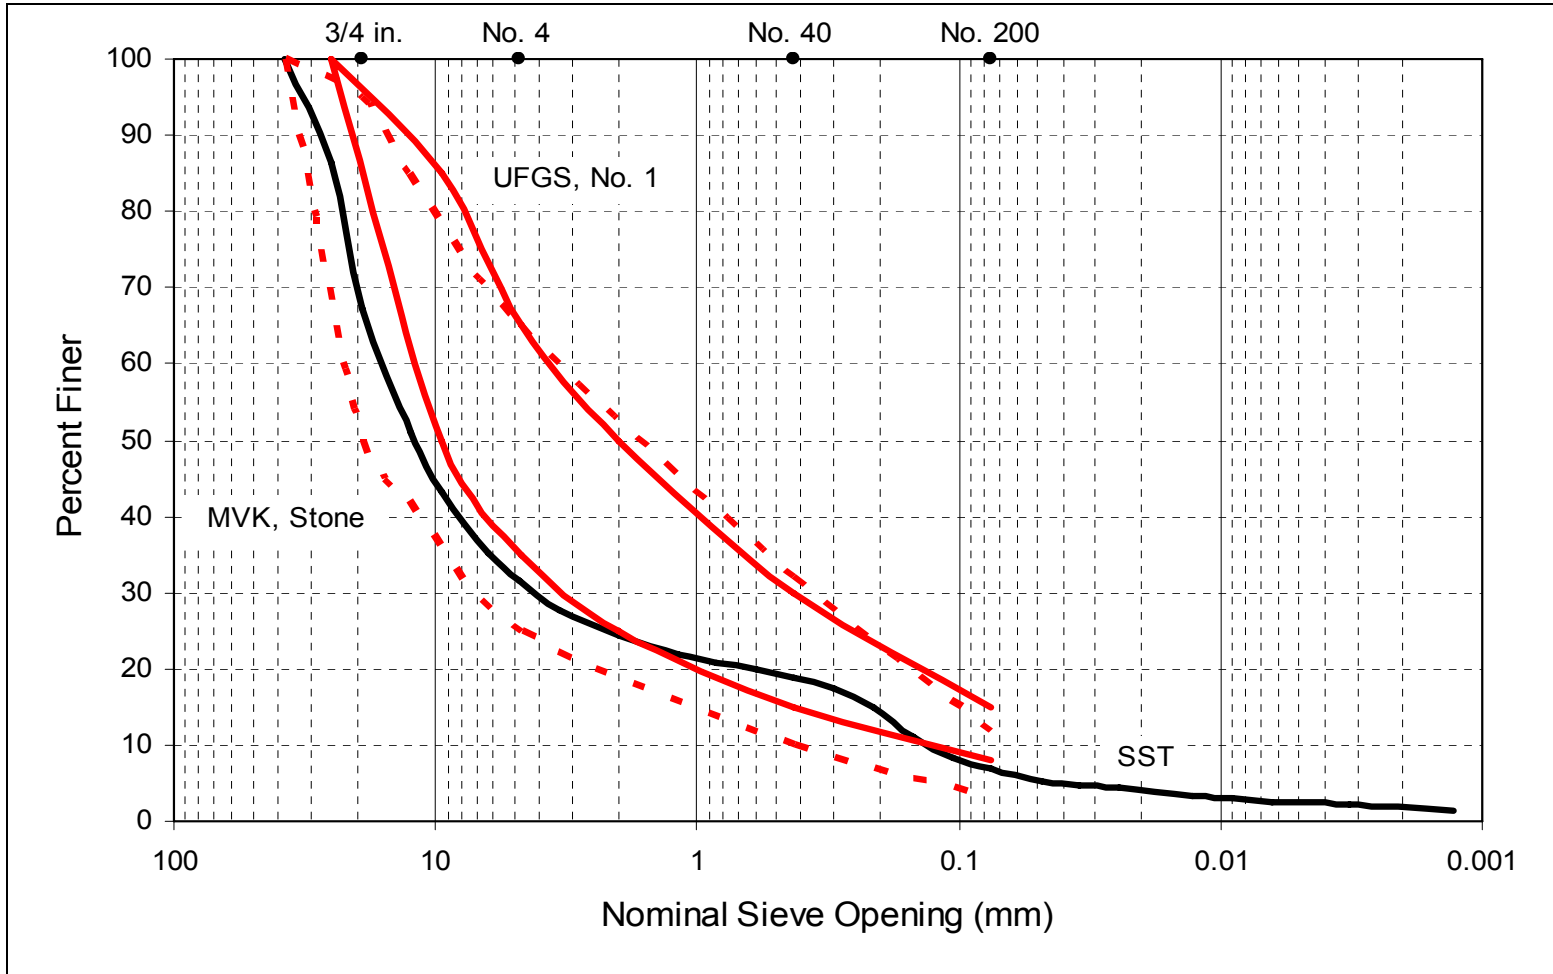
Figure 40. Comparison of as-received SST grading to USACE specifications

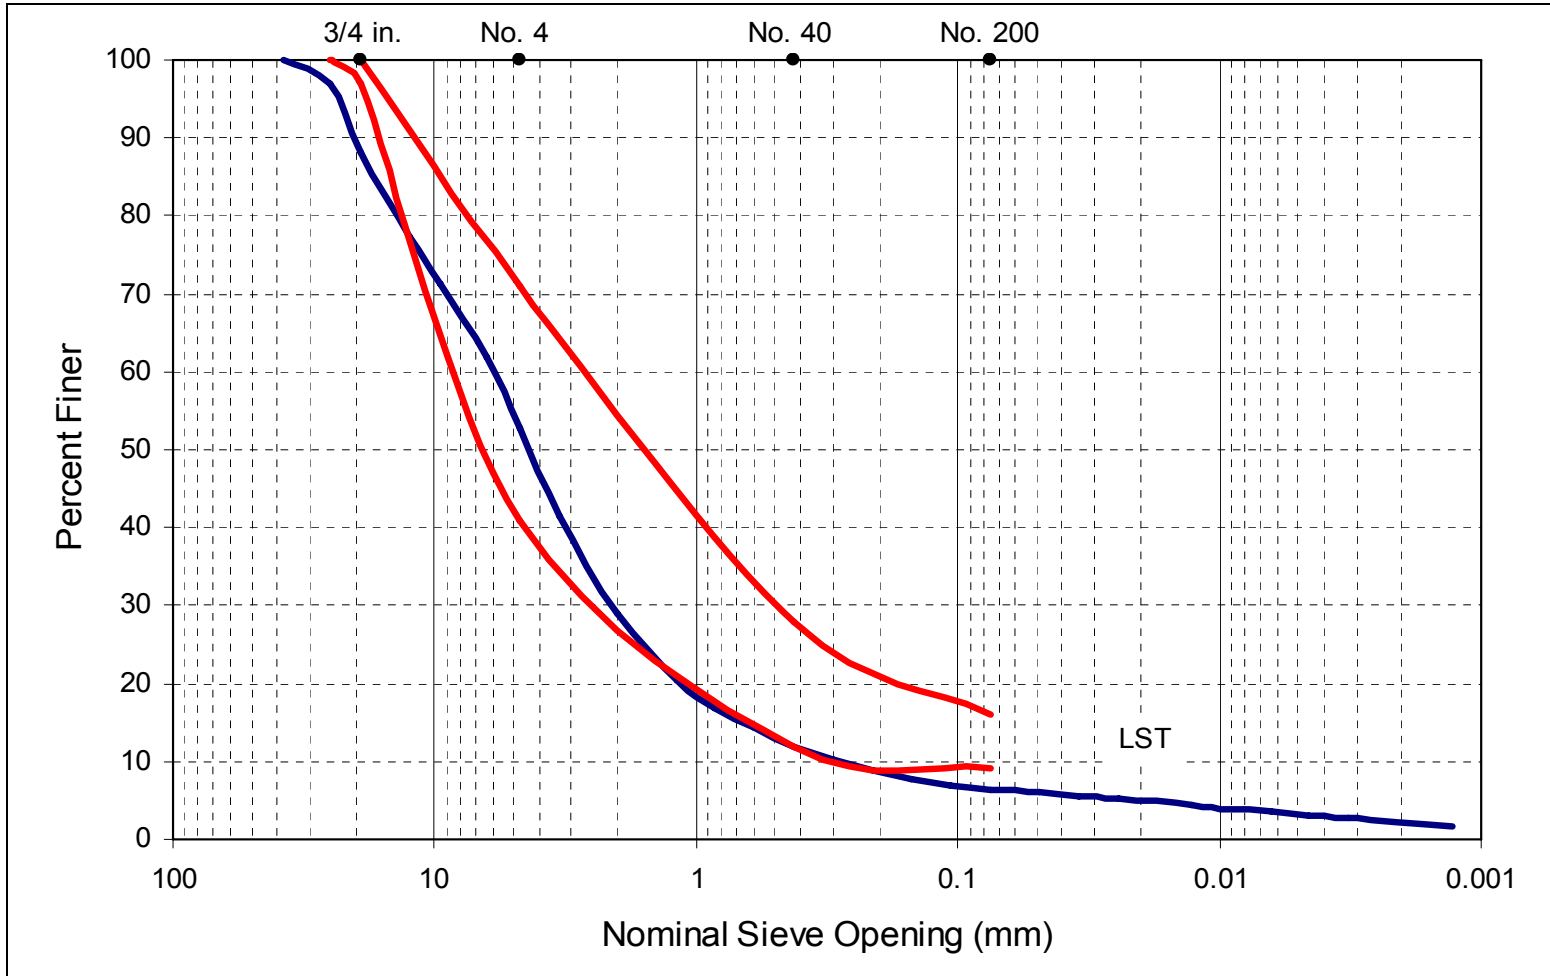
Figure 45. Comparison of as-received LST grading to FHWA specifications

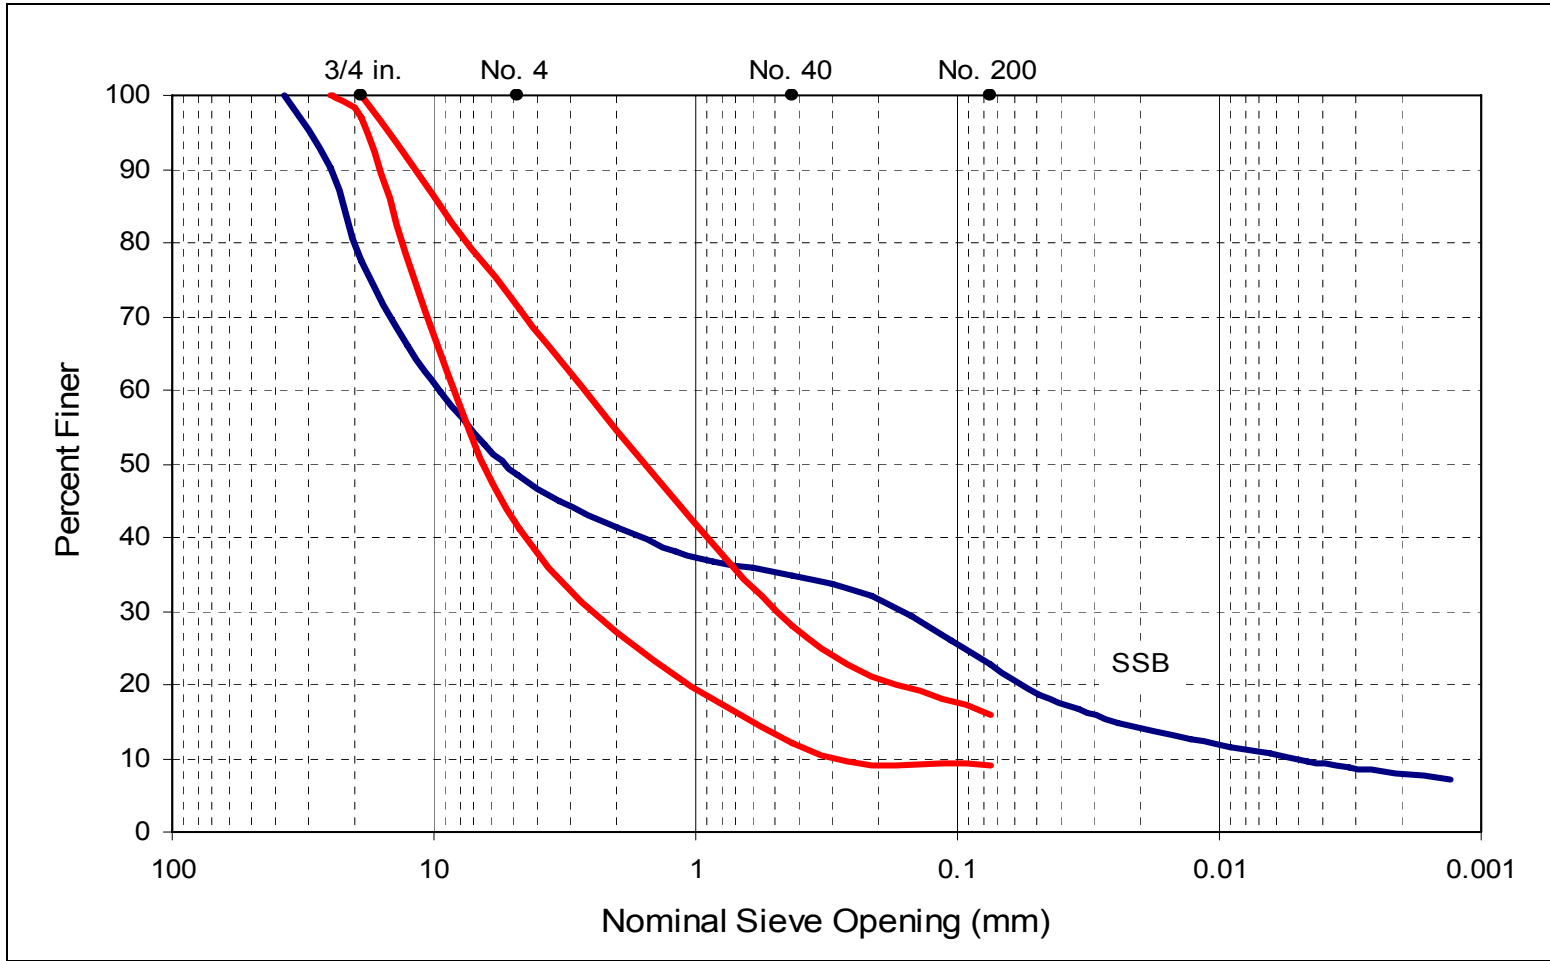
Figure 51. Comparison of as-received SSB grading to FHWA specifications

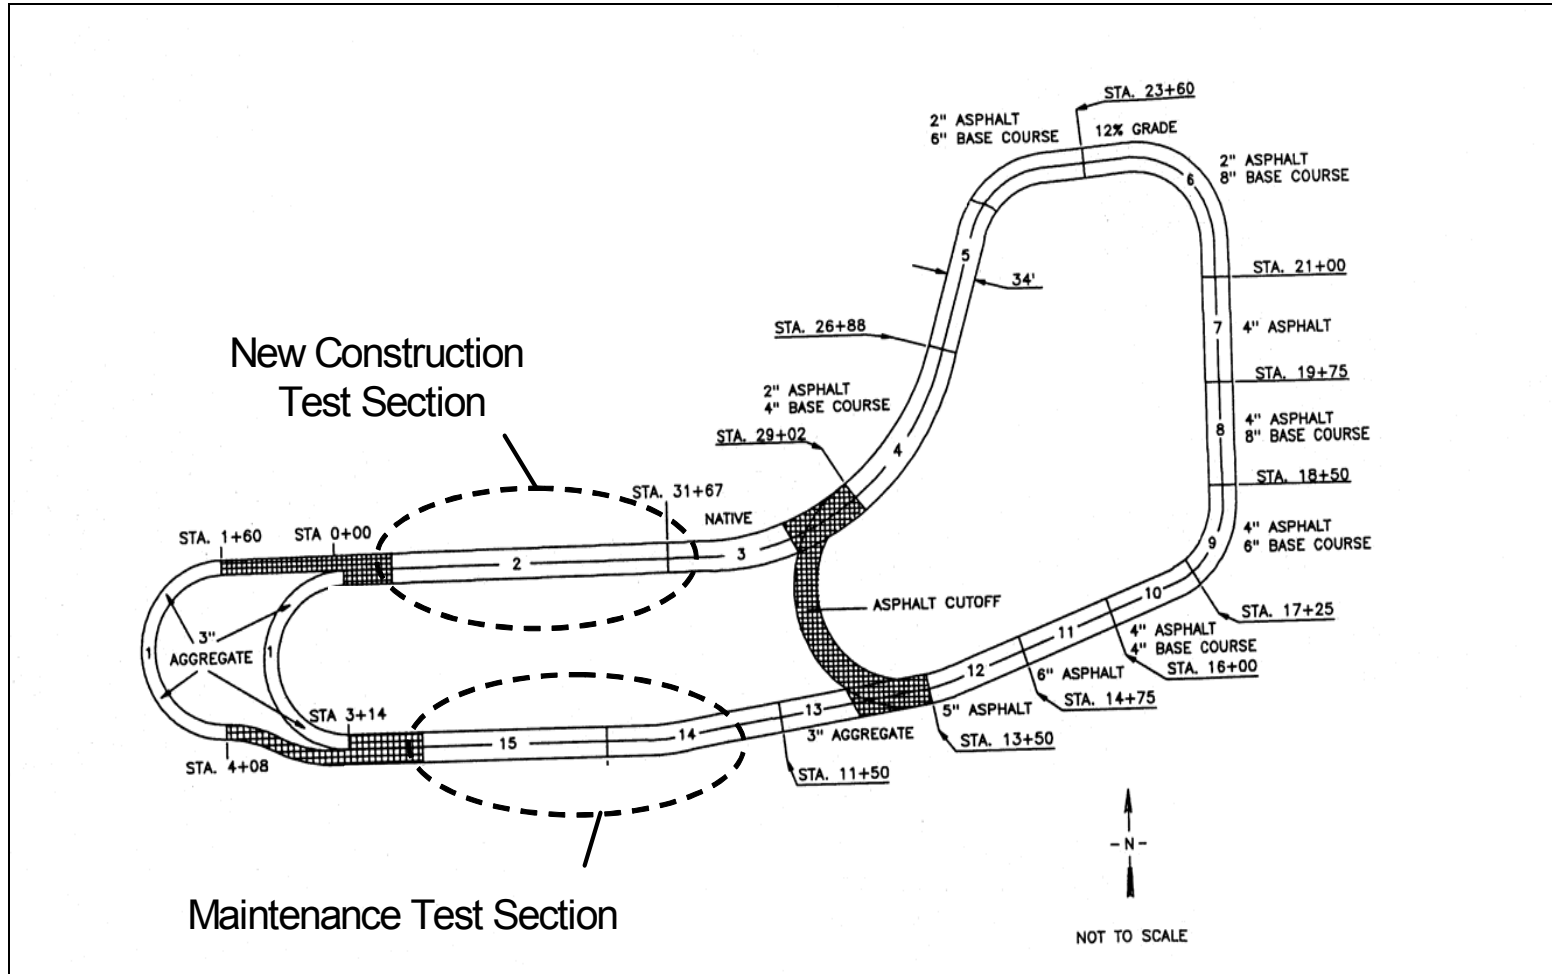
Figure 54. Test track with approximate locations of test sections

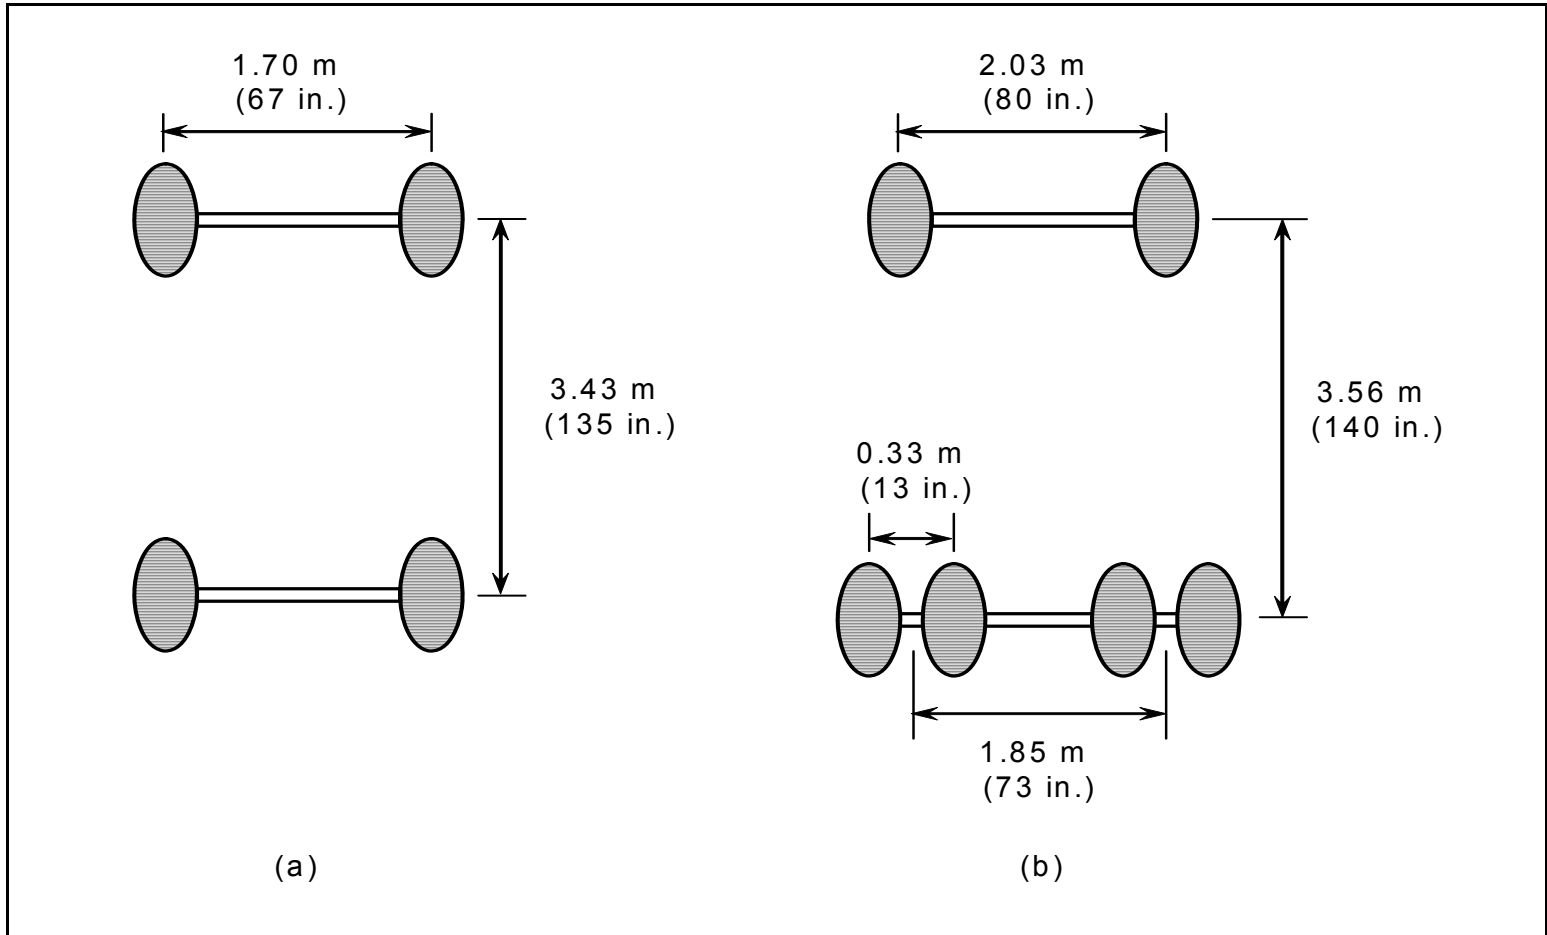
Figure 56. Footprint dimensions for the (a) pickup truck and the (b) dump truck

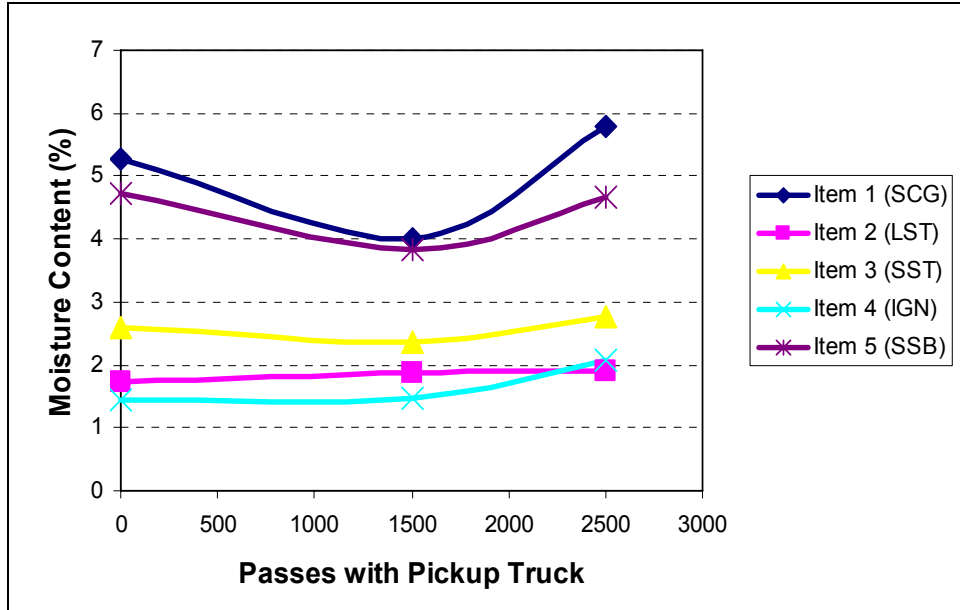
Figure 59. Moisture contents for surface aggregates on maintenance test section, dry lane, 2,500 passes with pickup truck

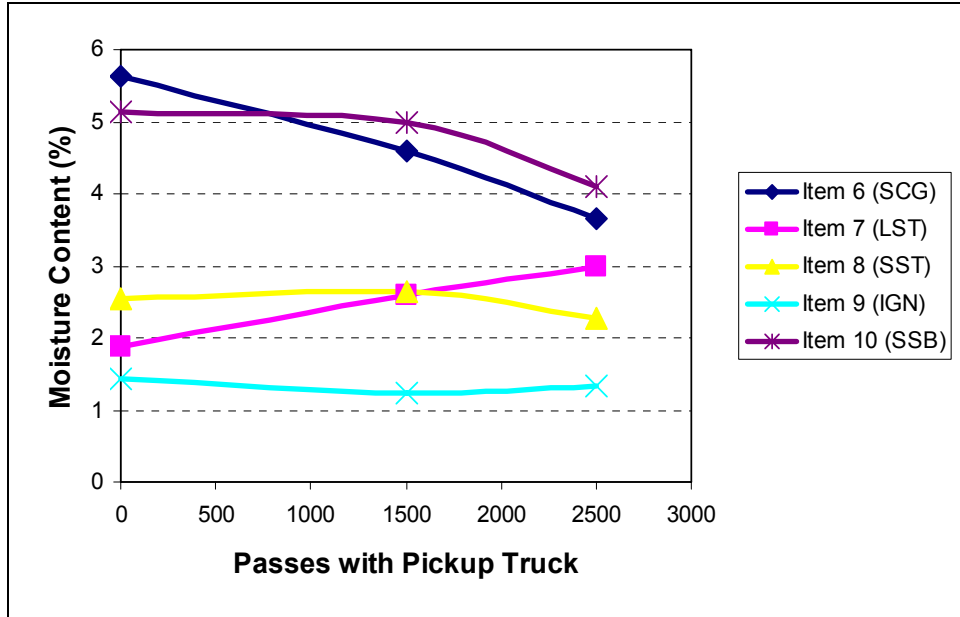
Figure 88. Moisture contents for surface aggregates on new construction test section, dry lane, 2,500 passes with pickup truck

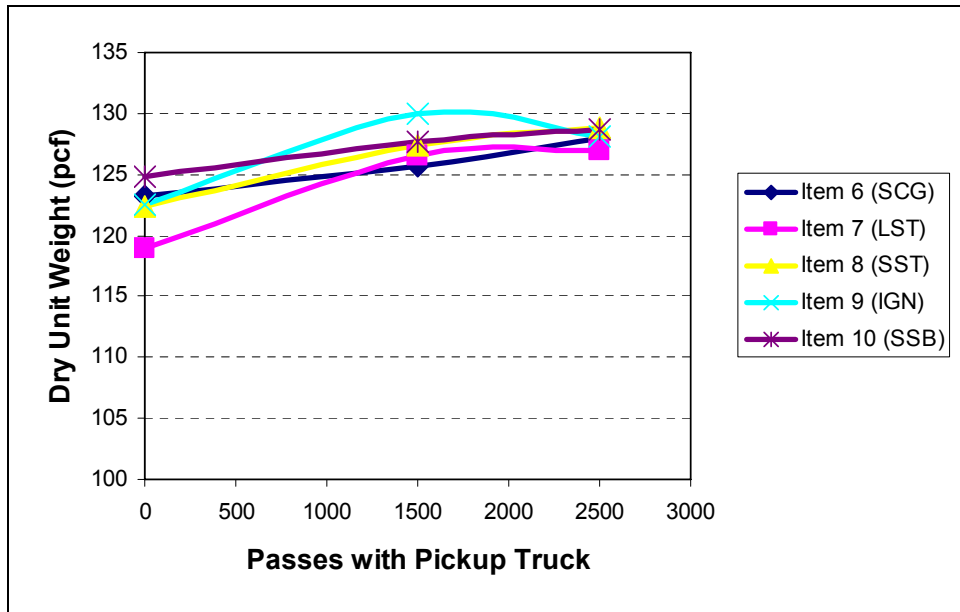
Figure 89. Dry unit weights for surface aggregates on new construction test section, dry lane, 2,500 passes with pickup truck

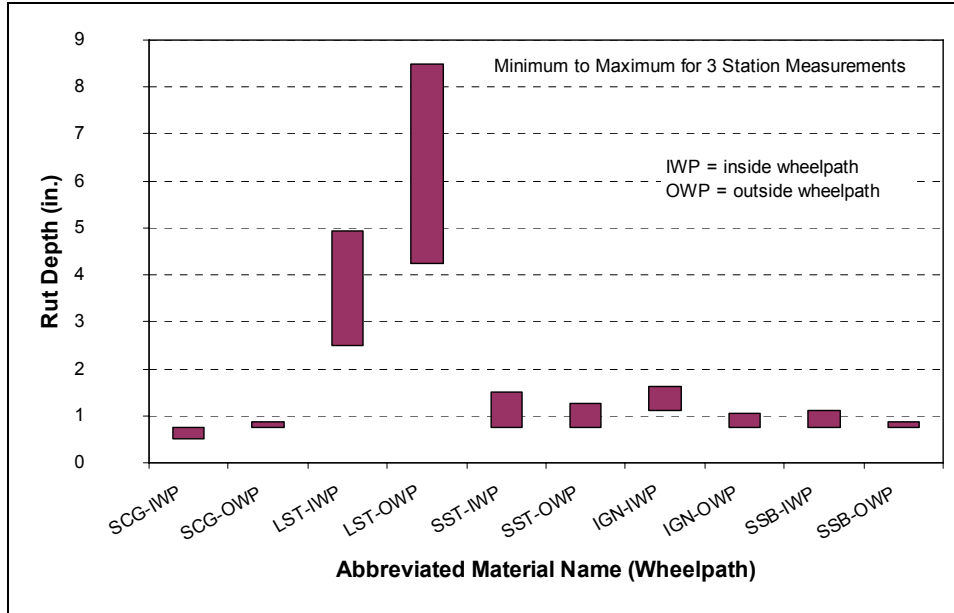
Figure 96. Rut depths for all items, new construction test section, wet lane, 10 passes with pickup truck (August 2004)
