A Survey and Comparison of Several Space Shuttle External Tank (ET) Ice/Frost Detection and Evaluation Systems

Working Paper and Progress Report

**Visual Perception Laboratory
US Army TARDEC
6501 East Eleven Mile
AMSRD-TAR-R/MS 263
Warren, MI**

June 1, 2004

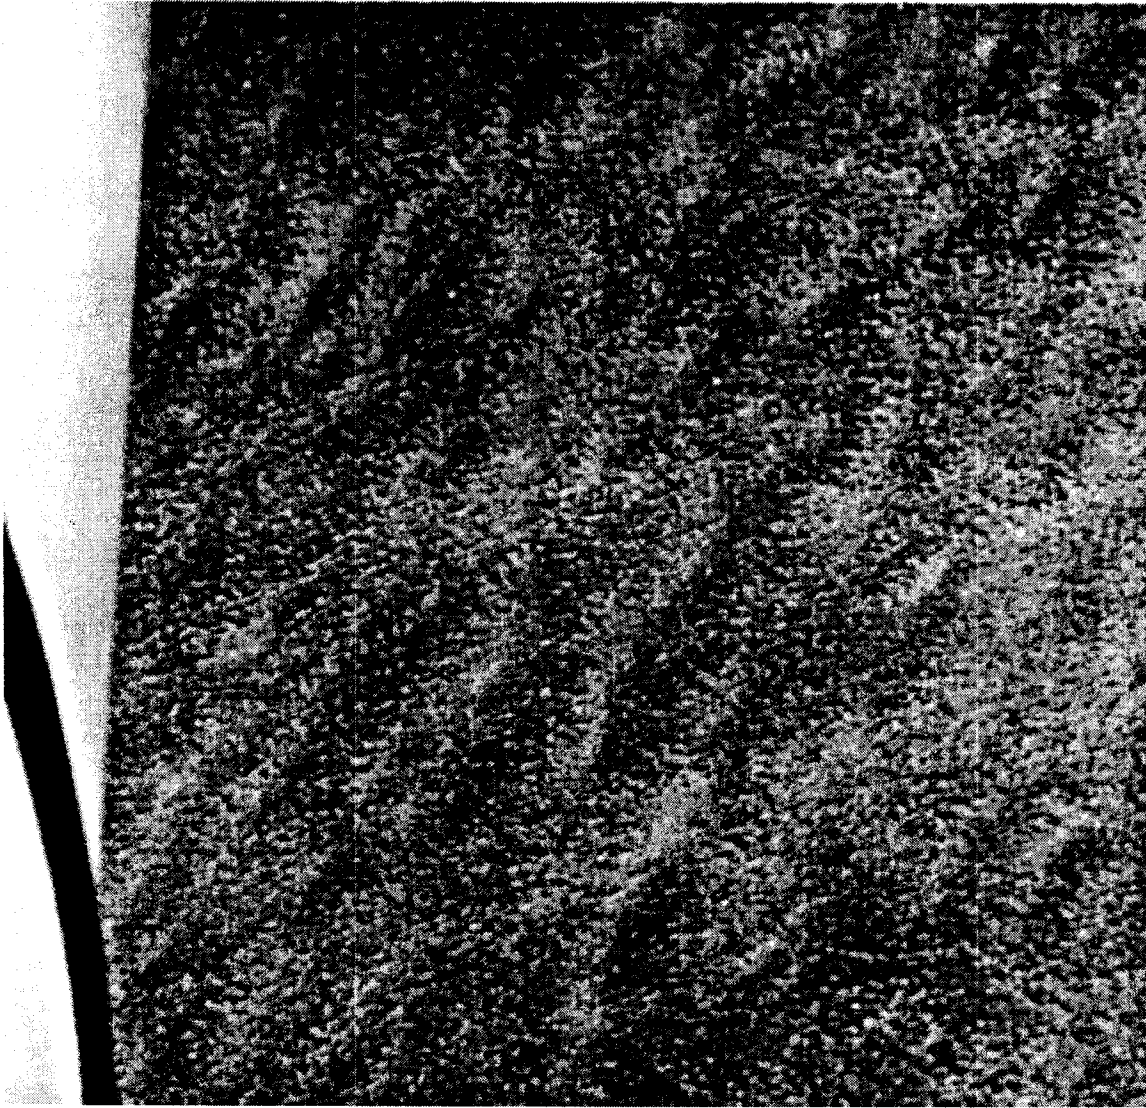
Fig. 4 Close-up view of ice/frost accumulation on the rough surface of ET acreage SOFI. The accumulation was less than 1/16th in. and acceptable per the LCC.

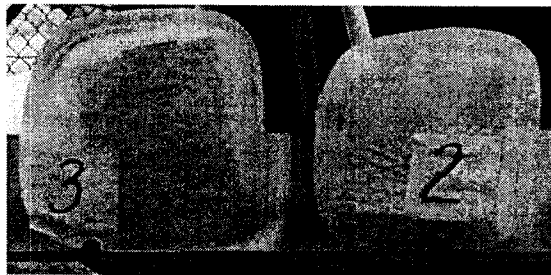
Fig. 20 Samples 3 and 2

Images of the ice-covered ET foam samples were obtained using a Kodak DC265 digital camera. A sample image is shown below in Fig. 20. The corresponding calibrated infrared image that is output from the MD Robotics camera is shown in Fig. 21.

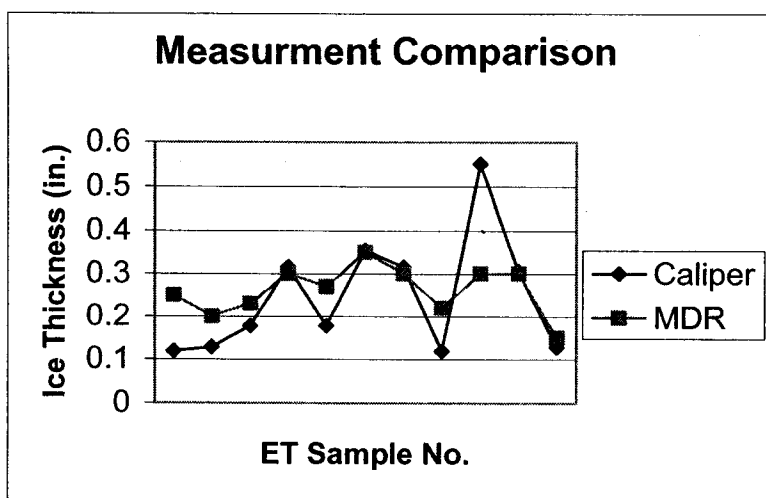
Fig. 22 Caliper measurements of ice on foam and MD Robotics camera measurements

Table 2 shows the caliper measurements of ice thickness on ET foam (columns two to four), and MD Robotics camera measurements (column five) for the first MD Robotics test on 10 February 2004. Absolute and relative differences in the measurements are listed in columns six and seven, respectively. Fig. 22 shows the graph of the caliper measurements of ice on ET foam and MD Robotics camera measurements. It should be noted that the MD Robotics data might not be fully valid because of earlier noted lens problems during the February test. However, the data have been included in this progress report for completeness.

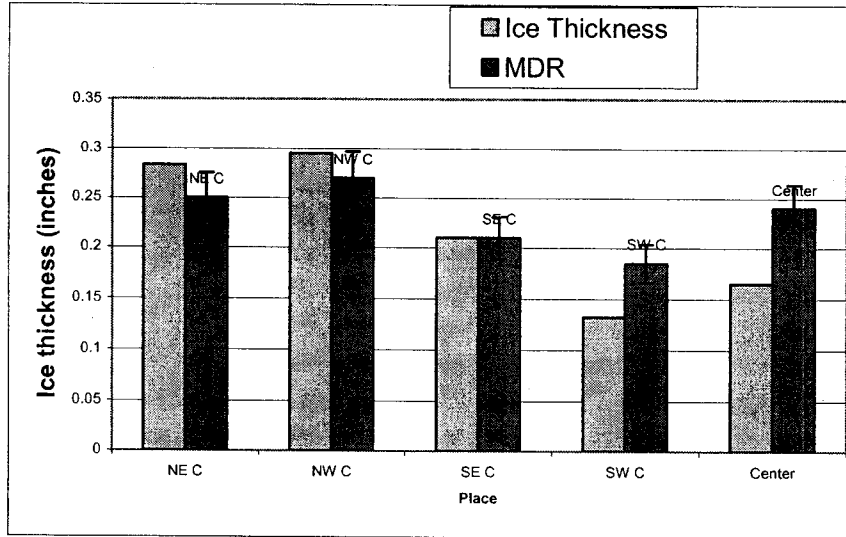
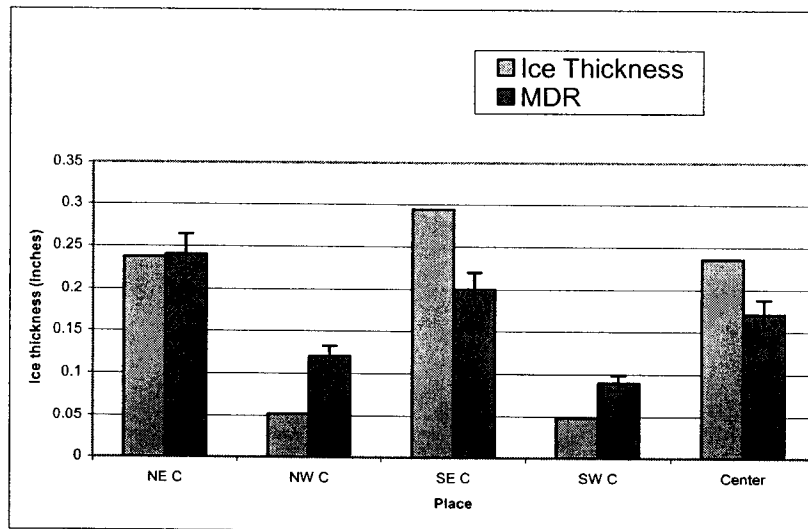
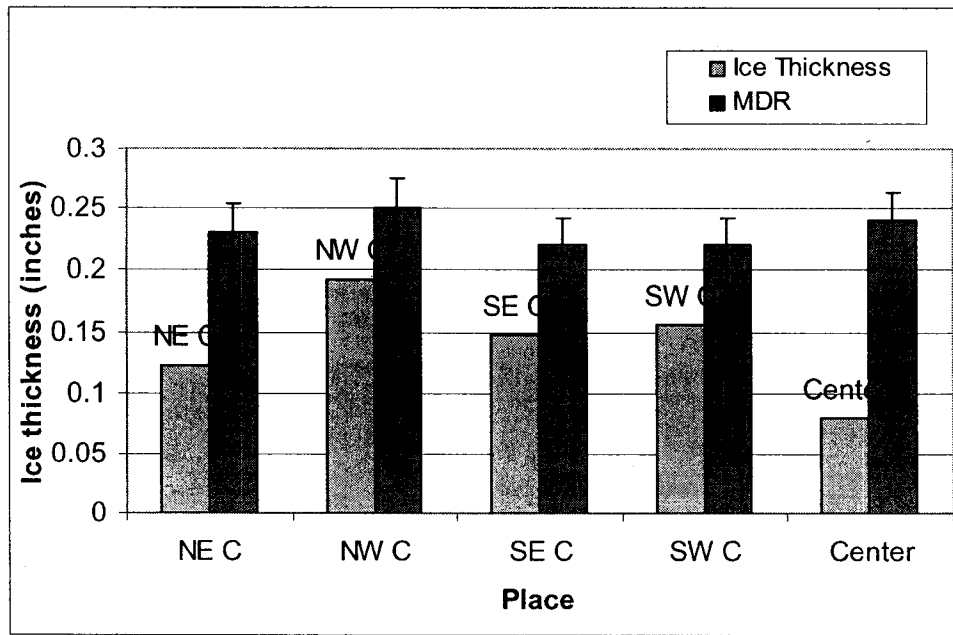
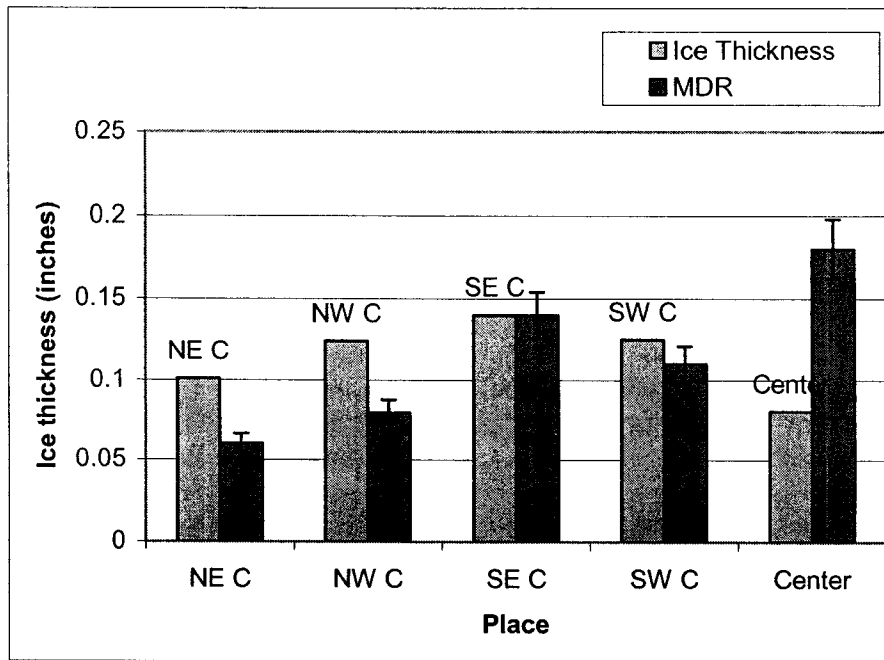
Fig. 28 Sample No. 1 thickness measurements

Fig. 29 Sample No. 2 thickness measurements

Fig. 30 Sample No. 3 thickness measurements

Fig. 31 Sample No. 5 thickness measurements

Fig. 32 Sample No. 7 thickness measurements

Figures 28 through 32 are graphs that show comparisons of the ice thickness of the samples as indicated by the MD Robotics system and measured by the Fowler height gauge. Error bars shown for MD Robotics reading are those recommended by the manufacturer.

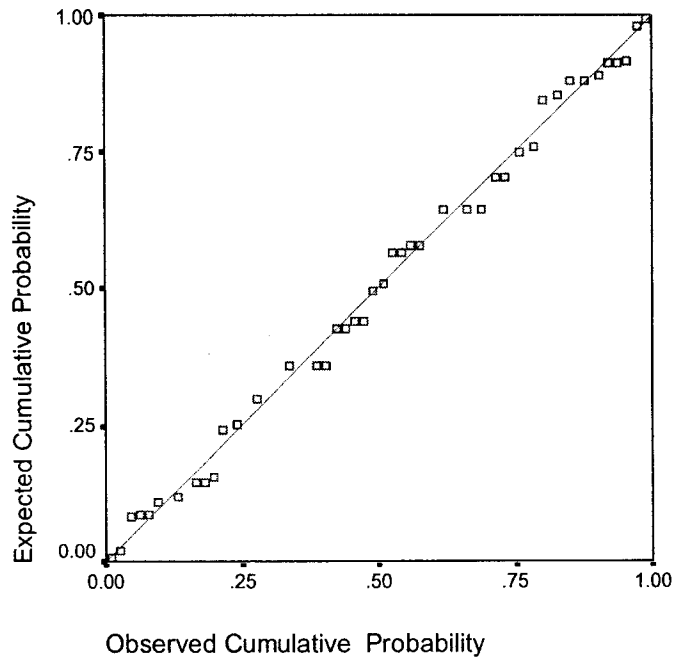
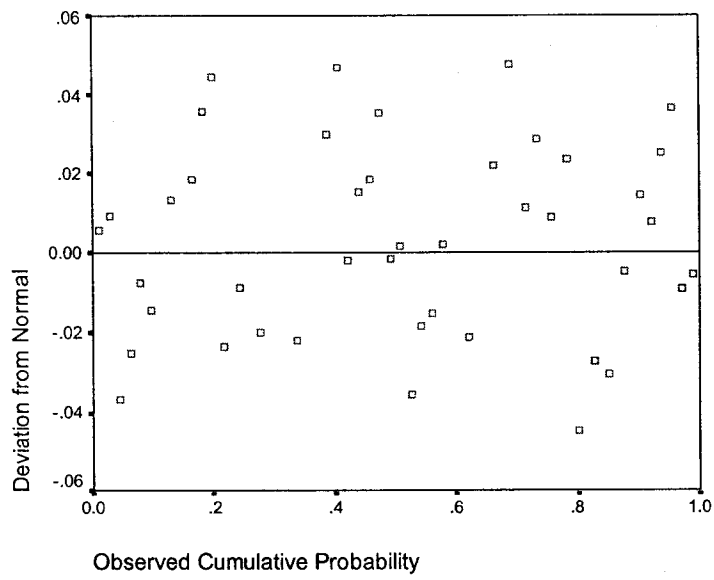
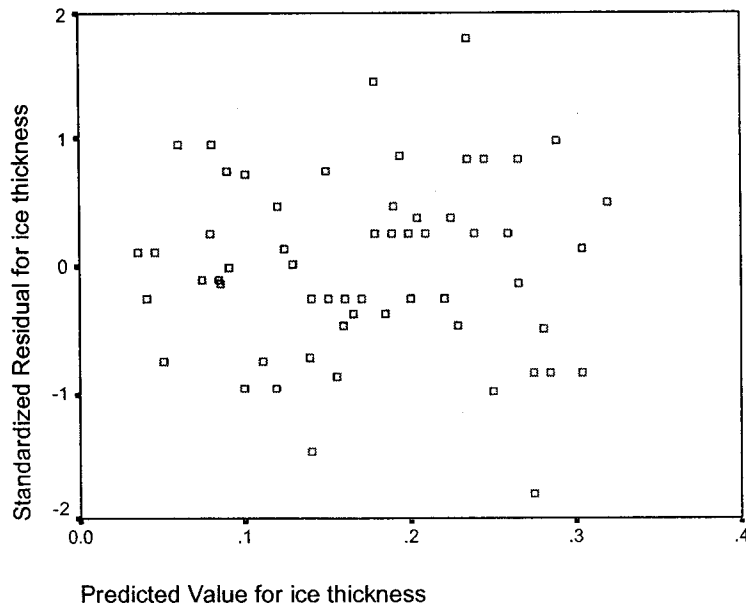
Fig. 33 Normal probability plot of standardized residuals

Fig. 34 De-trended plot of standardized residuals

Fig. 35 Graph of standardized residuals versus measuring device type

Fig. 36 Graph of standardized residuals versus foam sample

Fig. 37 Graph of standardized residuals versus predicted values

In other words, the figures 33 through 37 show that the data fit to the model is good and that it is possible to state with confidence that there is significant difference between the hand operated gauge and the MD Robotics system measurements. Although the values between the hand operated gauge and the MD Robotics system are significantly different in value, the two measurement methods are strongly correlated as shown in Tables 4, 5, and 6.

Figure 36 shows that the standard deviation or precision of the device over the range of the data does not vary. In other words, over the range of ice thicknesses used during testing, the precision was constant and not variable as noted by the manufacturer—MD Robotics.

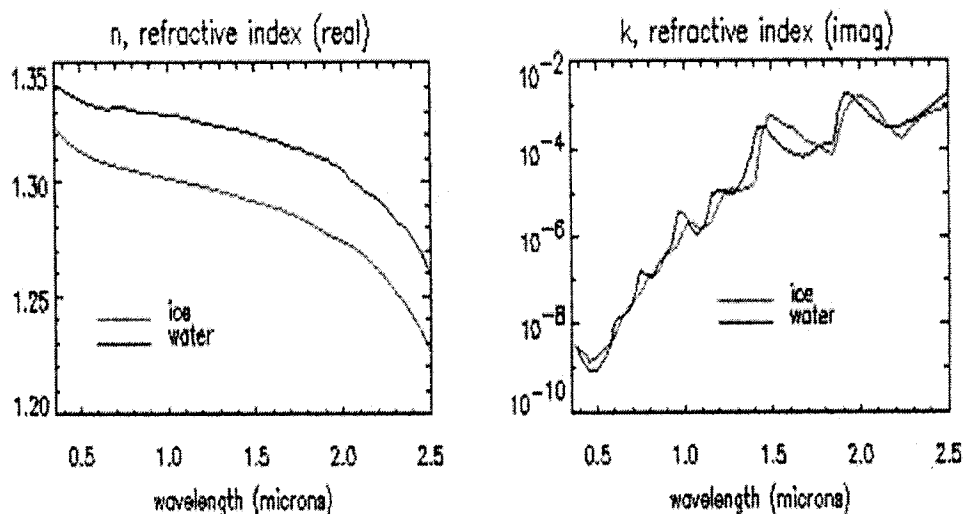
Fig. 43 Wavelength dependence of the real and imaginary parts of the refractive index

Future TARDEC VPL work is also planned to investigate the use of a passive system for ice detection and thickness determination using a sensor fusion concept. One possibility is the use of a technique of the addition or subtraction of several bands of the IR spectrum obtained from a multi-band Charged Coupled Device (CCD) camera and infrared camera data. These sensors would be used in conjunction with Sarnoff image processing boards to perform image and data addition and subtraction much like logic circuits in a computer. Since the refractive index of ice is wavelength dependent (see Fig. 43), this physical characteristic should be of value for imaging and ice thickness determination.
