# Bonded Repair of a Gun Carriage Using Electroformed Nickel Reinforcements

DSTO-TR-1930

A repair technology based on the use of adhesively bonded electroformed nickel reinforcements was successfully developed to repair the trails of 105 mm light field guns operated by ADF which had been damaged by fretting or mechanical contact in service. The success was judged by the measured reduction in strain in the reinforced regions (~40%) and the durability of these repairs in service for a period exceeding five years, including three years of active field exercises in a humid tropical environment.

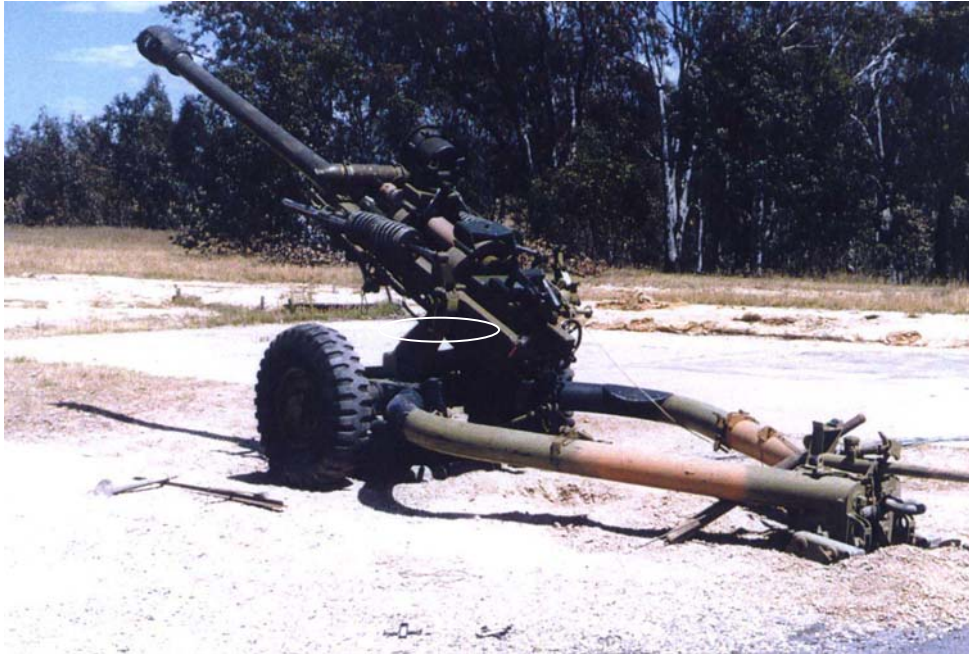
Figure 1 Hamel 105 mm light field guns in firing position

The weight of the Hamel gun is minimised by the use of high-strength steel hollow tubular and box sections in the carriage assembly (the gun trail), Figure 1. The steel used is a weldable corrosion-resistant precipitation-hardened steel with the specification<sup>1</sup> STA60. Table 1 lists some of the properties specified.

Gun trails are subject to damage from several sources. An example is fretting or abrasion caused by metal chains used inadvertently to immobilize the trails during transportation. Figure 2 shows a particularly severe example of damage caused in this way to the boss region circled in Figure 1; the damage is somewhat less severe than it appears in the figure as it is highlighted by damage to the paint film. Repair of damage in this trail was not attempted, but a trail with similar but less severe damage, Figure 3, was repaired.

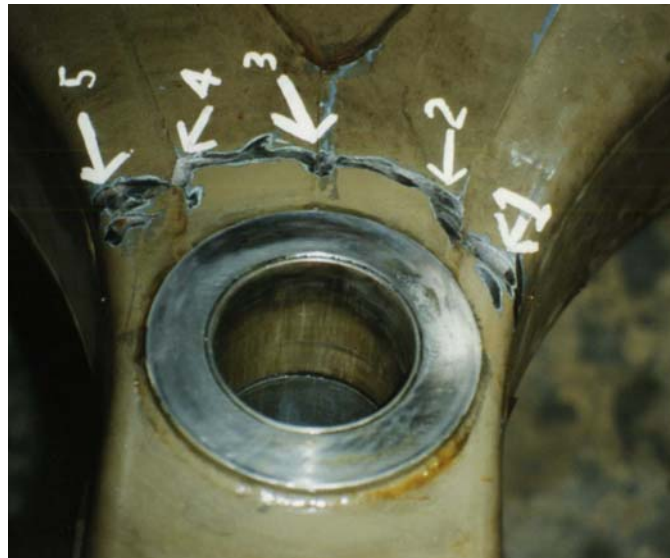
Figure 2 Gun trail showing severe chain scored region ~ 20 mm from boss rim; the region is shown circled in Figure 1- the arms extend from the top of this photograph

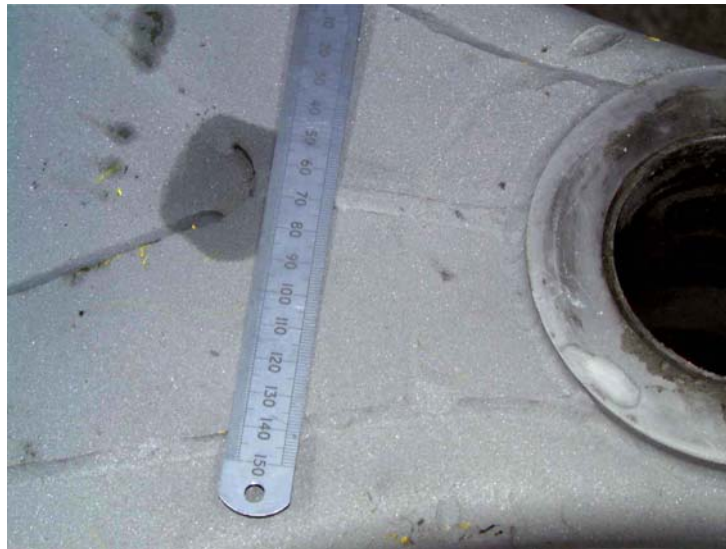
*Figure 3 Gun trail showing chain scored region, selected for repair study*

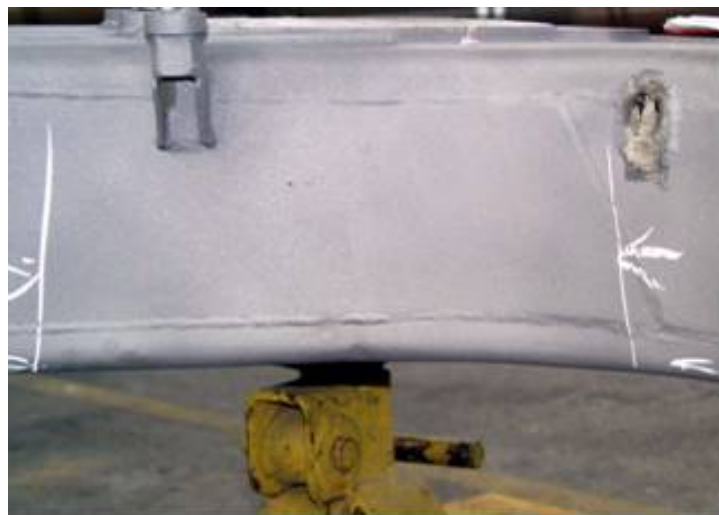
Other examples of damage, shown in Figure 4, likely caused by boulder impact and in Figure 5 caused by abrasion to the trail from metal fittings by contact with metal fittings. Further damage was caused by spikes in the firing platform when the platform was being manipulated for transportation. Whilst, in most cases the damage was quite shallow so did not appear to be a serious threat to the integrity of the trails, on the basis of the advice provided by the OEM, any visible damage is grounds for rejection or repair. However, the sharp grooves caused by the firing platform spikes were smoothed out by sanding to reduce the stress concentration.

*Figure 4 Gun trail showing damage to the base of the box section selected for repair study*

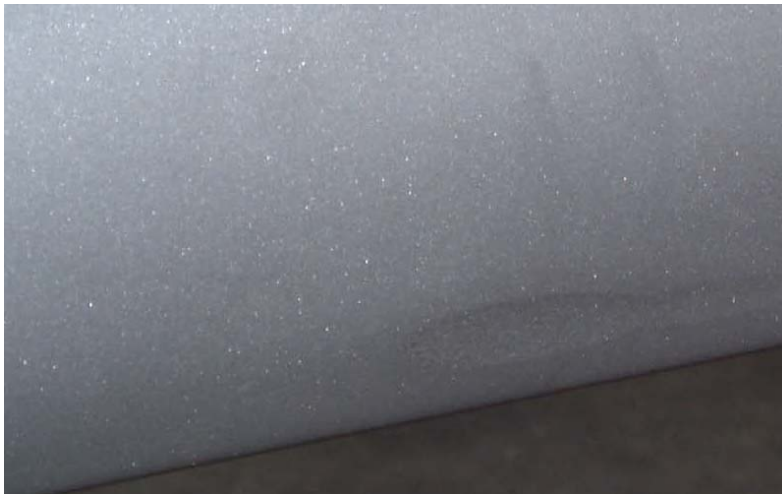
Figure 5 Gun trail showing damage to the arm, selected for repair study

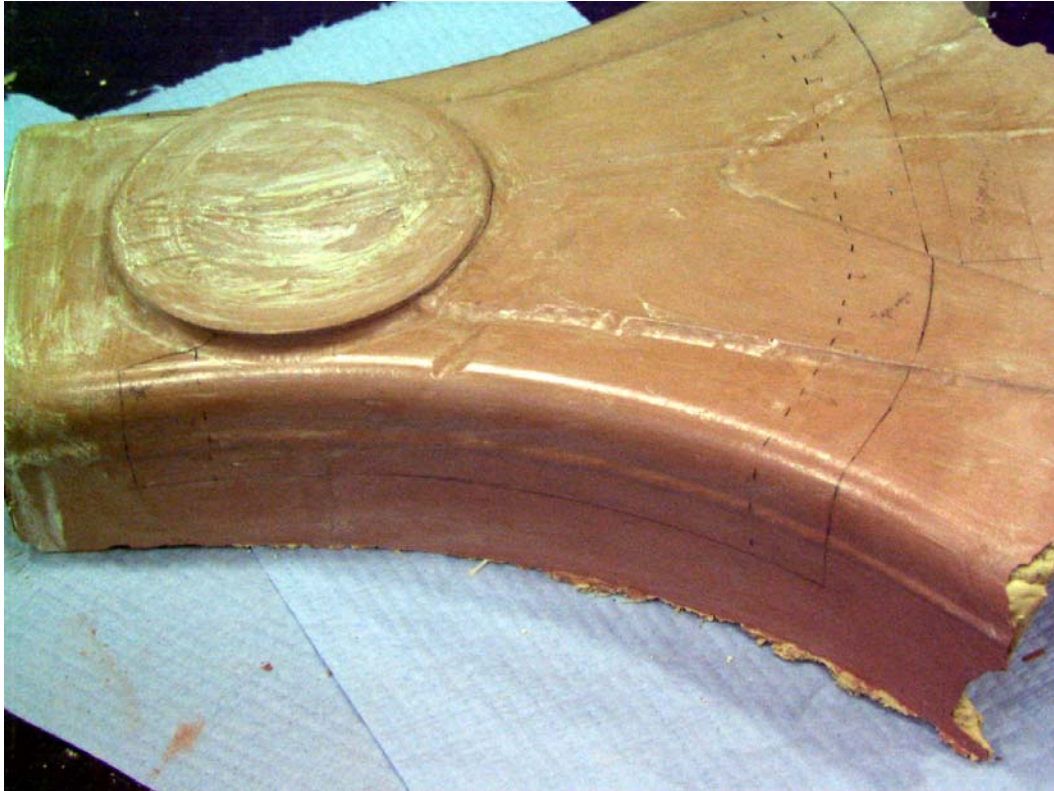
*Figure 9 Glass/epoxy mould for electroforming the nickel reinforcement for the boss region of the trail*

To make the moulds for the two damaged Hamel gun trails all attachments were removed and the coating removed by sand blasting to bare steel. An area equal to the proposed reinforcement size was marked on the trail and two layers of wax sheeting of thickness 0.25 mm to allow for the adhesive thickness were moulded onto the trail. Moulding plaster was then applied over the wax in sufficient thickness to provide structural integrity.

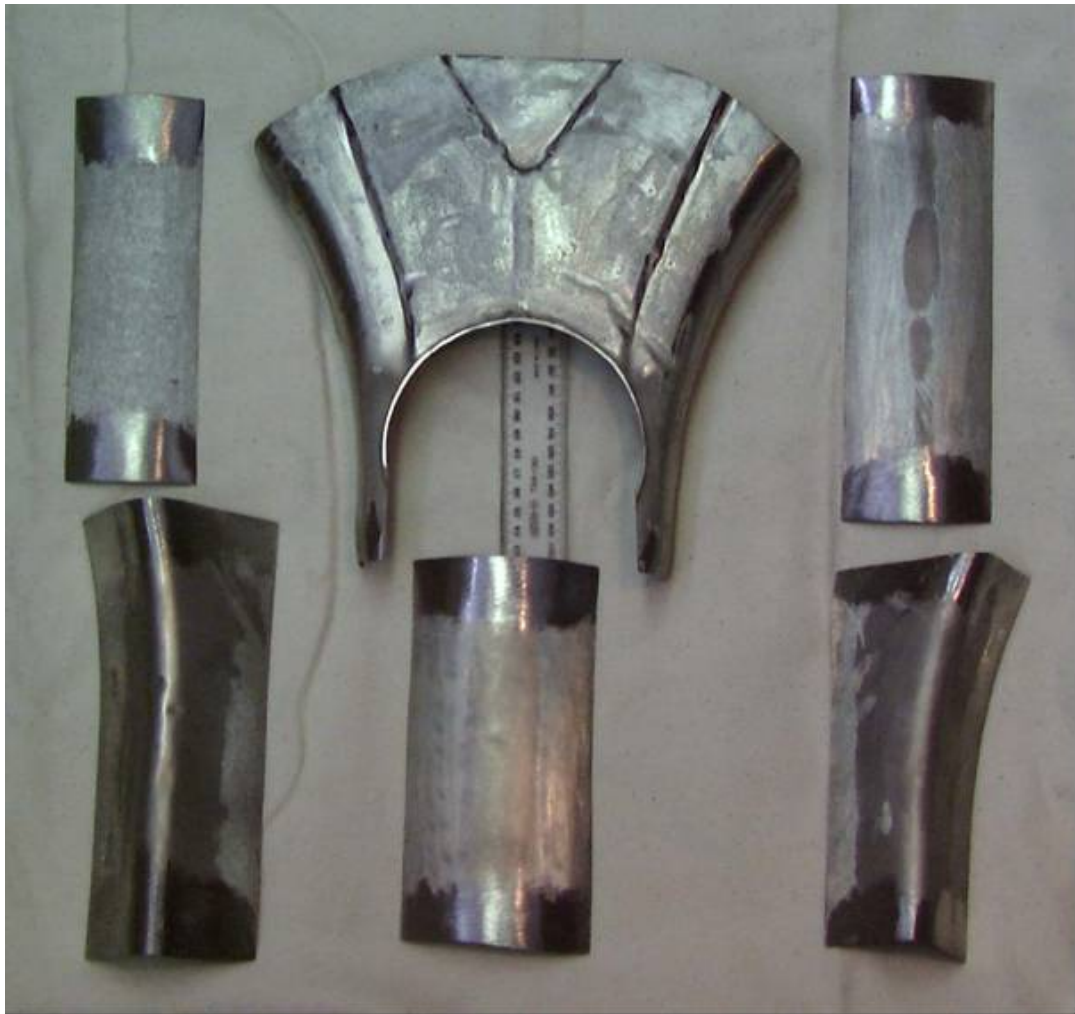
Figure 10 shows the resulting reinforcements. Note the high level of fidelity in the larger electroform, including the damage indentation (which ideally should have been filled in prior to making the mould).

*Figure 10 Electroformed reinforcements, clockwise from the top left regions D, A, E (outer) and B, E (inner) and C*

During electroforming it was found that several nodules had formed at the edges of the electroform in regions of local high current density – mainly at the outer edges. These were removed by grinding - an extra 20 mm had been included in the length of electroform for this purpose.

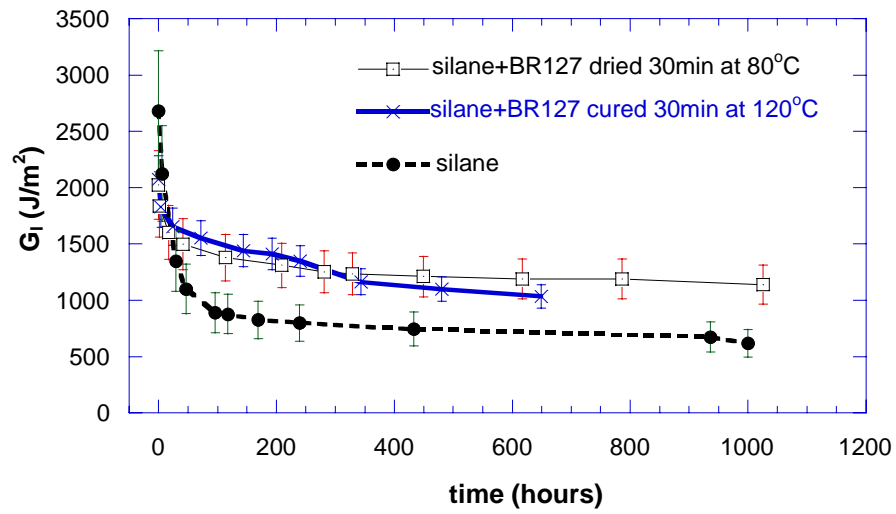
The value for  $G_{Ic}$  obtained for the nickel-coated specimens compares very well with results for aluminium alloys obtained using the grit-blast silane process<sup>18</sup>, Figure 13. This is encouraging as the grit-blast silane process has been shown to provide excellent long-term durability with bonded repairs to aluminium alloys<sup>5</sup>.

Figure 13 Plot of strain-energy release rate  $G_I$  versus time from long crack extension specimens, with 2024 T3 lever arms. Taken from Reference 18

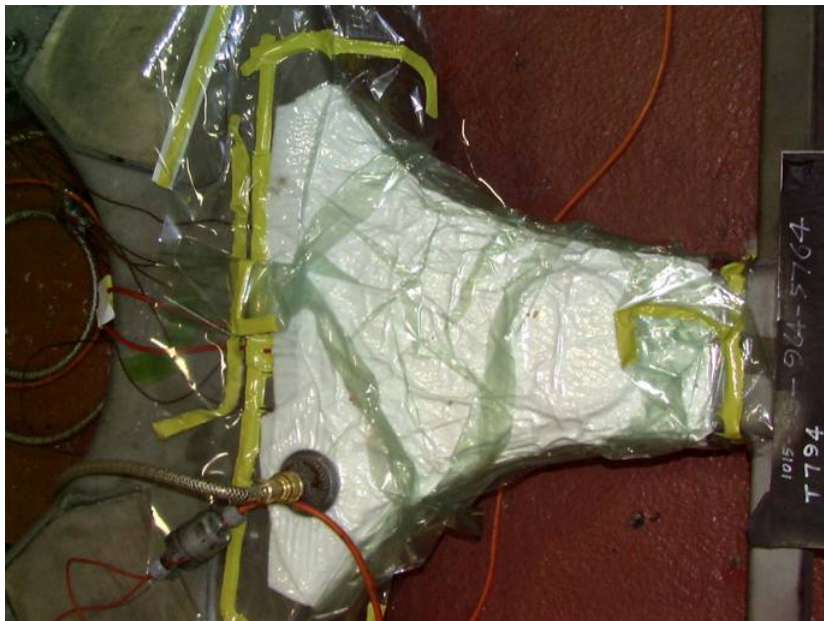
Figure 14 Application of the reinforcement region A in the boss region, showing vacuum bagging assembly

The reinforcements were bonded to the gun trails using a silicon-rubber heater blanket to heat the structure and a vacuum bag to apply atmospheric pressure. Two layers of FM73 adhesive were cut to the size of the reinforcement and the adhesive was placed over the damaged region of the trail. The heater blanket was placed over the reinforcement with thermocouples to monitor and control temperature and a bleeder cloth was placed over the heater to provide a passage for expulsion of air etc. A nylon vacuum bag was then formed over the assembly and sealed with butyl rubber. The finished vacuum-bag assembly is shown in Figure 14 for the doubler applied to the boss region of the trail. Cure of the adhesive was achieved at a temperature 120° C for four hours under atmospheric pressure.

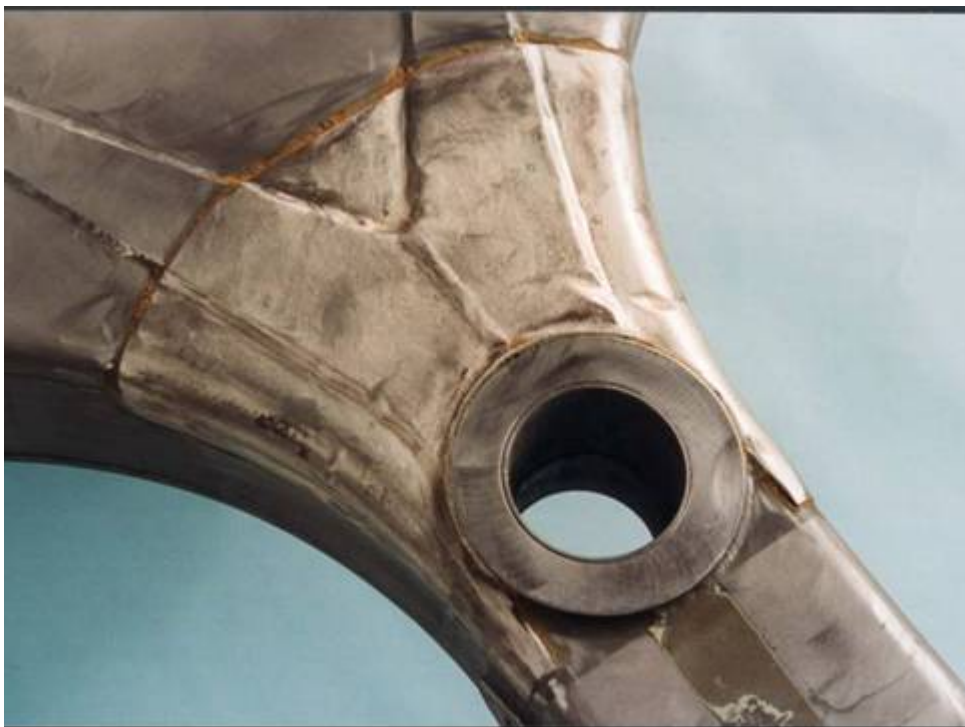
*Figure 16 Reinforcement bonded to boss region A*

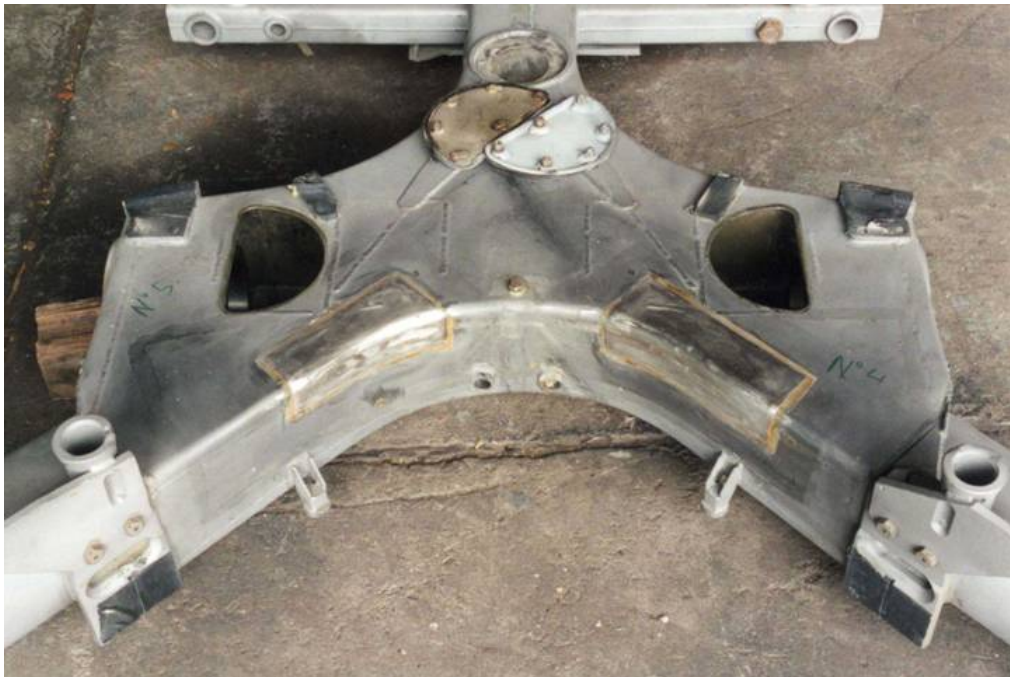
Figure 17 Reinforcements bonded to region C (left and region B right

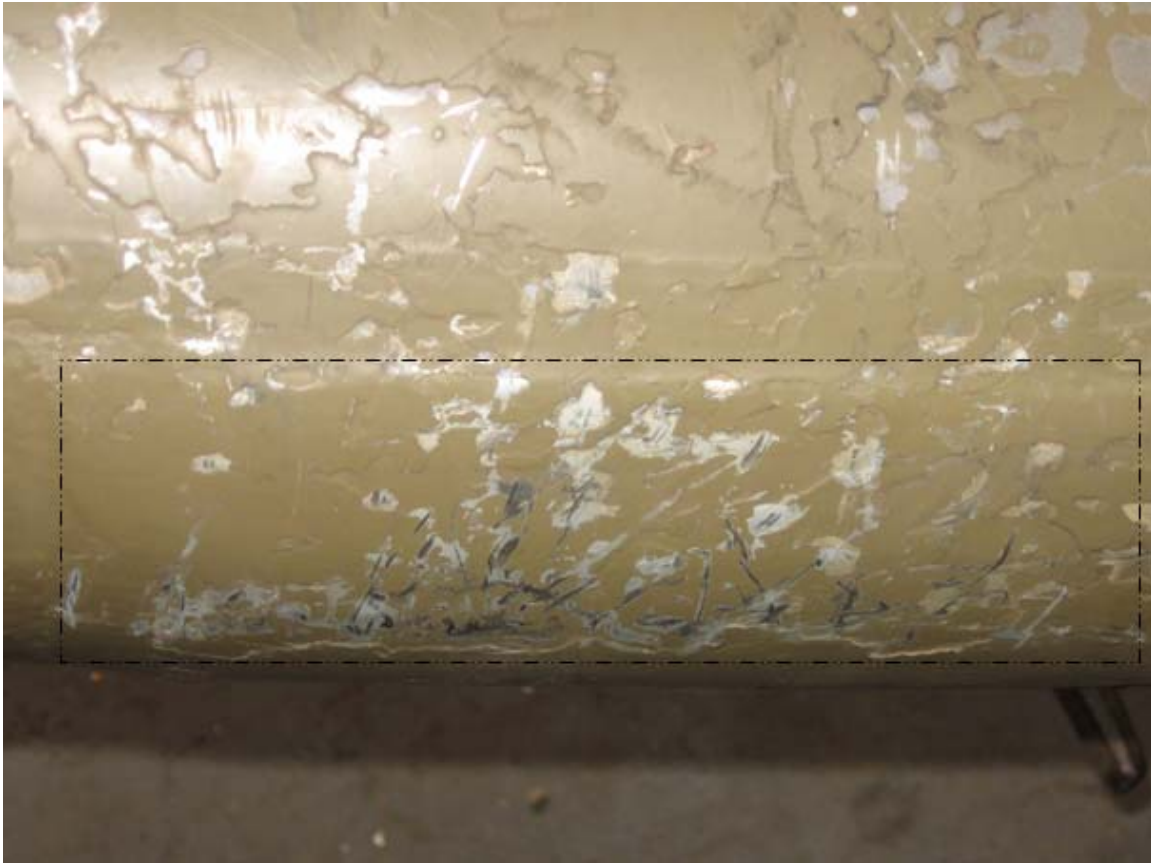
All the reinforcements appeared to be in excellent condition with no evidence of disbonding - indicating that no fatigue or environmental degradation has occurred.

However, as shown in Figure 20 there is evidence of significant mechanical contact in the form of extensive chips and scratches to the paint scheme. The observation justifies the choice of nickel for the reinforcements; if polymer-matrix composite reinforcements had been used severe damage would almost certainly have occurred. Refurbishment of the trails involves removal of the paint scheme by grit blasting followed by steam cleaning prior to re-coating – this could prove damaging to a polymer composite reinforcement, unless very carefully undertaken. For the electroformed reinforcements, the only caution given is to avoid removal of the epoxy coating at the reinforcement edges – or replacement prior to painting if removal occurs.

*Figure 20 Reinforcement from region E, showing mechanical damage after three years of active service. No evidence was found of debonding in this or any of the other reinforcements*
