AFRL-WS-WP-TR-2007-9002

**EVALUATION OF SKIN-SPAR JOINT
RESISTANCE TO HYDRODYNAMIC RAM**

780th Test Squadron (780 TS/OL-AC)

Final Report for 01 October 2003 – 30 November 2005

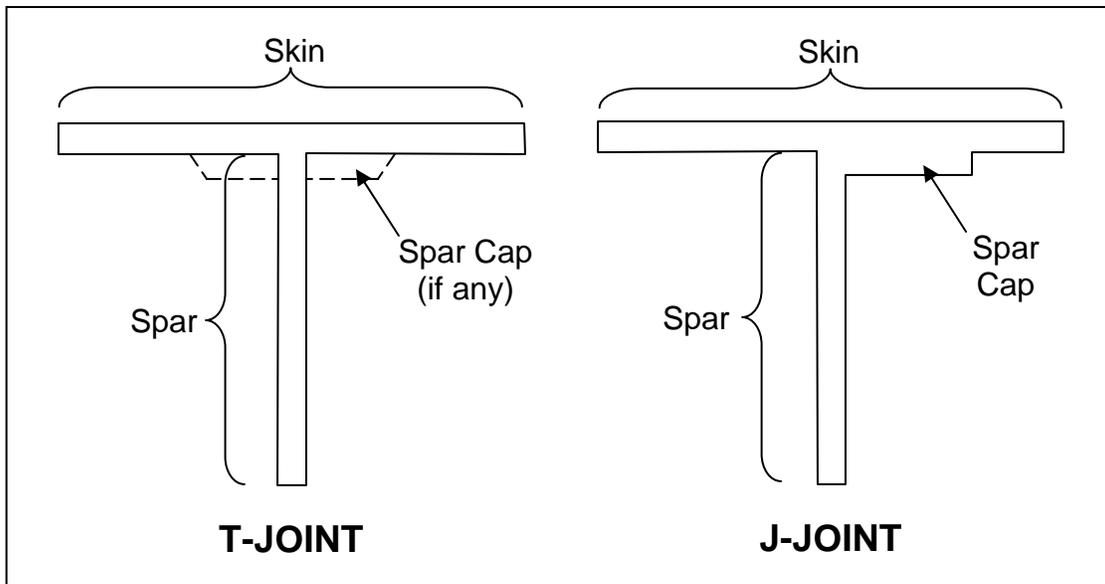
Figure 1.1.1: T-joint and J-Joint components

Figure 1.1.1 is a diagram that standardizes notation of the T-joint and J-joint described throughout this report.

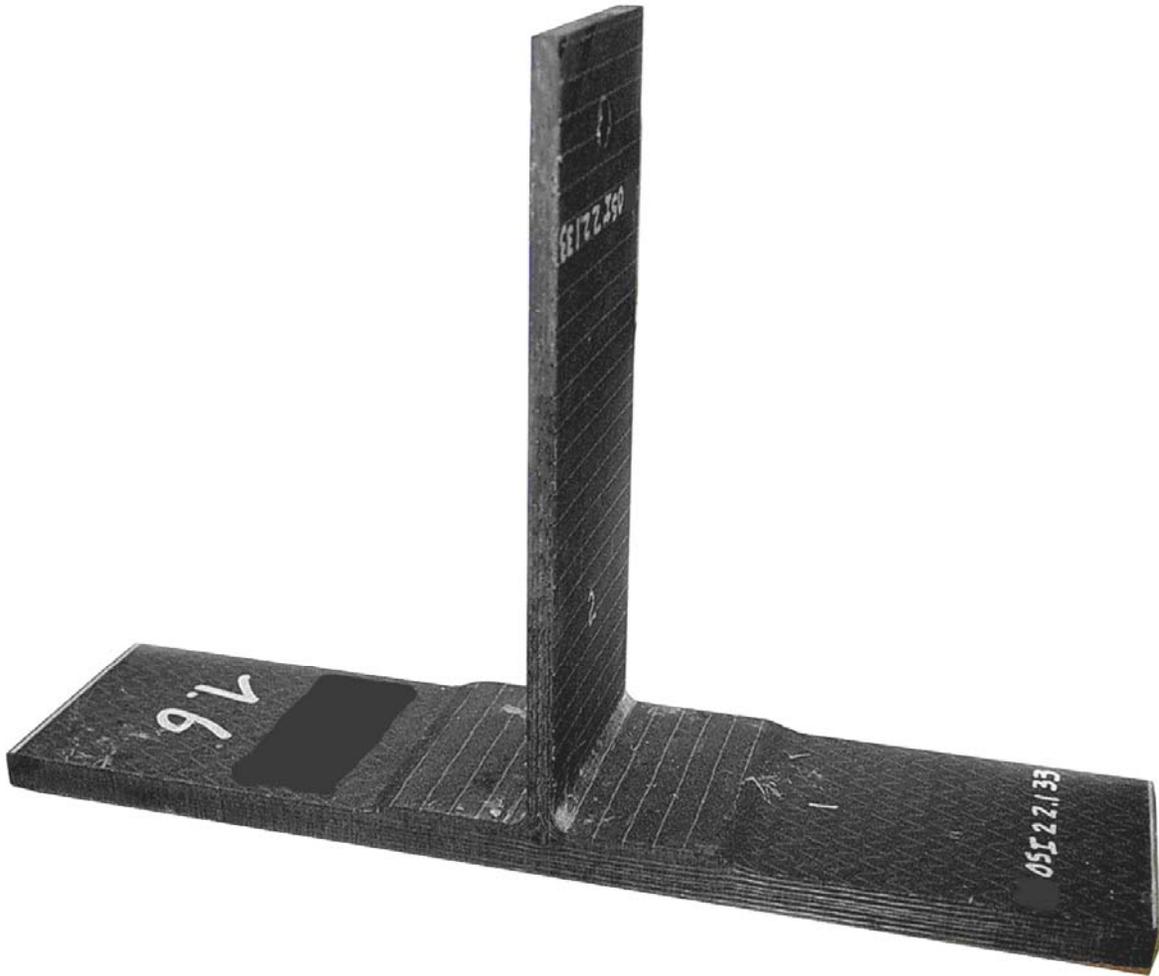
Figure 2.2: Example single spar T-joint

A sample of a single joint (representing one of ten designs submitted for evaluation) is shown in Figure 2.2. For each joint design, five symmetric T pull-off tests were conducted by the Air Force Research Laboratory (AFRL) using a conventional quasi-static loading method. Load and strain-to-failure were recorded. Similarly, for each joint design, five symmetric T pull-off tests were conducted by the 46 TW using the new high-strain rate (dynamic) loading method. Strain-to-failure values were recorded.

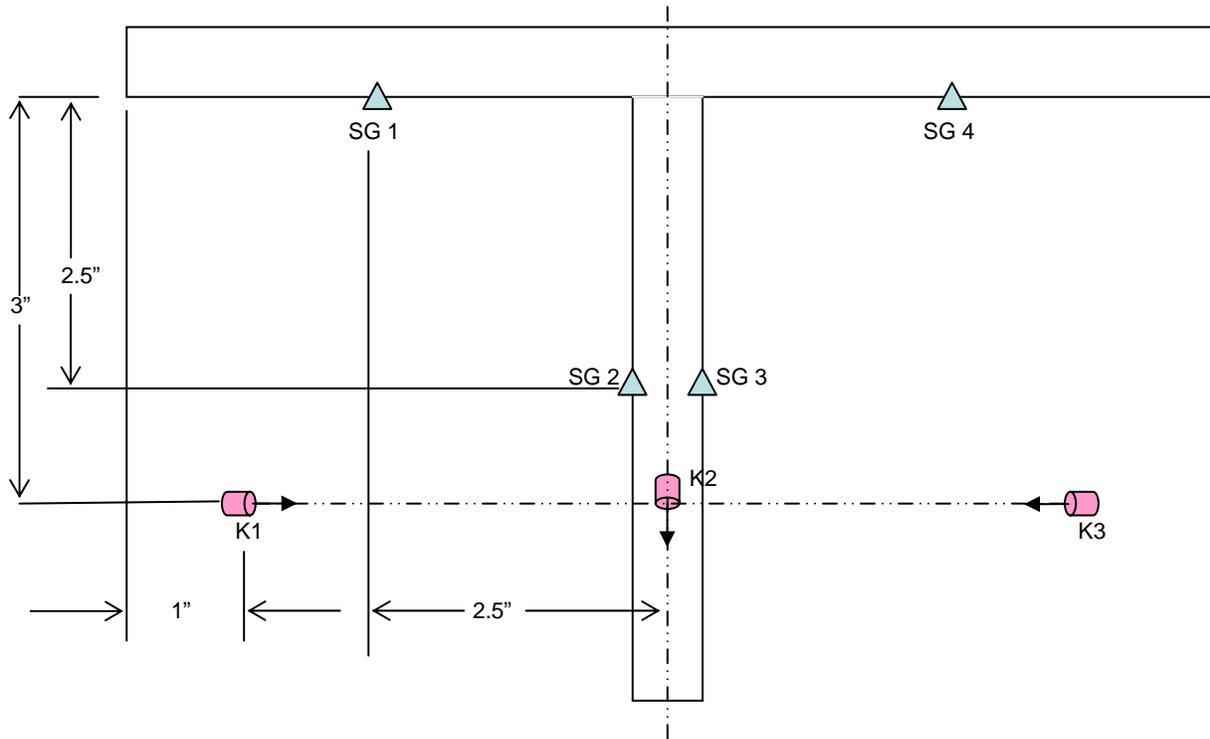
Figure 3.1.2: Layout of instrumentation on T-joint (looking down from above)

Figures 3.1.2 and 3.1.3 show side and end-view sensor layouts on and around the test specimen. The exception is for specimen set 11 where positions of skin and spar gages are noted in the above paragraph.

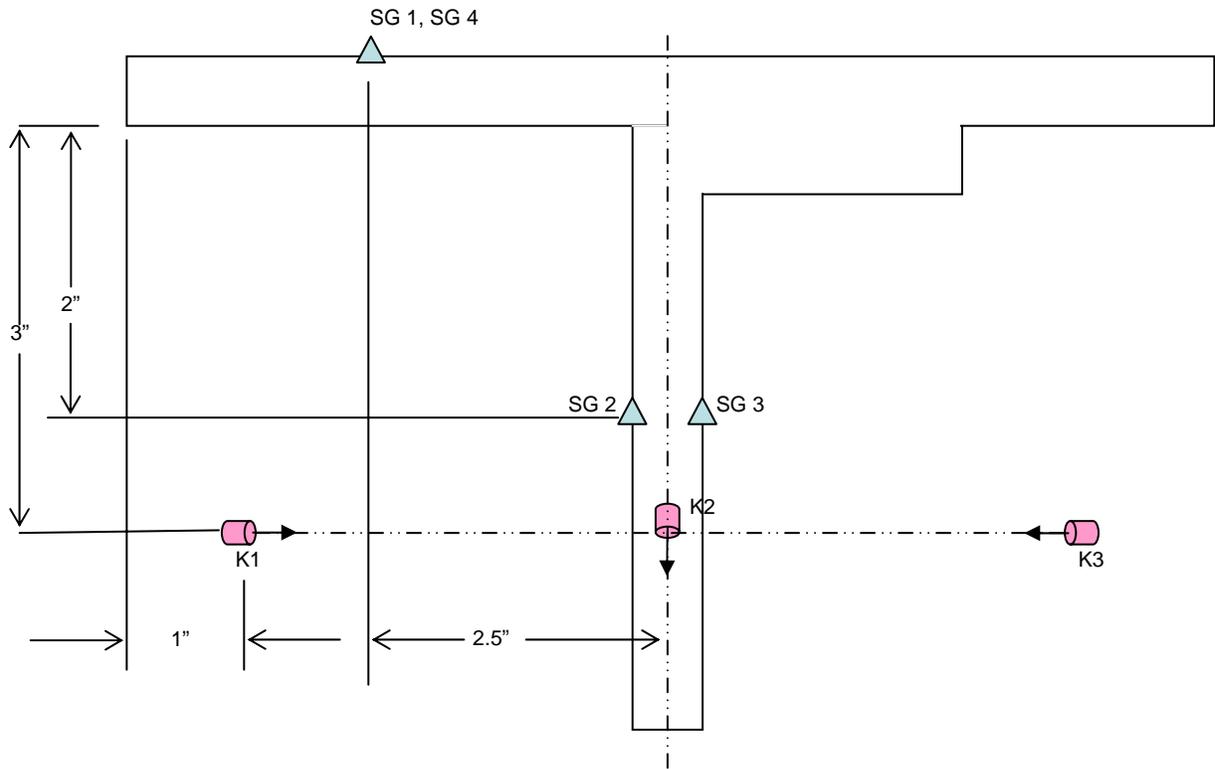
Figure 3.2.2: Layout of instrumentation on J-joint (looking down from above)

Figures 3.2.2 and 3.2.3 show side and end-view sensor layouts on and around the test specimen. Instrumentation details can be found in Appendix A.

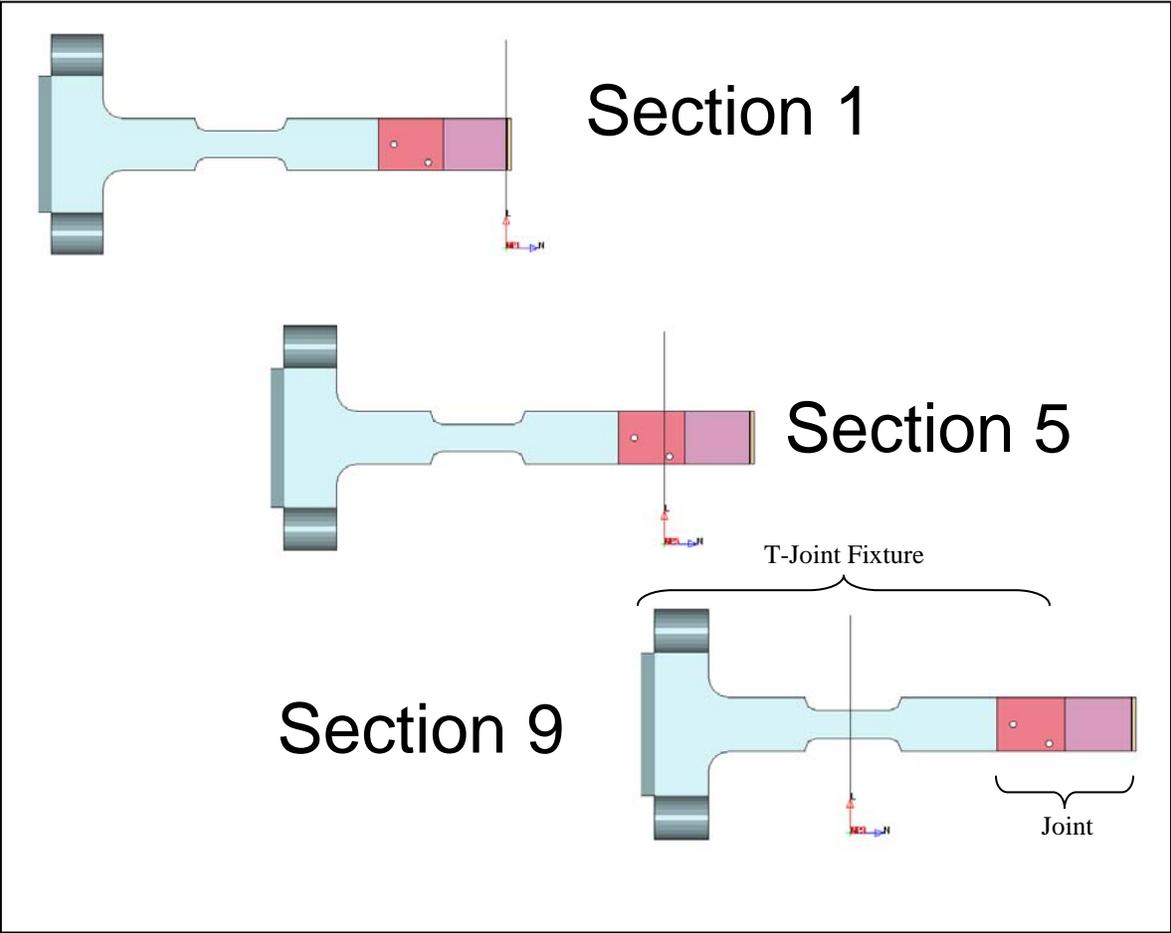
Figure 3.4.1: Three section cuts through the FEM

Figure 3.4.1 shows the finite element model of the setup and three section cuts through the model at different locations. Section 1 is located where joint failure is most likely to occur. Section 5 is on the joint's web, near web strain gages 2 and 3. Section 9 is at an assumed strain gage location on the T-Joint Fixture (positioned within the RamGun's Test Article Chamber).

In order to better understand this phenomenon, we performed a modeling study in which a finite element model (FEM) of the holding fixture and sample joint specimen was subjected to the measured pressure pulse. The model was sectioned at various locations, and the loads at those sections were observed as a function of time.

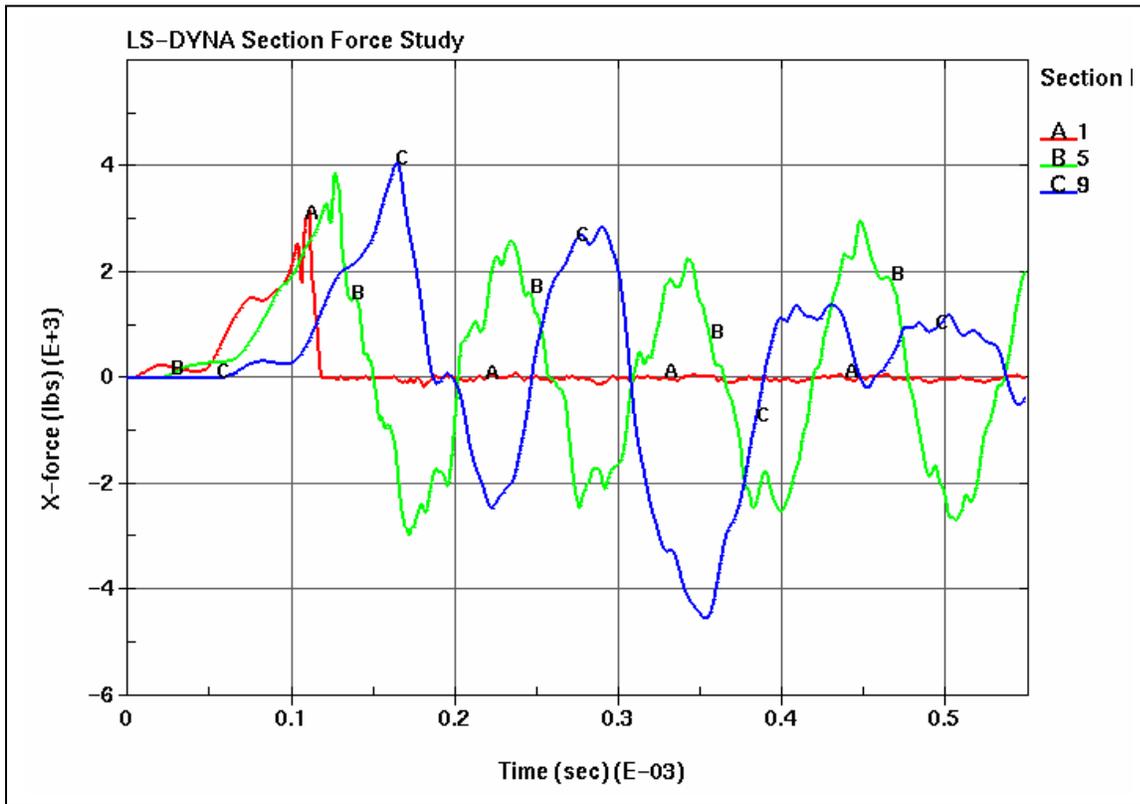
Figure 3.4.2: Load vs. time at the three section cuts

Figure 3.4.2 shows a plot of the loads occurring in the model at each of the three section cuts. By observing the comparison of these curves, one can see the effects of the mass/inertia of the structures downstream of the section cuts. In the figure, curve A represents the load at the expected failure location (Section 1), curve B represents the load on the joint's web (Section 5), and curve C represents the load that would be measured on the T-Joint Fixture. The failure load at Section 1 is 3,000 pounds at 0.12 msec. The failure load at Section 5 is 3,800 pounds at 0.14 msec. And the failure load at Section 9 is 4,000 pounds at 0.17 msec. Stated differently, the load that causes joint failure is actually 3000 pounds. As the distance from the specimen skin increases, the apparent load increases (due to fixture-mass acceleration) to much higher values that have little real meaning. Because dynamic failure loads can be misleading, the authors opt for strain as a preferred metric describing dynamic failure.

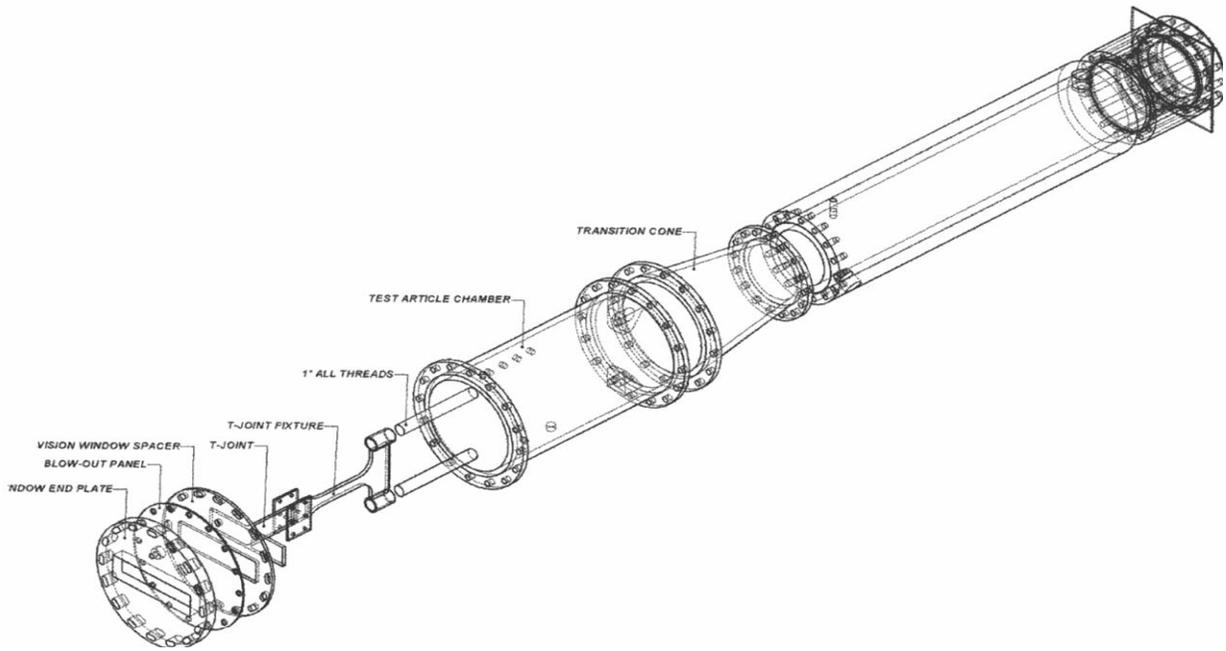
Figure 4.2.1: Schematic drawing of RamGun test apparatus

To replicate projectile-generated ram conditions, a pressure pulse, with requisite peak and impulse characteristics, had to be created. This was achieved using a hydrodynamic ram simulator, called the RamGun, as shown in Figures 4.2.1 through 4.2.3. The RamGun is a large-diameter gas gun designed to launch a 379.5g cylindrical polymer (Delrin) puck against a steel impact that caps a fluid column. Impact creates a pressure wave that traverses down the fluid column to later interact with a T-joint test specimen at the far-end. Pressure wave interaction with the T-joint occurs in a manner consistent with projectile-generated hydrodynamic ram within an aircraft fuel tank.¹

Blow-Out Panel – diaphragm seals the tail of the RamGun’s fluid column until specimen failure.

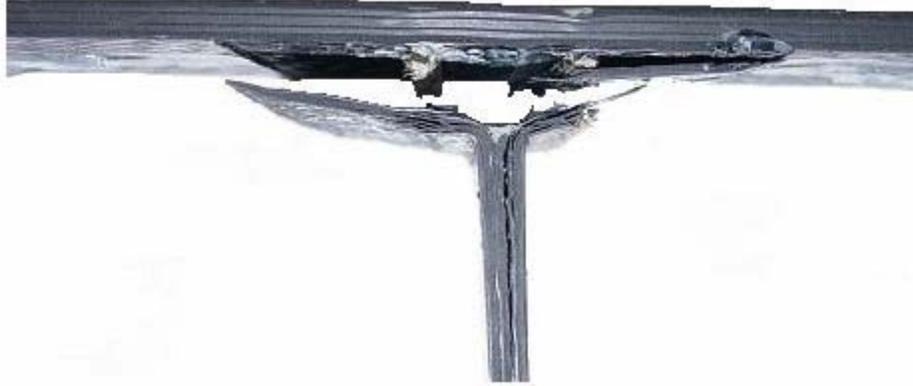
Figure 5.1: Example specimen failure as a result of dynamic test.

This section prescribes the method by which dynamic RamGun data are analyzed. The discussion refers to an example T-joint (Figure 5.1) that was subjected to RamGun testing.^b Four example graphs are presented to display and analyze the test outcome.

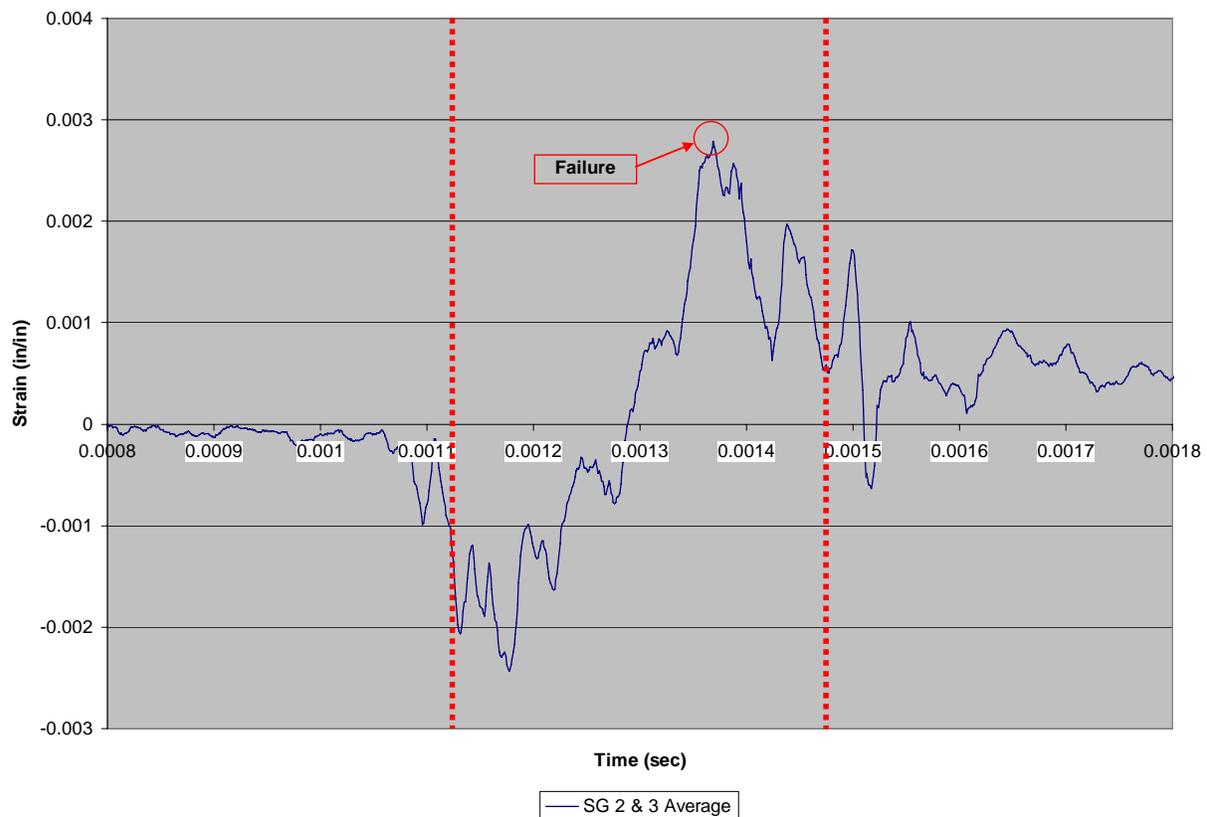
Figure 5.3.1: Average spar-strain vs. time (example)

The fourth and final graph in the data analysis process is used to assess failure metrics. The graph shows average strain (for spar gages SG2 and SG3) versus time (reference Figure 5.3.1).

In this graph, the peak tensile strain (maximum pull-off strain) is assumed to correspond with the time of failure. By taking the average, bending effects (due to load asymmetries) are eliminated from consideration. In this example, the dynamic strain at failure is 2.8×10^{-3} in/in.

This dynamic strain-at-failure is the easily-understood and critical metric which we seek. While it can be compared 1:1 with its quasi-statically obtained counterpart, dynamic strain-at-failure (as produced by the RamGun) is a structural mechanical property that relates directly and realistically to projectile-induced ram loading conditions. Dynamic strain-at-failure can either be used to rank a series of candidate joint designs for inherent resistance to hydrodynamic ram, or as a joint failure criterion within finite element codes.

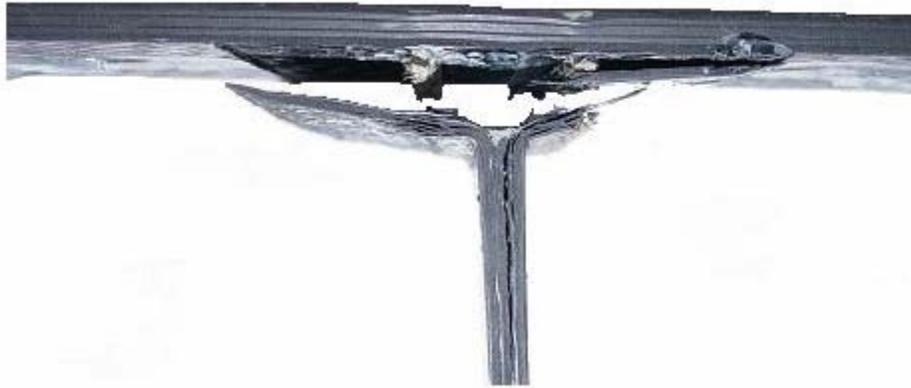
Figure 6.1.1.1: Specimen 1a after dynamic test

Figure 6.1.1.1 shows a complete and somewhat asymmetric failure of joint Specimen 1a. Fracture occurred mostly along the spar cap to skin interface, although a portion of the spar cap on the right side became severed at the stitch-line and remained attached to the skin. Without considering visual aspects of the failure, the strain data analysis (presented in Appendix C, Section C.1) revealed that failure was asymmetric.

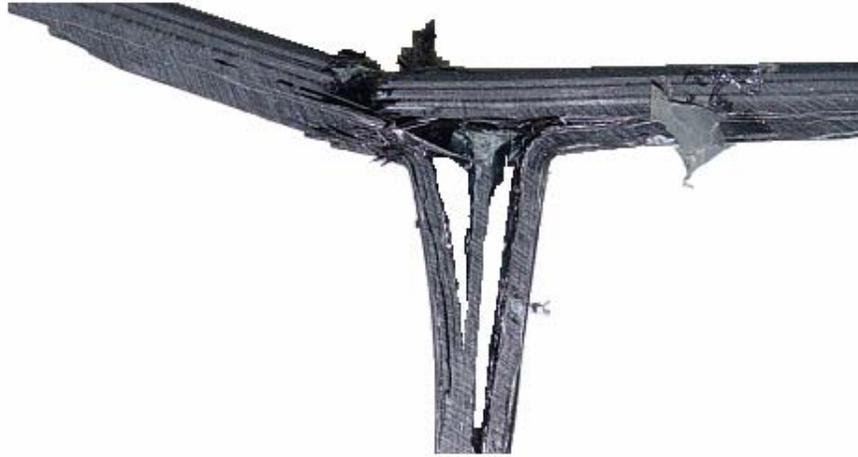
Figure 6.1.1.2: Specimen 1b after dynamic test

Figure 6.1.1.2 shows an asymmetric and incomplete (skin remained attached) fracture of joint Specimen 1b. Severe skin fracture occurred just to the left of the spar web. Delamination ran down the center of the web. Without considering visual aspects of the failure, the strain data analysis (presented in Appendix C, Section C.1) revealed that failure symmetry was inconclusive.

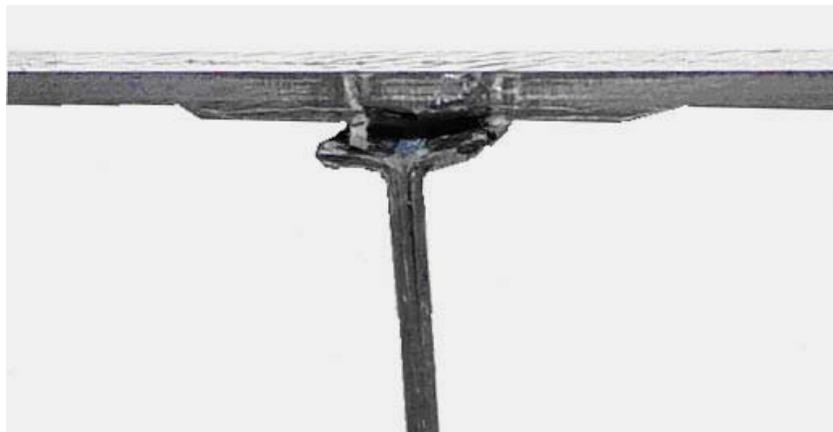
Figure 6.1.1.3: Specimen 1c after dynamic test

Figure 6.1.1.3 shows a complete and symmetric failure of joint Specimen 1c. Spar cap fracture occurred along the stitch-lines. Without considering visual aspects of the failure, the strain data analysis (presented in Appendix C, Section C.1) revealed that failure was asymmetric.

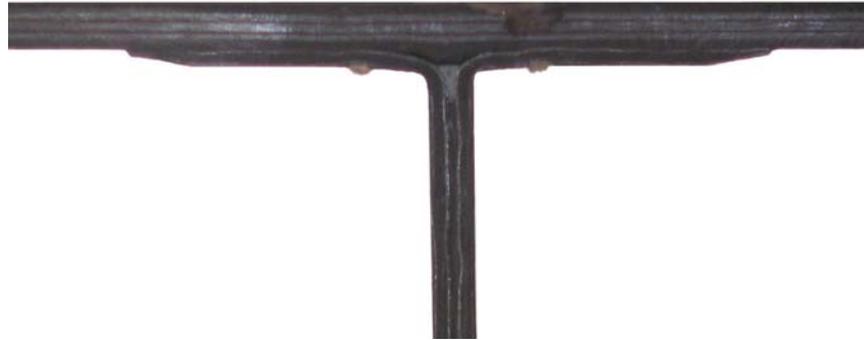
Figure 6.1.1.4: Specimen 1d after dynamic test.

Figure 6.1.1.4 shows that joint Specimen 1d did not fail at the joint. (It pulled out of the grip and through the bolt hole at the end of the spar.) Strain data obtained prior to grip pull-out (presented in Appendix C, Section C.1) revealed that initial aspects of the failure were asymmetric. Failure

initiated at the noodle, with spar-cap cracks stopping at the stitching and another crack running down the center of the spar.

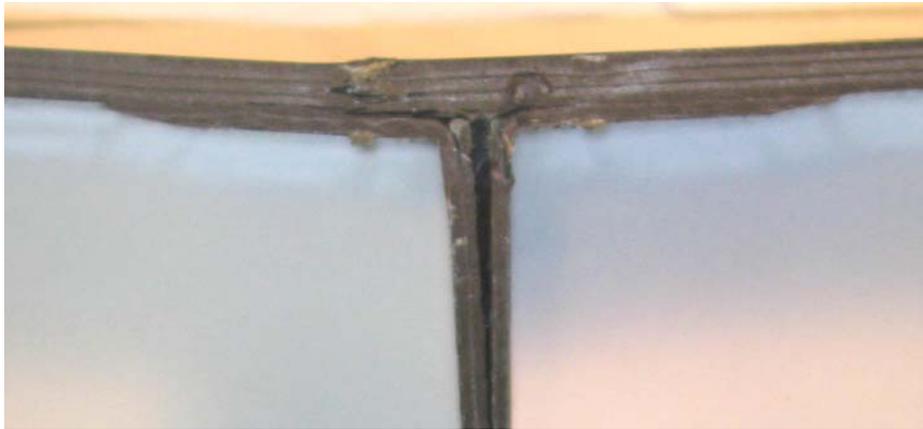
Figure 6.1.2.1: Specimen 1e after static test.

Figure 6.1.2.1 shows a somewhat symmetric and incomplete fracture of joint Specimen 1e. Joint failure consisted of a skin fracture immediately to the left of the spar web, delamination that extends for a short distance along the spar cap interface with the skin, and delamination that extends down the center of the spar web.

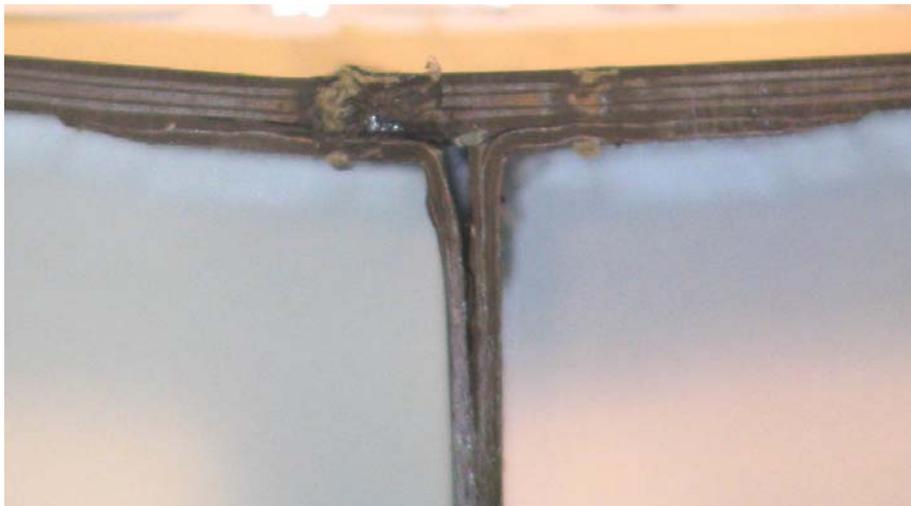
Figure 6.1.2.2: Specimen 1f after static test.

Figure 6.1.2.2 shows a symmetric and incomplete fracture of joint Specimen 1f. Joint failure consisted of a skin fracture directly above the spar web, delamination that extends for a short distance along the spar cap interface with the skin, and delamination that extends down the center of the spar web.

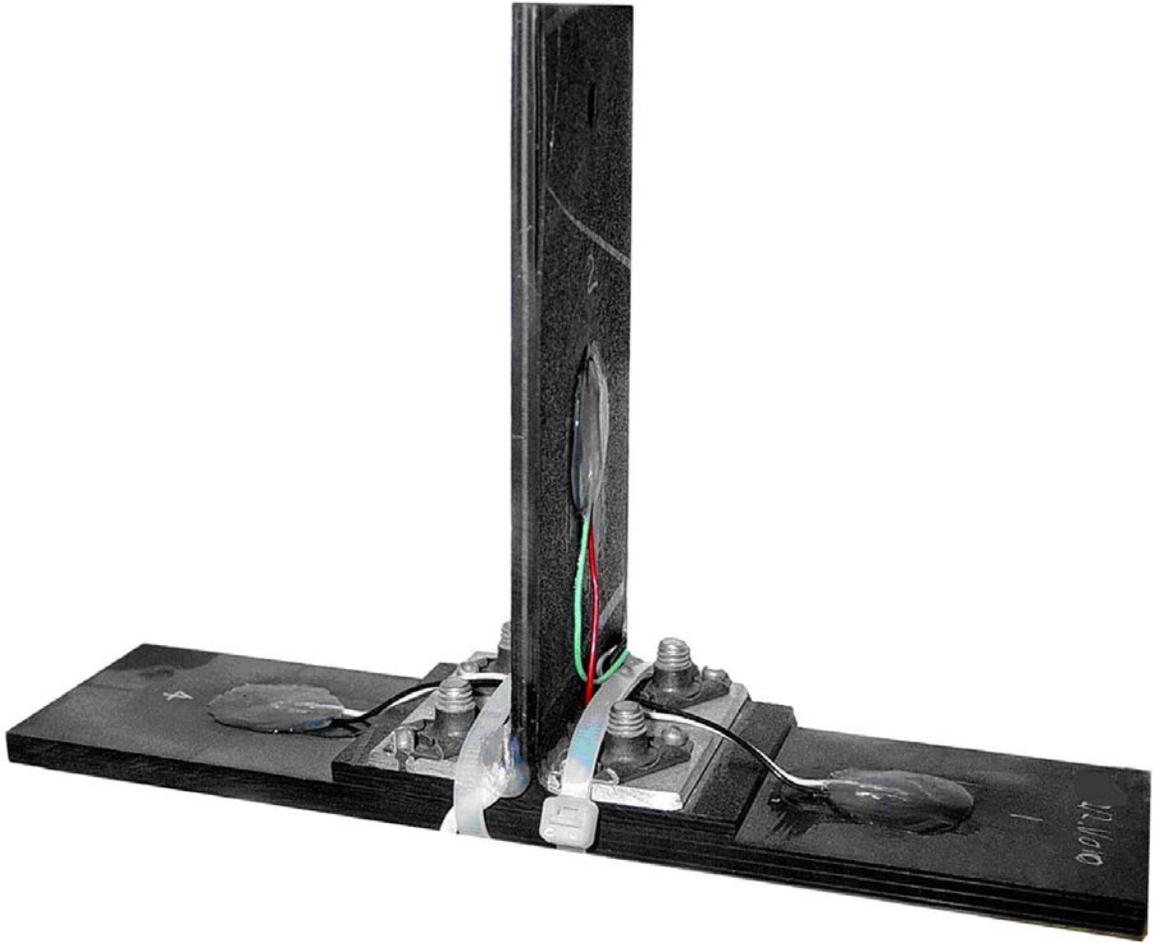
Figure 6.2.2: Example image of joint from Specimen Set 2 (pretest)

Figures 6.2.2 and 6.2.3 are representative of Specimen Set 2 constructions. These images were collected prior to testing and show strain gage instrumentation. (Nylon wire tie-downs were removed after specimen installation in the test fixture.)

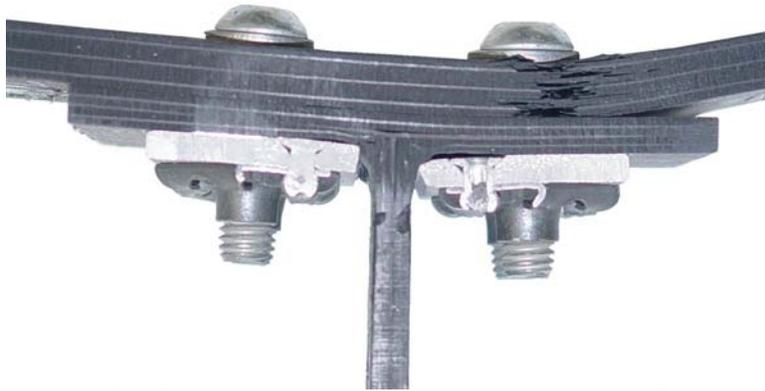
Figure 6.2.1.3: Specimen 2c after dynamic test

Figure 6.2.1.3 shows an incomplete and asymmetric failure of joint Specimen 2c. There is delamination at the spar web-cap interface. Skin fracture occurred along the right bolt-line. Without considering visual aspects of the failure, the strain data analysis (presented in Appendix C, Section C.2) revealed that failure symmetry was inconclusive.

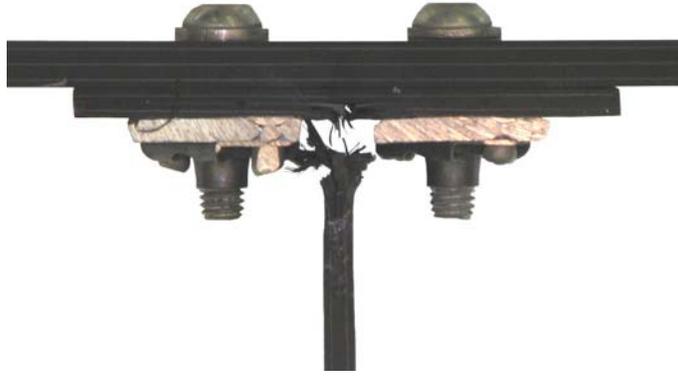
Figure 6.2.1.4: Specimen 2d after dynamic test.

Figure 6.2.1.4 shows a complete and symmetric failure of joint Specimen 2d. The spar web detached from the spar cap, with separation localized between the nut-plates. Without considering visual aspects of the failure, the strain data analysis (presented in Appendix C, Section C.2) revealed that failure symmetry was inconclusive.

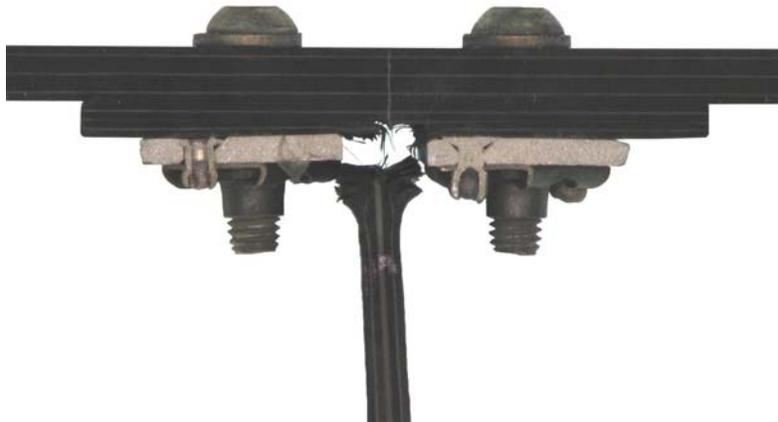
Figure 6.2.1.5: Specimen 2e after dynamic test.

Figure 6.2.1.5 shows a complete and symmetric failure of joint Specimen 2e. The spar web detached from the spar cap, with separation localized between the nut-plates. Without considering visual aspects of the failure, the strain data analysis (presented in Appendix C, Section C.2) revealed that failure was symmetric.

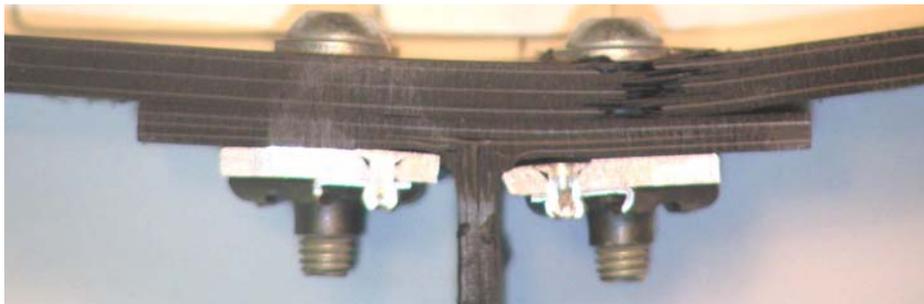
Figure 6.2.2.2: Specimen 2g after static test.

Figure 6.2.2.2 shows an asymmetric and incomplete fracture of joint Specimen 2g. Joint failure consisted of a skin fracture along the right bolt line.

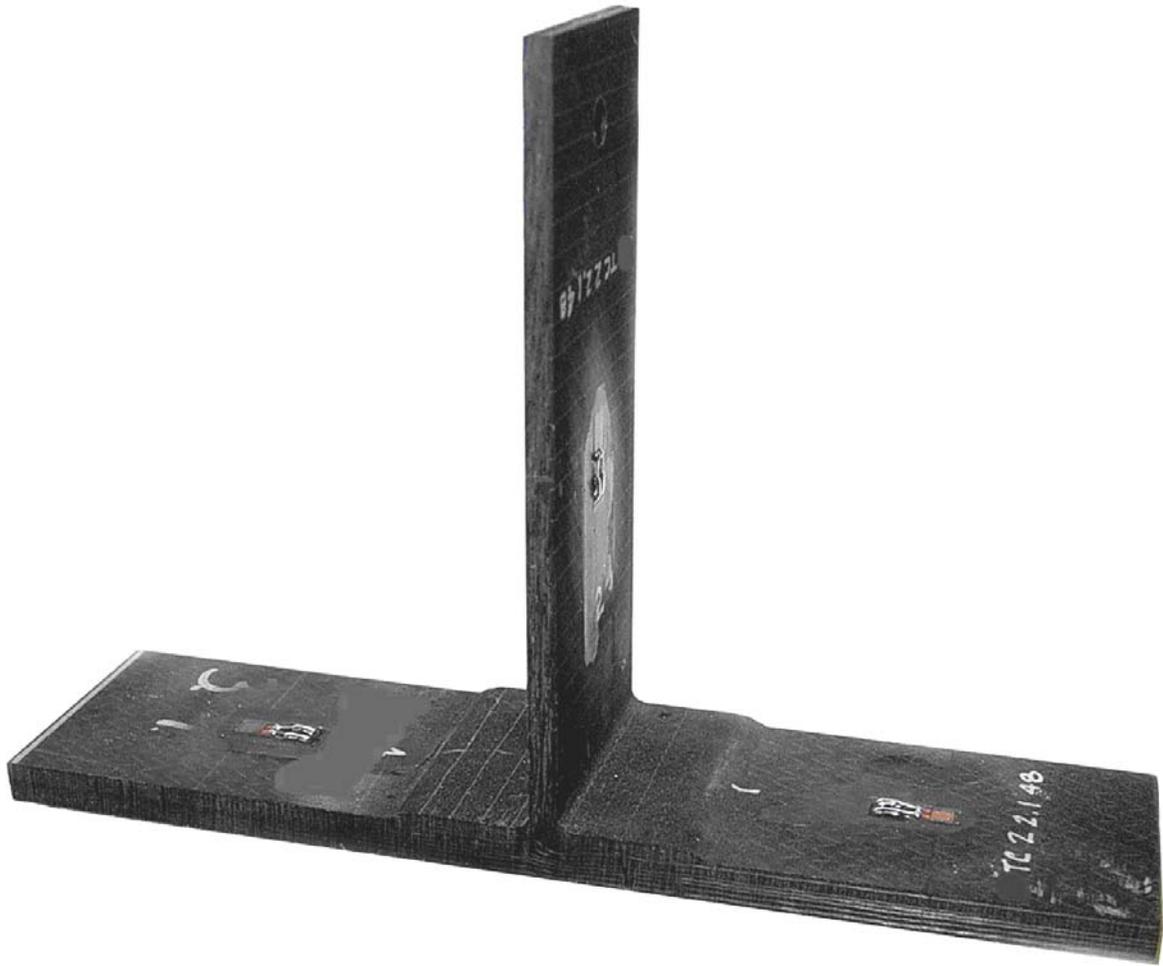
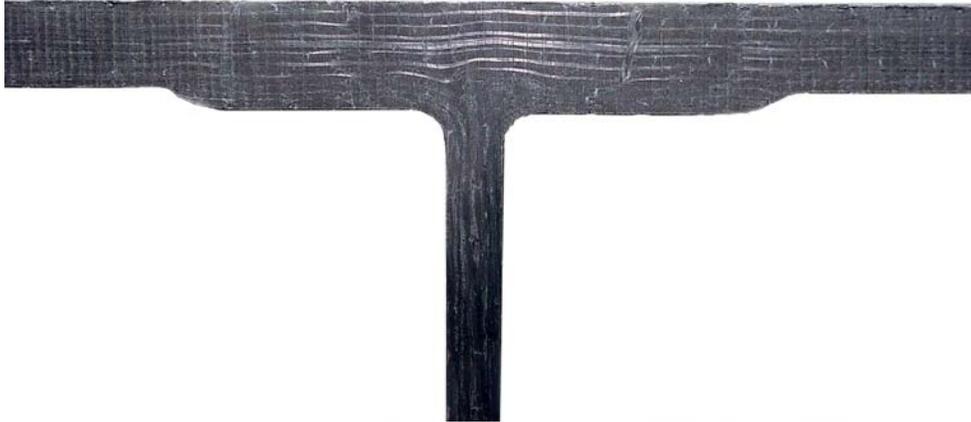
Figures 6.3.2 and 6.3.3 are representative of Specimen Set 3 construction.

Figure 6.3.2: Example image of joint from Specimen Set 3 (pretest)

Figure 6.3.3: Example cross section of joint from Specimen Set 3 (pretest)

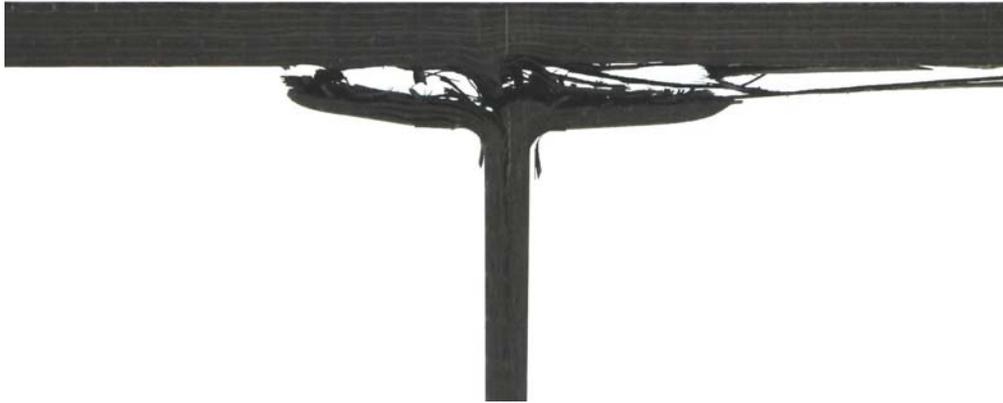
Figure 6.3.1.1: Specimen 3a after dynamic test

Figure 6.3.1.1 shows a complete and largely symmetric failure of joint Specimen 3a. Joint debonding and carbon tuft failure occurred at the spar-cap to skin interface. Delamination extended down the center of the spar web. Without considering visual aspects of the failure, the strain data analysis (presented in Appendix C, Section C.3) revealed that failure was symmetric.

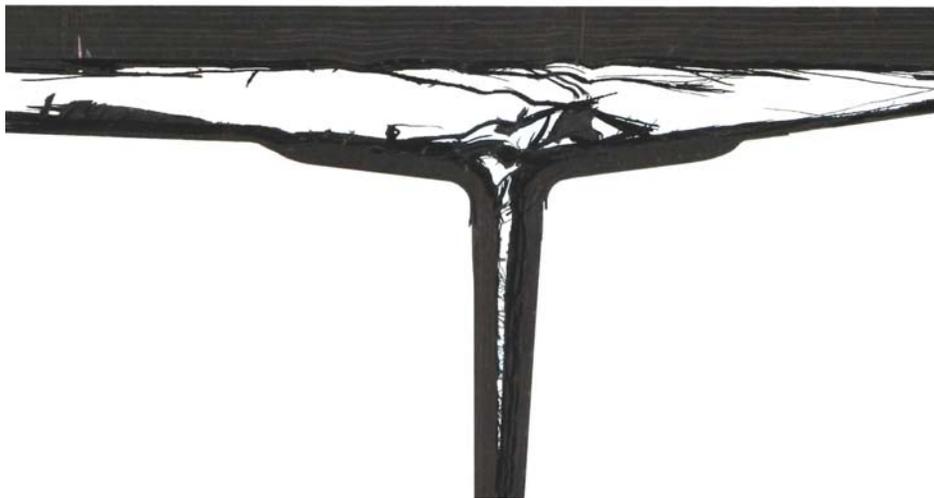
Figure 6.3.1.2: Specimen 3b after dynamic test

Figure 6.3.1.2 shows a complete and largely symmetric fracture of joint Specimen 3b. Joint debonding and carbon tuft failure occurred several plies into the skin. Delamination extended down the center of the spar web. Without considering visual aspects of the failure, the strain data analysis (presented in Appendix C, Section C.3) revealed that failure symmetry was inconclusive.

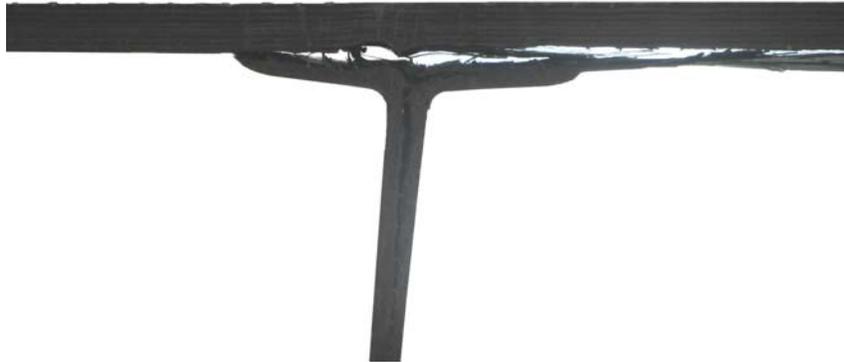
Figure 6.3.1.3: Specimen 3c after dynamic test

Figure 6.3.1.3 shows a complete and asymmetric failure of joint Specimen 3c. Joint debonding and carbon tuft failure occurred at the spar-cap to skin interface (extending into the skin on the right). Delamination extended down the center of the spar web. Without considering visual aspects of the failure, the strain data analysis (presented in Appendix C, Section C.3) revealed that failure was symmetric.

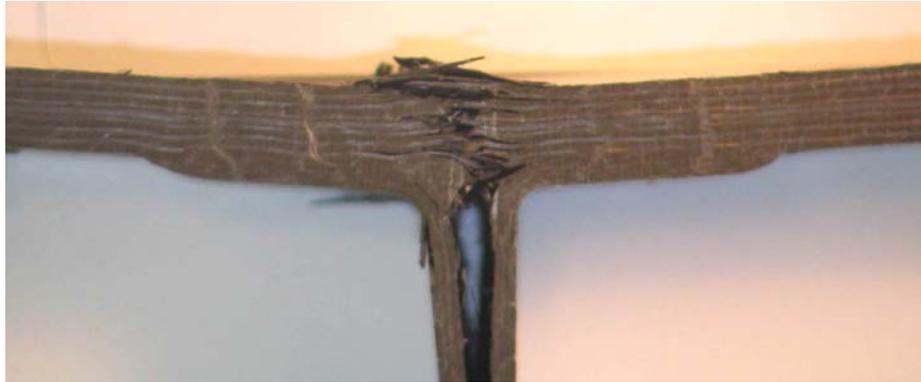
Figure 6.3.2.1: Specimen 3f after static test.

Figure 6.3.2.1 shows a symmetric and incomplete fracture of joint Specimen 3f. Joint failure consisted of a skin fracture immediately above the spar web and delamination that extends down the center of the spar web.

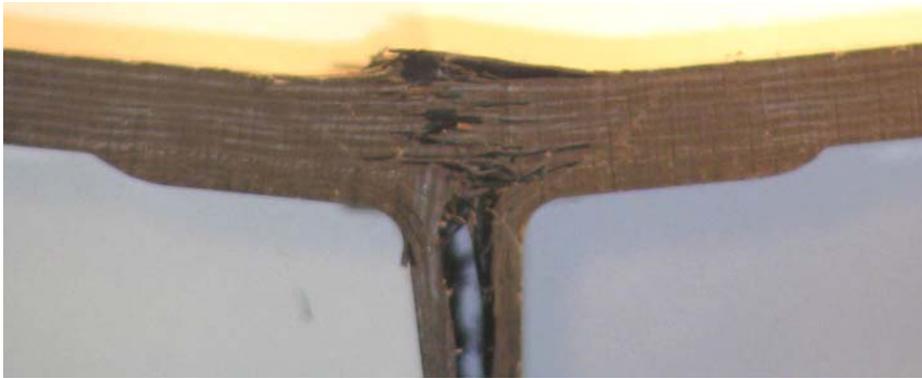
Figure 6.3.2.2: Specimen 3g after static test.

Figure 6.3.2.2 shows a symmetric and incomplete fracture of joint Specimen 3g. Joint failure consisted of a skin fracture immediately above the spar web and delamination that extends down the center of the spar web.

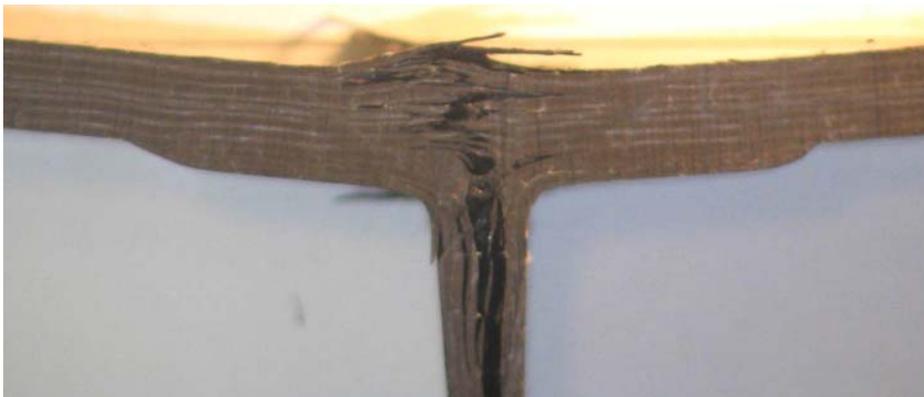
Figure 6.3.2.3: Specimen 3h after static test.

Figure 6.3.2.3 shows a symmetric and incomplete fracture of joint Specimen 3h. Joint failure consisted of a skin fracture immediately above the spar web and delamination that extends down the center of the spar web.

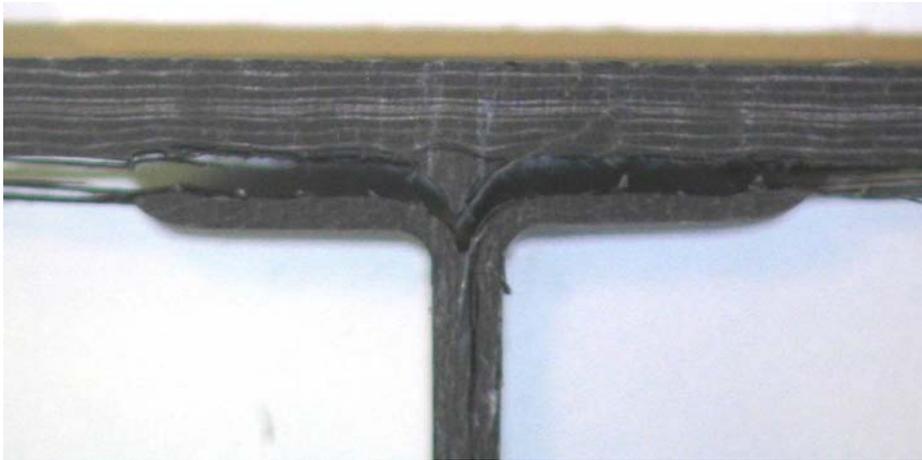
Figure 6.3.2.4: Specimen 3i after static test.

Figure 6.3.2.4 shows a symmetric and complete fracture of joint Specimen 3i. Joint failure consisted of debonding and tufted fiber fracture along the spar cap to skin interface. In addition, delamination extends a short distance down the center of the spar web.

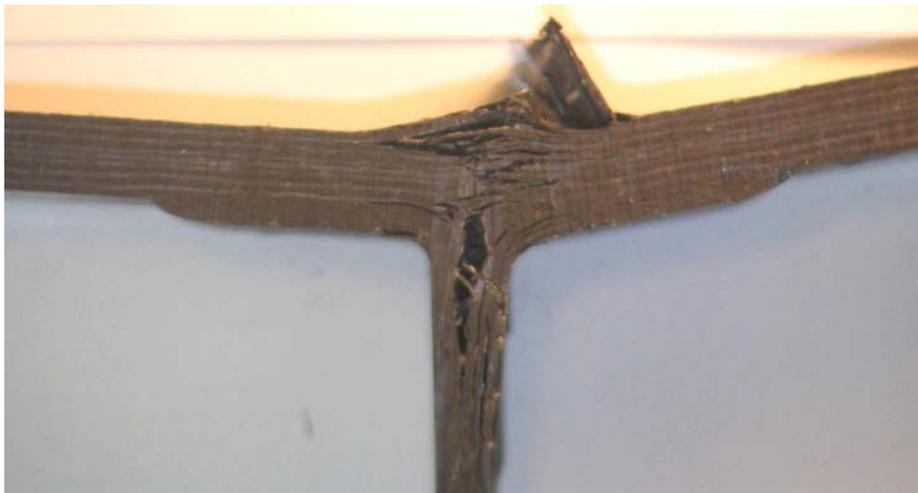
Figure 6.3.2.5: Specimen 3j after static test.

Figure 6.3.2.5 shows a symmetric and incomplete fracture of joint Specimen 3j. Joint failure consisted of a skin fracture immediately above the spar web and delamination that extends down the center of the spar web.

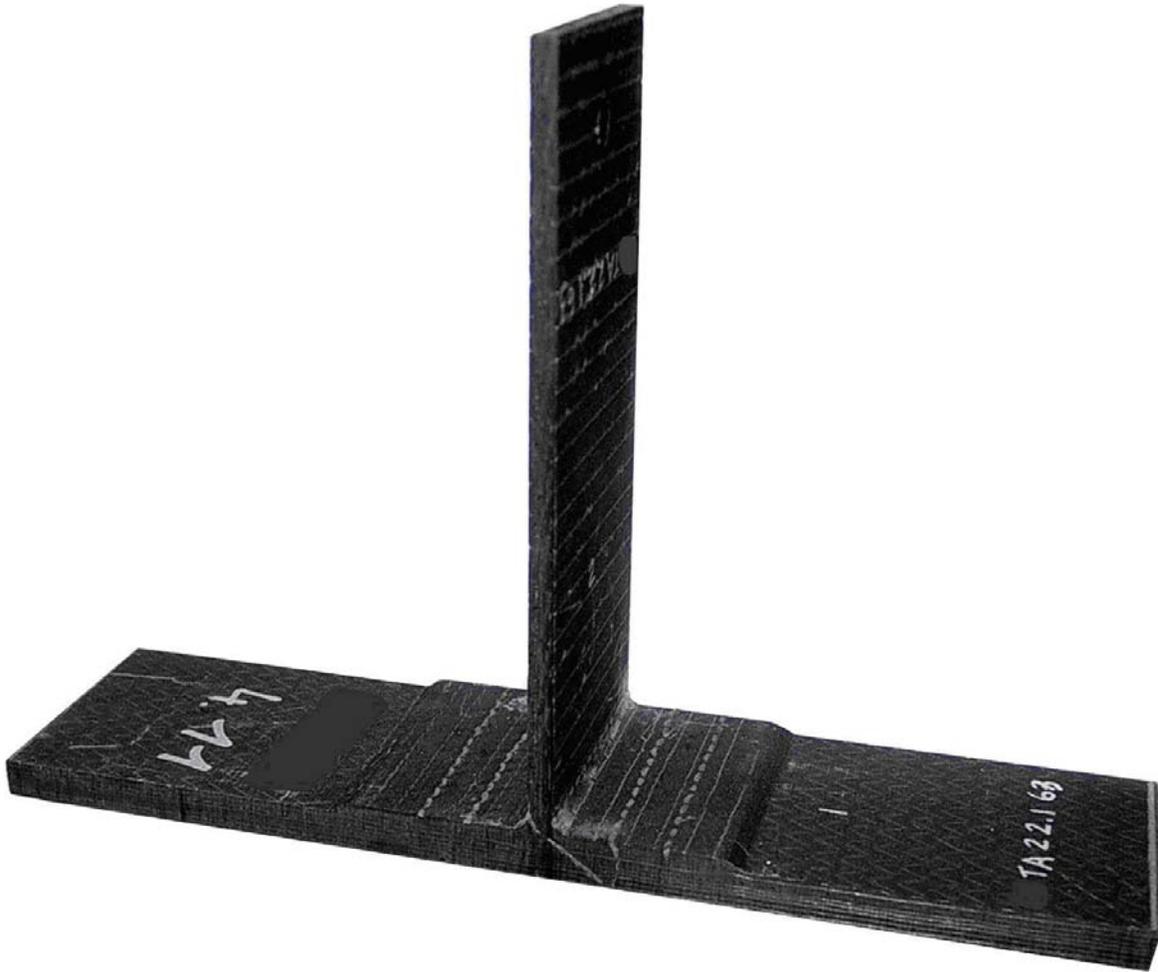
Figure 6.4.2: Example image of joint from Specimen Set 4 (pretest)

Figures 6.4.2 and 6.4.3 are representative of Specimen Set 4 construction.

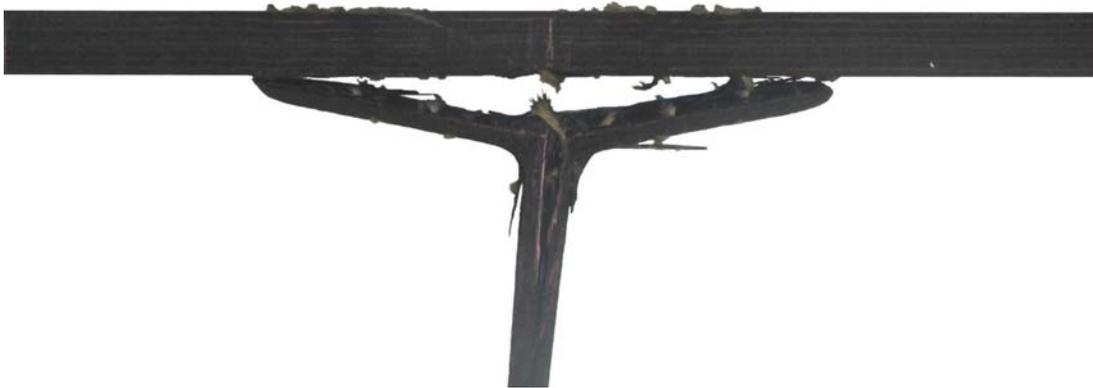
Figure 6.4.1.1: Specimen 4a after dynamic test

Figure 6.4.1.1 shows a complete and largely symmetric failure of joint Specimen 4a. Joint failure consisted of debonding and Aramide fiber fracture at the spar-cap to skin interface. Delamination extended down the center of the spar web. Without considering visual aspects of the failure, the strain data analysis (presented in Appendix C, Section C.4) revealed that failure symmetry was inconclusive.

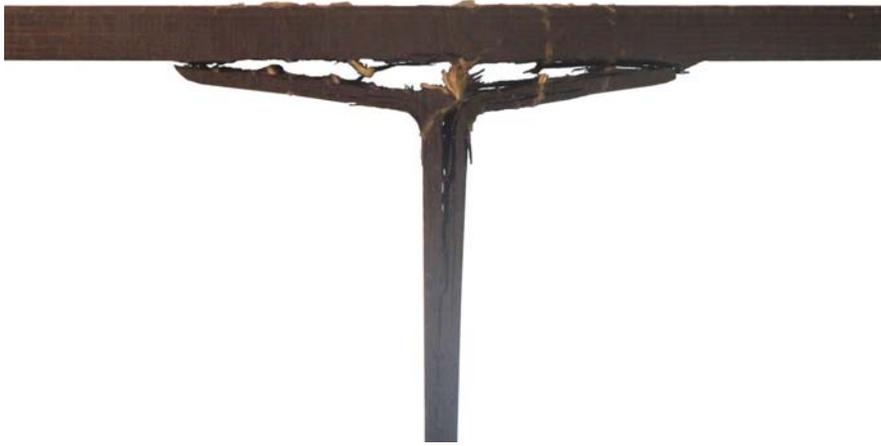
Figure 6.4.1.2: Specimen 4b after dynamic test

Figure 6.4.1.2 shows a symmetric and complete fracture of joint Specimen 4b. Joint failure consisted of debonding and Aramide fiber fracture at the spar-cap to skin interface. Delamination extended down the center of the spar web. Without considering visual aspects of the failure, the strain data analysis (presented in Appendix C, Section C.4) revealed that failure was symmetric.
