AFRL-WS-WP-TR-2007-9002

**EVALUATION OF SKIN-SPAR JOINT
RESISTANCE TO HYDRODYNAMIC RAM**

780th Test Squadron (780 TS/OL-AC)

Final Report for 01 October 2003 – 30 November 2005

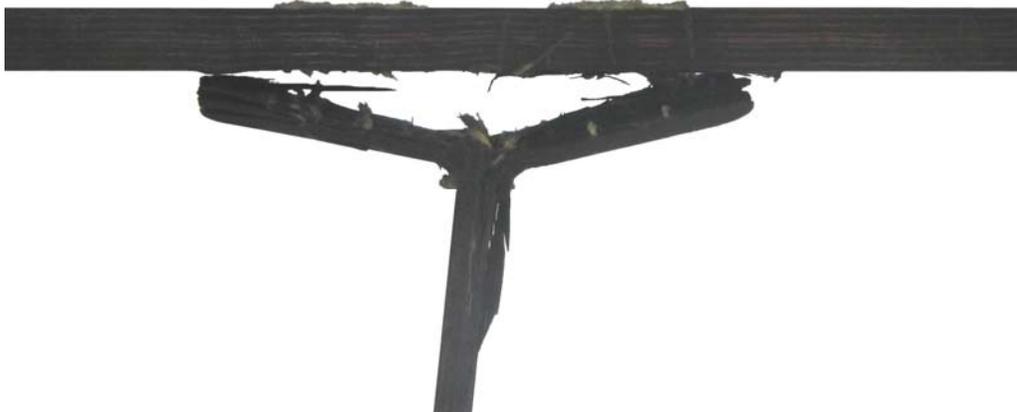
Figure 6.4.1.3: Specimen 4c after dynamic test

Figure 6.4.1.3 shows a complete and symmetric failure of joint Specimen 4c. Joint failure consisted of debonding and Aramide fiber fracture at the spar-cap to skin interface. Delamination extended down the center of the spar web. Without considering visual aspects of the failure, the strain data analysis (presented in Appendix C, Section C.4) revealed that failure was symmetric.

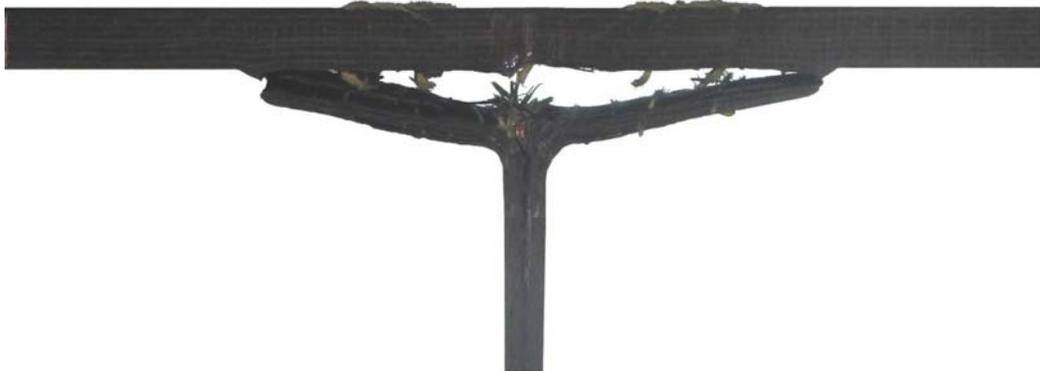
Figure 6.4.1.4: Specimen 4d after dynamic test.

Figure 6.4.1.4 shows a complete and symmetric failure of joint Specimen 4d. Joint failure consisted of debonding and Aramide fiber fracture at the spar-cap to skin interface. Delamination extended down the center of the spar web. Without considering visual aspects of

the failure, the strain data analysis (presented in Appendix C, Section C.4) revealed that failure was symmetric.

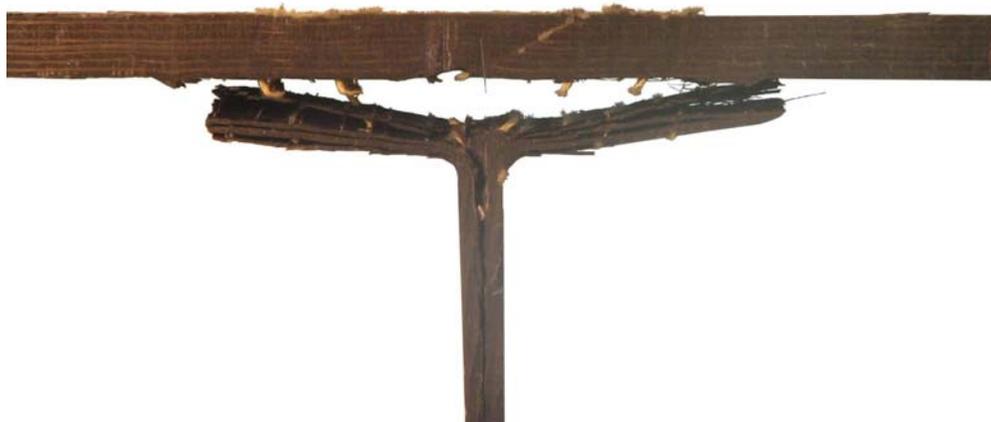
Figure 6.4.1.5: Specimen 4e after dynamic test.

Figure 6.4.1.5 shows a complete and symmetric failure of joint Specimen 4e. Joint failure consisted of debonding and Aramide fiber fracture at the spar-cap to skin interface. Delamination was extensive throughout the spar cap and extended down the center of the spar web. Without considering visual aspects of the failure, the strain data analysis (presented in Appendix C, Section C.4) revealed that failure was symmetric.

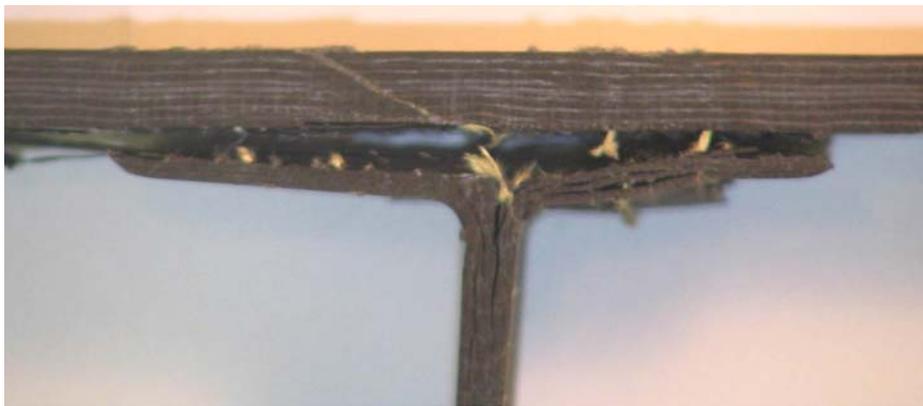
Figure 6.4.2.1: Specimen 4f after static test.

Figure 6.4.2.1 shows a mostly symmetric and complete fracture of joint Specimen 4f. Joint failure consisted of debonding and Aramide fiber fracture along the spar cap to skin interface. In addition, delamination extends a short distance down the center of the spar web.

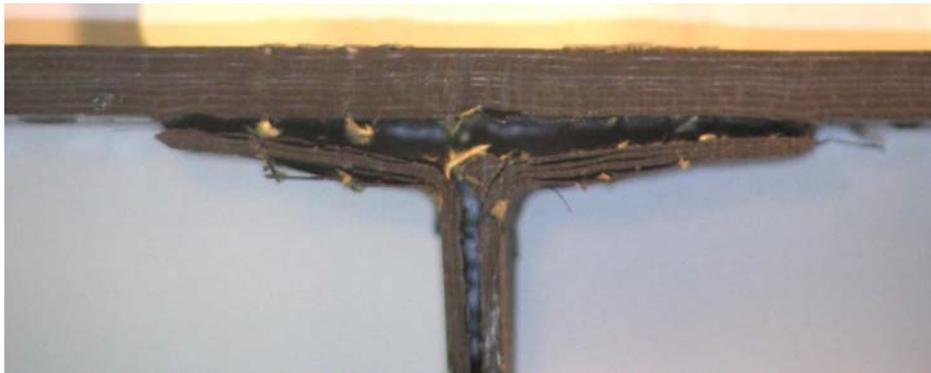
Figure 6.4.2.3: Specimen 4h after static test.

Figure 6.4.2.3 shows a symmetric and complete fracture of joint Specimen 4h. Joint failure consisted of debonding and Aramide fiber fracture along the spar cap to skin interface. In addition, delamination extends a short distance down the center of the spar web.

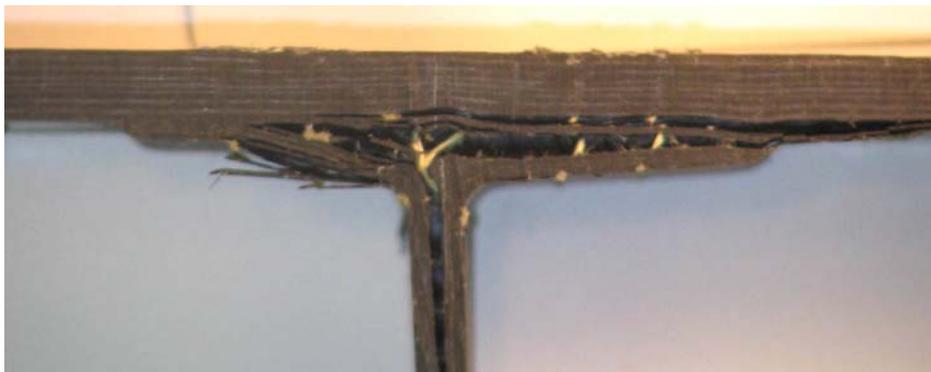
Figure 6.4.2.5: Specimen 4j after static test.

Figure 6.4.2.5 shows an asymmetric and incomplete fracture of joint Specimen 4j. Joint failure consisted of debonding and Aramide fiber fracture along the spar cap to skin interface. In addition, delamination extends down the center of the spar web.

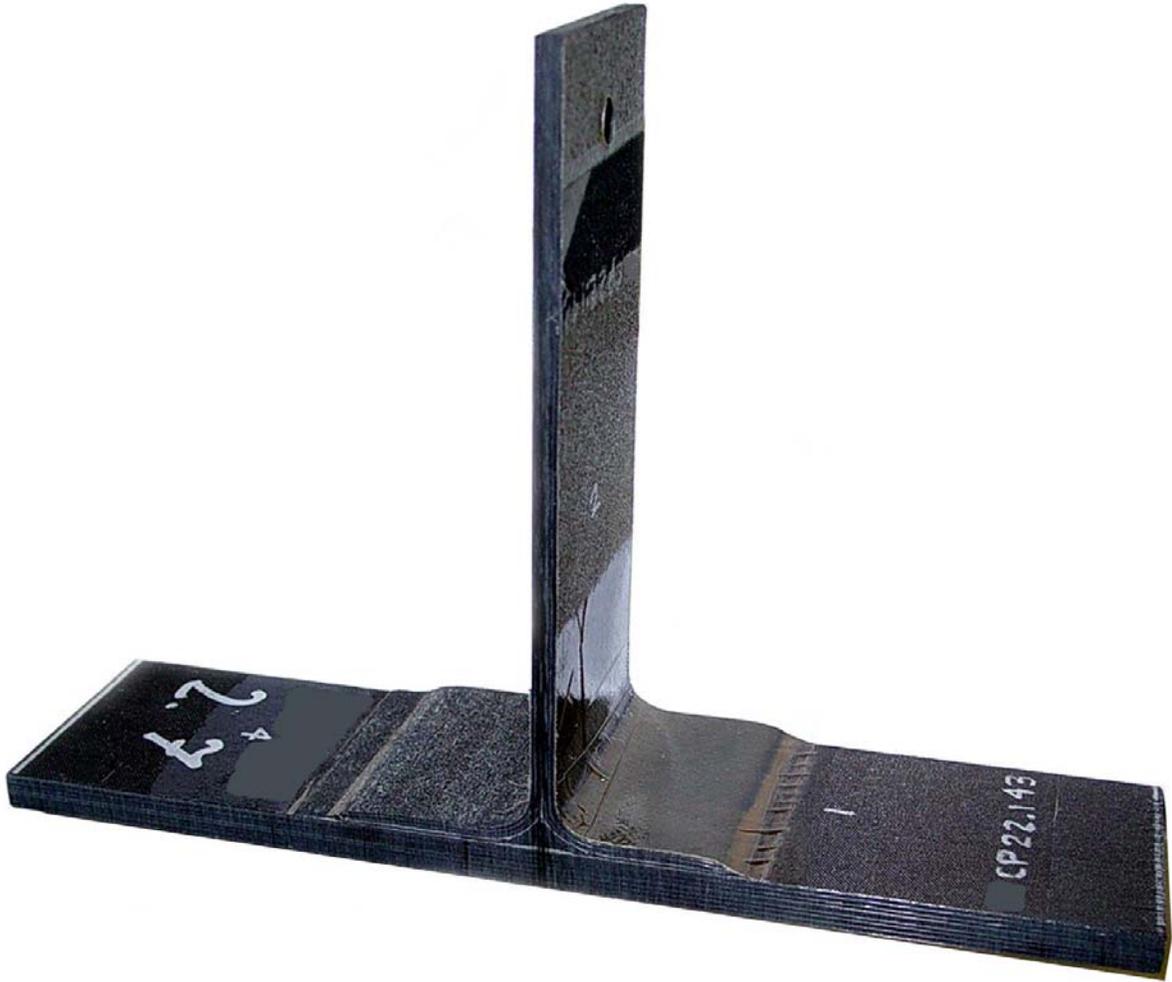
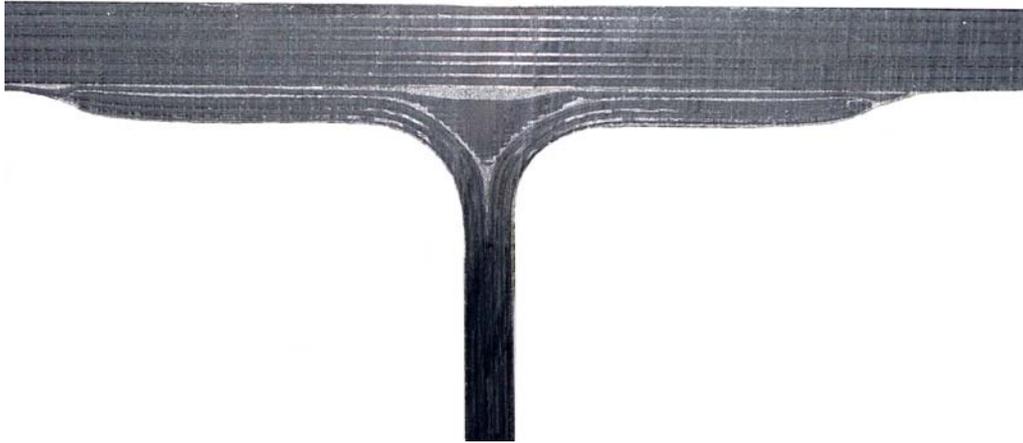
Figures 6.5.2 and 6.5.3 are representative of Specimen Set 5 construction.

Figure 6.5.2: Example image of joint from Specimen Set 5 (pretest)

Figure 6.5.3: Example cross section of joint from Specimen Set 5 (pretest)

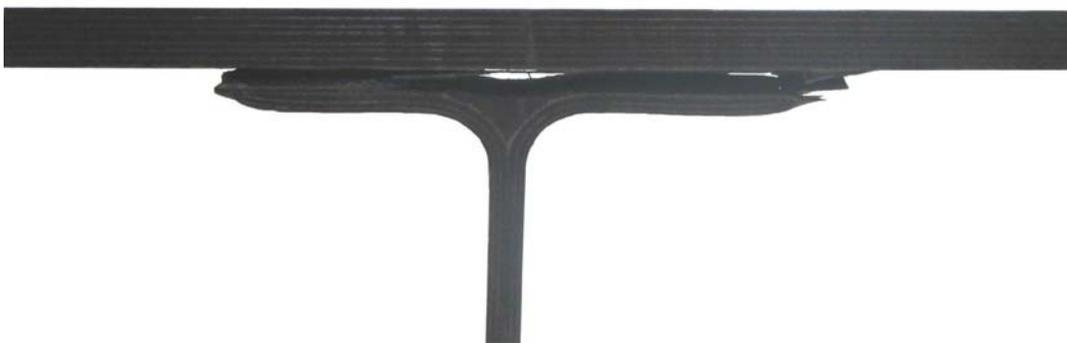
Figure 6.5.1.1: Specimen 5a after dynamic test

Figure 6.5.1.1 shows a complete and largely symmetric failure of joint Specimen 5a. Joint failure consisted of debonding and fracture along the spar-cap to skin interface. Without considering visual aspects of the failure, the strain data analysis (presented in Appendix C, Section C.5) revealed that failure was symmetric.

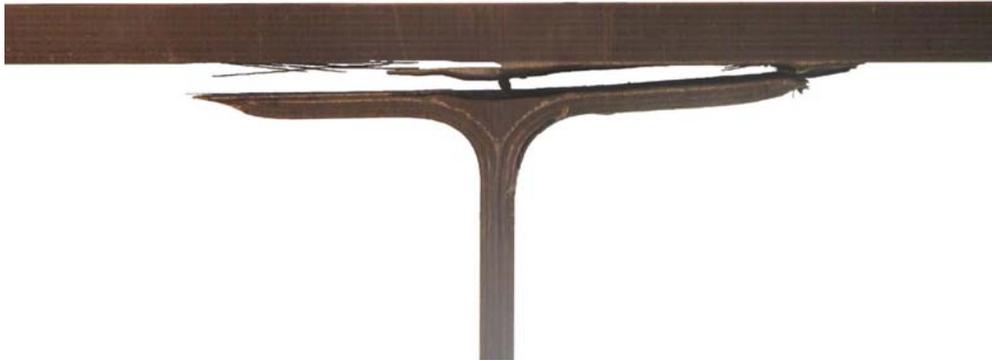
Figure 6.5.1.2: Specimen 5b after dynamic test

Figure 6.5.1.2 shows a complete and largely symmetric failure of joint Specimen 5b. Joint failure consisted of debonding and fracture along the spar-cap to skin interface. Without considering visual aspects of the failure, the strain data analysis (presented in Appendix C, Section C.5) revealed that failure symmetry was inconclusive.

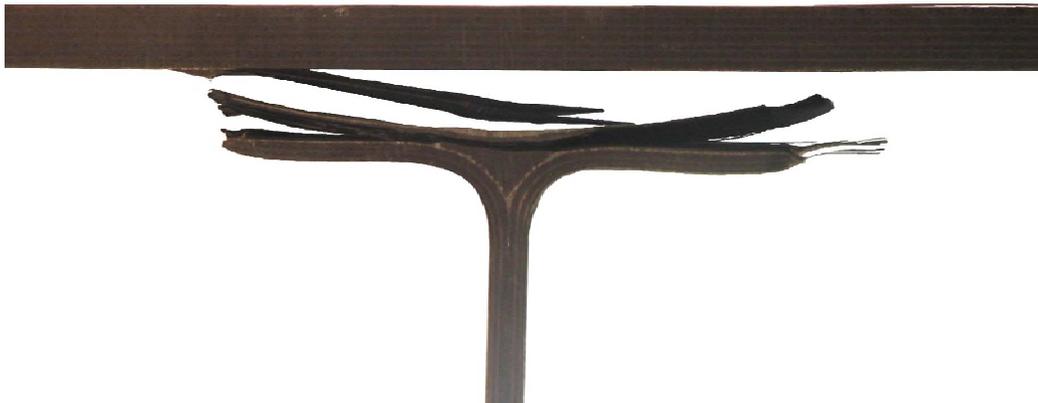
Figure 6.5.1.3: Specimen 5c after dynamic test

Figure 6.5.1.3 shows a complete and symmetric failure of joint Specimen 5c. Joint failure consisted of debonding and fracture along the spar-cap to skin interface. Without considering visual aspects of the failure, the strain data analysis (presented in Appendix C, Section C.5) revealed that failure was symmetric.

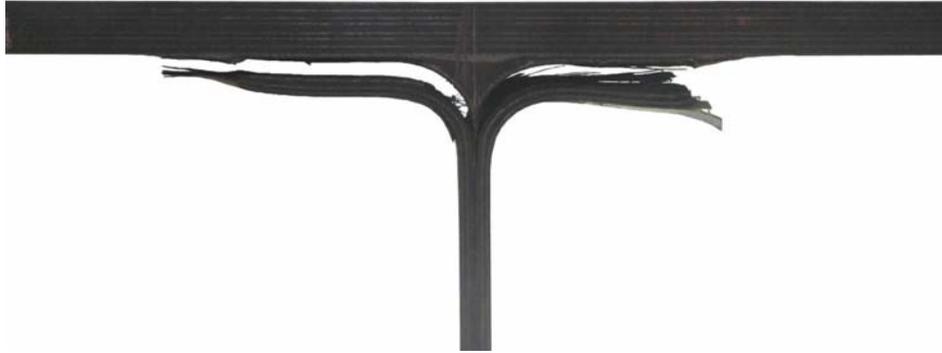
Figure 6.5.1.4: Specimen 5d after dynamic test.

Figure 6.5.1.4 shows a complete and mostly symmetric failure of joint Specimen 5d. Joint failure consisted of debonding and fracture along the spar-cap to skin interface. The noodle remained attached to the skin. Delamination extended down the center of the spar web. Without considering visual aspects of the failure, the strain data analysis (presented in Appendix C, Section C.5) revealed that failure was symmetric.

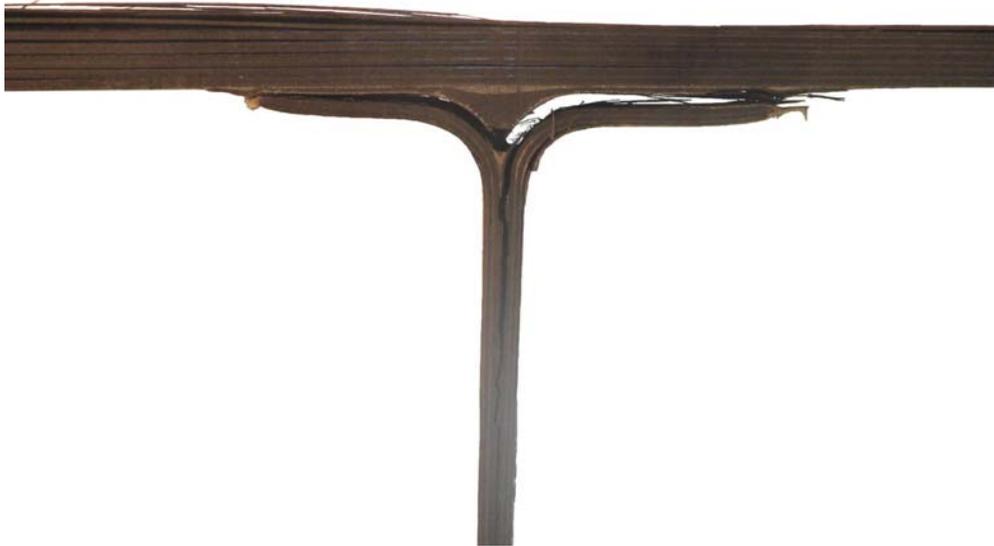
Figure 6.5.1.5: Specimen 5e after dynamic test.

Figure 6.5.1.5 shows a complete and symmetric failure of joint Specimen 5e. Joint failure consisted of debonding and fracture along the spar-cap to skin interface. The noodle remained attached to the skin. Delamination extended down the center of the spar web. Without considering visual aspects of the failure, the strain data analysis (presented in Appendix C, Section C.5) revealed that failure was symmetric.

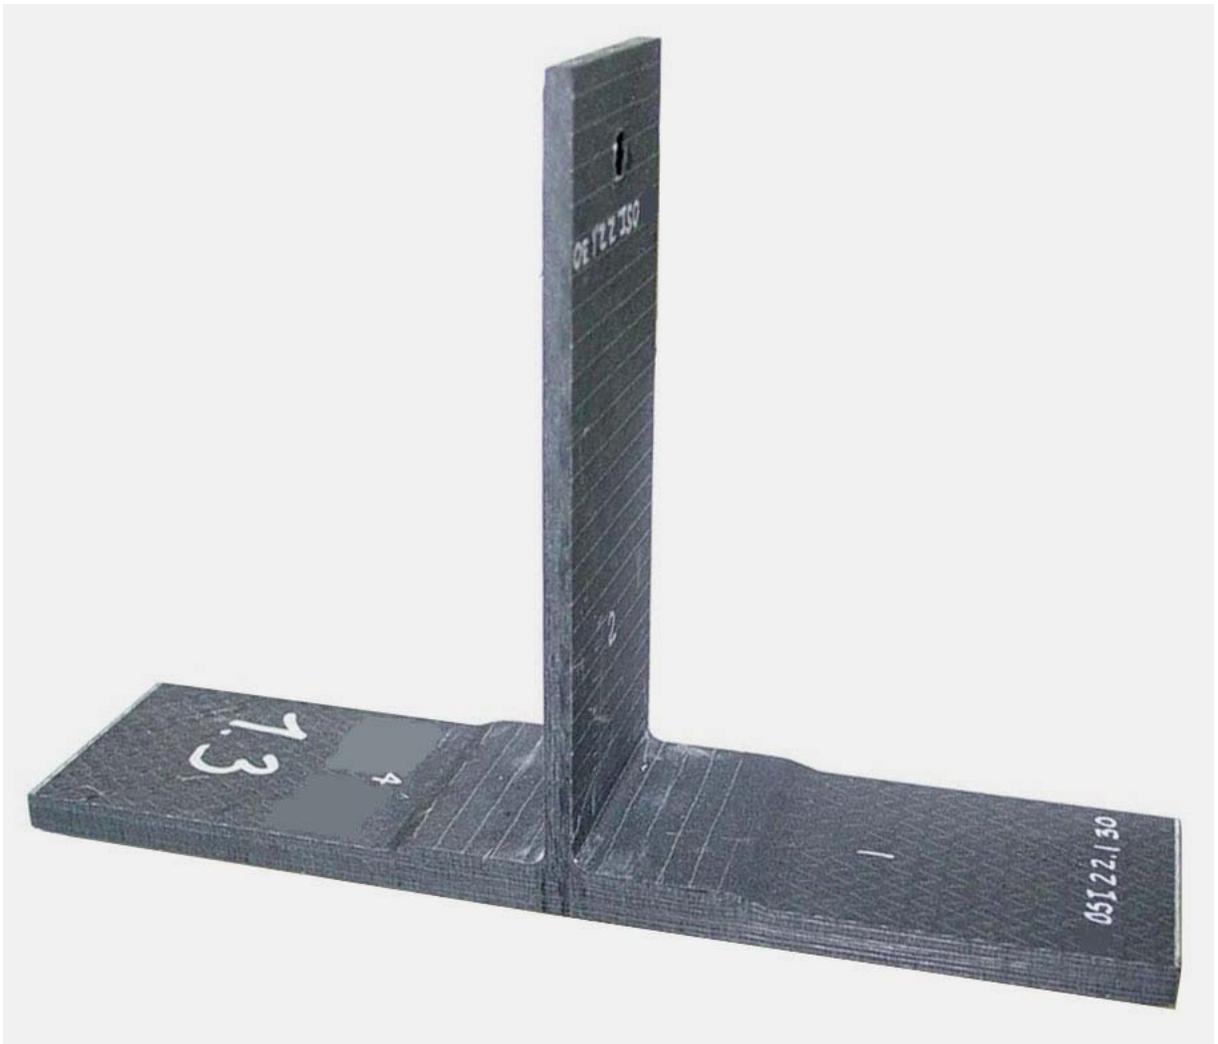
Figure 6.6.2: Example image of joint from Specimen Set 6 (pretest)

Figures 6.6.2 and 6.6.3 are representative of Specimen Set 6 construction. Basic material is non-criped fabric, standard modulus carbon fiber. The noodle is braided carbon fiber. The lay-up was fixed by binder to form a textile preform. The whole preform was infiltrated with RTM 6 Epoxy resin in an autoclave process.

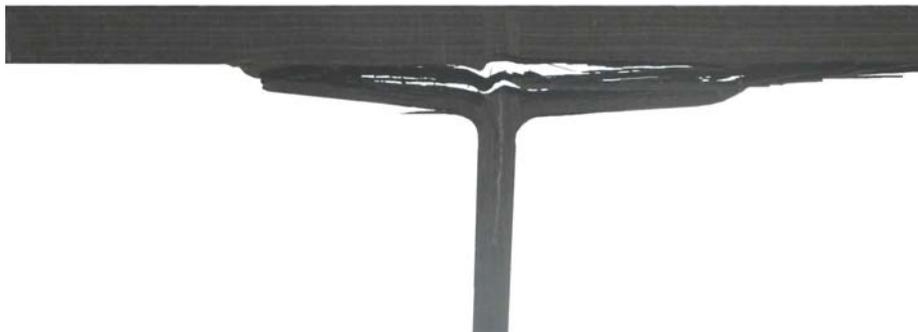
Figure 6.6.1.1: Specimen 6a after dynamic test

Figure 6.6.1.1 shows a complete and symmetric failure of joint Specimen 6a. Joint failure consisted of debonding and fracture along the spar-cap to skin interface. Some delamination extended into the skin (to the right) and for a short distance down the center of the spar web. Without considering visual aspects of the failure, the strain data analysis (presented in Appendix C, Section C.6) revealed that failure was symmetric.

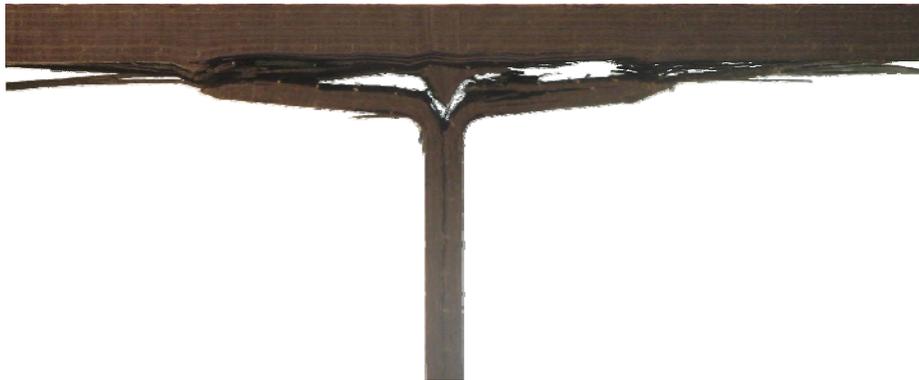
Figure 6.6.1.2: Specimen 6b after dynamic test

Figure 6.6.1.2 shows a symmetric and complete fracture of joint Specimen 6b. Joint failure consisted of debonding and fracture along the spar-cap to skin interface. Delamination extended into lower skin plies on either side of the joint and down the center of the spar web. Without considering visual aspects of the failure, the strain data analysis (presented in Appendix C, Section C.6) revealed that failure was asymmetric.

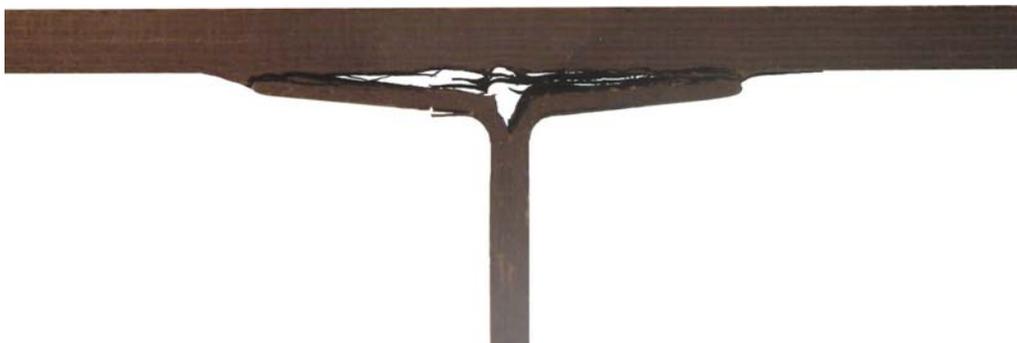
Figure 6.6.1.3: Specimen 6c after dynamic test

Figure 6.6.1.3 shows a complete and symmetric failure of joint Specimen 6c. Joint failure consisted of debonding and fracture along the spar-cap to skin interface. Without considering visual aspects of the failure, the strain data analysis (presented in Appendix C, Section C.6) revealed that failure was symmetric.

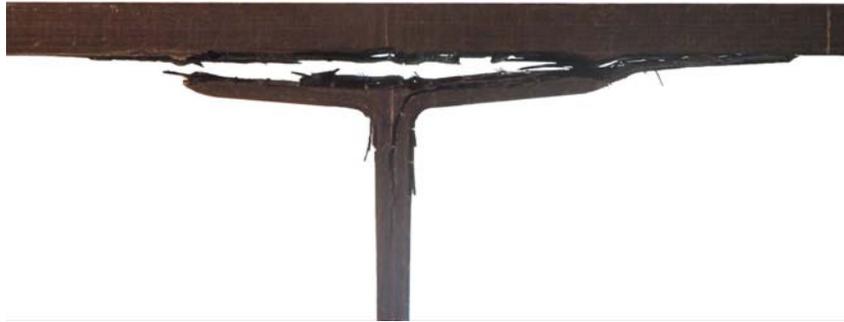
Figure 6.6.1.4: Specimen 6d after dynamic test.

Figure 6.6.1.4 shows a complete and symmetric failure of joint Specimen 6d. Joint failure consisted of debonding and fracture along the spar-cap to skin interface. Delamination extended a short distance down the center of the spar web. Without considering visual aspects of the failure, the strain data analysis (presented in Appendix C, Section C.6) revealed that failure was symmetric.

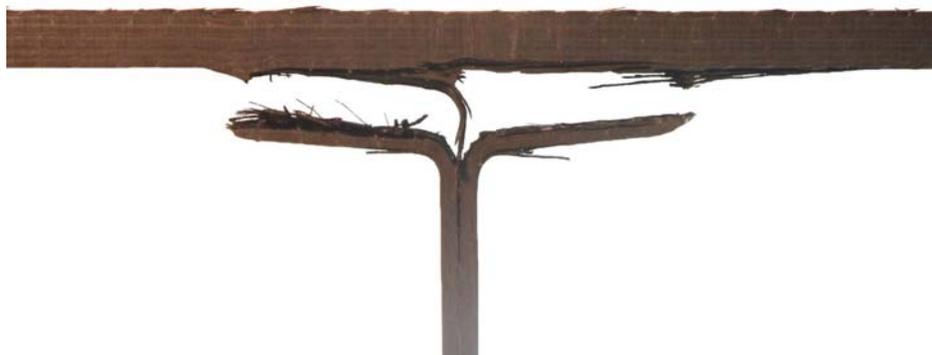
Figure 6.6.1.5: Specimen 6e after dynamic test.

Figure 6.6.1.5 shows a complete and symmetric failure of joint Specimen 6e. Joint failure consisted of debonding and fracture along the spar-cap to skin interface. Delamination extended a short distance down the center of the spar web. Without considering visual aspects of the failure, the strain data analysis (presented in Appendix C, Section C.6) revealed that failure was symmetric.

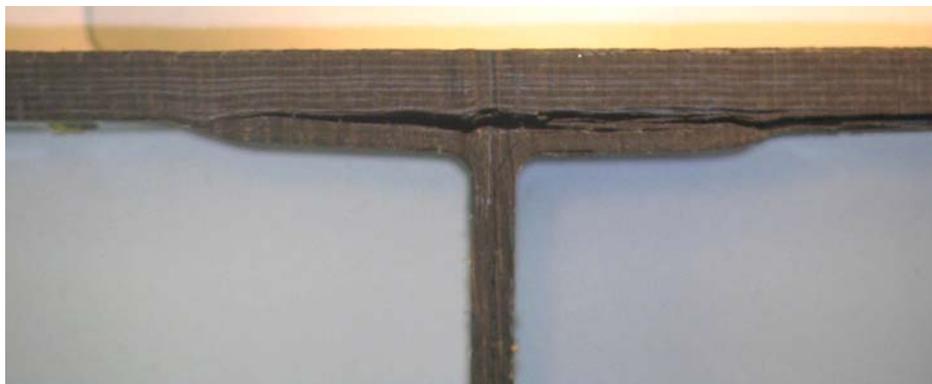
Figure 6.6.2.2: Specimen 6g after static test.

Figure 6.6.2.2 shows a symmetric and complete fracture of joint Specimen 6g. Joint failure consisted of debonding and fiber fracture along the spar cap to skin interface.

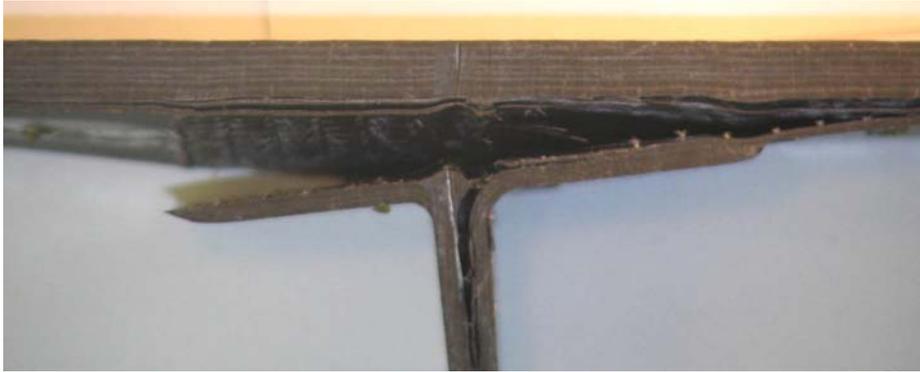
Figure 6.6.2.5: Specimen 6j after static test.

Figure 6.6.2.5 shows a mostly symmetric and complete fracture of joint Specimen 6j. Joint failure consisted of debonding and fiber fracture along the spar cap to skin interface. In addition, delamination ran down the center of the spar web.

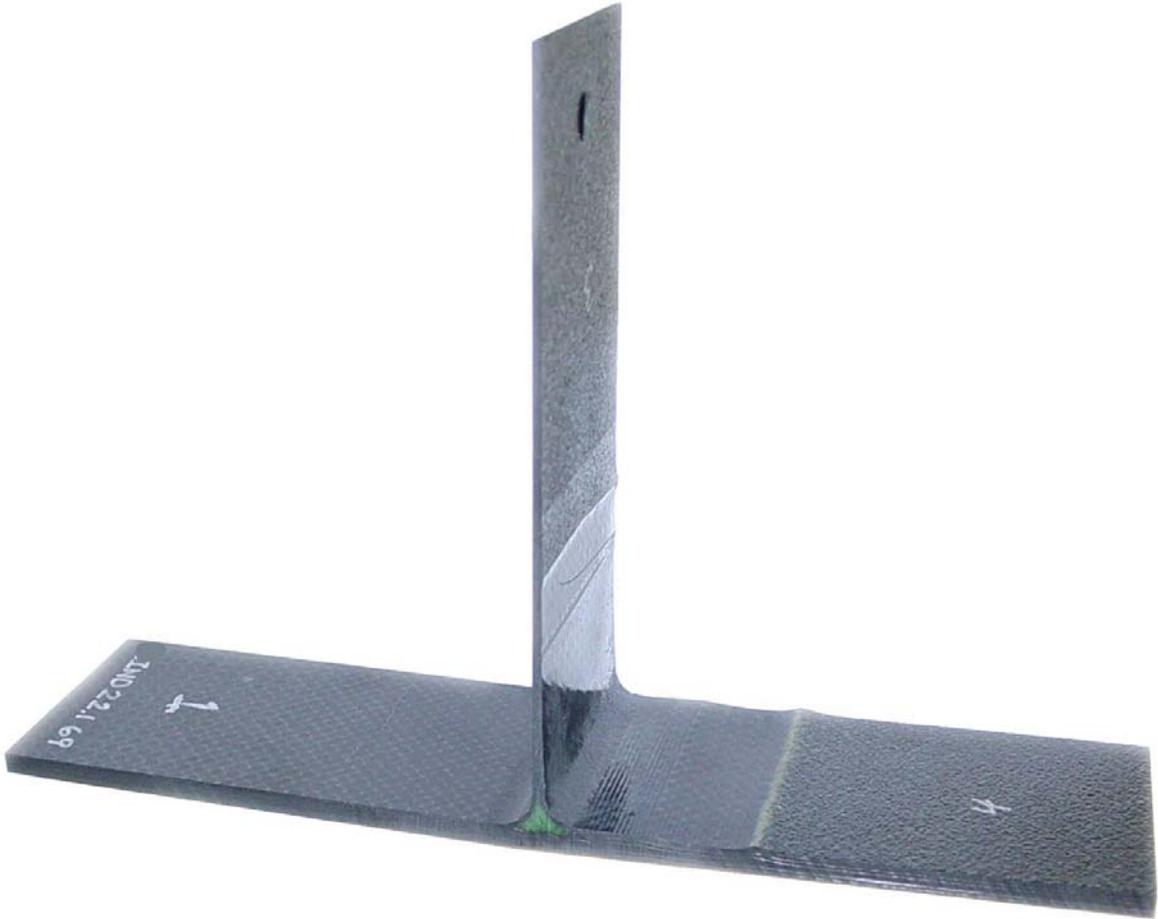
Figure 6.7.2: Example image of joint from Specimen Set 7 (pretest)

Figures 6.7.2 and 6.7.3 are representative of Specimen Set 7 construction.

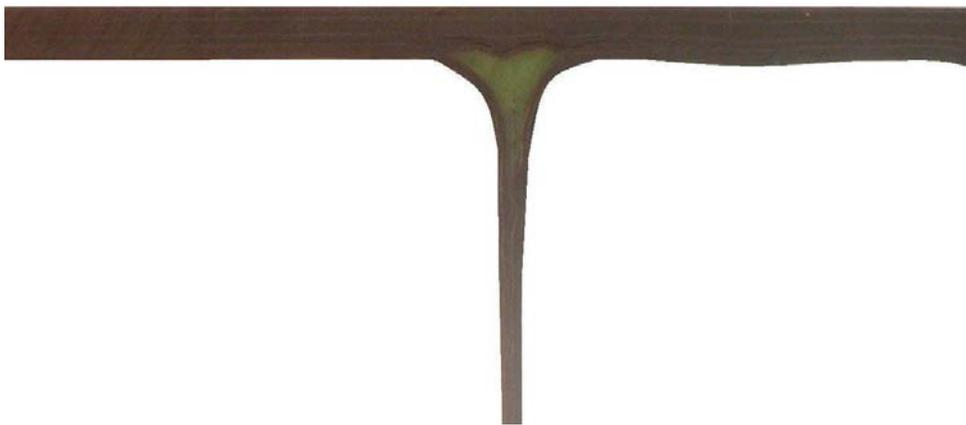
Figure 6.7.1.1: Specimen 7a after dynamic test

Figure 6.7.1.1 shows an incomplete failure of joint Specimen 7a. The joint pulled through the grip at the end of the spar. Still, some delamination is noted directly above the noodle. Without considering visual aspects of the failure, the strain data analysis (presented in Appendix C, Section C.7) revealed that initial failure remained symmetric.

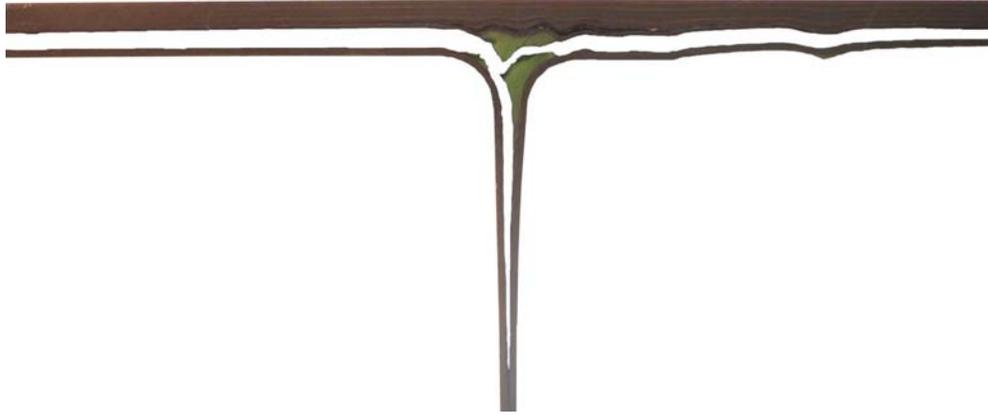
Figure 6.7.1.2: Specimen 7b after dynamic test

Figure 6.7.1.2 shows a complete and symmetric failure of joint Specimen 7b. Joint failure consisted of debonding along the wrap-around spar cap to skin interface. Delamination extended down the center of the spar web. Without considering visual aspects of the failure, the strain data analysis (presented in Appendix C, Section C.7) revealed that failure was asymmetric.

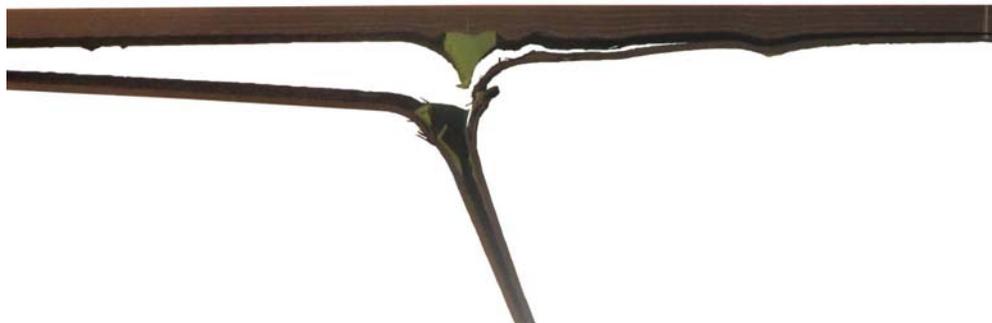
Figure 6.7.1.3: Specimen 7c after dynamic test

Figure 6.7.1.3 shows a complete and asymmetric failure of joint Specimen 7c. Joint failure on the left side consisted of debonding along the wrap-around spar cap to skin interface. Failure on the right side has fiber fracture at the noodle. Delamination extended down the center of the spar web. Without considering visual aspects of the failure, the strain data analysis (presented in Appendix C, Section C.7) revealed that failure was asymmetric.

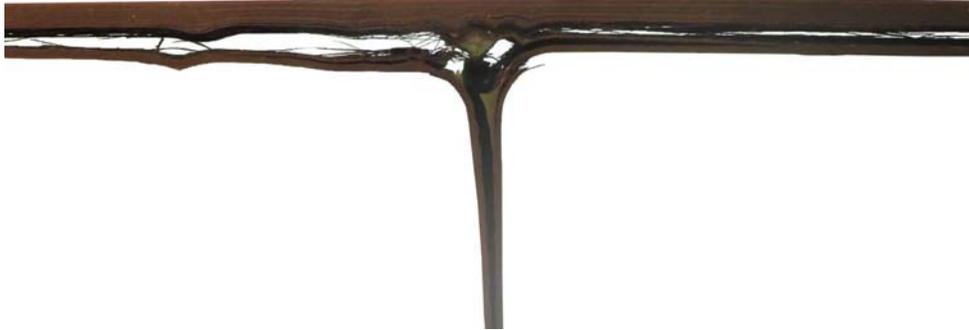
Figure 6.7.1.4: Specimen 7d after dynamic test.

Figure 6.7.1.4 shows a complete and symmetric failure of joint Specimen 7d. Joint failure consisted of debonding along the wrap-around spar cap to skin interface. Delamination extended down the center of the spar web. Without considering visual aspects of the failure, the strain

data analysis (presented in Appendix C, Section C.7) revealed that failure symmetry was inconclusive.

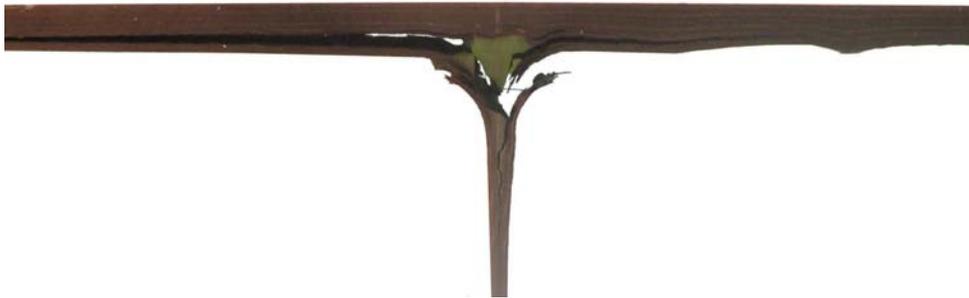
Figure 6.7.1.5: Specimen 7e after dynamic test.

Figure 6.7.1.5 shows a complete and asymmetric failure of joint Specimen 7e. Joint failure on the left consisted of debonding along the wrap-around spar cap to skin interface. Failure on the right included fiber fracture at the noodle. Delamination extended a short distance down the center of the spar web. Without considering visual aspects of the failure, the strain data analysis (presented in Appendix C, Section C.7) revealed that failure was asymmetric.

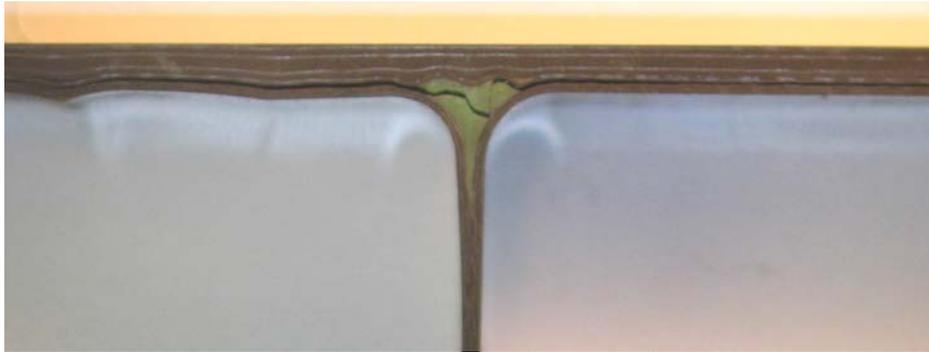
Figure 6.7.2.1: Specimen 7f after static test.

Figure 6.7.2.1 shows a symmetric and incomplete fracture of joint Specimen 7f. Joint failure consisted of debonding along the spar cap to skin interface.

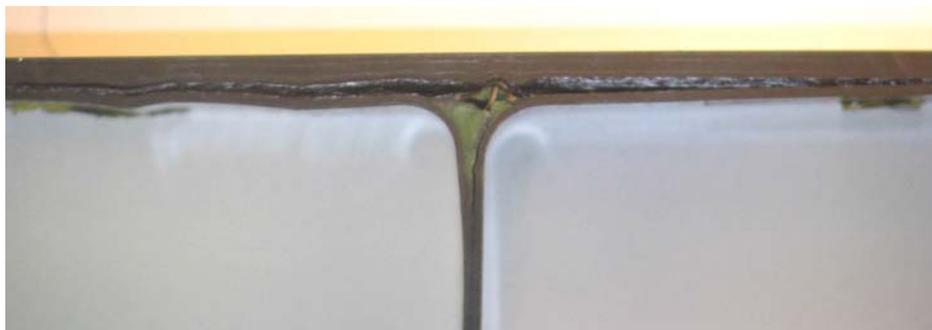
Figure 6.7.2.2: Specimen 7g after static test.

Figure 6.7.2.2 shows a symmetric and incomplete fracture of joint Specimen 7g. Joint failure consisted of debonding along the spar cap to skin interface.

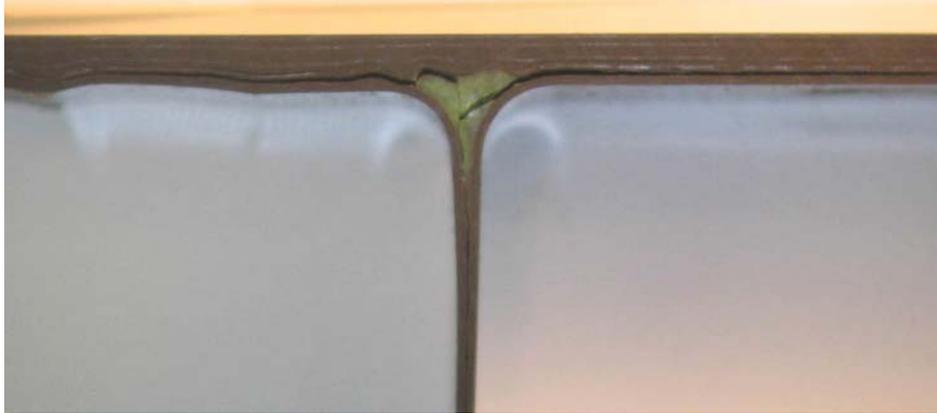
Figure 6.7.2.3: Specimen 7h after static test.

Figure 6.7.2.3 shows a symmetric and incomplete fracture of joint Specimen 7h. Joint failure consisted of debonding along the spar cap to skin interface.

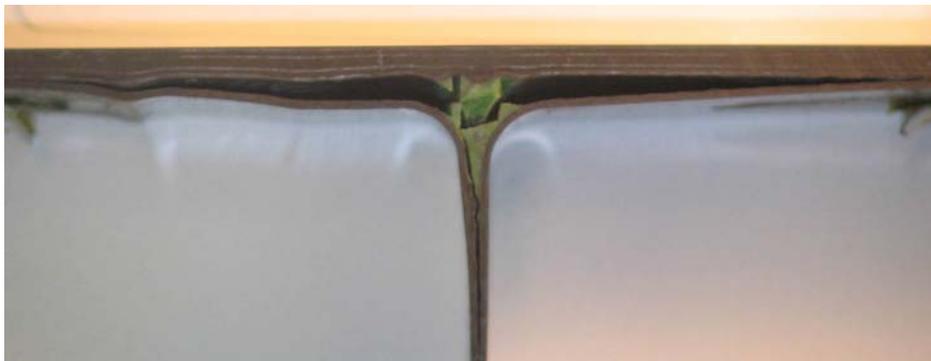
Figure 6.7.2.4: Specimen 7i after static test.

Figure 6.7.2.4 shows a symmetric and incomplete fracture of joint Specimen 7i. Joint failure consisted of debonding along the spar cap to skin interface. In addition, delamination ran down the center of the spar web.

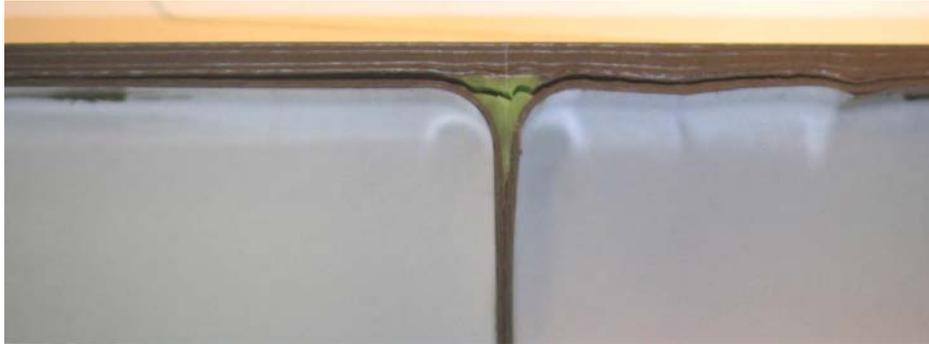
Figure 6.7.2.5: Specimen 7j after static test.

Figure 6.7.2.5 shows a symmetric and incomplete fracture of joint Specimen 7j. Joint failure consisted of debonding along the spar cap to skin interface. In addition, delamination ran down the center of the spar web.

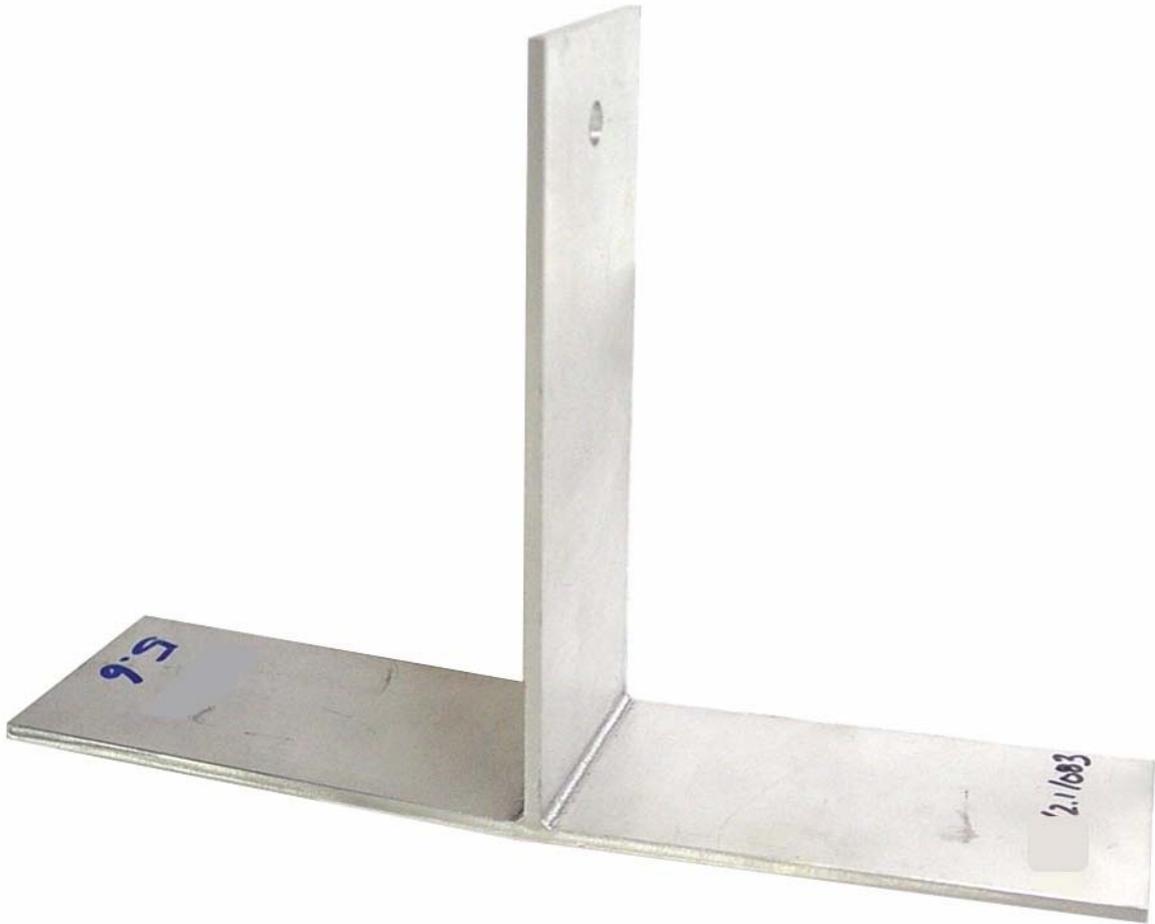
Figure 6.8.2: Example image of joint from Specimen Set 8 (pretest)

Specimen Set 8 consists of laser beam welded aluminum skin-spar joints. These samples are made from aluminum alloy 6056 sheet of 3 mm thickness for both skin and spar. The two parts were clamped together and welded by a Nd YAG laser beam in two runs, one side of the joint at a time. The welding filler wire was AlSi12 (12% Si). Samples were checked by the manufacturer via penetrant testing and were assessed to be free of cracks. Figure 6.8.1 and Table 6.8.1 show average joint dimensions for Specimen Set 8.

Figures 6.8.2 and 6.8.3 are representative of Specimen Set 8 construction.

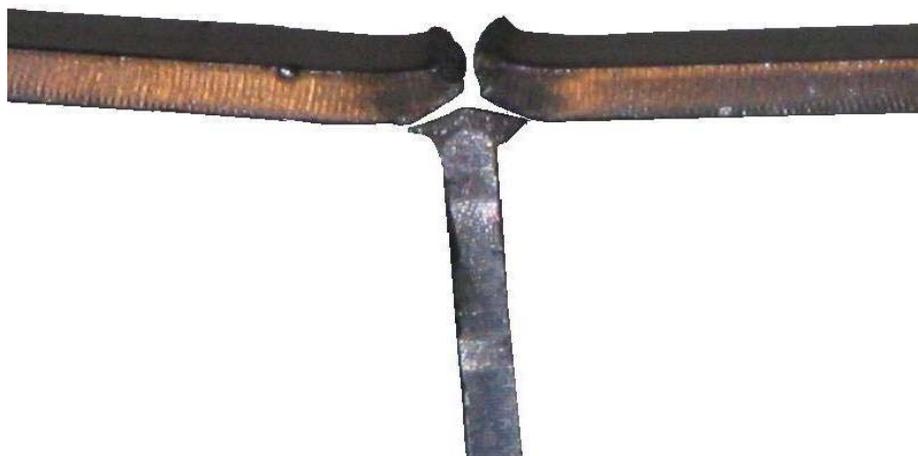
Figure 6.8.1.1: Specimen 8a after dynamic test

Figure 6.8.1.1 shows a complete and symmetric failure of joint Specimen 8a. Joint failure consisted of a three-way fracture at the weld. Without considering visual aspects of the failure, the strain data analysis (presented in Appendix C, Section C.8) revealed that failure was symmetric.

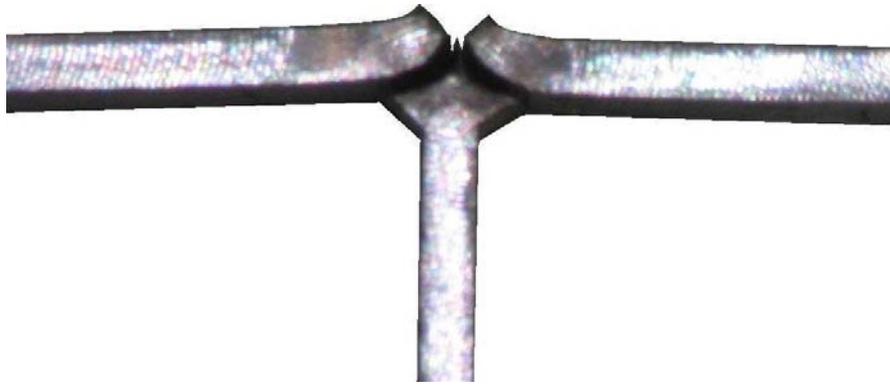
Figure 6.8.1.2: Specimen 8b after dynamic test

Figure 6.8.1.2 shows a complete and symmetric fracture of joint Specimen 8b. Joint failure consisted of a three-way fracture at the weld. Without considering visual aspects of the failure, the strain data analysis (presented in Appendix C, Section C.8) revealed that failure symmetry was inconclusive.

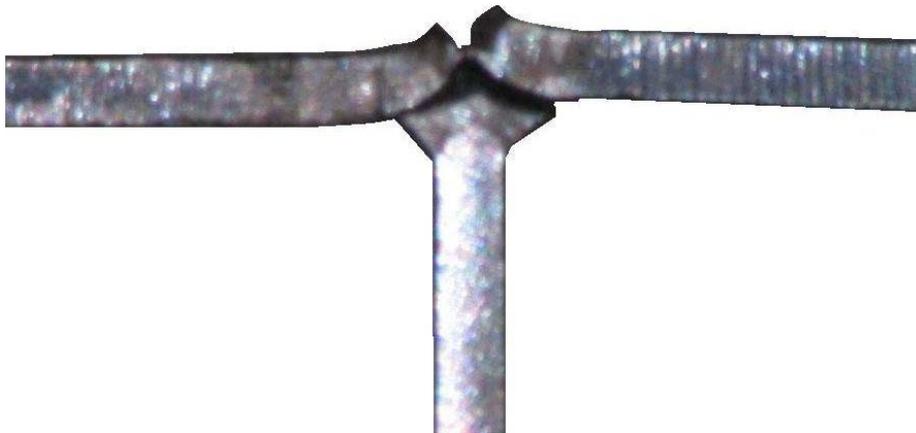
Figure 6.8.1.3: Specimen 8c after dynamic test

Figure 6.8.1.3 shows a complete and symmetric failure of joint Specimen 8c. Joint failure consisted of a three-way fracture at the weld. Without considering visual aspects of the failure, the strain data analysis (presented in Appendix C, Section C.8) revealed that failure symmetry was inconclusive.

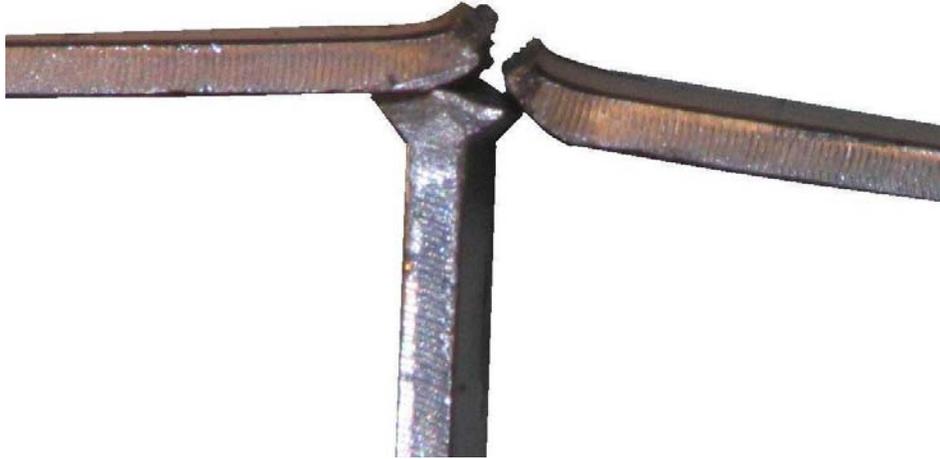
Figure 6.8.1.4: Specimen 8d after dynamic test.

Figure 6.8.1.4 shows a complete and symmetric failure of joint Specimen 8d. Joint failure consisted of a three-way fracture at the weld. Without considering visual aspects of the failure, the strain data analysis (presented in Appendix C, Section C.8) revealed that failure symmetry was inconclusive.

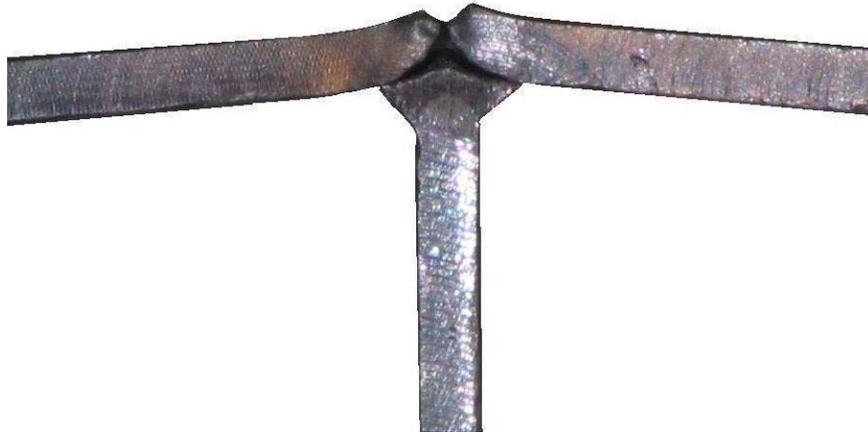
Figure 6.8.1.5: Specimen 8e after dynamic test.

Figure 6.8.1.5 shows a complete and symmetric failure of joint Specimen 8e. Joint failure consisted of a three-way fracture at the weld. Without considering visual aspects of the failure, the strain data analysis (presented in Appendix C, Section C.8) revealed that failure symmetry was inconclusive.

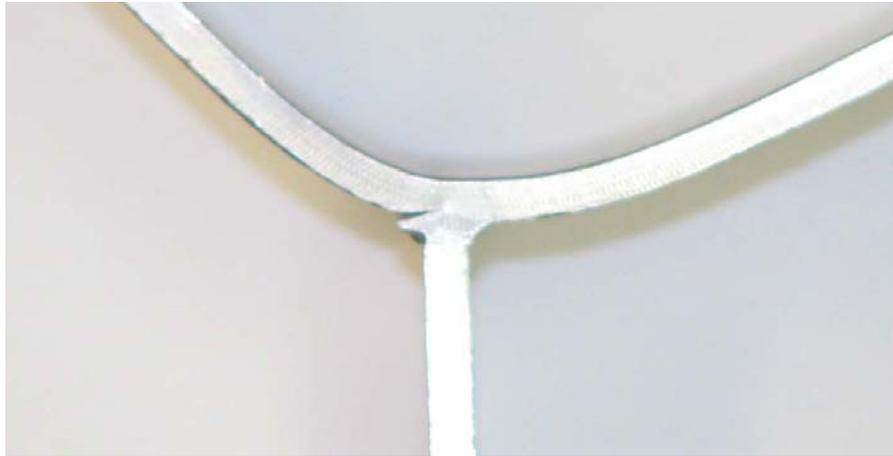
Figure 6.8.2.1: Specimen 8f after static test.

Figure 6.8.2.1 shows a symmetric and complete fracture of joint Specimen 8f. Joint failure consisted of excessive skin deformation and a weld fracture at the skin-spar interface.

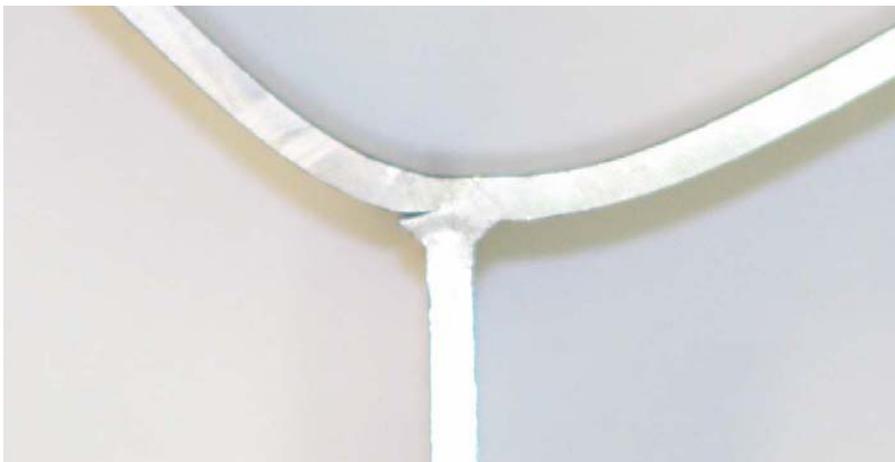
Figure 6.8.2.2: Specimen 8g after static test.

Figure 6.8.2.2 shows a symmetric and incomplete fracture of joint Specimen 8g. Joint failure consisted of excessive skin deformation and a weld fracture at the skin-spar interface.

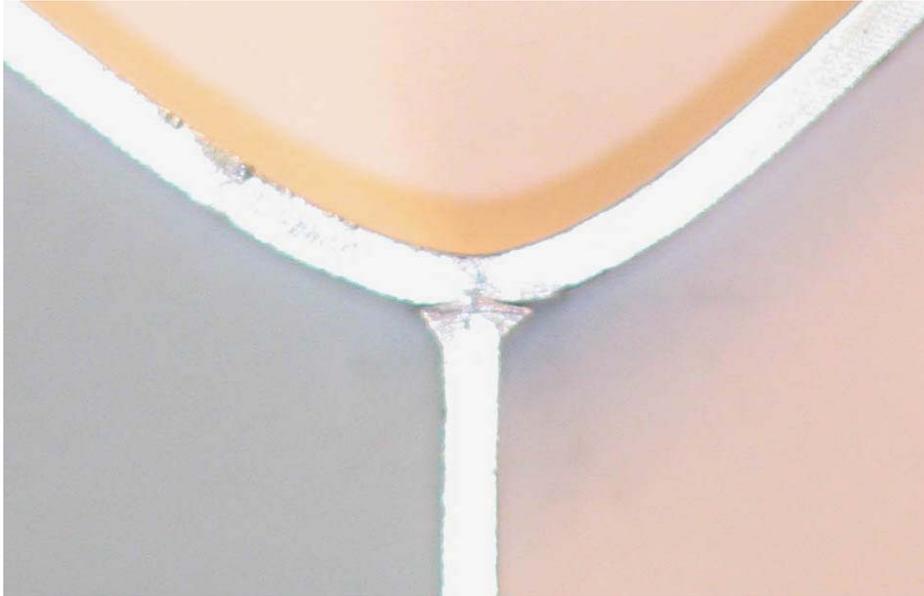
Figure 6.8.2.3: Specimen 8h after static test.

Figure 6.8.2.3 shows a symmetric and incomplete fracture of joint Specimen 8h. Joint failure consisted of excessive skin deformation and a weld fracture at the skin-spar interface.
