AFRL-WS-WP-TR-2007-9002

**EVALUATION OF SKIN-SPAR JOINT
RESISTANCE TO HYDRODYNAMIC RAM**

780th Test Squadron (780 TS/OL-AC)

Final Report for 01 October 2003 – 30 November 2005

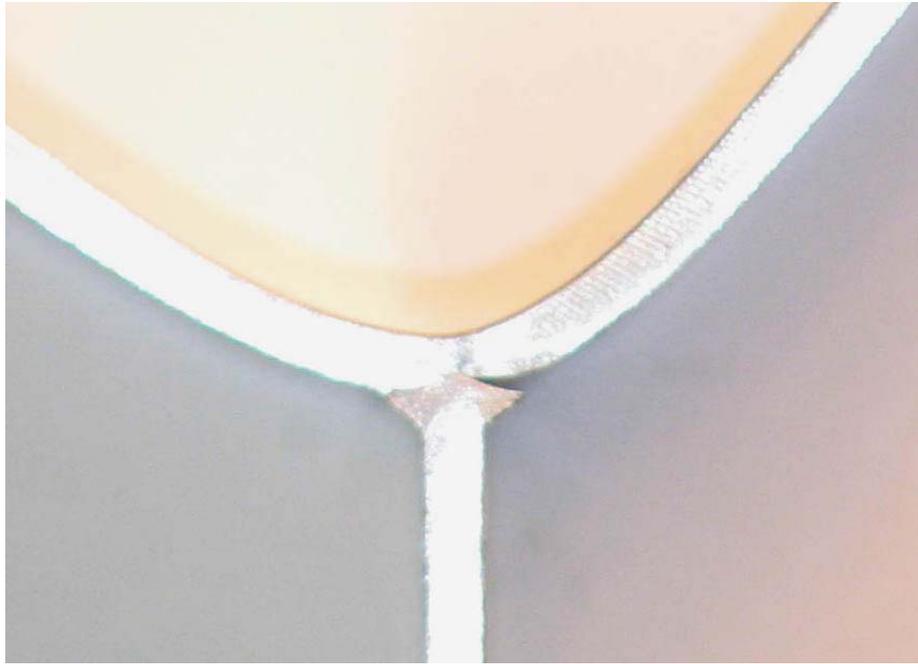
Figure 6.8.2.4: Specimen 8i after static test.

Figure 6.8.2.4 shows a symmetric and incomplete fracture of joint Specimen 8i. Joint failure consisted of excessive skin deformation and a weld fracture at the skin-spar interface.

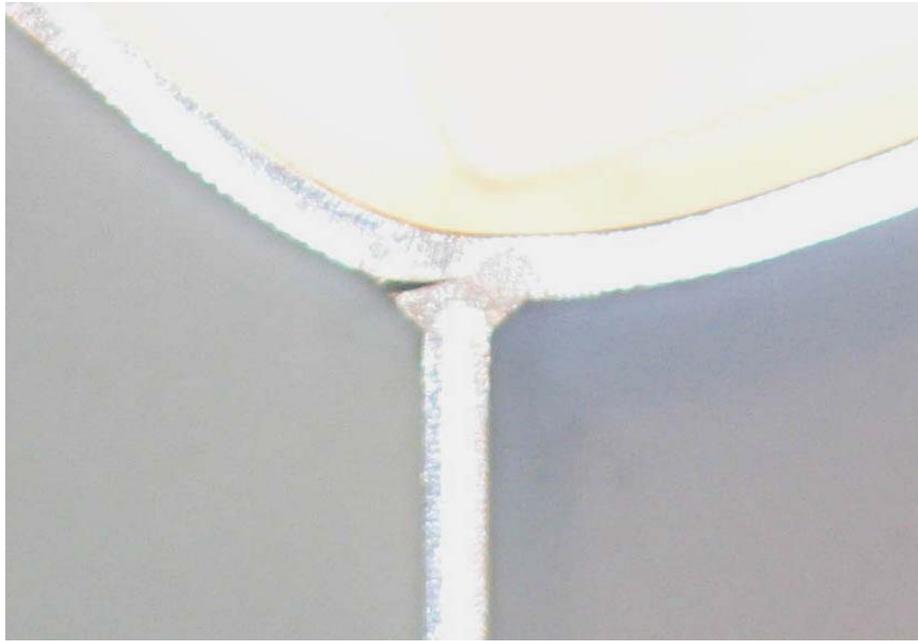
Figure 6.8.2.5: Specimen 8j after static test.

Figure 6.8.2.5 shows a symmetric and incomplete fracture of joint Specimen 8j. Joint failure consisted of excessive skin deformation and a weld fracture at the skin-spar interface.

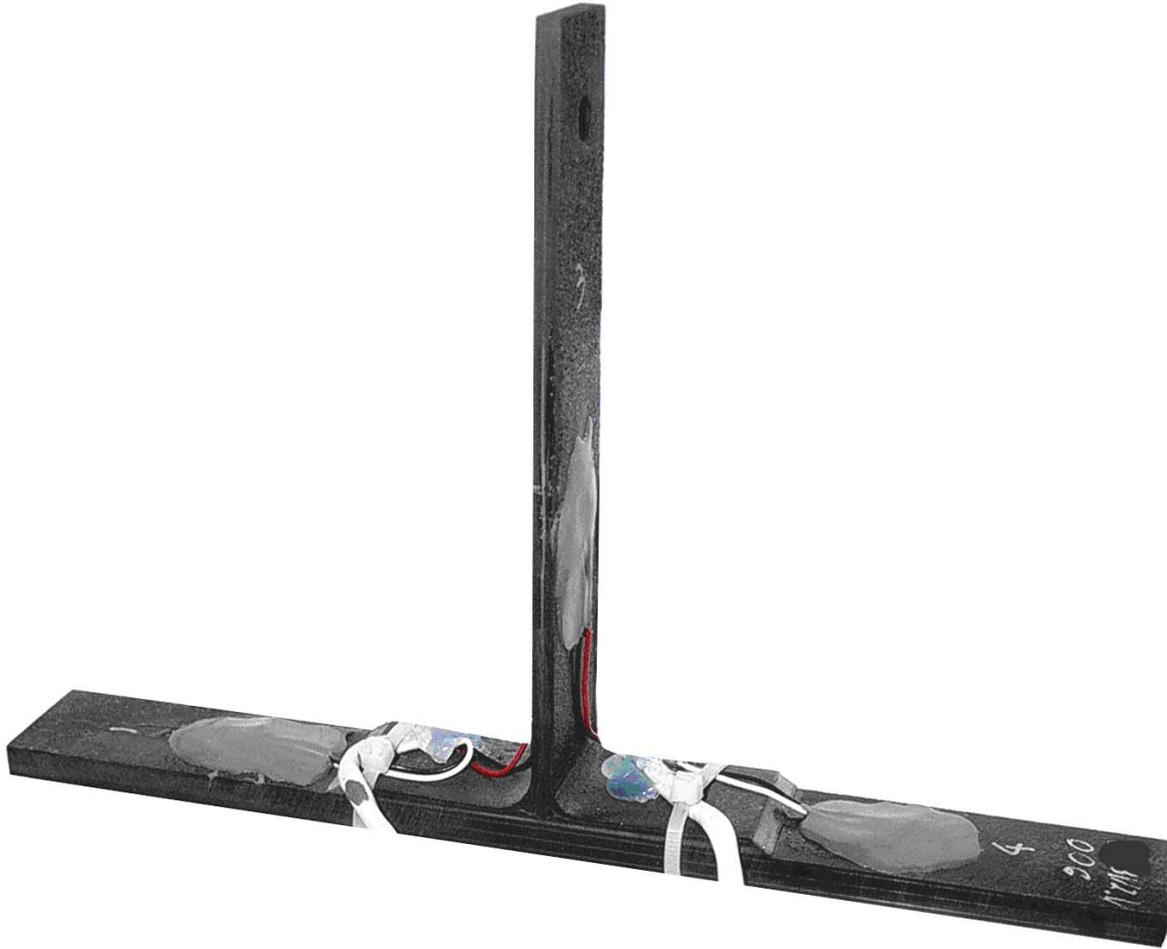
Figure 6.9.2: Example image of joint from Specimen Set 9 (pretest)

Figures 6.9.2 and 6.9.3 are representative of Specimen Set 9 construction. These images were collected prior to testing and show strain gage instrumentation.

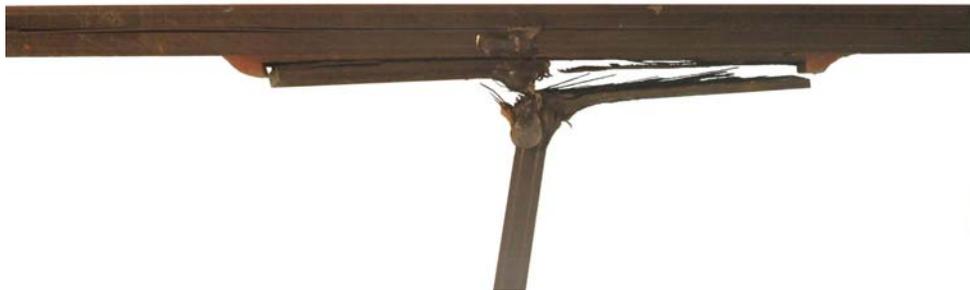
Figure 6.9.1.1: Specimen 9a after dynamic test

Figure 6.9.1.1 shows a complete and asymmetric failure of joint Specimen 9a. Joint failure on the left side consists of a severed and debonded spar cap. The cap on the right side has fiber-fracture at the spar web intersection and is detached from the skin. Delamination extended a short distance down the center of the spar web. Without considering visual aspects of the failure, the strain data analysis (presented in Appendix C, Section C.9) revealed that failure symmetry was inconclusive.

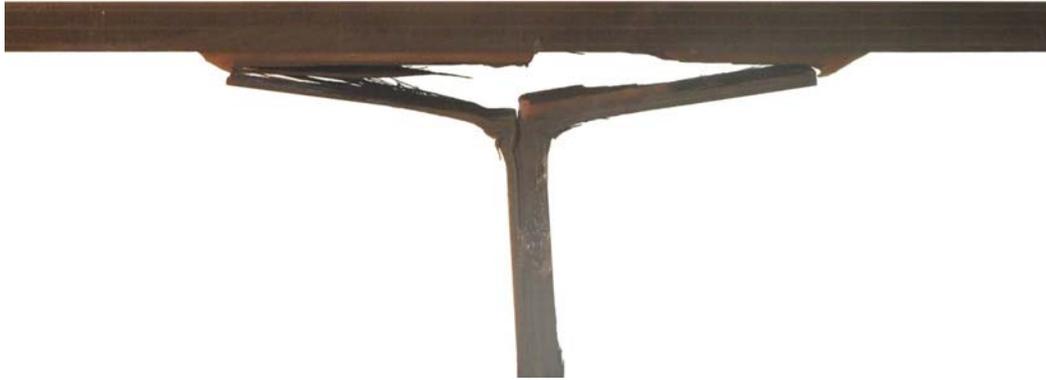
Figure 6.9.1.2: Specimen 9b after dynamic test

Figure 6.9.1.2 shows a complete and largely symmetric fracture of joint Specimen 9b. Joint failure occurred along the length of the spar cap, much of which avoided the actual bond line. The upper half of the left cap and a portion of the right cap remained bonded to the skin. Delamination extended a short distance down the center of the spar web. Without considering visual aspects of the failure, the strain data analysis (presented in Appendix C, Section C.9) revealed that failure was asymmetric.

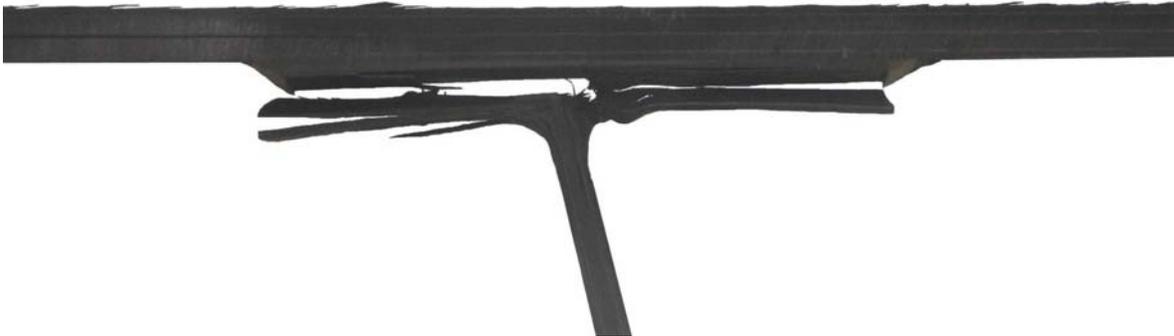
Figure 6.9.1.4: Specimen 9d after dynamic test.

Figure 6.9.1.4 shows a complete and somewhat asymmetric failure of joint Specimen 9d. Joint failure occurred along the length of the spar cap, much of which avoided the actual bond line. A portion of left and right spar caps remain bonded to the skin. Without considering visual aspects

of the failure, the strain data analysis (presented in Appendix C, Section C.9) revealed that failure was asymmetric.

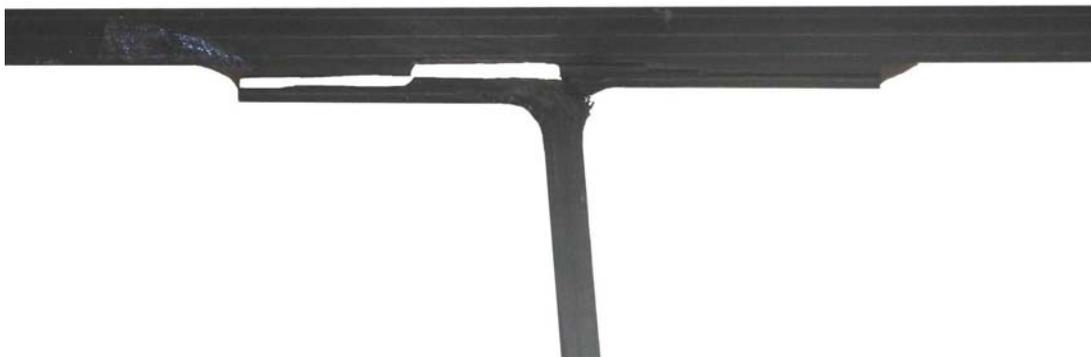
Figure 6.9.1.5: Specimen 9e after dynamic test.

Figure 6.9.1.5 shows a complete and asymmetric failure of joint Specimen 9e. Joint failure occurred along the length of the left spar cap, much of which avoided the actual bond line. The upper half of the left cap and the entire right cap remained bonded to the skin. Without considering visual aspects of the failure, the strain data analysis (presented in Appendix C, Section C.9) revealed that failure symmetry was inconclusive.

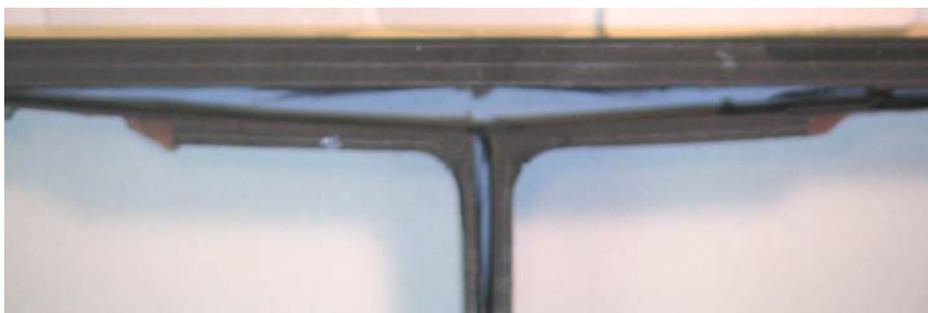
Figure 6.9.2.2: Specimen 9g after static test.

Figure 6.9.2.2 shows a symmetric and complete fracture of joint Specimen 9g. Joint failure consisted of debonding along the spar cap to skin interface. In addition, delamination ran down the center of the spar web.

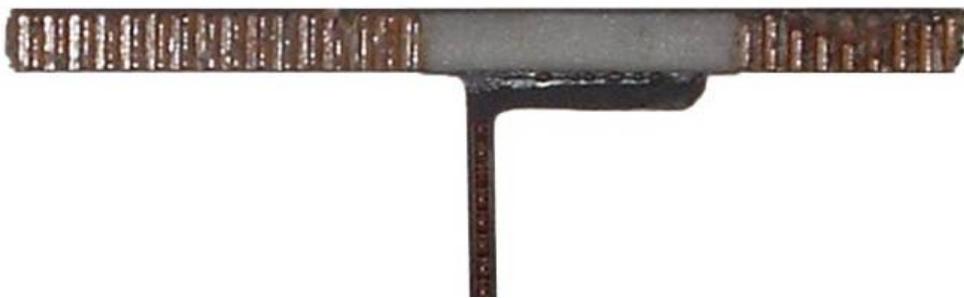
Figure 6.10.3: Example cross section of joint from Specimen Set 10 (pretest)

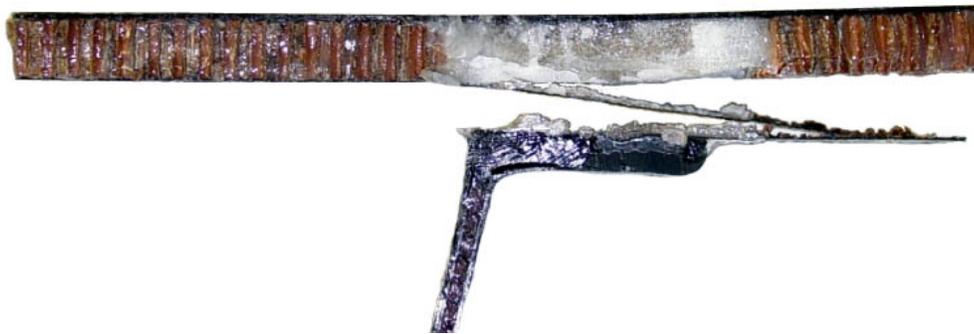
Figure 6.10.1.1: Specimen 10a after dynamic test

Figure 6.10.1.1 shows a complete and asymmetric failure of joint Specimen 10a. Joint failure occurred along bond-line and core interfaces, extending to the right (in the direction of the J). Without considering visual aspects of the failure, the strain data analysis (presented in Appendix C, Section C.10) revealed that failure symmetry was inconclusive.

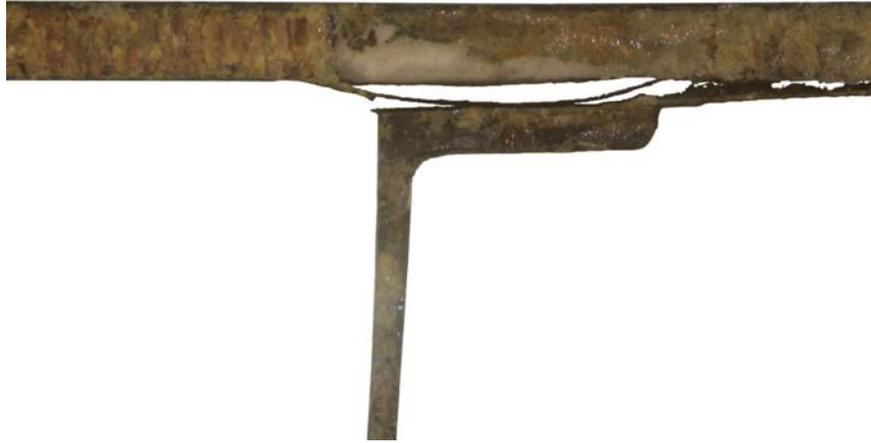
Figure 6.10.1.2: Specimen 10b after dynamic test

Figure 6.10.1.2 shows a complete and asymmetric fracture of joint Specimen 10b. Joint failure occurred along bond-line and core interfaces, extending to the right (in the direction of the J). Without considering visual aspects of the failure, the strain data analysis (presented in Appendix C, Section C.10) revealed that failure symmetry was inconclusive.

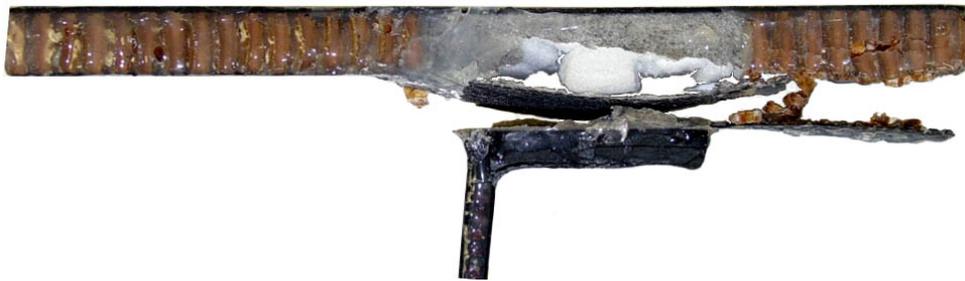
Figure 6.10.1.3: Specimen 10c after dynamic test

Figure 6.10.1.3 shows a complete and asymmetric failure of joint Specimen 10c. Joint failure occurred along bond-line and core interfaces, extending to the right (in the direction of the J). Without considering visual aspects of the failure, the strain data analysis (presented in Appendix C, Section C.10) revealed that failure was asymmetric.

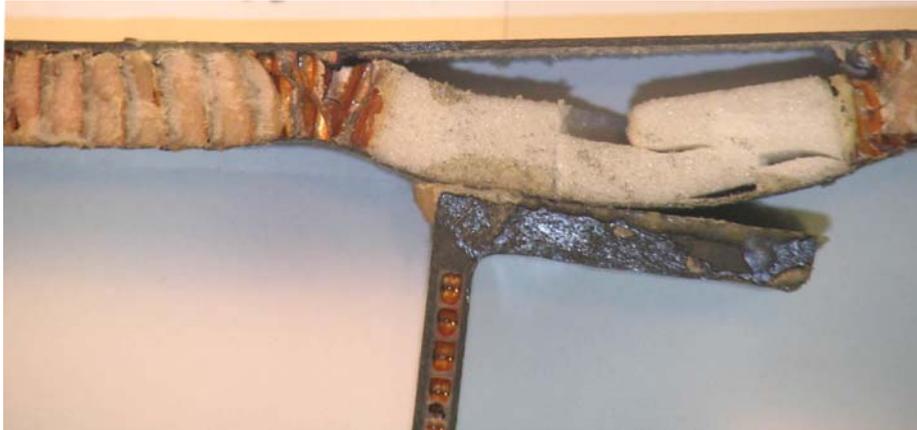
Figure 6.10.2.1: Specimen 10d after static test.

Figure 6.10.2.1 shows an asymmetric and incomplete fracture of joint Specimen 10d. Joint failure occurred through a combination of core disbonding and spar cap separation from the inner skin plies.

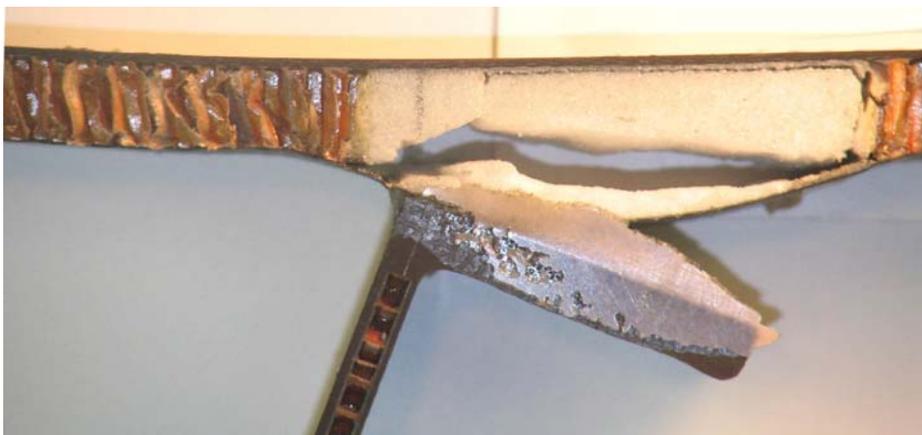
Figure 6.10.2.2: Specimen 10e after static test.

Figure 6.10.2.2 shows an asymmetric and complete fracture of joint Specimen 10e. Joint failure occurred through a combination of core fracture and spar cap separation from the inner skin ply.

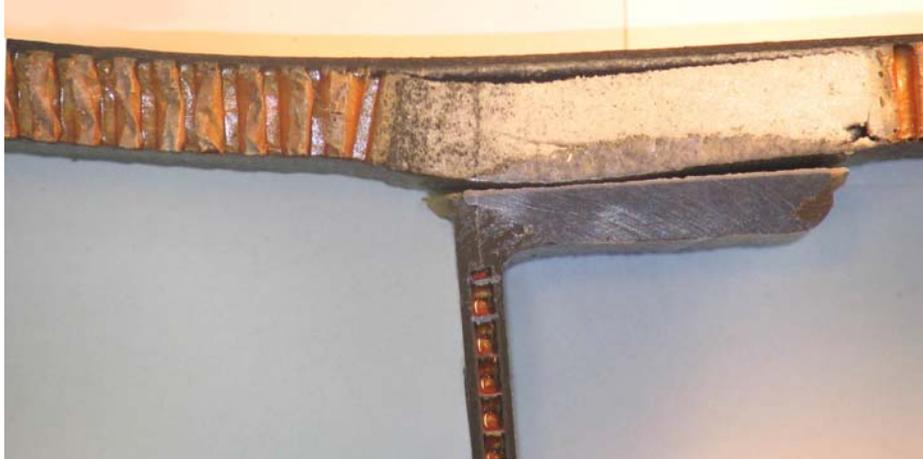
Figure 6.10.2.3: Specimen 10f after static test.

Figure 6.10.2.3 shows an asymmetric and complete fracture of joint Specimen 10f. Joint failure occurred through core and spar cap disbonding from the inner skin plies.

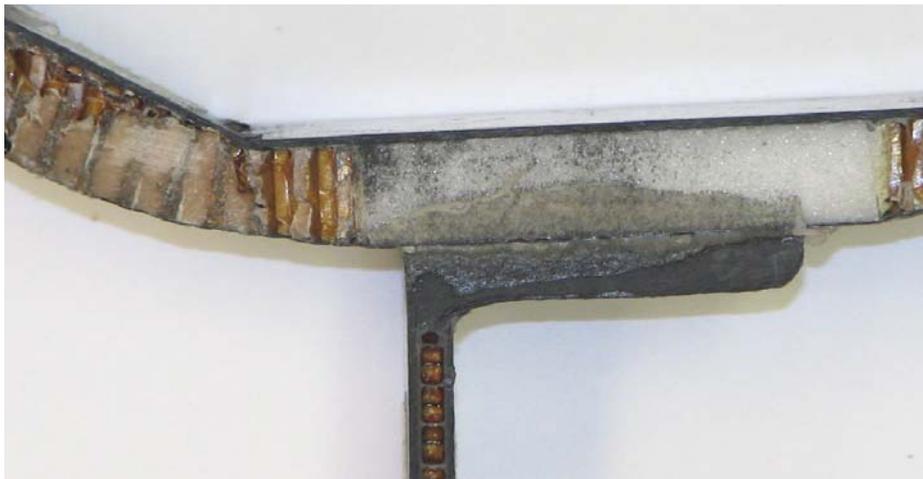
Figure 6.10.2.4: Specimen 10g after static test.

Figure 6.10.2.4 shows an asymmetric and incomplete fracture of joint Specimen 10g. Joint failure occurred through core shear and skin fracture on the left. Early failure on the left caused joint rotation in the fixture, creating a bending condition in the spar web (placing SG2 in compression and SG3 in tension). The average web strain is therefore lower than expected.

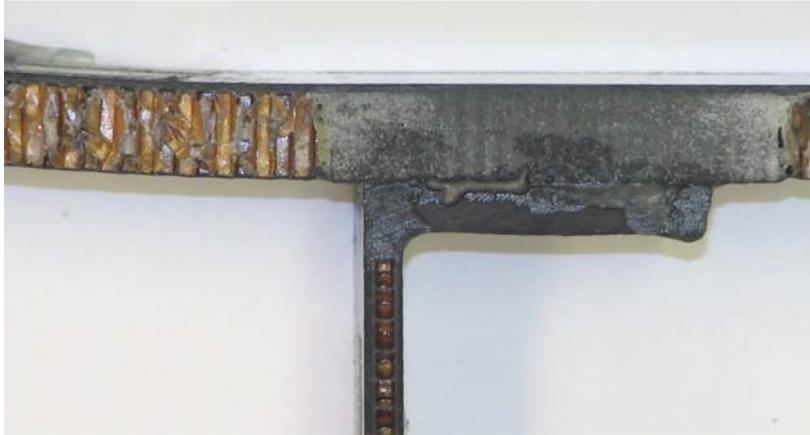
Figure 6.10.2.5: Specimen 10h after static test.

Figure 6.10.2.5 shows an asymmetric and incomplete fracture of joint Specimen 10h. The test truncated prematurely when a displacement limit of 1” was reached. The limit should have been set to 2” as was the case in all other tests.

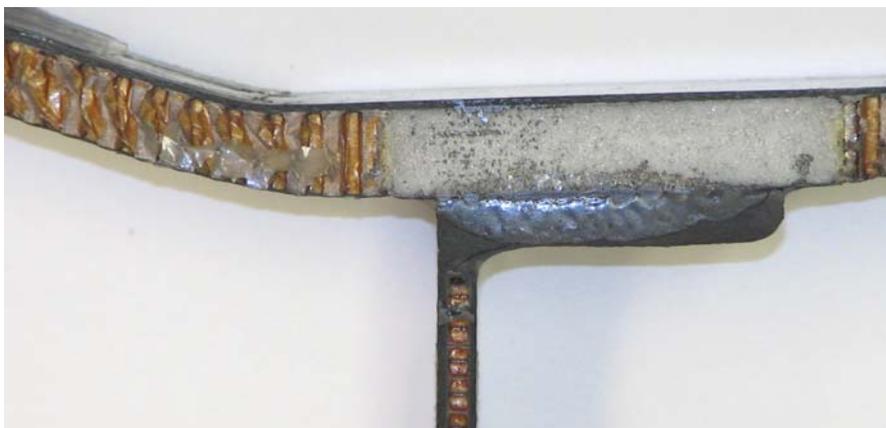
Figure 6.10.2.6: Specimen 10i after static test.

Figure 6.10.2.6 shows an asymmetric and incomplete fracture of joint Specimen 10i. Joint failure occurred through core shear and skin fracture on the left. Early failure on the left caused joint rotation in the fixture, creating a bending condition in the spar web (placing SG2 in compression and SG3 in tension). The average web strain is therefore lower than expected.

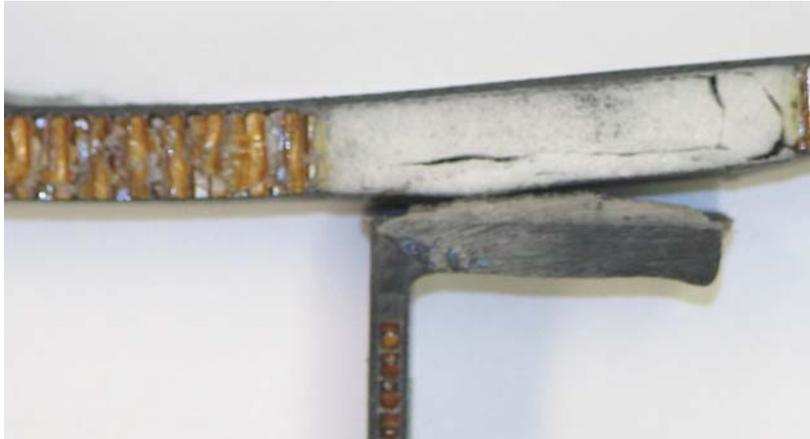
Figure 6.10.2.7: Specimen 10j after static test.

Figure 6.10.2.7 shows an asymmetric and complete fracture of joint Specimen 10j. Joint failure occurred through core fracture and spar cap disbonding from the inner skin plies.

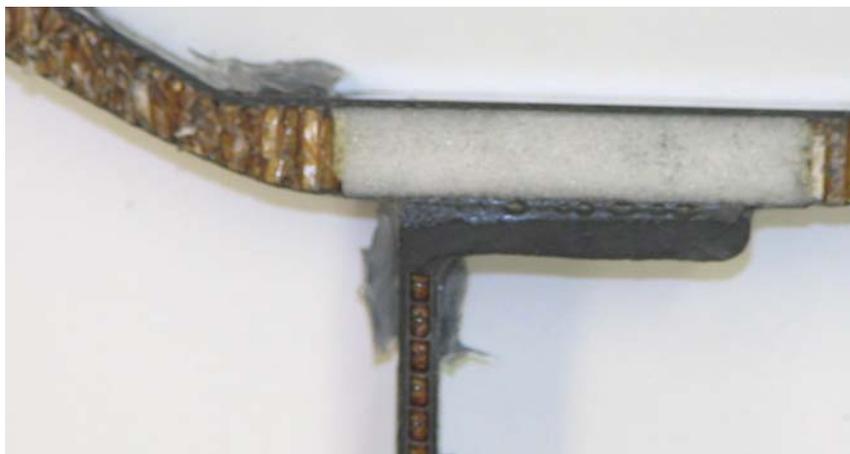
Figure 6.10.2.8: Specimen 10k after static test.

Figure 6.10.2.8 shows an asymmetric and incomplete fracture of joint Specimen 10k. Joint failure occurred through core shear on the left. Early failure on the left caused joint rotation in the fixture, creating a bending condition in the spar web (placing SG2 in compression and SG3 in tension). The average web strain is therefore lower than expected.

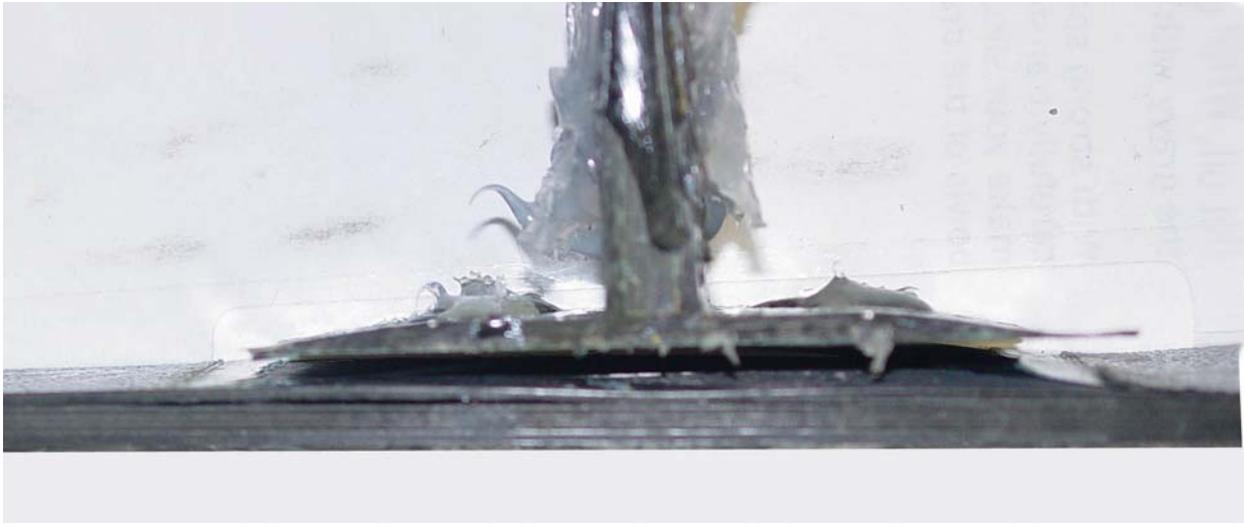
Figure 6.11.1.1: Specimen 11a after dynamic test

Figure 6.11.1.1 shows a complete and symmetric failure of joint Specimen 11a. Joint failure consists of a debonded spar cap. Delamination is also present within skin layers. Without considering visual aspects of the failure, the strain data analysis (presented in Appendix C, Section C.11) revealed that failure symmetry was inconclusive.

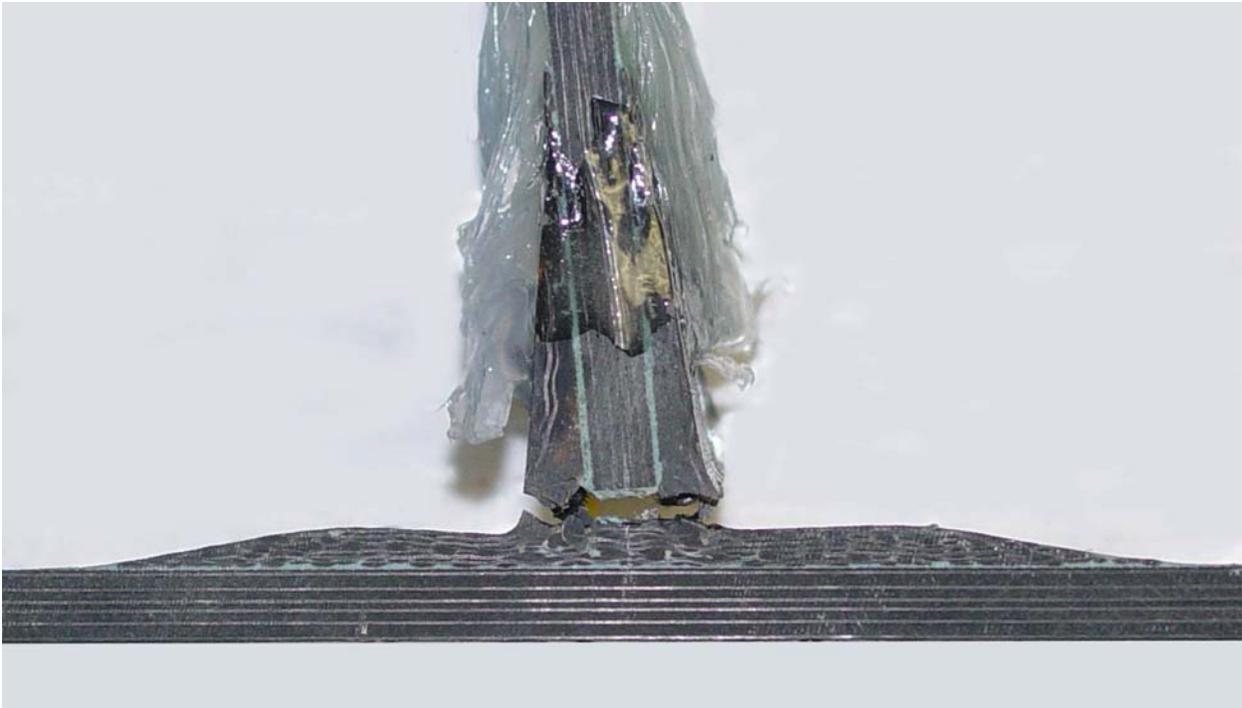
Figure 6.11.1.2: Specimen 11b after dynamic test

Figure 6.11.1.2 shows a complete and symmetric fracture of joint Specimen 11b. Joint failure occurred at the web's intersection with the spar cap. (The web is completely severed from the cap.) Without considering visual aspects of the failure, the strain data analysis (presented in Appendix C, Section C.11) revealed that failure symmetry was inconclusive.

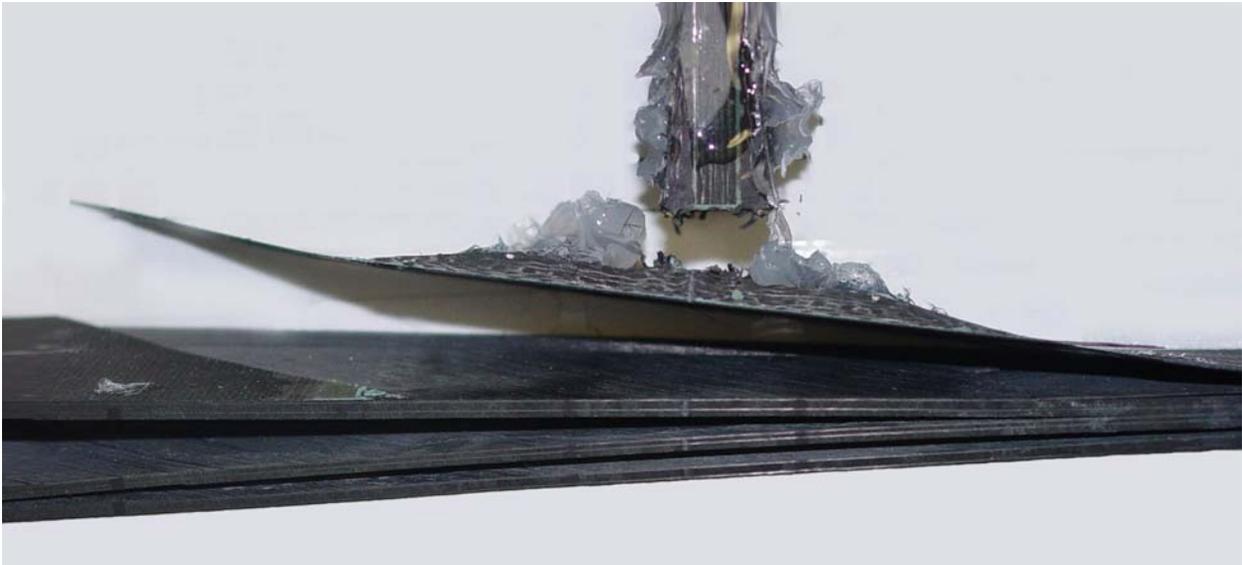
Figure 6.11.1.3: Specimen 11c after dynamic test

Figure 6.11.1.3 shows a complete and somewhat asymmetric failure of joint Specimen 11c. Joint failure occurred along the length of the spar cap, but one or two plies deep within the skin. Extensive through-thickness skin delamination is present. There is also a complete separation of the web from the spar cap. Without considering visual aspects of the failure, the strain data analysis (presented in Appendix C, Section C.11) revealed that failure was symmetric.

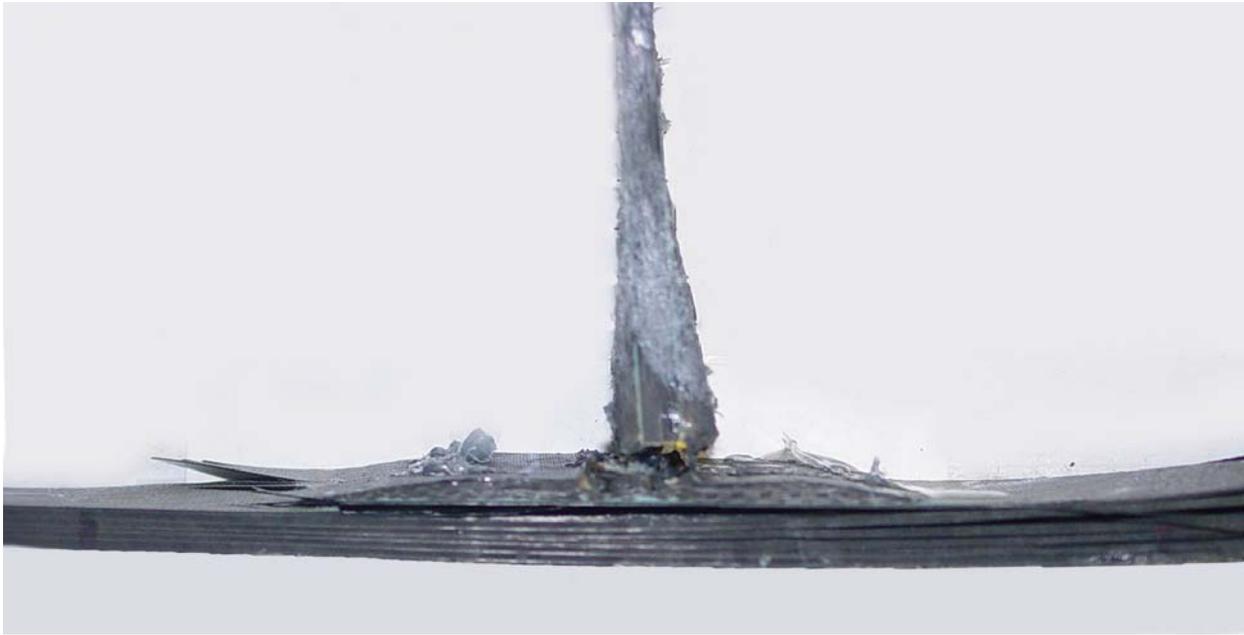
Figure 6.11.1.4: Specimen 11d after dynamic test.

Figure 6.11.1.4 shows a complete and somewhat asymmetric failure of joint Specimen 11d. Joint failure occurred along the length of the spar cap, but one or two plies deep within the skin. Through the thickness skin delamination is also present on the right side of the specimen. In addition, the web is severed from the spar cap. Without considering visual aspects of the failure, the strain data analysis (presented in Appendix C, Section C.11) revealed that failure symmetry was inconclusive.

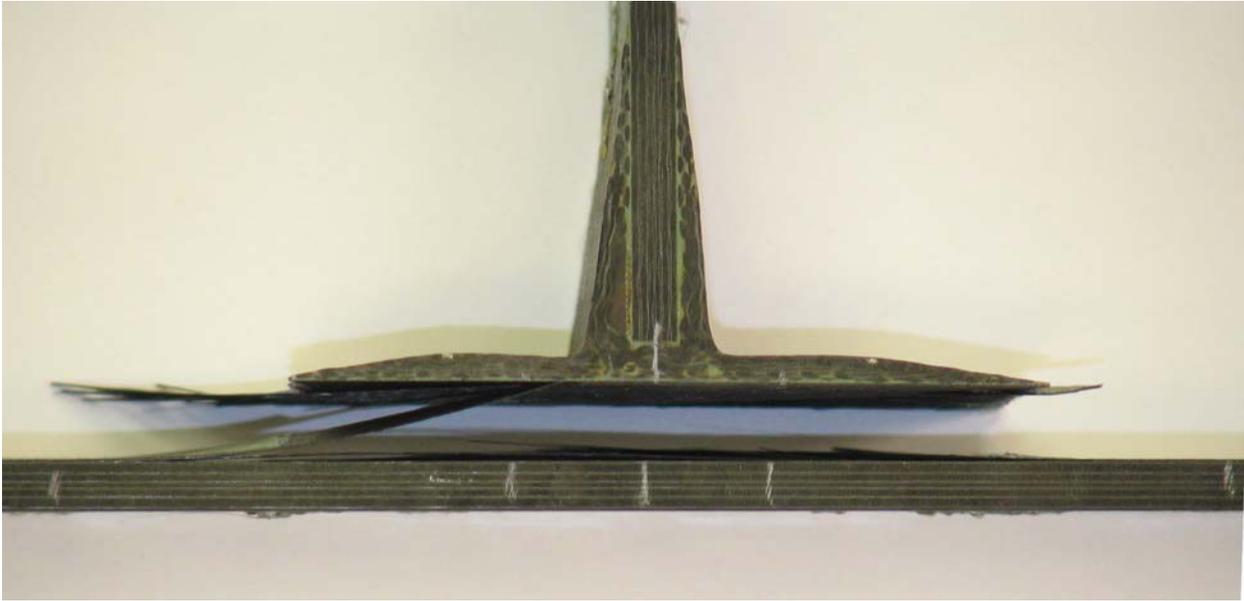
Figure 6.11.2.1: Specimen 11e after static test.

Figure 6.11.2.1 shows a symmetric and complete fracture of joint Specimen 11e. Joint failure consisted of debonding along the spar cap to skin interface.

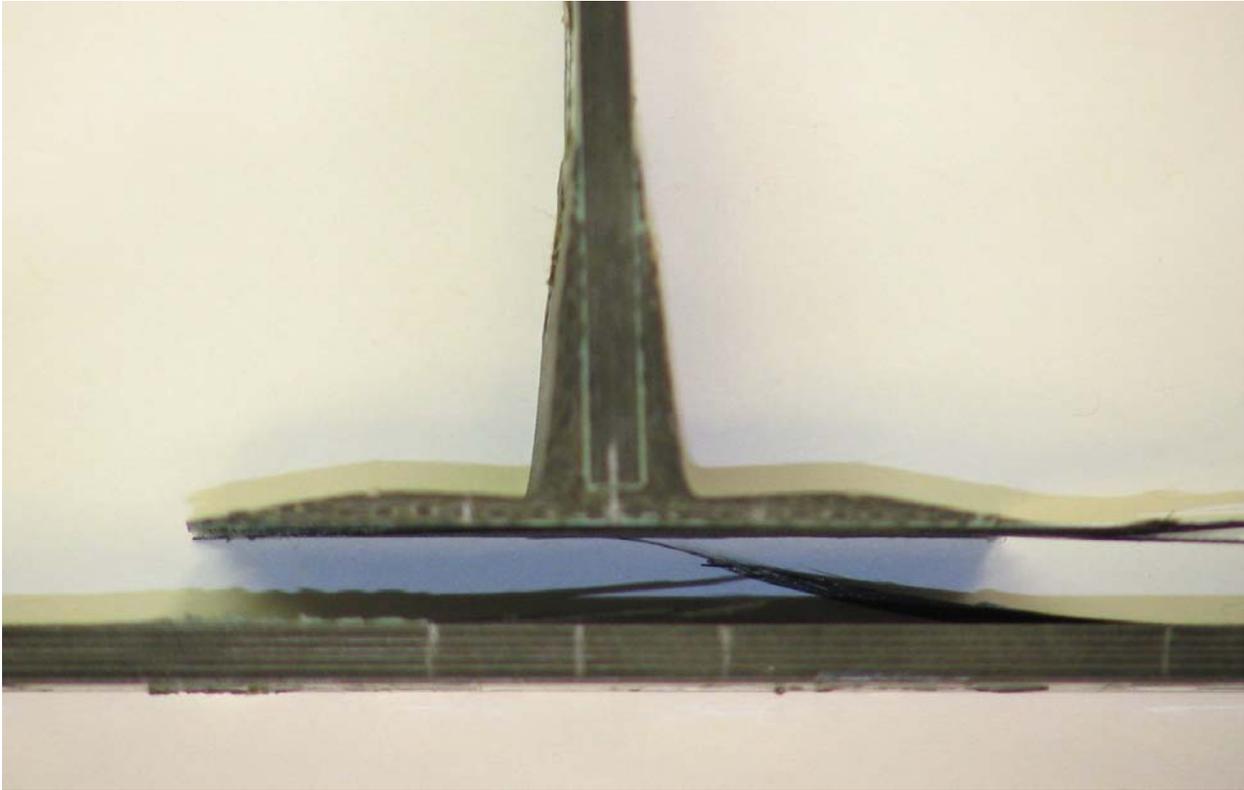
Figure 6.11.2.2: Specimen 11f after static test.

Figure 6.11.2.2 shows a symmetric and complete fracture of joint Specimen 11f. Joint failure consisted of debonding along the spar cap to skin interface.

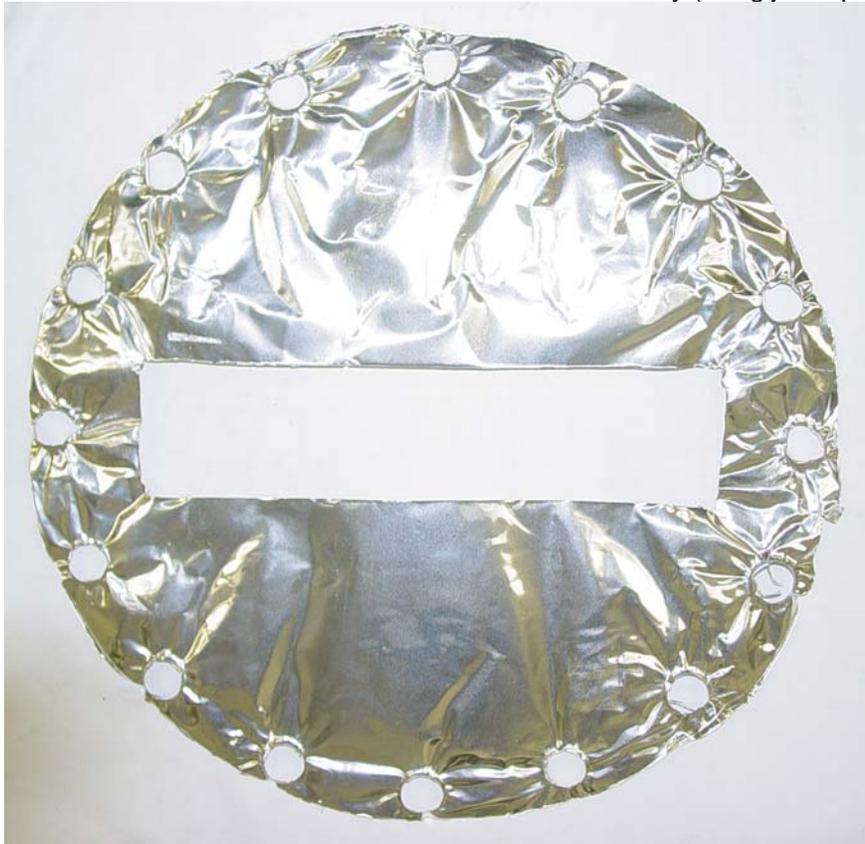
Figure B.1: Typical failure of an aluminum diaphragm.

encourage rupture, was applied with a pen-knife. This UHMWPE diaphragm was then used for tests 5-24. Continued variations in ram pressure, combined with observation that etched UHMWPE remained resistant to tearing, forced a reevaluation of diaphragm materials. Reevaluation consisted of a brief series of RamGun tests using three candidate diaphragm materials (0.015" thick and 0.125" thick UHMWPE, and 0.003" thick 1100 aluminum alloy sheet). Each was independently evaluated without a T-joint in place. (See Appendix B for test results.) Results demonstrated that, for the diaphragm materials tested, the inherent resistance to rupture did not influence ram pressure amplitude. As such, measured differences in ram pressure amplitude are assumed to be caused by a combination of projectile-impact conditions (projectile alignment, projectile fracture, and plate deformation) and an absence of entrained air in the fluid column. Because pressure amplitudes proved more than adequate to fail all T-joint test specimens, the fact that pressures (during some tests) continued to rise higher did not seem to influence the specimen's failure strain. Based on preferred aluminum-diaphragm failure properties (observed shear with little stretching), 0.003" thick aluminum foil was installed as a diaphragm for all remaining tests, 25-63.

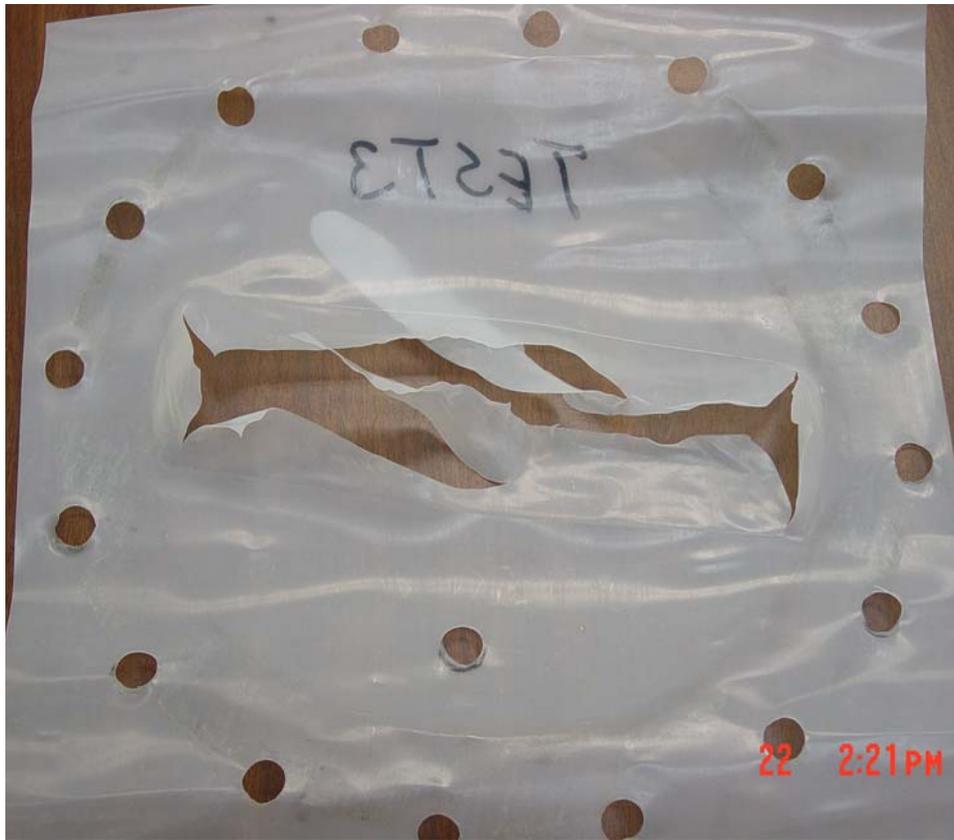
Figure B.2: Typical failure of a UHMWPE diaphragm (0.015 thick).

The first four specimens were tested with a 0.015” thick high-density polyethylene (HDPE) diaphragm (blow-out panel). Observed variation in ram pressures (despite consistent projectile impact velocities) were a cause for concern that lead to replacing the diaphragm with a corner-etched piece of 0.015” thick ultra-high molecular weight polyethylene (UHMWPE). Etching, to

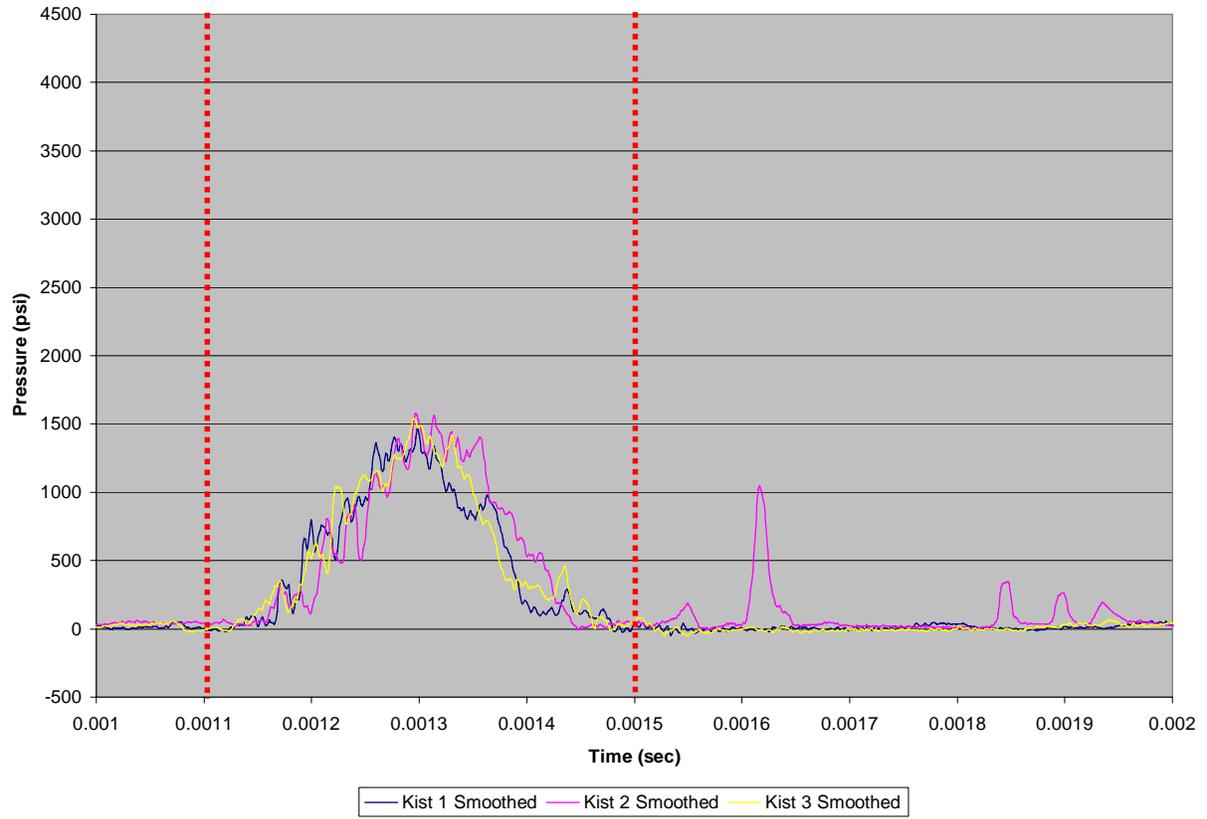
Figure CA.2e.1: Kistler pressure vs. time (Specimen 2e)

For Specimen 2e, the load interval (and therefore the strain vs. time interval of interest) is approximately 1.10ms-1.50ms as shown in Figure C.2e.1. As desired, pressure sensors K1 and K3 are largely in agreement, indicating side-to-side uniformity of load on the test specimen. During the load interval, Figure C.2e.2 shows that SG1 and SG4 remain roughly in phase and of similar amplitude. Similarly, SG2 and SG3 on the spar also appear to remain roughly in phase and of similar amplitude (as seen in Figure C.2e.3) indicating a symmetric failure. Failure metrics for Specimen 2e are derived from Figure C.2e.4. Failure strain occurred at 1.437ms with a maximum strain of 0.001654 in/in.

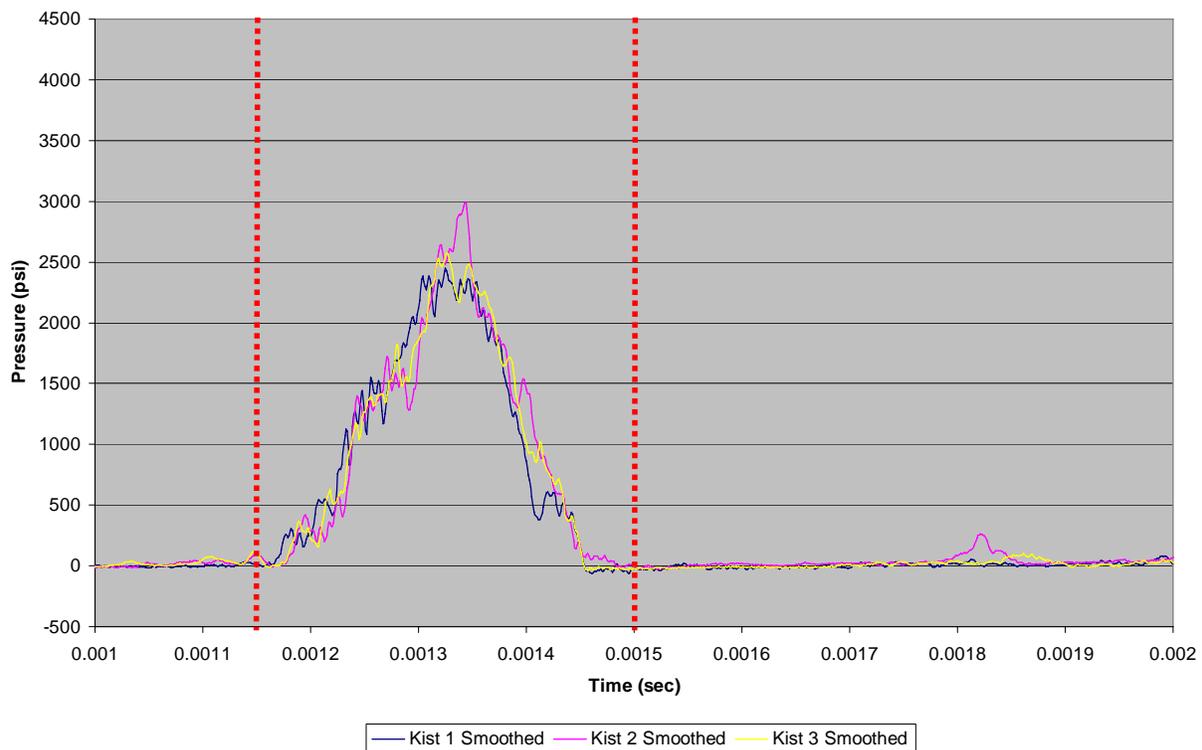
Figure C.3a.1: Kistler pressure vs. time (Specimen 3a)

For Specimen 3a, the load interval (and therefore the strain vs. time interval of interest) is approximately 1.15ms - 1.50ms as seen in Figure C.3a.1. As desired, pressure sensors K1 and K3 are largely in agreement, indicating side-to-side uniformity of load on the test specimen. During the load interval, Figure C.3a.2 shows that SG1 and SG4 tend to stay in phase and of similar amplitude indicating the skin pulled away from the spar in a symmetric fashion. Similarly, SG2 and SG3 are in phase and of similar amplitude (as seen in Figure C.3a.3) substantiating symmetric failure. Failure metrics for Specimen 3a are derived from Figure C.3a.4. Failure strain occurred at 1.438ms with a maximum strain of 0.00570 in/in.

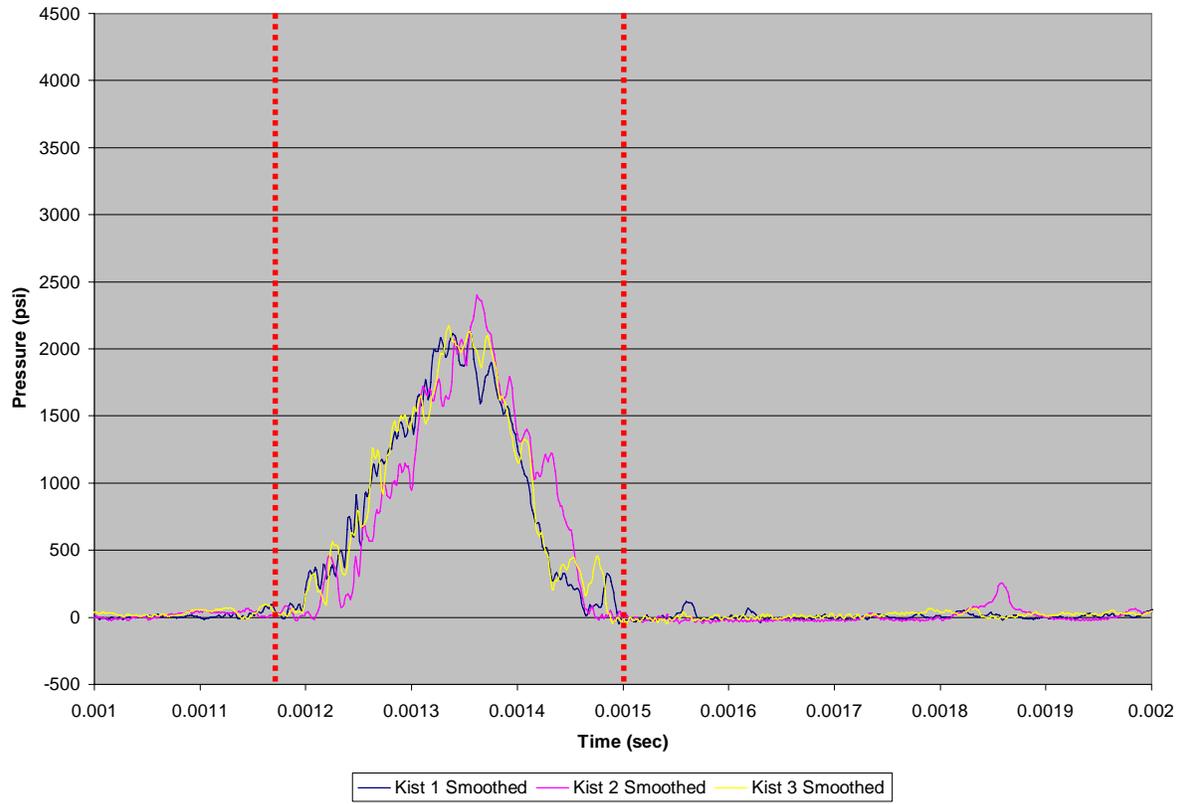
Figure C.3b.1: Kistler pressure vs. time (Specimen 3b)

For Specimen 3b, the load interval (and therefore the strain vs. time interval of interest) is approximately 1.17ms - 1.50ms as seen in Figure C.3b.1. As desired, pressure sensors K1 and K3 are largely in agreement, indicating side-to-side uniformity of load on the test specimen. During them load interval, Figure C.3b.2 shows that SG1 and SG4 are in phase indicating the skin pulled away from the spar in a symmetric fashion. While SG2 and SG3 are in phase (as seen in Figure C.3b.3), there are strain amplitude variances. This suggests a measure of asymmetry. Failure metrics for Specimen 3b are derived from Figure C.3b.4. Failure strain occurred at 1.483ms with a maximum strain of 0.00384 in/in.

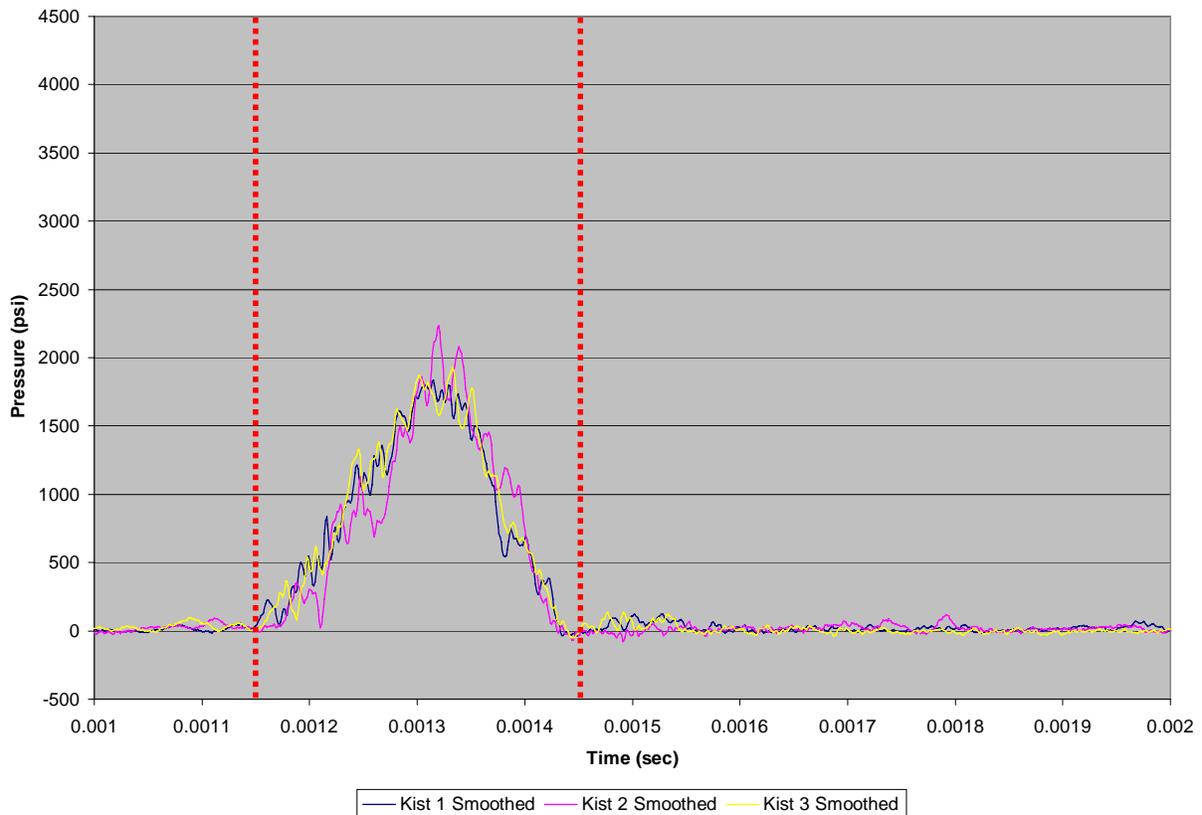
Figure C.3c.1: Kistler pressure vs. time (Specimen 3c)

For Specimen 3c, the load interval (and therefore the strain vs. time interval of interest) is approximately 1.15 ms to 1.45ms as shown in Figure C.3c.1. As desired, pressure sensors K1 and K3 are largely in agreement, indicating side-to-side uniformity of load on the test specimen. During the load interval, Figure C.3c.2 shows that SG1 and SG4 are in phase and of similar amplitude, indicating the skin pulled away from the spar in a symmetric fashion. SG2 and SG3 on the spar also appear in phase and of similar amplitude (as seen in Figure C.3c.3), implying symmetric failure. Failure metrics for Specimen 3c are derived from Figure C.3c.4. Failure strain occurred at 1.434ms with a maximum strain of 0.00336 in/in.
