AFRL-WS-WP-TR-2007-9002

**EVALUATION OF SKIN-SPAR JOINT
RESISTANCE TO HYDRODYNAMIC RAM**

780th Test Squadron (780 TS/OL-AC)

Final Report for 01 October 2003 – 30 November 2005

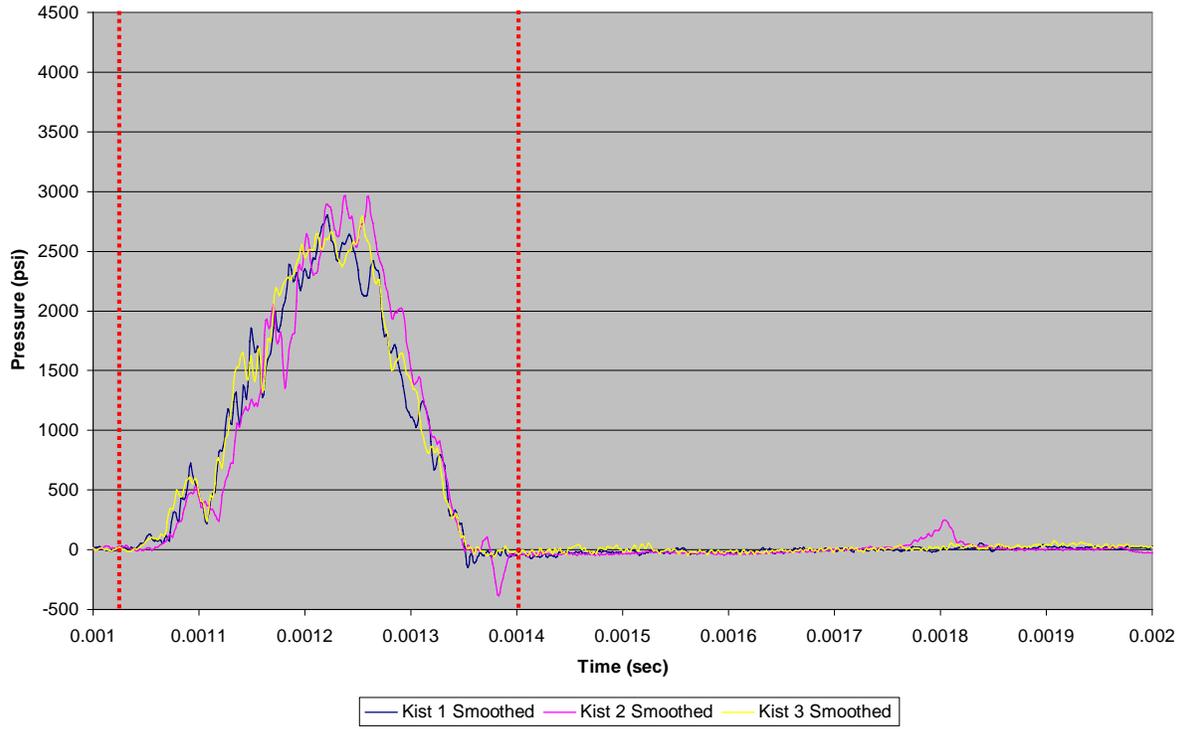
Figure C.3d.1: Kistler pressure vs. time (Specimen 3d)

For Specimen 3d, the load interval (and therefore the strain vs. time interval of interest) is approximately 1.02ms-1.40ms as shown in Figure C.3d.1. As desired, pressure sensors K1 and K3 are largely in agreement, indicating side-to-side uniformity of load on the test specimen. During the load interval, Figure C.3d.2 shows that SG1 and SG4 remain in phase and are of similar amplitude. SG2 and SG3 on the spar are in phase but, at the moment of failure, are of different amplitude (as seen in Figure C.3d.3). The difference in strain amplitudes implies asymmetric failure. Failure metrics for Specimen 3d are derived from Figure C.3d.4. Failure strain occurred at 1.245ms with a maximum strain of 0.005063 in/in.

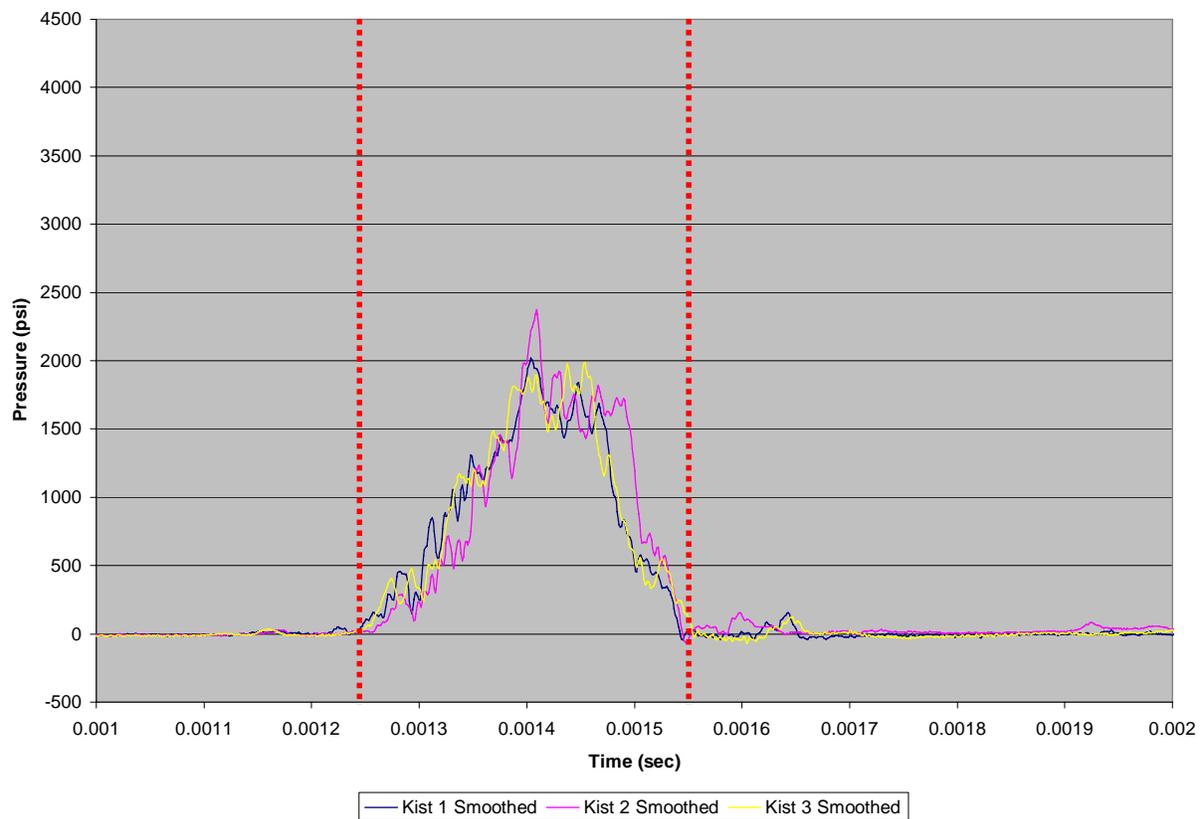
Figure C.3e.1: Kistler pressure vs. time (Specimen 3e)

For Specimen 3e, the load interval (and therefore the strain vs. time interval of interest) is approximately 1.24ms-1.55ms as shown in Figure C.3e.1. As desired, pressure sensors K1 and K3 are largely in agreement, indicating side-to-side uniformity of load on the test specimen. During the load interval, Figure C.3e.2 shows that SG1 and SG4 remain in phase and are of similar amplitude. SG2 and SG3 are initially somewhat out of phase (as seen in Figure C.3e.3), but come in phase and are of similar amplitude prior to failure. As such, failure is deemed symmetric. Failure metrics for Specimen 3e are derived from Figure C.3e.4. Failure strain occurred at 1.450ms with a maximum strain of 0.003985 in/in.

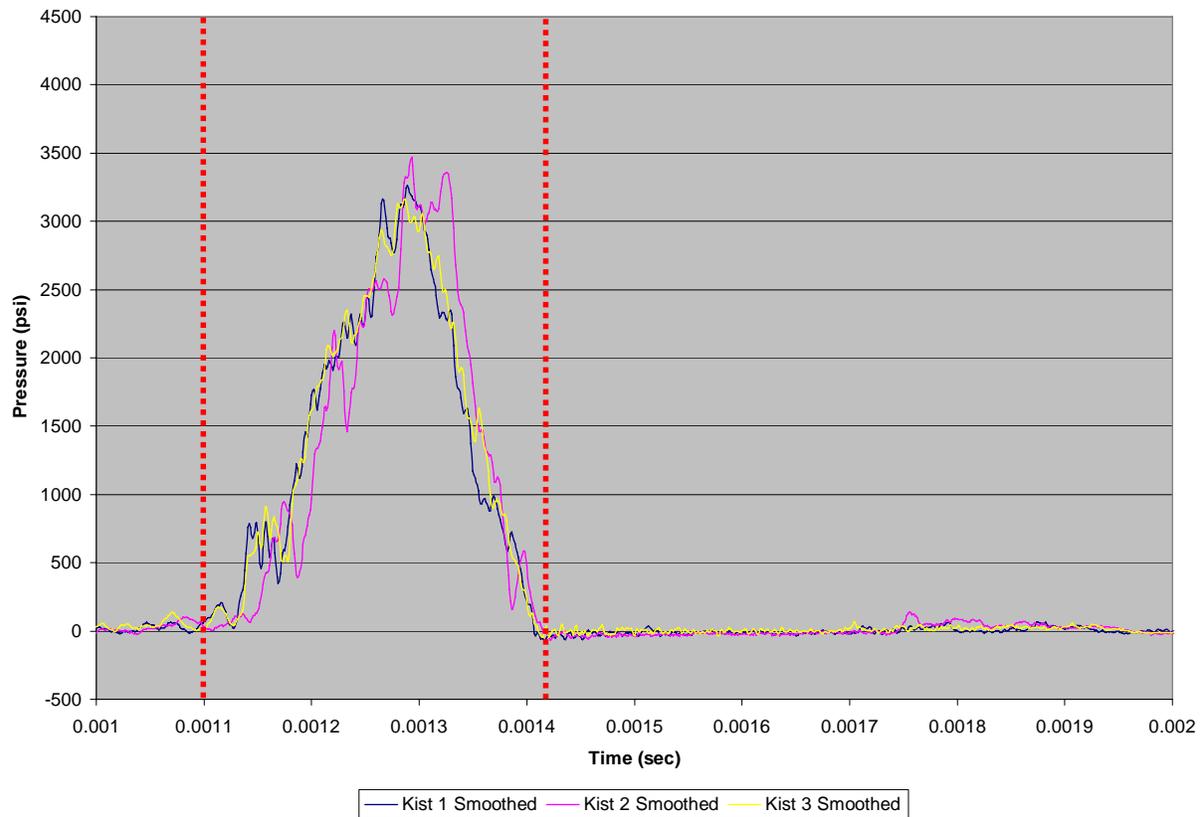
Figure C.4a.1: Kistler pressure vs. time (Specimen 4a)

For Specimen 4a, the load interval (and therefore the strain vs. time interval of interest) is approximately 1.10ms - 1.42ms as seen in Figure C.4a.1. As desired, pressure sensors K1 and K3 are largely in agreement, indicating side-to-side uniformity of load on the test specimen. During the load interval, Figure C.4a.2 shows that SG1 and SG4 stay in phase and are of similar amplitude, indicating the skin pulled away from the spar in a symmetric fashion. While SG2 and SG3 are in phase (as seen in Figure C.4a.3), their amplitudes differ, implying asymmetric failure. Failure metrics for Specimen 4a are derived from Figure C.4a.4. Failure strain occurred at 1.412ms with a maximum strain of 0.00438 in/in.

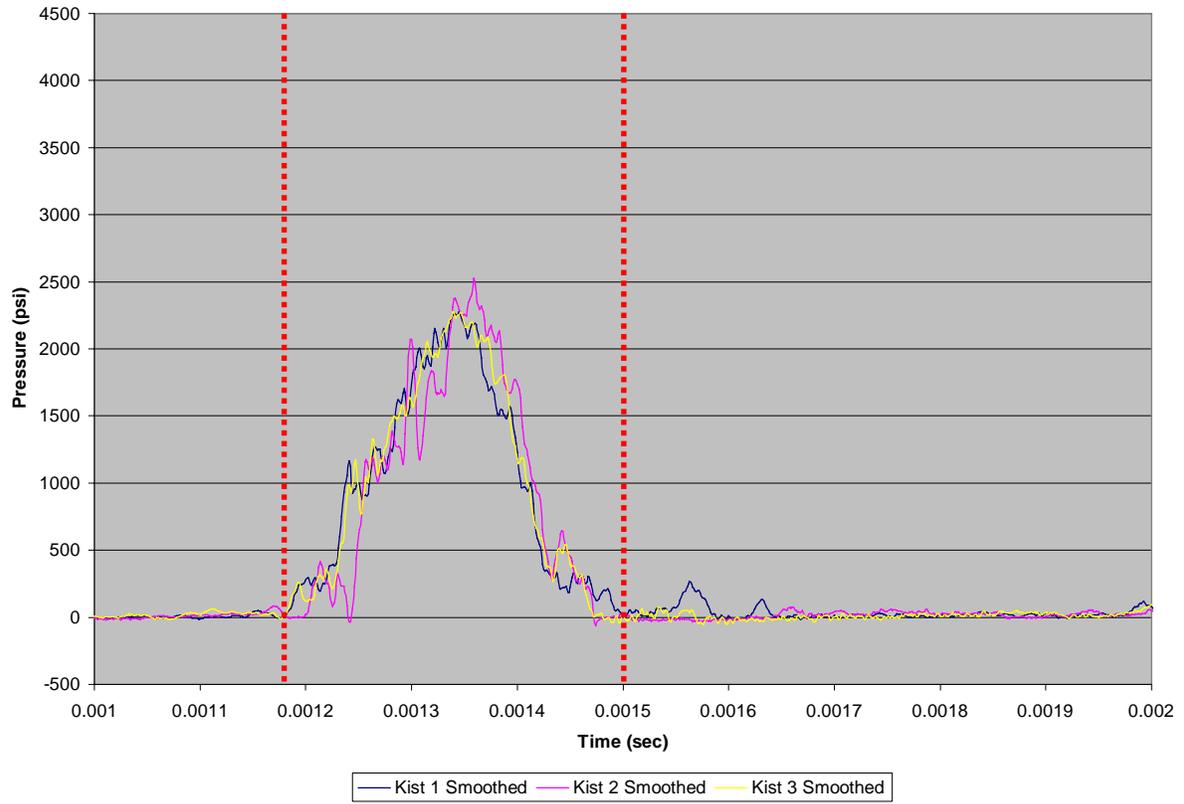
Figure C.4b.1: Kistler pressure vs. time (Specimen 4b)

For Specimen 4b, the load interval (and therefore the strain vs. time interval of interest) is approximately 1.20ms - 1.50ms as seen in Figure C.4b.1. As desired, pressure sensors K1 and K3 are largely in agreement, indicating side-to-side uniformity of load on the test specimen. During the load interval, Figure C.4b.2 shows that SG1 and SG4 are clearly in phase indicating the skin pulled away from the spar in a symmetric fashion. Similarly, SG2 and SG3 are in phase (as seen in Figure C.4b.3) implying symmetric failure. Failure metrics for Specimen 4b are derived from Figure C.4b.4. Failure strain occurred at 1.451ms with a maximum strain of 0.00388 in/in.
