REPORT NO: NAWCADPAX/TR-2007/11

### **FATIGUE OF Ti-3Al-2.5V ALLOY TUBE AND ROD**

**28 February 2007**

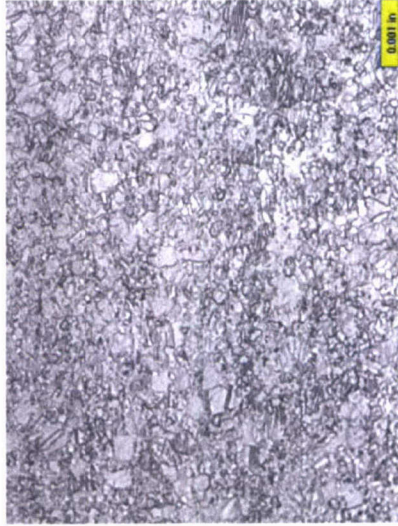
Figure A-5: Micrographs of Tube and Rod

For both of the tube and rod specimens, the micrographs of the longitudinal face showed elongated light alpha grains and that of the cross-section equiaxed light alpha grains with small amount of dark beta along grain boundaries, figure A-5. The diameters of the equiaxed alpha grains were 4 µm and 5 µm for the tube and rod specimens, respectively.

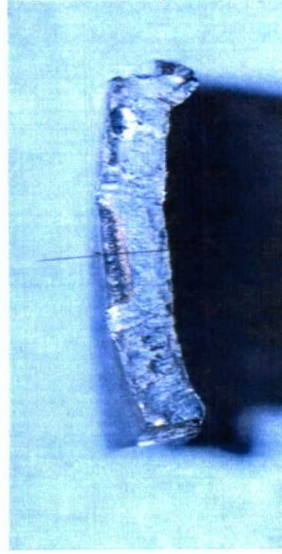
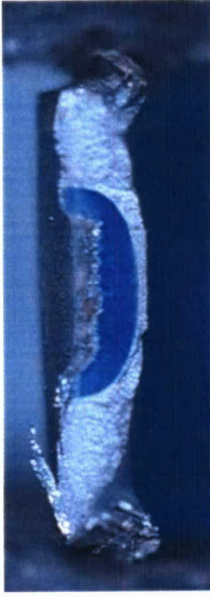
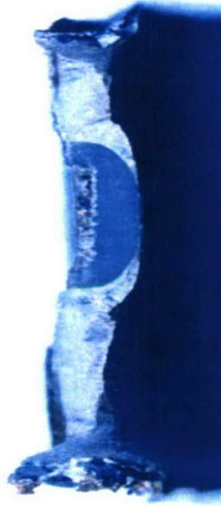
Figure A-6: Crack Surface of Tube Specimen, Subjected to Hydraulic Impulse Fatigue and Heat-Tinting

After hydraulic impulse fatigue test for a given number of pressurization cycles and heat-tinting, the crack in a tube specimen was opened up. Such crack surfaces are shown in figure A-6. The gray area along the tube OD surface is Laser notch and the blue area the heat-tinted area of crack growth. The blue (tinted) area grew larger with increasing pressurization cycle and eventually penetrated through the tube wall.

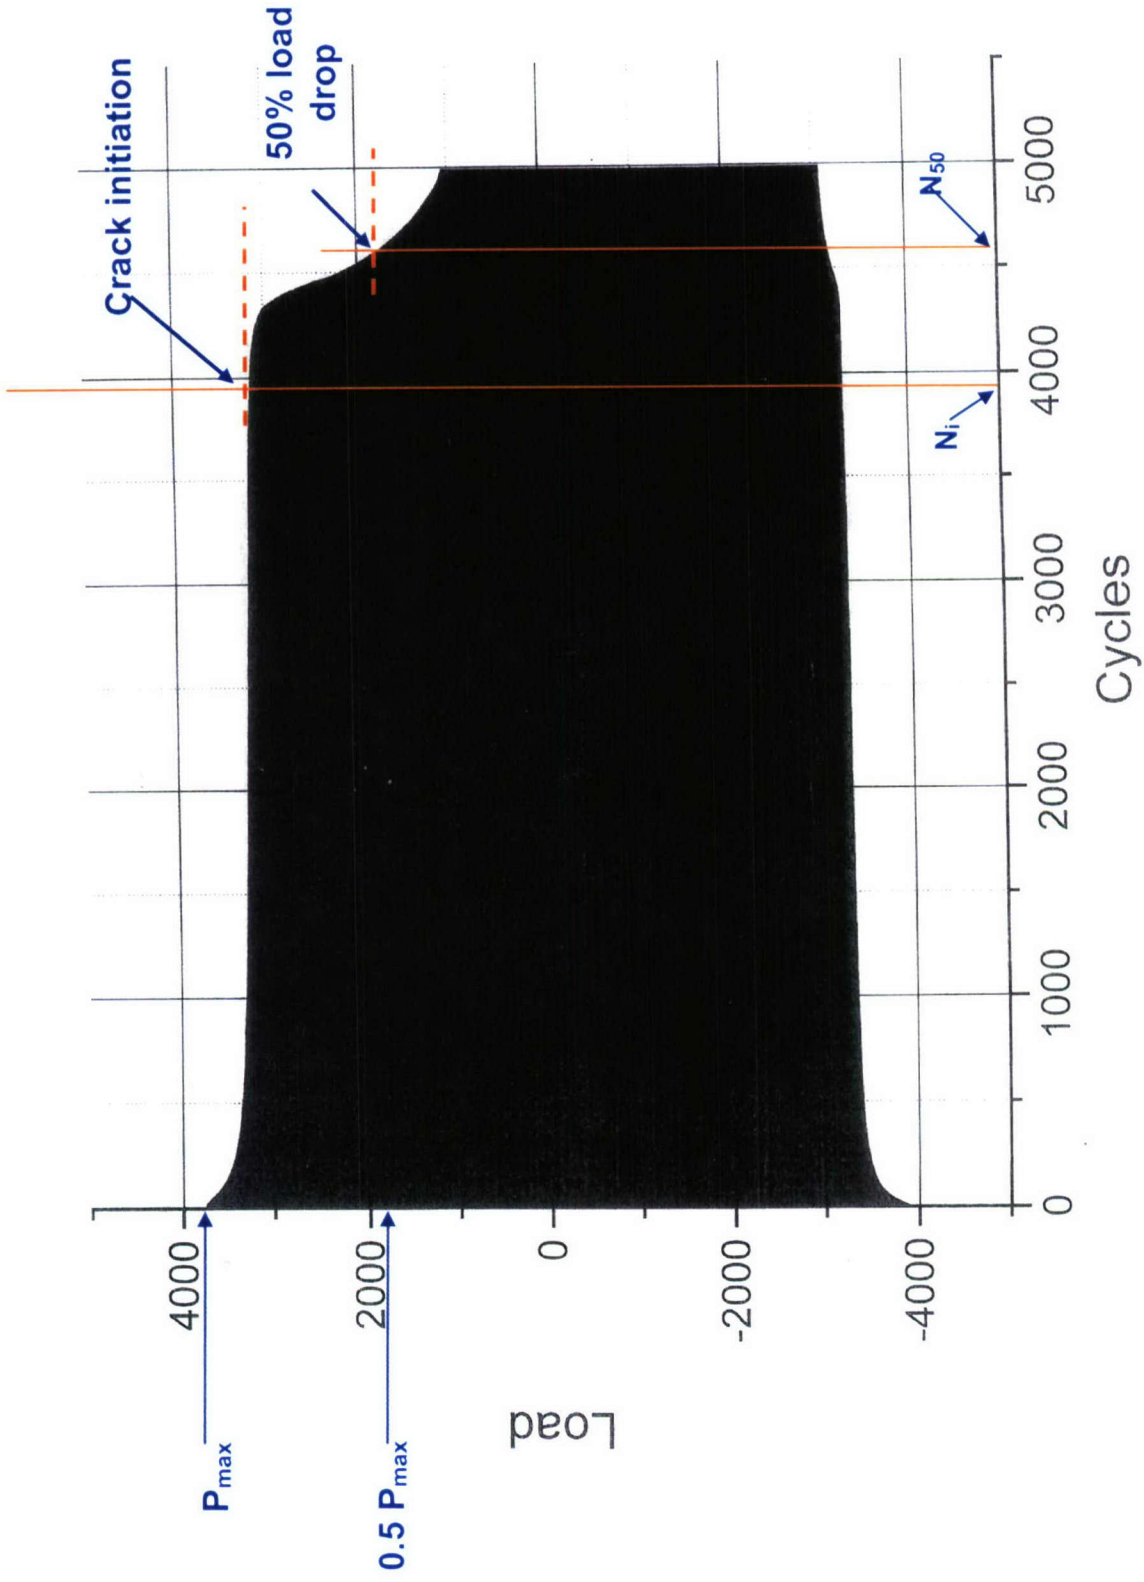
Figure A-12: Plot of Load Versus Strain Cycle

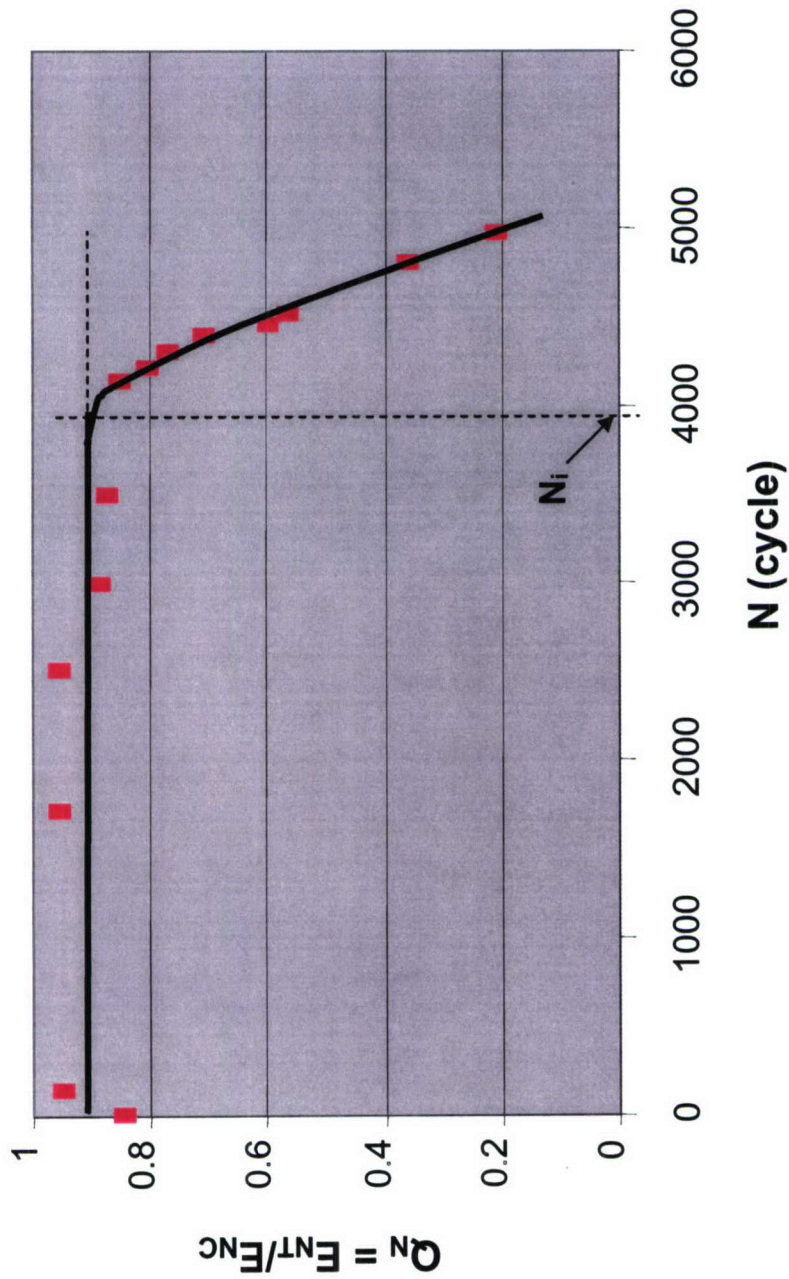
Figure A-13: Plot of Modulus Ratio  $Q_N$  Versus Strain Cycle N

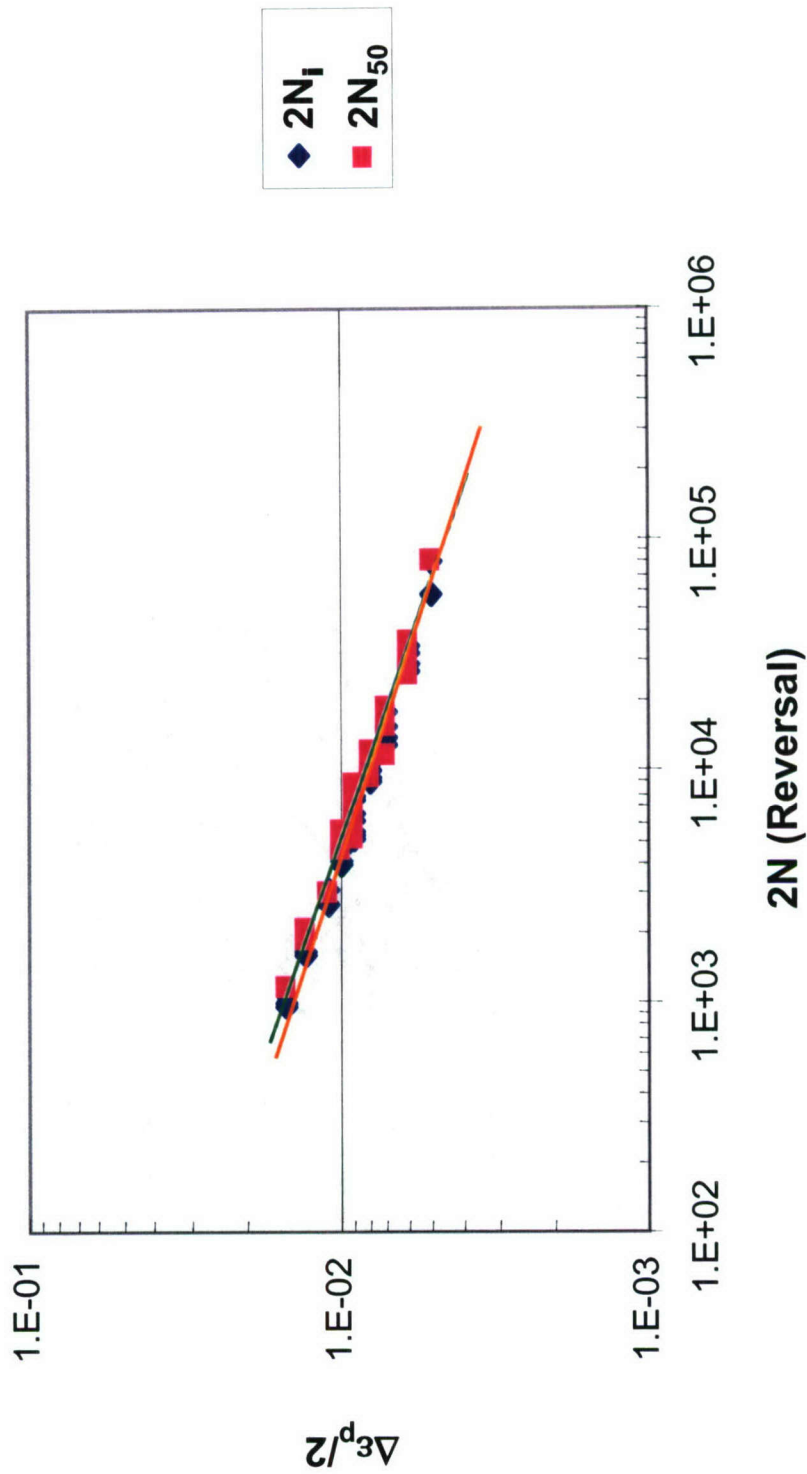
Figure A-16: Strain-Life Curves for Fatigue Crack Initiation and 50% Load Drop in Tube Specimen

The strain-life curves of strain amplitude,  $\Delta\varepsilon_p/2$ , versus strain reversal,  $2N_i$  or  $2N_{50}$ , for fatigue crack initiation and 50% load drop in tube specimens are shown in figure A-16. The linear relationship on log-log coordinates can be expressed by the following equations:

$$\Delta\varepsilon_p/2 = (8.95 \times 10^{-2})(2N_i)^{-0.262} \quad (5)$$

$$\Delta\varepsilon_p/2 = (3.21 \times 10^{-1})(2N_{50})^{-0.400} \quad (6)$$

The two curves nearly overlap each other, indicating that most of the fatigue life was consumed for crack initiation.

Figures A-16 and A-17 and the corresponding equations (5) through (9) evidence the applicability of the Coffin-Manson relationship (references 9 and 10) to the fatigue crack initiation and 50% load drop in the tube and rod of Ti-3Al-2.5V alloy, as well as to the fatigue fracture in the rod.

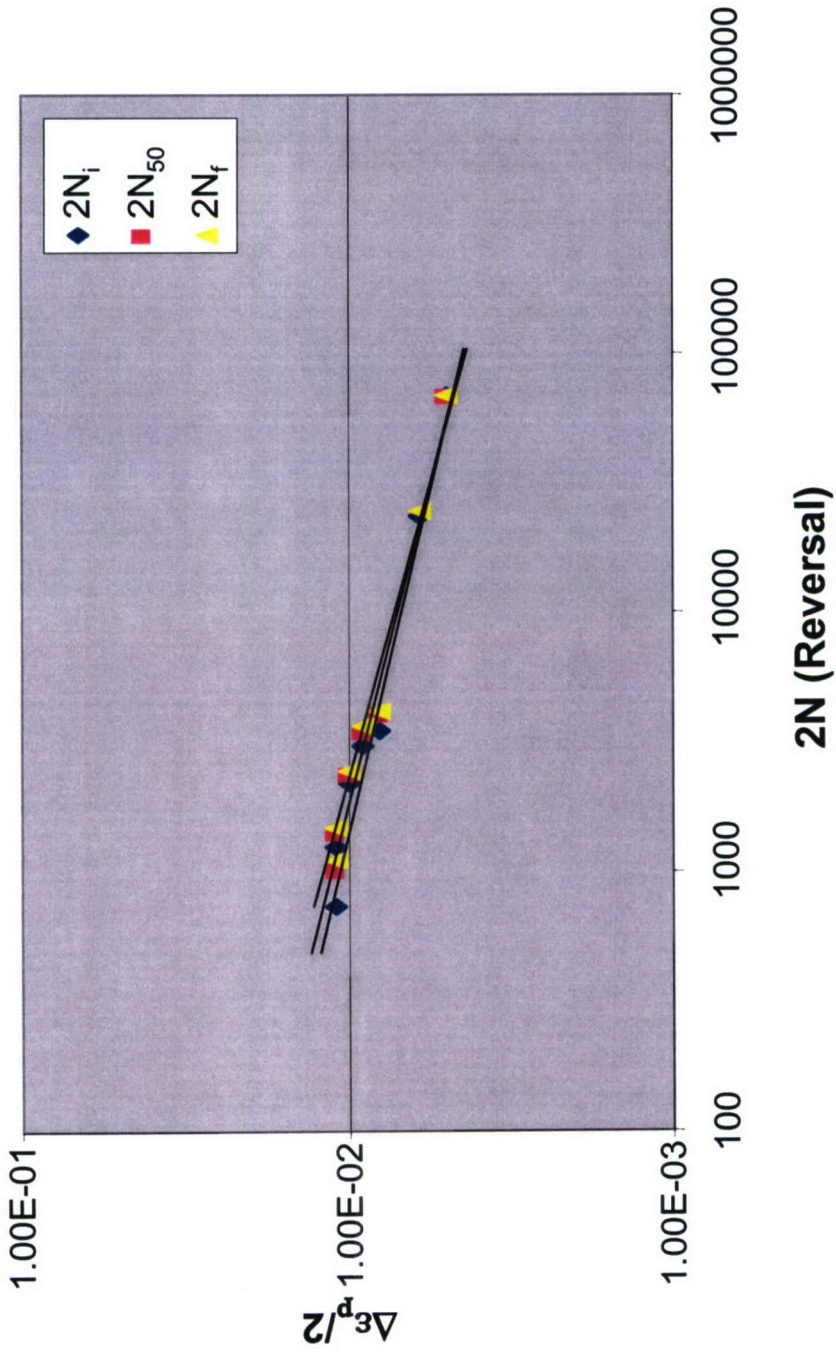
Figure A-17: Strain-Life Curves for Fatigue Crack Initiation, 50% Load Drop and Fracture in Rod Specimen

The strain-life curves of strain amplitude,  $\Delta\varepsilon_p/2$ , versus strain reversal,  $2N_i$ ,  $2N_{50}$ , and  $2N_f$ , for fatigue crack initiation, 50% load drop, and fracture in rod specimens are shown in figure A-17, and they can be expressed by the following equations:

$$\Delta\varepsilon_p/2 = (3.90 \times 10^{-2})(2N_i)^{-0.185} \quad (7)$$

$$\Delta\varepsilon_p/2 = (4.37 \times 10^{-2})(2N_{50})^{-0.195} \quad (8)$$

$$\Delta\varepsilon_p/2 = (4.57 \times 10^{-2})(2N_f)^{-0.200} \quad (9)$$

The three curves also nearly overlap each other, indicating the long fatigue crack initiation life and the short fatigue crack propagation life.
