**US Army Corps  
of Engineers®**  
Engineer Research and  
Development Center

# **A Comparative Field Study of Permastripe™ Polymer Concrete and Waterborne Airfield Pavement Markings**

June 2007

Final report

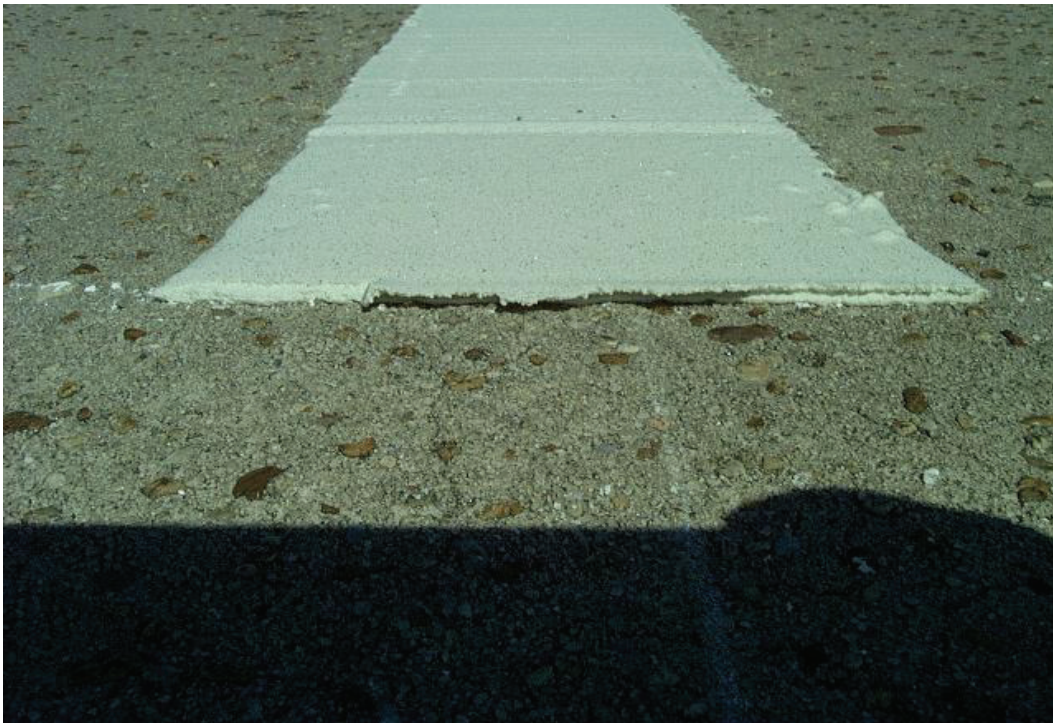
Figure 1. End-on view of PermaStripe™ line from Test 1 at Tyndall AFB showing thickness.
