Hurricane Barriers in New England and New Jersey — History and Status After Four Decades

Andrew Morang

September 2007

Final report

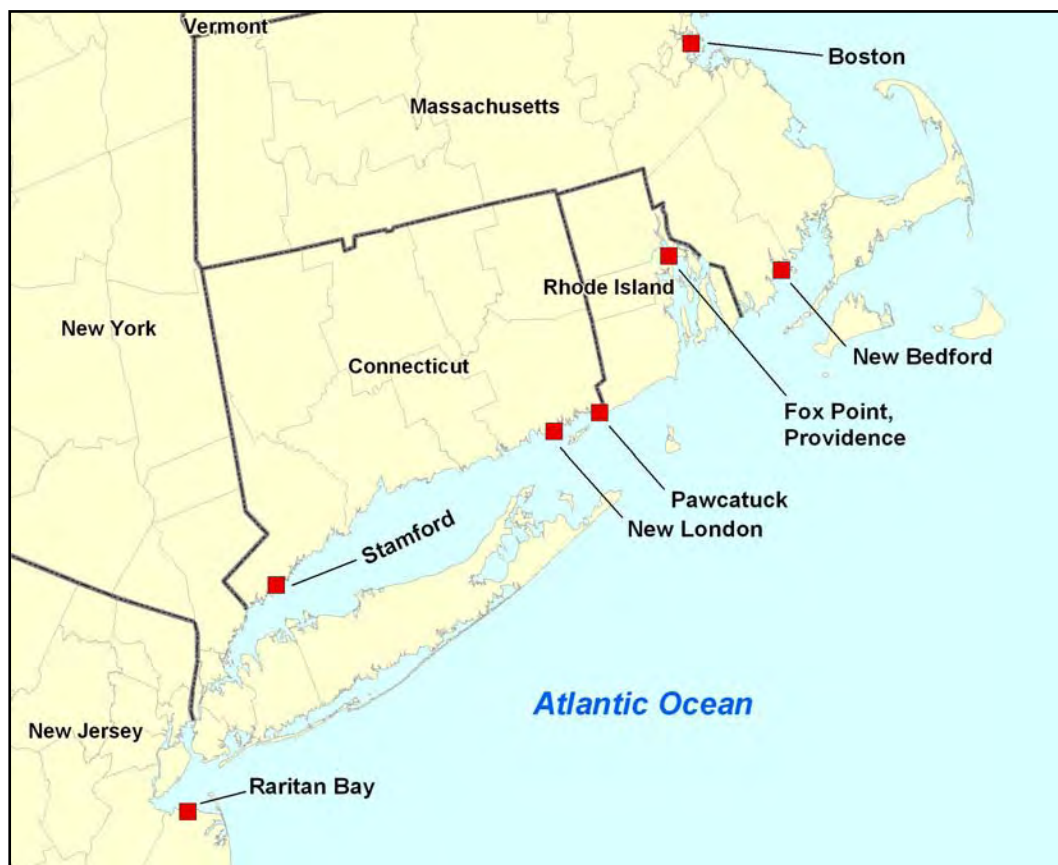
Figure 1. New England and New Jersey hurricane barriers.

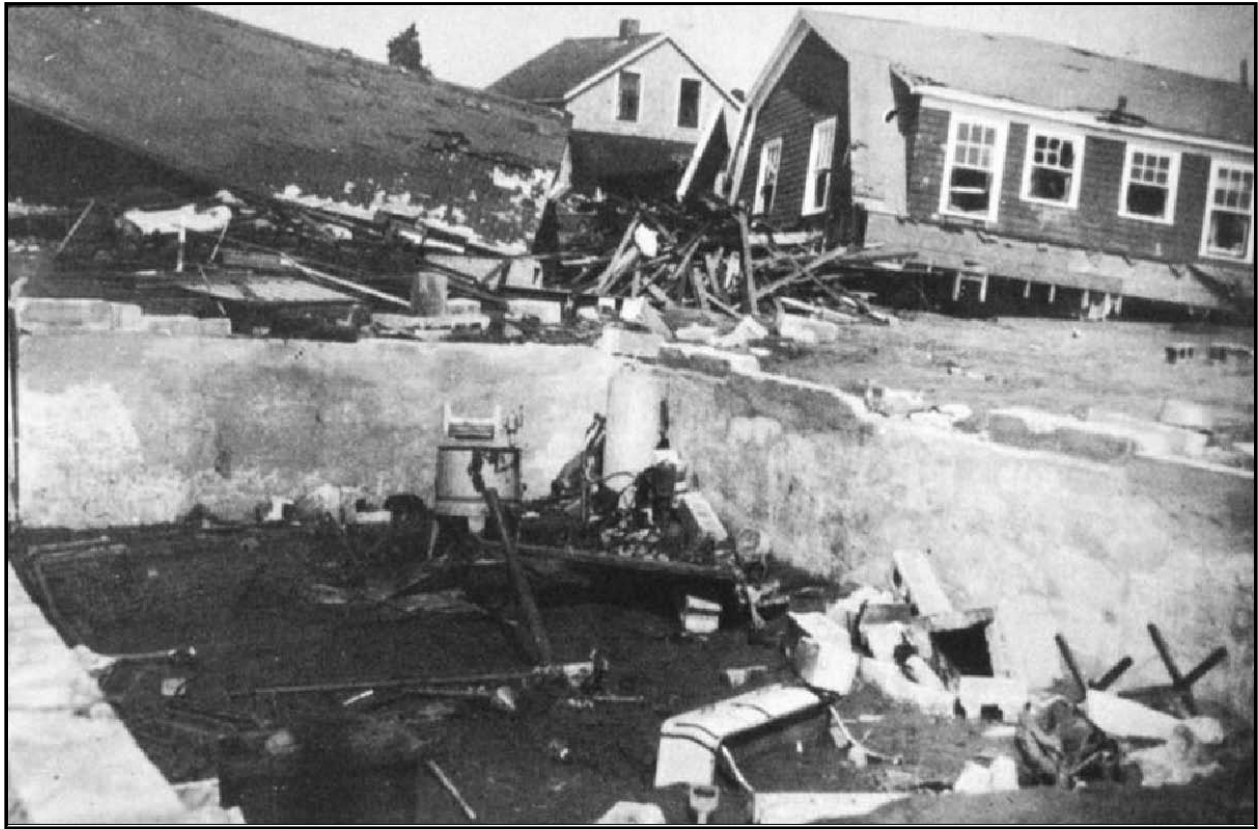
Figure 3. Island Park, near Portsmouth, RI, was overwashed by breaker (surge?) with reported height of 30 to 40 ft. From *The New England Hurricane, Federal Writers' Project of WPA*, 1938 (NOAA, <http://www.photolib.noaa.gov/historic/nws/nwind31.htm>, 15 November 2006).

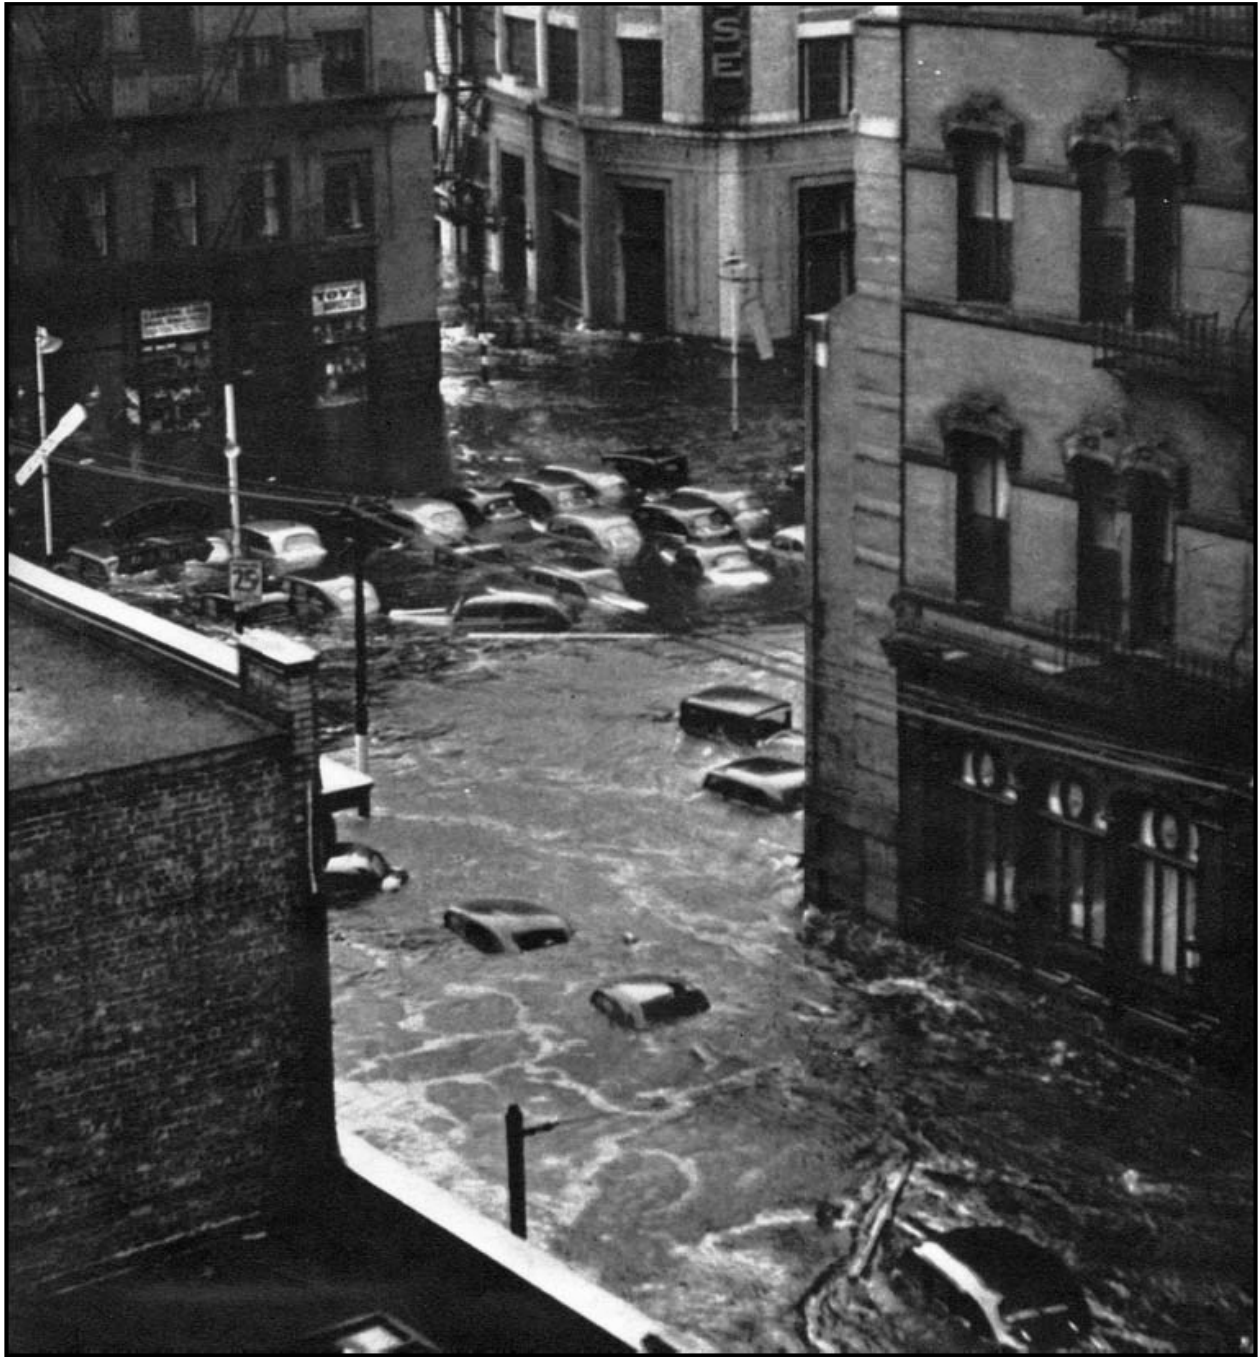
Figure 5. Dorrance Street, downtown Providence, 21 September 1938. Photograph by L.E. Wagner, from Providence Journal (1938).

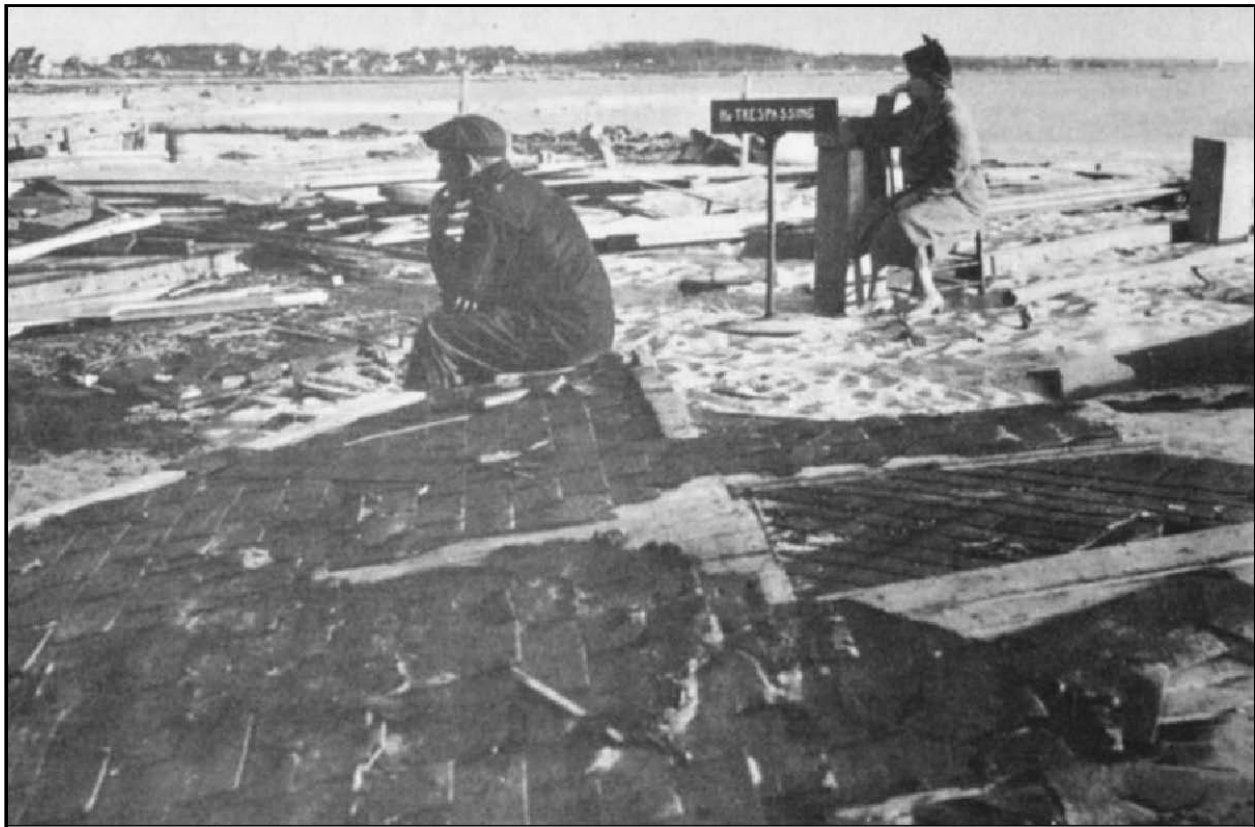
Figure 6. New Bedford damage from 1938 hurricane. Bay in background is approximately where hurricane barrier is now located. From *The New England Hurricane*, Federal Writers' Project of WPA, 1938 (NOAA, <http://www.photolib.noaa.gov/historic/nws/nwind31.htm>, 15 November 2006).

Coastal residents suffered the greatest from the storm because the surge coincided almost exactly with the autumnal high tide. Long Island and southern Rhode Island residents reported that a 25- to 40-ft wall of water overwashed the barrier islands with virtually no warning (Allen 1976). Along the southern Rhode Island shore, entire beach communities were washed away, and this author has seen remnants of chimneys and foundations exposed in the sand on East Beach, RI, after winter storms. The surge funneled up Narragansett Bay, causing untold damage to East Greenwich, Barrington, Warwick, and Portsmouth (Providence Journal 1938; Figure 3). The business district of Providence was flooded with over 14 ft of water, submerging trolley cars, automobiles, and the ground floors of buildings (Figures 4 and 5). The incoming water entered the city so swiftly, within 10 min the downtown was engulfed, trapping people in the upper floors of buildings, and, tragically, in automobiles. It was almost 2 weeks before many stores and businesses could dig out debris, pump flooded basements, restore electricity, and resume business. New Bedford was similarly inundated, and the fishing fleet largely destroyed (Figure 6).

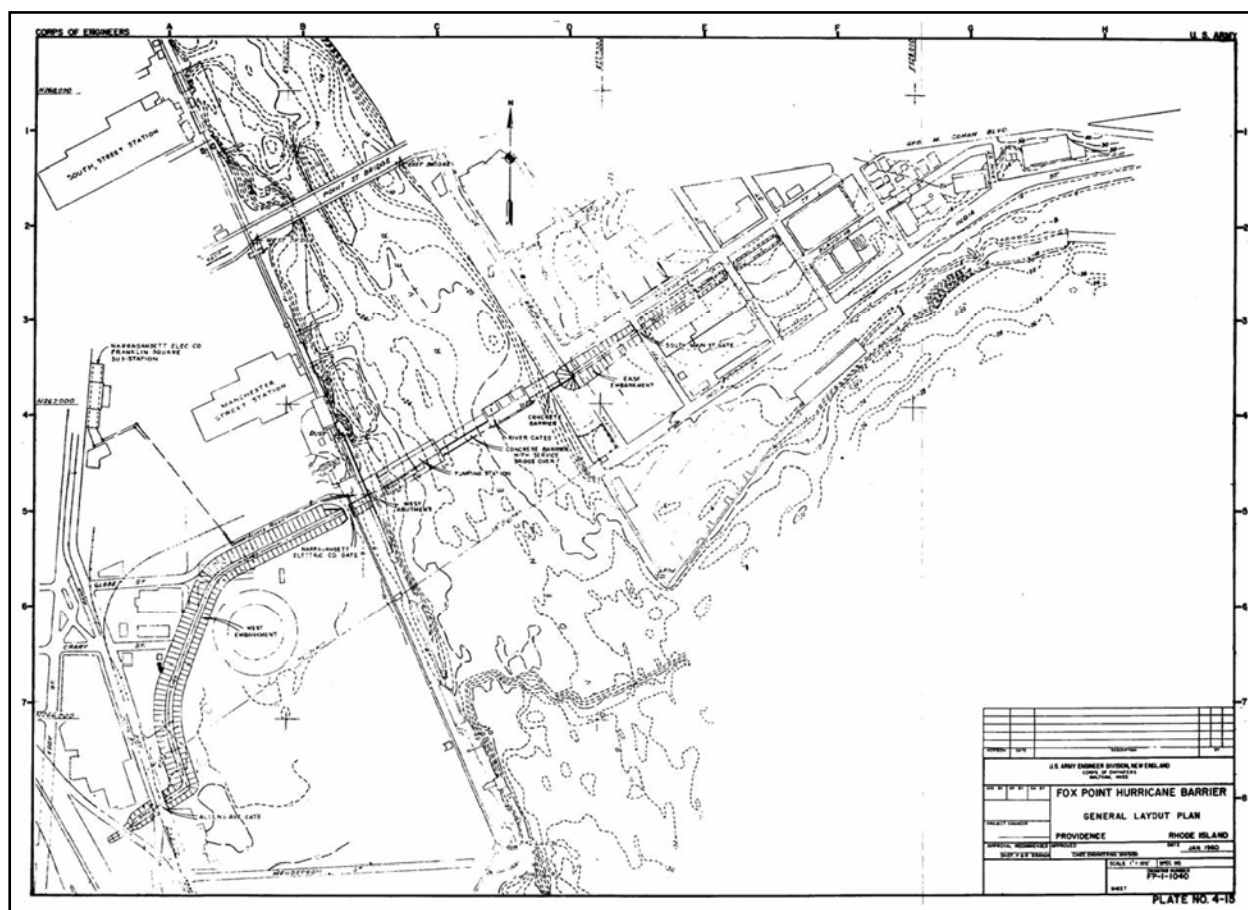
Figure 8. Fox Point project elements, from General Design Memorandum No. 4, January 1960.

There are three vehicular gates located at Allens Avenue, South Main Street, and the Narragansett Electric Company and five sewer gates that prevent high tides from backing up through the sewer lines.

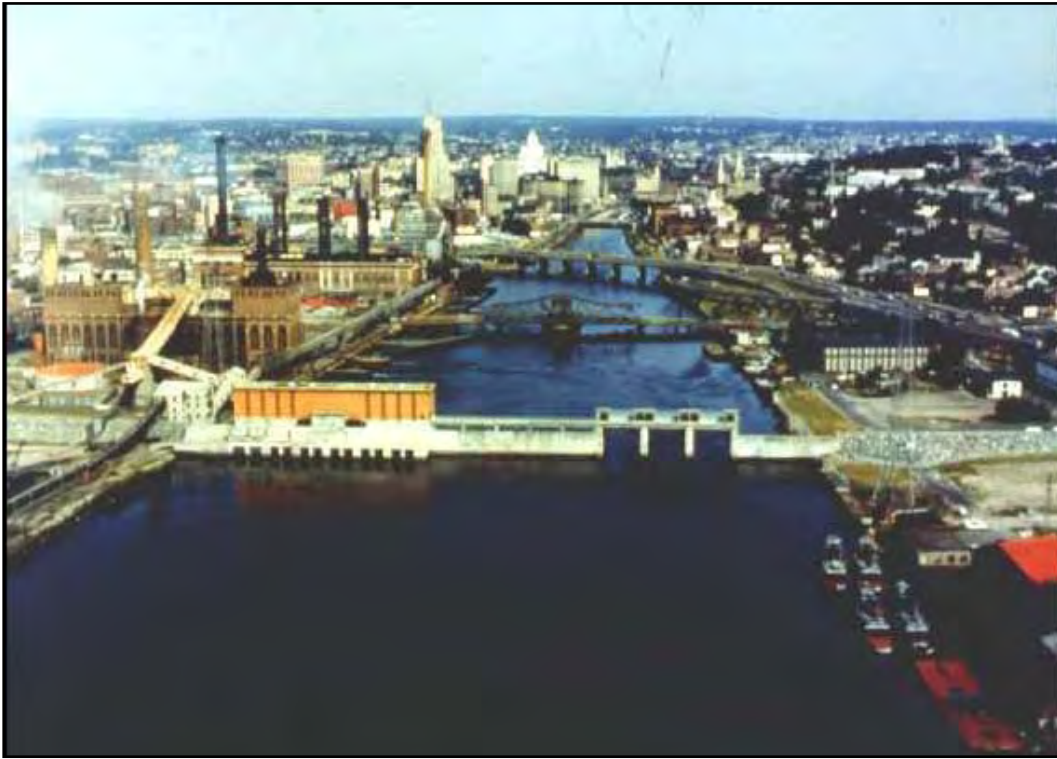
Figure 9. Fox Point hurricane barrier, view looking north toward downtown Providence. 2005 photograph predates the new I-195 bridge.

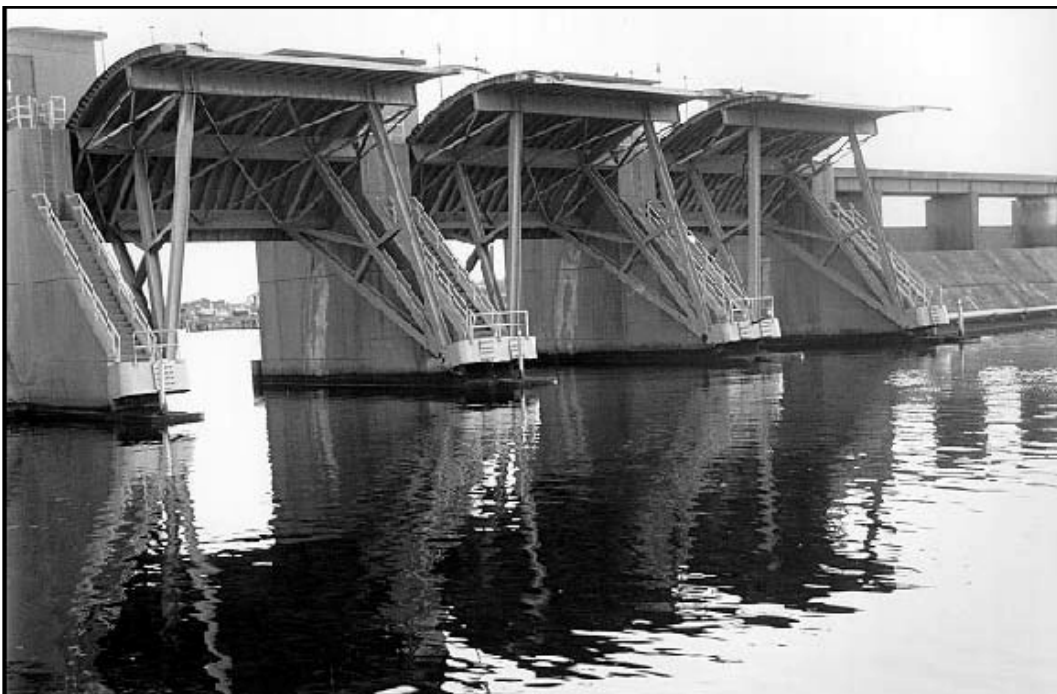
Figure 10. View of Providence River (north) side of barrier with gates up (undated photograph from City of Providence).

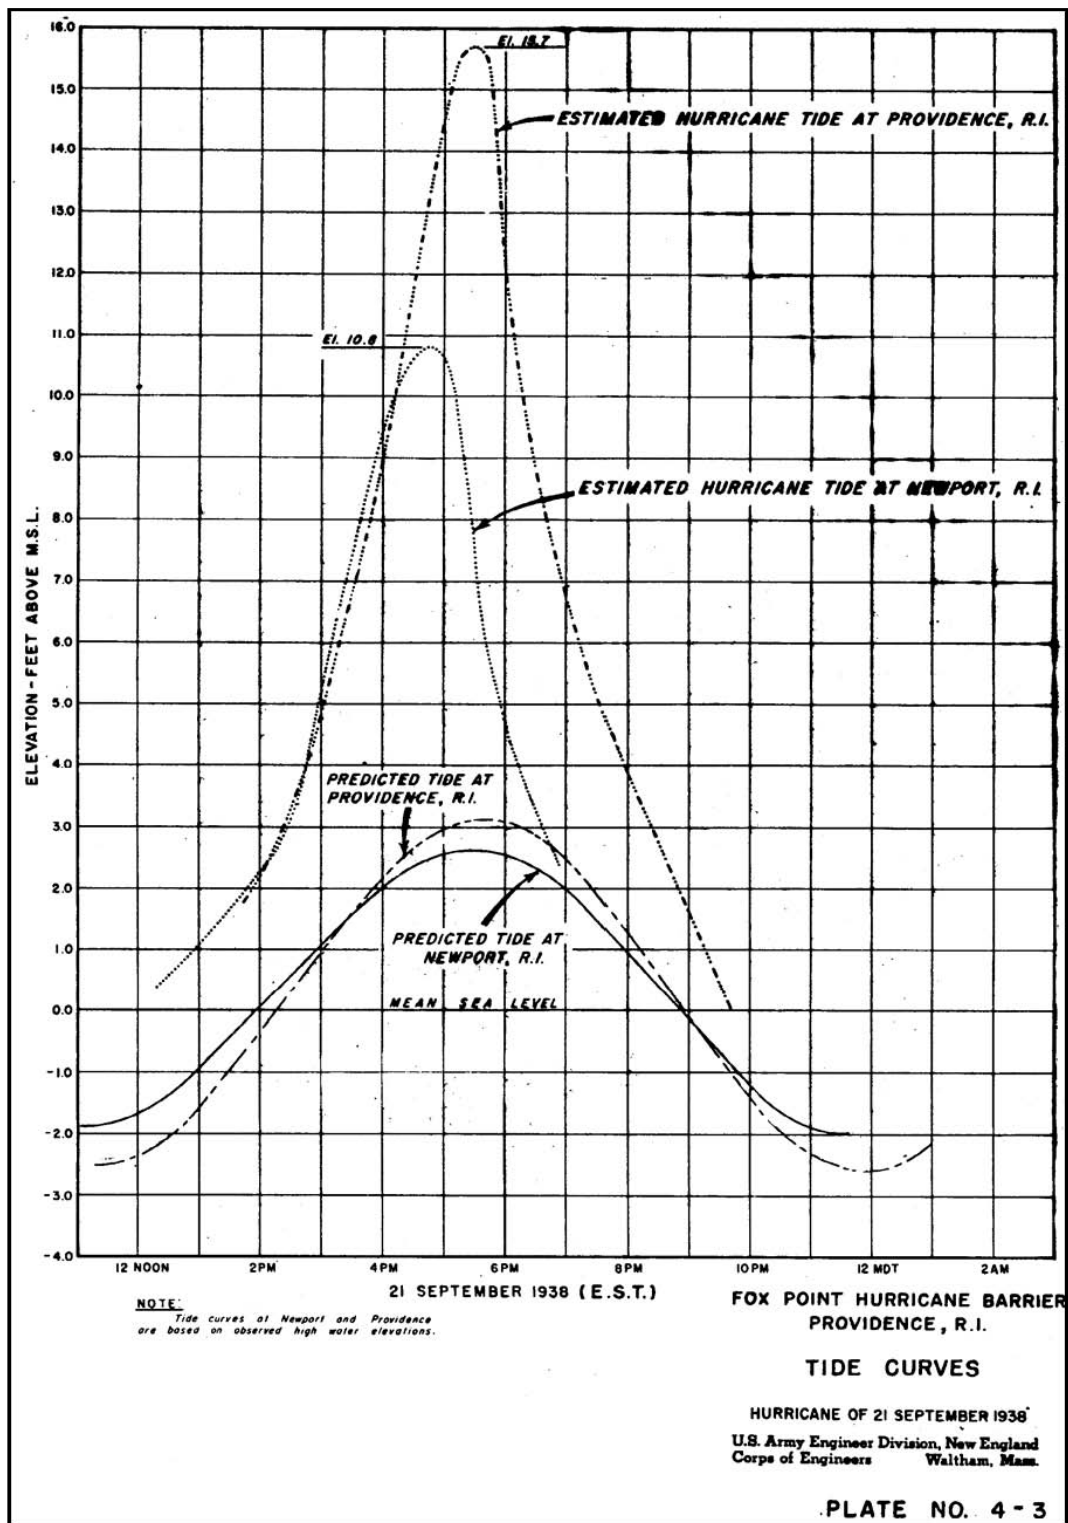
Figure 11. Water elevations for September 1938 hurricane at Providence and Newport. Peaks were at 15.7 and 10.8 ft.

Table 1 summarizes hydraulic conditions at this site, and Figures 11, 12, and 13 (from the General Design Memorandum), show hurricane elevation curves. Figure 14 is the elevation-frequency curve based on 320 years of record.

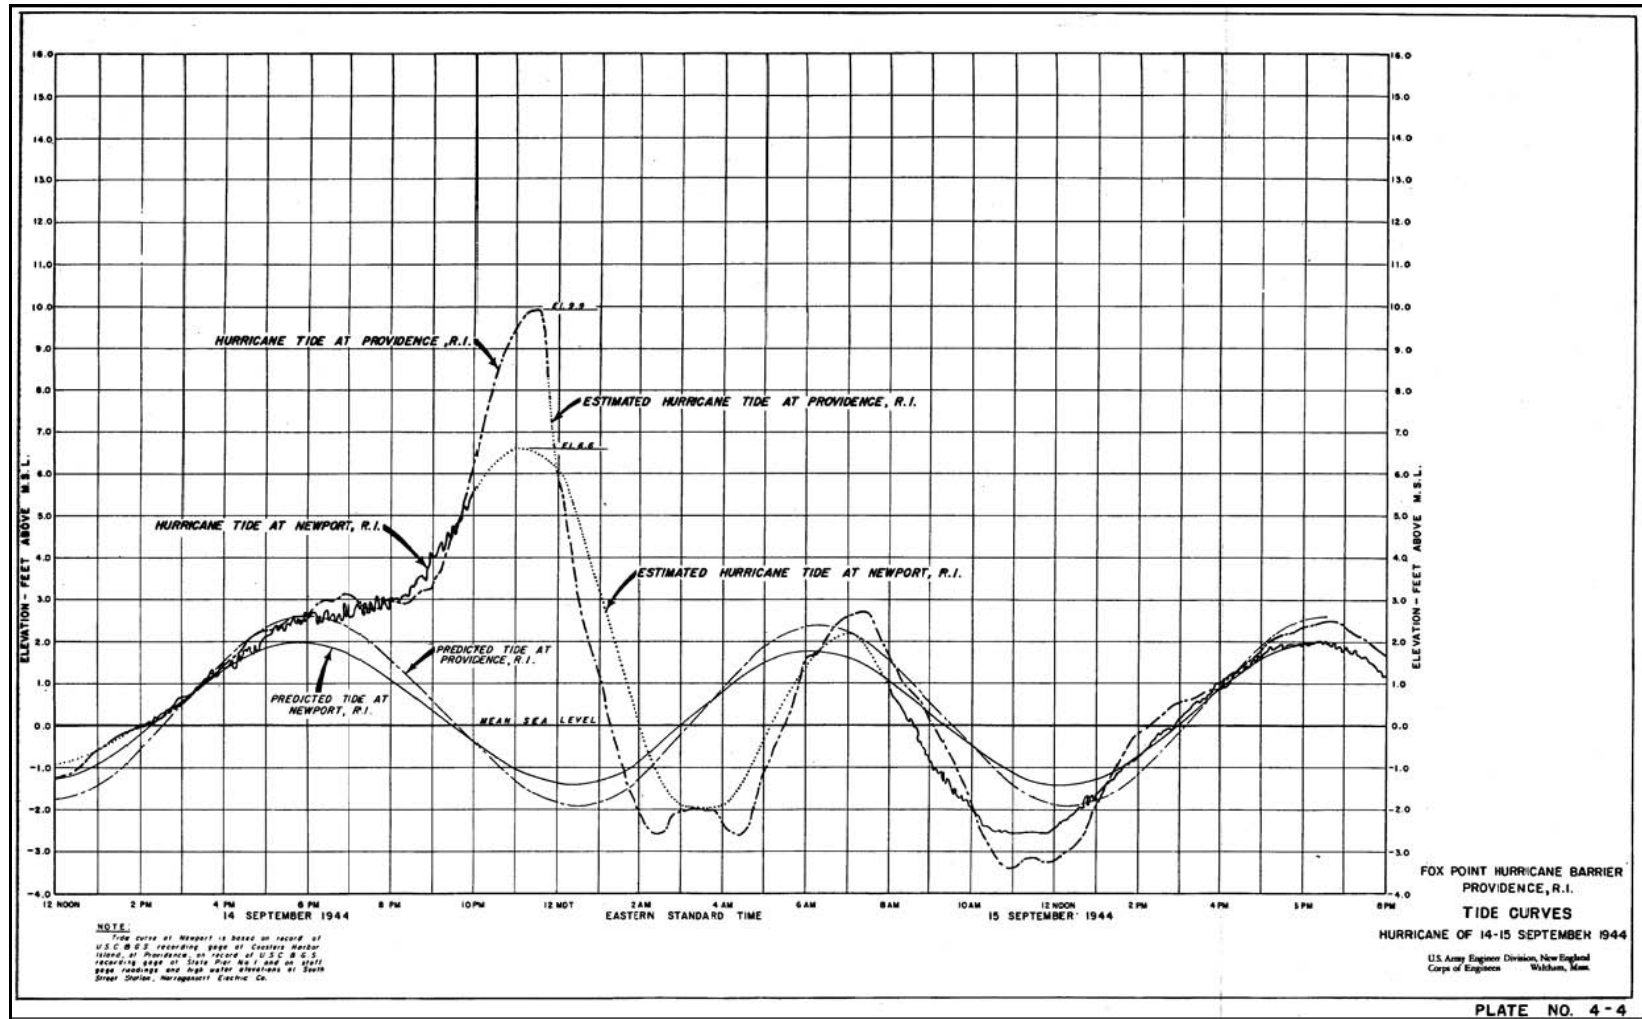
Figure 12. Water elevations for 1944 hurricane at Providence and Newport. Providence peak was 9.9 ft.

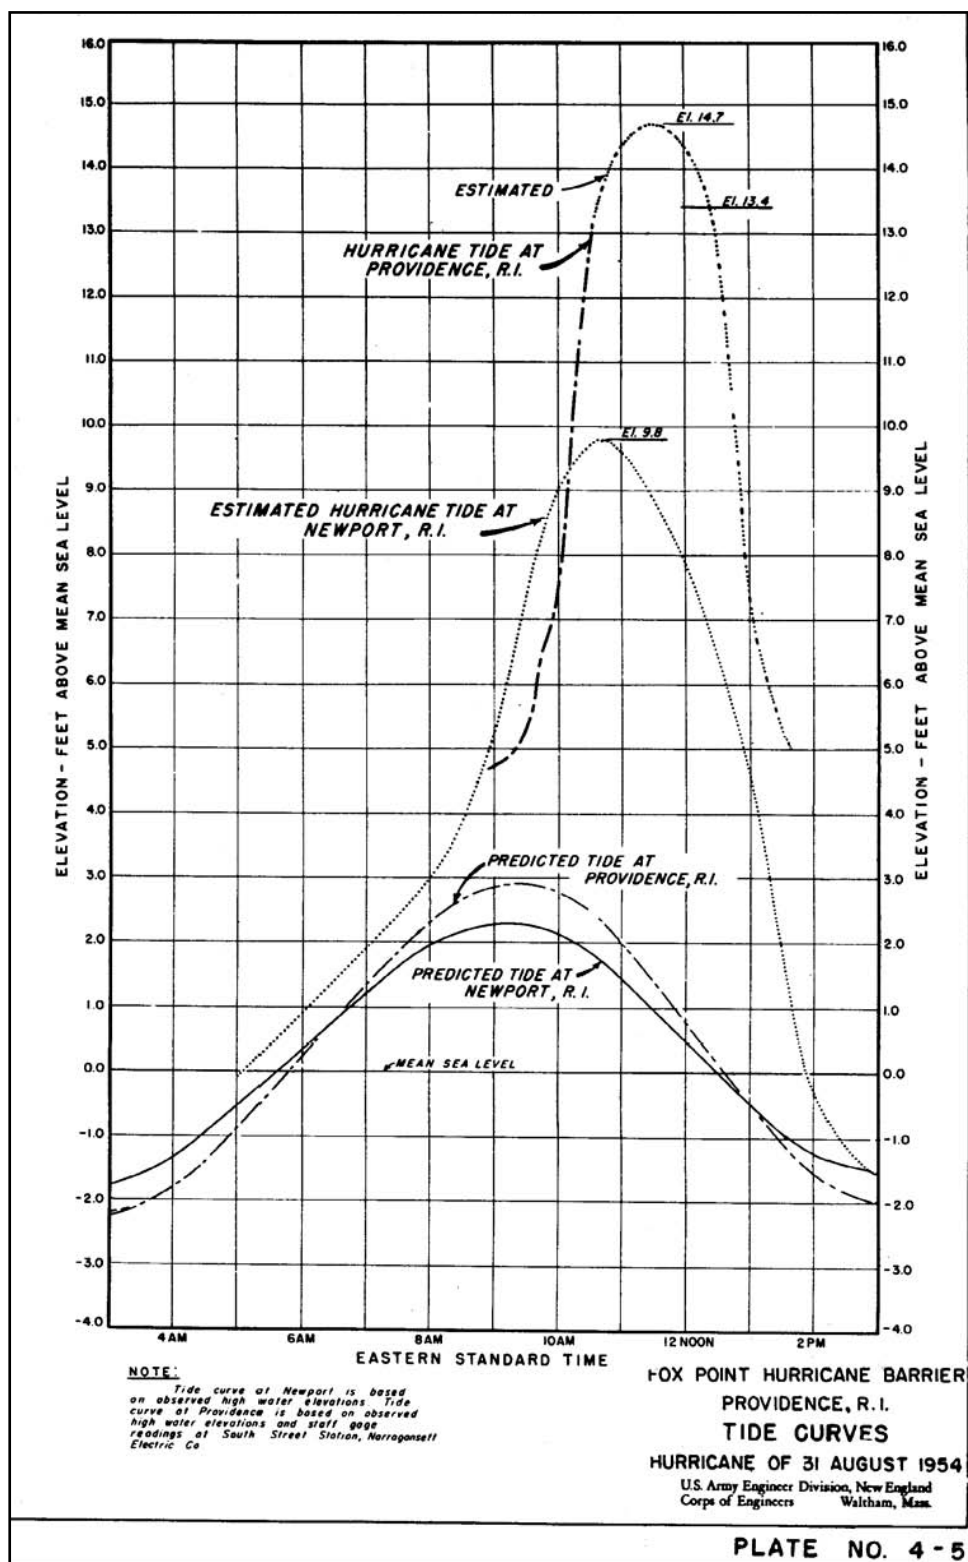
Figure 13. Water elevations for Hurricane Carol at Providence and Newport. Peaks were at 14.7 and 9.8 ft.

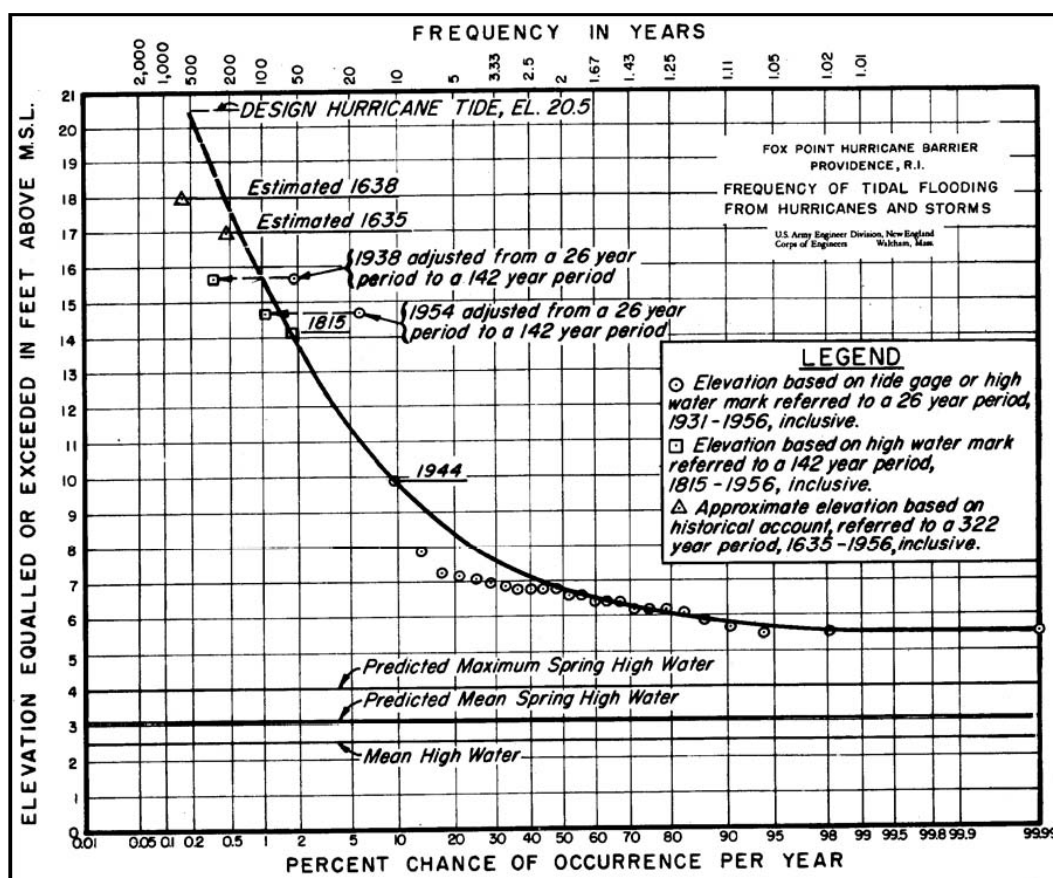
Figure 14. Providence elevation-frequency curve.

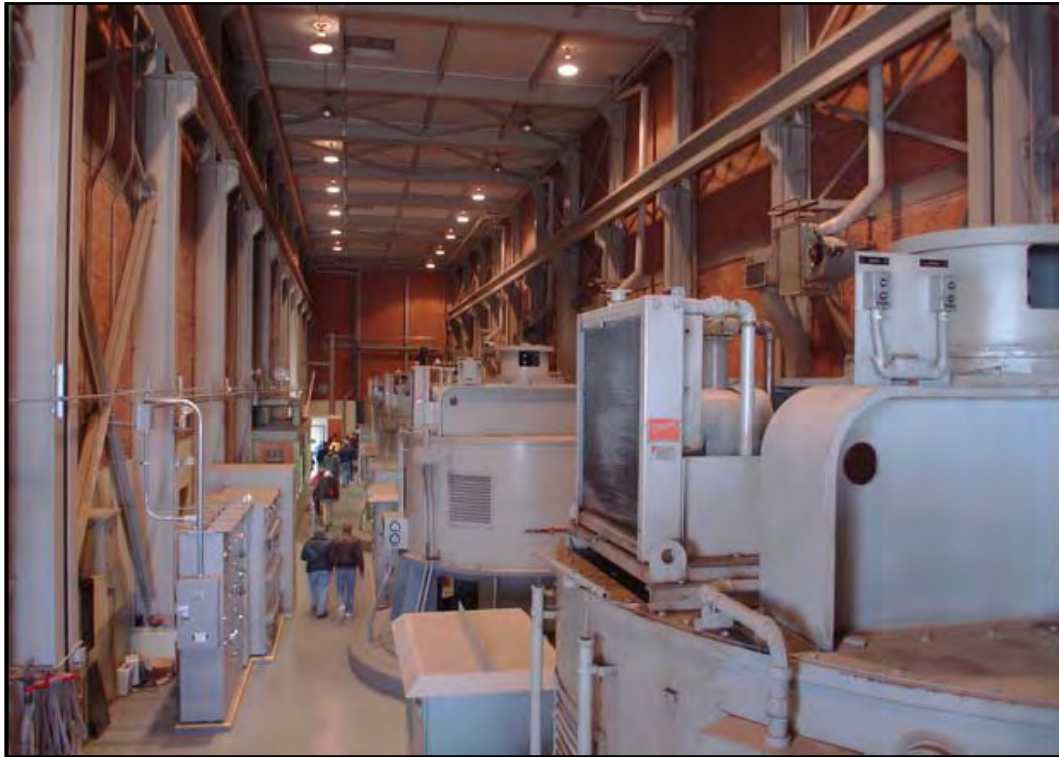
Figure 15. Fox Point pump house, 4 November 2006.

During a site visit on 4 November 2006, City of Providence engineers reported that the plant and equipment were in good mechanical condition, and the pumps were recently overhauled. The electrical controls are original and need to be upgraded. The controls use electromechanical relays, and parts are increasingly difficult to replace (Figure 17). They reported that if electricity were interrupted in an emergency, the tide gates could be lowered by hand by manually releasing brakes. However, it would be impossible to raise the gates without electricity for the motors, and, of course, the pumps would not function to push Providence River water out to Narragansett Bay.

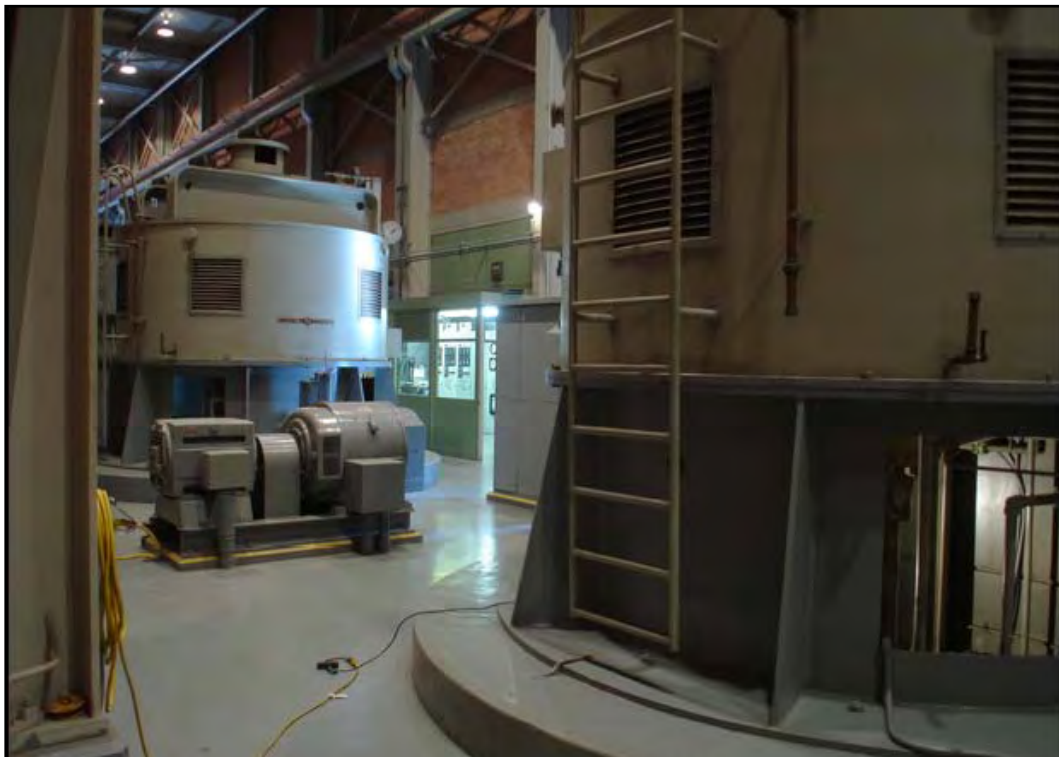
Figure 16. Pumps at Fox Point barrier, 4 November 2006.

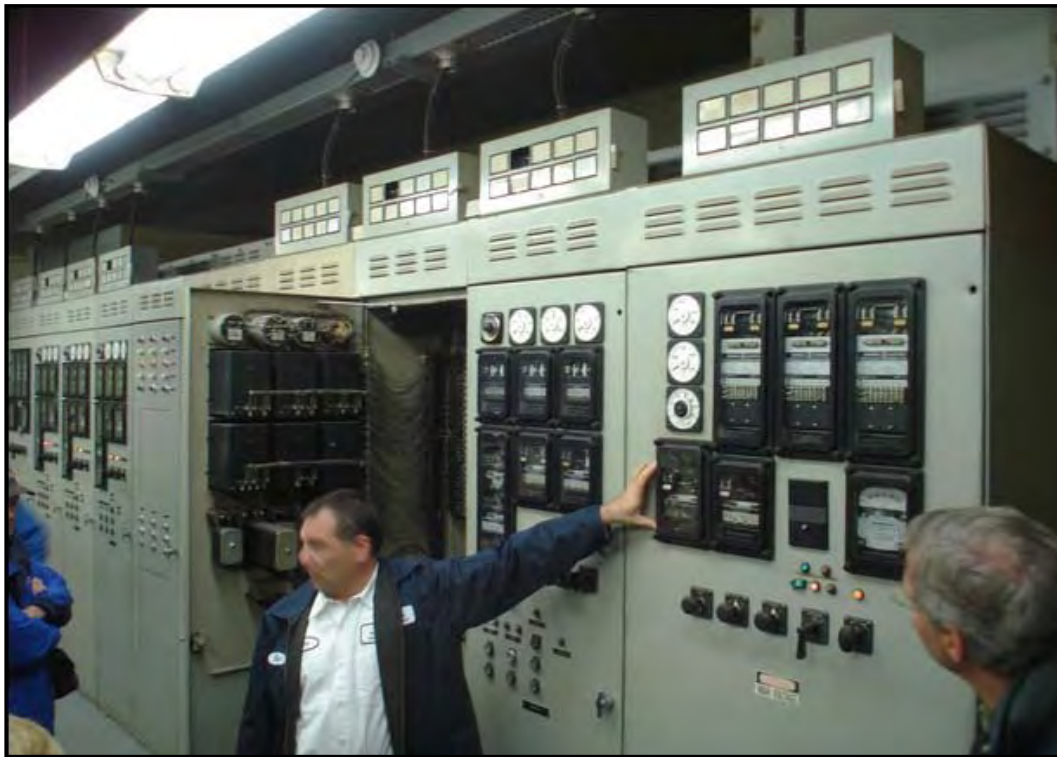
Figure 17. Controls for pumps and equipment, Fox Point pump house, 4 November 2006. Engineers are City of Providence employees.

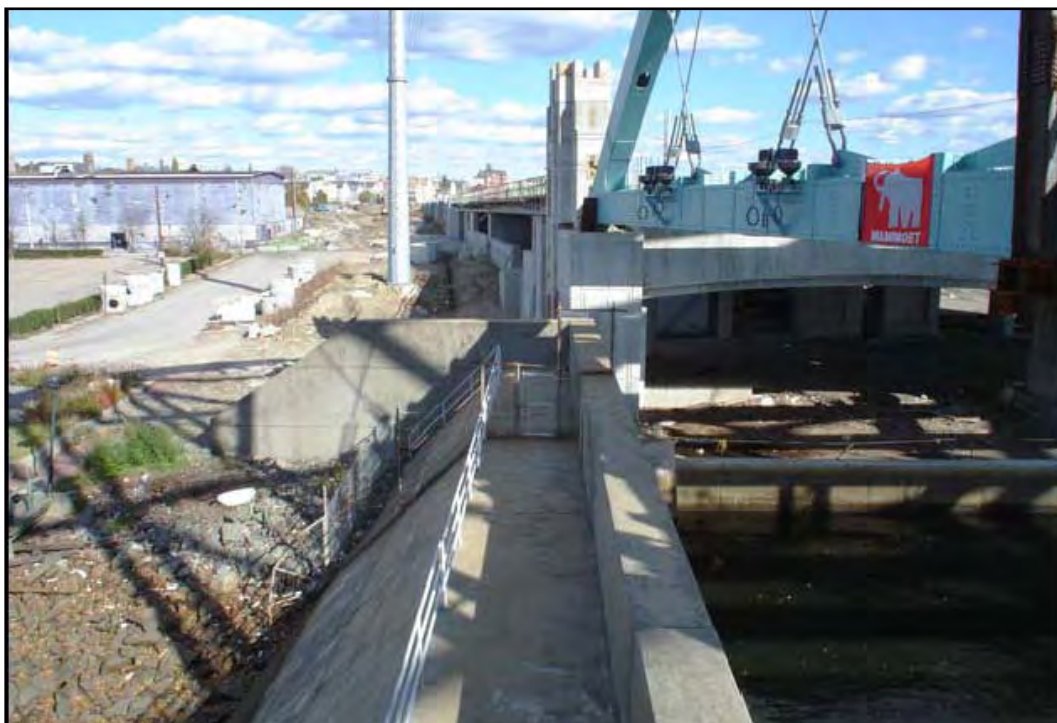
Figure 18. View east from Fox Point hurricane barrier showing ramps and newly-built I-195 bridge, 4 November 2006. Concrete freeway ramps substitute for some of original dike.

The new I-195 bridge has just been erected immediately south of the hurricane barrier. Part of the dike east of the river has been incorporated into the freeway ramps (Figure 18). The bridge had to be situated close to the barrier because of sewers and other conduits that cross under the Providence River further south. As a result, the pile foundation had to be carefully designed to avoid interfering with the H-piles of the hurricane barrier.

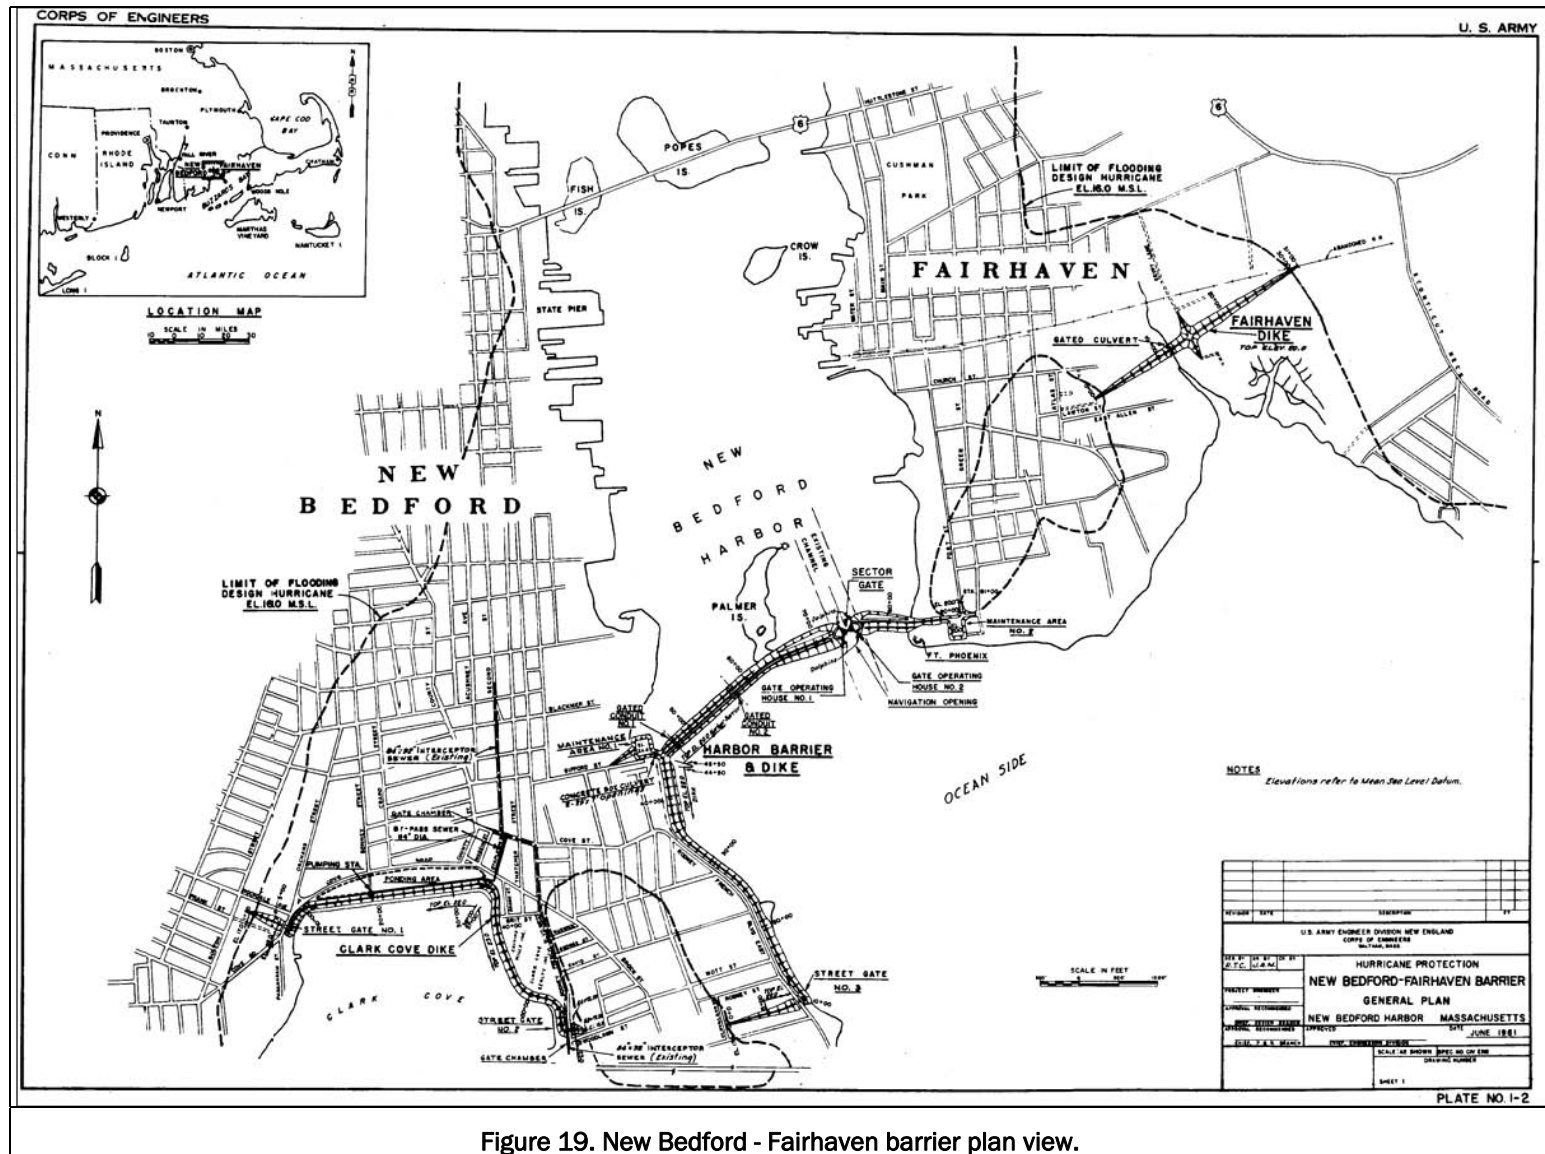
Figure 19. New Bedford - Fairhaven barrier plan view.

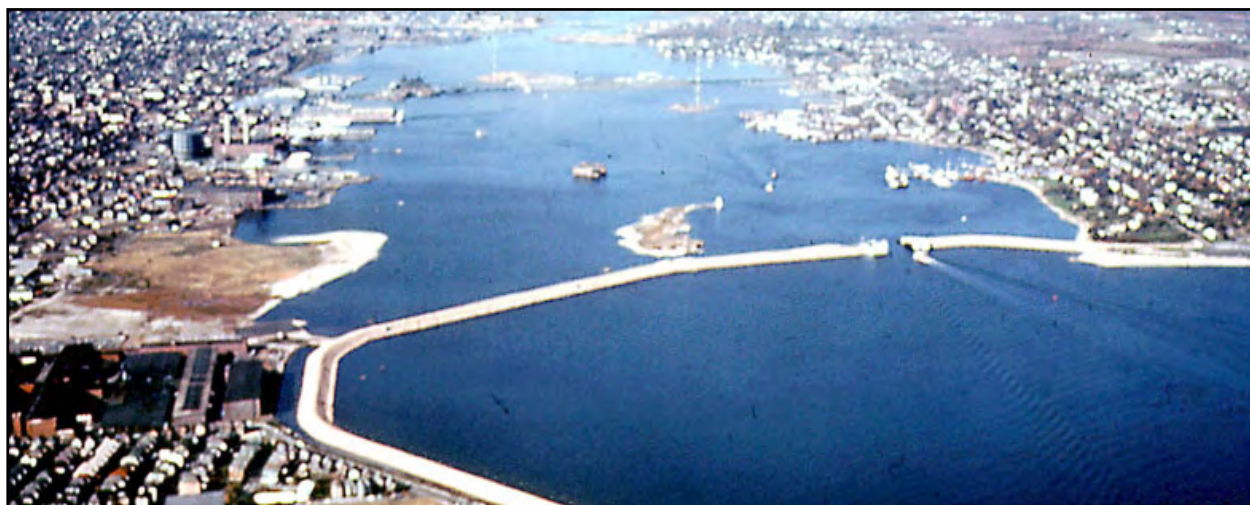
Figure 20. New Bedford dike and navigation gate.

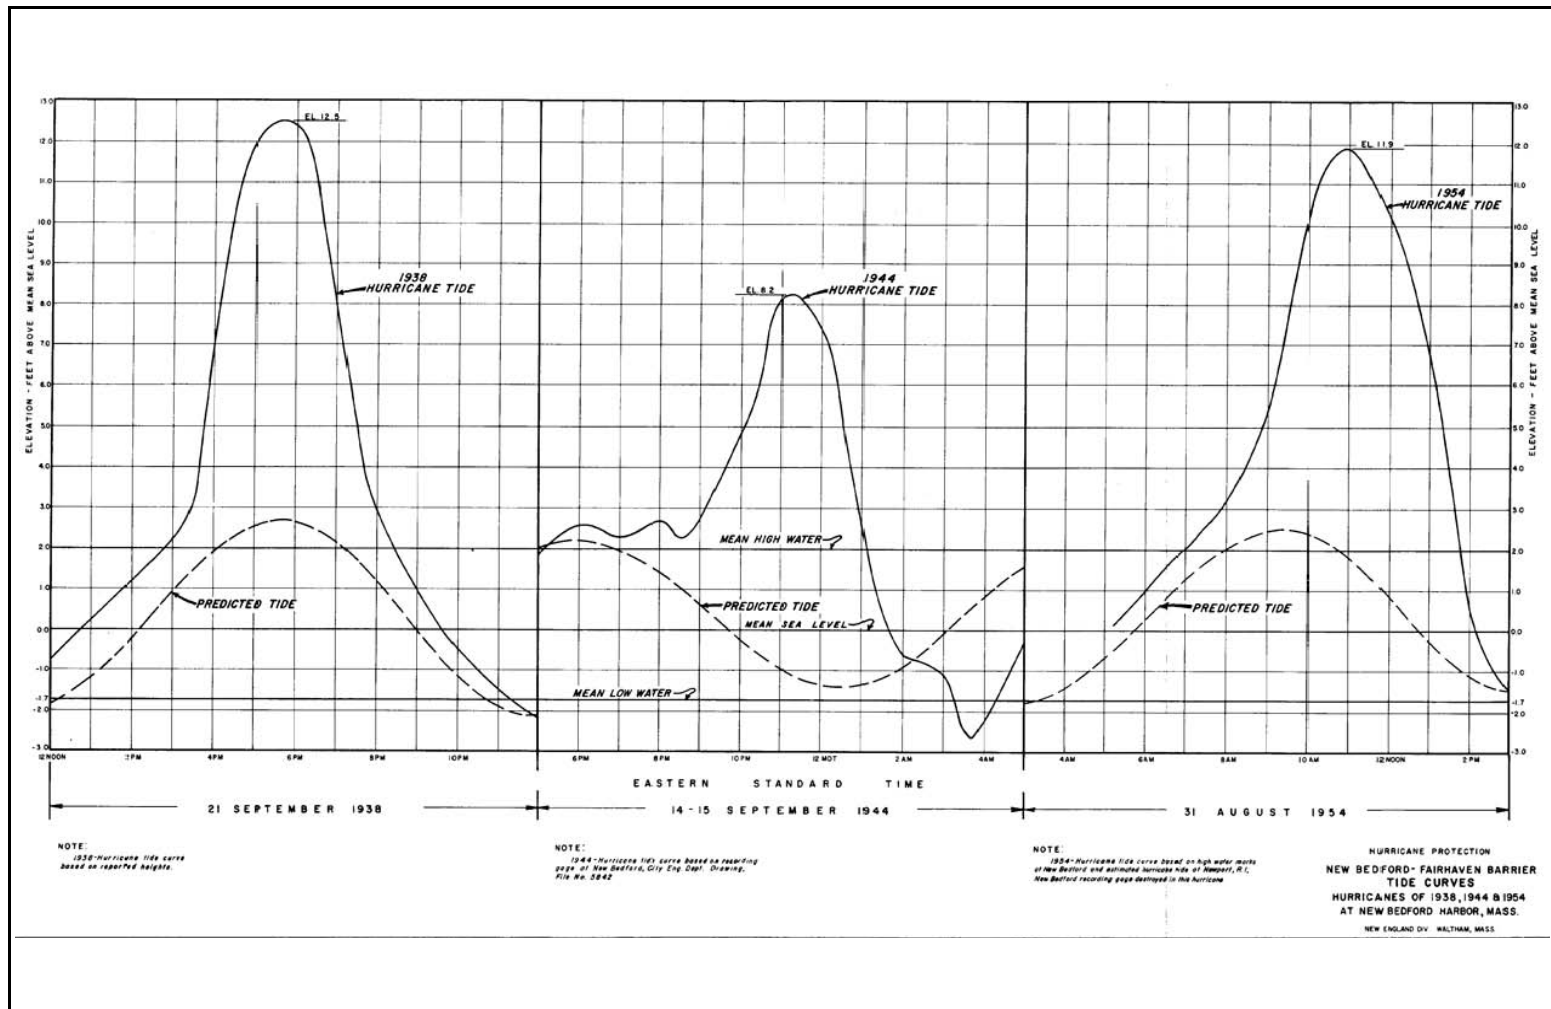
Figure 21. Water elevations for 1938, 1944, and 1954 hurricanes in New Bedford.

The following design summary is from the New England District web page.¹ This is the same Design Hurricane used for the Fox Point project. Table 2 summarizes hydraulic conditions and Figures 21 and 22, from the General Design Memorandum, show the hurricane surge levels and the elevation-frequency curve.

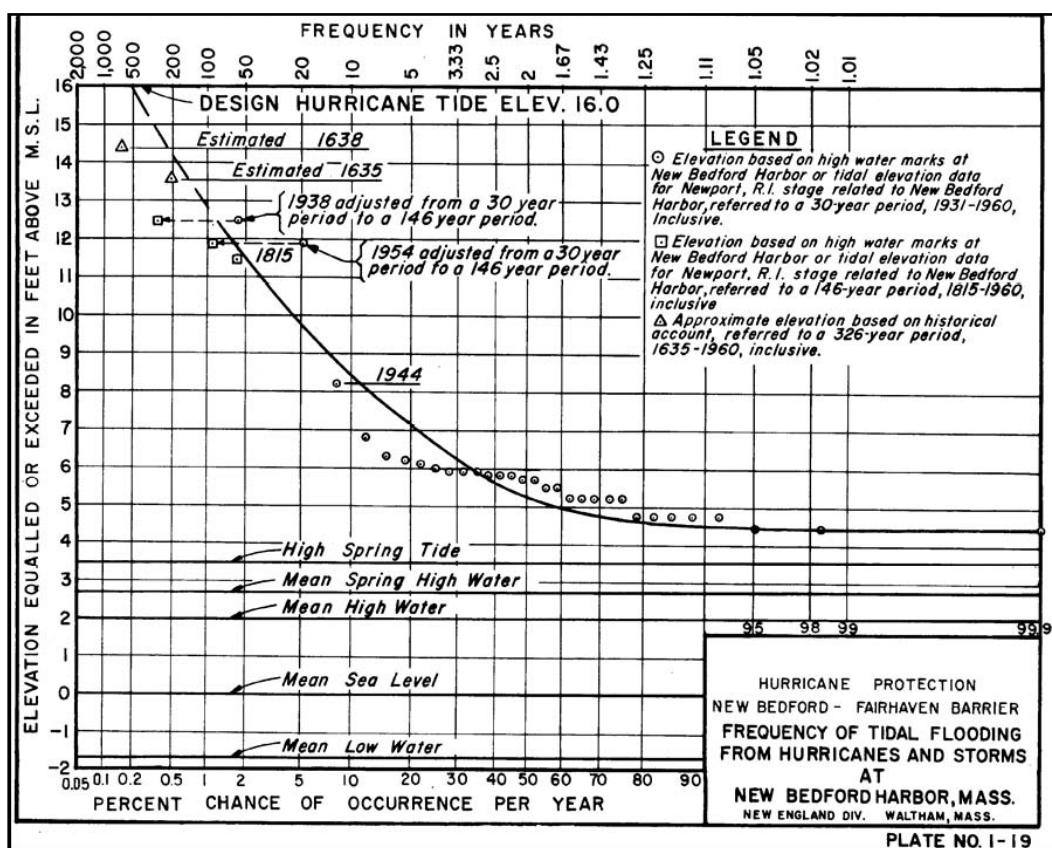
Figure 22. New Bedford elevation-frequency curve.
