Hurricane Barriers in New England and New Jersey — History and Status After Four Decades

Andrew Morang

September 2007

Final report

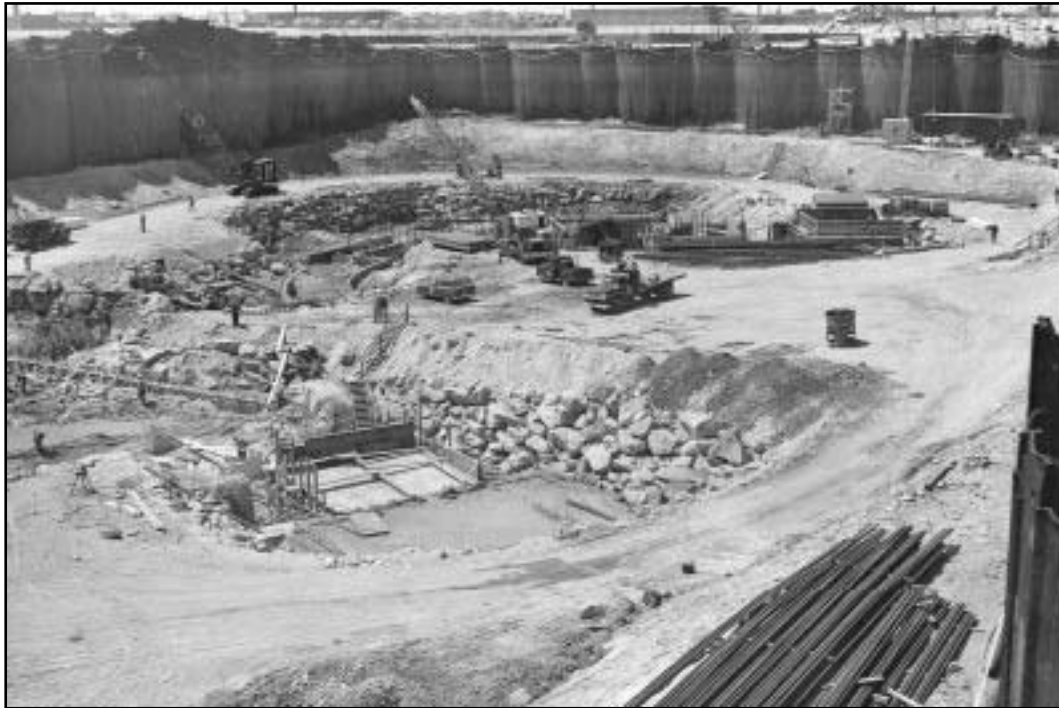
Figure 23. Sector gate foundation work within protective cofferdam, 5 May 1964 (photograph courtesy of New England District).

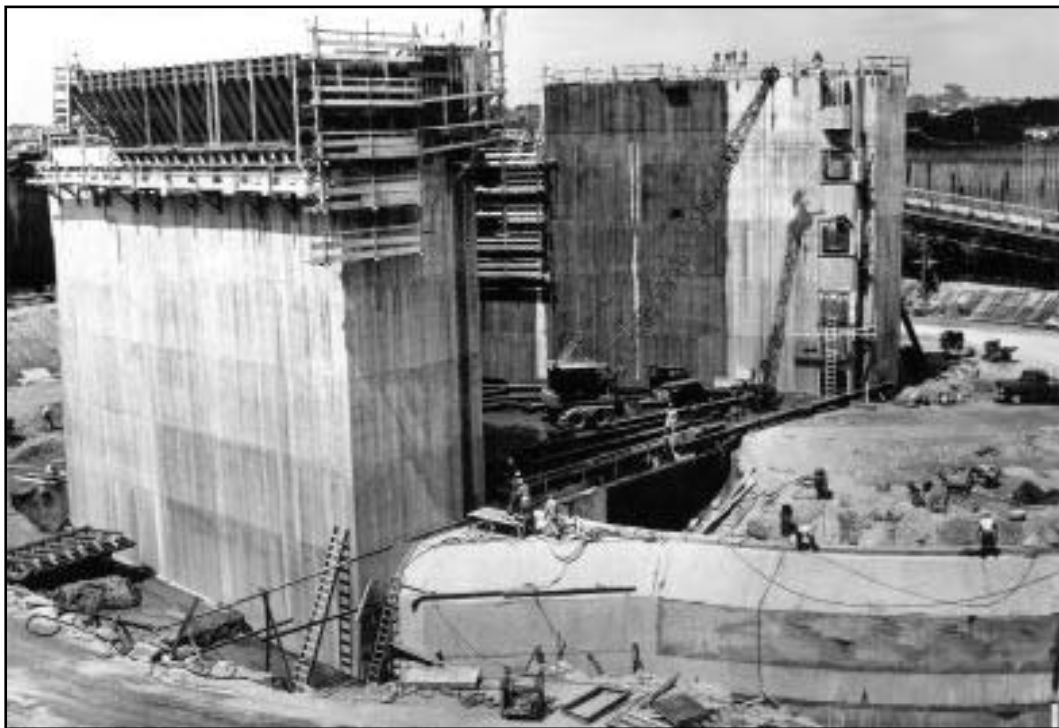
Figure 24. Construction of gate house, 1964. Structure in lower right is guide for gate rollers and also contains tunnel through which gate operators can walk under channel (photograph courtesy of New England District).

When the gates are moving across the channel, a roller runs in a channel cast into the top of the tunnel (Figures 24 and 25). Because the channel fills with silt, a compressed air system was installed with nozzles near the roller to clean out the channel. The air is also needed to clear silt in the gate pockets where the gates are parked in their open position. This has not been fully satisfactory, and a pump system to maintain a constant flow of water to flush the pockets has been proposed.

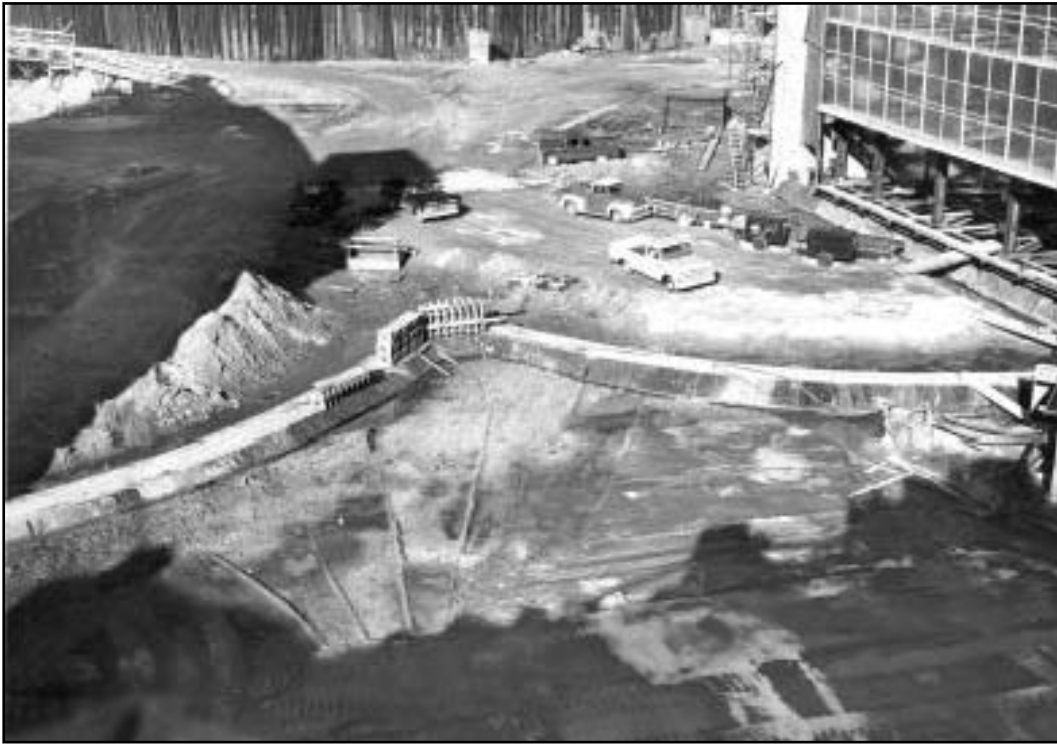
Figure 25. Construction of guide for sector gates, 16 December 1964. Trucks show scale of this project (photograph courtesy of New England District).

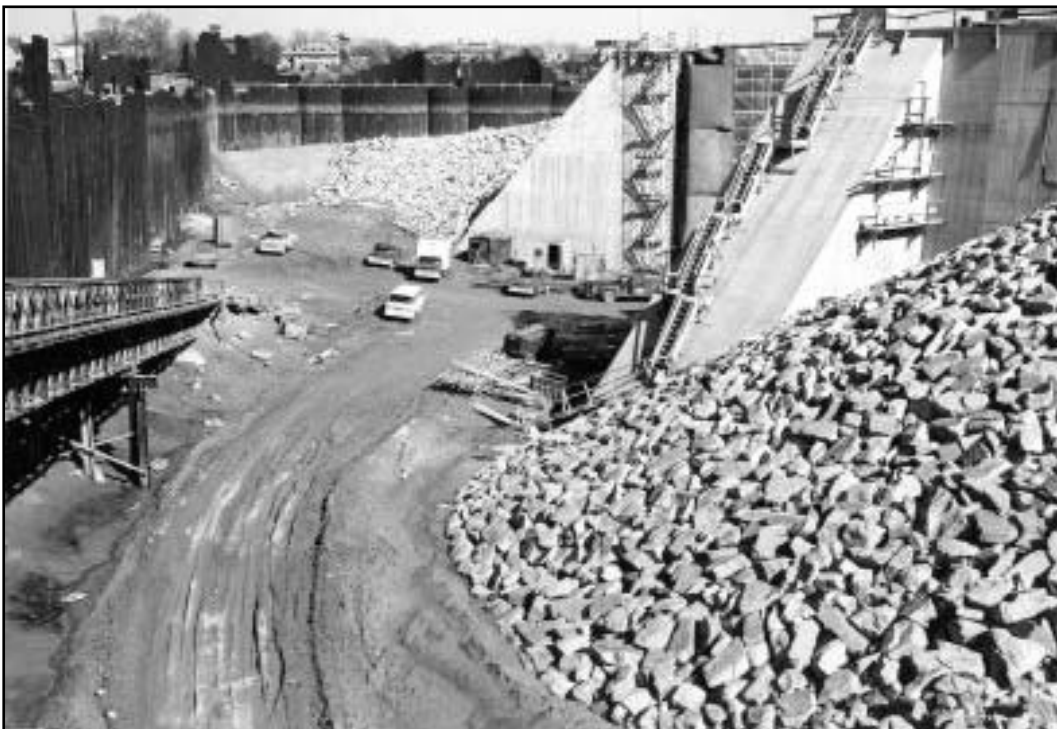
Figure 26. Harbor side of section gate looking east toward Fairhaven, 1965 (photograph courtesy of New England District).

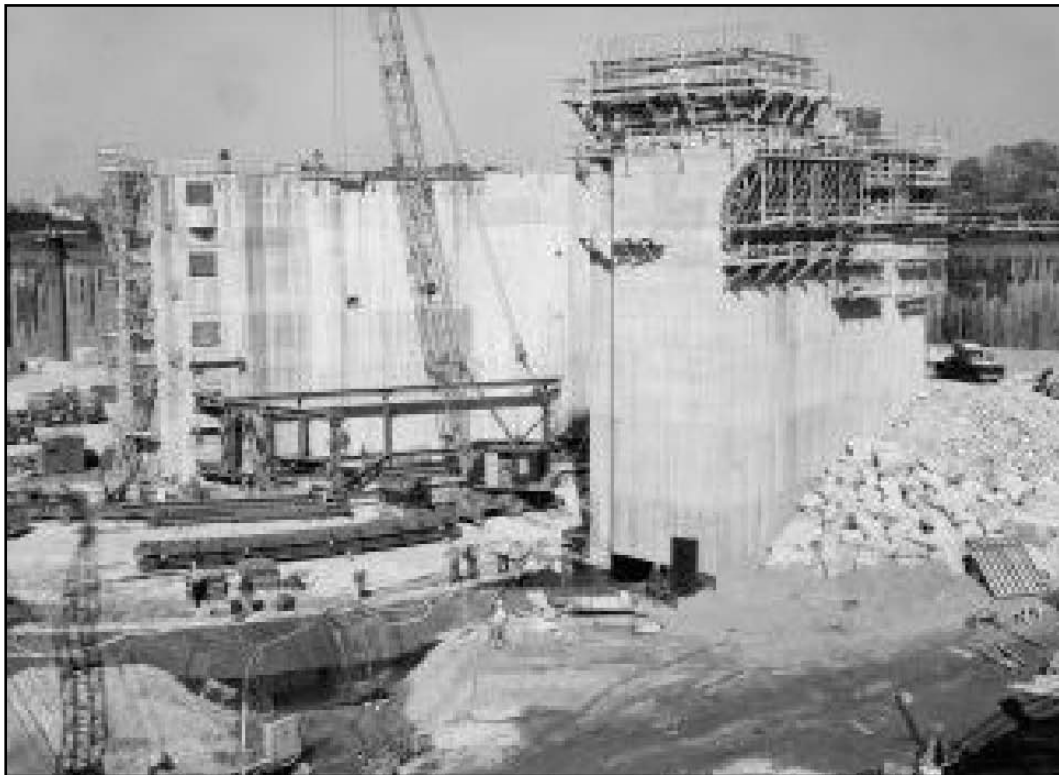
Figure 27. East sector gate steel erection, 15 October 1964 (photograph courtesy of New England District).

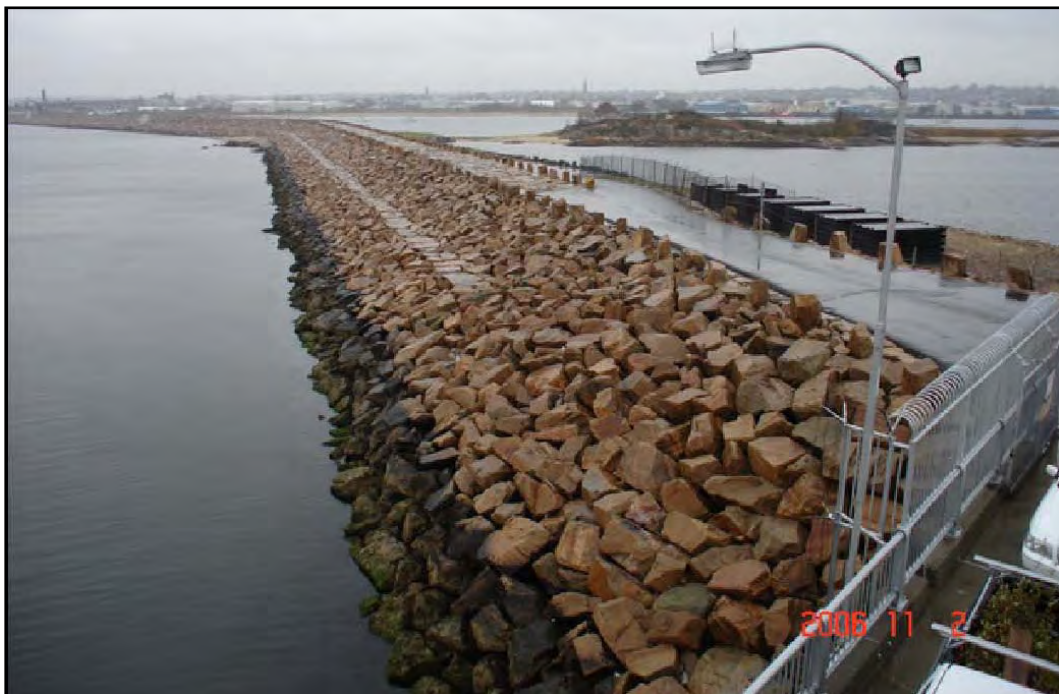
Figure 28. View looking west along New Bedford hurricane dike from gate house, 2 November 2006.

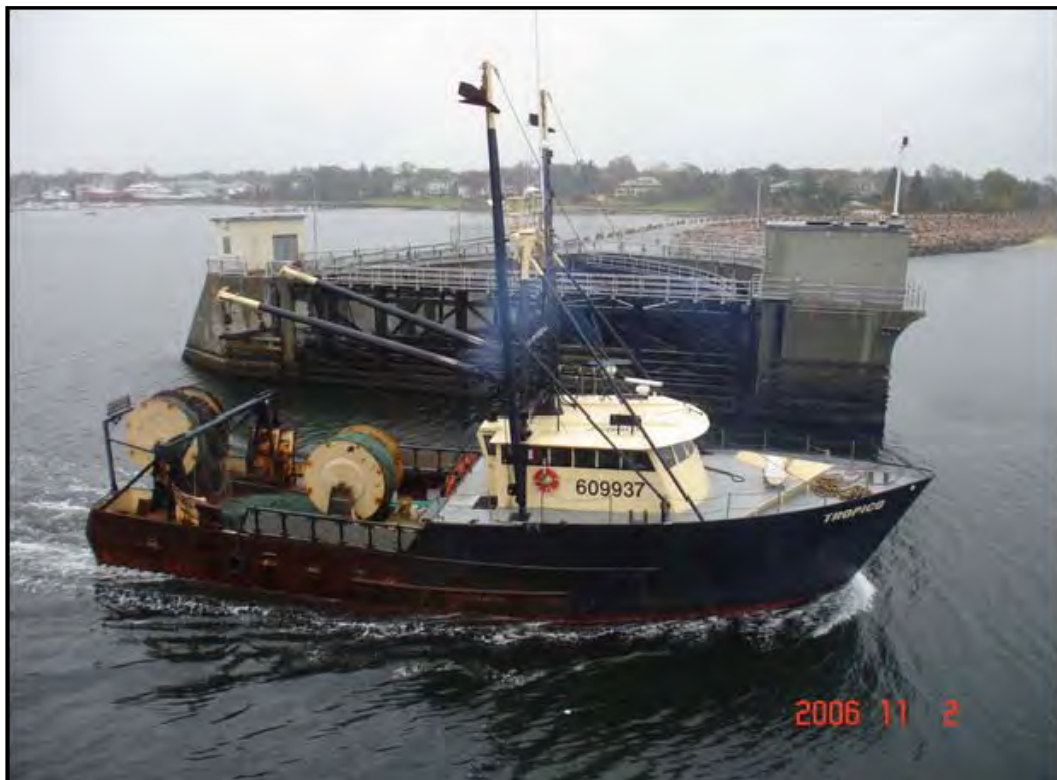
Figure 29. Fishing boat passing through 150-ft-wide Federal navigation channel in New Bedford hurricane barrier. View from gate control house looking east, 2 November 2006.

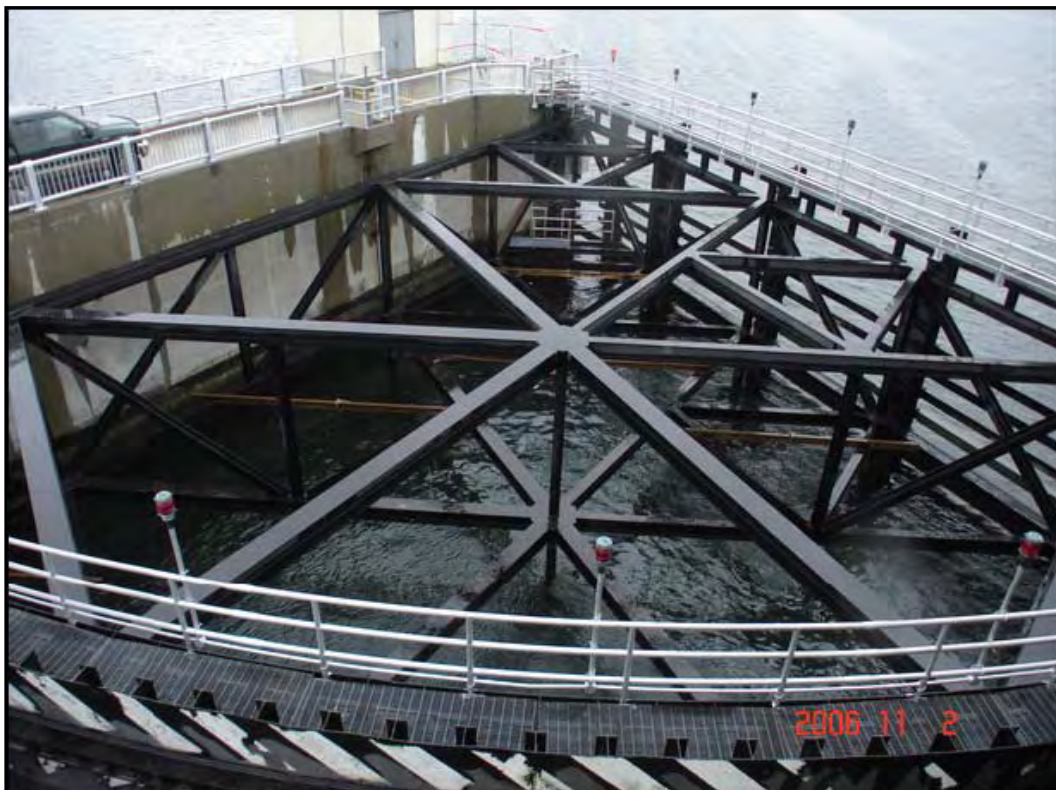
Figure 30. West side section gate in rest position, New Bedford hurricane barrier. Pivot is at upper center of photograph and ship channel is to right.

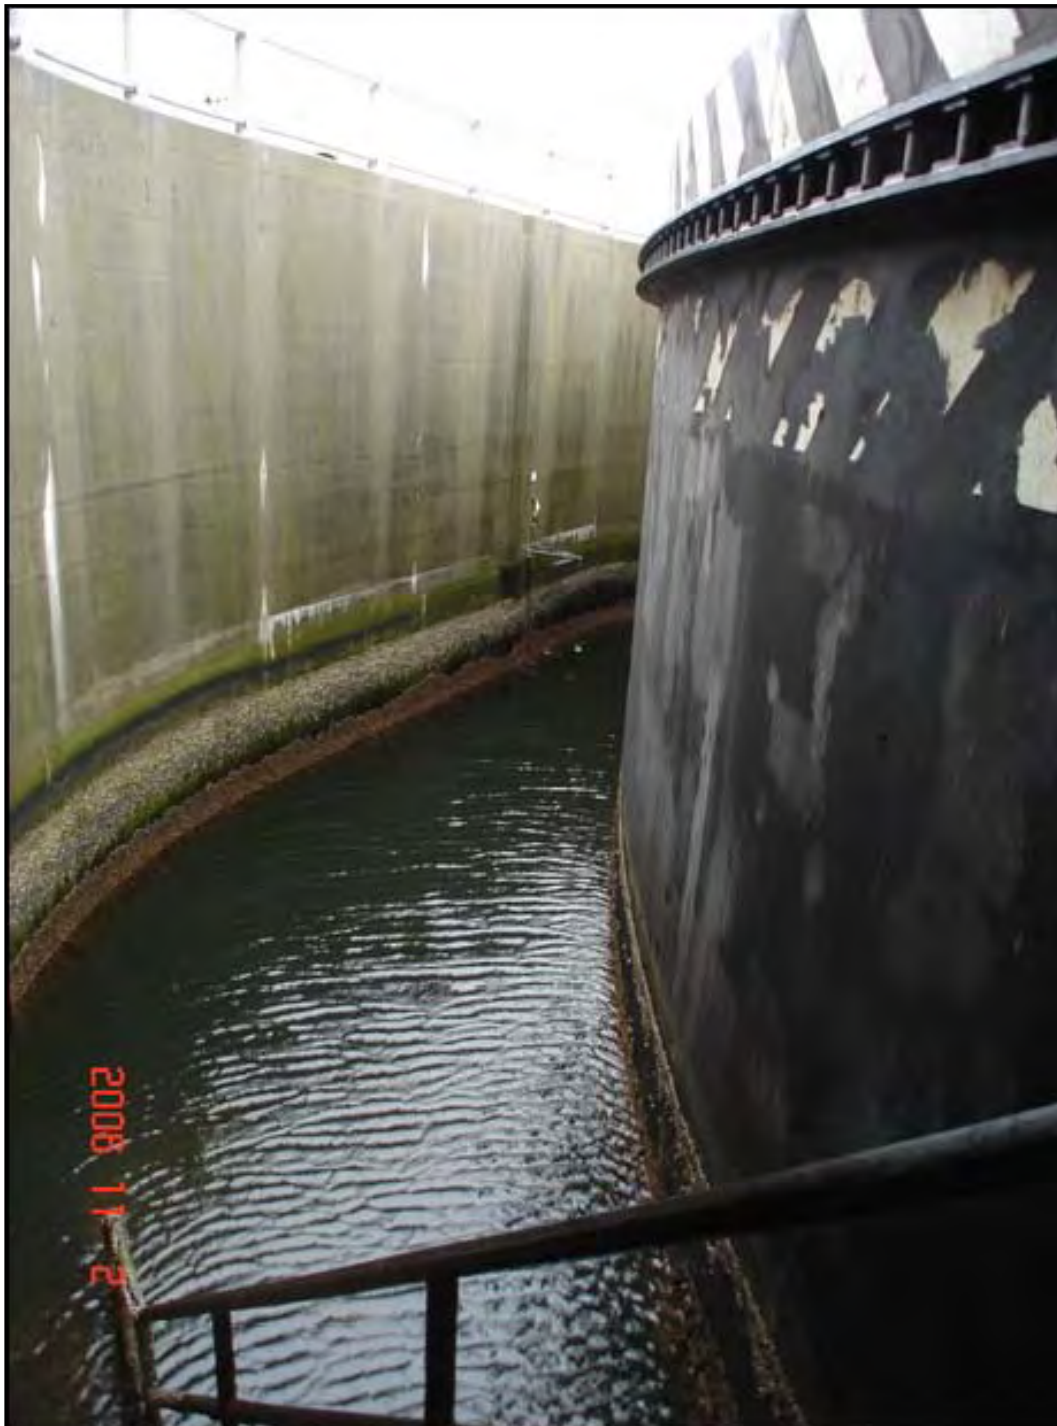
Figure 31. West side section gate in its well. Cogs near top of gate are engaged by teeth of opening mechanism. Silt builds up in well and has to be flushed with compressed air, but gates are often difficult to fully retreat.

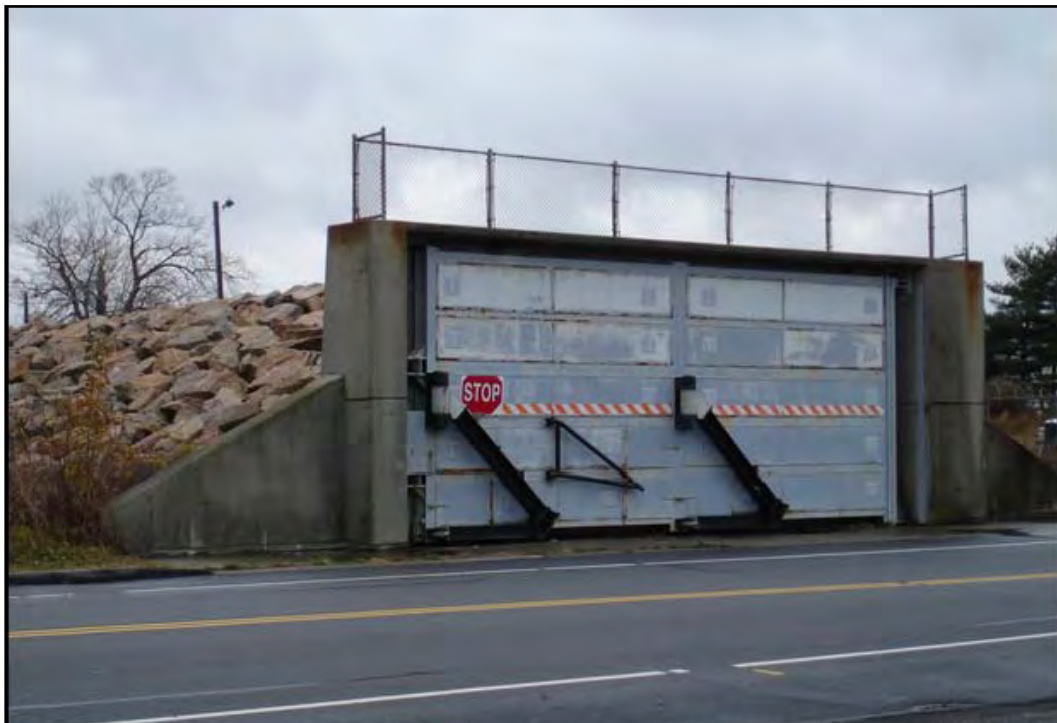
Figure 32. Steel swing gate at E Rodney French Boulevard, New Bedford.

Along with the 18,000 ft of dike, the project includes two steel swing gates to seal off city streets (Figure 32) and a pumping station at Clark Cove (Figure 33). These are operated by the City of New Bedford. At Clark Cove, a broad grassy area about the size of a soccer field serves as a catchment basin for storm water runoff. The pump station was built by the USACE as part of the original project.

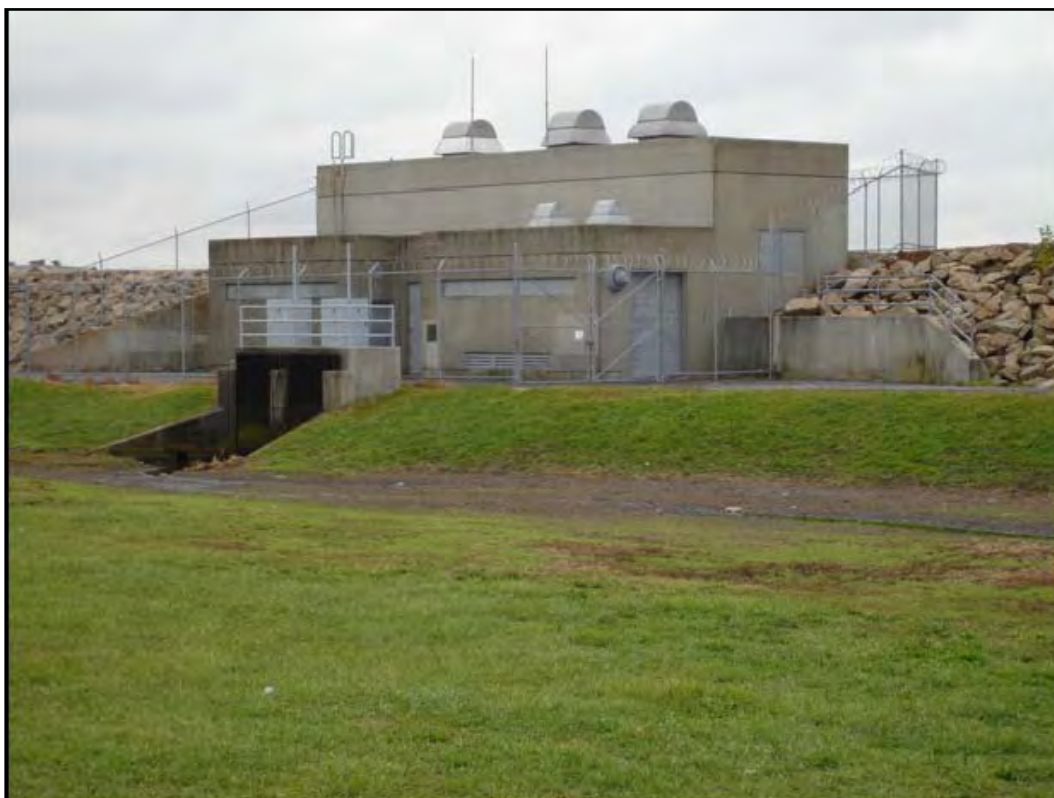
Figure 33. Clark Cove pump station, operated by City of New Bedford. Grassy field in foreground serves as temporary storage after heavy rain.

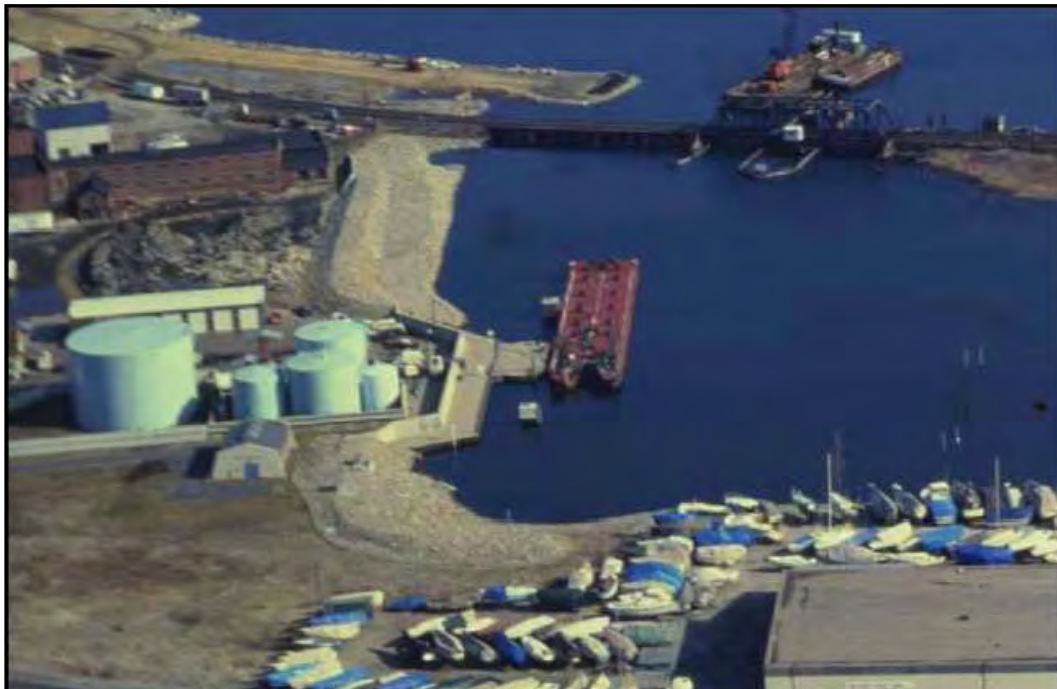
Figure 36. New London, CT, dike, 2005 (photograph courtesy of New England District).

The following project summary is from the New England District¹ and Figures 35 and 36 show project features:

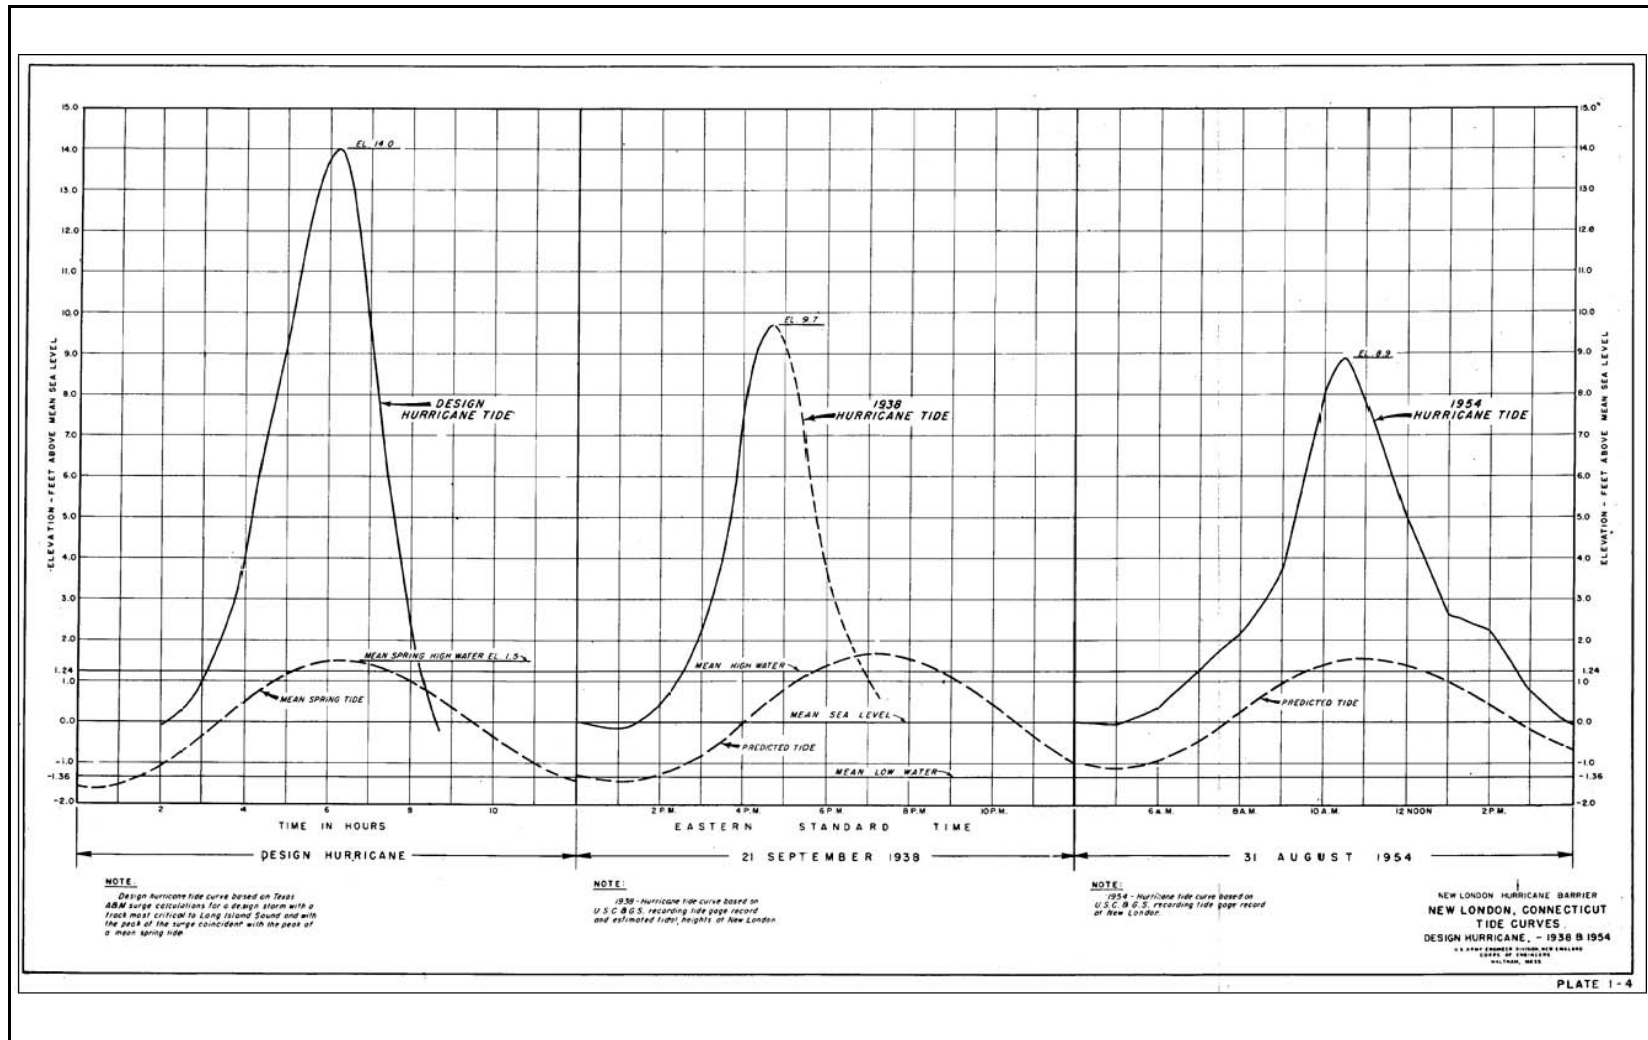
Figure 37. Water elevation for 1938 and 1954 hurricanes in New London.

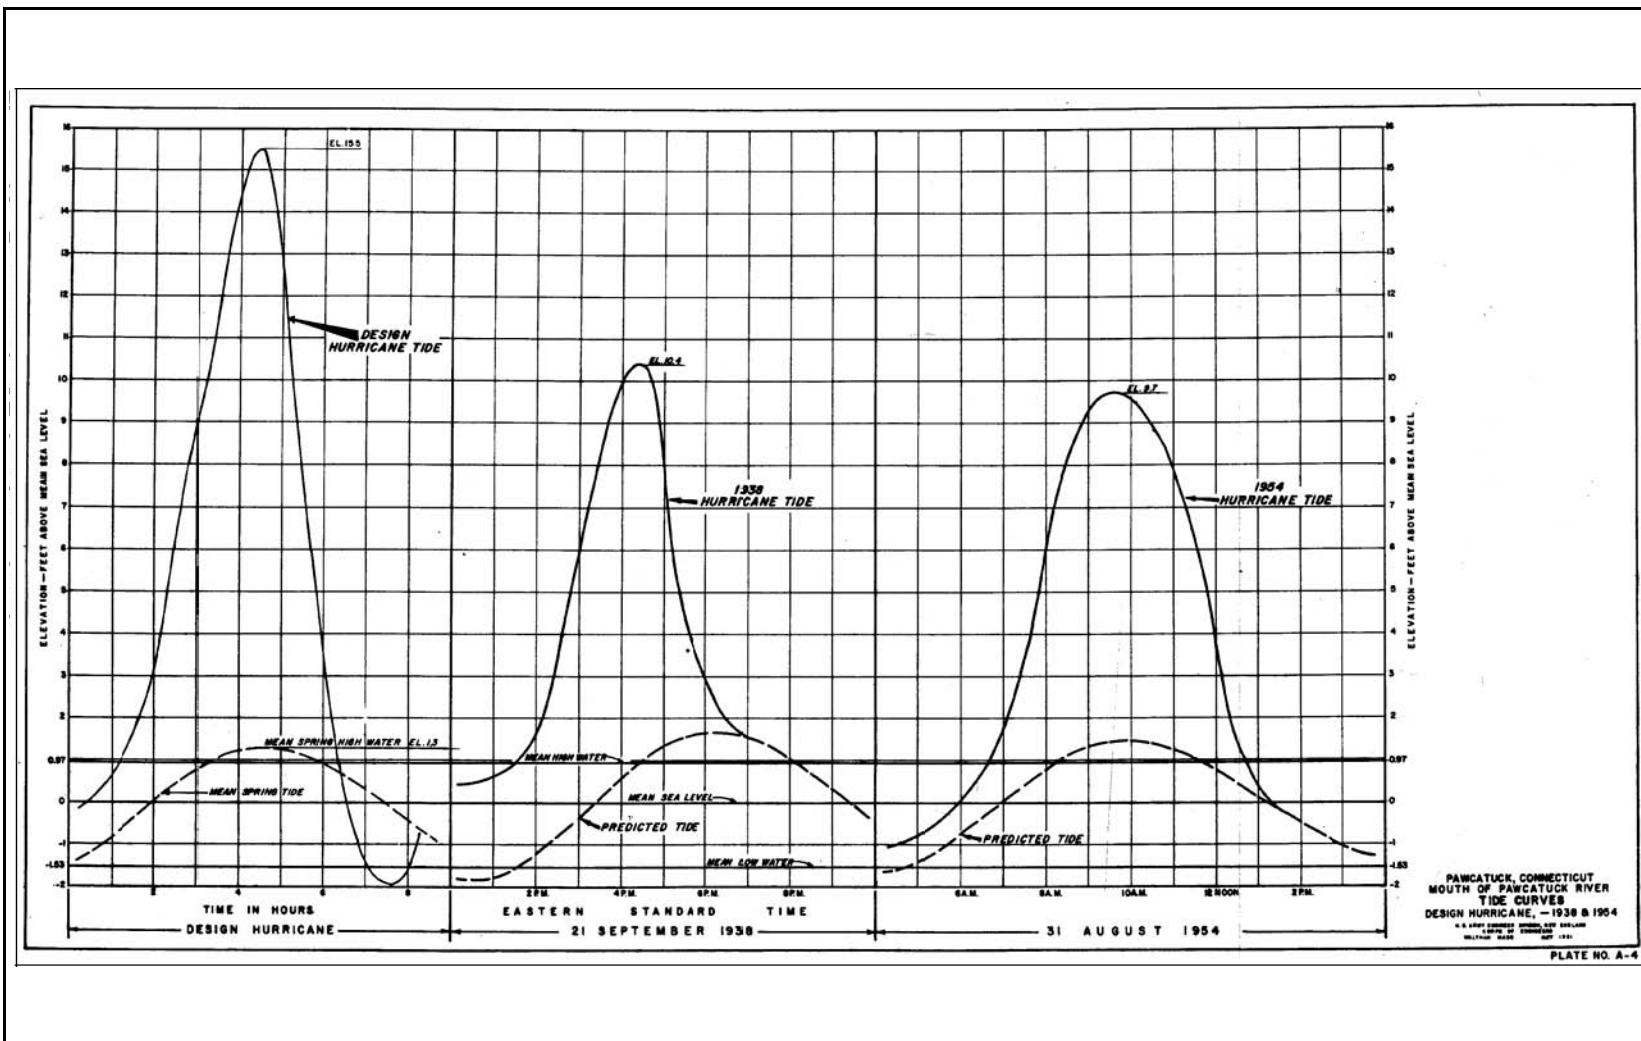
Figure 40. Pawcatuck, CT, hurricane levels.

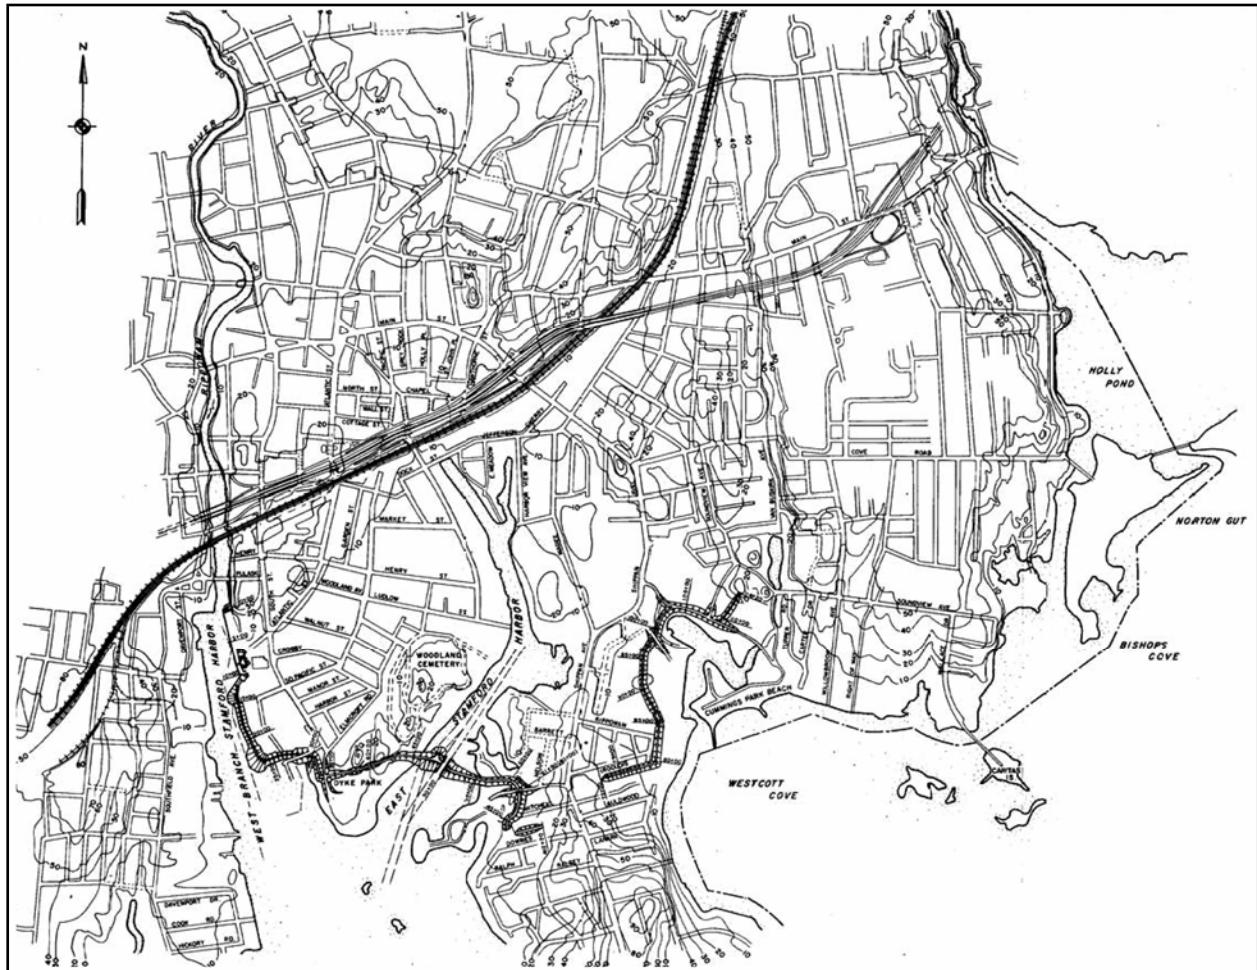
Figure 41. Stamford, CT, hurricane project elements.

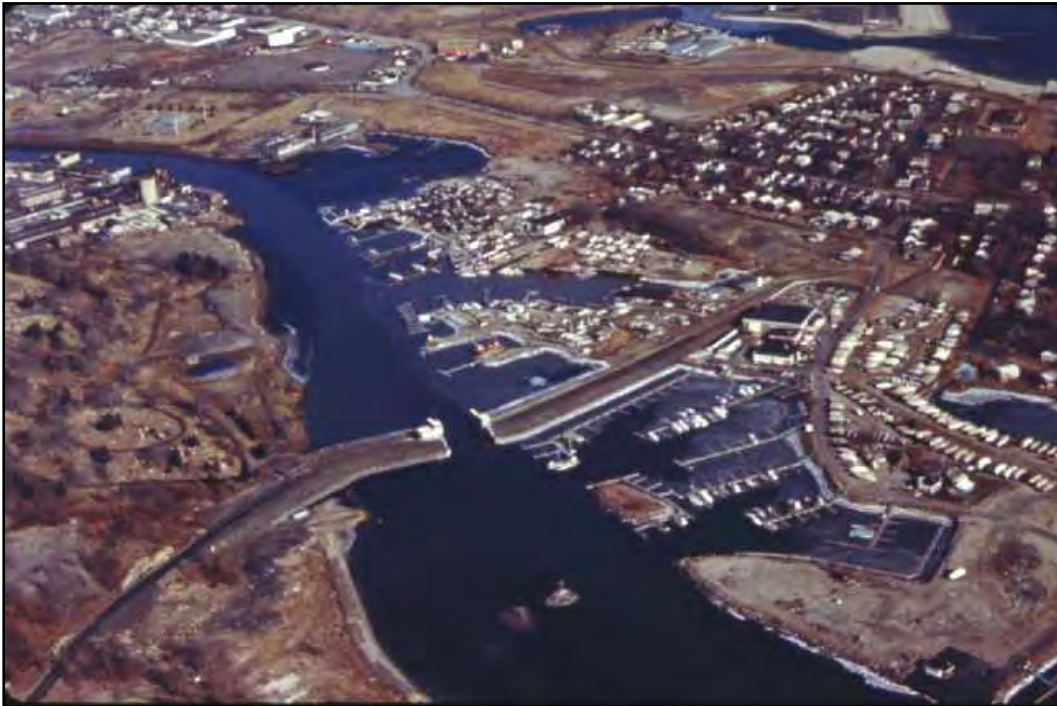
Figure 42. Aerial photograph of Stamford hurricane barrier (photograph courtesy of New England District).

Figures 41, 42, and 43 show project elements. The following description is from the New England District web page:¹

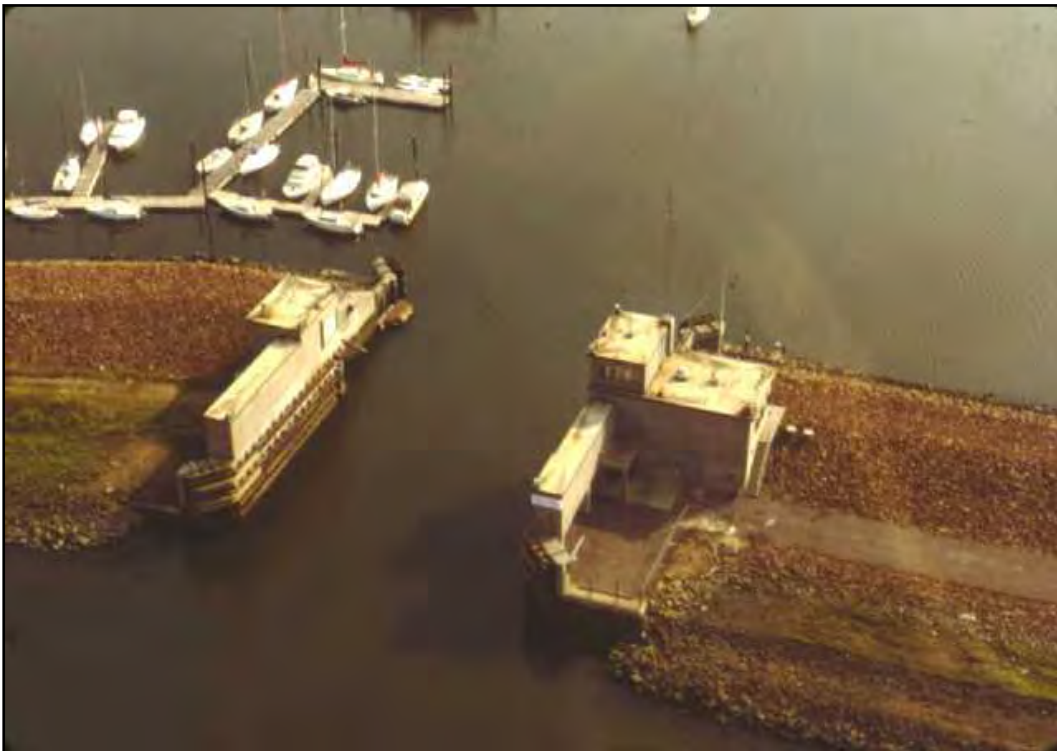
Figure 43. Stamford hurricane barrier (photograph courtesy of New England District).

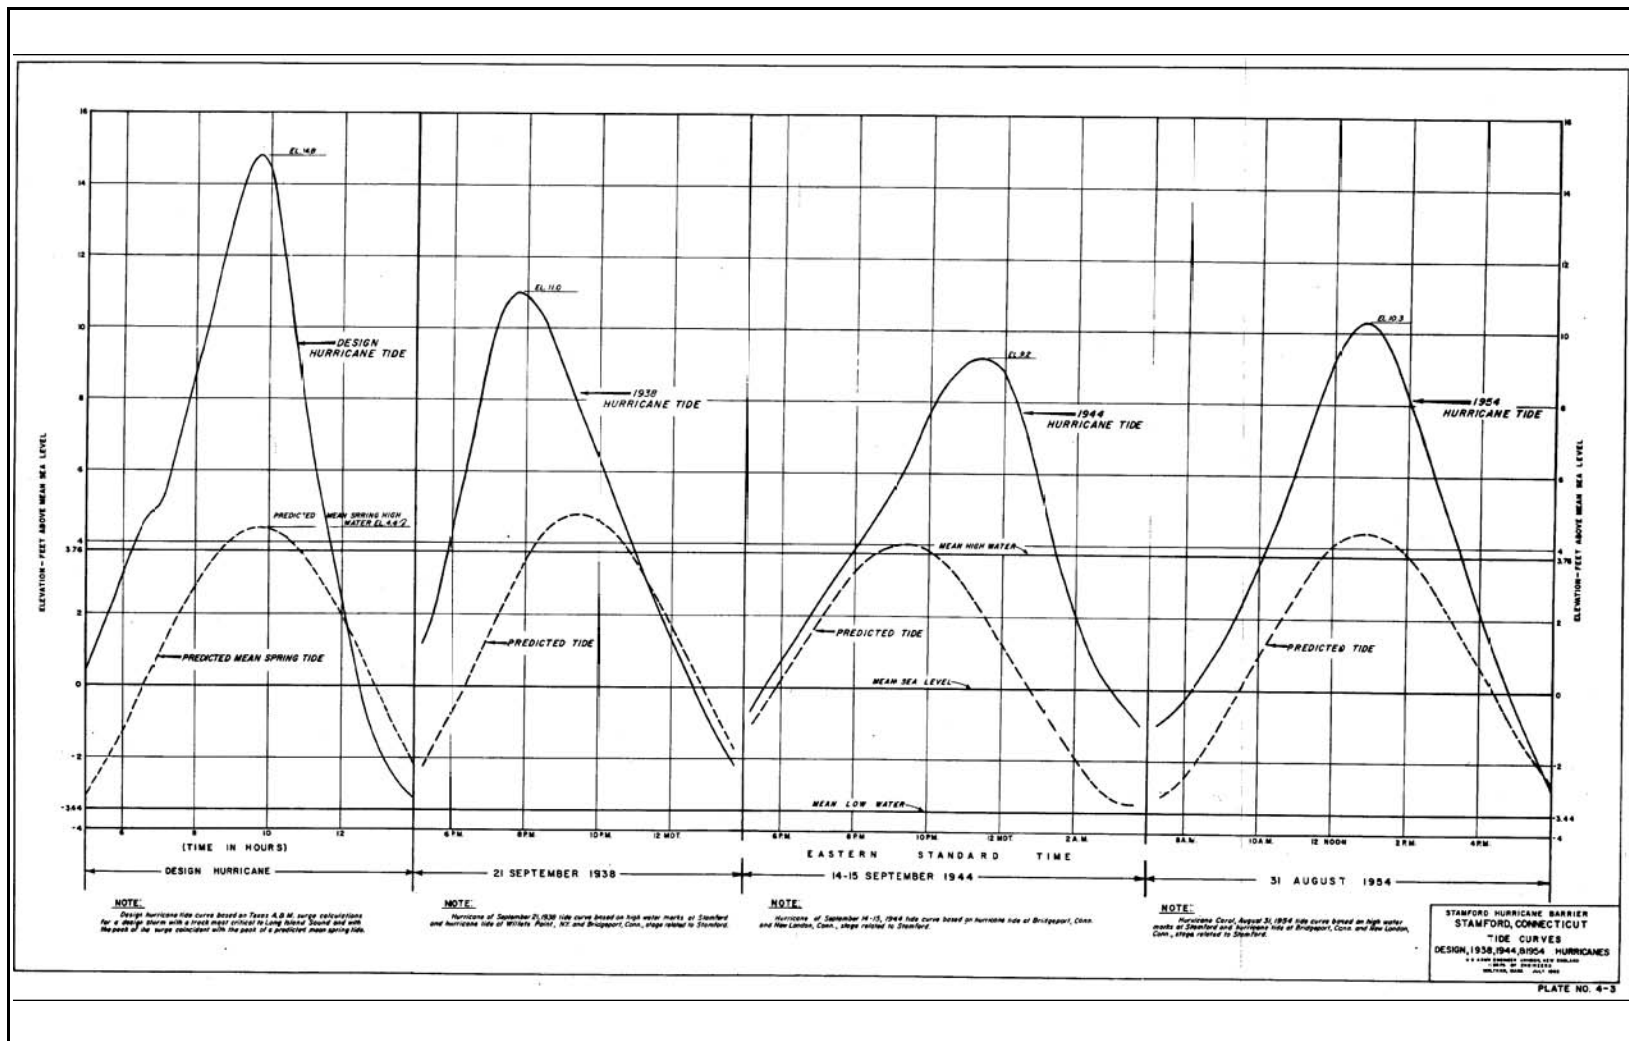
Figure 44. Stamford, CT, hurricane water levels.

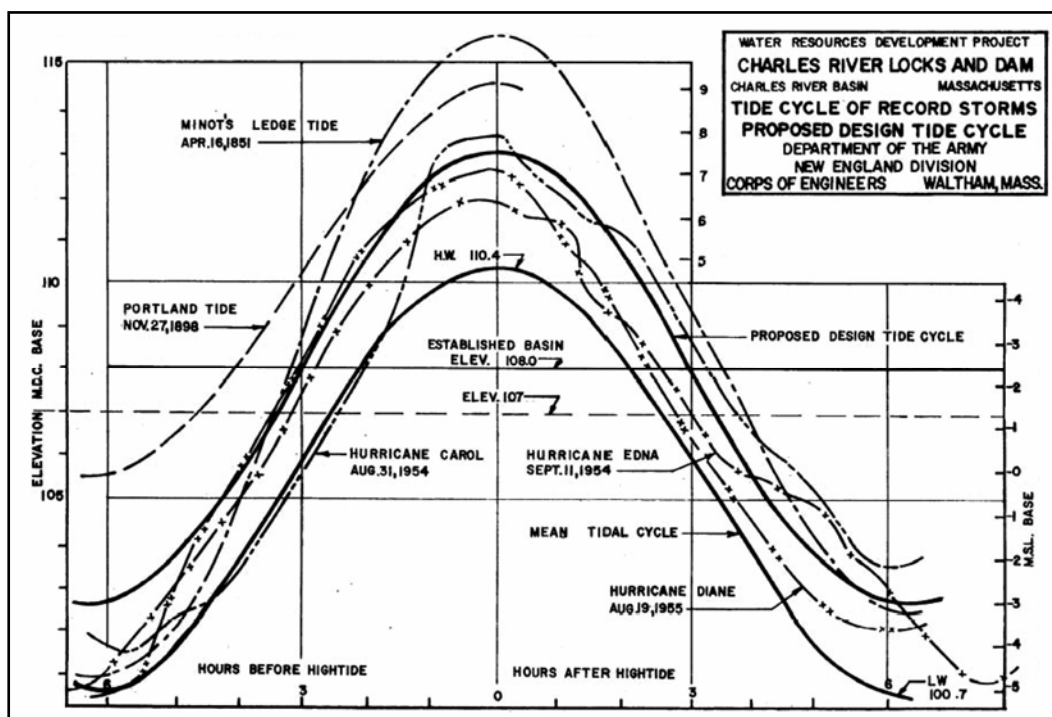
Figure 46. Charles River dam tide cycle of historical storms. Elevations on left axis are the Metropolitan District Commission local datum. This plot was drawn before Blizzard of 1978.

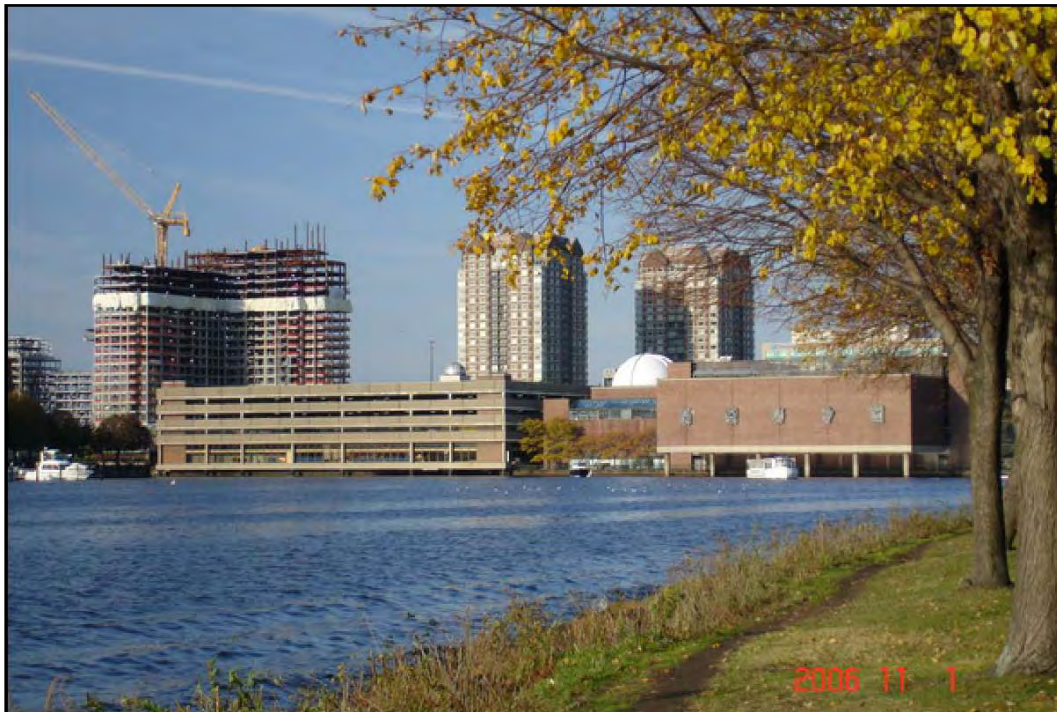
Figure 47. Original 1910 Charles River Dam, on which Boston Museum of Science was built. Charles River Basin is in foreground.

The Charles River Dam is a more multi-function project than the other hurricane barriers. Not only was it designed to protect against unusually high tide or surge in Boston Harbor but also to maintain a restricted range of water level in the Charles River Basin. The Basin between Boston and Cambridge was formerly an expanse of mudflats that were exposed twice daily and renowned for mosquitoes and nasty aromas in summer. The original 1910 dam converted the basin into an agreeable fresh-water body, along which fashionable homes, a landscaped esplanade, and institutions of higher learning were located (Whitehill 1968). Little of the original dam can be seen because a busy highway crosses it and the Museum of Science was built on the dam in 1950 (Figure 47).

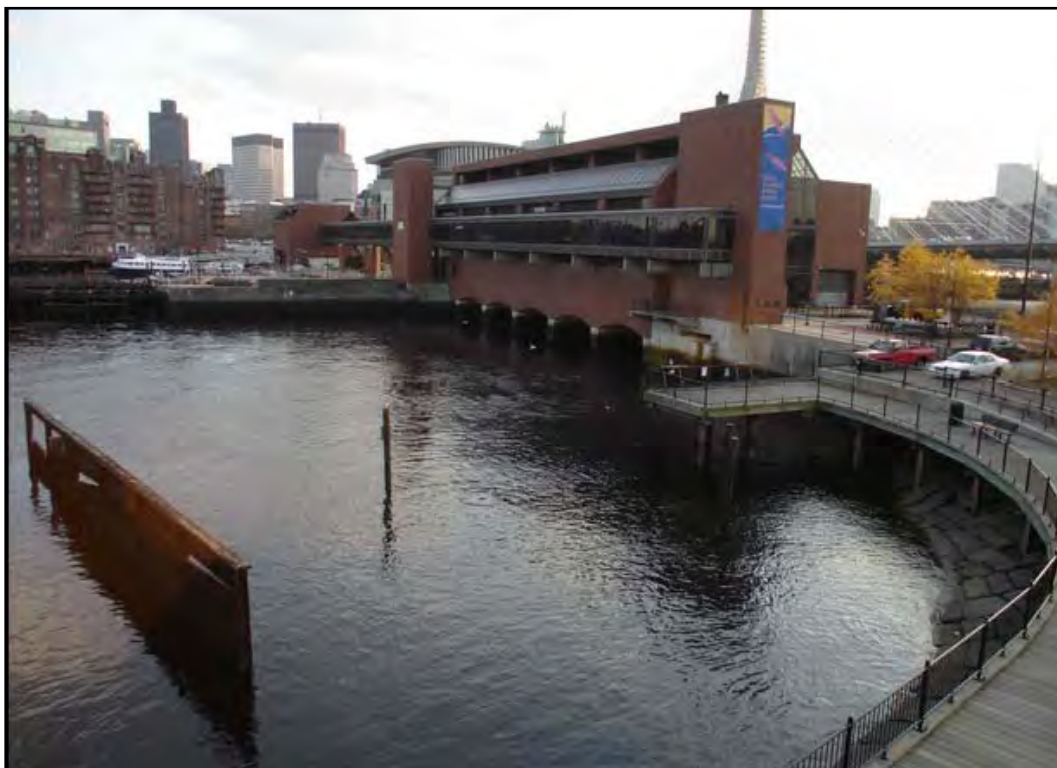
Figure 48. Charles River Dam from Charleston Bridge (Route 99), view looking south, 1 November 2006. Brick structure contains pumps. Water in foreground is tidal.

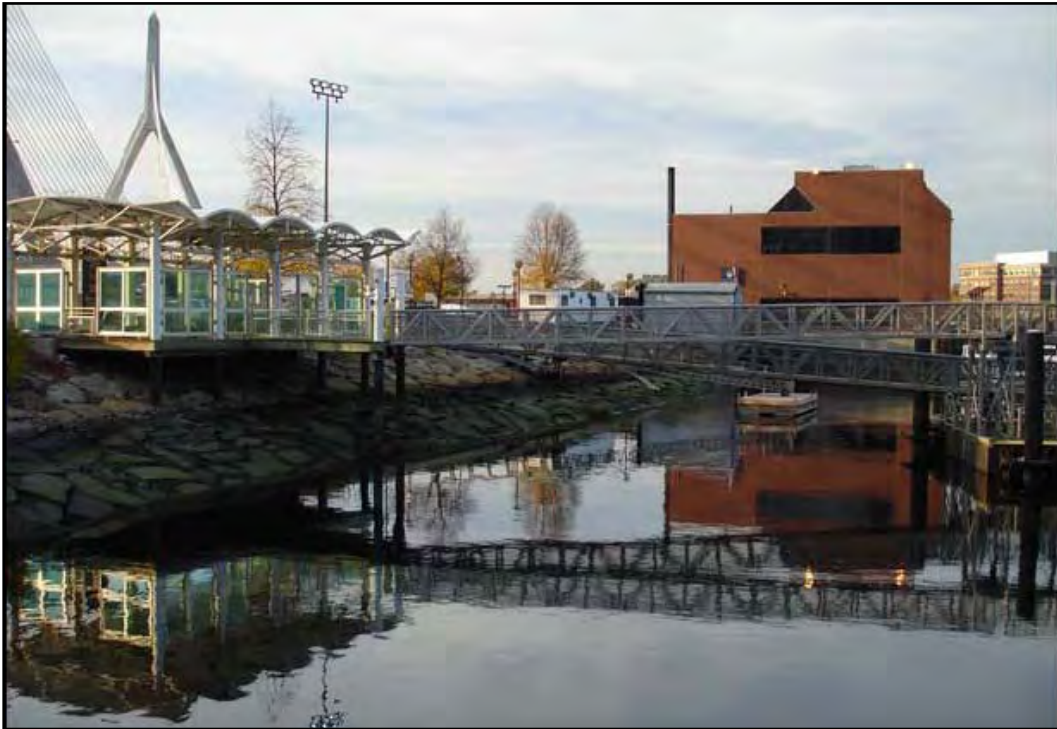
Figure 49. Charles River Dam harbor side, view from Boston shore looking NW, 1 November 2006.

The new dam was completed in 1978 about 0.6 mile east or downstream of the older one, at the site of the former Warren Avenue Bridge. The project consists of a rock-faced dam, locks, and a pumphouse (Figures 48-51). The pumps are diesel-powered and independent of the municipal power grid (Figure 52).

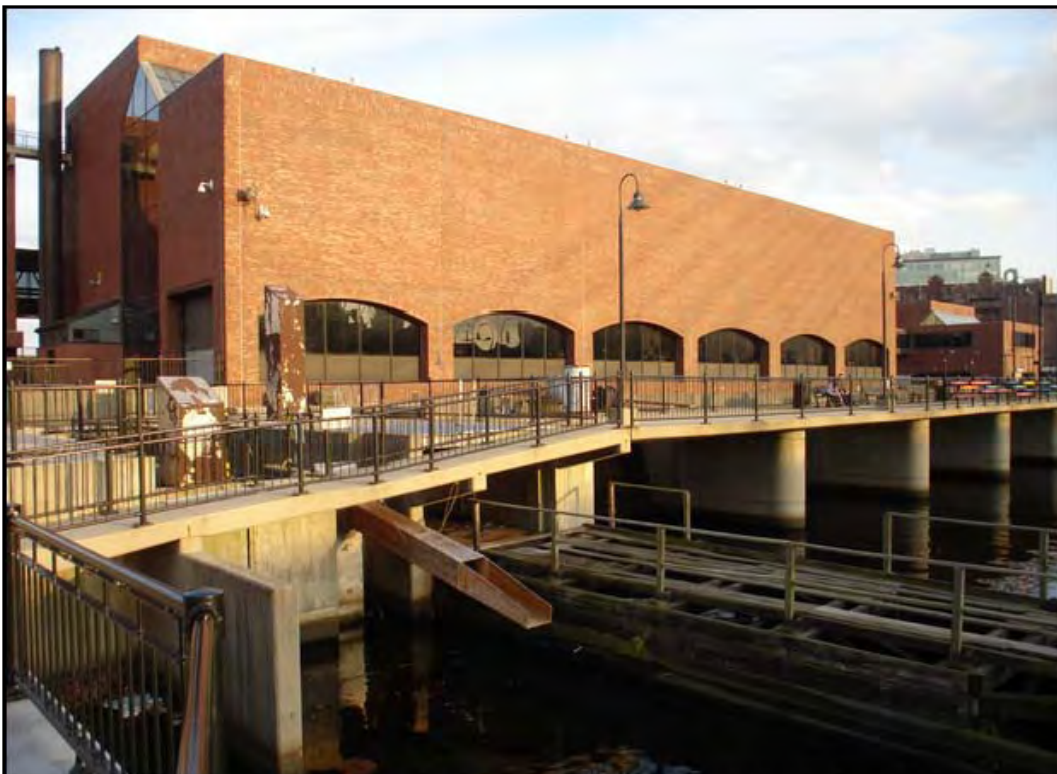
Figure 50. West side of Charles River Dam pump house, 1 November 2006.
