Hurricane Barriers in New England and New Jersey — History and Status After Four Decades

Andrew Morang

September 2007

Final report

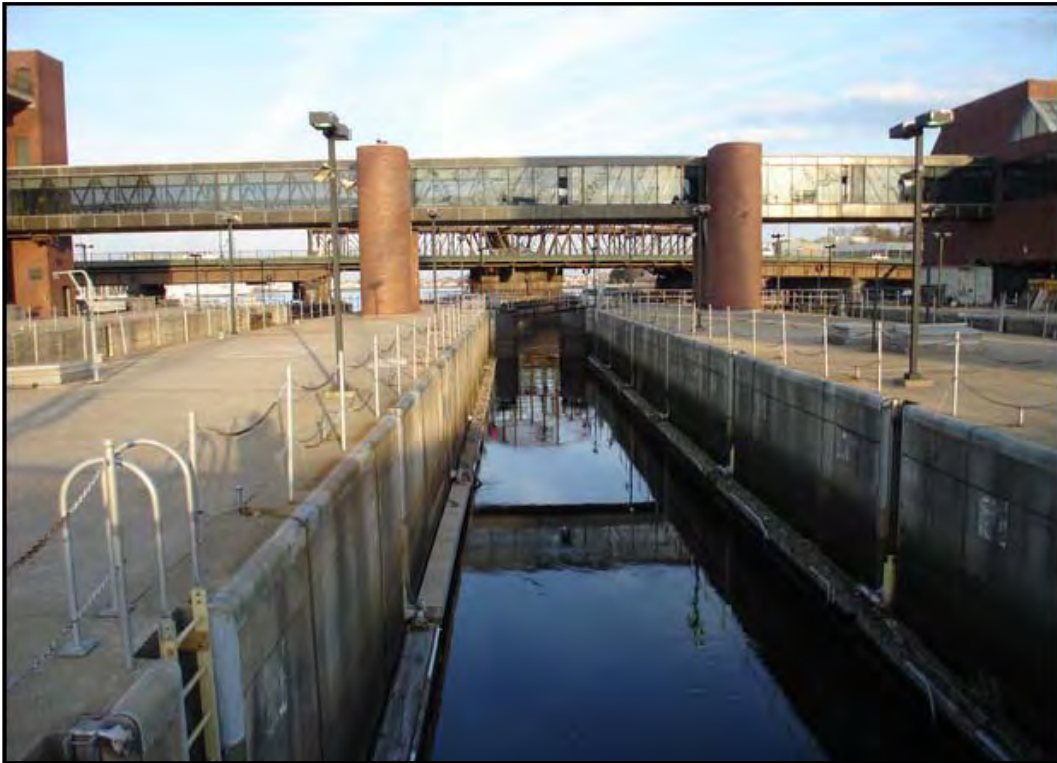
Figure 51. Navigation lock, Charles River Dam, view looking east towards Boston Harbor, 1 November 2006.

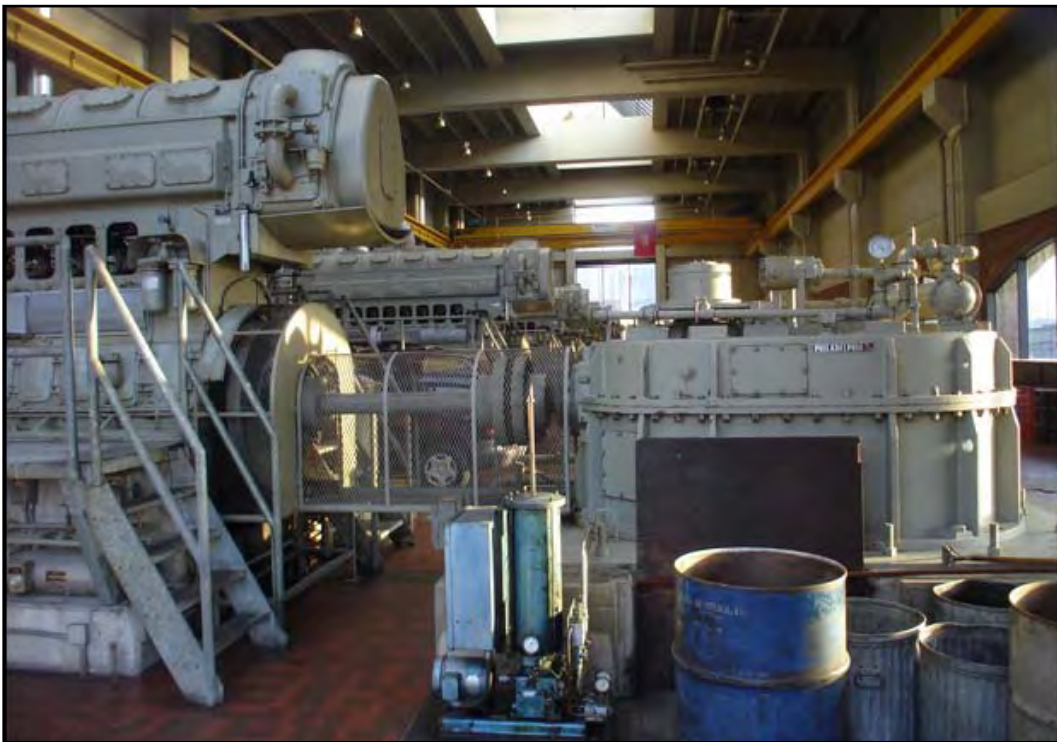
Figure 52. Diesel engines and pumps in Charles River Dam, 1 November 2006.

The new dam was completed in 1978 about 0.6 mile east or downstream of the older one, at the site of the former Warren Avenue Bridge. The project consists of a rock-faced dam, locks, and a pumphouse (Figures 48-51). The pumps are diesel-powered and independent of the municipal power grid (Figure 52).

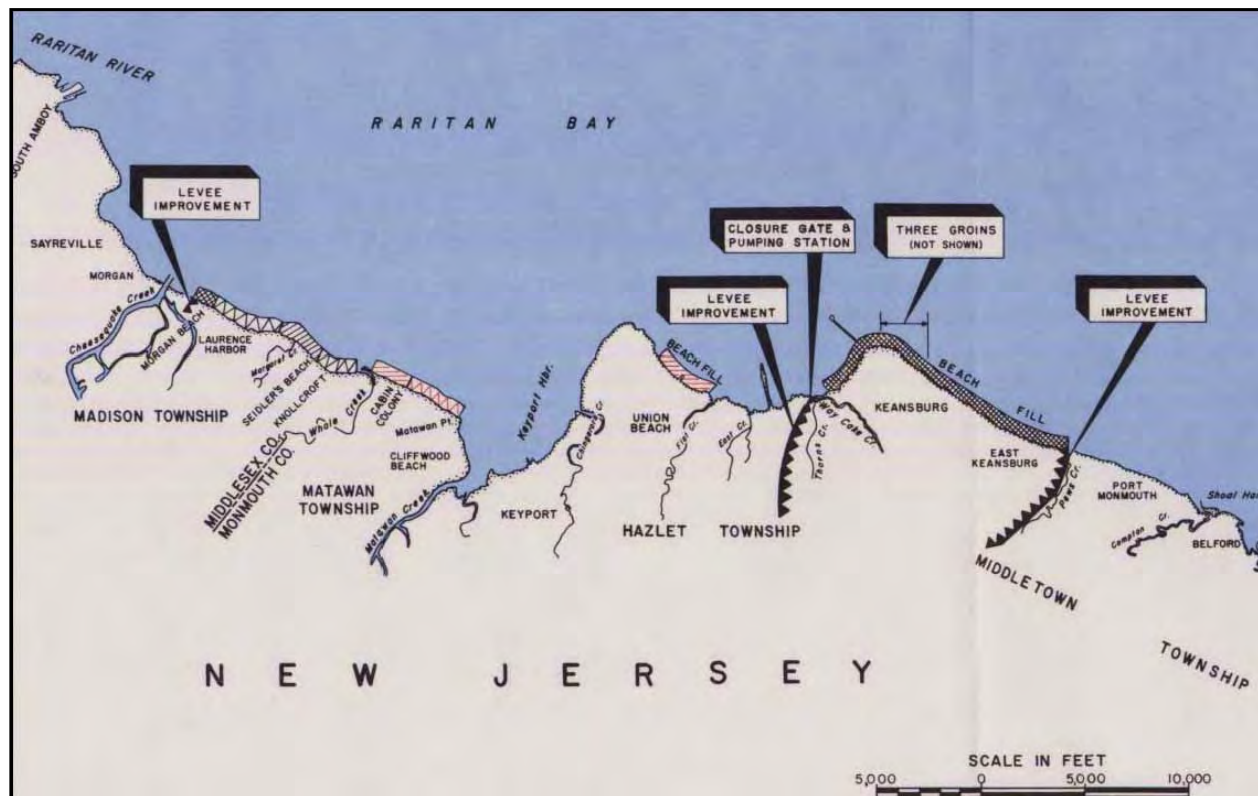
Figure 53. Raritan Bay project elements (from USACE digital project notebook). Sawtooth pattern represents levees. Fill and Levees in Matawan Township and fill in Union Beach (in red) were never built. North is to top.

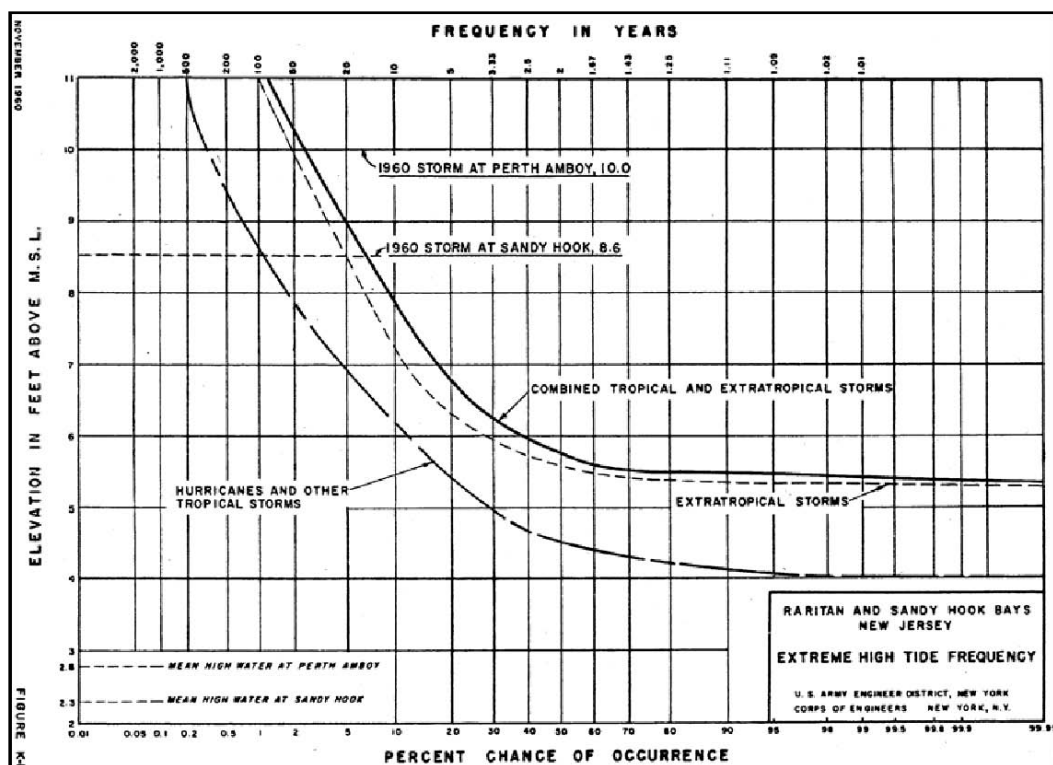
Figure 54. Storm frequency curve for Raritan Bay (from interim hurricane study, New York District 1960). Design elevation of surge added to high tide was +12.9 ft MSL.

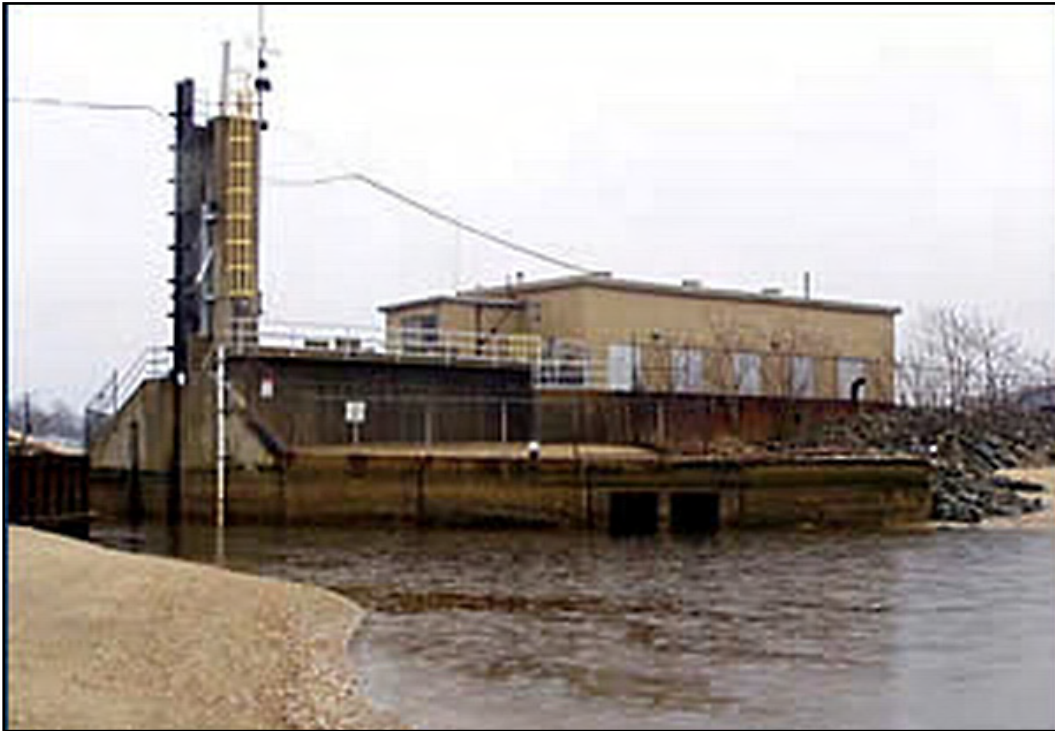
Figure 55. Bayshore floodgate and pump station, at junction of Waackaach and Thorns Creeks. From New Jersey Department of Environmental Protection (<http://www.state.nj.us/dep/shoreprotection/bayshore.htm>, 8 January 2007).

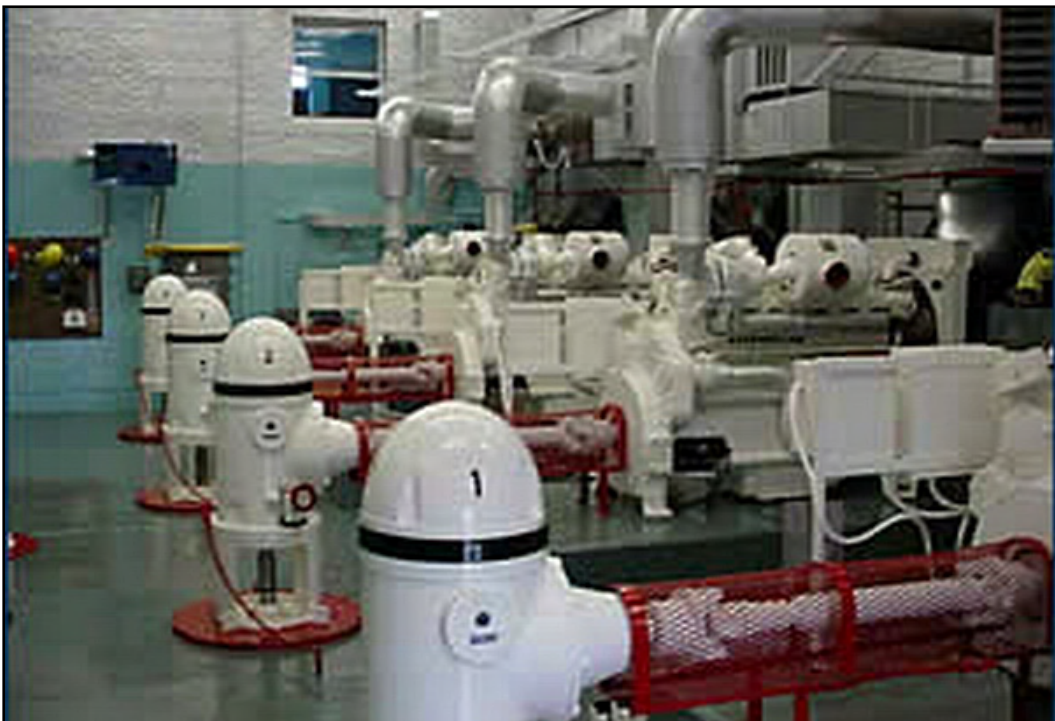
Figure 56. Pump house at Bayshore Floodgate Facility. From NJ Dep (<http://www.state.nj.us/dep/shoreprotection/bayshore.htm>, 8 January 2007).
