ECBC-TR-526

EVALUATION OF THE STERIS SENSITIVE EQUIPMENT DECONTAMINATION (SED) APPARATUS ON A 463L PALLET

September 2007

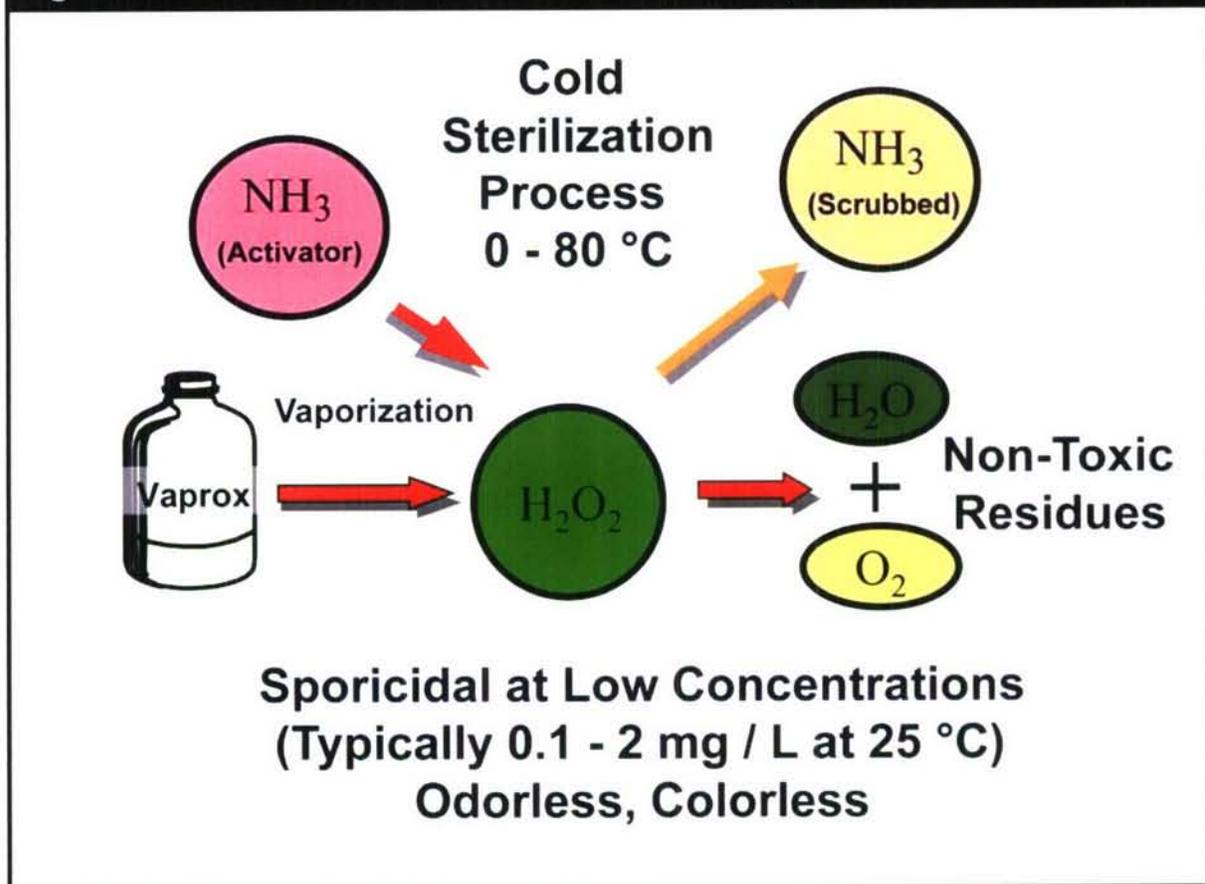
Figure 1.2.1: mVHP[®] Decontamination Chemistry

mVHP is a broad spectrum decontaminant composed of vaporous hydrogen peroxide and a small amount of ammonia gas used within a specified set of conditions. The mVHP decontamination process evaluated is the combination of the patented mVHP decontaminant and decontamination operating conditions.^{12,13}

The mVHP decontamination process has been shown effective at atmospheric pressure and at ambient temperatures. The process is completely vapor phase hydrogen peroxide and ammonia. Hydrogen peroxide vapor readily forms hydroxyl free radicals that have been found to react with various micromolecules. VHP rapidly decomposes into two environmentally benign products: oxygen and water vapor (Figure 1.2.1). Metal oxide catalysts are used for large-scale, one-through processes requiring more rapid decomposition on the exhaust stream. The current processes uses up to 30 ppm of ammonia which is below the Permissible Exposure Limit (PEL) of 50 ppm. Unreacted ammonia is scrubbed out of the exhaust air through an appropriate filter. The large systems monitor the exhaust for both ammonia and hydrogen peroxide to ensure no fumigant post the filter bed.

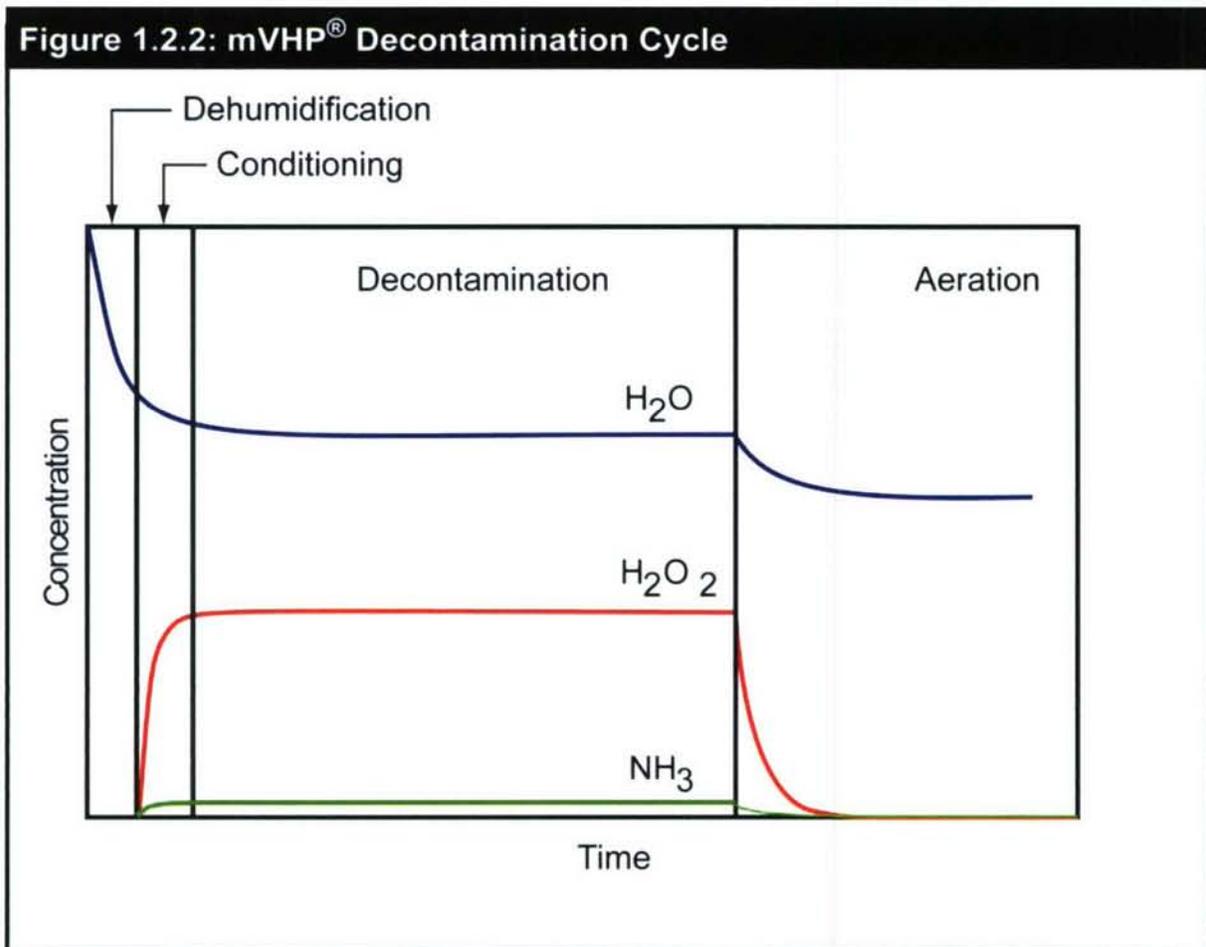
Decontamination of an interior/enclosed space using the modular mVHP system is a four-phase process involving preparation of the interior air (dehumidification), achieving a steady state decontaminant level (conditioning), performing the decontamination, and then aerating the space for safe entry (Figure 1.2.2).

Dehumidification

Hydrogen peroxide vapor can co-condense with water vapor producing an undesired condensate high in hydrogen peroxide. If ambient conditions are likely to permit condensation – high humidity and/or cold temperatures – this can be prevented by circulating dry, heated air through the interior prior to injection of the hydrogen peroxide vapor. The target humidity level is determined by the concentration of vapor to be injected and the desired steady state

During the conditioning phase, injection of ammonia and hydrogen peroxide vapor is initiated. Injection rates are selected to rapidly raise the concentrations to the desired set point without condensation. Internal sensors measure and report the ammonia and hydrogen peroxide concentrations to the control system. When the concentrations reach the set point values, the ammonia and hydrogen peroxide injection rates are lowered to maintain the set-point concentrations. Once all the interior monitors reach or exceed the set point concentration, the system proceeds to the next phase.

Decontamination is a timed-phase dependent on the hydrogen peroxide vapor concentration, ammonia vapor concentration and temperature. A decontamination timer counts down from the preset decontamination time. If the concentrations or temperature values fall below the set point, the timer stops. This ensures that during the decontamination phase, the interior space is exposed to at least the minimum decontamination conditions for the desired exposure time.

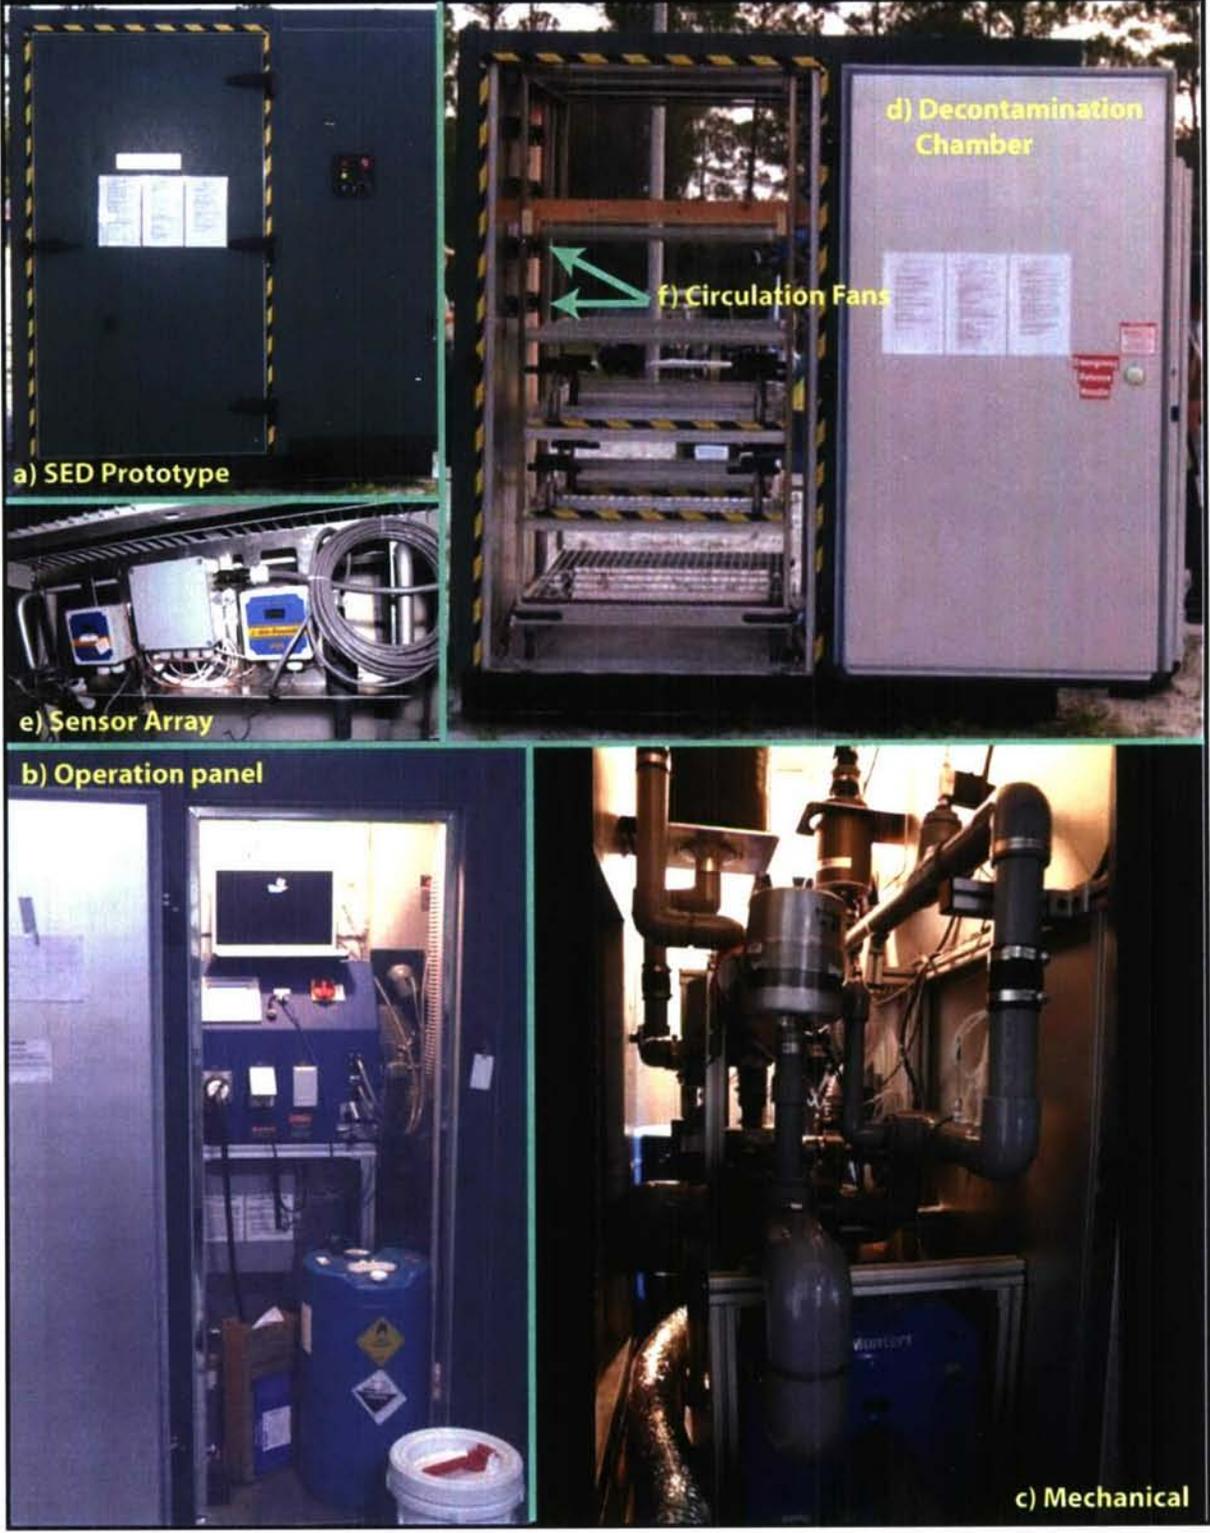
Figure 2.1: Steris Sensitive Equipment Decontamination Prototype

Steris provided the Sensitive Equipment Decontamination Prototype on the 463L Pallet for testing at ECBC (Figure 2.1a). The SED prototype measures 8-ft tall by 9-ft long by 7-ft 4-in. wide. The SED prototype is operated through a side entry door (Figure 2.1b). The dehumidifier, fumigant generator, hydrogen peroxide, ammonia, and exhaust filters are compactly built into the unit (Figure 2.1c). The prototype was configured to operate from land power for the testing. The Steris design for the field unit would also contain a generator in the mechanical area. The decontamination chamber is accessed through two side doors. The decontamination chamber measures 7-ft 6-in tall by 8-ft 4-in long by 4-ft wide. The SED prototype is designed to fit into a hot – cold line with separate access for the dirty and clean sides (Figure 2.1a,d). The SED prototype contains a stainless steel rack for the placement of items for decontamination. The rack is adjustable and can be configured to the type of the articles being treated. The SED prototype was received with a 5-shelf cart. The shelves were not adjusted during the loading spacing test. The biological coupon and test article tests were performed using a set of plastic shelving. The SED prototype was fitted with two ATI sensor arrays (Figure 2.1e). Each array contained a 0-2000 ppm hydrogen peroxide sensor, 0-100 ppm ammonia sensor, temperature sensor and relative humidity sensor. One sensor array was mounted on the decontamination chamber wall near the top above the inlet port. The second sensor array was mounted to the shelving unit to measure the conditions at the middle shelf where test articles and coupons were placed. Fumigant was distributed in the decontamination chamber by 16 small fans mounted to the decontamination chamber walls (Figure 2.1f).

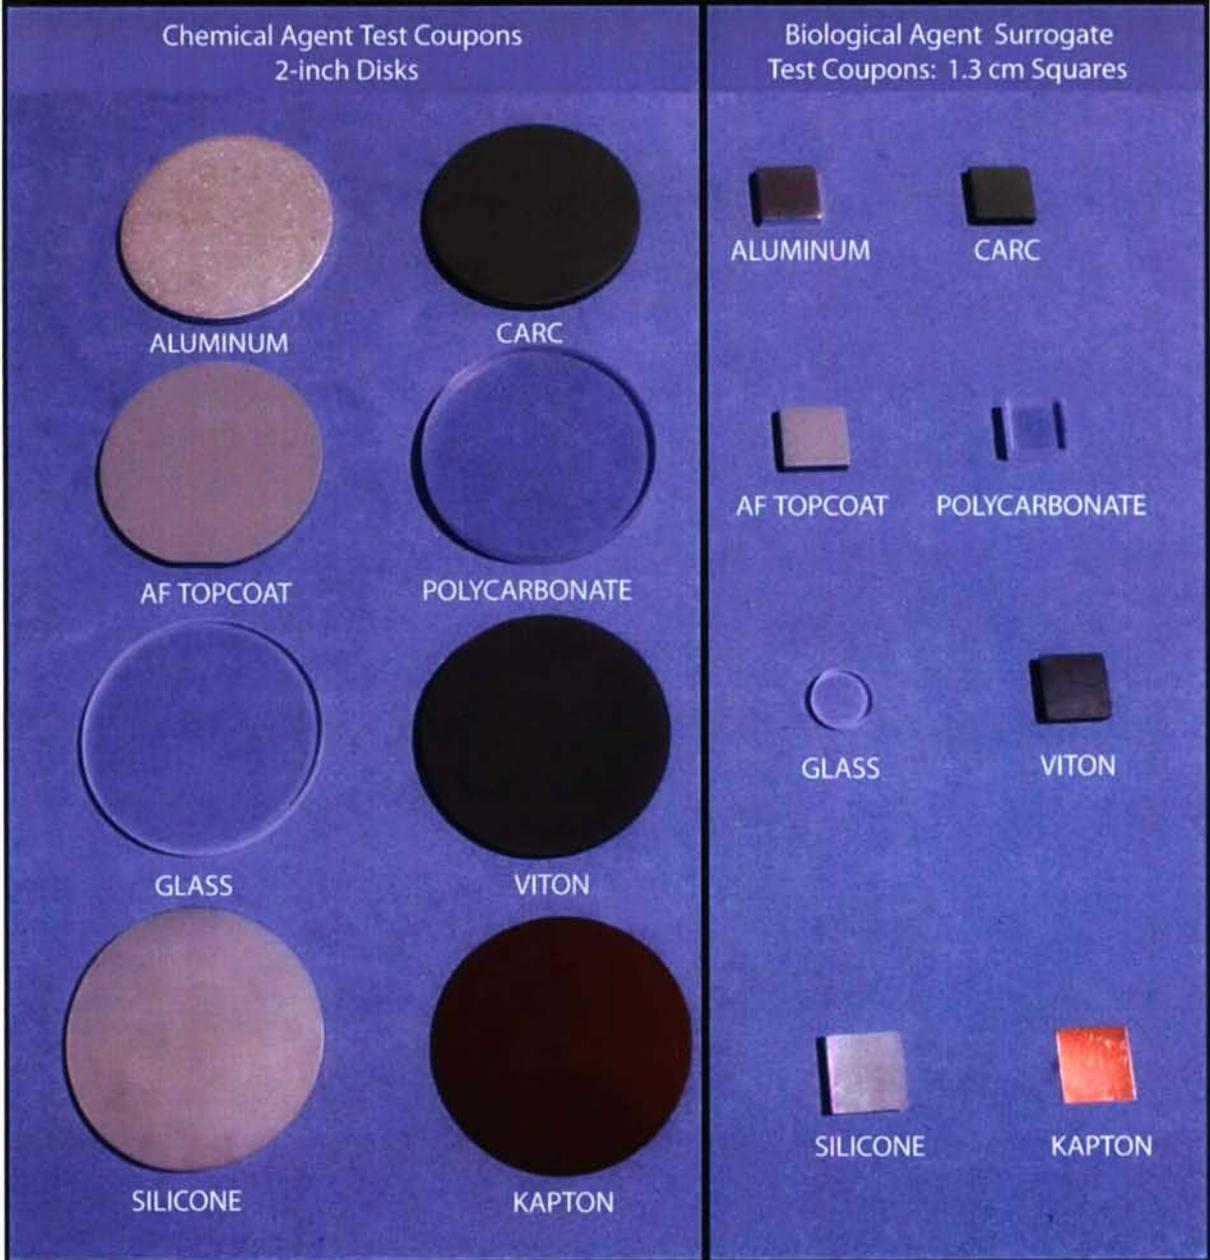
Figure 2.2: Chemical and Biological Test Coupons

The selected test materials span a variety of structural and functional materials common to aircraft, vehicles, protective- and sensitive-equipment that encompass a variety of material properties, compositions and porosities. The test materials include bare aluminum, CARC-painted aluminum, AF-topcoat-painted aluminum, glass, polycarbonate, Viton[®], Kapton[®] and silicone (Figure 2.2). The biological agent surrogate test coupons are 1.3 cm squares, except glass, which is round. The chemical agent test coupons are 2-inch circular disks with a surface area of 3.14 in² (20.27 cm²).⁸ The glass chemical agent test coupons were ordered pre-cut from McMaster-Carr. All other chemical and biological test coupons were cut from stock material. Uniformity is assured by obtaining a large enough quantity of material that multiple test samples can be prepared with uniform characteristics (e.g., test coupons will all be cut from the interior rather than the edge of a large piece of material). All coupons are stored in zip-tight bags in containers in order to prevent/limit contact with foreign substances until the coupons are needed for testing. The biological test coupons were sterilized prior to use. The coupon preparation information including material vendors and descriptions is provided in Appendix A.

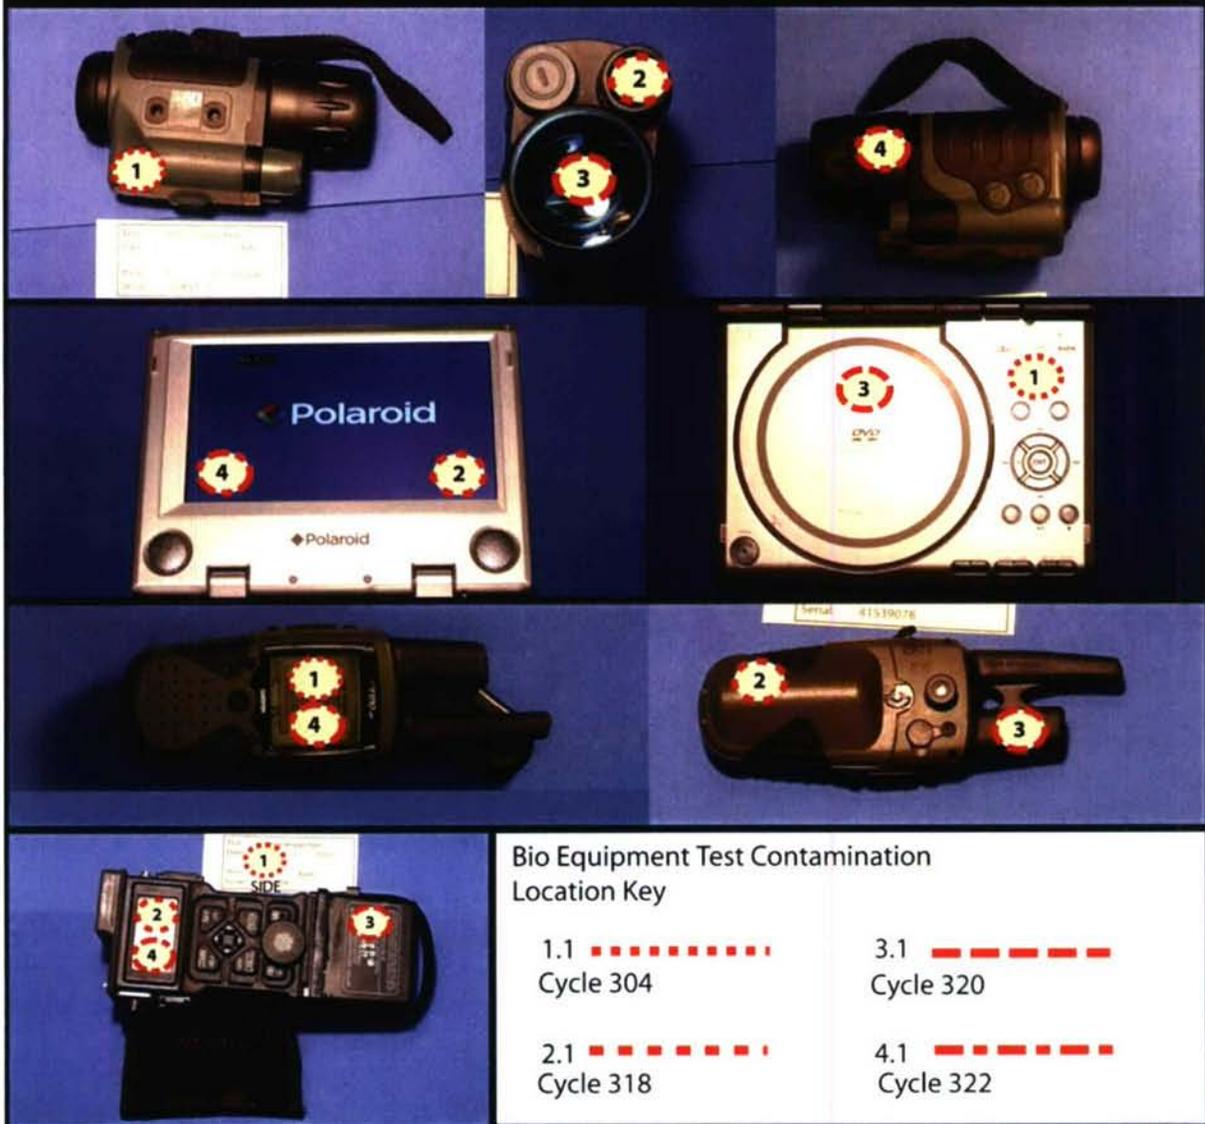
Figure 2.5: Biological Spore on Equipment Contamination Areas

Four locations were selected on each biological contamination test article for the placement of the spores. Different locations were used for each test for two primary reasons. First, using new locations would enable the evaluation of the different types of surfaces on pieces of equipment such as screen, buttons and plastic casing. Second, the use of new locations for each test would reduce potential for cross-contamination between tests. The test items contaminated with biological spores included DVD players, GPS units, night vision monocular units and radios. The contamination areas were shown in Figure 2.5.

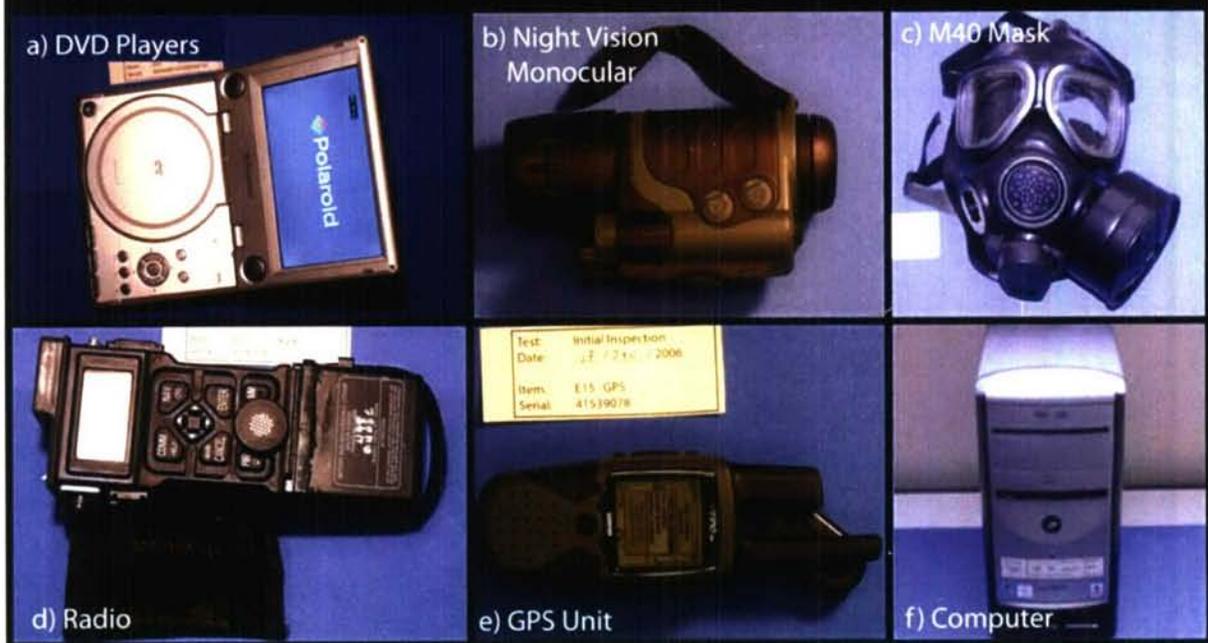
Figure 2.8: Representative Articles of Sensitive Equipment

The sensitive equipment exposure tests were conducted to determine the impact of repeated mVHP decontaminant exposures on visual appearance and, for some items, operational function. The test articles included six DVD players, four radios, four night vision monocular (NVM) units, five GPS units, one M40 mask and one desktop personal computer (PC). The six DVD players are Polaroid DVD Players, Model PDM-0711. The four radios are A/N-PRQ-7 Radio Sets. The four Night Vision Monoculars tested were Yukon CE Model NV-MT2 24022, 3 x 42-power, made in Russia. The five GPS units provided for testing were all Garmin Rino 120 models. The PC used in this test had been previously been exposed to the fumigant mixture during testing on the fumigation of the interior of a C-141 Starlifter aircraft at Davis-Monthan AFB, Arizona. One production test model of a CB Protective Respirator, M40 series, with C2 Filter Canister were provided. A representative photograph of the each group of items studied is provided in Figure 2.8. The detailed photograph inspections are provided in Appendix C.

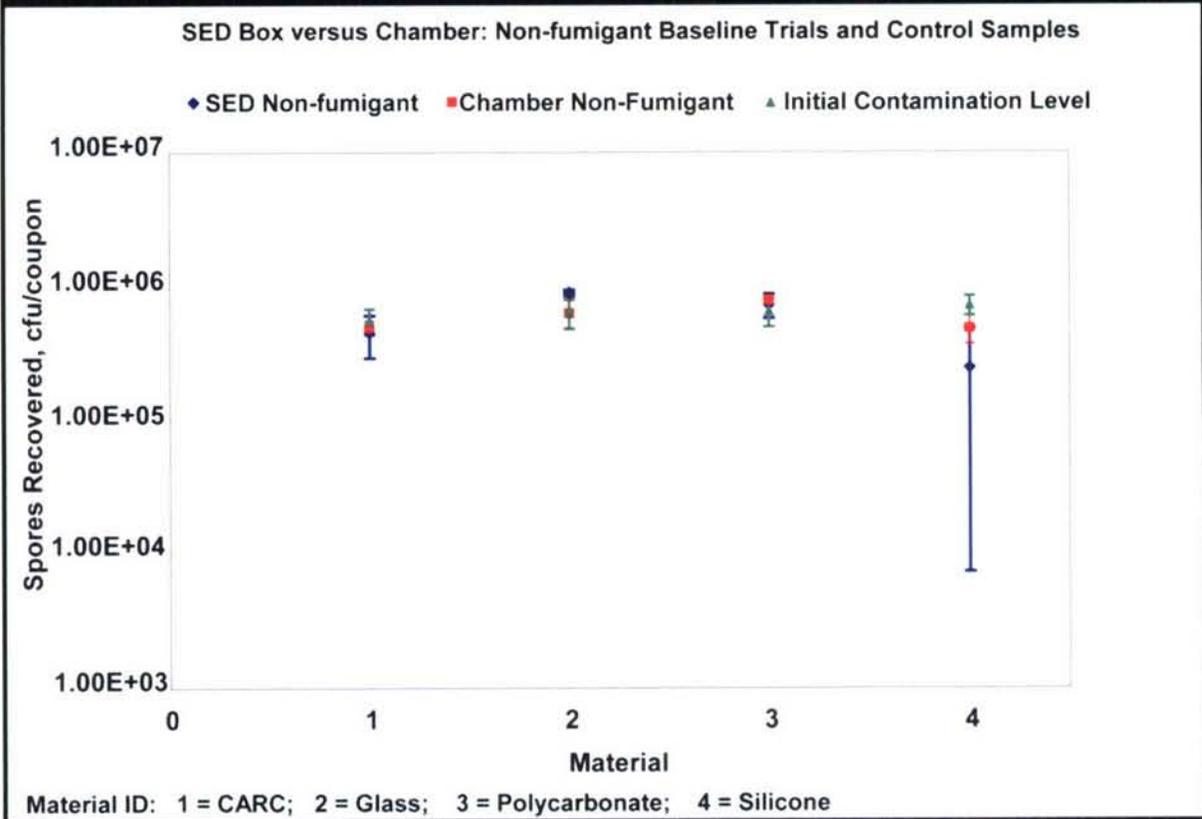
Figure 3.2.2: Reproducible Recoveries from Coupon Materials

Student’s t-test was calculated using the data from similar coupons in the two chambers to determine if there were statistically significant differences between the performances of the two chambers. For all four coupon materials, the Student’s t-test values calculated using the two-tailed, heteroscedastic values with four degrees of freedom are unable to reject the hypothesis that the two data sets are statistically identical at the $p=0.1$ significance level. Therefore, from the data available, we cannot say that the data sets are statistically different.

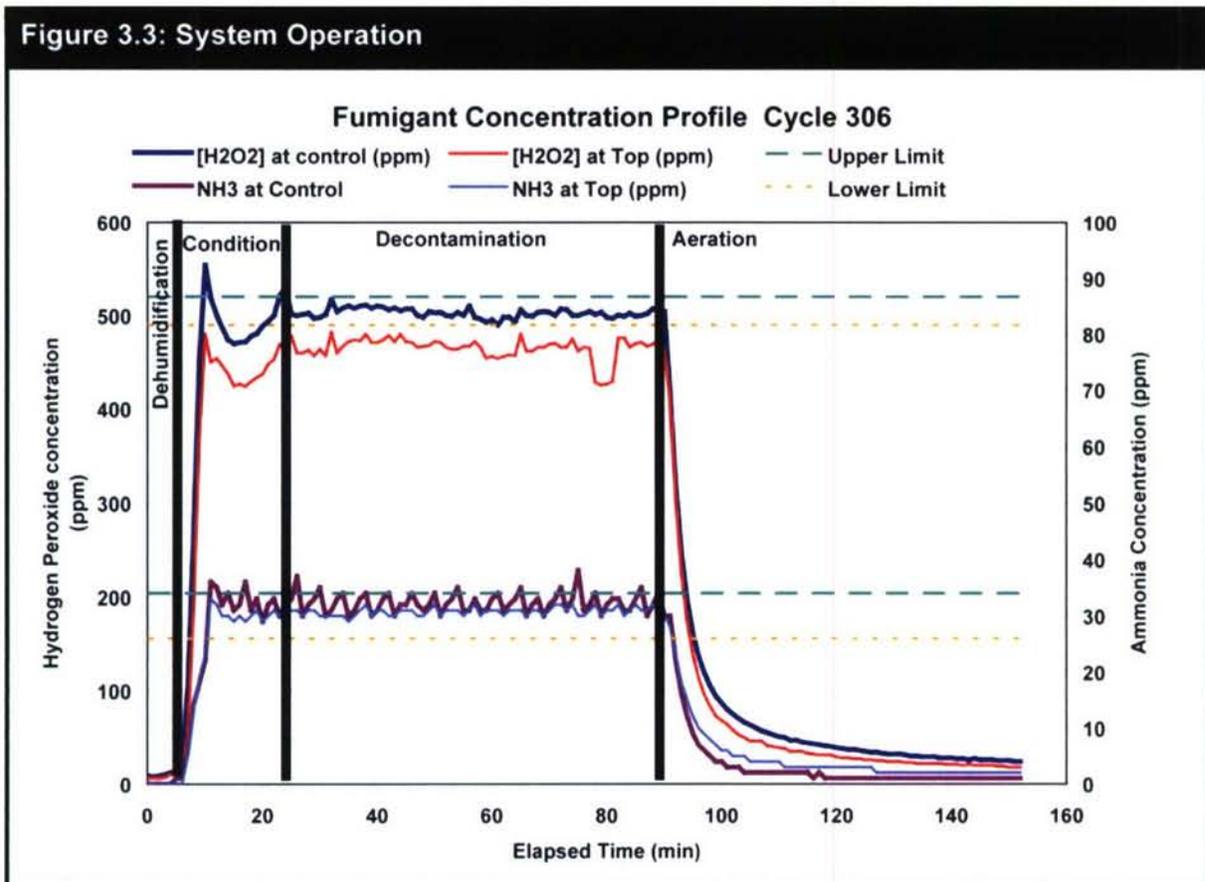
Figure 3.3: System Operation

The SED prototype operation is straight forward. The unit has a computer driven user interface for entering the target fumigant concentrations and phase durations. Once initiated, the prototype conducts the four-phase process from start to finish. The system tracks the actual time to complete each step. For example, if the user would enter 1-minute for the dehumidification process, the system ensures that the target relative humidity is achieved by dehumidifying to the required level before advancing to the next phase. The system can also be programmed with all test information such that only one button needs to be pressed to start the cycle. The time for each phase and total cycle time for these tests is discussed in Section 3.13. An example of a SED decontamination cycle showing the four phases is provided in Figure 3.4. The control charts for each run showing fumigant concentration, temperature, humidity, sample loading and removal are provided in Appendix C.

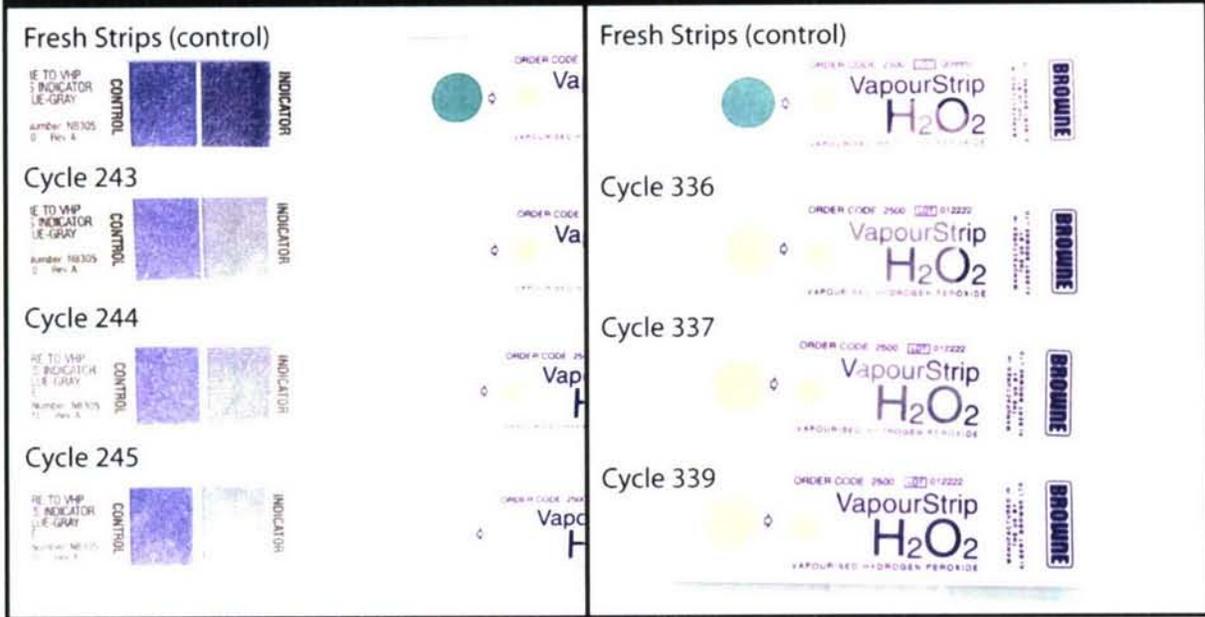
Figure 3.5.2: Loading Test Chemical Indicator Strip Result Samples

The Browne and Steris chemical indicator strips are both sensitive to hydrogen peroxide; however, the strips differ in observed color and response time when used in the SED box and Lexan replica. The Browne chemical indicator strips turn from green to pink. The Browne strips were determined to be appropriate strips for runs shorter than four hours at 500-ppm hydrogen peroxide. The Steris chemical indicator strips change from blue to beige. The Steris strip color change to beige was not change was not observed in runs shorter than four hours at 500-ppm hydrogen peroxide vapor. The Steris strip color change to beige-yellow was observed at closer to eight hours at 500-ppm hydrogen peroxide vapor. Both indicator brands were used during early studies. The final tests utilized the Browne indicator strips. Representative chemical indicator strips from each run are shown in Figure 3.5.2.

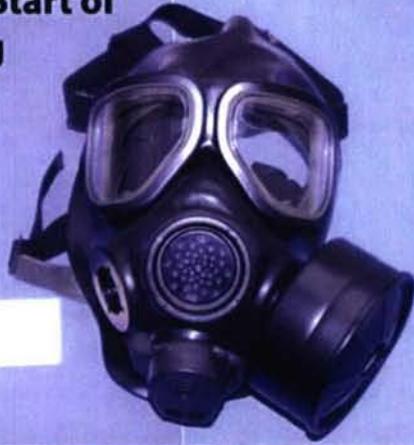
a) Mask, Start of Testing

M40 Military Mask: Prior to testing, the M40 mask underwent a comprehensive physical inspection. The article was initially photographed to determine prior damage. The mask was inspected according to IOP DS05005, *Visual Inspection and Operation Evaluation of Test Articles: M40 mask units*. Inspectors performed an initial physical inspection noting any wear, rough spots, discoloration, cracking, or other damages on the M40 rubber. Mask webbing was examined to determine any loss in elasticity or cracking. Any damages to the M40 eyepieces, including peeling and scratches, were noted. Careful note was taken as to any damage to the metal voice plate, the metal canister, and the drink tube. Lastly, inspectors ensured that the canister filter could be easily unscrewed. Any observed damages were recorded on the M40 mVHP Sensitive Equipment Evaluation data test form. Observed damages were also documented with photographs. This thorough examination was repeated following each mVHP cycle to which the article was subjected. Following the final inspection, the article was photographed showing any changes. A summary of the initial and final inspections is provided in Sections 3.11.2 and 3.11.4, respectively. The initial and final pictures for each test article are provided in Appendix B.

Figure 3.6.4.1: M40 Mask mVHP Exposure History - Visual Inspection

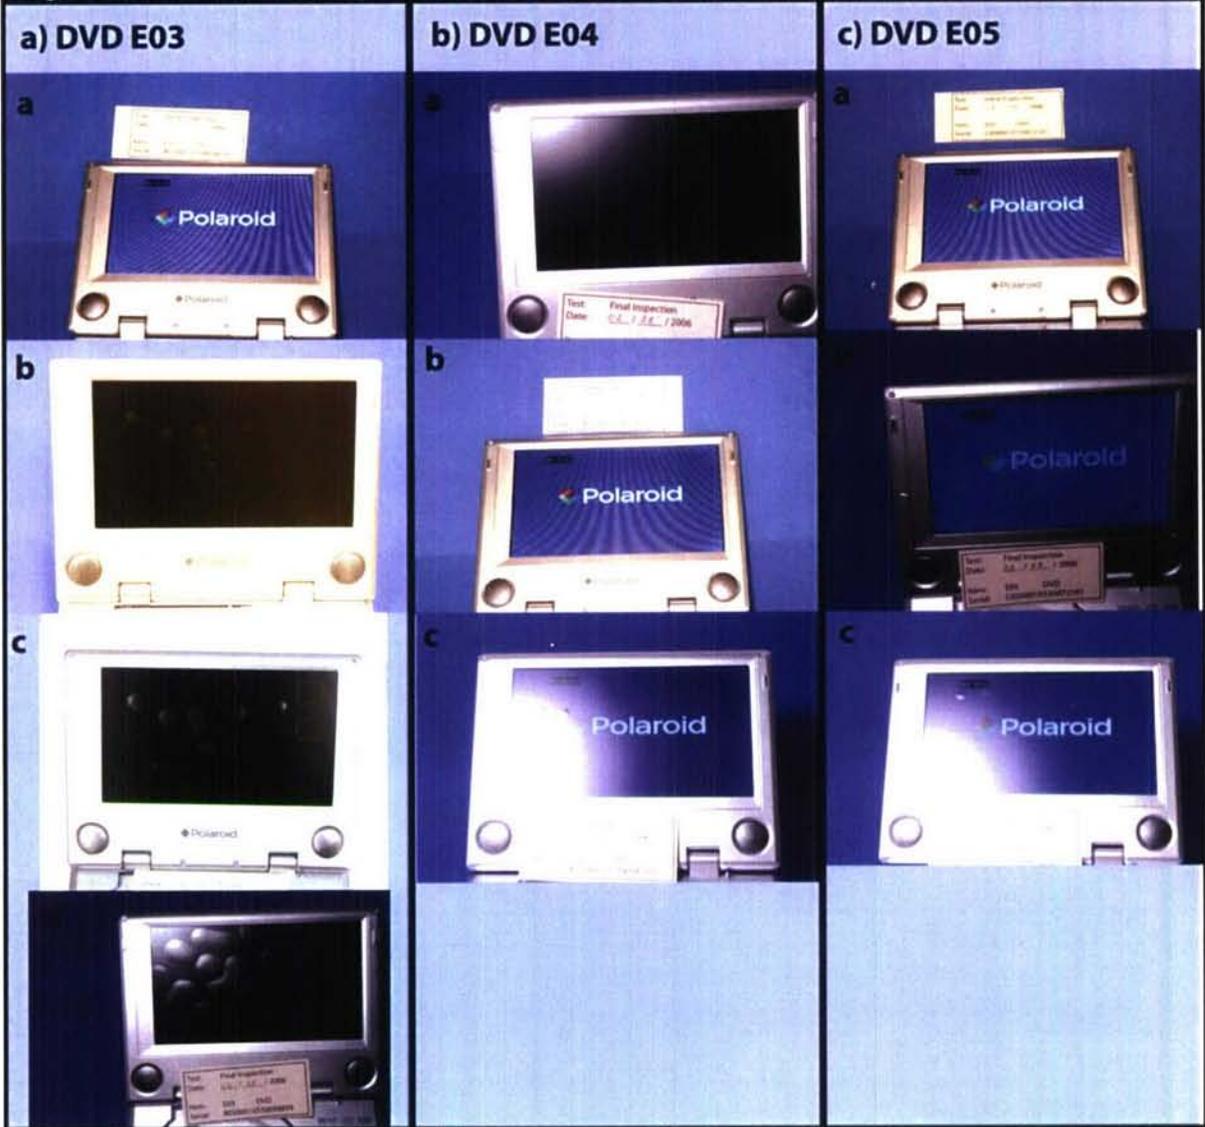
Figure 3.6.4.2.1: DVD Player mVHP Exposure History - Visual Inspection

DVD Players: Prior to testing, each DVD article underwent comprehensive physical and operational inspections. Each article was initially photographed to determine prior damage and functionality. Following IOP DS05003, *Visual Inspection and Operation Evaluation of Test Articles: DVD players*, inspectors performed an initial physical inspection consisting of noting any wear, rough spots, discoloration, cracking, or other damages on the DVD case. Any damages to the DVD screen, including peeling, were noted. Inspectors noted damages to the battery connectors including possible corrosion. Lastly, inspectors ensured that all buttons remained resilient following depression. Following the physical inspection, inspectors performed operational tests including: ability to power up using AC or DC power, ability to load DVD, ability to advance scenes, and functionality of speakers and headphone jack. Any observed damages were recorded on the DVD mVHP Sensitive Equipment Evaluation data test form. Observed damages were also documented with photographs. This thorough examination was repeated following each mVHP cycle to which the article was subjected. Following the final inspection, each article was photographed showing any changes. A summary of the initial and final inspections is provided in Sections 3.11.2 and 3.11.4, respectively. The initial and final pictures for each test article are provided in Appendix B.

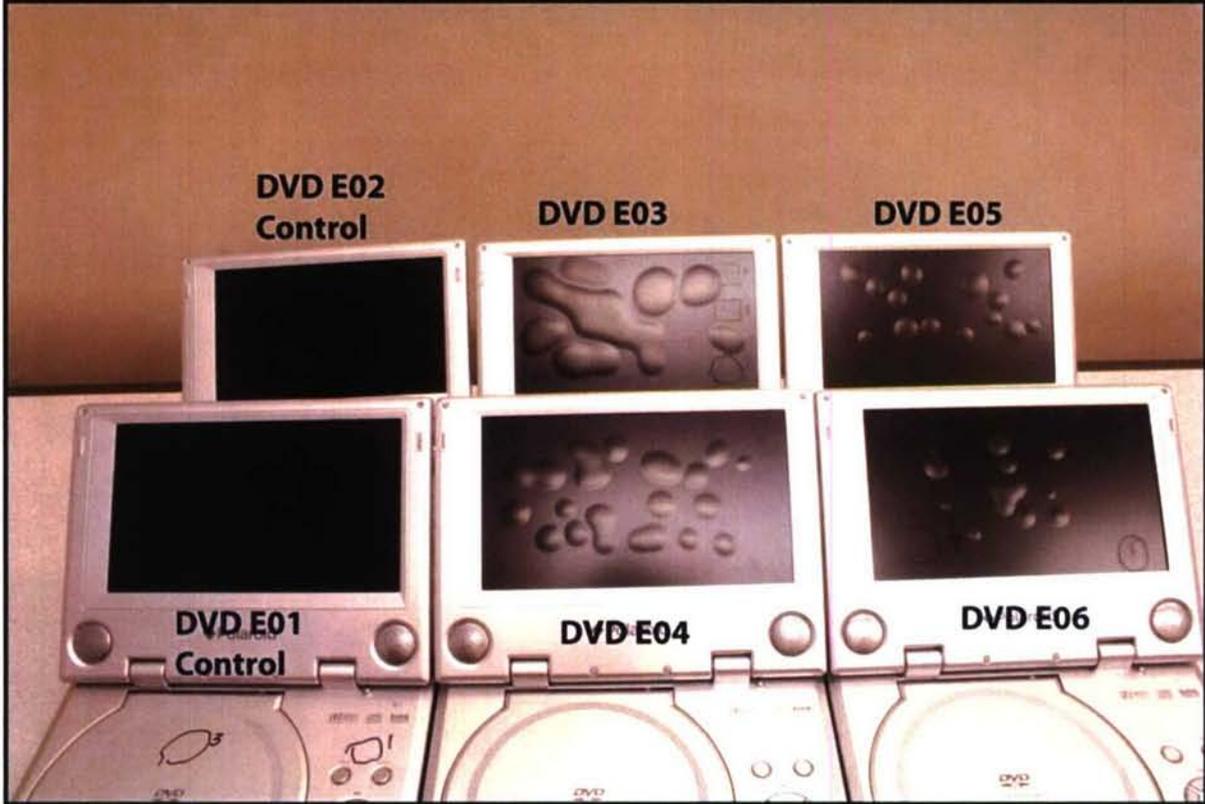
Figure 3.6.4.2.2: DVD Player mVHP Exposure History - Visual Inspection

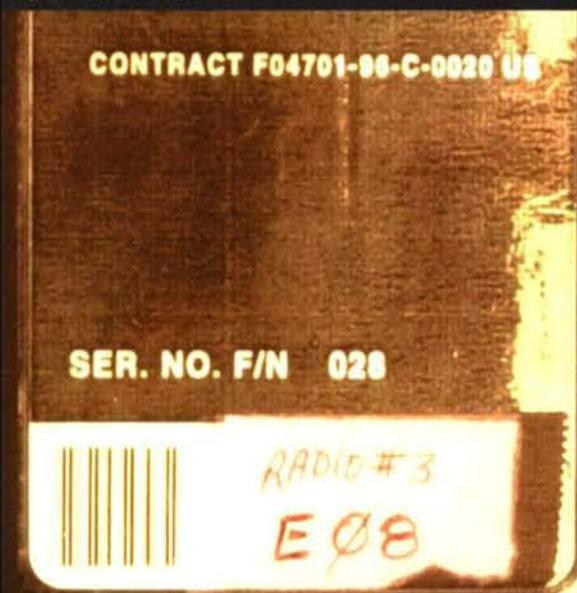
a) Radio E08

Radios: Prior to testing, each Radio article underwent comprehensive physical inspections. Due to the nature of the radio’s functionality, they were not engaged to prevent inadvertent emergency beaconing. Each article was initially photographed to determine prior damage. Following IOP DS05006, *Visual Inspection and Operation Evaluation of Test Articles: Radio units*, inspectors performed an initial physical inspection consisting of noting any wear, rough spots, discoloration, cracking, or other damages on the Radio shell. Any damages to the Radio screen, including peeling, were noted. Lastly, inspectors ensured that all buttons remained resilient following depression. Any observed damages were recorded on the Radio mVHP Sensitive Equipment Evaluation data test form. Observed damages were also documented with photographs. This thorough examination was repeated following each mVHP cycle to which the article was subjected. Following the final inspection, each article was photographed showing any changes. A summary of the initial and final inspections is provided in Sections 3.11.2 and 3.11.4, respectively. The initial and final pictures for each test article are provided in Appendix B.

Figure 3.6.4.3.2: Radio mVHP Exposure History - Visual Inspection

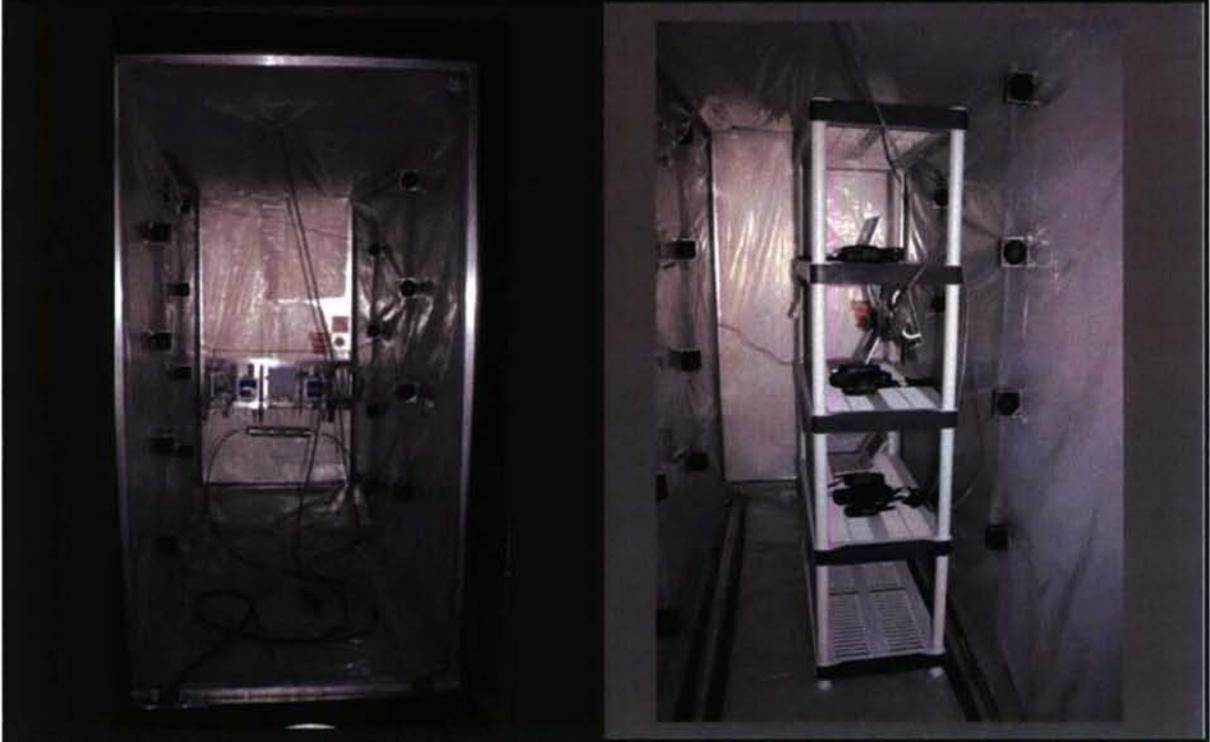
Figure 3.10: Plastic-Lined Interior and Shelving Unit

To test this new hypothesis, the test team decided to replace the metal sample cart with a plastic shelving unit, and to “tent” the inside surfaces with polyethylene sheeting in an effort to reduce the consumption of peroxide. A large roll of polyethylene sheeting was purchased from a local hardware store, along with chemical resistant duct tape, and this was used to completely cover the interior walls, ceiling, and floor, and the inside surfaces of the access doors. Holes were punched through the plastic to permit the inlet and outlet, fans, and sensor blocks free access to the interior of the test chamber. Figure 3.10 illustrates the SED box wall modification.

Once the entire chamber interior had been covered, the test team ran several engineering test runs to see if the modifications were effective. Peroxide consumption rates, as measured by the pumping rates, dropped dramatically, and the chamber was able to easily maintain 500 ppm, and could readily achieve 1000 ppm.

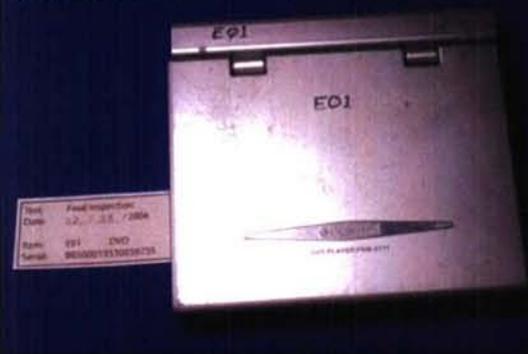
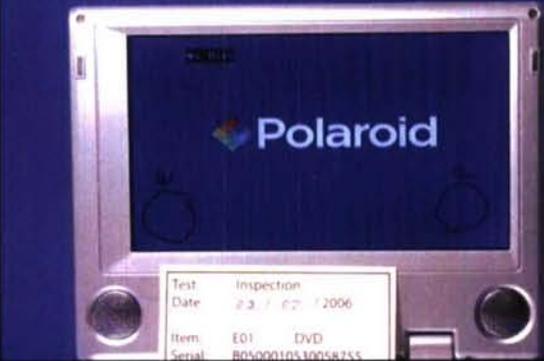
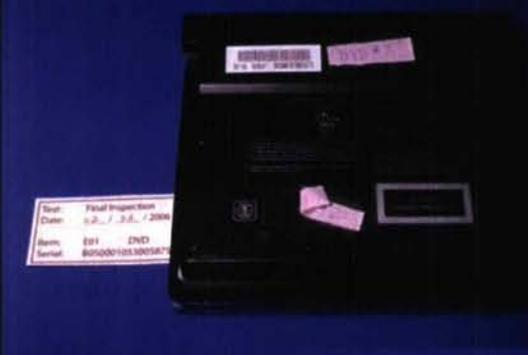
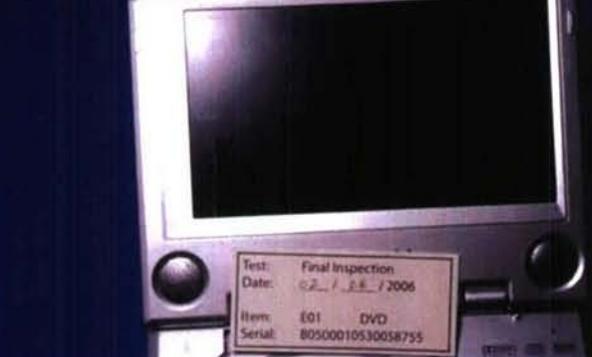
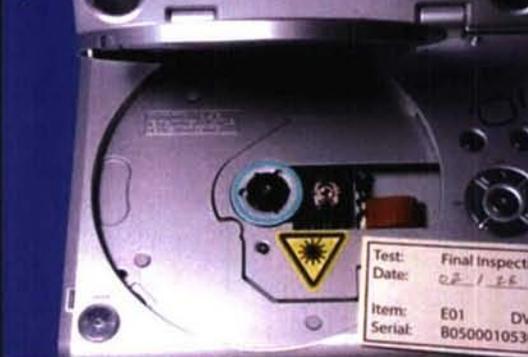
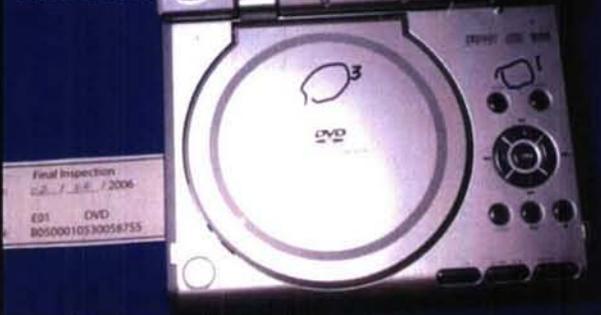
Figure B.1.2 Final Inspection DVD Player E01

Figure B.1.2: DVD Final Inspection, Item E01

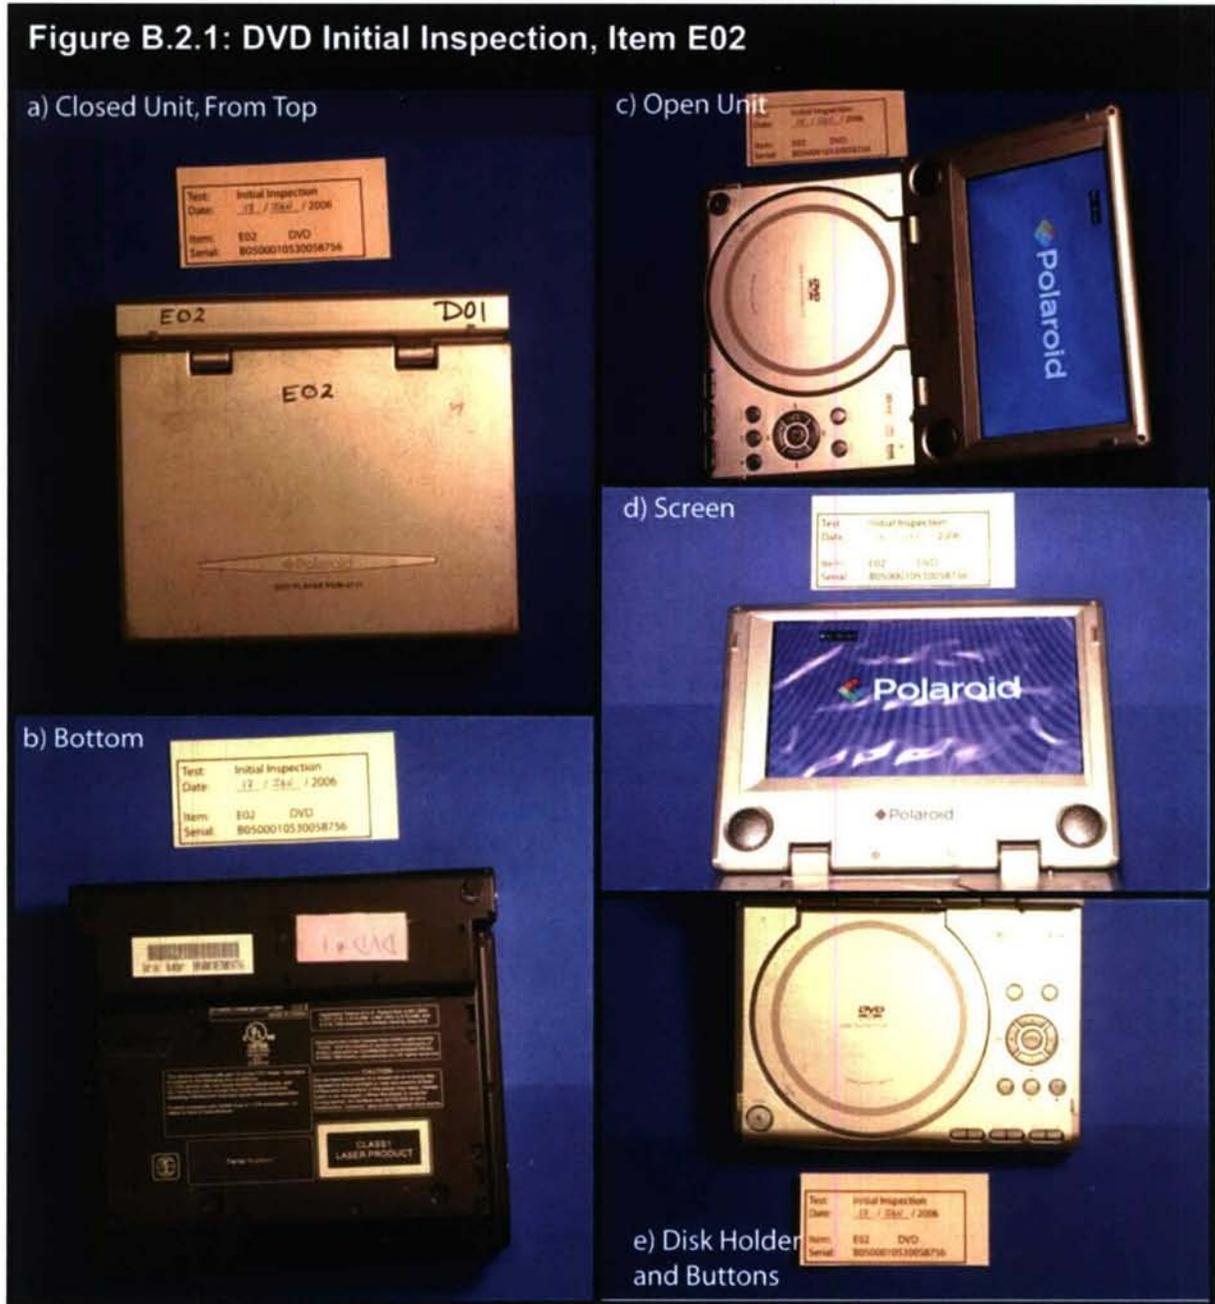
Figure B.2.1: DVD Initial Inspection, Item E02

Figure B.2.1 Initial Inspection DVD Player E02

- b. DVD E02 (Ser. # B0500010530058756): This item had extensive, though minor and cosmetic, scratches on the outside cover. The screen appeared to have suffered extensive bubbling and smudging, but on later inspection, this was revealed to be a sacrificial, peel-off plastic protective sheet. When peeled off, the screen was revealed to be in like-new condition. There were still some grains of sand stuck into small spaces, and three of the rubber pads on the bottom were missing. Functionally, the DVD player worked almost to specification – it played DVDs, it could advance from scene to scene, the speakers and headphone jack worked, and the batteries, though low, would accept and hold a charge. The lid for the DVD did not always latch securely, and even after the STOP button was pushed, the disk often continued to spin.
