ECBC-TR-526

EVALUATION OF THE STERIS SENSITIVE EQUIPMENT DECONTAMINATION (SED) APPARATUS ON A 463L PALLET

September 2007

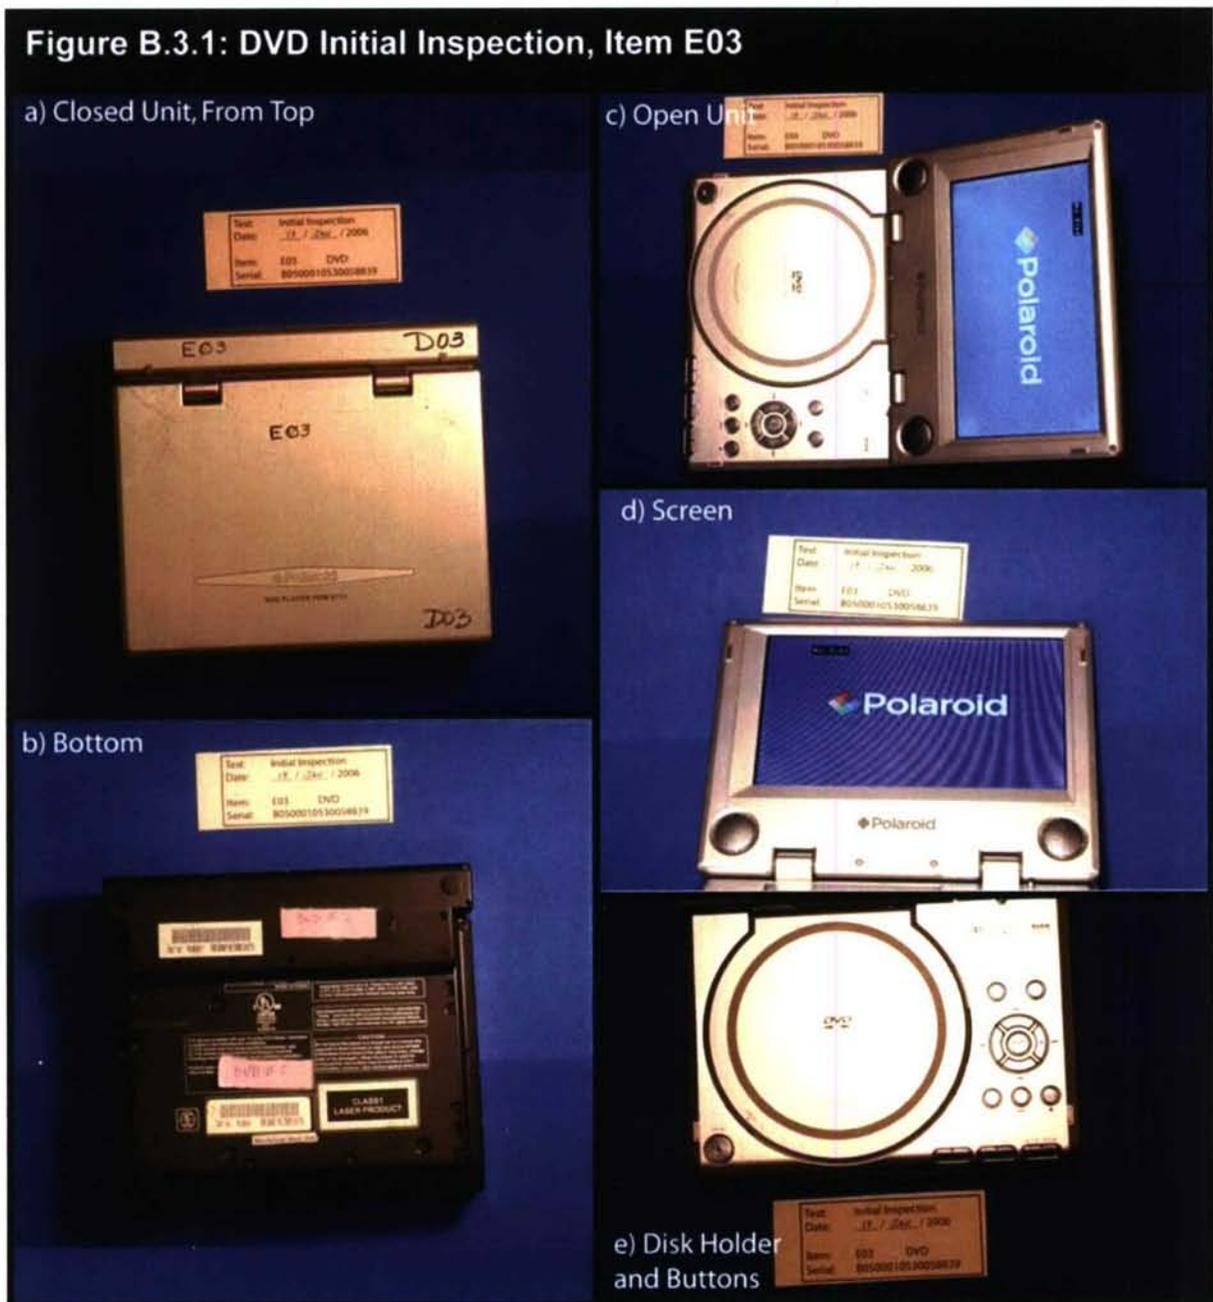
Figure B.3.1: DVD Initial Inspection, Item E03

Figure B.3.1 Initial Inspection DVD Player E03

- c. DVD E03 (Ser. # B0500010530058839): This item had minor scratches on the outside cover. There were a few grains of sand stuck into small spaces and one of the rubber pads on the bottom was missing. Functionally, the DVD player worked to specification – it played DVDs, it could advance from scene to scene, the speakers and headphone jack worked, and the batteries, though low, would accept and hold a charge.

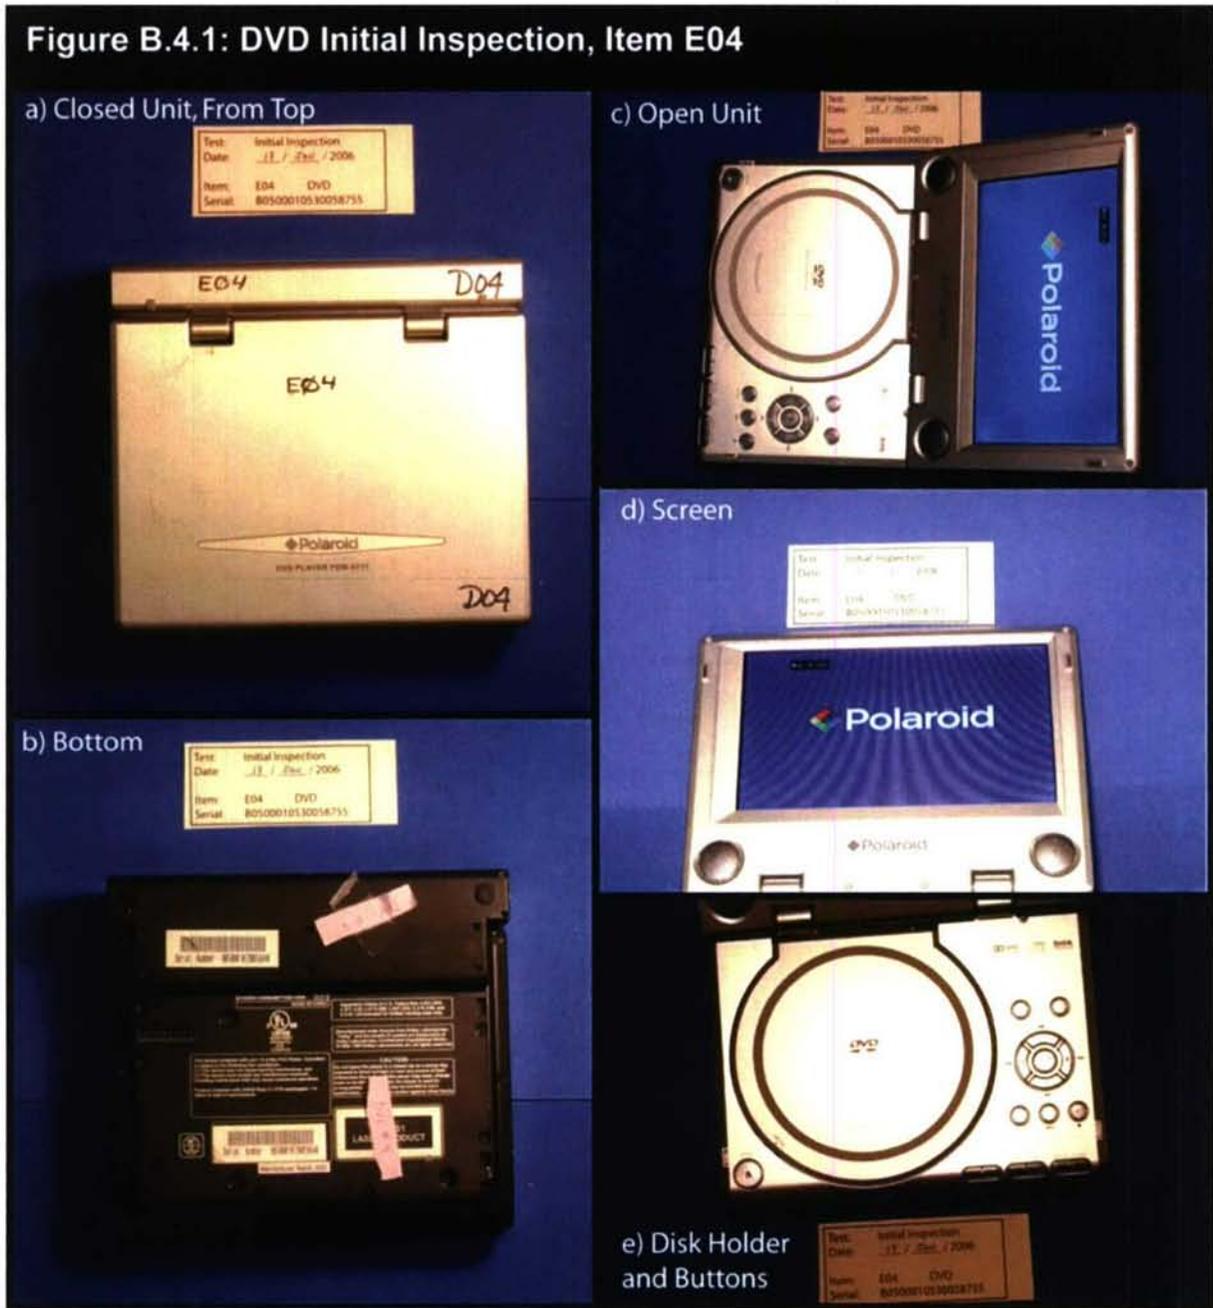
Figure B.4.1 Initial Inspection DVD Player E04

- d. DVD E04 (Ser. # B0500010530058840): This item had very minor scratches on the outside cover. Two of the rubber pads on the bottom were missing. Functionally, the DVD player worked to specification – it played DVDs, it could advance from scene to scene, the speakers and headphone jack worked, and the batteries, though low, would accept and hold a charge.

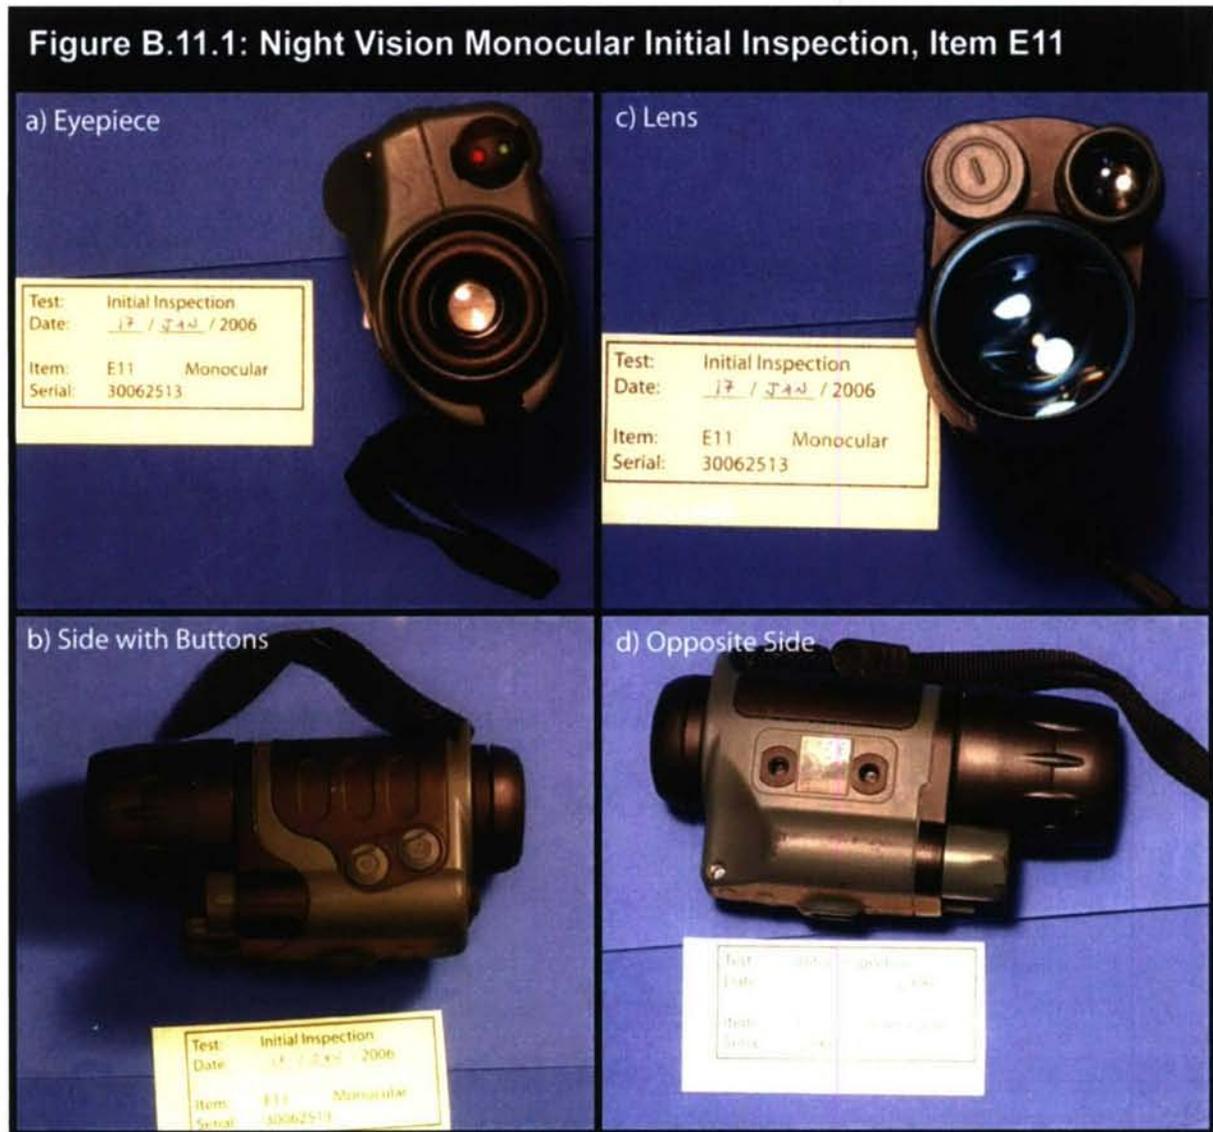
Figure B.11.1 Initial Inspection Night Vision Monocular E11

NVM units: Prior to testing, each NVM article underwent comprehensive physical and operational inspections. Each article was initially photographed to determine prior damage and functionality. Following IOP DS05004, *Visual Inspection and Operation Evaluation of Test Articles: NVM units*, inspectors performed an initial physical inspection consisting of noting any wear, rough spots, discoloration, cracking, or other damages on the NVM shell. Any damages to the NVM lenses, including peeling, were noted. Inspectors noted whether the lenses continued to freely rotate—as necessary for focusing article. Lastly, inspectors ensured that both buttons remained resilient following depression. Following the physical inspection, inspectors performed operational tests to ensure the article’s ability to power up and utilize the IR focus. Any observed damages were recorded on the NVM mVHP Sensitive Equipment Evaluation data test form. Observed damages were also documented with photographs. This thorough examination was repeated following each mVHP cycle to which the article was subjected. Following the final inspection, each article was photographed showing any changes. A summary of the initial and final inspections is provided in Sections 3.11.2 and 3.11.4, respectively. The initial and final pictures for each test article are provided in Appendix B.

- a. NVM E11 (Ser. # 30062513): This unit worked to specification. It showed cosmetic scratches and wear on the raised points. About $\frac{3}{4}$ of the name plate was missing upon the initial inspection.

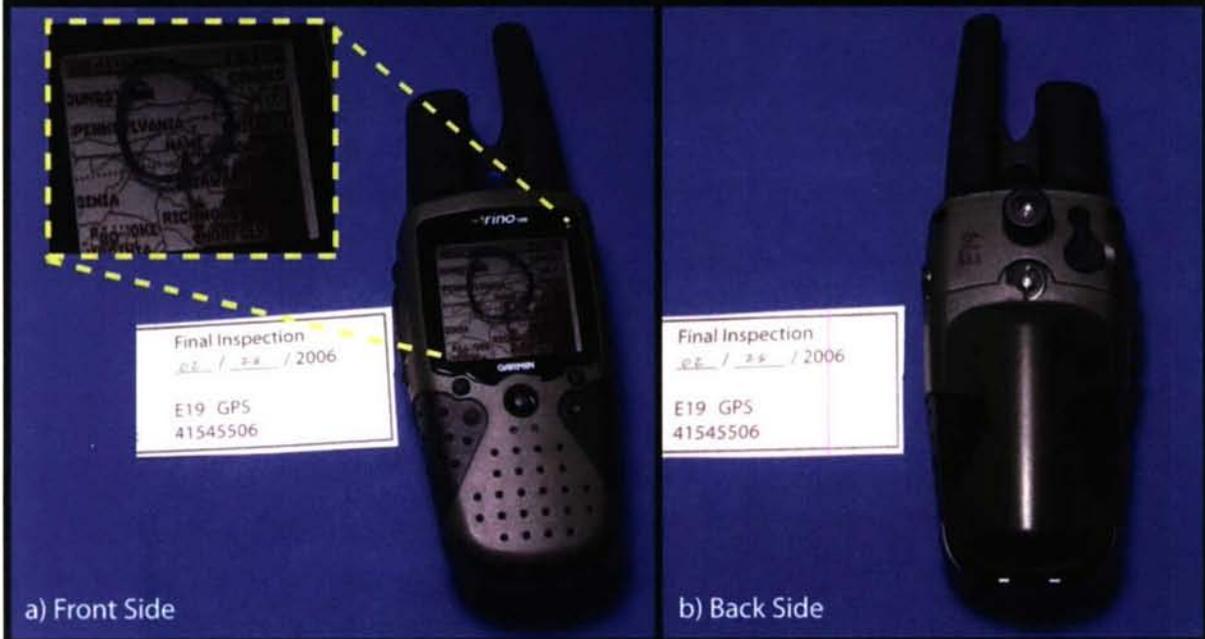
Figure B.19.2 Final Inspection GPS Unit E19

- e. GPS E19 (Ser. # 41545506): This item was never exposed to mVHP. No physical changes were noted at any time. The unit worked to specification at all times.

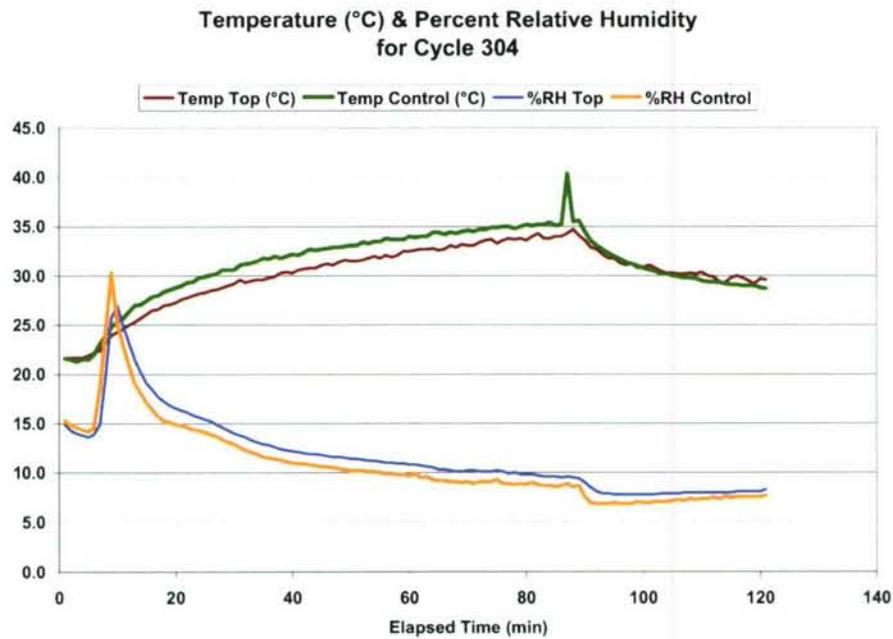
Figure C.1.2 Relative Humidity and Temperature Control Chart Cycle 304

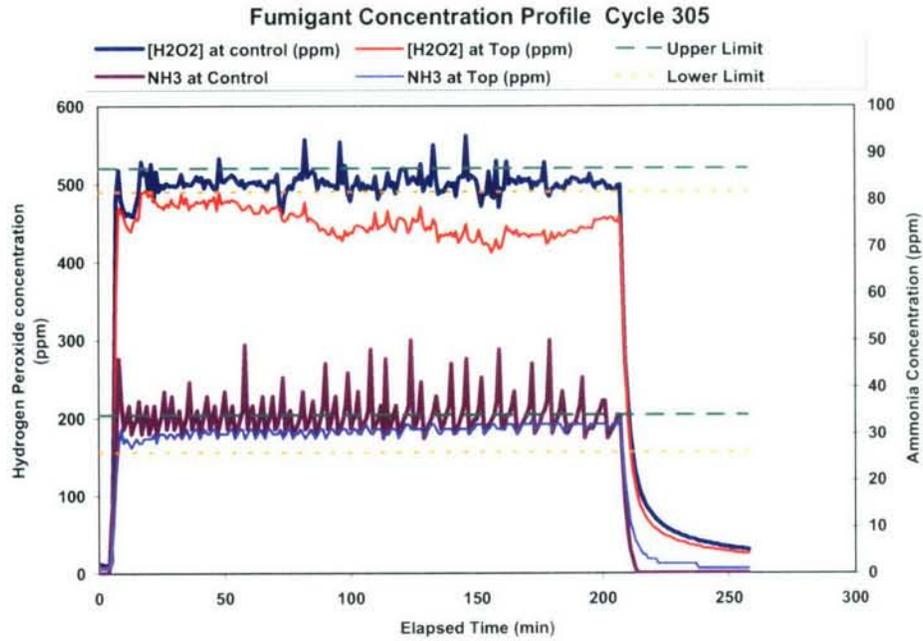
Figure C.2.1 Hydrogen Peroxide and Ammonia Control Chart Cycle 305

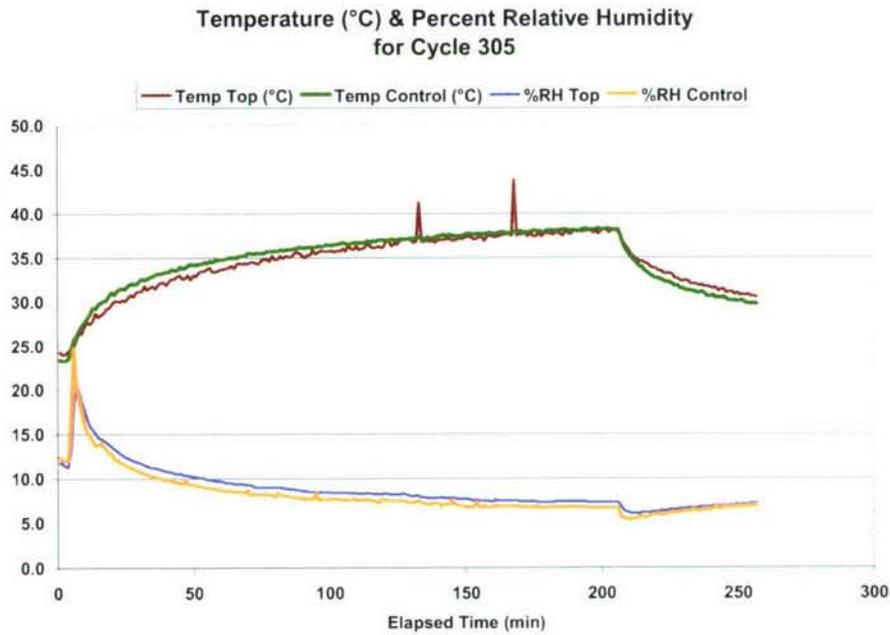
Figure C.2.2 Relative Humidity and Temperature Control Chart Cycle 305

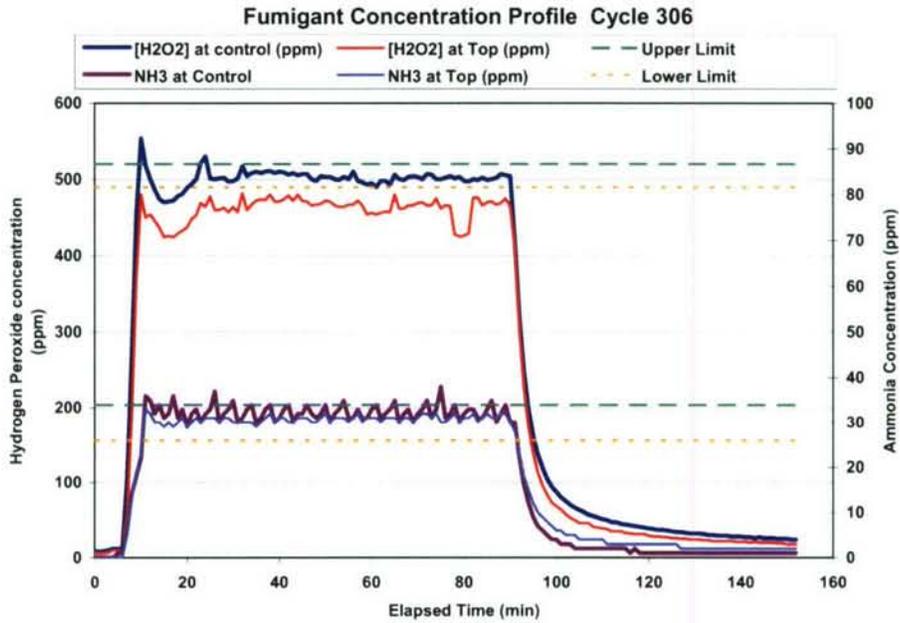
Figure C.3.1 Hydrogen Peroxide and Ammonia Control Chart Cycle 306

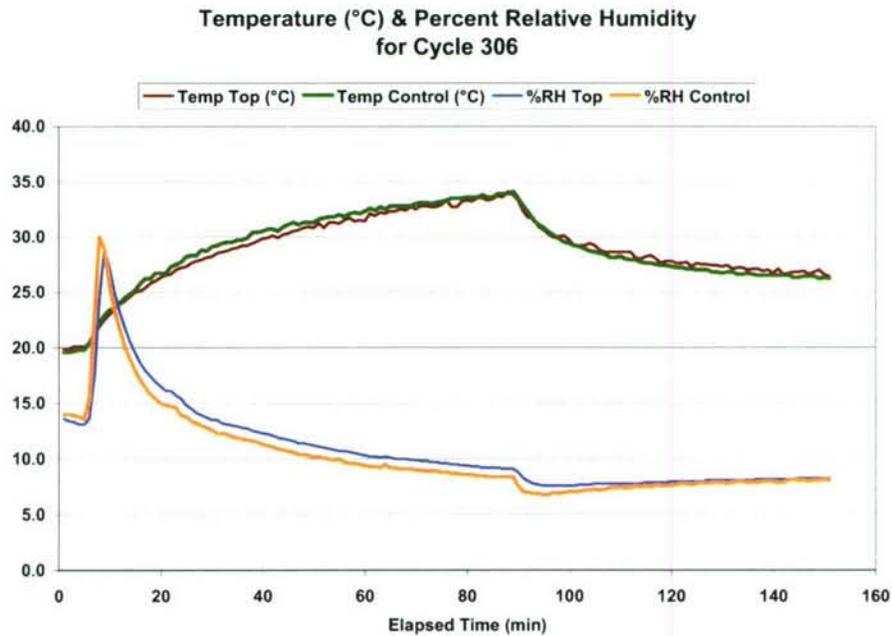
Figure C.3.2 Relative Humidity and Temperature Control Chart Cycle 306
