EXCLUDED FROM AUTOMATIC REGRAPING TECHNICAL INFORMATION SECTION DOES NOT APPLY TECHNICAL INFORMATION SECTION REPORT No. T.R 2/2.

TRIALS AGAINST CONQUEROR TANKS WITH

ADDITIONAL BALLISTIC PROTECTION PART 2

THE USE OF LARGE HOLLOW-CHARGE WARHEADS.

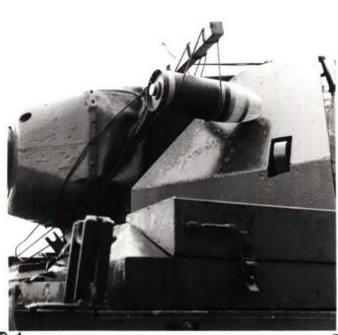
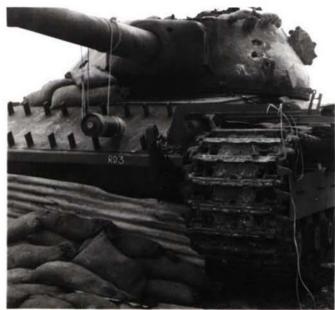
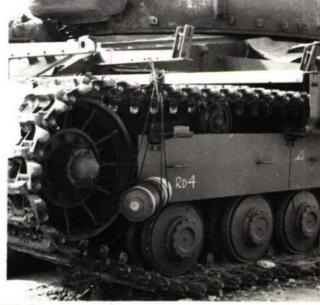
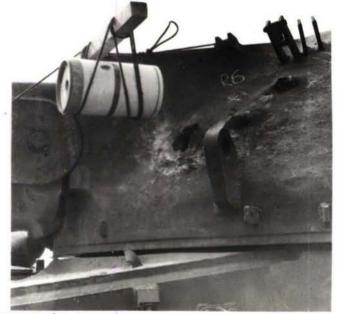
FIGURE 5. POSITIONS OF WARHEADS

ROUND 1

ROUND 2 (SPACED ARMOUR AS FOR ROUND 1)

ROUND 3

ROUND 4

ROUND 5

ROUND 6 (MALKARA)

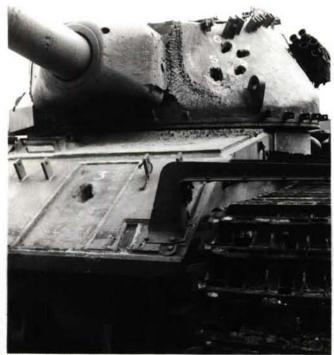
GENERAL VIEW

3.1.2 External Damage No serious external damage was caused by the "Dart" rounds; the "Malkara" round produced more external damage, and also, around the jet hole, a large area of characteristic hollow-charge pitting (figure 6), which was sufficient to prevent elevation of the gun by burring the mantlet (KILL damage). This pitting was noticeably The use of a absent in the "Dart" rounds (which have no metal case). metal case undoubtedly produces more secondary damage and should also improve penetration (according to B.R.L. reports) but it increases the warhead weight appreciably; e.g., the "Dart" round (with ballistic cap) weighed 23 pounds; the experimental "Malkara" round (without ballistic cap) weighed 52 pounds.

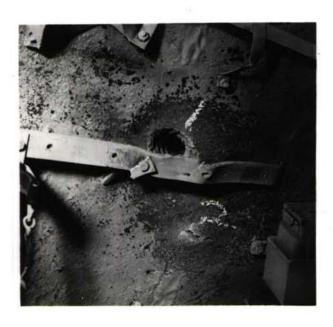
INTERIOR DAMAGE TO ARMOUR BY DART.

ROUNDS 1 AND 2

Spaced armour (14 m.m.) holed 1.7" x 2.5"; four spacer tubes removed
but assembly still in position. Hole through main armour 2.25" x 2.0" on
face, decreasing to 1.6" x 1.7" on inside. Face damage: 4.7" x 5.7".

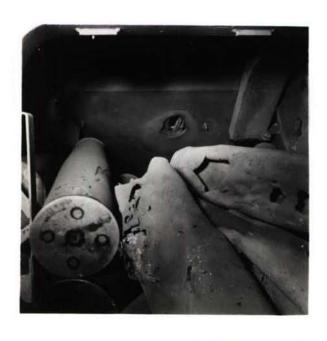
BACK DAMAGE DART. ROUND 3.

FIGURE 6. TYPICAL JET HOLES AND DAMAGE

Round 3 - "Dart" Attack on Up-armoured Glacis Opposite Ammunition Stowage 20 m.m. applique plate holed 6" x 5", broken in two pieces and blown off. Main armour holed 2.6" x 2.6" on face, decreasing to 2.5" x 2.0" inside. Face damage: 6" x 4". Back damage: 7" x 5" including spall 5" x 3" x 0.75" thick.

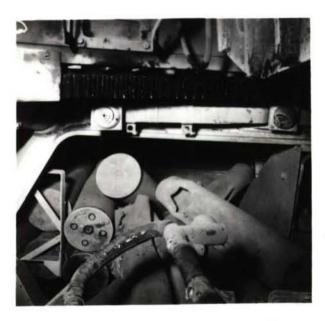
FIGURE 8. TYPICAL CARTRIDGE CASE DAMAGE

ROUND 3 (HULL NOSE)

Six empty 120 m.m. cartridge cases stowed under glacis holed. Two amplifier boxes (aluminium alloy) on turret turntable, 5 ft. from point of attack, holed: one 1" dia. hole and two .125" dia. holes; this damage had no effect on the amplifiers. 16 gauge steel witness plates at rear of fighting compartment dished 6" over 34° x 22". Three holes 0.06 to 0.5" dia. in engine compartment bulkhead.

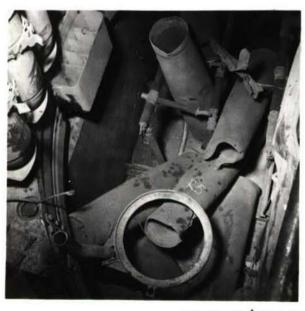
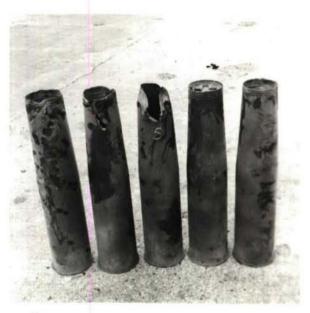
ROUND 5 (TURRET FRONT)

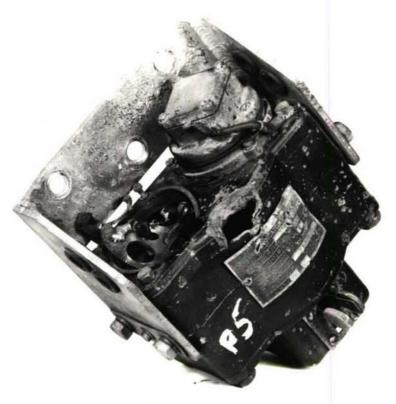
FIGURE 9. TYPICAL INTERNAL DAMAGE

TRAVERSE INDICATOR CONTROL DAMAGED BY ROUND 6

Magslip re-setter unit No. 1 casing fractured across fixing bolt holes. Traverse indicator control smashed. Range setter on gunner's sighr damaged by strike on pinion rack.
