Proof of Performance Test Report

MANTIS

April 2005

**Proof of Performance Test Report
on
Mine Clearing/Survivable Vehicle
(Mantis)**

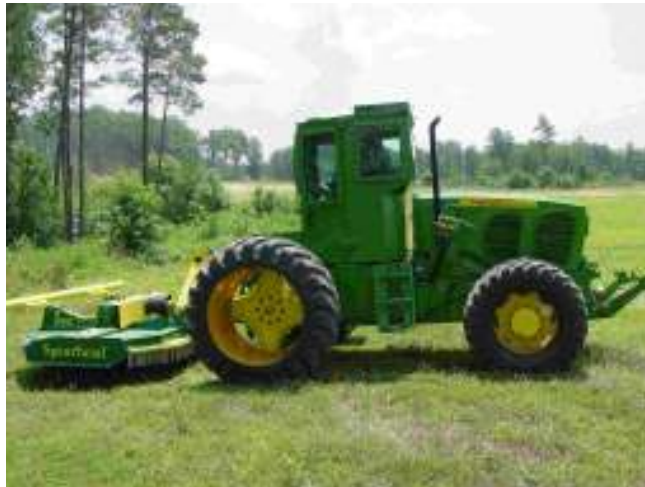
Figure 1: Mine Clearing/Survivable Vehicle (MCSV) with Rotary Mower

The MCSV is a modified and armored John Deere 6920 farm tractor capable of operating a number of specialized and off-the-shelf commercial implements to address some of the vegetation clearing, soil preparation, area reduction, quality assurance, and mine removal and neutralization problems in humanitarian demining operations. The system is equipped with front and rear power take-offs (PTO), standard three-point hitches front and rear, and a modified loader frame. The tractor was modified, armored, and reassembled by *Pearson Engineering Ltd.*, Newcastle upon Tyne, England, under contract to the US Army NVESD.

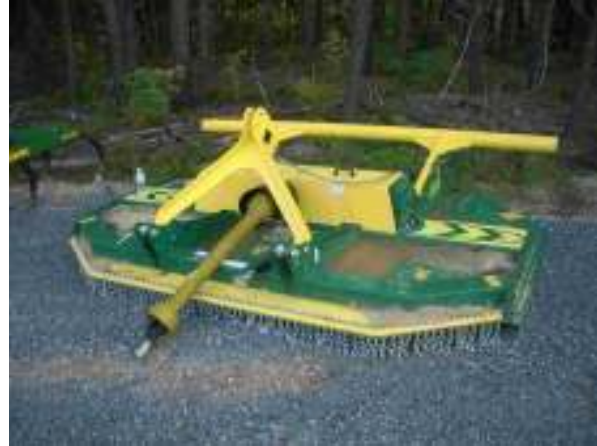
Figure 3: Rotary Mower

The rotary mower worked very well in Categories 1 and 2 vegetation. Mowing in Category 1 vegetation resulted in stubble was between 1 ¼ to 1 ¾ inches (3 – 4.5 cm) high. When encountering an area of tall or dense Category 2 vegetation, the operator found it necessary to make the first cut high (approximately ½ meter) and then remove the area or, for a dense clump, to bring the mower deck down on the area to complete the mowing. This procedure led to the first problem of the test.

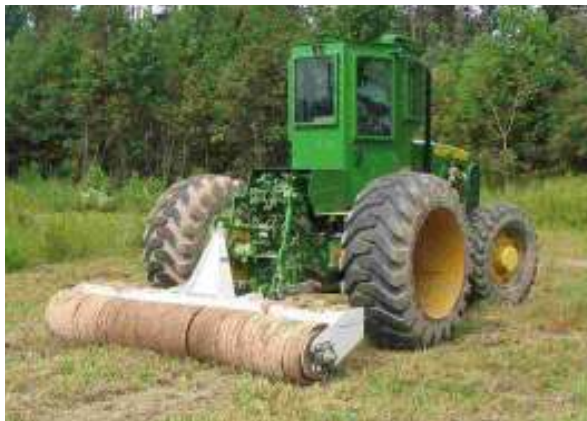
Figure 4: Area Reduction Roller

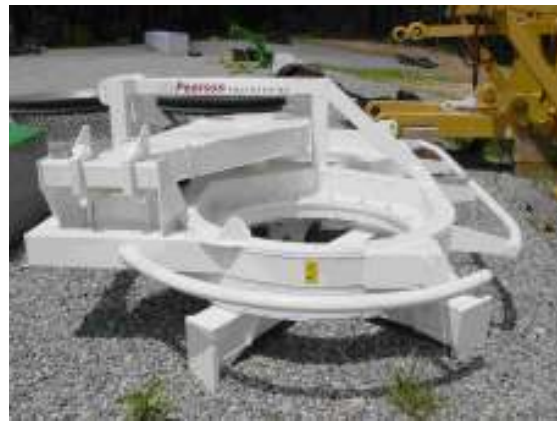
Figure 5: Rotary Mine Comb

The Rotary Mine Comb, designed and built by Pearson Engineering, Ltd., is an adaptation of an old idea for a garden tiller. The two sets of counter-rotating tillers, canted slightly outward, bring mines to the surface and then slowly, and gently, move the mines to the sides of the tiller and deposits them in windrows. Throughout the demonstration, the Rotary Mine Comb handled all vegetation conditions, ranging from dense Category 1 to very heavy Category 3, with ease. The 40 cm operating depth of the cultivating tines removed not only the above ground vegetation, including 15 to 20 ft (4.6 to 6.1 meter) tall trees up to 3 inches (7.6 cm) in diameter, but also dug up the trees' root systems. This tool, without exception, was the best area-proofing and mine-removal tool tested during the MCSV proof of performance. Pictures showing the Rotary Mine Comb in action and the results of its operation are shown in Figure 30.

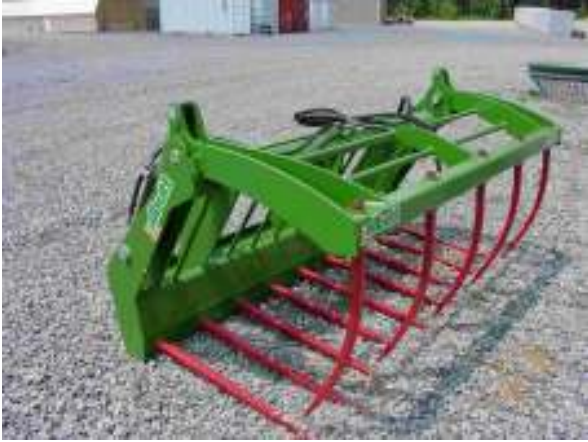
Figure 6: Grab

The Grab, designed to pick up cut brush, debris from forestry operations, or any loose material resulting from a vegetation-clearing project, is mounted to the tractor using the Universal Mount. Although operator visibility of the tool is limited when the tool is on the ground, with a minimal amount of experience the operator is able to use the tool with no trouble. As can be seen, lifting capacity, by weight, is sufficient to handle large debris-clearing jobs. No tests, other than the demonstration shown, were conducted.

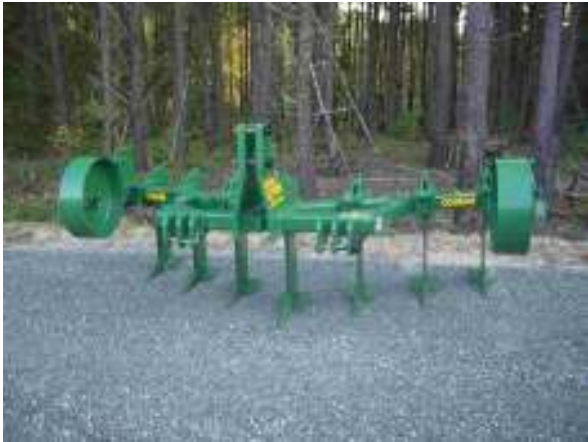
Figure 8: Heavy Cultivator

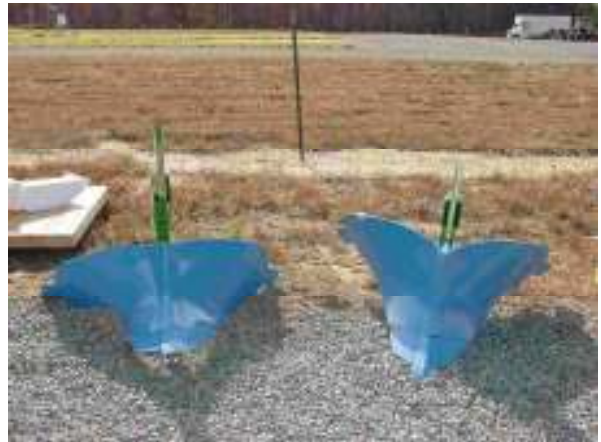
Figure 9: Bed Formers

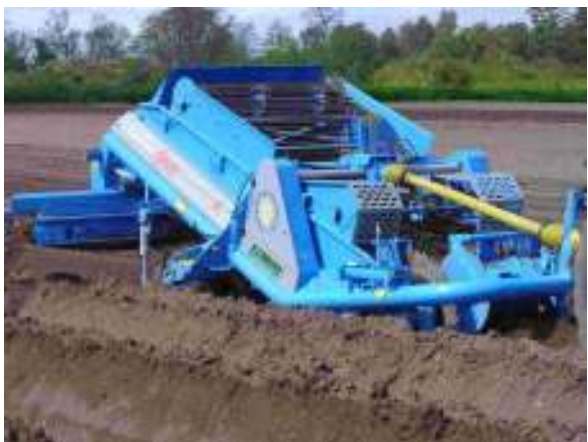
Figure 10: Mine Sifter

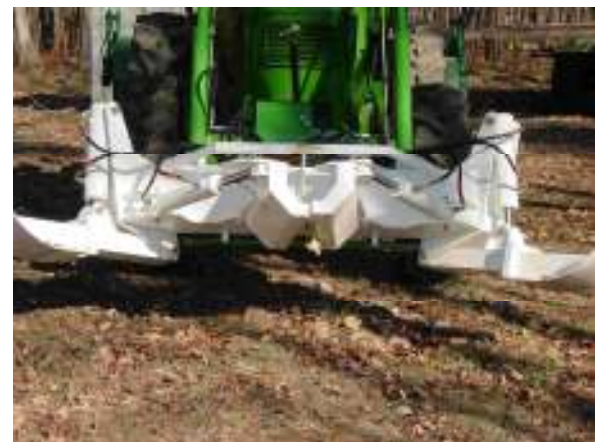
Figure 11: Tree Picker

The Tree Picker, also supplied by Pearson Engineering, Ltd., is a hydraulically actuated attachment that mounts to the MCSV using the standard 3-point hitch on the front of the vehicle. The picker is actuated by two electronically controlled hydraulic feed lines off the MCSV's hydraulic system, mounted one on each side of the 3-point hitch. These operate the left and right power outriggers on the picker as well as the central tree-grabbing mechanism. Limited training on and use of, the tree picker occurred during the assessment. However, the demonstration did include the removal of a 12 inch (30.5 cm) diameter tree well in excess of 60 feet tall.

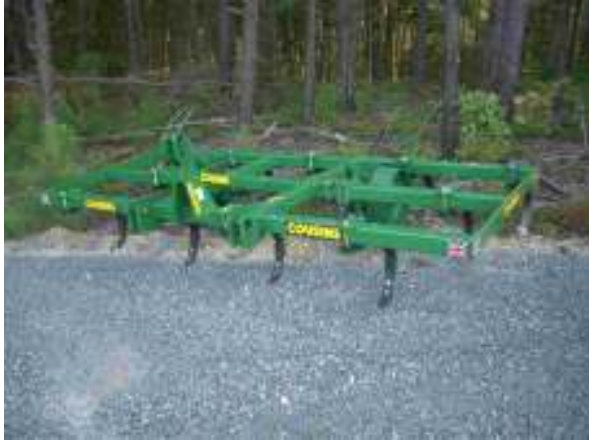
Figure 12: Spring Tine Cultivator

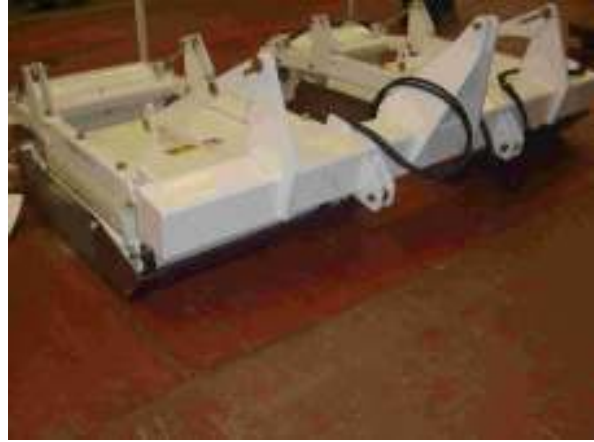
Figure 13: Magnet

Tests of the magnet were limited to assessing its ability to pick up various sized pieces of ferrous material from a field-grass-covered area and the ease with which the retrieved items could be removed from the magnet. The magnet, a large rare-earth permanent magnet, had no trouble picking up all the ferrous scrap distributed in the test area. There were, however, problems with removal. The face of the magnet is covered with a large sheet of stainless steel. Recovered ferrous scrap, attracted to the magnet through the stainless steel, will adhere to the underside of the stainless steel. In principle, when the stainless steel shield is offset from the magnet, the recovered scrap should be beyond the influence of the magnet and fall to the ground. In fact, only the larger pieces of ferrous scrap broke free by virtue of their own weight. The smaller pieces were still caught in the magnetic field and had to be removed by hand.

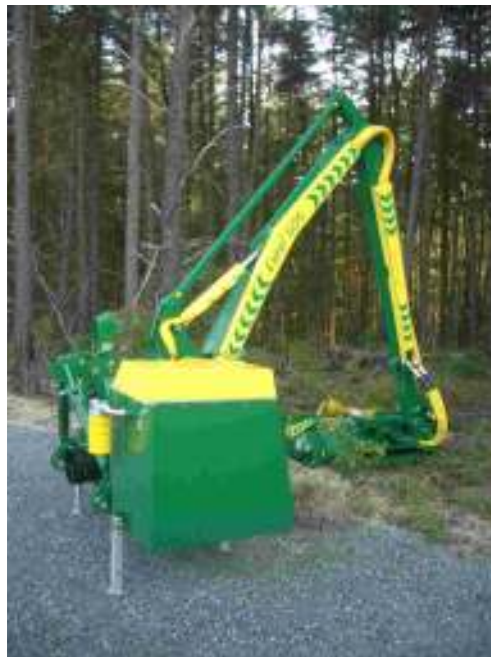
Figure 14: Hedge Cutter

The Hedge Trimmer, designed to be mounted on the rear 3-point hitch of the tractor, is powered by the rear PTO. The PTO drives an on-board hydraulic system that controls the movement of the boom and powers the cutter head. The boom allows the hedge cutter to operate over an intervening guard rail or other similar obstacle and cut the vegetation beyond

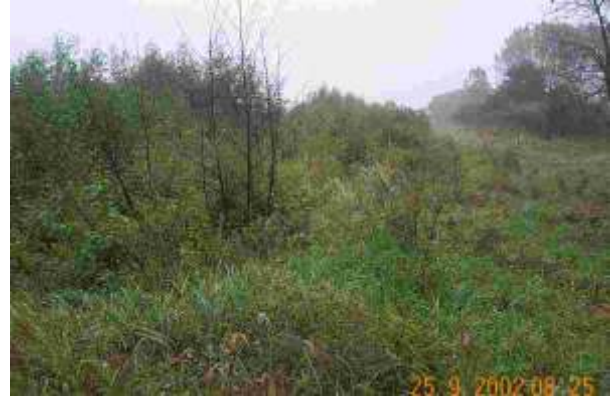
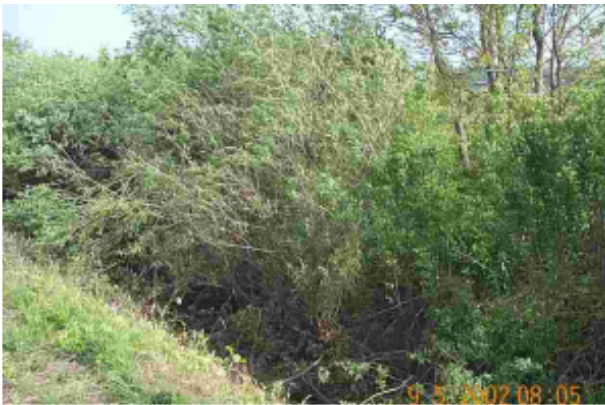
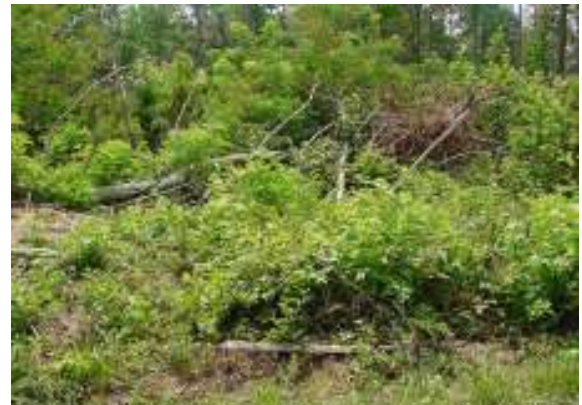
All four vegetation categories were represented at the test site and are shown below in Figure 15 through Figure 18. Table 3 gives definitions of each category.

Figure 15: Category 1, Easy

Figure 16: Category 2, Moderate

Figure 17: Category 3, Difficult

Figure 18: Category 4, Very Difficult

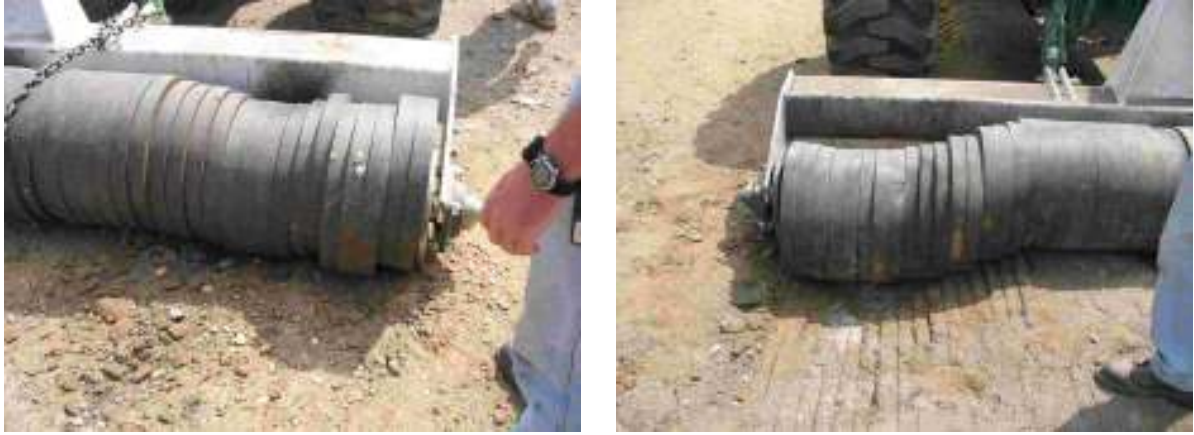
Blast tests were also conducted against the roller. The explosive, designed to simulate a heavy AP mine, consisted of ½ pound of TNT initiated by a small U.S. AP mine. Three explosive charges were laid with the initiator mine's detonator just above the surface. The tractor, with the roller attached on the front, was pulled over each of the explosive devices. The roller sustained no damage. See Figure 23.

Figure 23: Results of Blast Test Against Roller

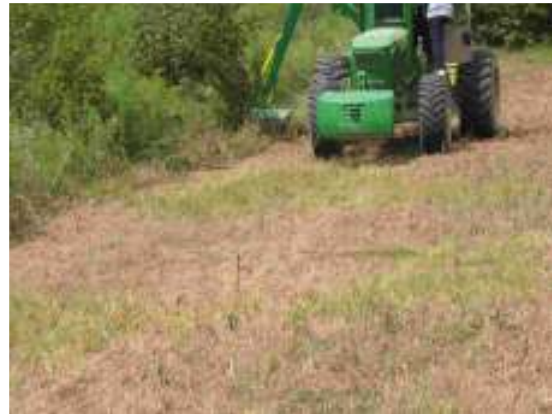
the obstacle. The cutter is powerful, quiet, with very minimal vibration, indicating excellent balance of the cutting rotor. The cutting rotor has a double row of cutters with 14 cutters per row. The cutting swath is 1 meter. With the boom fully extended, and with no intervening obstacle, the cutting head is able to reach out 13.33 ft (4 m). The Hedge Cutter had no problem cutting Category 1 and 2 vegetation. On Category 3 vegetation, the cutter was able to cut the vegetation down to ground level only by cutting the vegetation in stages, beginning at the top, and working down. The Hedge Cutter was not designed to be operated in this fashion; however, it can be done, albeit awkwardly. The Hedge Cutter appears to be sufficiently robust to operate for extended periods of time against Categories 1 and 2 vegetation. No trials of area versus time were made. No mechanical problems were encountered.

Figure 25: Brush Cutter Operations

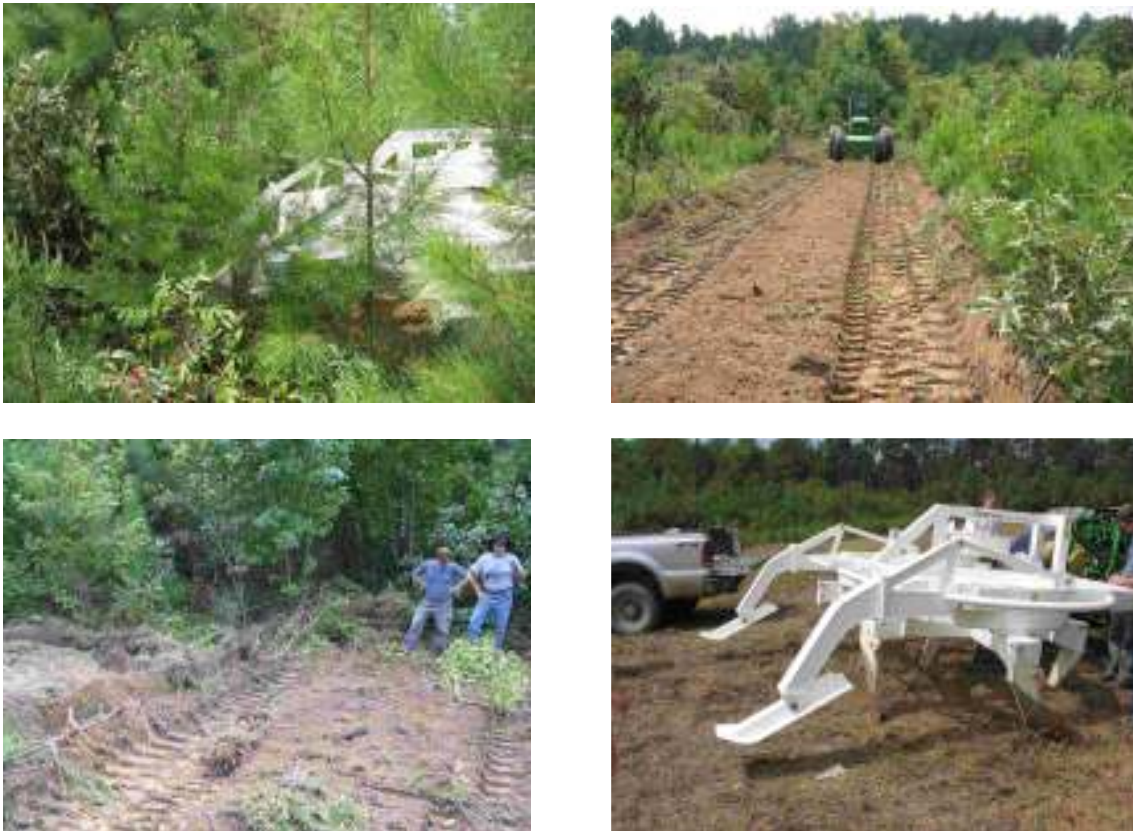
Figure 30: Rotary Mine Comb Demonstration

During the performance demonstration in heavy Category 2 and Category 3 vegetation, the operator had trouble steering in a straight line with the mine comb pulling the tractor on a gentle curve to the left. If the ground is not level, the Rotary Mine Comb digs more deeply on the low side. This in turn exerts a pull to that side causing the tractor to

An operational transit problem presented itself and a workable solution was devised. In the full-up position with the Rotary Mine Comb out of the ground and the PTO shaft connected to the Rotary Mine Comb, the Rotary Mine Comb clears the ground by scant inches. When moving from a staging area to a work site over anything other than a flat, smooth surface, the Rotary Mine Comb digs into the ground as the MCSV pitches and sways over the uneven surface. Since the PTO shaft is the limiting link in determining ground clearance in the all-up position, it is recommended that the PTO shaft not be connected until the Rotary Mine Comb is at the work site. This allows additional ground clearance when in the all-up position. When departing a work site, the PTO shaft should be disconnected.

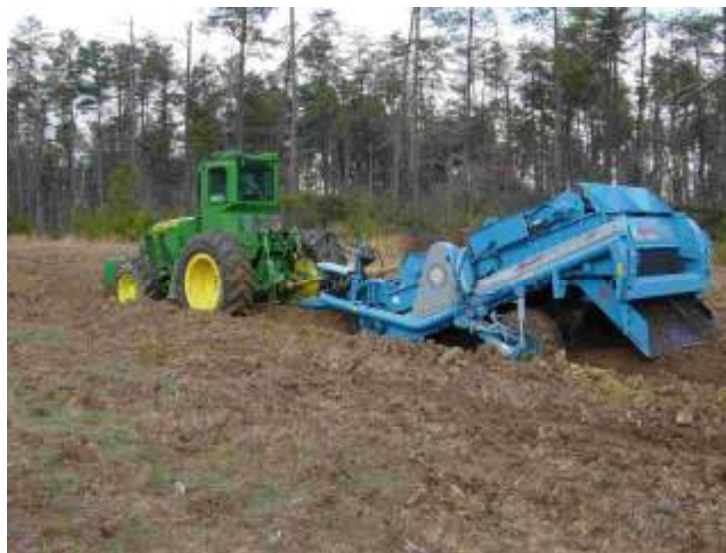
at the rear of the sifter. Experience showed that the sifter was much more efficient when operated at the lower of the PTO speeds (540 rpm vs. 1000 rpm). At a forward speed of 1 mph (1.61 kph), the sifter is capable of sifting 3,033 square yards per hour (2,773 square meters per hour).

Figure 31: Mine Sifter in Operation

There are four drawbacks to using this attachment, one potentially serious, three easily correctable. The serious drawback is that the MCSV would have to drive over a mined area to prepare the soil with the Soil Loosener and Bed Formers prior to using the Mine Sifter. The second drawback involves the rear-facing chute. Because of its width, mines can be deposited in the trough between the sifted windrows and might be covered with a thin layer of soil that slides down the sides of the sifted windrows. This can pose a hazard to deminers who would walk in the troughs looking to recover sifted mines. An easy correction to keep the mines on top of the sifted windrow is to install a choke in the discharge chute, ensuring that the mines are deposited in the center portion of the windrows. The third drawback is that the MCSV operator cannot see what is being deposited by the rear facing discharge chute, and therefore alert waiting deminers of a sifted AP mine. It is thought that an observer using binoculars should be able to spot sifted mines. Finally, SETCO tires with standard hubs, and not the blast-off hubs, have to be used to match the tire track width of the sifter.

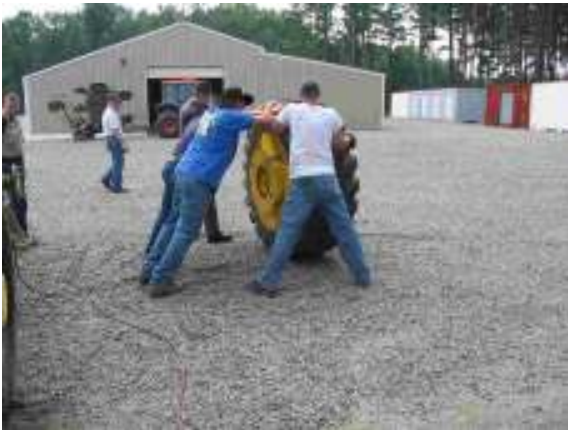
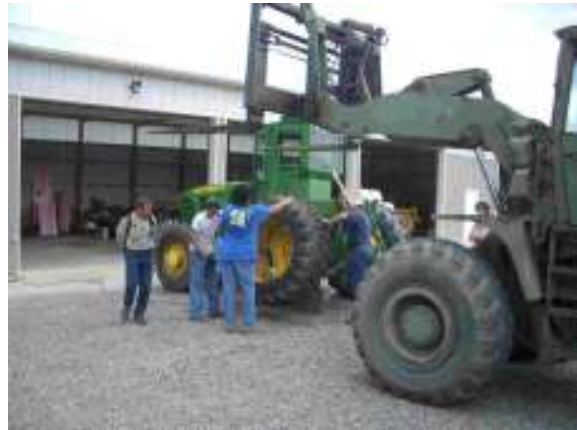
Changing of the rear SETCO tires requires some means of lifting the tires and two to three strong men to position them on the axle. During the proof of performance demonstration, a forklift was used to lift the tire into position. See Figure 35.

Figure 35: Mounting SETCO Rear Tires

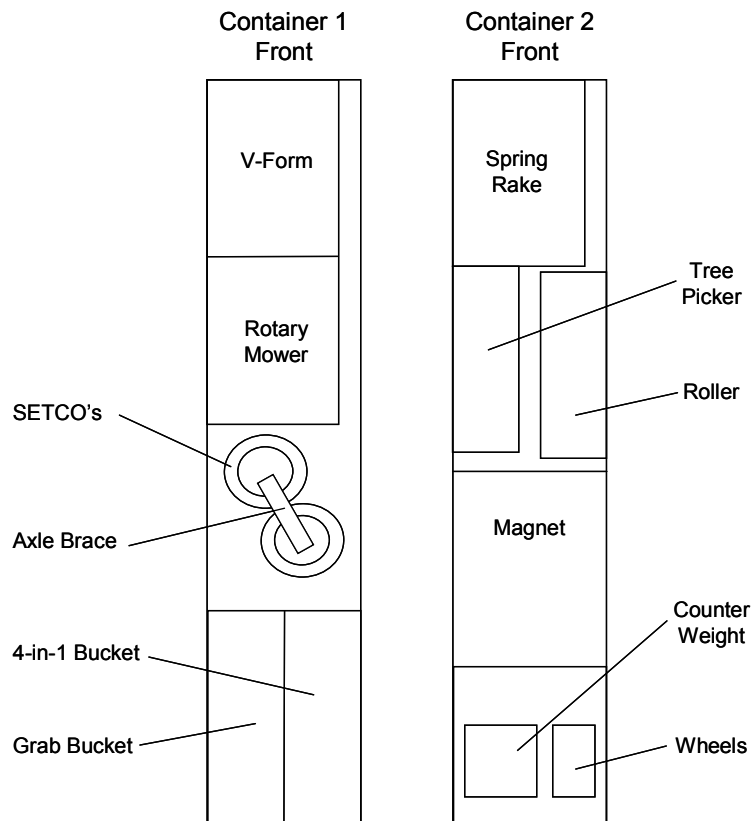
For overseas or long-distance in-country shipment, the MCSV tools and attachments will be loaded into two, 40 foot long CONEX containers according to the loading plan shown in Figure 36. The tractor will be driven into or onto a ship, flatbed rail car, or flatbed trailer and chained in place for shipment.

Figure 36: MCSV Load Plan: Two 40-foot Containers
