**ESTCP Project UX-200327  
Remote Excavation of Heavily Contaminated UXO Sites  
The Range Master  
Phase II Final Report**

Prepared by  
USA Environmental, Inc.  
5 September 2007

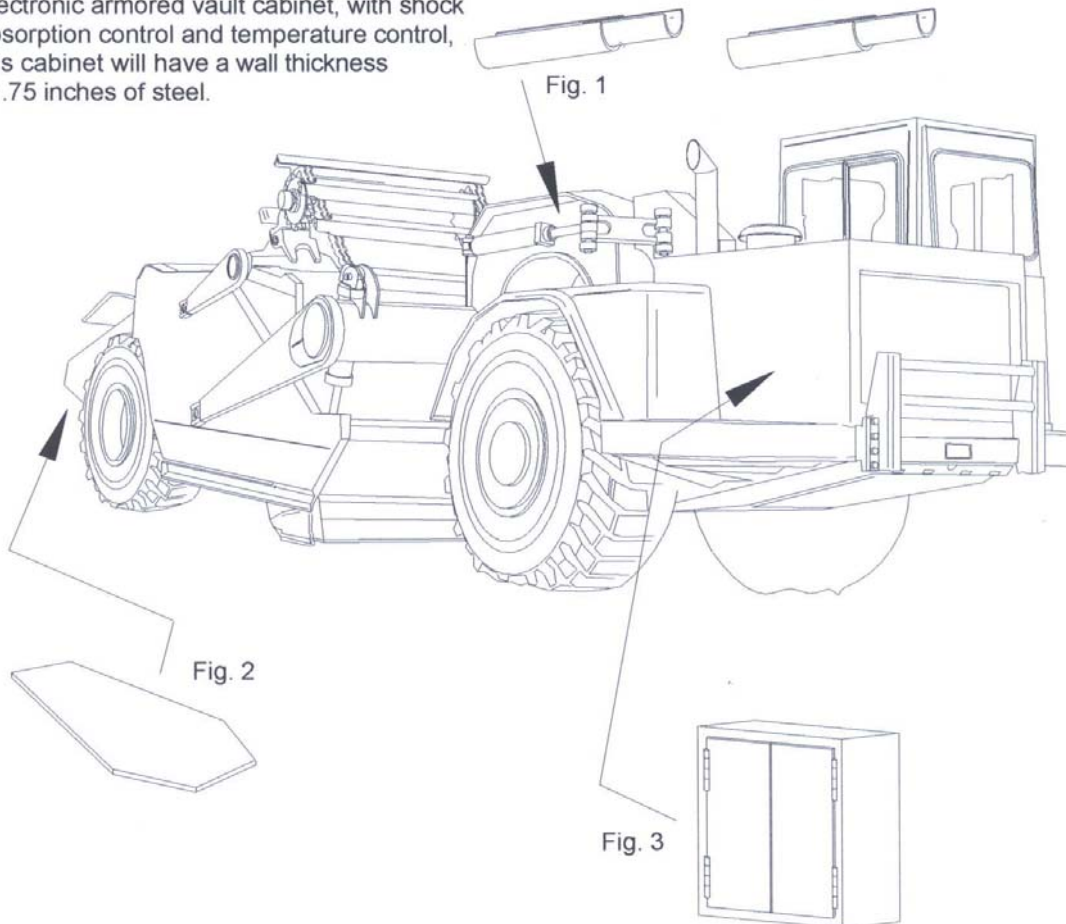
**Figure 10: Range Master Armor Design 1 of 2**

Fig. 3, is the Telemetry Guidance System and Electronic armored vault cabinet, with shock absorption control and temperature control, this cabinet will have a wall thickness of .75 inches of steel.

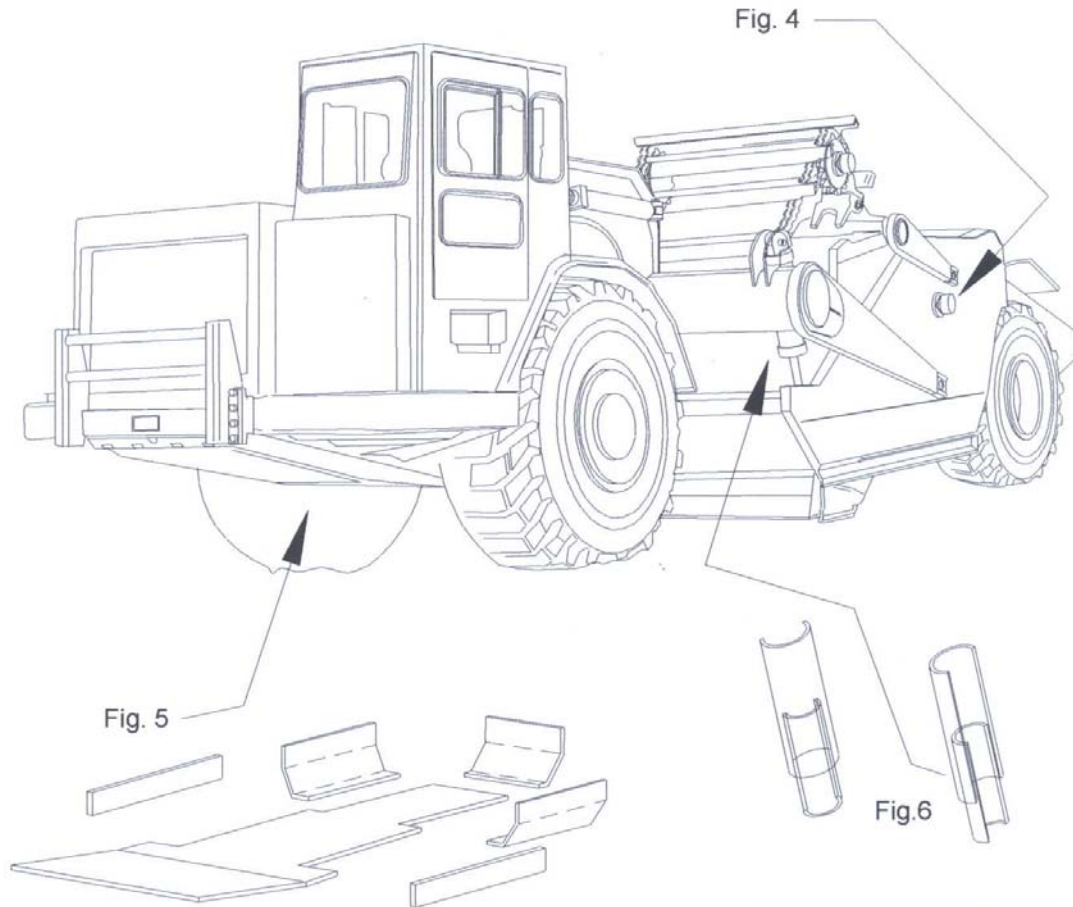
**Figure 11: Range Master Armor Design 2 of 2**

Fig. 4, Is the Power Screen Drive and it is exposed outward of the machine side body, the lead-in hydraulic lines and motor will be shielded by .75 and .5 steel plate

Fig. 5, Is the the most completed part of the armor cover, this has to segmented for access to major machine components, drive differential, transmission, lower power train, power takeoff and, hydraulic drives - pumps. All steel is .75 inch thickness.

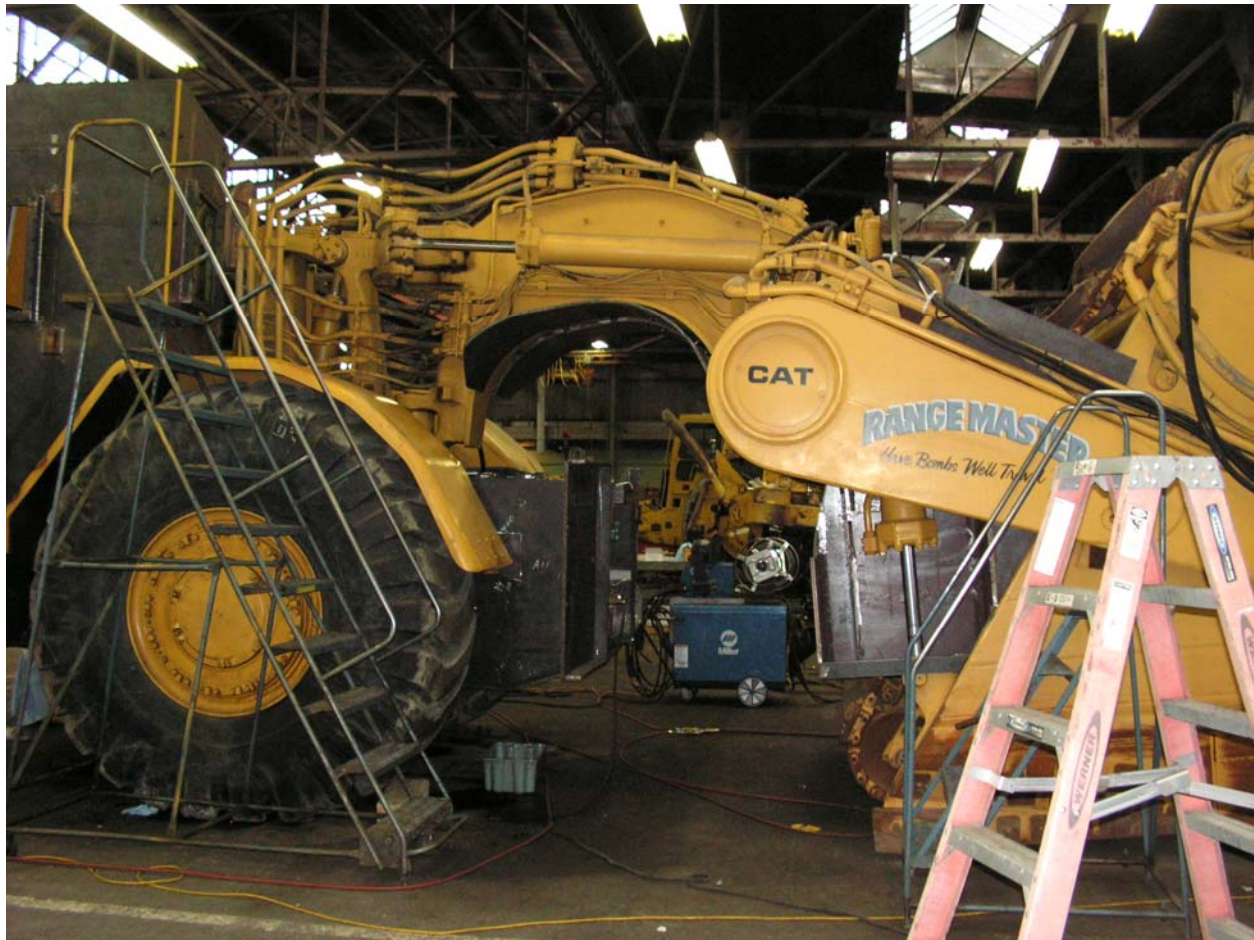
**Figure 12: Phase II Armor Installation**  
**(Note Steel under Neck, behind Engine and Depth Ram)**

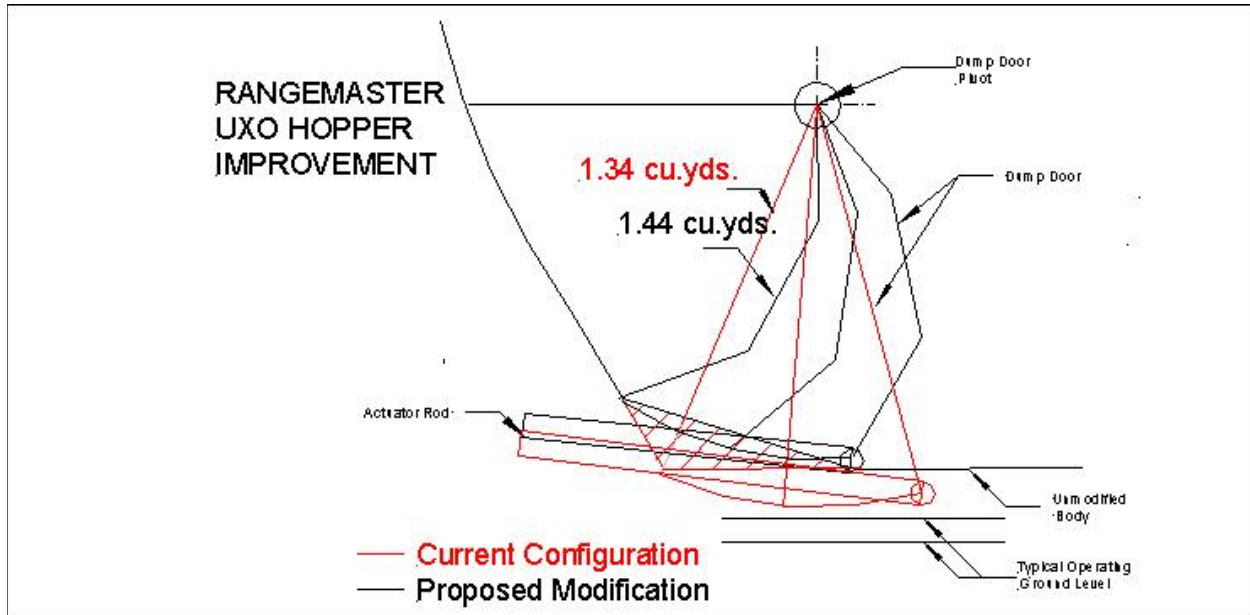
Figure 15: Phase I and Phase II Hopper Design

The Phase I screened hopper design was modified so it did not contact and drag on the ground when fully open. Figure 15 shows the original hopper design and the Phase II design. The upgraded hopper design increased the hopper capacity from 3.34 cubic yards to 3.44 cubic yards.

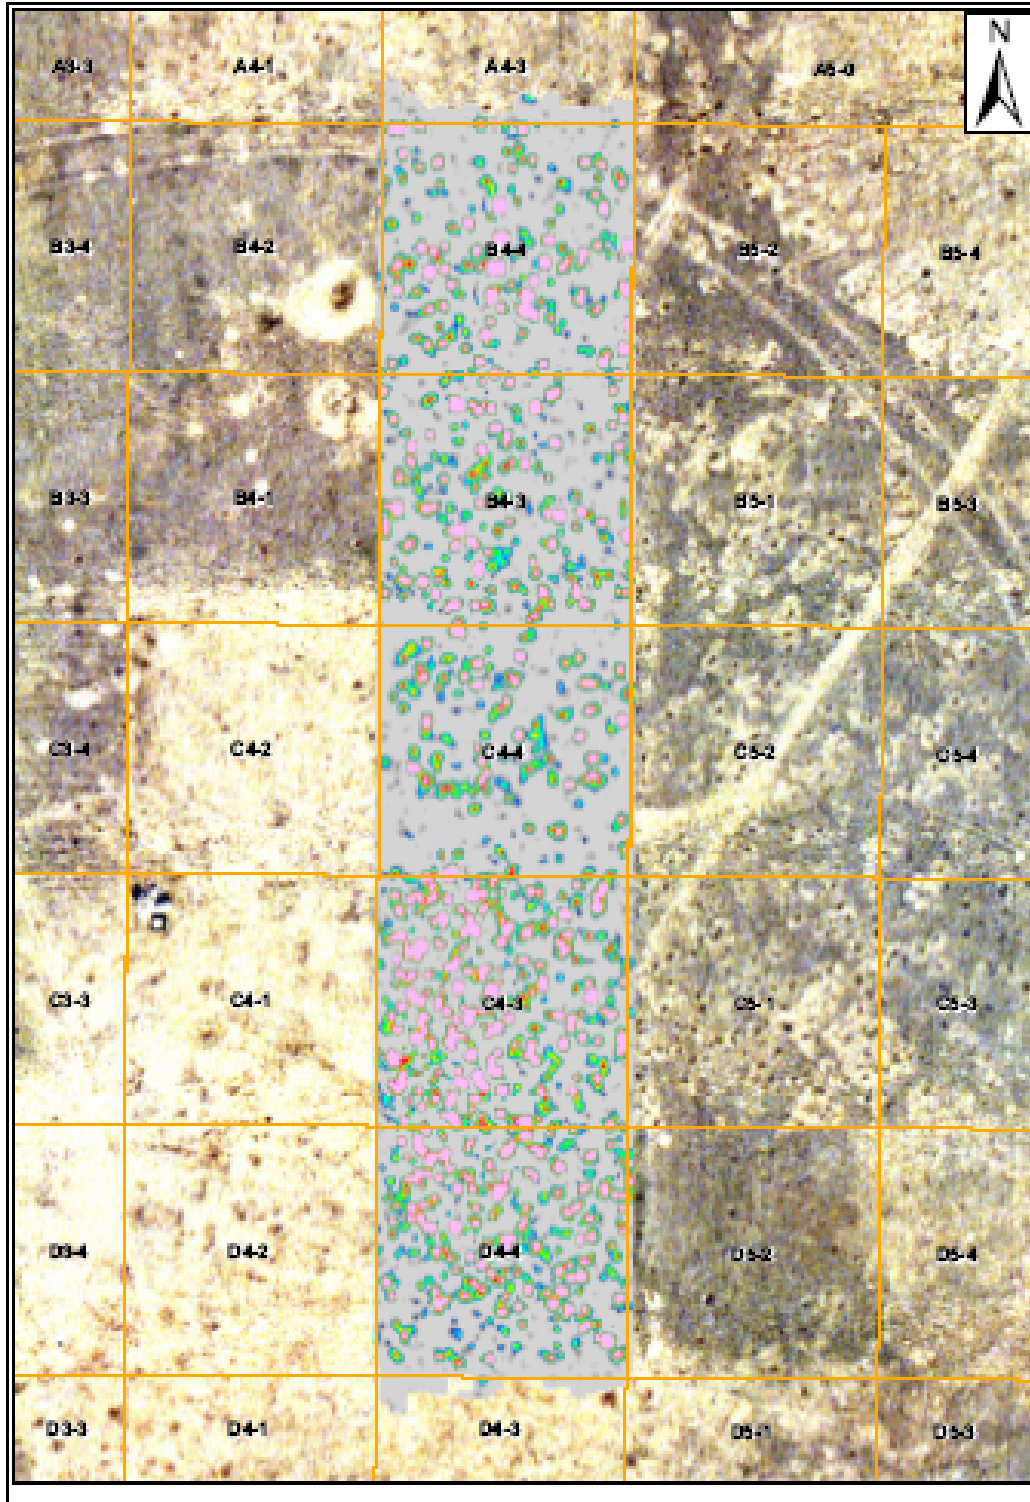
Figure 30: Pre-Excavation DGM of Demonstration Grids at FLBGR BT#2

Following the initial surface sweep of the five consecutive 50- x 50-m demonstration grids by Shaw, Sky Research (Sky) performed the pre-excavation DGM of the selected grids. USA processed and analyzed all of the time gates from the EM61-MK2 array deployed by Sky. The DGM data from time gate 3 showed the best overall response and documented that the grids were heavily contaminated with subsurface metal, typical of areas adjacent to a bombing target. This data was acquired with an array of EM61-MK2 all metals detectors. The data shown in Figure 30 is for Time Gate 3 and documents that the selected demonstration area is a high density site.

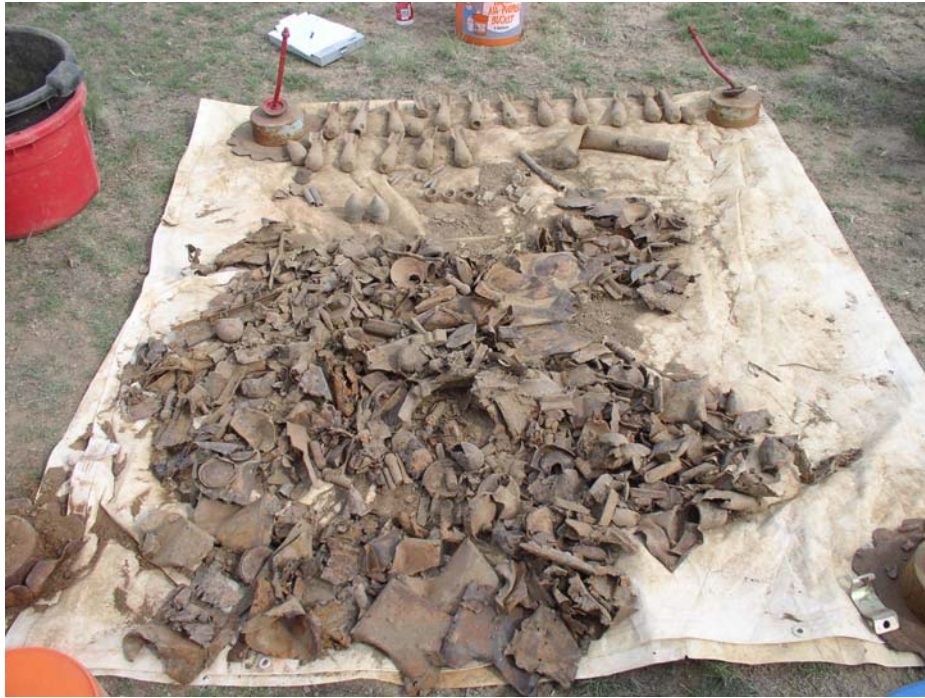
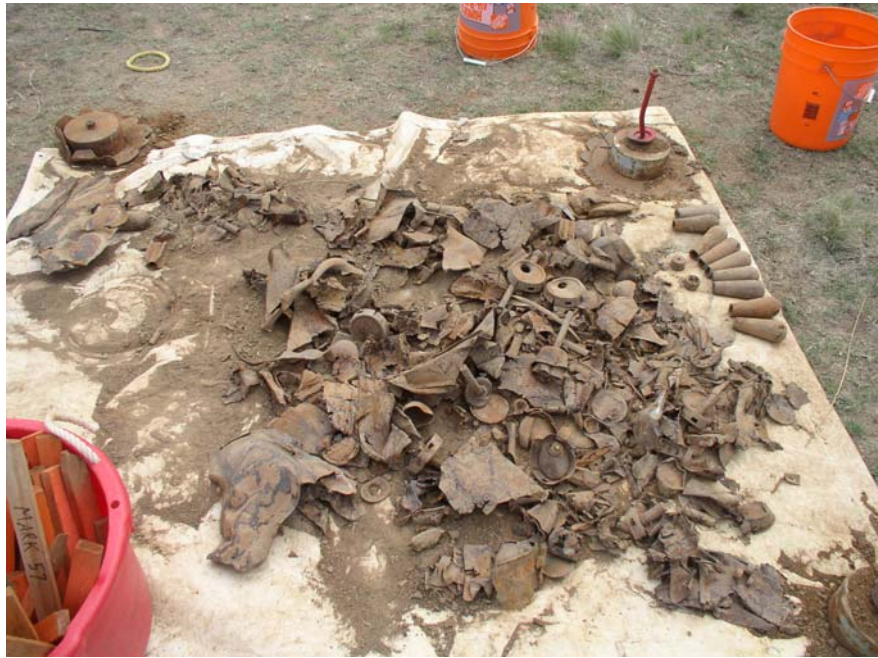
**Figure 34: Photographs of Items Excavated by Range Master from FLBGR BT#2**

Item Excavated	From Dump Piles		From Grids	
	Count	Unit	Count	Unit
Mk 23 Bomb	35	each	15	each
Booster Cup	3	each		
Booster (M152 Fuze)	2	each		
HE Bomb Frag	1	each		
HE Frag	3	each		
OE Scrap	2,059	each		
2.25" Rocket	1	each		
Small Arms	11	each		
Non OE Scrap	3	each		
Subtotals	2,118	each	15	each
Estimated Weight of Items Excavated	443	lbs	65	lb

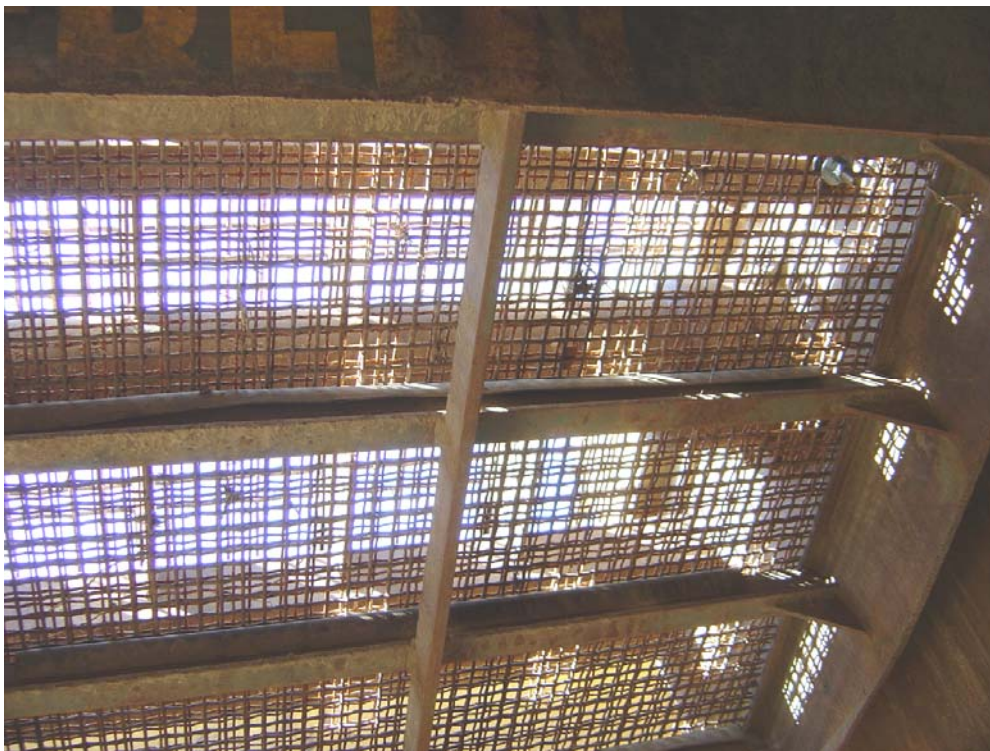
**Figure 35: 0.75-in. Over 1.0-in. Secondary Screen**

It was noted that the 0.75-in. screen bolted to the 1.0-in. secondary screen created an effective screen mesh finer than the desired 0.75 in. This had the effect of loading the hopper with unprocessed soil prior to reaching the end of each excavation run. At the end of the day, together with the State Regulator, and ESTCP, it was decided to remove the 0.75-in. screen and continue with the 2.0-in. primary screen and the 1.0-in. secondary screen.

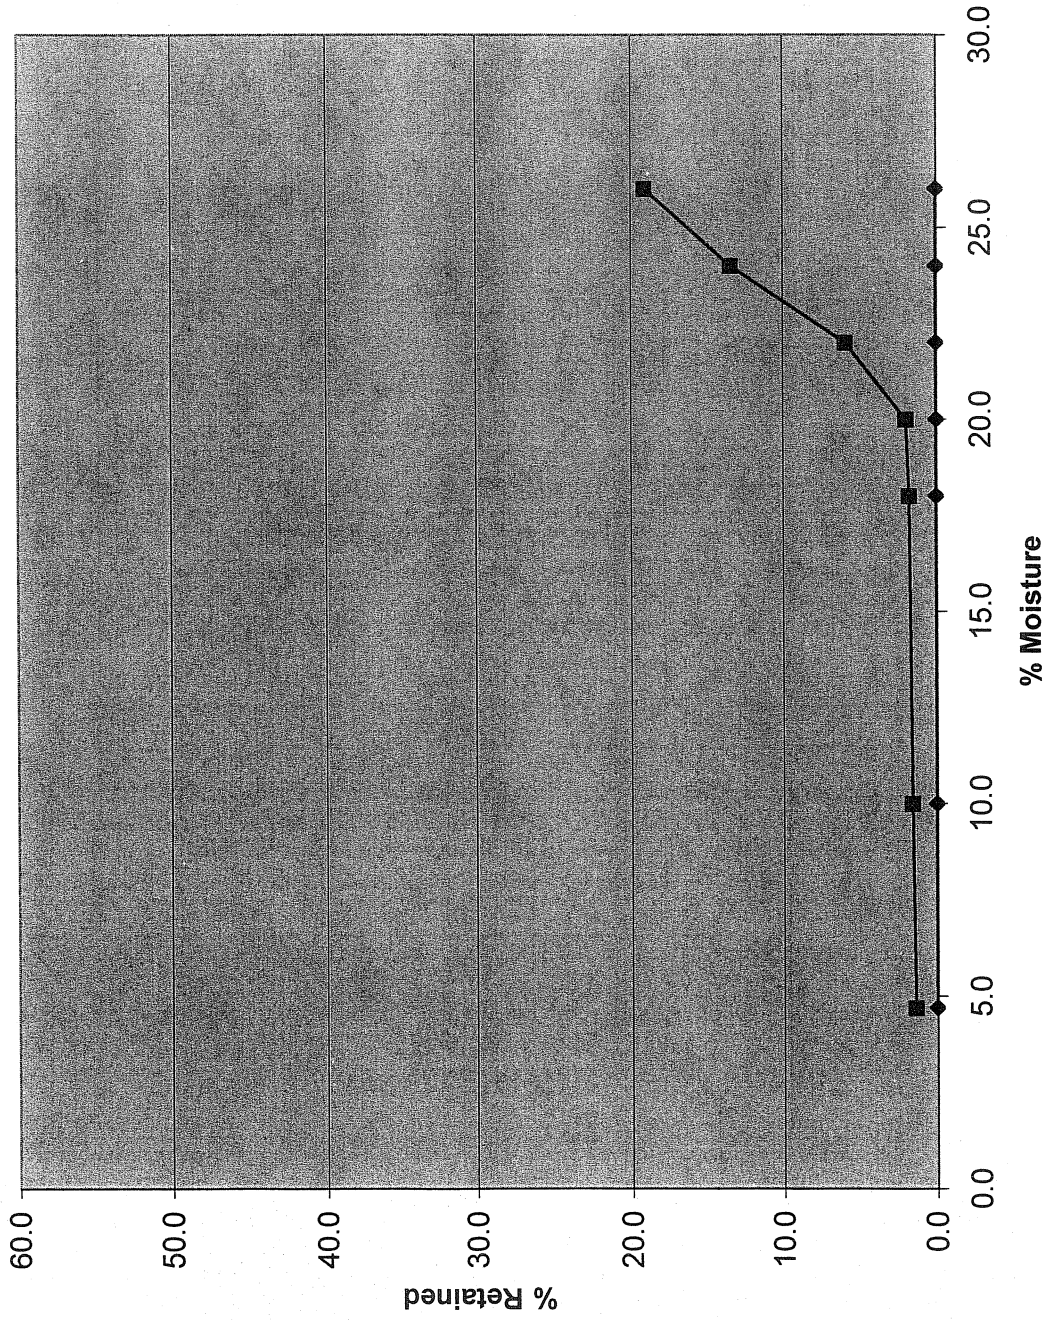
# 2" and 1" Sieve Combination

◆ % Retained 2" Sieve (2-1")  
■ % Retained 1" Sieve (2-1")

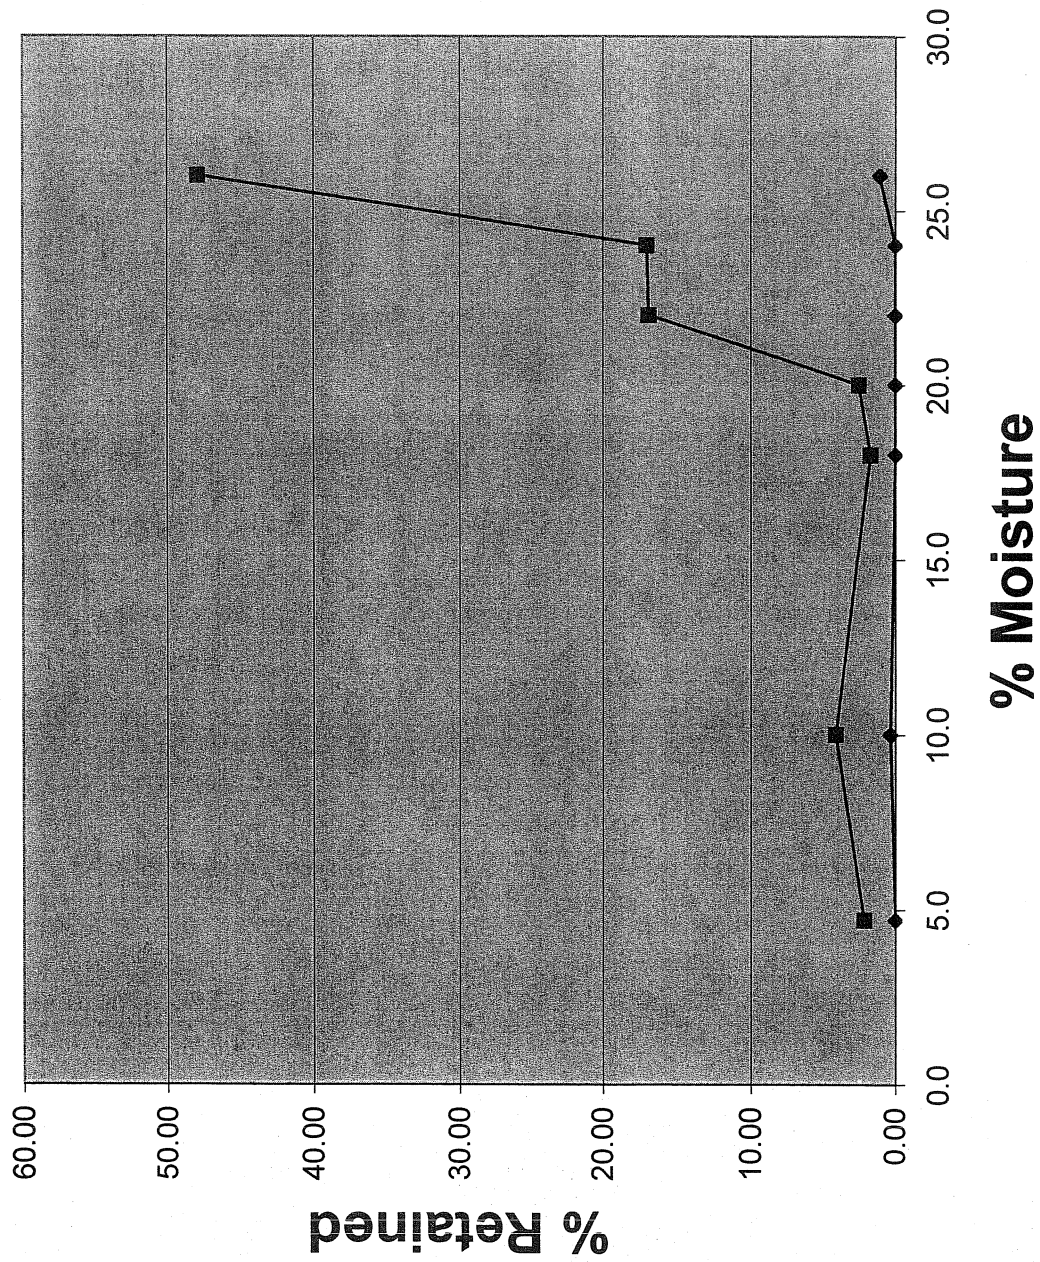
# 2" and 3/4" Sieve Combination

◆ % Retained 2" Sieve (2-3/4")  
■ % Retained 3/4" Sieve (2-3/4")
