# Final Draft Environmental Assessment

## San Antonio Creek Restoration

### Vandenberg Air Force Base California

**27 June 2008**

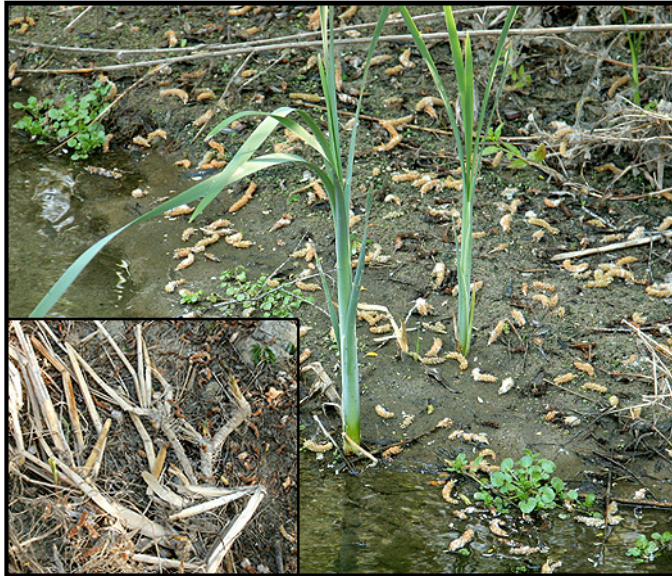
Figure 2. *Typha* sp. and *Rorippa nasturtium-aquaticum*, watercress, recolonizing creek bank. Inset: *Typha* sp. resprouting from exposed rhizome.

Fresh water marsh occurs primarily as an understory to the willow riparian in and along the creek, on low lying benches, and along ephemeral and secondary channels. Fresh water marsh grows in areas subject to scouring during winter high flows. *Typha* spp. (cattails), and *Scirpus* spp. (rushes) dominate in and along the creek, and ephemeral and secondary channels. Species such as *Urtica dioica* (stinging nettle) and *Baccharis douglasii* (marsh Baccharis) dominate on low lying benches. Much of this vegetation was washed away during the 2007-2008 winter rains. In the course of the present survey, it appeared in an early successional state, dominated by seedlings or resprouts from buried root material, with bare ground predominating. Due to the early successional state of this vegetation type, it is likely to become

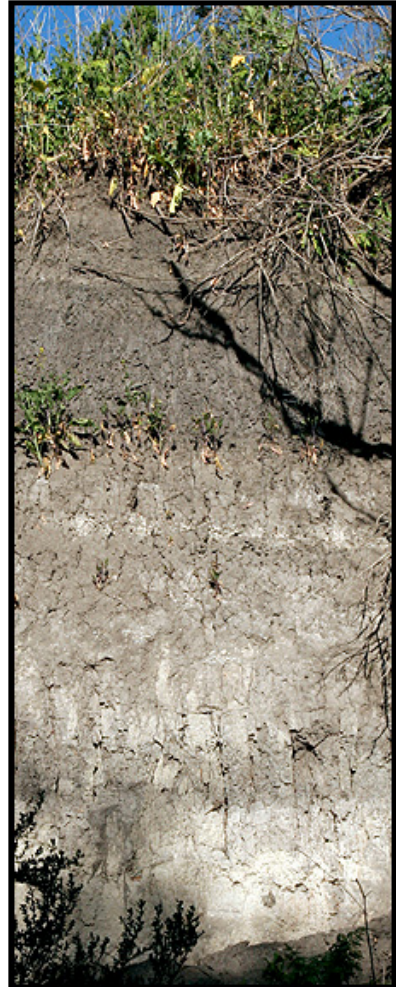
Figure 4. The dark upper layer visible on this eroding cliff face is a silty clay loam reflective of relic hydric conditions

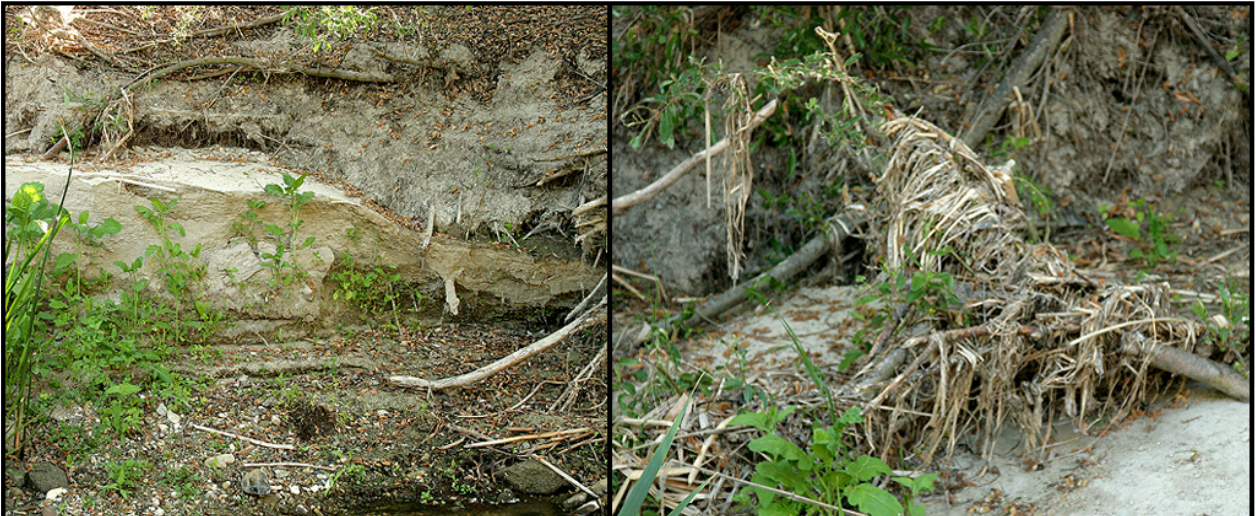
Figure 5. Shelving on the bank (left) and sediment deposits (right) were two features used to determine the OHWM.
