AIRBORNE LIDAR SURVEYS AND REGIONAL SEDIMENT MANAGEMENT

Jennifer McClung Wozencraft¹ and Jennifer L. Irish²

ABSTRACT

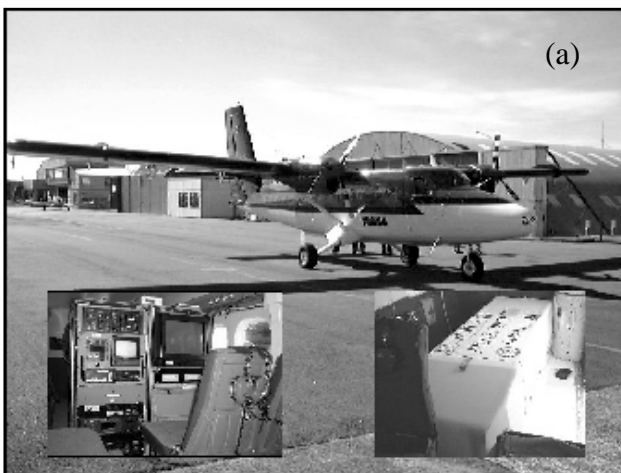
Figure 5. (a) SHOALS system mounted on a Twin Otter and (b) layout of SHOALS system inside Twin Otter.

The SHOALS ALB system operates from both fixed-wing and rotary-wing platforms (Figure 5a, 2, 4, 5). Inside the aircraft are the laser transceiver, operator interface consoles, and pilot guidance system (Figure 5). The SHOALS system's laser transceiver emits two energy frequencies: a blue-green frequency (532 nm) and an infrared frequency (1064). In addition, the transceiver records laser energy return time series (waveforms) with four receivers. One receiver records the infrared energy

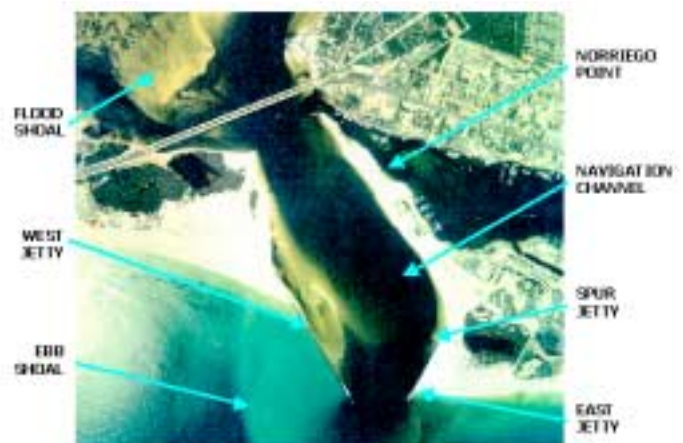
Figure 7. East Pass, Florida, U.S.A. Aerial photo taken in 1989. North is to the top.

East Pass is a tidal inlet located on the Florida panhandle (8). It connects Choctawhatchee Bay with the Gulf of Mexico. Figure 7 is an aerial photo taken at East Pass in 1989. The rubble mound jetties were built in a converging design as part of a Federal navigation project. A navigable depth of 4.3 m is maintained within the Federal channel alignment by periodic dredging activity. Norriego Point is a sand spit that has grown across the channel connecting the inlet interior with Old Pass Lagoon. Old Pass Lagoon marks an historical location for access to Choctawhatchee Bay, when the inlet mouth was located several miles to the east. Other dominant features at the pass include extensive, sandy ebb and flood shoals.
