Innovative Engineers Pave New Paths in Afghanistan

By Major Steven A. Baker

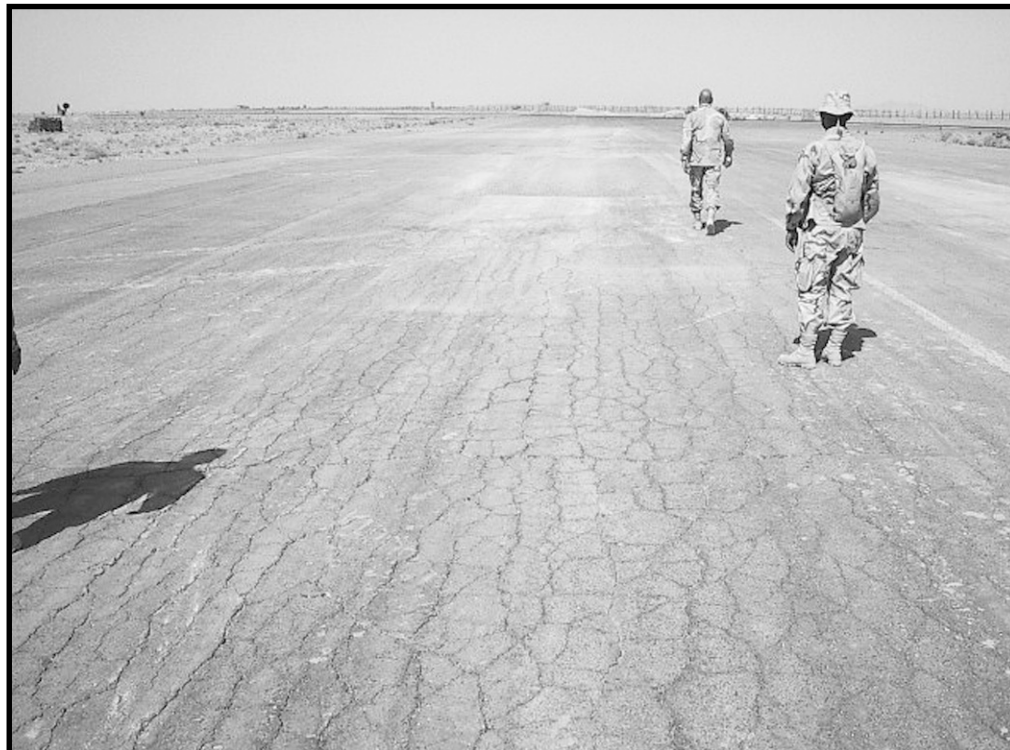
Task force engineers inspect a damaged section of asphalt.

The first step of the method is cutting out and excavating the damaged areas of asphalt. The key to this step is the use of a concrete saw with a diamond-tipped blade to create clean, linear cuts and a skid steer loader to quickly excavate the damaged asphalt down to the subgrade. The subgrade is then compacted and additional fill gravel is added so that the concrete patch created

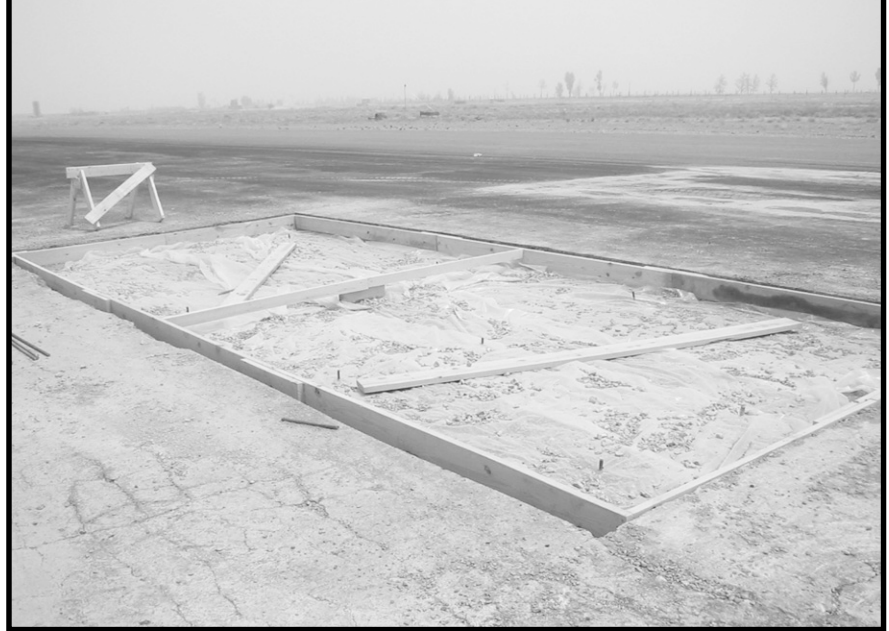
Offset framework, complete with vapor barrier, is ready for the arrival of the concrete truck and crew.

will be 8 to 10 inches thick. The form is cut and installed to create individual cells that are typically no bigger than 300 square feet. Plastic sheeting is placed over the gravel to prevent water required for hydration from percolating through the gravel. No. 5 rebar (12 inches on center with lateral bracing that is 16 inches on center) provides additional strength and minimizes cracking.

To ensure that enough water is available for hydration, sandbags are placed over each new pad and watered regularly. After several days of curing, gravel is placed in the gap up to the level of the existing asphalt and then cold-patch asphalt is added and compacted to create a level surface for aircraft use. Asphalt sealant is then spread over the asphalt and the cold-patch to waterproof

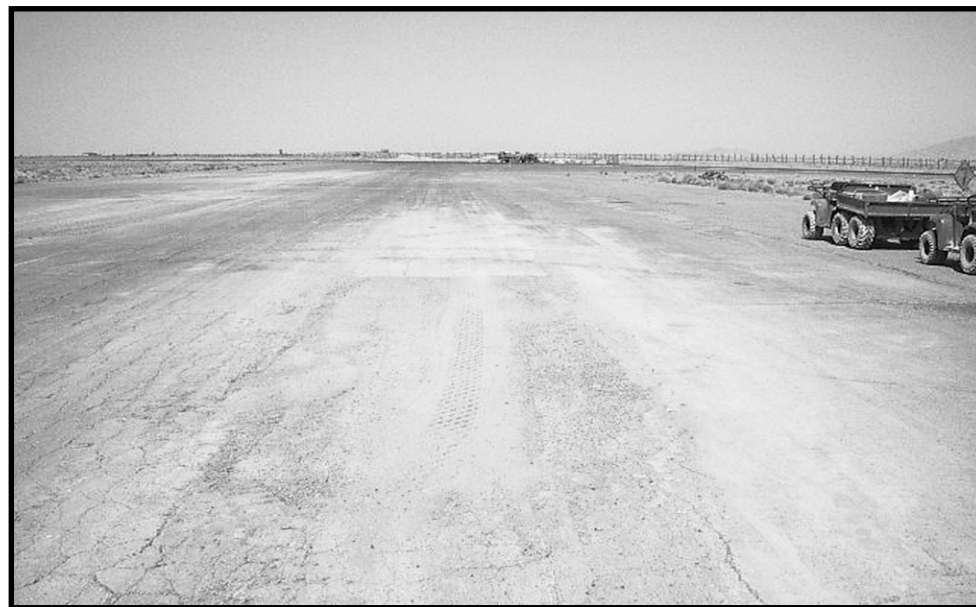
A recently stabilized soil patch is prepared for an application of dust control agent.

The early steps in this method mirror those of a preplanned concrete patch. A square or rectangular patch is cut and excavated down to the level of the subgrade. Then 2-inch slump concrete is placed in 2- to 3-inch lifts, raked of large aggregate, and covered with a thin layer of coarse sand. This process is repeated until the grade of the existing asphalt pavement is reached.

The last step of the method involves dust control. To prevent “brown-out” conditions that hamper visibility, EK 35®, a commercial dust control agent, is spread over the soil patches in several thin coats until the agent begins to pool. This nonflammable, non-corrosive binding agent not only prevents brownouts, it actually increases the durability of the soil patch. The dust control agent has been so successful that it has been used on many of the high-traffic shoulder areas of the airfield and on many of the helicopter landing zones throughout the Afghanistan area of operations.

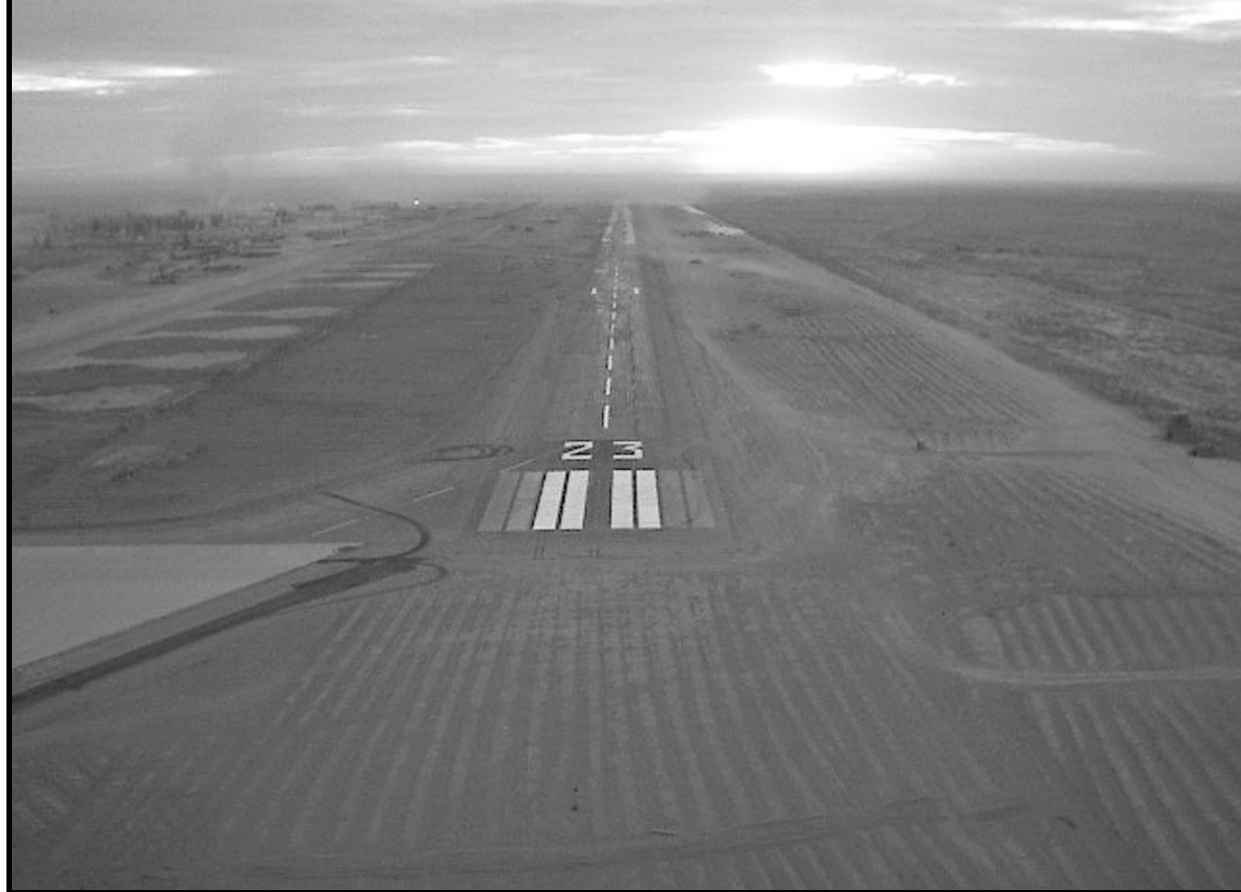
An overhead view of Runway 23 shows that Federal Aviation Administration-approved reflective paint, plus a recent application of asphalt sealant, can make a runway look new despite its age.
