**EFFECT OF STEAM ENVIRONMENT ON CREEP BEHAVIOR OF  
NEXTEL720/ALUMINA-MULLITE CERAMIC MATRIX  
COMPOSITE AT ELEVATED TEMPERATURE**

THESIS

AFIT/GSS/ENY/09-M03

***AIR FORCE INSTITUTE OF TECHNOLOGY***

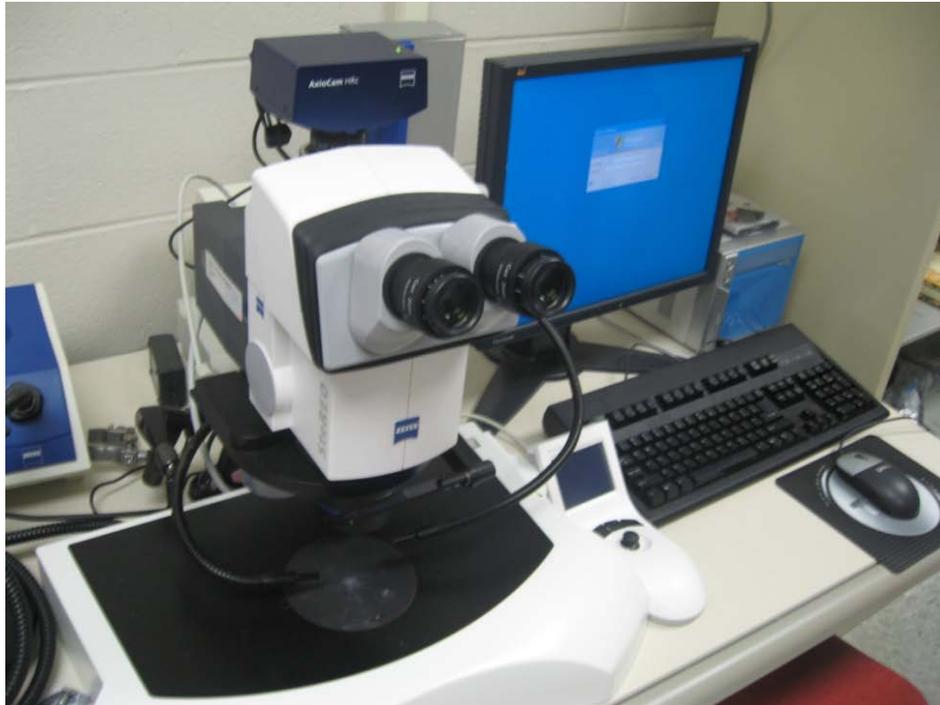
Figure 15. Zeiss Discovery V12 Optical Microscope.

Both an optical microscope and a scanning electron microscope (SEM) were used for post test analysis of the failed specimens' fracture surfaces. A Zeiss Discovery V12 optical microscope equipped with a Zeiss AxiCam HRC digital camera was used to examine the damage zones of the specimens. Figure 15 shows a Zeiss Discovery V12 optical microscope. Micrographs were taken at various magnifications up to 100X by the optical microscope.
