NON-DESTRUCTIVE EVALUATION OF AEROSPACE COMPOSITES

THESIS

AIR FORCE INSTITUTE OF TECHNOLOGY

Degree of Master of Science in Materials Science

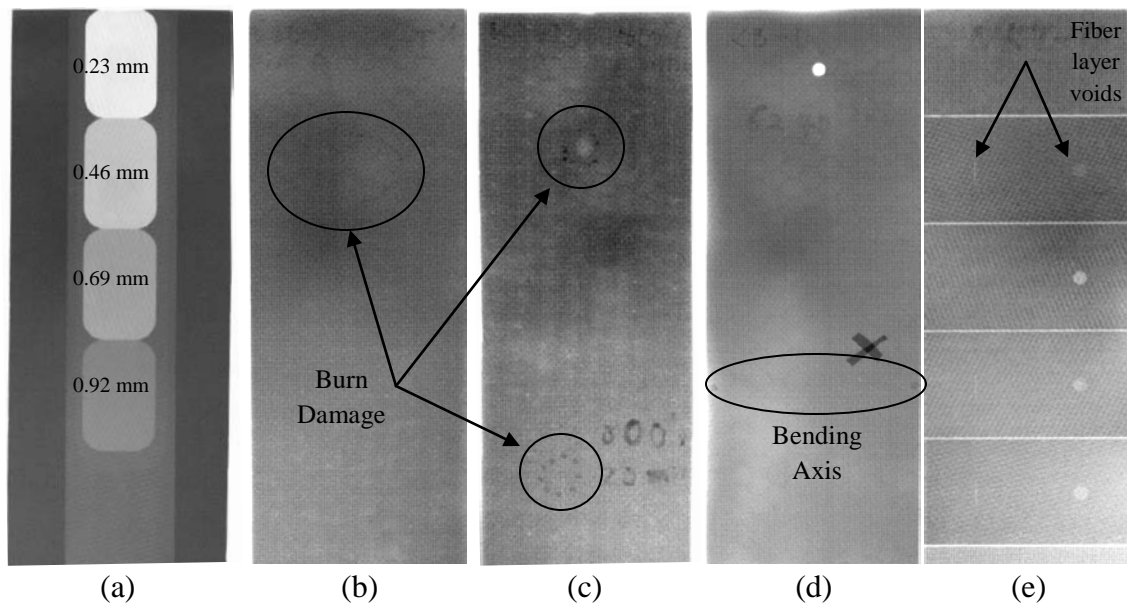
Figure 12. X-ray through scans of fiberglass composite samples showing front views of (a) thickness variation, (b) 4 minute 830°F burn damage, (c) 6 minute 810°F and 20 minute 800°F burn damage, (d) bending damage, and (e) sub-surface voids and delamination.

The five shadowgraphs depicted in Figure 12 are the result of the frame averaging of 32 digital snapshots taken of each sample at a rate of 1 fps. Only one side of each sample was scanned. The lighter areas indicate higher material transmittance of X-rays while darker areas are regions of greater material absorption or scattering of X-rays. The image contrast provides information about the material's relative density and thickness. The digital images' contrast ratios were individually altered for better viewing of the internal structure and/or defects. The digital images' contrast ratios were individually altered for better viewing of the internal structure and/or defects. No penetrant or dye was used to aid damage detection.

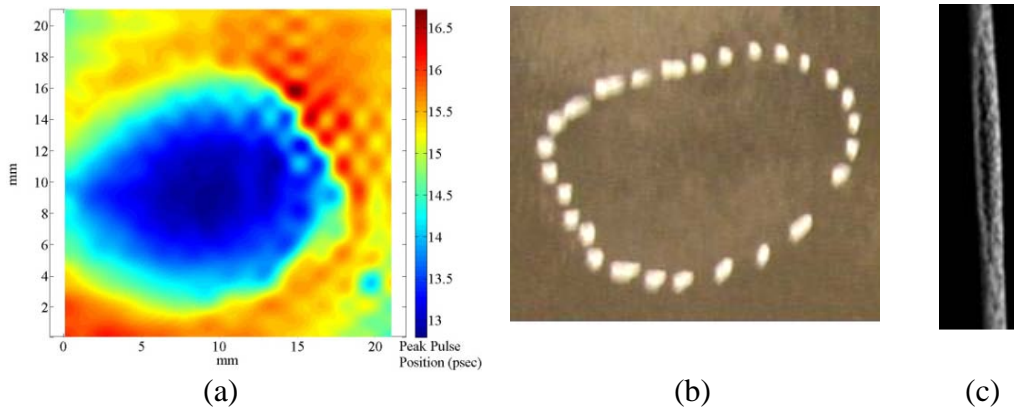
Figure 18. A fiberglass composite sample with a spot burned for 4 minutes at 830°F imaged with (a) pulsed THz imagery showing the return time delays of the reflected peak pulses, (b) still photography, and (c) X-ray Computed Tomography showing the internal cross-section.

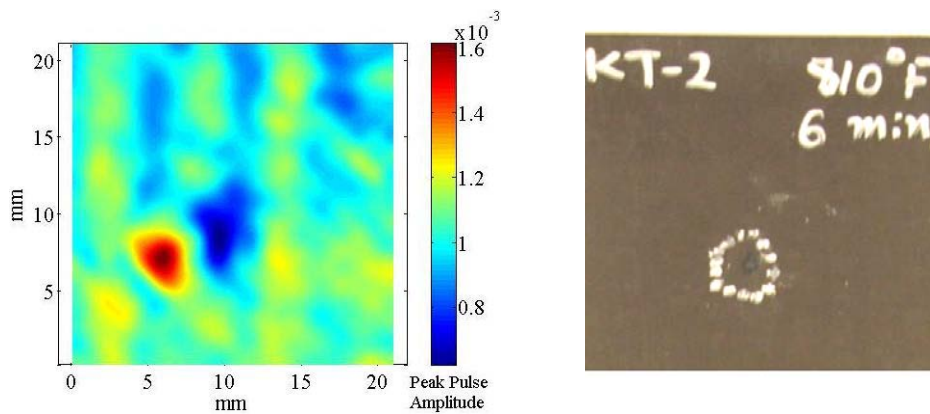
Figure 19. Pulsed THz imagery of a fiberglass sample showing reflected peak pulse amplitudes of 6 minute 810°F burn damage and white marker dots.
