# Performance of the Tin-Free Antifouling Coating International *Ecoloflex* in DSTO/RAN Trials

**Maritime Platforms Division**  
Defence Science and Technology Organisation

DSTO-TR-2203

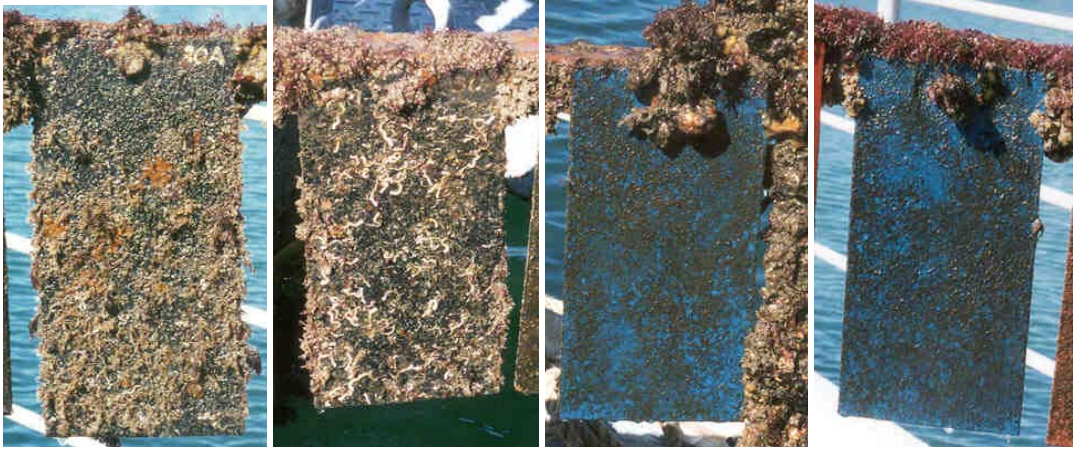
Figure 1: Test panels on Williamstown raft, 23 March 2000: left, control panels after 43 days immersion; right, Ecoloflex panels after 39 months (first immersed 23 Dec 1996)

Trials recommenced in December 1996 with fresh panels of the *Ecoloflex* system immersed at this time. At the inspection on 3 May 2000, these panels were free of macrofouling growth after 40 months immersion. Figure 1 illustrates the appearance of the panels at the inspection on 23 March 2000. Only slime and mud tubes built by free-living amphipods were present on the *Ecoloflex* panels, whereas the control panels, after less than 2 months, were heavily fouled by tubeworms, macroalgae, barnacles, bryozoans and ascidians. Fouling and physico-chemical data for the raft site over this period are included in the Appendix.

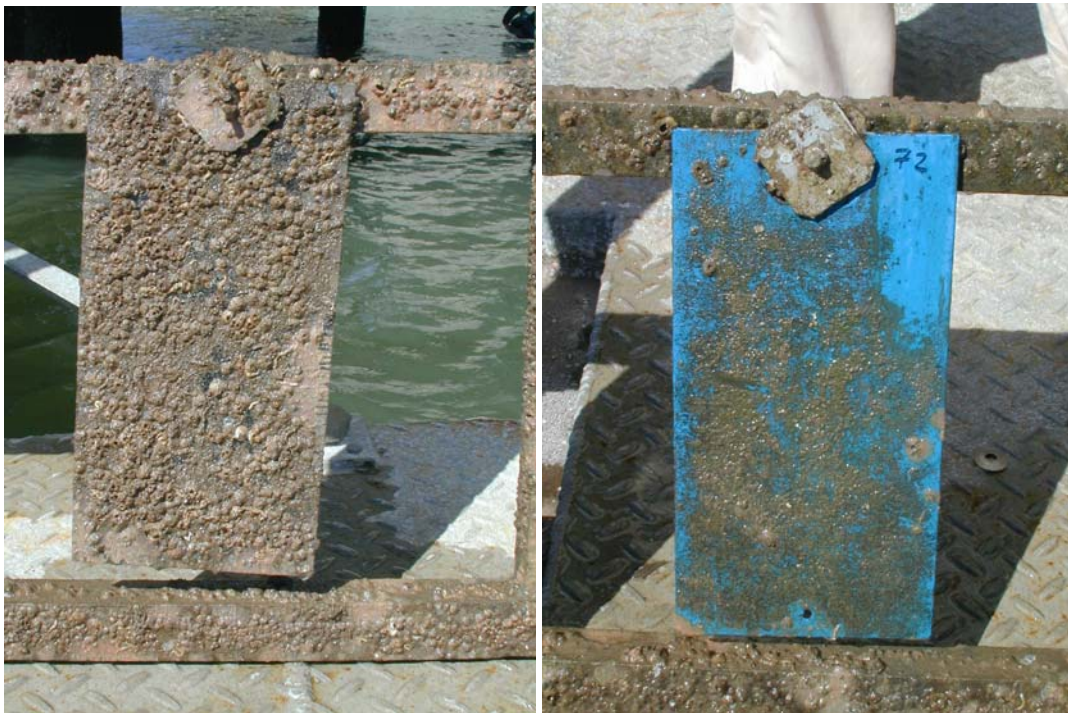
Figure 2: Test panels on Cairns raft, 12 May 2000: left, control panel after approximately 3 months immersion; right, Ecoloflex panel after 33 months (first immersed 14 August 1997)

*Ecoloflex* panels were immersed on the raft at *HMAS Cairns*, Trinity Inlet, Cairns, in August 1997. When inspected in May 2000, the panels were predominantly covered by a thick slime, unlike the control which was heavily fouled by barnacles and other fouling species (Figure 2). Several barnacles and bryozoan colonies were present on the surface of the *Ecoloflex* panels, but these were loosely adherent and easily dislodged.

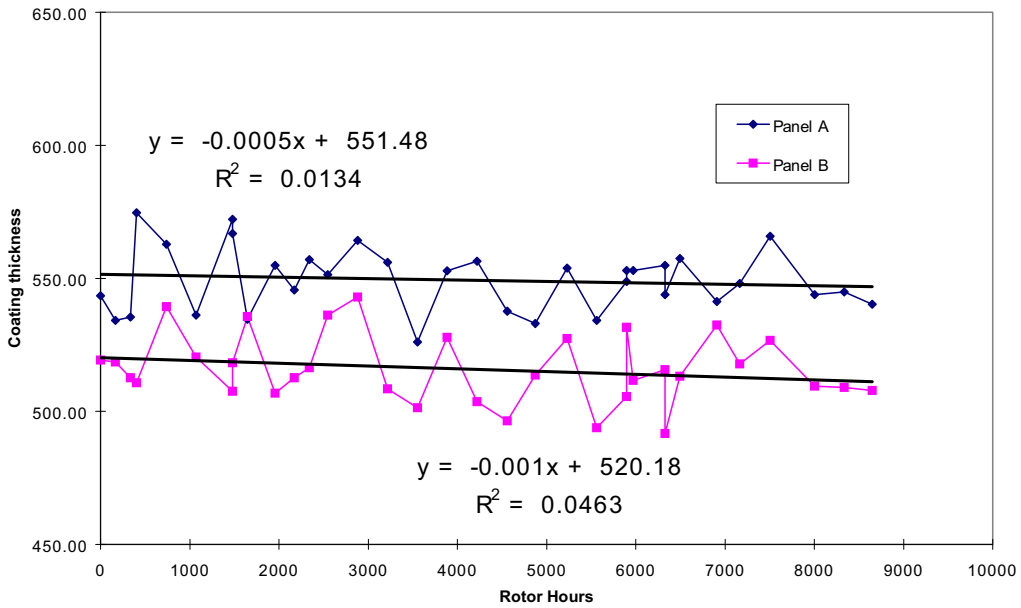
Figure 4: Ablation of the Tin-Free system BGA535/537 in the 1994/1995 rotor trial

The first rotor trial which included *Ecoloflex* commenced in March 1994 and continued through until October 1995, the effective rotor exposure time totalling more than 8500 hours. Two panels of each system were included in the trial. Graphs showing the performance in this trial of three *International* systems, a TBT-containing self-polishing copolymer coating (*Intersmooth BFA956/959*), an ablative tin-free coating (*BGA535/536*) and *Ecoloflex* (*XRS071/071*), are illustrated in Figures 3-5. The TBT system is the same system used at that time by the RAN on large surface vessels. The ablative tin-free is the system that gave unacceptable performance when used by the RAN as an alternative to TBT in the early 1990s. The graphs show that, unlike the ablative tin-free product, the *Ecoloflex* ablated consistently through the duration of the trial. Ablation rates for the three systems, calculated by linear regression of the measured data, are summarised in Table 1.

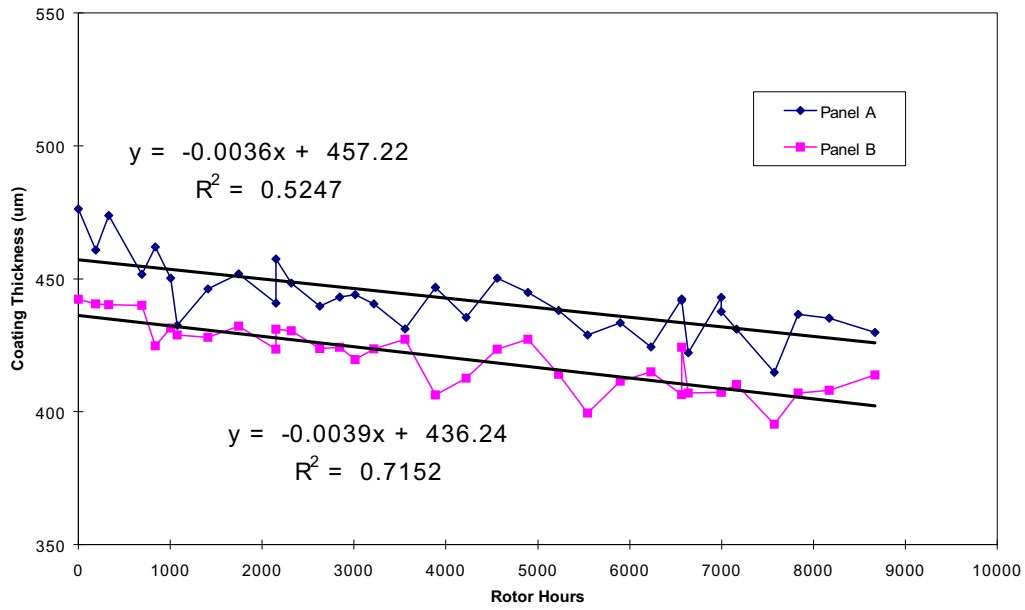
Figure 5: Ablation of the Ecoloflex system XRS 071/072 in the 1994/1995 rotor trial

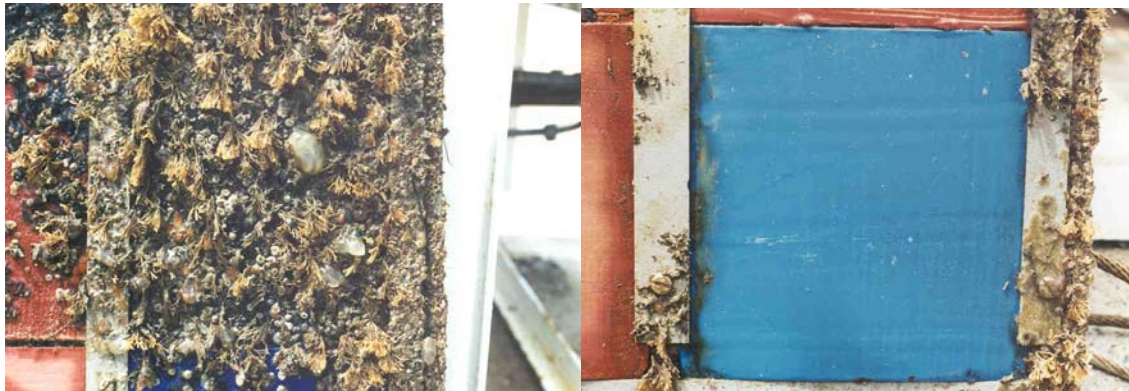
Figure 8: Ecoloflex panel (right) and non-toxic control (left) after static immersion during 1996/1997 rotor trial

In this trial, one panel of each pair was also suspended under Breakwater Pier for 10 weeks from September until December 1997. At the end of this period the *Ecoloflex* panel remained completely free of macrofouling, whereas the non-toxic control panel was heavily fouled by a diversity of fouling organisms (Figure 8).

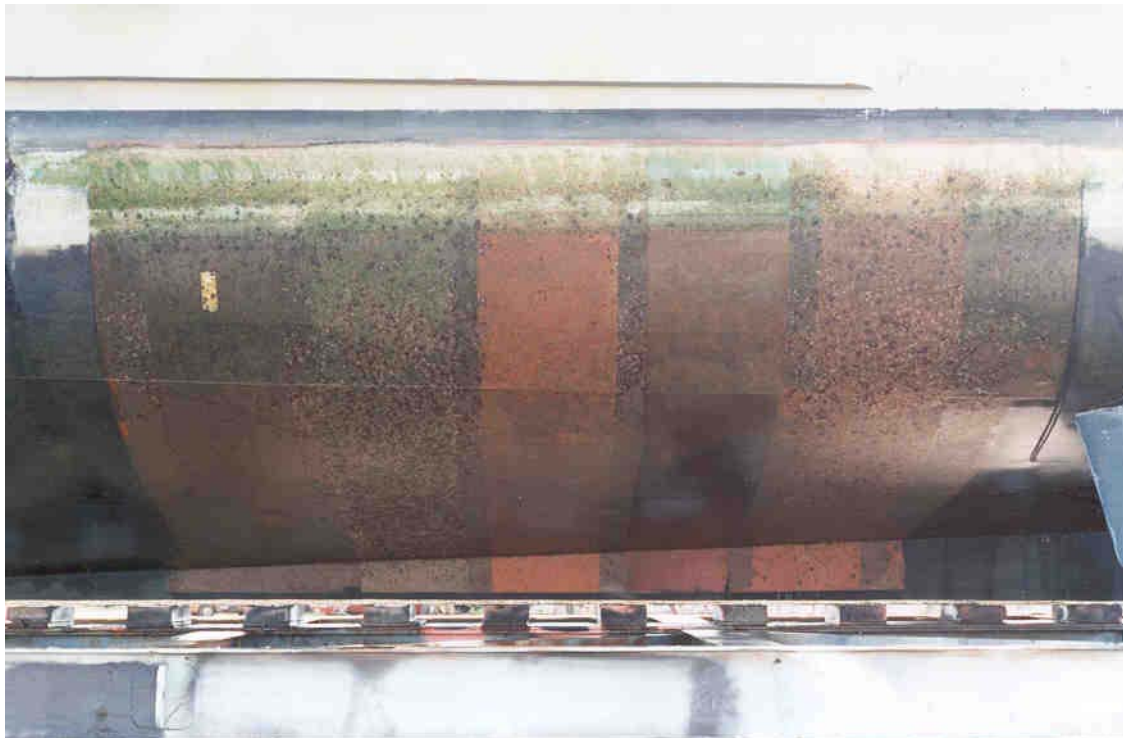
*Figure 9: Port side midships test strips on HMAS TOWNSVILLE at completion of trial after 31 months*

Although *Ecoloflex* was not one of the coating systems tested in this trial, the results are of value as a base for assessing antifouling performance on vessels based in Cairns. At the completion of this trial, after 31 months, all five coatings tested had fouled (Figure 9); all were fouled by green macroalgae near the water surface, and all but one were also fouled by macrofouling animals deeper down.

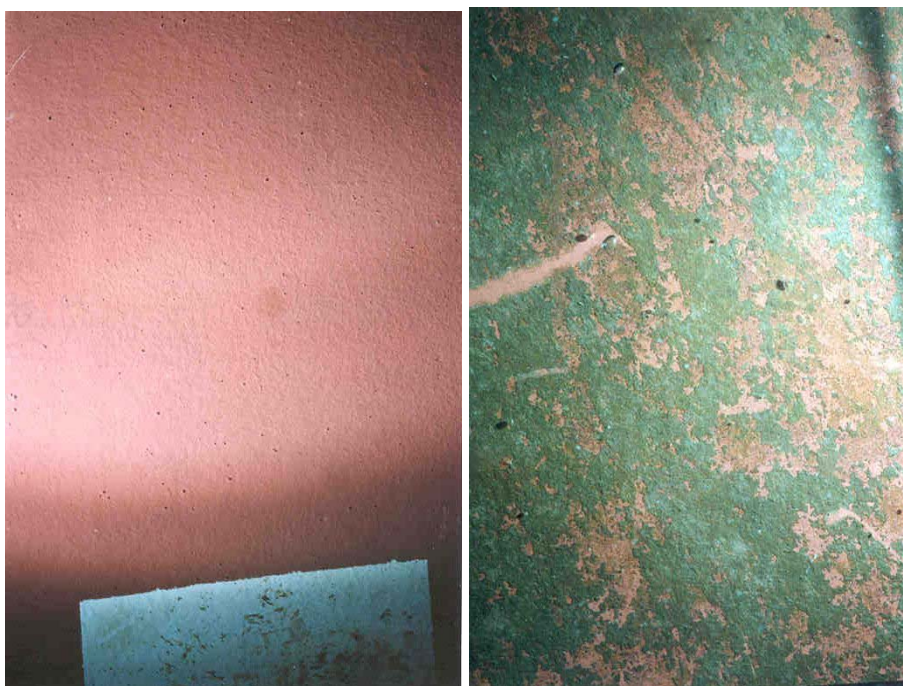
*Figure 10: Underwater photographs of Ecoloflex strip on HMAS BENDIGO in January 1995 (left) and October 1997 (right) showing only slime*

The first inspection of the test strips after the trial commenced on *HMAS Bendigo* in November 1993 was by divers in January 1995, and this showed the *Ecoloflex* coating to be in pristine condition (Figure 10). The more detailed inspection shortly after this, at the docking in Darwin in February 1995, confirmed the superior performance of the *Ecoloflex* system over the other five systems (Table 3, Figure 11). A second diver inspection in October 1997 found only slime on the *Ecoloflex* surface (Figure 10).

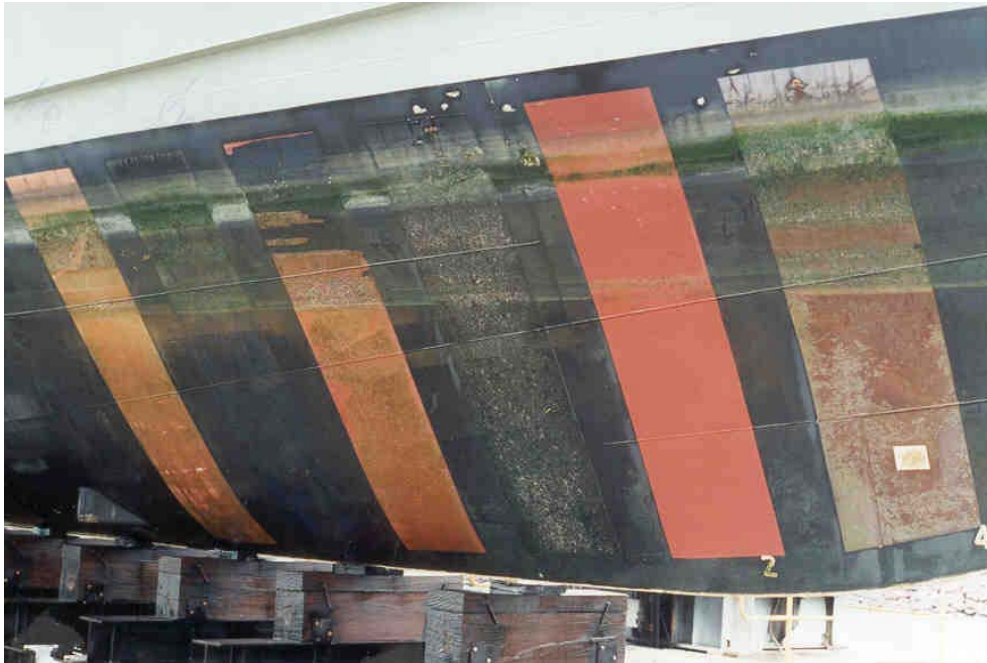
*Figure 11: Starboard side strips on HMAS BENDIGO, February 1995. Ecoloflex strip is second from right.*

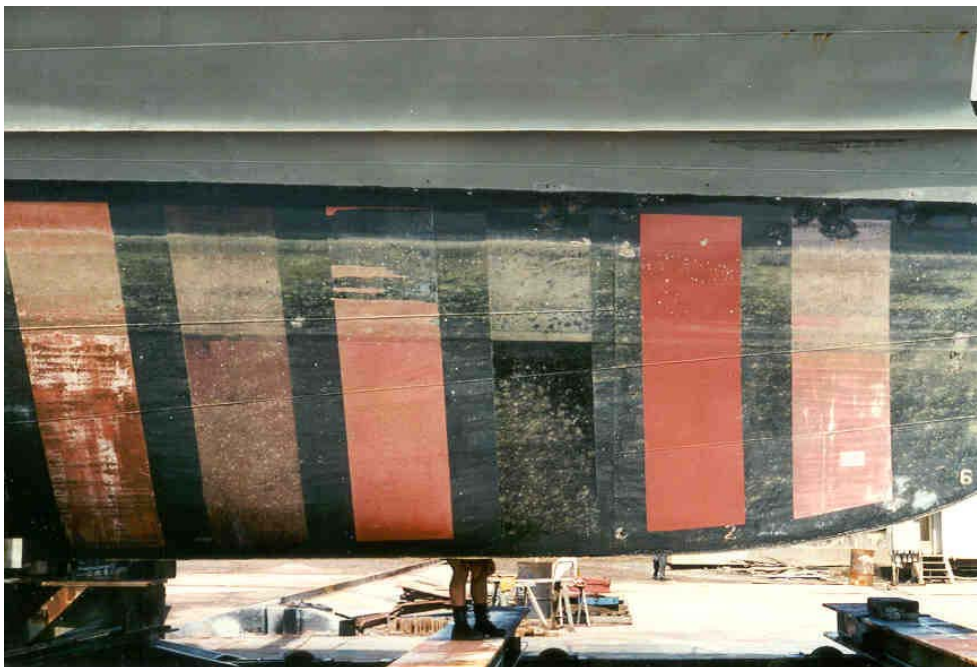
Figure 13: Starboard side strips on HMAS BENDIGO, April 1998

Unfortunately the timing and nature of the emergency docking of *HMAS Bendigo* in January 1998 did not allow for a detailed inspection of the test strips. However, a photograph taken shortly after the docking clearly shows continued good performance of the *Ecoloflex* system (Figure 12). At this docking the underwater hull, including the test strips, were high pressure washed. Continued good performance of the *Ecoloflex* was evident at the final inspection in April 1998 (Figure13).

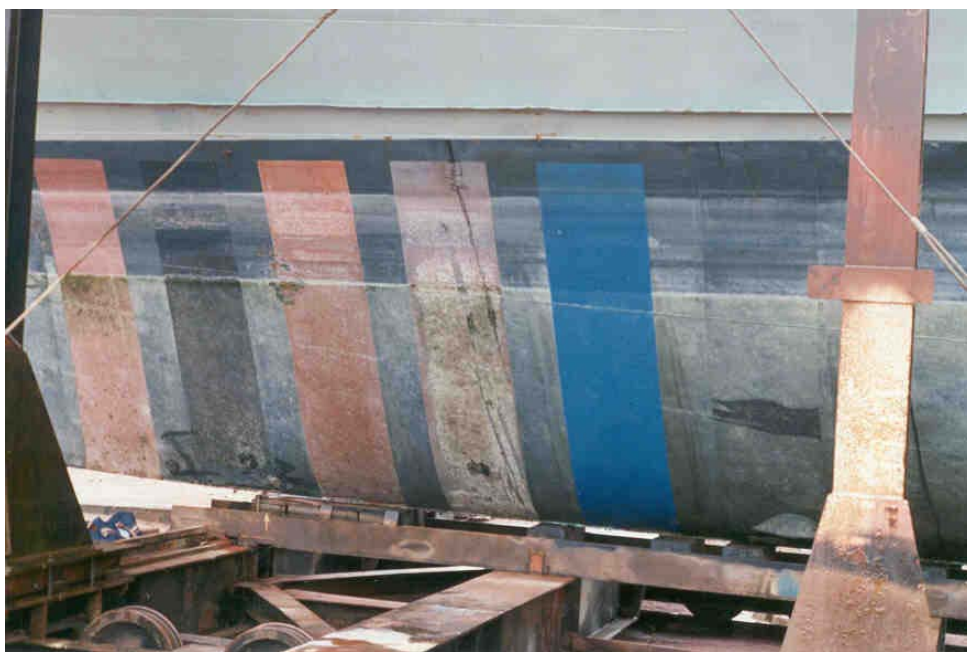
Figure 14: Port side strips on HMAS BUNBURY, February 1996. Blue strip is Ecoloflex

At the docking of *HMAS Bunbury* for refit in January 1996, the *Ecoloflex* was clearly the best performing coating in terms of both antifouling efficacy and coating integrity (Table 4, Figure 14).

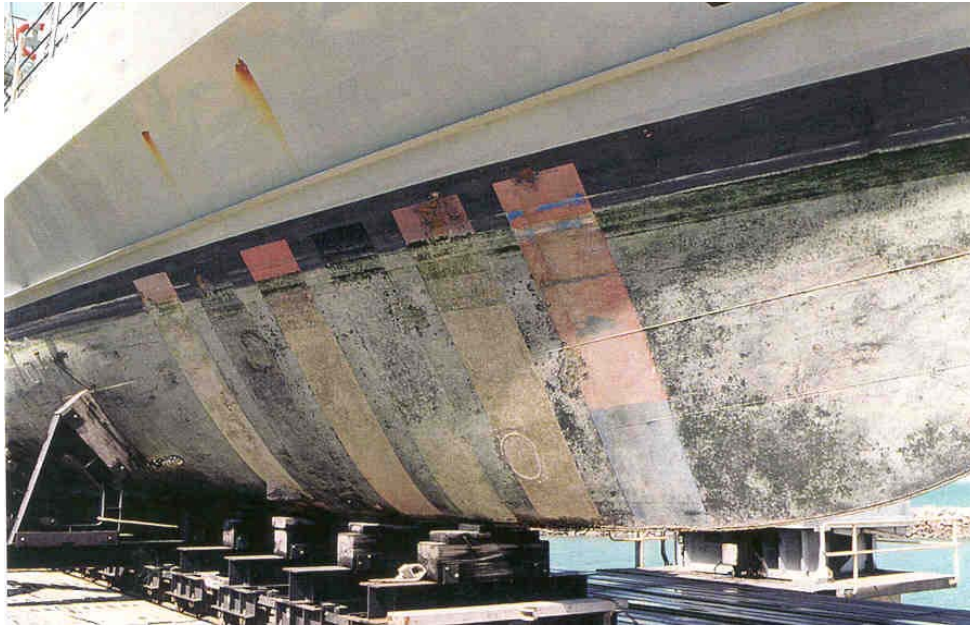
*Figure 15: Starboard side strips on HMAS BUNBURY, May 1998. Ecoloflex strip is first from right.*

DSTO staff were unable to inspect *HMAS Bunbury* at the docking in Darwin in May 1998, which preceded the premature removal of the test strips. However, the hull surveyors, G.A. Glanville & Co (Naval Architects) Pty Ltd, provided a brief report and photographs of the trial areas. The photographs (Figures 15, 16) show the *Ecoloflex* system to be performing effectively, and the report includes the comment:

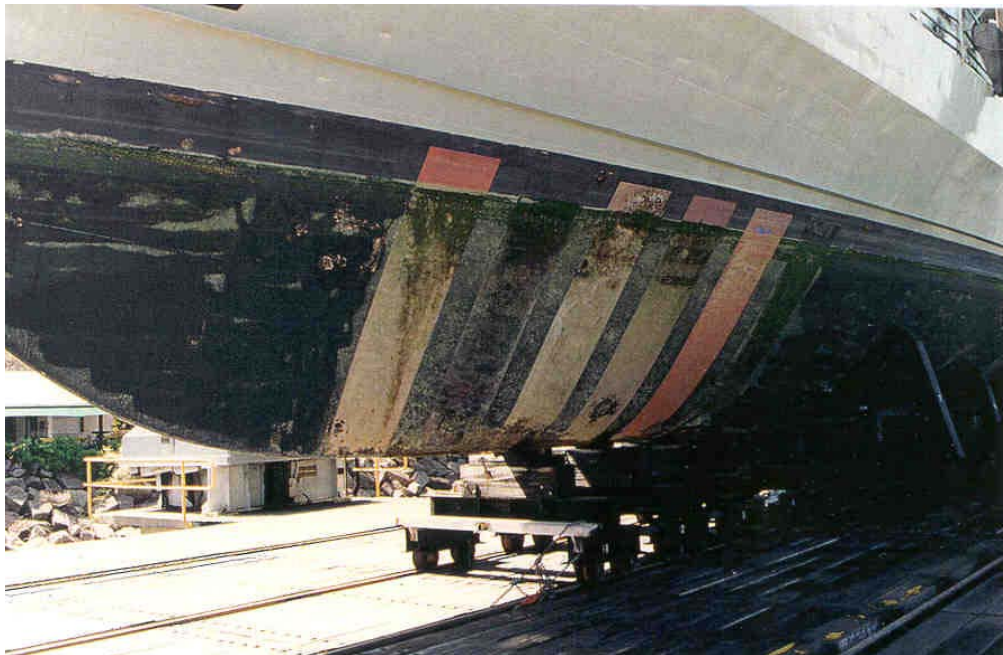
*Figure 16: Port side strips on HMAS BUNBURY, May 1998*

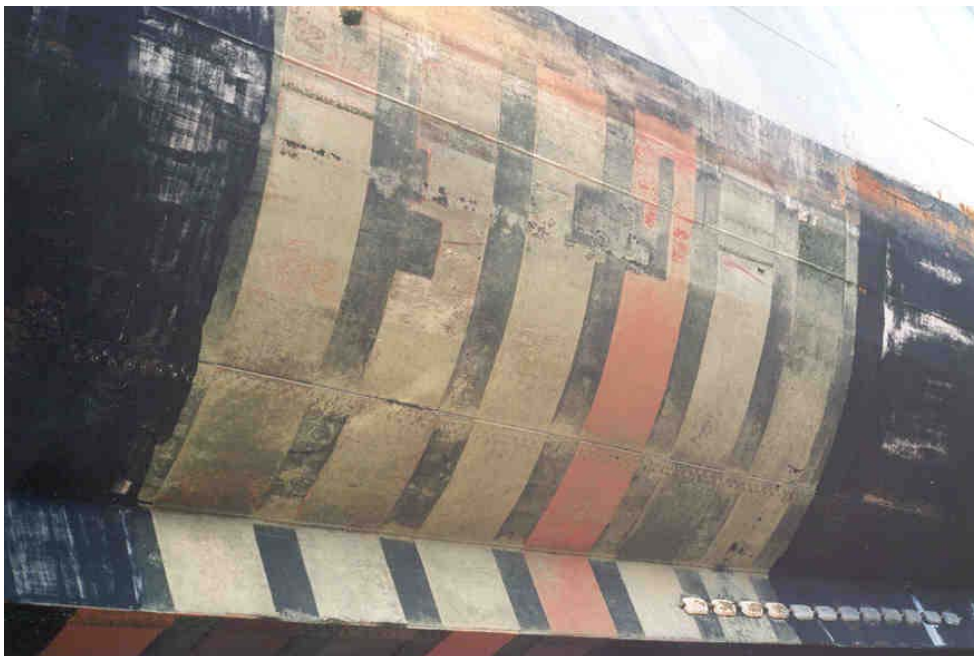
Figure 17: Port side strips on HMAS BRISBANE, May 1996. Ecoloflex strip is third from right.

When the trial areas on *HMAS Brisbane* were inspected at a docking in May 1996, after 30 months, the *Ecoloflex* system was showing superior performance in both fouling control and coating integrity (Table 5, Figure 17). This effective performance was maintained through to the end of the trial in March 1999, a total period of 64 months (Figure 18).

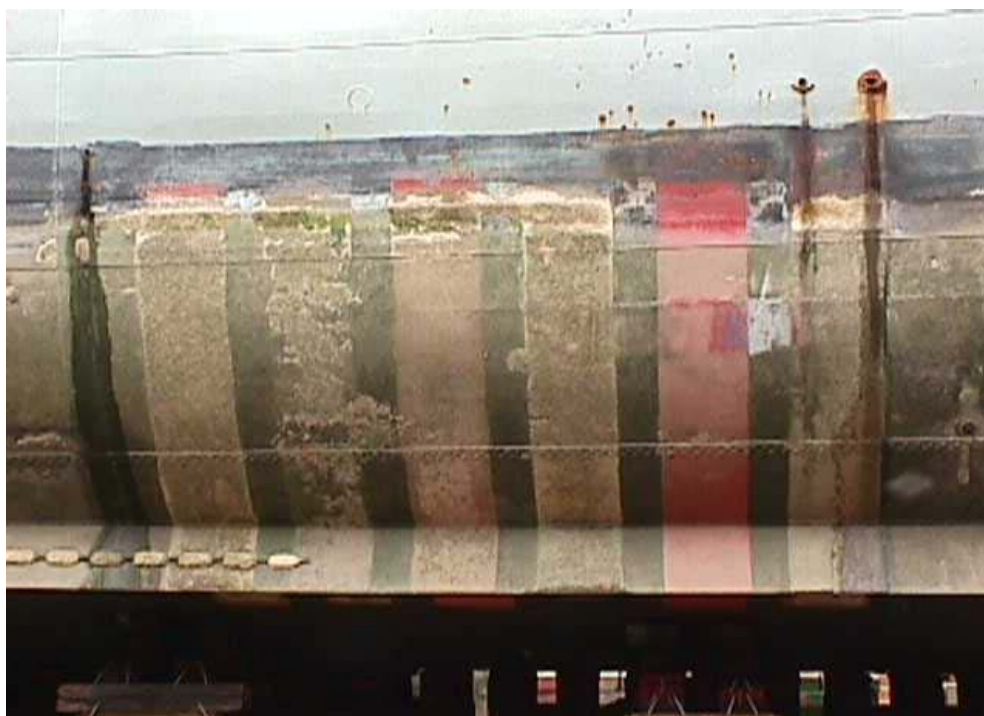
Figure 18: Starboard side strips on HMAS BRISBANE, March 1999. Ecoloflex strip is second from right.

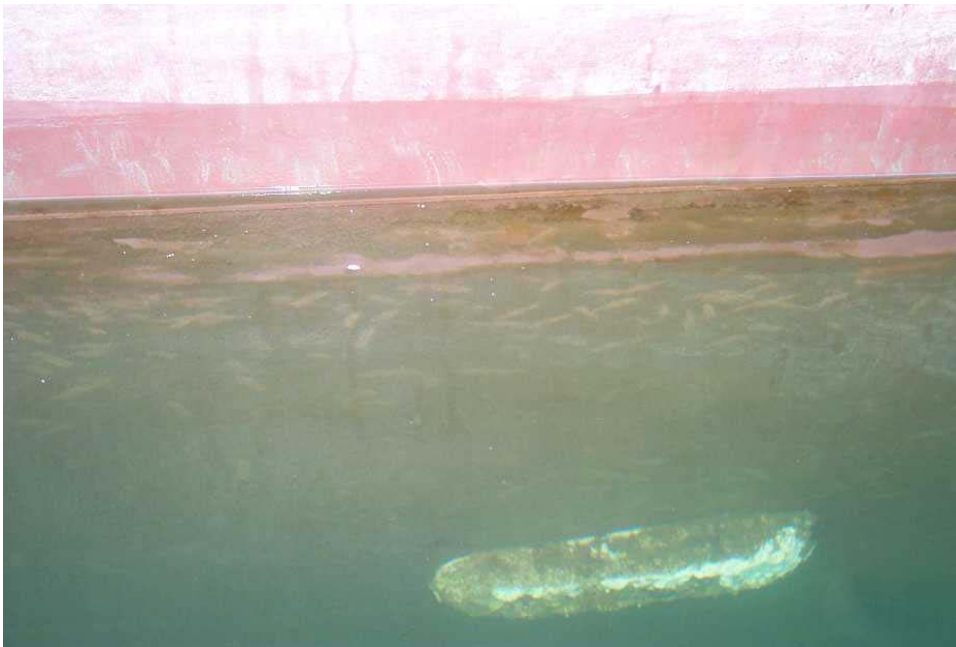
*Figure 19: Transom of NUSHIP WARRAMUNGA at Williamstown May 2000*

*Figure 20: Starboard side of NUSHIP WARRAMUNGA at Williamstown, May 2000*

When inspected from a small boat alongside in May 2000, aided by clear water conditions, *NUSHIP Warramunga* only slime was visible on the submerged surfaces (Figures 19, 20). The integrity of the coating at and above the water line was also sound with no signs of physical degradation.

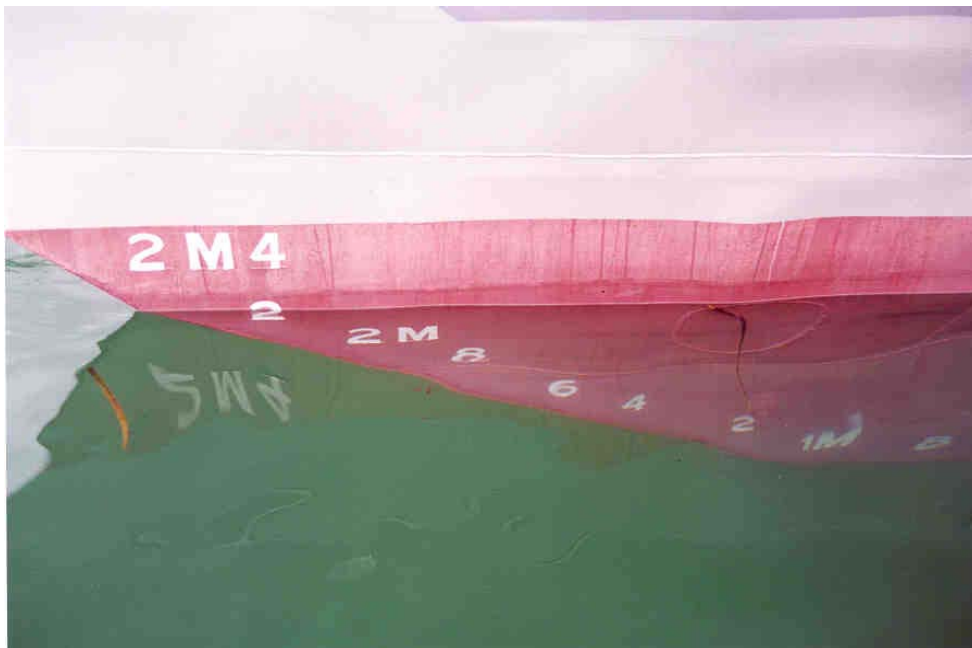
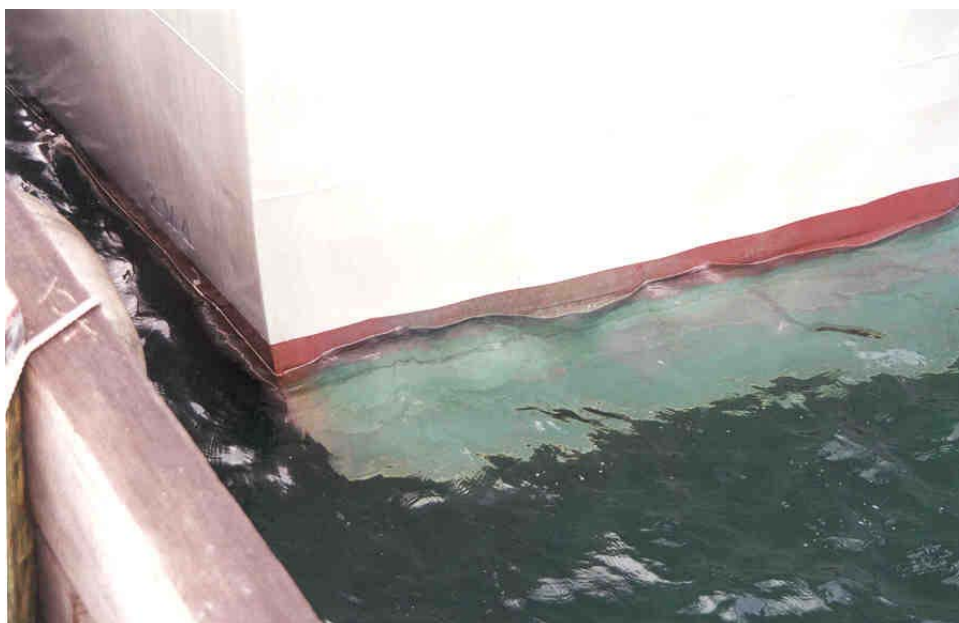
Figure 21: Forward port side of HMAS GERALDTON, Garden Island WA, April 2000

Figure 22: Transom of HMAS GERALDTON, Garden Island WA, April 2000

Photographs taken of the hull of *HMAS Geraldton* from alongside in April 2000 showed no signs of fouling growth (Figures 21, 22).

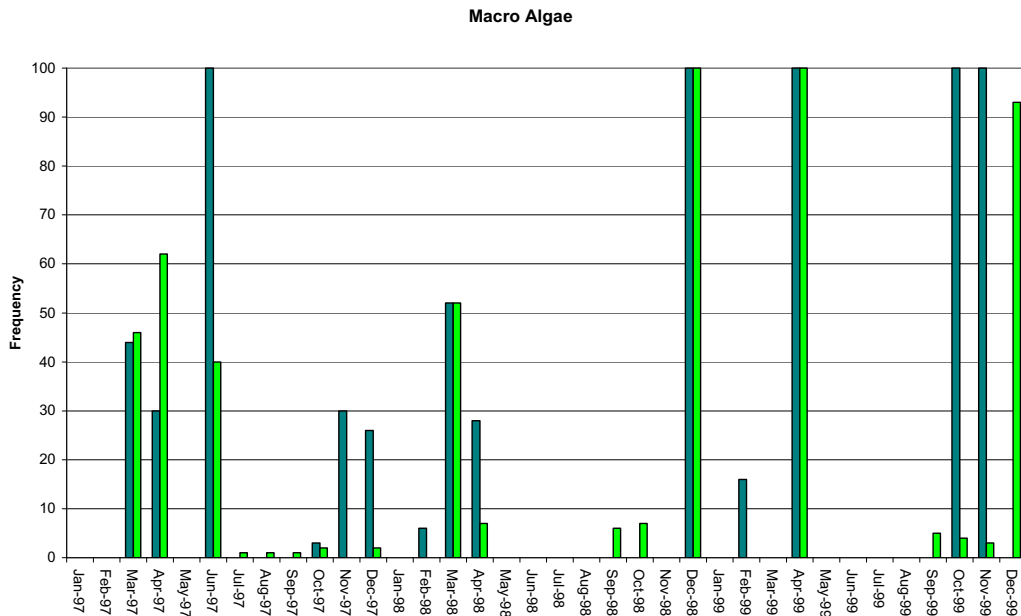
Figure A.2 Seasonal variation in abundance of macroscopic algal fouling on the control panels (December 1996 – January 2000)

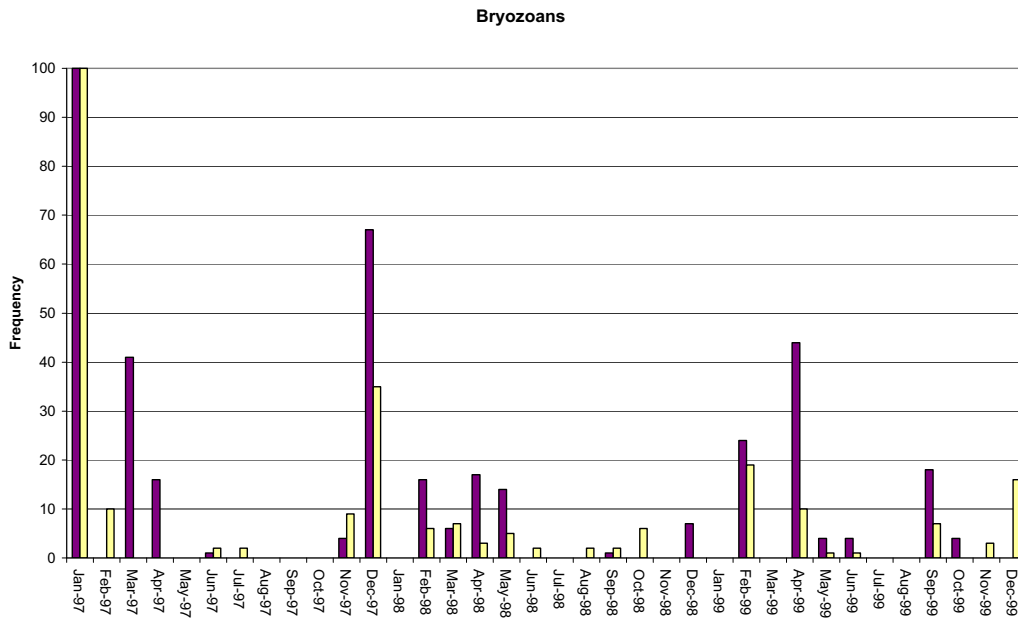
Figure A.5 Seasonal variation in abundance of bryozoans on the control panels (December 1996 – January 2000)

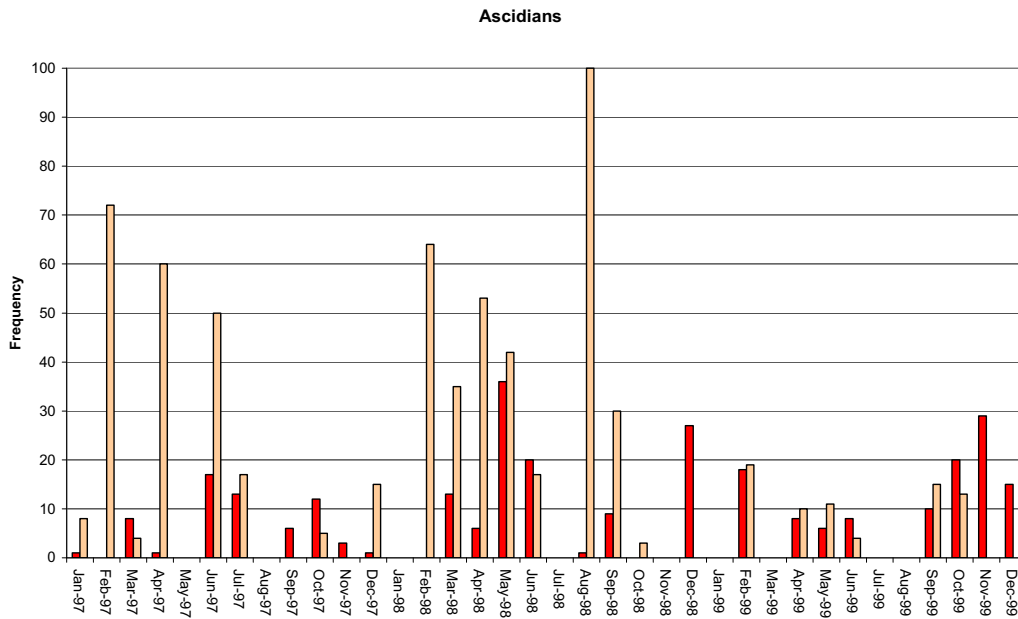
Figure A.6 Seasonal variation in abundance of ascidians on the control panels (December 1996 – January 2000)
