Reducing Fracture Tendencies in PCBN FSW Tools

ONR Contract Number N00014-09-C-0288

Semi Annual Report No. 1

Period: February 3, 2009 through July 31, 2009

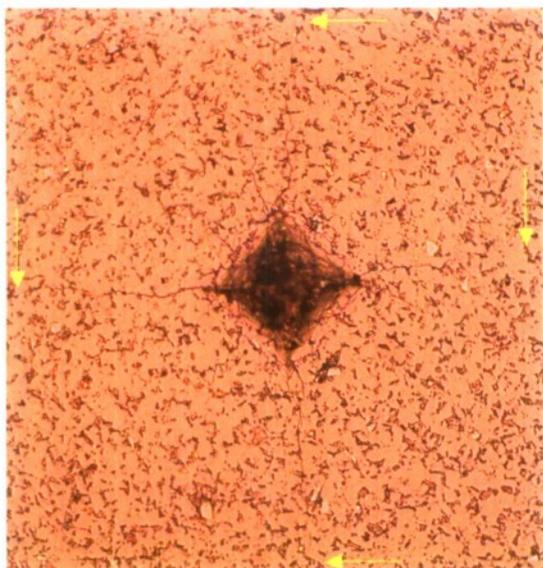
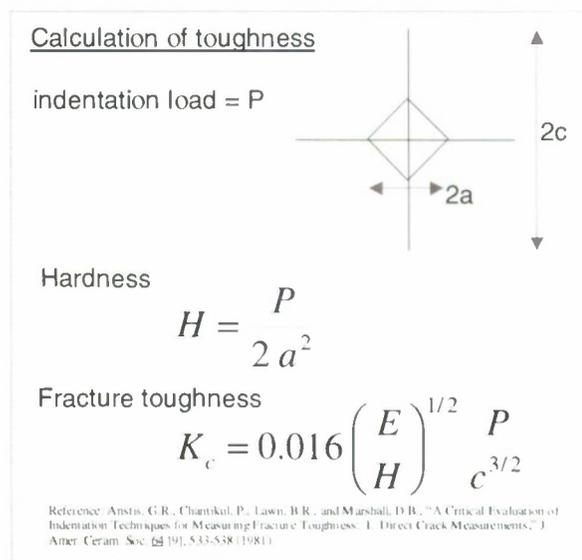
Fig. 1. Indentation method for measurement of fracture toughness: (a) Vickers indentation (200N load) in polished surface of polycrystalline cubic BN (MS80). Arrows indicate positions of crack tips, which can be readily located in higher magnification optical micrographs; (b) Schematic of indentation and cracks, with fracture mechanics expression from which the fracture toughness can be evaluated.

The fracture toughnesses of the three MS80 materials described above were measured by indentation fracture. The method, which is summarized in Fig. 1, involves loading a Vickers diamond indenter on a

polished surface, generating a contact zone of plastic deformation (from which the hardness can be evaluated) and two half-penny cracks centered on the indentation and aligned normal to the surface along the indentation diagonals. A fracture mechanics analysis of the formation of these cracks gives the expression in Fig. 1b, which is valid if the cracks are sufficiently large compared with the contact zone. This expression can be used to evaluate the fracture toughness from the measured crack lengths.

This technique has been developed extensively with ceramic materials, although it has not been applied previously to PCBN materials. Indentations in PCBN at loads smaller than ~50 N generally produce irregular crack patterns because of their high hardness and relatively large grain size. However, at higher loads well developed cracks are produced, as in Fig. 1.

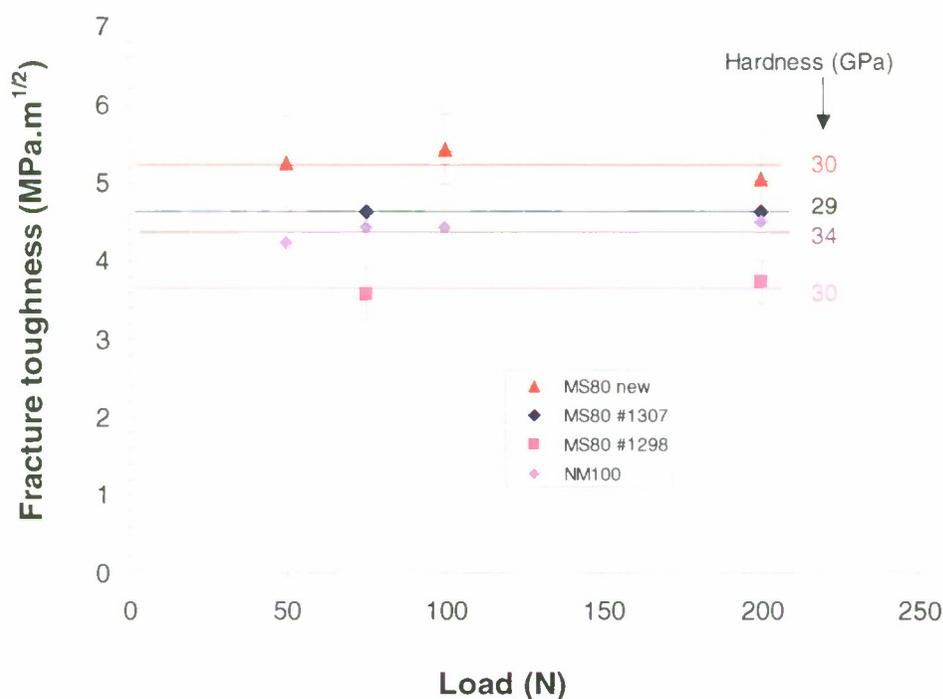
Fig. 2. Indentation fracture toughness measurements from several PCBN materials. Error bars indicate standard deviations.

The results of toughness measurements from the three MS80 materials are summarized in Fig. 2. Also shown are measurements from another PCBN material (MN100) which has much higher volume fraction of BN and smaller amount of grain boundary phase (AlN). For each material the toughness was evaluated from indentations at several different loads within the range 50 to 200 N, with each data point being an average of at least 10 measurements. The observation in Fig. 2 that, in all cases, the toughness is

independent of the indentation load confirms the functional form of the toughness equation and thus the validity of the underlying fracture mechanics analysis.

Significant differences are evident in the fracture toughnesses of the three MS80 materials. The highest toughness ($5.2 \text{ MPa}\cdot\text{m}^{1/2}$) is observed in the new material which was also much more difficult to grind and polish than the other two materials. However, the relative ranking for the other two materials is opposite to their relative performance in FSW: the material with lower toughness (#1298) is the one with the longer FSW life. Further measurements will be made to investigate whether this trend is followed in other materials.

The hardness of these materials is expected to scale with the volume fraction of BN and be relatively insensitive to subtle microstructural variations that influence fracture toughness. The measured hardnesses listed in Fig. 2 are consistent with this expectation: the values for the three MS80 materials are indistinguishable (30 GPa) whereas the value for the MN100 material is higher (34 GPa).

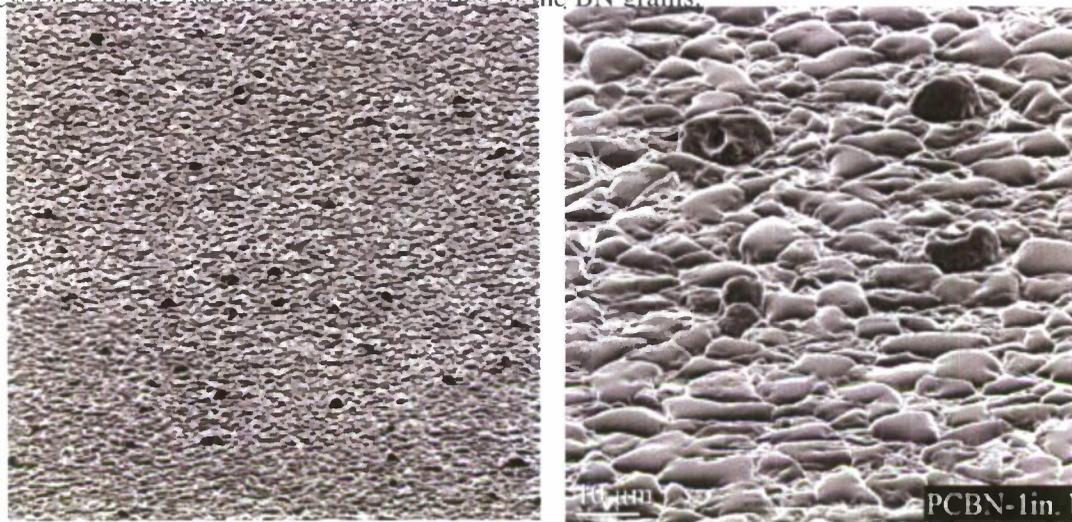
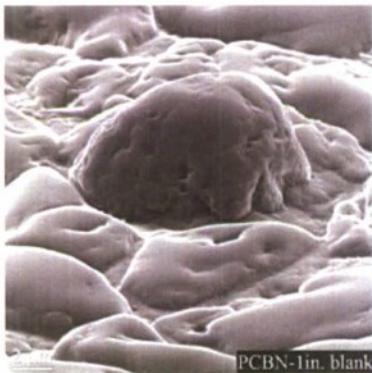
Fig. 3 SEM micrographs of new MS80 material showing surface after polishing with diamond impregnated cloth which produced relief of diamond particles (same area at three different magnifications). Dark grains in (a) are diamond

The new MS80 material was much more difficult to cut and polish than other PCBN materials. After initial attempts to polish the surface of this material using a relatively soft cloth that produced a good polish on other PCBN materials, we found that strong relief was produced, with some grains remaining raised significantly above the majority of grains (Fig. 3). EDS analysis indicated that these grains were

carbon. Analysis by Raman microprobe spectroscopy confirmed that the grains are diamond. The diamond grains were distributed very uniformly throughout the material, with a volume fraction of several percent. Their size is similar to that of the BN grains.

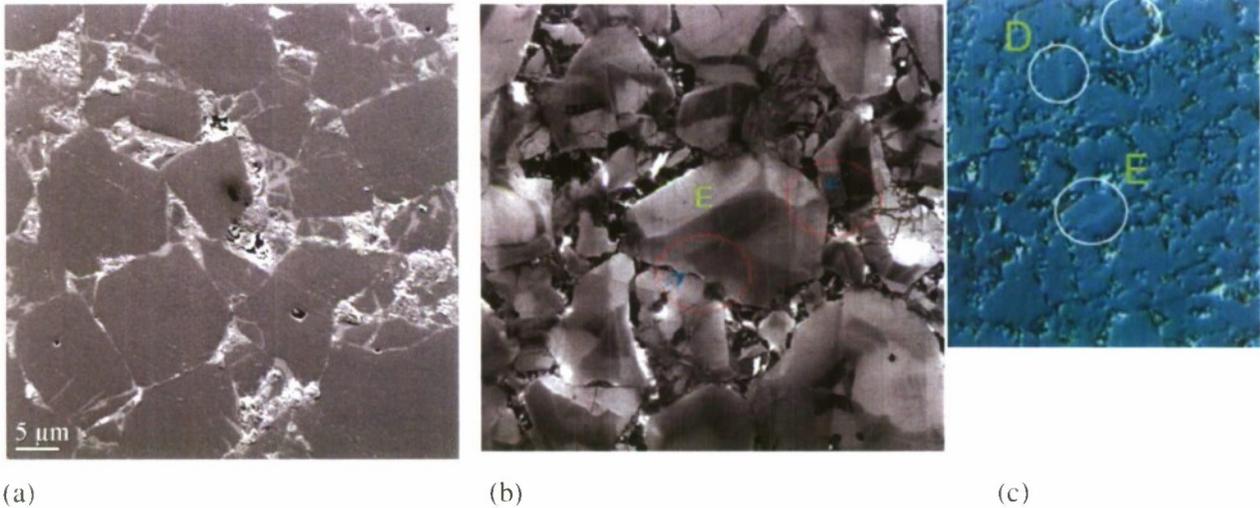
Fig. 4. Polished surface of MN100 material: (a) SEM image from surface coated with conducting layer of gold; (b) SEM image from uncoated surface (micrograph from Qingyuan Liu, Megadiamond); (c) Nomarski interference micrograph from area in (b), showing surface relief features in some grains.

In the course of SEM examination of these materials we discovered (in collaboration with Megadiamond) an imaging method that reveals internal crystallographic structures in BN grains, which are not normally detectable by SEM. An example is shown in Fig 4. When imaged with secondary electrons, with a thin conducting layer of gold deposited on the surface to prevent charging (the usual procedure for insulating materials), the BN grains are featureless and the AlN grain boundary phase shows lighter contrast (Fig.

4a). Similar contrast is seen in backscattered electron images (Fig. 5). However, when imaged with secondary electrons without a conducting layer on the surface, dramatically different contrast is observed (Fig. 4b): crystallographic features resembling twins are clearly evident, more contrast detail is visible within the grain boundary phases, and there is a general reversal of contrast between the grains and the grain boundary phase (the BN grains being lighter than the grain boundary phase). In many grains, there is a one-to-one correspondence between these crystallographic features and lines of surface relief visible by Nomarski interference (Fig. 4c). The surface relief may result from different polishing rates in regions of different crystallographic orientations.

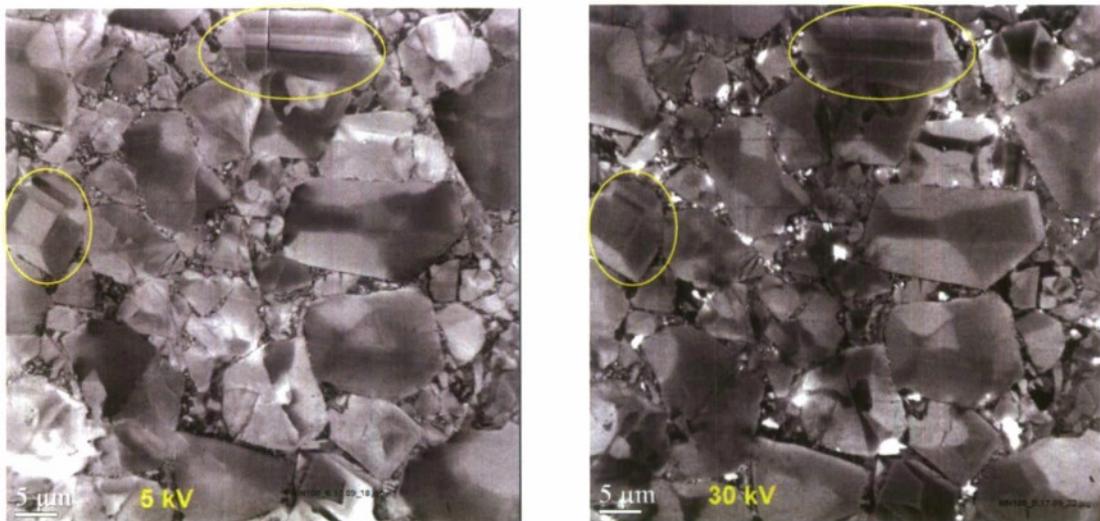
Fig. 5. Reversal of contrast in secondary electron images from uncoated surface of MN100 material at two different accelerating voltages: (a) 5 KV; (b) 30 KV.

The detailed contrast in images such as Fig. 4b was found to be sensitive to the accelerating voltage, with reversals of contrast occurring within some grains when the voltage was changed (Fig. 5). This and the observation that the contrast within the BN grains disappears when surface is coated with conducting gold suggests that contrast may be associated with charging. (The image contrast also disappears when the surface is coated with carbon, Fig. 6, thus eliminating the possibility that the contrast is obscured by scattered electrons from the gold coating.)

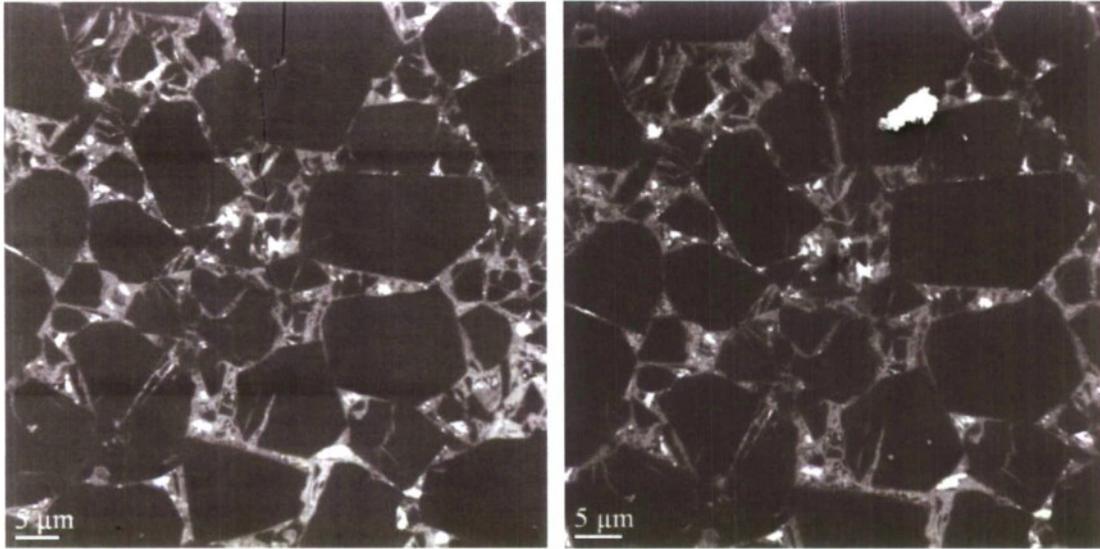
Fig. 6. Images from area of Fig. 5: (a) backscattered electron image, uncoated surface; (b) secondary electron image after coating the surface with carbon.

We hypothesize that these contrast features may correspond to internal twins or other deformation structures in BN grains, possibly caused local contact forces due to grain-to-grain contact during high pressure consolidation. Similar contrast features are observed in the MS80 materials, although only a small fraction of grains show internal features (consistent with expectation that, with the higher binder content, less damage occurs in MS80 from neighboring grains being in direct contact during densification).
