# **Cold Spray Process Development for the Reclamation of the Apache Helicopter Mast Support**

**by P. F. Leyman and V. K. Champagne**

**ARL-TR-4922**

**August 2009**

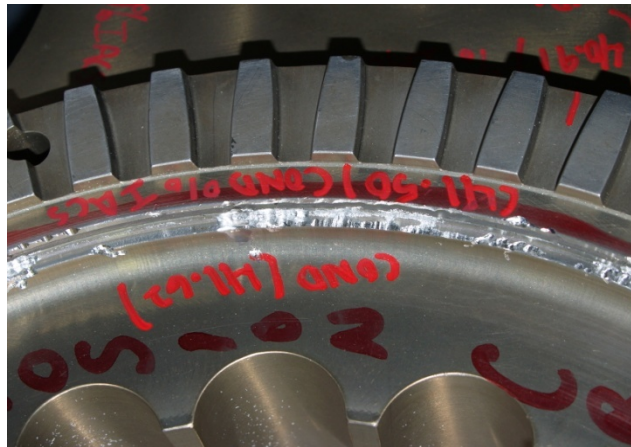
Figure 7 shows the second type of repair that would be performed on the mechanical damage. To demonstrate this repair, the entire snap ring groove area would be removed, as shown in figure 8. The damaged region cross section is completely removed (figure 8), the cold spray material is deposited on the entire area (figure 9), and then it is contoured by re-machining to the original shape and dimension (schematically depicted in figure 10).

Figure 7. Mechanical damage to the snap ring groove of the Army mast support.

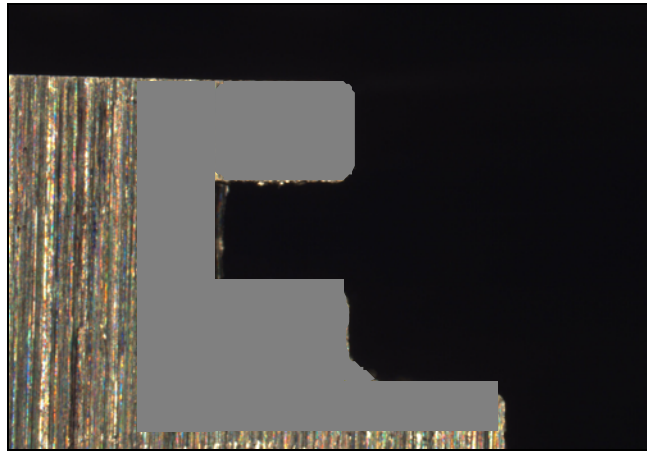
Figure 10. Cold spray material machined back to the original dimensions.

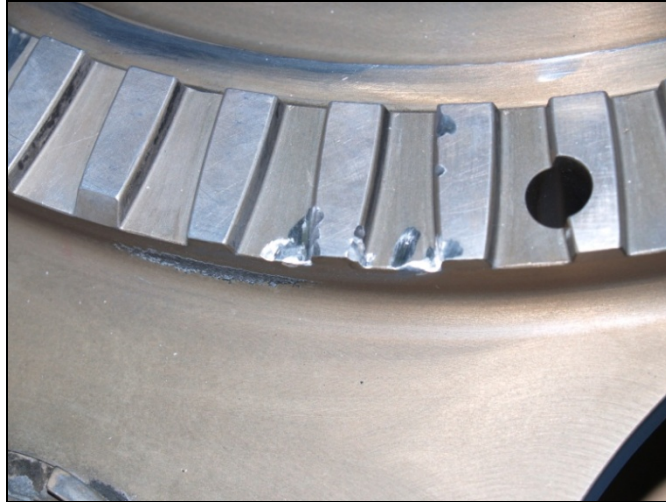
An additional area where mechanical damage occurs is on the splines, as shown in figure 11. To demonstrate the effectiveness of the cold spray repair method, a section of the spline was mechanically removed using a milling machine, filled in using cold spray, then contoured via re-machining to the original dimensions.

Figure 11. Mechanical damage to the splines on the Army helicopter mast support.

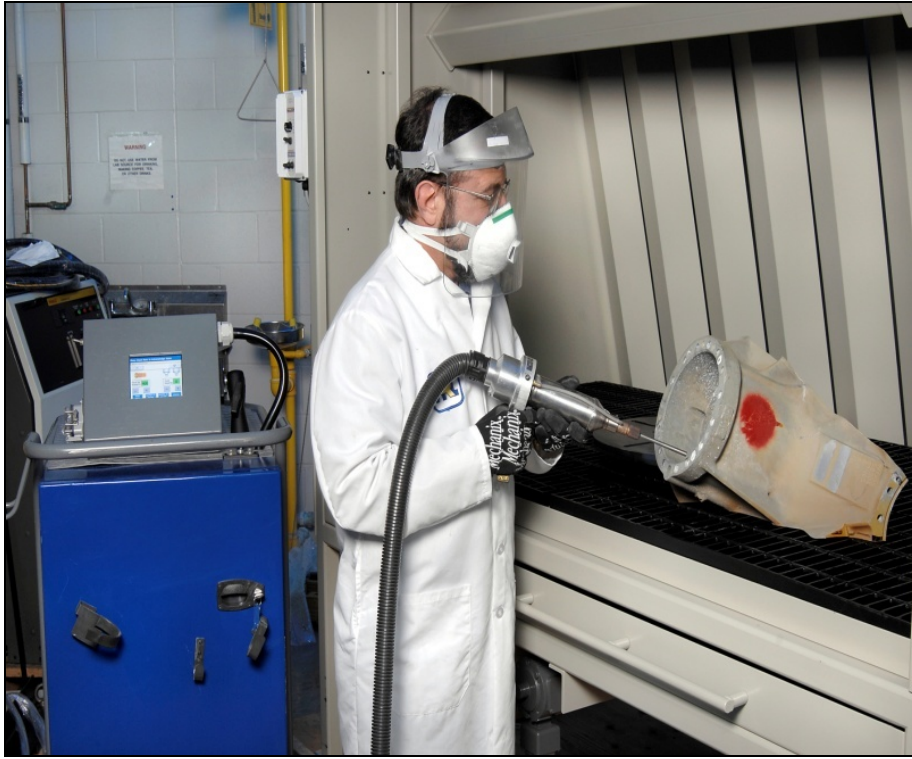
Figure 12. Operator using a Centerline Portable Cold Spray System to repair a rotorcraft component.

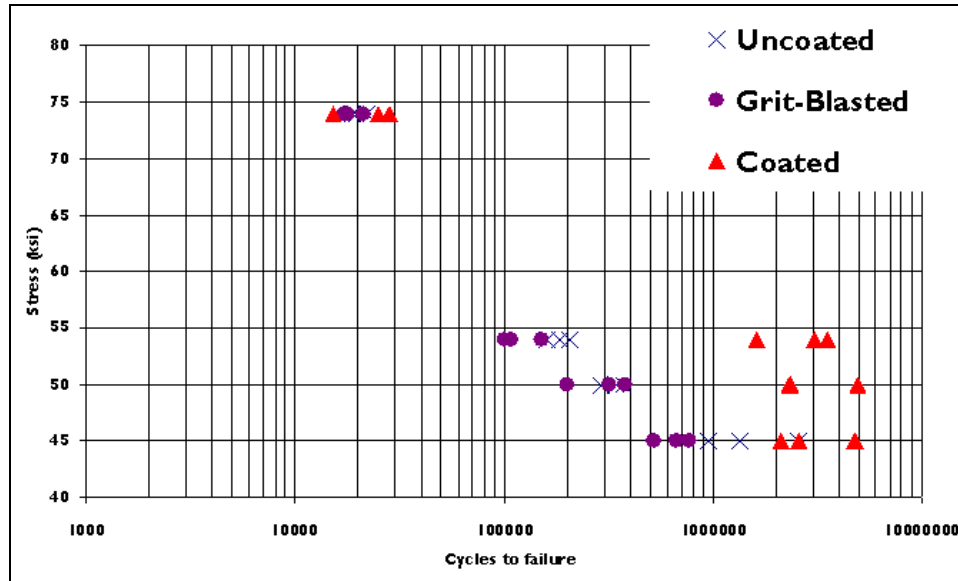
fatigue tests are performed at fully reversed ( $r = -1$ ) loading at loading frequency of 100 Hz (6000 rpm), similar to the RR Moore fatigue testing. These were compared to specimens that were uncoated in addition to specimens that had been grit blasted using the same process as the coated specimens. The plot of the resultant data is shown in figure 20. The uncoated and grit blasted specimens had very similar cycles before failure, while the cold spray aluminum coated specimens had a consistently higher number of cycles before the specimens failed. The cold spray aluminum coating had an improved fatigue life and enhanced the fatigue performance of the 7075 aluminum alloy.

Figure 20. Plot of RCB fatigue test results for cold spray aluminum on 7075 aluminum RCB fatigue specimens. (Australian Defence Science and Technology Organization)

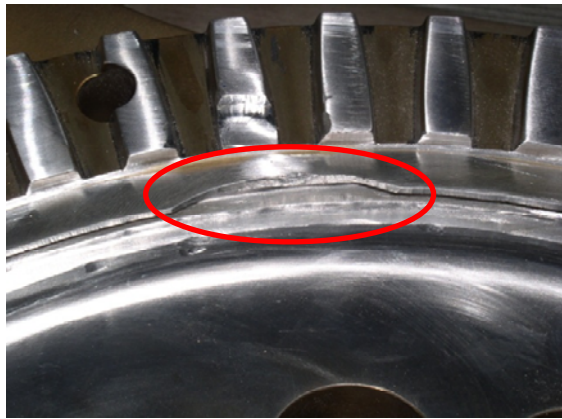
Figure 28. Mechanical damage on a snap ring groove.

After the successful completion of the first phase, the second phase of the demonstration was initiated, which consisted of remediation at Ft. Hood, TX, on otherwise non-serviceable, Category D hardware. All process feasible cold spray repairs similar to those developed at ARL on scrap components, but at other locations on actual hardware, were also evaluated. The Centerline Portable Cold Spray System was transported to the test site to perform a demonstration of the process on both corrosion pits (figures 25–27) and mechanical damage (figures 28–30) on a full-size scrap Army mast support component. The final machining was done by the machine shop on site, as shown in figure 31.

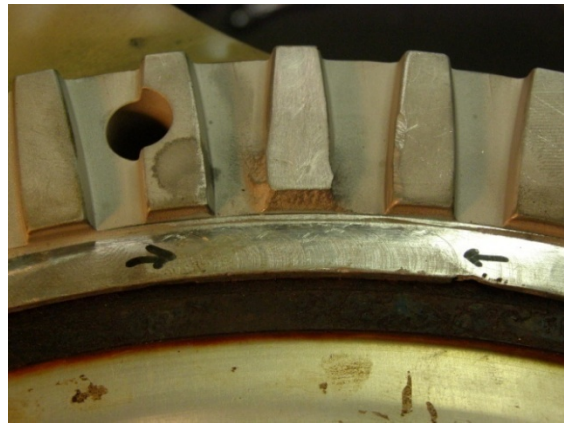
Figure 30. Cold spray aluminum fill machined back to the original dimensions.
