REACTIVE SILICATE COATINGS FOR PROTECTING AND BONDING REINFORCING STEEL IN CEMENT-BASED COMPOSITES

S. W. Morefield*, V. F. Hock*, C. A. Weiss, Jr.‡, P. G. Malone‡, and
M. L. Koenigstein§

*US Army Engineer Research and Development Center, Construction Engineering Research Laboratory,
Champaign, IL 61820

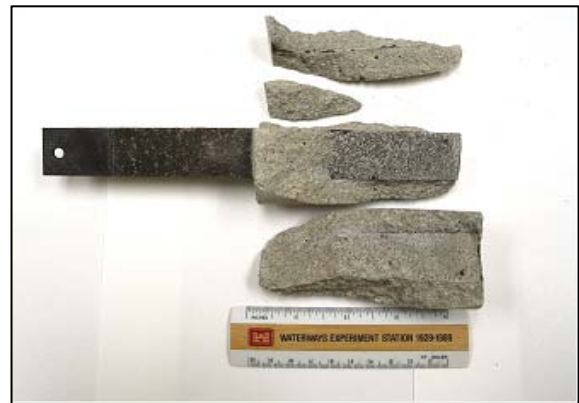
Fig. 2. Photo of coated strap in mortar cylinder after breaking the cylinder by withdrawing the strap. Note the mortar still adheres to the coating.

In order to obtain samples of enamel-cement mixture after it was fired on to steel, the adhering hydrated cement and the coating after interaction with cement paste; strap-shaped metal samples were coated and cast into mortar cylinders and the cylinders were broken (Fig. 2).

The coating consisted of 0.2 mm of coating on a 2 mm thick, 25 mm wide strip of mild steel. Details on the preparation are presented in (Lynch et. al. 2007). Samples of reacted and unreacted coating for examination by XRD were obtained by chipping and scraping the coating off the samples that were in as coated condition or that were broken out of the hardened mortar. Pieces of the strap were also cut into samples that would allow them to be examined using optical and scanning electron microscopy.

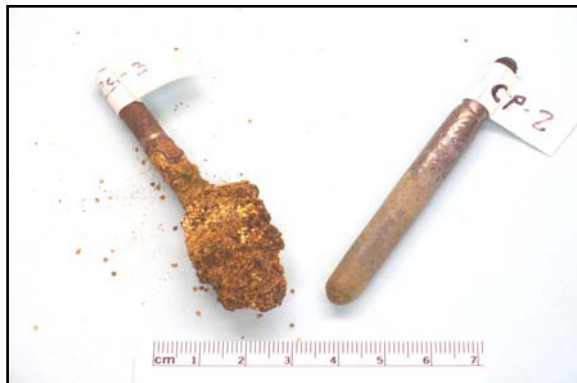
Fig. 9. Corrosion observed to uncoated (left) and coated test rods after 40-day exposure to a 3.5% NaCl solution. The dull surface of the coated rod is produced when the portland cement embedded in the glass hydrated.

Figure 9 shows the result of exposure of coated and uncoated steel test rods to a dilute solution for 40 days. The uncoated rod is badly corroded. The coated rod contained portland cement embedded in the enamel and the cement hydrated to produce a slightly rough surface. The glass-cement coating prevented contact with the salt solution and no corrosion occurred. Corrosion could only be produced if the enamel was purposely removed by drilling through the coating to expose the metal. When moistened the surface of the coating was alkaline (pH ≈ 12) when tested using colorimetric techniques.
