## **Vegetation and Channel Morphology Responses to Ordinary High Water Discharge Events in Arid West Stream Channels**

Robert Lichvar, David Cate, Corinna Photos,  
Lindsey Dixon, Bruce Allen, and Joel Byersdorfer

May 2009

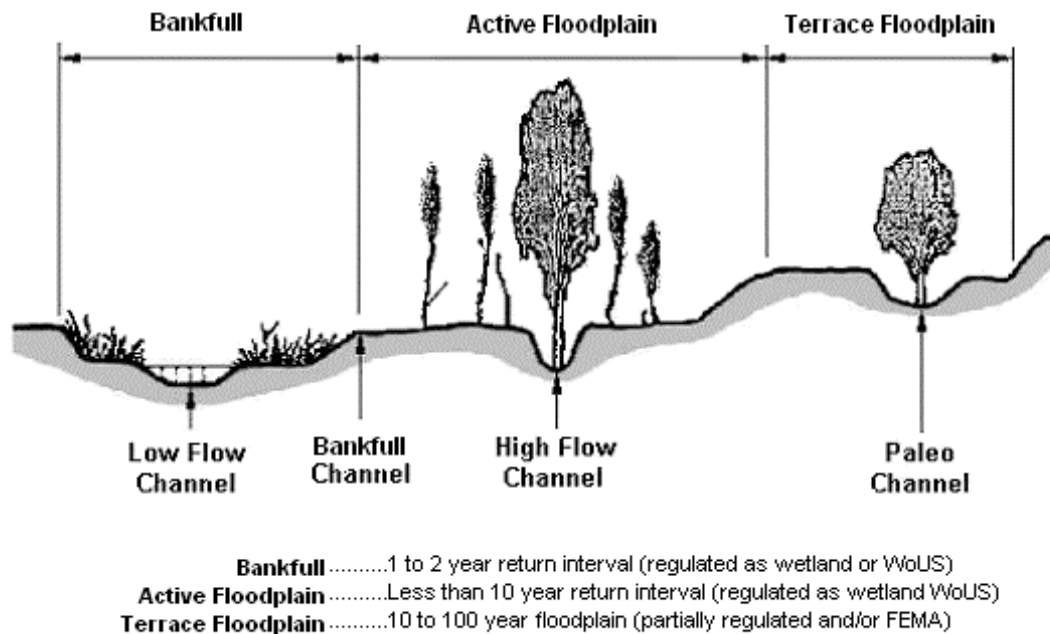
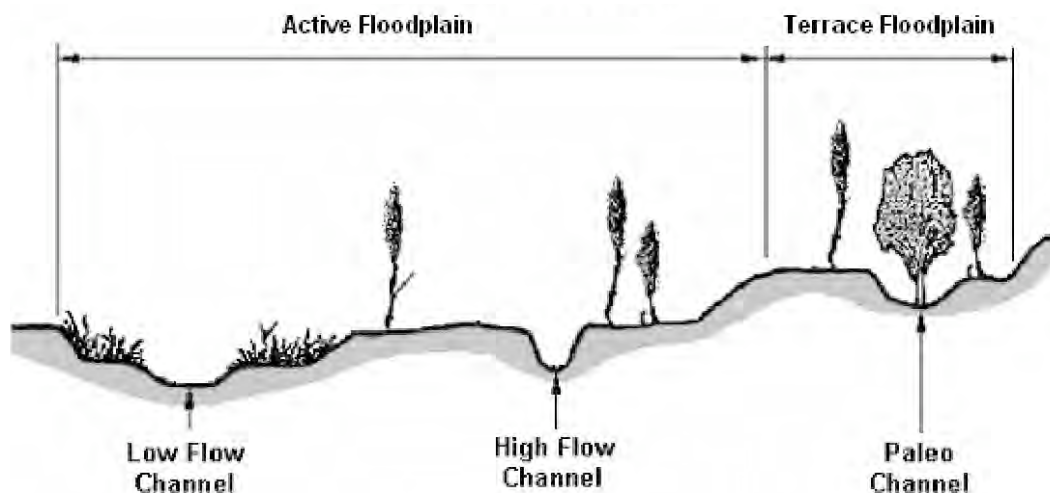
Figure 1. Typical cross section depicting hydrogeomorphic floodplain units for typical streams.

a. Perennial channel forms.

b. Intermittent and ephemeral channel forms.

Channel morphology is influenced by the hydrologic regime and by the tendency of the channel to establish a state of equilibrium (Field and Lichvar 2007). These components drive the quantity of sediment deposited and eroded in the channel, in turn influencing the geometry of the channel and the surrounding floodplain. Common fluvial features typical of the perennial channel and floodplain include a bankfull channel, the active floodplain, and the terrace floodplain (Figure 1).

In intermittent and ephemeral streams, low-flow channels in the active floodplain differ from the bankfull channel of perennial streams. In the Arid West, the low-flow channel of an intermittent or ephemeral stream will form and relocate during low to moderate discharge events (5–10 years) instead of being maintained by continuous flows, as in perennial streams. This channel is unstable because flashy discharge events alter the hydrologic regime and because sedimentary deposits and erosional features throw the system into imbalance.

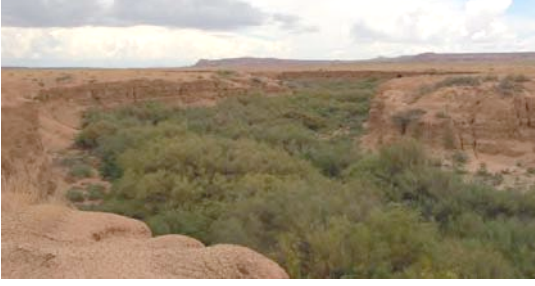
Stream Type	Photograph	Natural Processes
<p>Discontinuous ephemeral streams</p>

<ul style="list-style-type: none"> <li>- Alternating erosional and depositional reaches</li> <li>- Headcuts that form at downstream end of sheet flood zones and migrate upstream</li> <li>- Cycle of arroyo formation, widening, and backfilling into the valley floors</li> <li>- System in equilibrium as long as length of channelized areas relative to sheet flood zones remains constant</li> </ul>
<p>Compound channels</p>

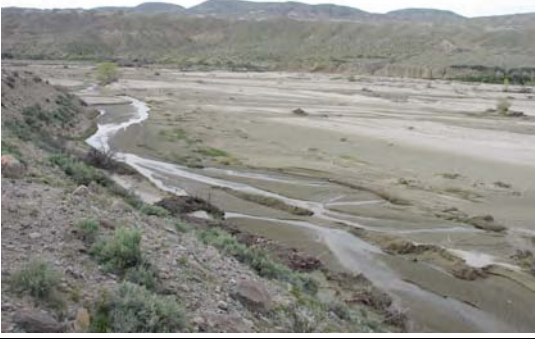
<ul style="list-style-type: none"> <li>- Rapid widening in response to increase in sediment transport capacity during extreme, brief discharge</li> <li>- Activation of braided channels after extreme flow events</li> <li>- Meandering form that develops after long sequence of low to moderate discharges</li> </ul>
<p>Alluvial fans</p>

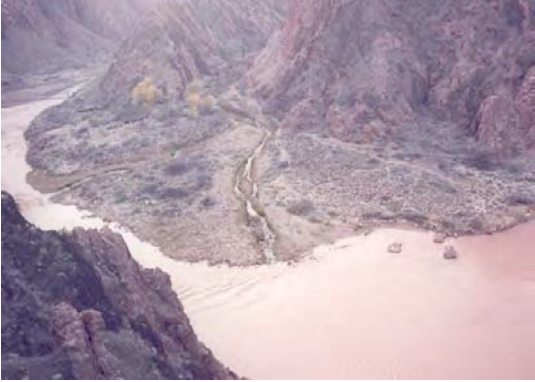
<ul style="list-style-type: none"> <li>- Fans that emerge from upland areas into zones of reduced stream power and are maintained by distributary flow</li> <li>- Enhanced deposition because of decreased stream power from headwaters to valley bottom, loss in flow confinement, and loss of discharge</li> <li>- Channel avulsions resulting from overbank flows emanating from channels on fan surface</li> </ul>

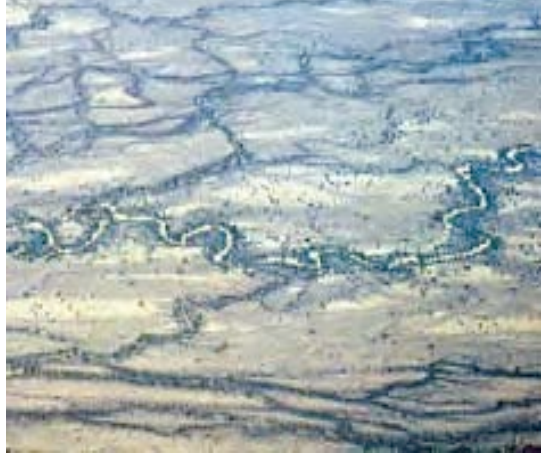
Stream Type	Photograph	Natural Processes
<p>Anastamosing rivers</p>

<p>(Copyright, Colin P. North, University of Aberdeen, Scotland; used by permission)</p>	<ul style="list-style-type: none"> <li>- Frequent channel avulsions</li> <li>- Smaller anabranch channels that grow headward towards the main channel in response to overbank flows emanating from aggrading main channel</li> </ul>
<p>Single-thread channels with adjacent floodplains</p>

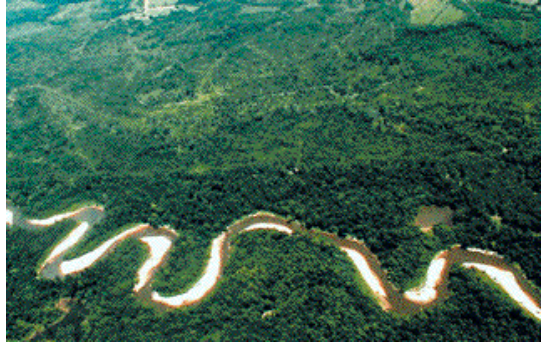
<ul style="list-style-type: none"> <li>- Meandering that develops to minimize amount of change at any point along river</li> <li>- Channel incision when sediment transport capacity of reach is elevated relative to sediment supplied to reach</li> <li>- Channel widening with bank destabilization</li> <li>- Aggradation due to decrease in capacity to transport sediment</li> </ul>

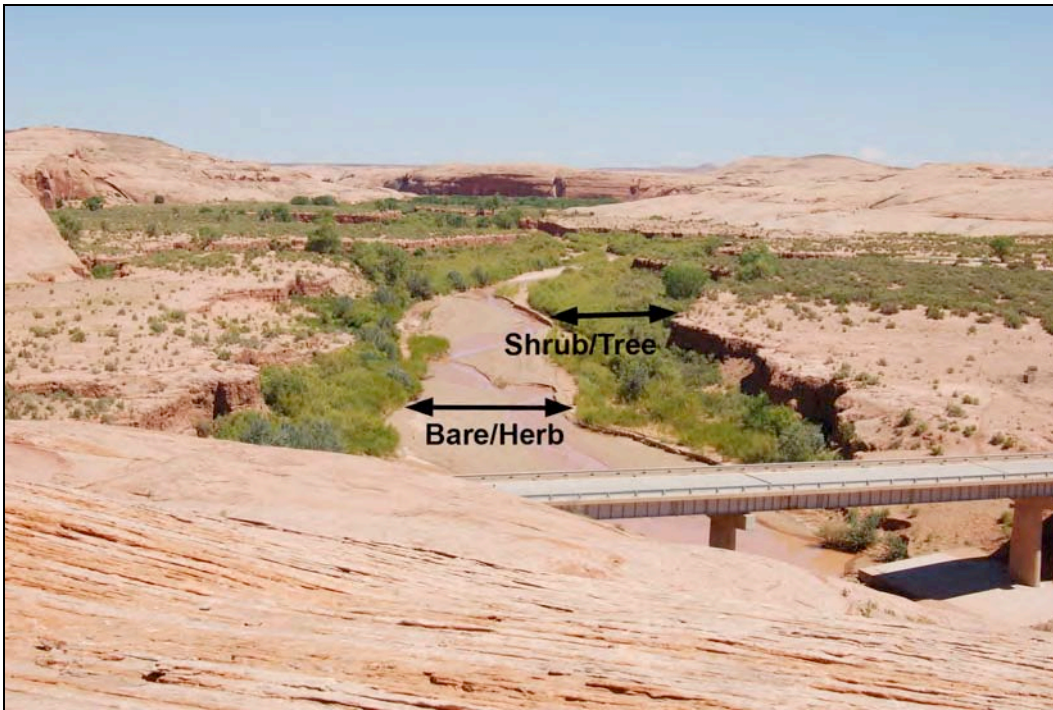
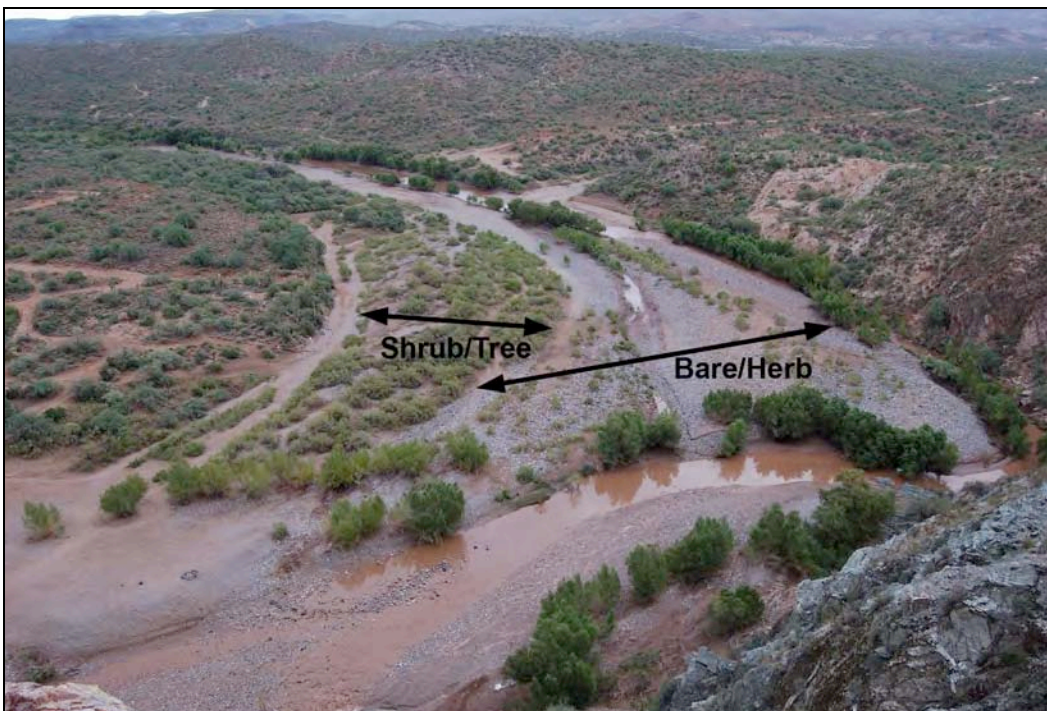
Figure 5. Vegetation categories at two sites.

a. Chinle Creek

b. Agua Fria

Once the hydrogeomorphic surfaces and vegetation boundaries were mapped, we calculated the areas for the bankfull channel and the active and terrace floodplains and for the vegetation within each of the hydrogeomorphic zones. From the areas occurring in each zone, we calculated percentages for each surface and vegetation type. We could then determine the changes in area between the two photos in each pair.

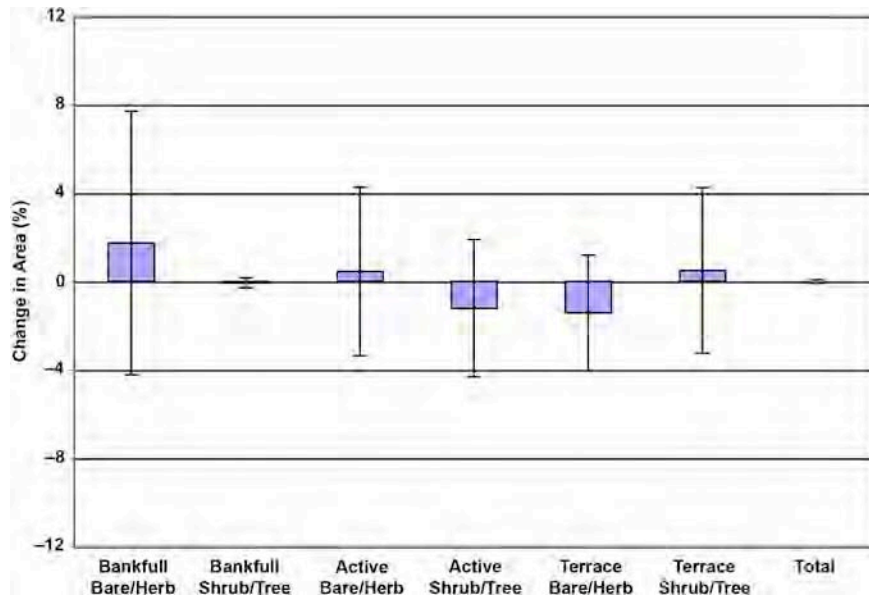
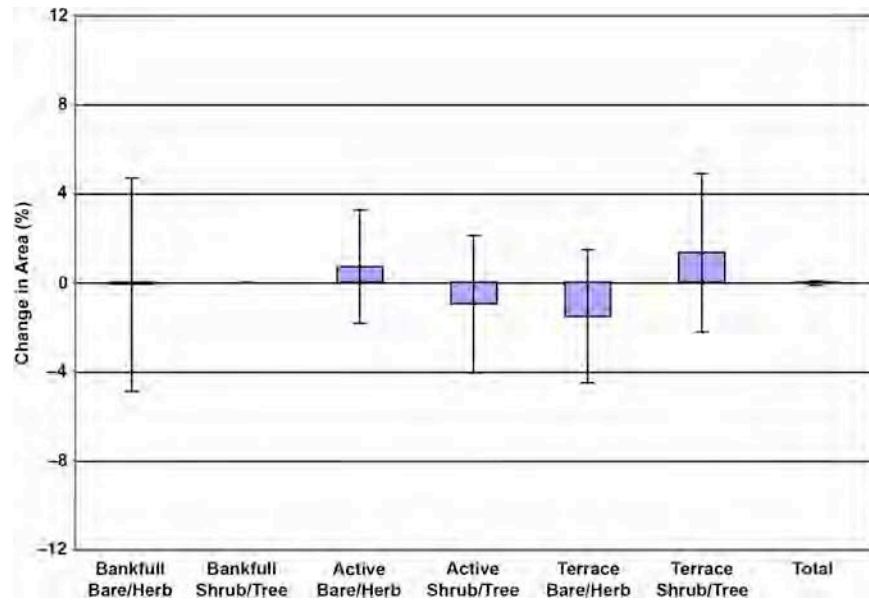
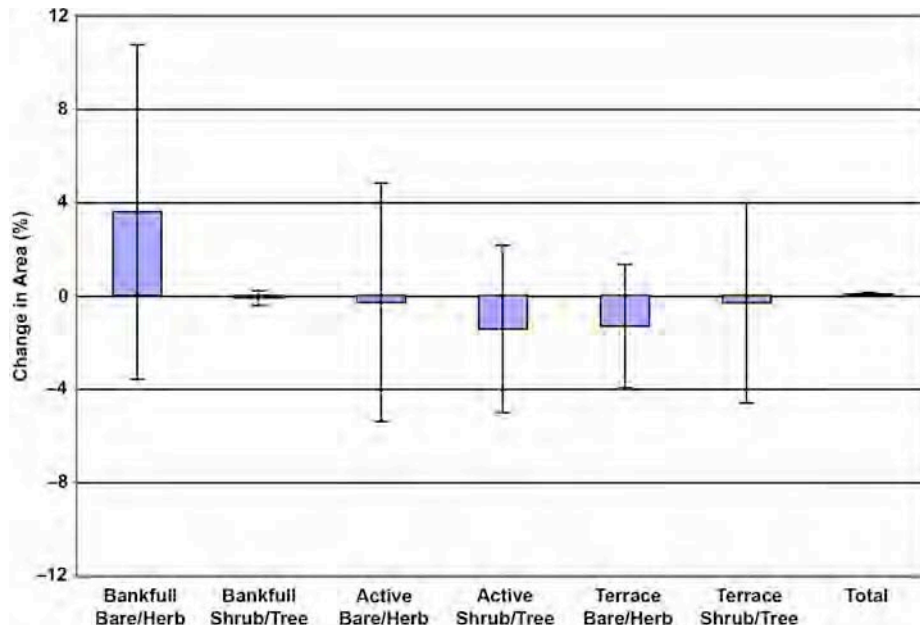
a. All sites.

b. Sites with <5-year discharge events.

Figure 7. Mean changes in vegetation for all sites ( $\pm$  one standard deviation).

c. Sites with >5-year discharge events.

Figure 7 (cont.) Mean changes in vegetation for all sites ( $\pm$  one standard deviation).

The amount of variability, as indicated by the size of the error bars in Figures 6 and 7, is consistent with our understanding of the dynamics of

ephemeral/intermittent channels in the Arid West. Figure 6 shows, for channel morphology, high variability for the area of the bankfull and active zones and low variability for the terrace. Since there was only one discharge event larger than 10 years, this is as expected; the events had little effect on the morphology of the terrace. For vegetation (Figure 7), the variability in the various categories was similar (except for shrub/tree in the bankfull zone, which makes sense because there were very few shrubs or trees in that zone).

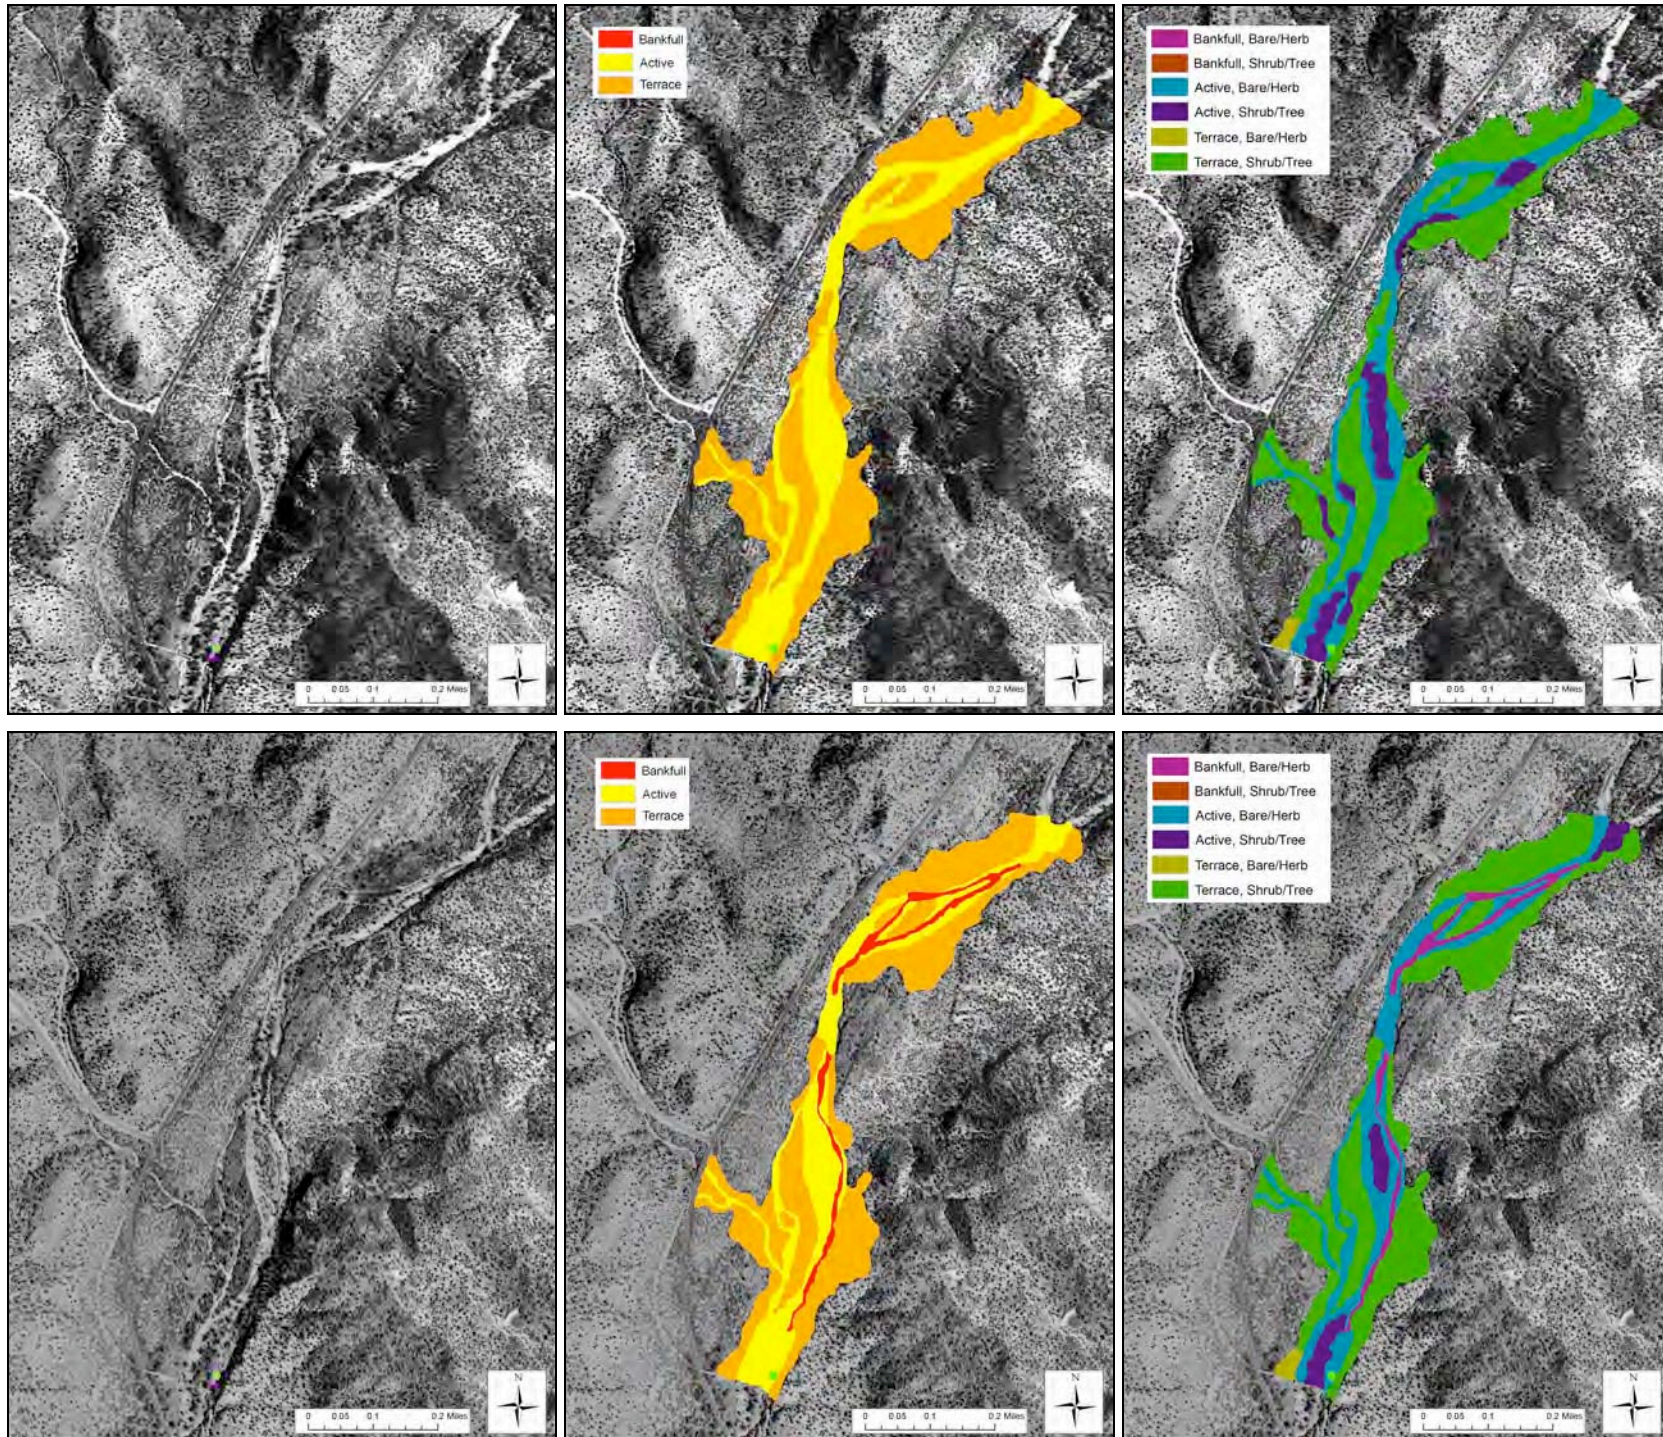
Figure C5. Dry Beaver Creek in 1997 (top three) and 2003 (bottom three) showing the change in channel morphology and vegetation.

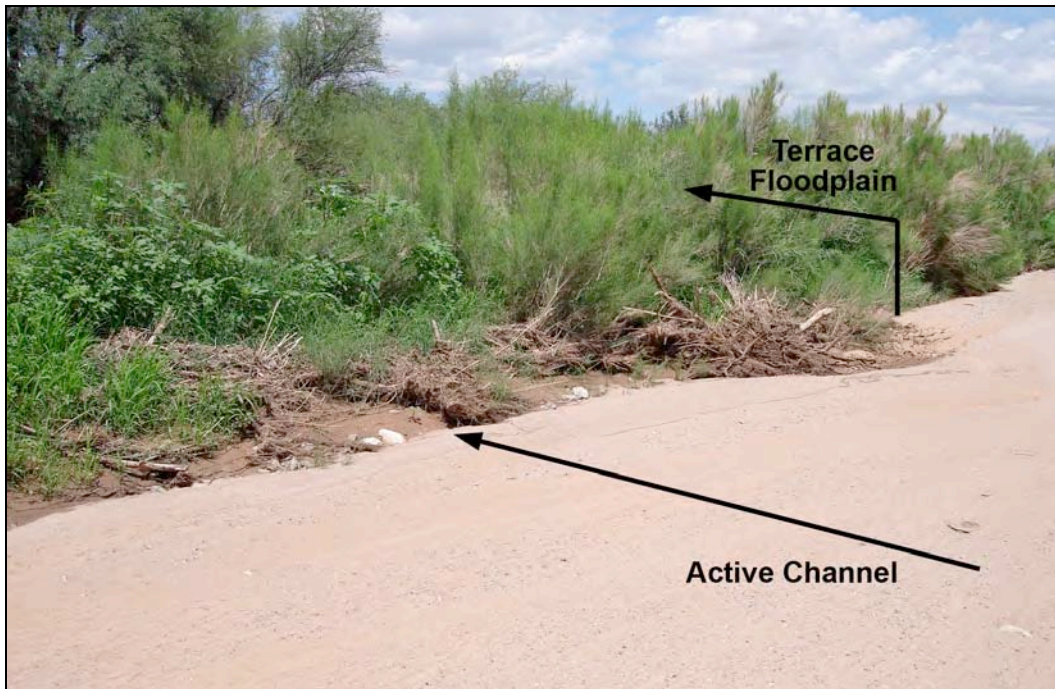
Figure E2. Drift at boundary of active channel, Altar Wash.

The active/terrace interface margins were much more stable than the bankfull margins. Regardless of the size of the discharge event, the boundaries between the active and terrace zones remained relatively stable. (An exception is the Cristianitos site, where there's no bankfull channel and the active/terrace boundary changed in places, although the relative areas didn't change much.) Appendix E contains ground photos showing active/terrace boundaries at several sites.

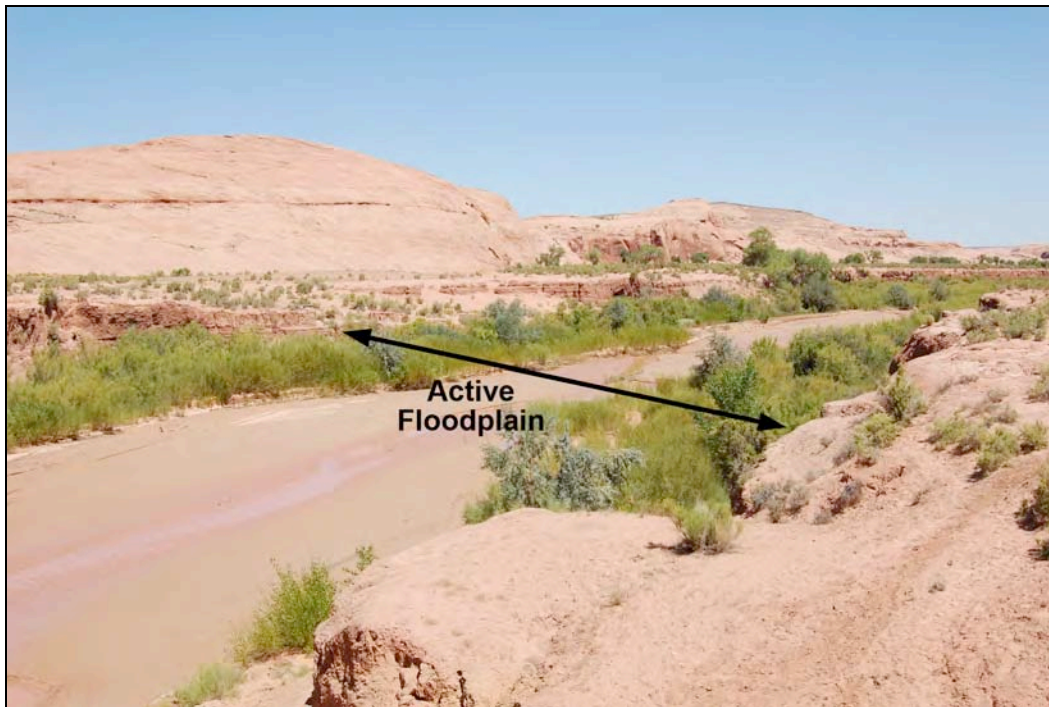
Figure E4. Active floodplain at Chinle Creek.

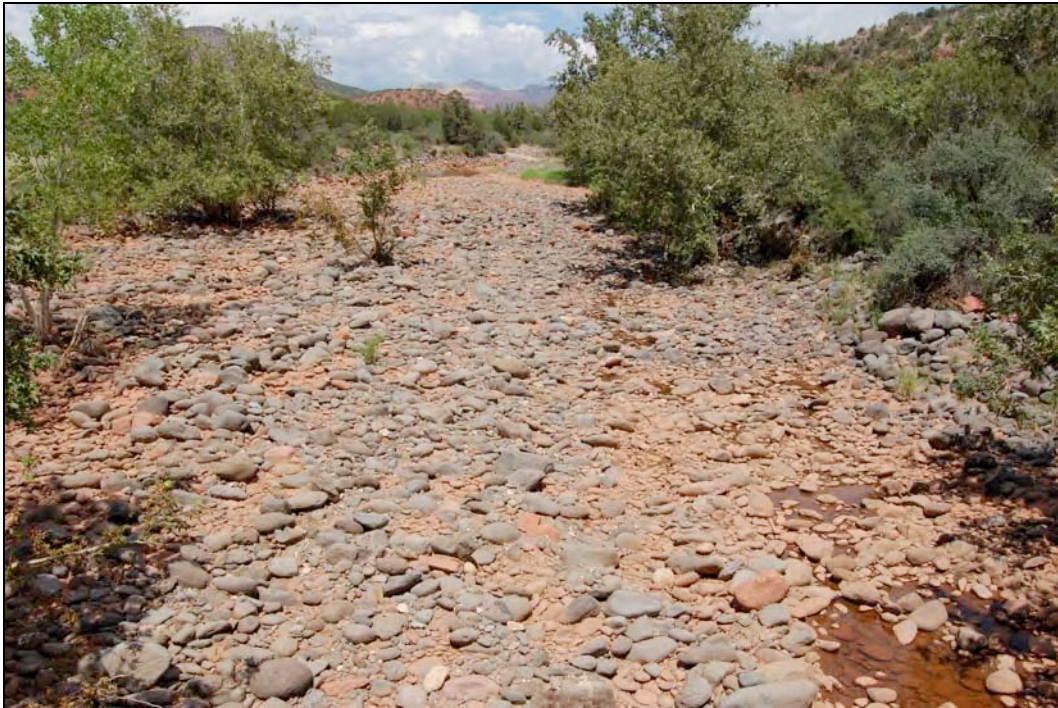
Figure E5. Active floodplain at Dry Beaver Creek.

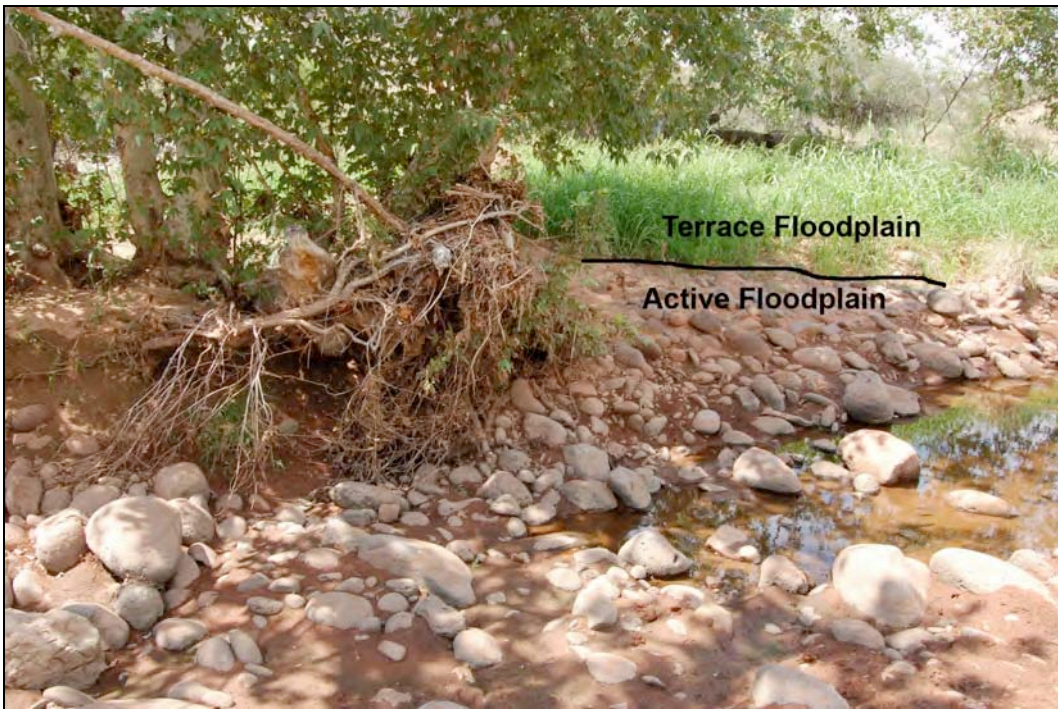
Figure E6. Boundary between the terrace floodplain and the active floodplain at Dry Beaver Creek.

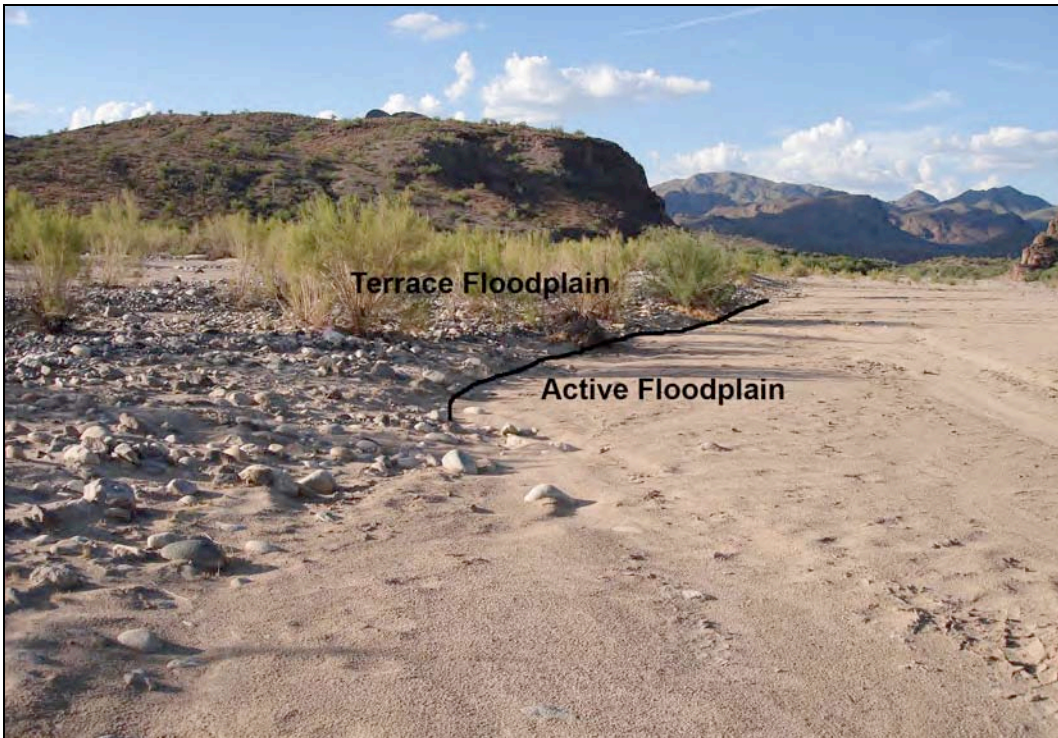
Figure E7. Boundary between the terrace floodplain and the active floodplain at Santa Maria Creek.

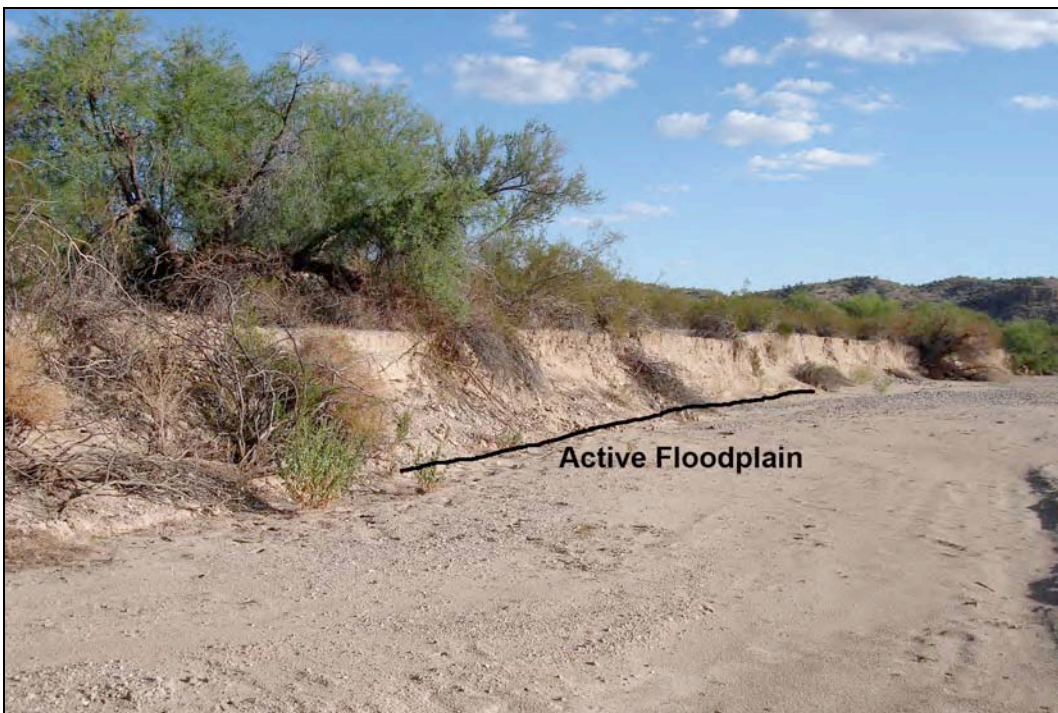
Figure E8. Active floodplain at Santa Maria Creek.

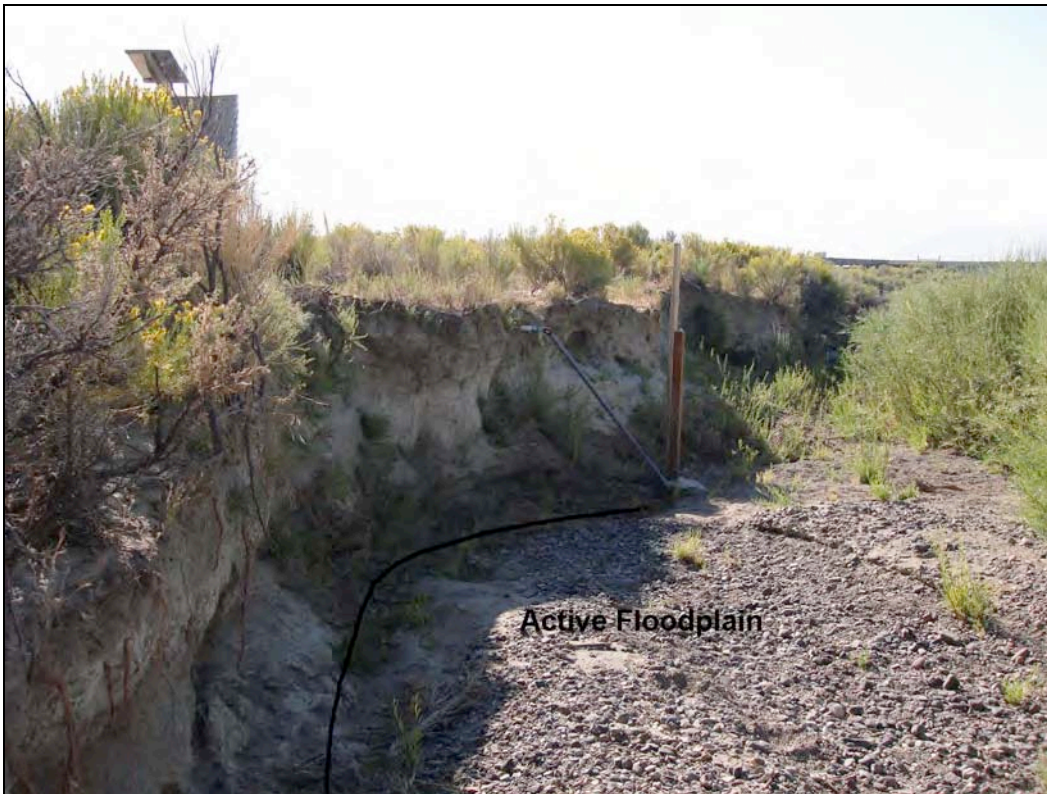
Figure E9. Active floodplain at the Susie Creek gauge.

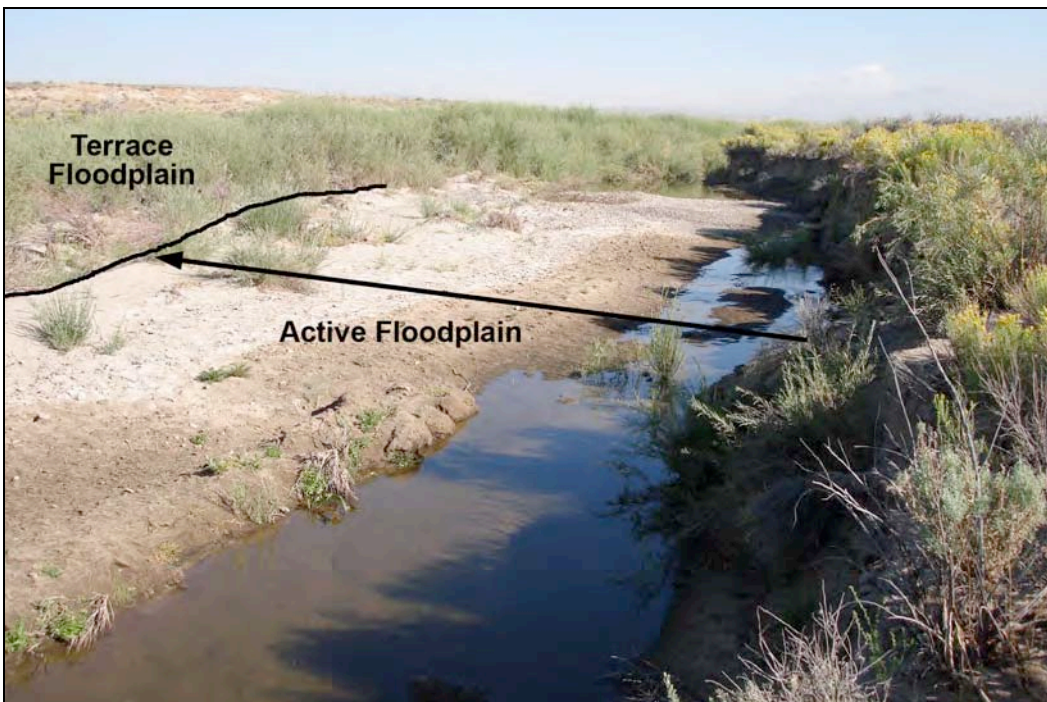
Figure E10. Boundary between the terrace floodplain and the active floodplain at Susie Creek.
