Performance Evaluation of CPCs Using Corrosion Sensors – Laboratory and Field Studies

Marta A. Jakab

Southwest Research Institute

13. SUPPLEMENTARY NOTES 2009 U.S. Army Corrosion Summit, 3-5 Feb, Clearwater Beach, FL					
14. ABSTRACT					
15. SUBJECT TERMS					
16. SECURITY CLASSIFICATION OF:			17. LIMITATION OF ABSTRACT	18. NUMBER OF PAGES	19a. NAME OF RESPONSIBLE PERSON

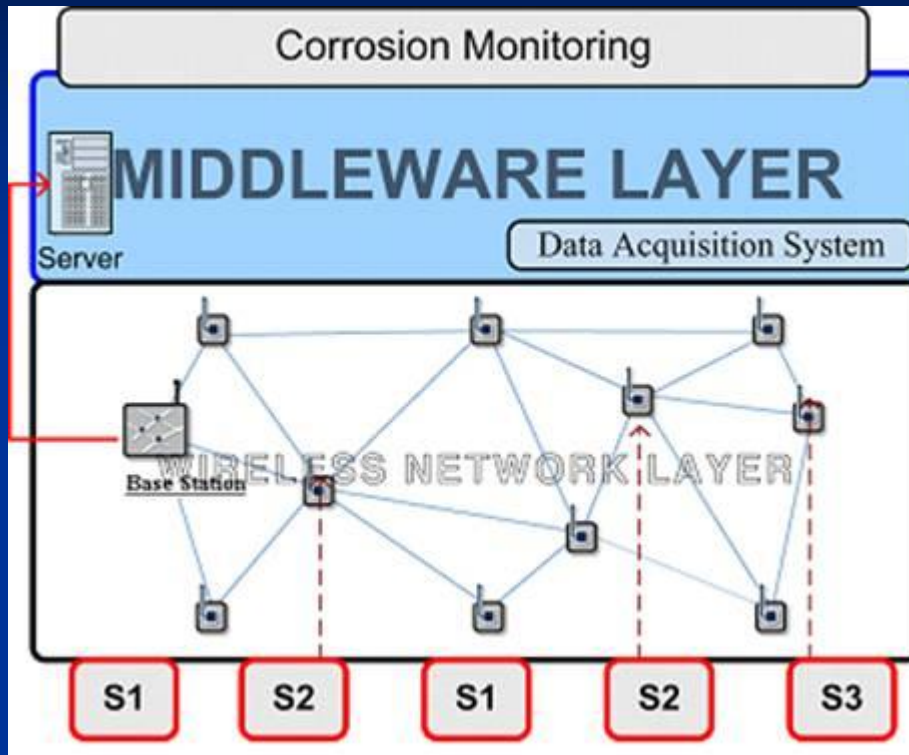
Data Transmission

Base station connected to web portal through data network

Data routed to base station through reader network

Autonomous sensors – data collection at programmed intervals

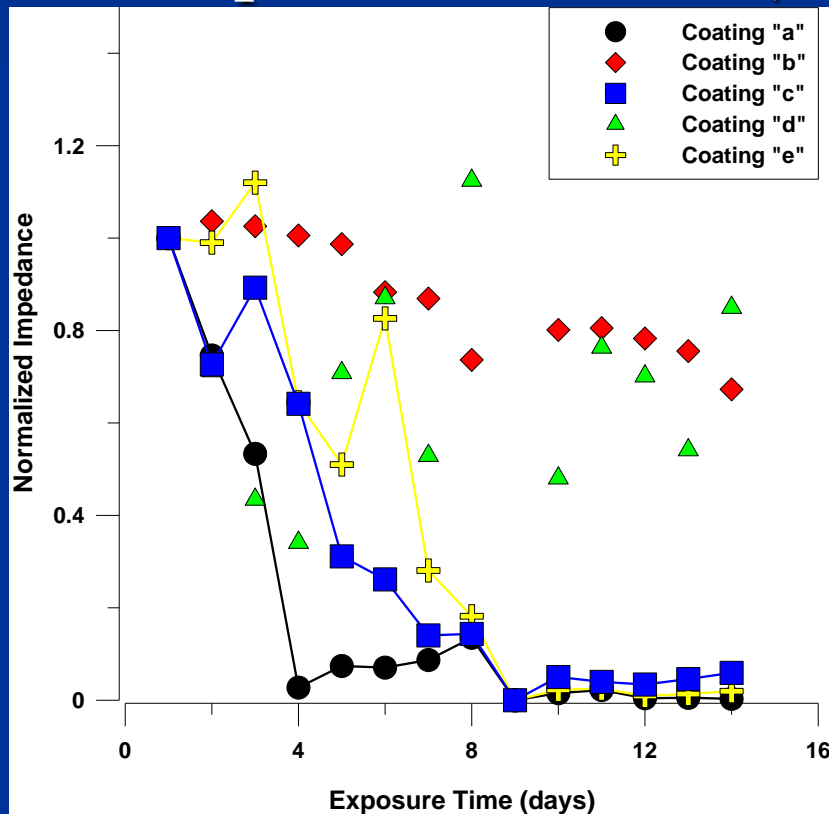
CDS Operation Principle

- Coating degradation is indicated by a drop in impedance values (magnitude and phase angle)

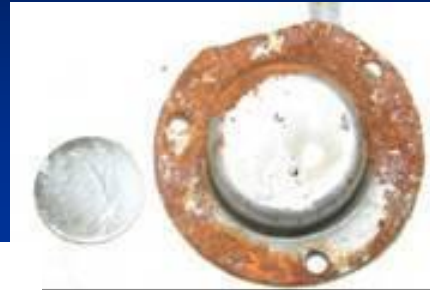
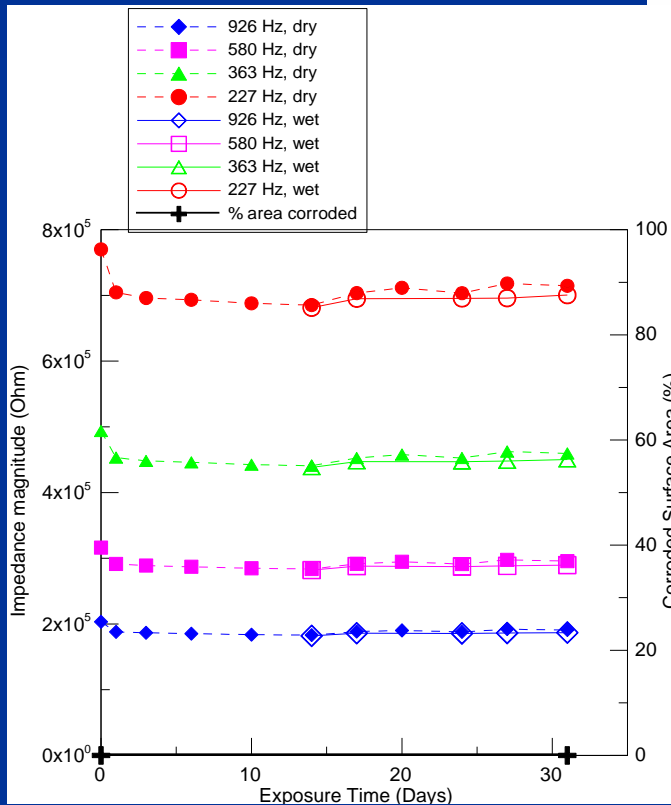
Occluded Sites

Treatment with CPC prior to exposure

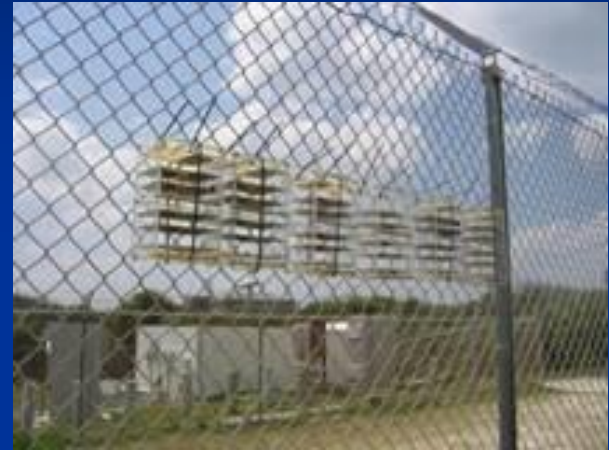
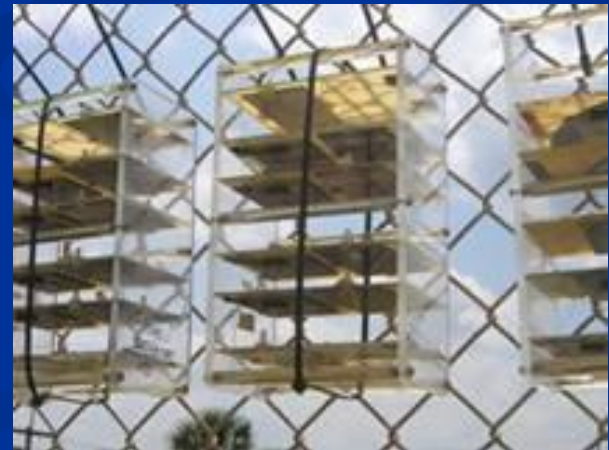
Field Studies

- Sensors exposed to coastal environment at Daytona Beach, FL for 149 days.
- Sensor package acquired and wirelessly transmitted relative humidity, temperature and impedance data to a web portal.
- EIS parameters:
 - Frequency: 1000 Hz
 - AC amplitude: 200 mV
 - Measurement interval: once every hour

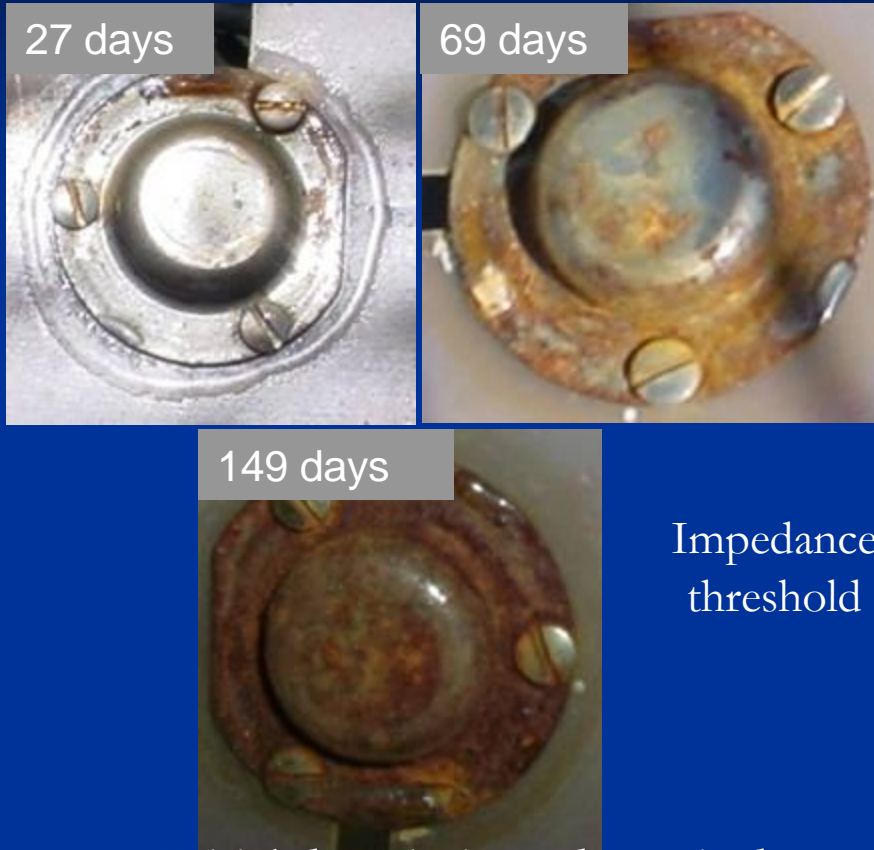
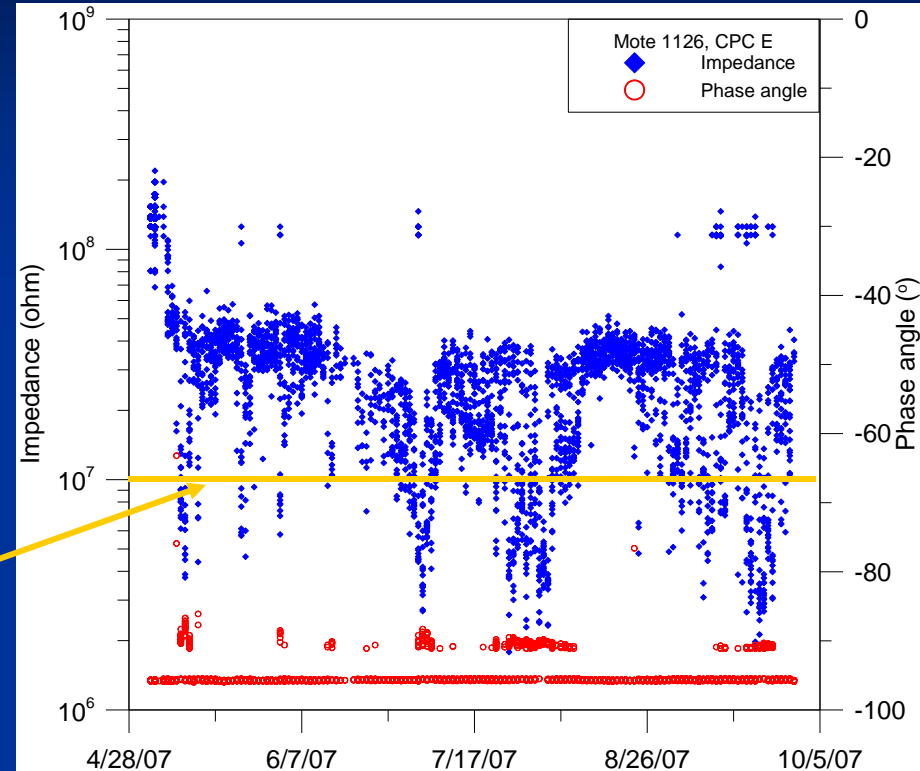
Results – The “Bad”

- Initial drop in impedance is due to water uptake.
- Coating failure: drop of impedance below $10^7 \Omega$.
- Recovery: during low RH periods, sensor surface dries out.
- Phase angle changes follow impedance magnitude trends.

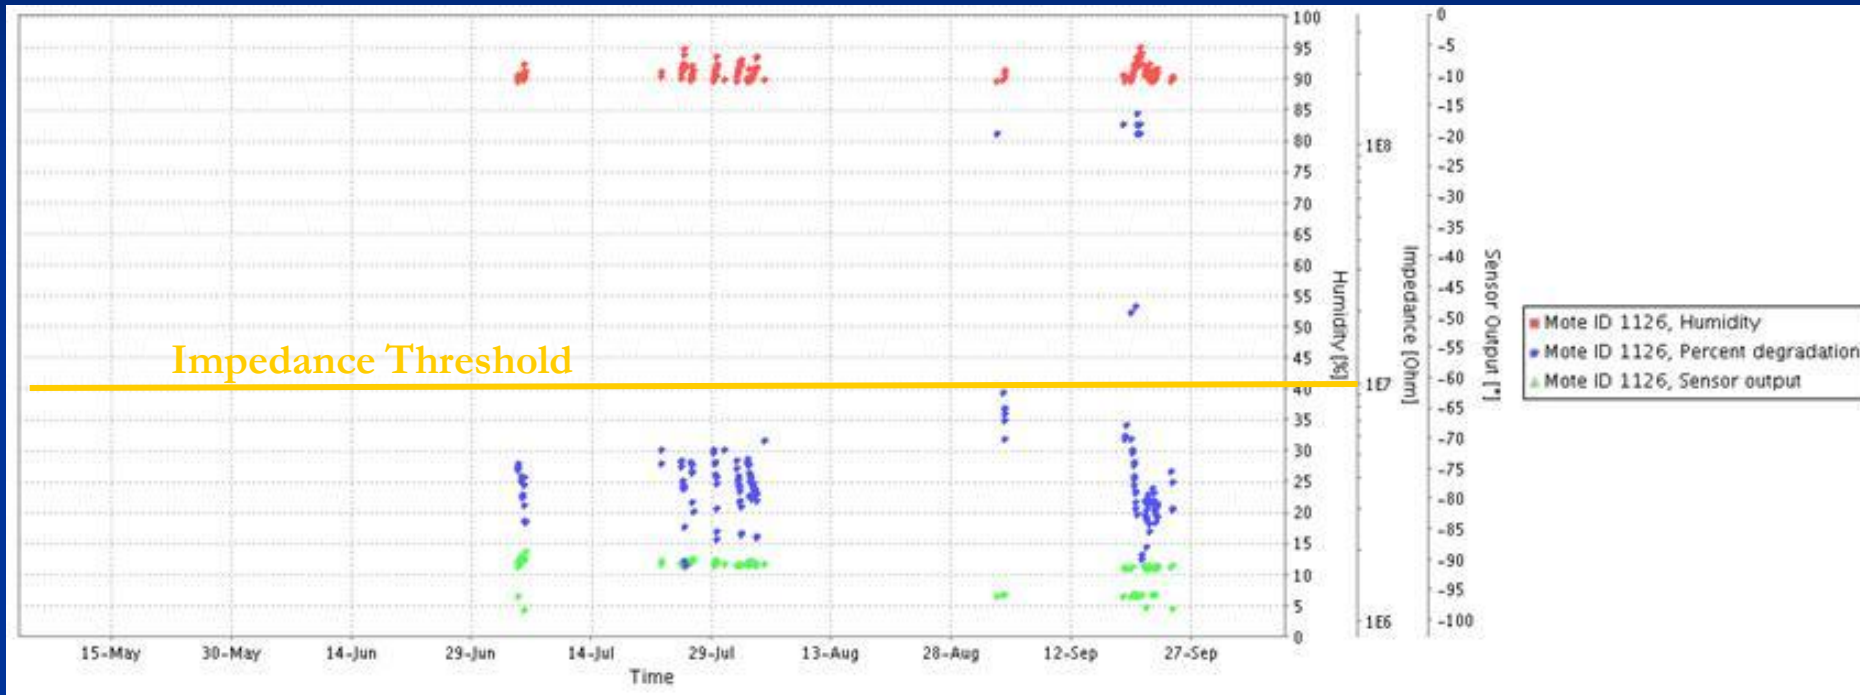
Sensor Output, RH: 80-100 %

- Most significant changes.
- Water condensation + salt deposits – high conductivity medium for corrosion.

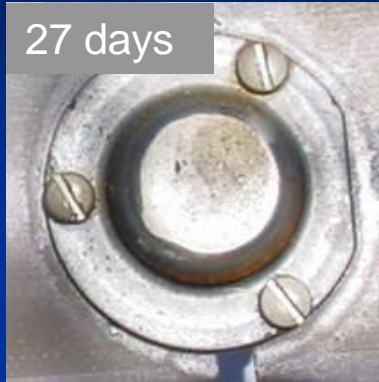
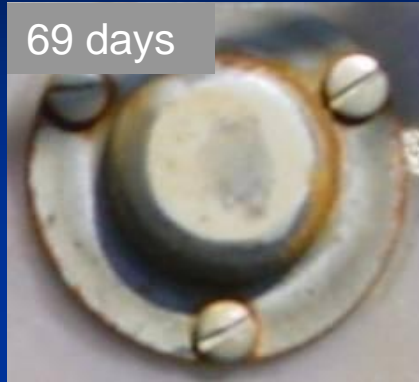
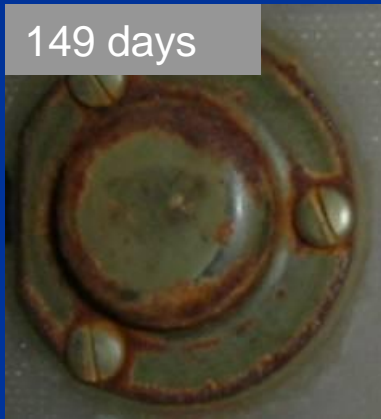
Results – “The Good”

- Initial drop in impedance is due to water uptake.
- No corrosion is observed on treated top surface.
- No significant drop of impedance below threshold.
- No change of phase angle.

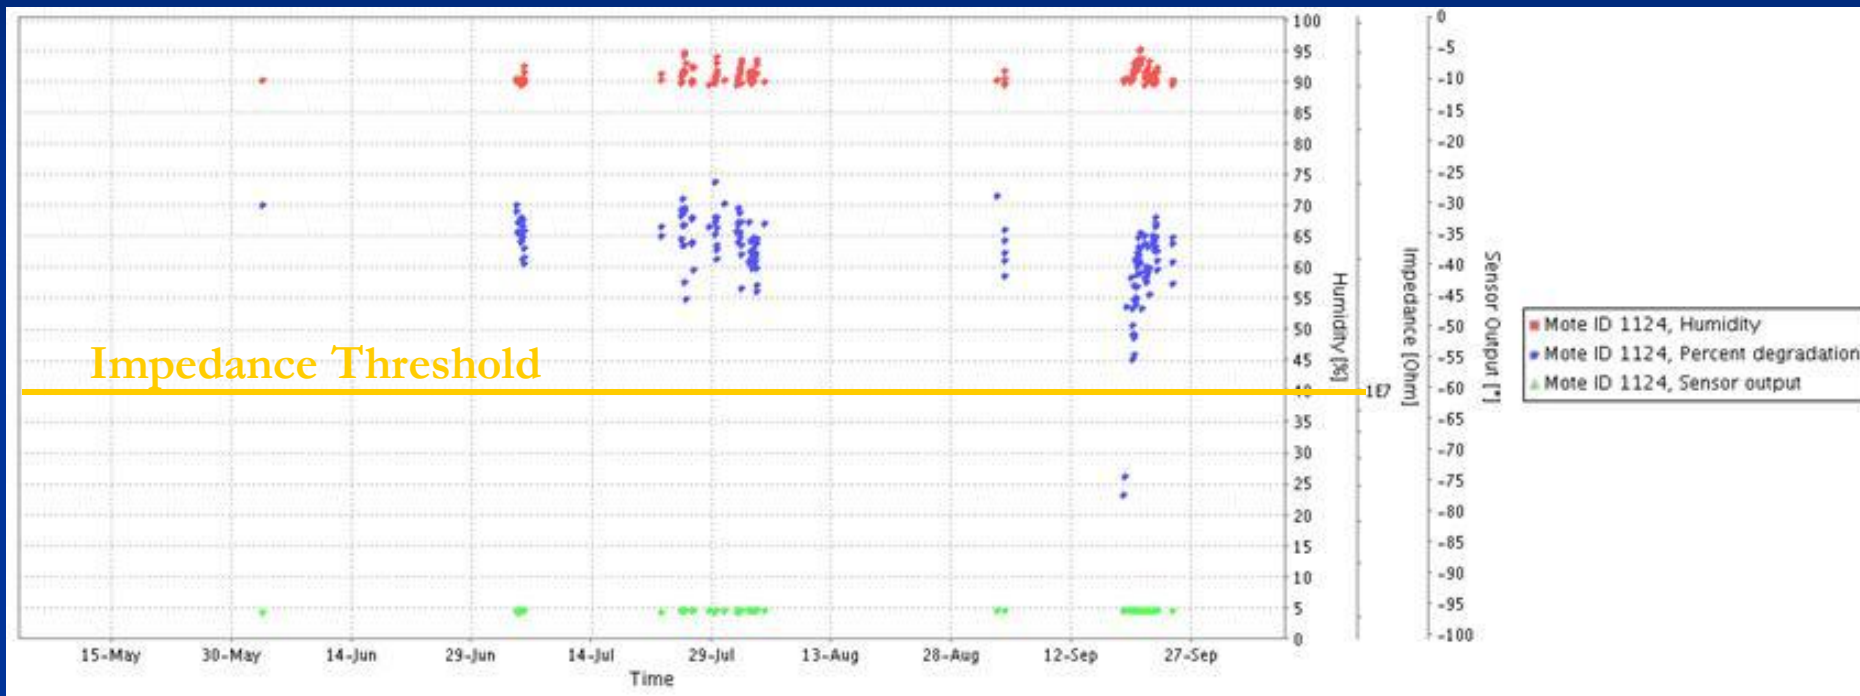
Sensor Output, RH: 80-100 %

- No drop below impedance threshold for up to 110 days.
- No change in phase angle.
- This CPC provides excellent corrosion protection even under high humidity conditions.

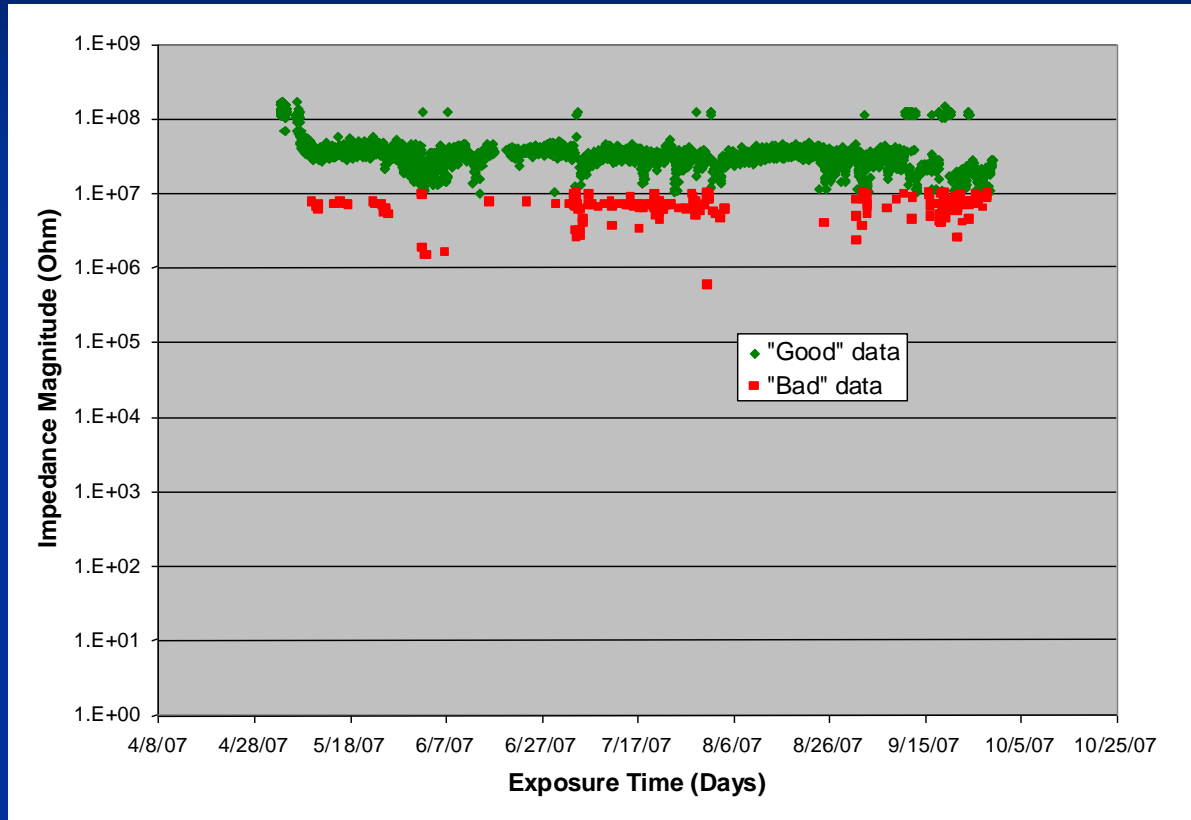
Cumulative Damage Analysis

$$Cumulative\ Damage = \int_0^t \left| 10^7 - Impedance\ Magnitude \right|_{if\ I < 10^7\ \Omega} dt$$

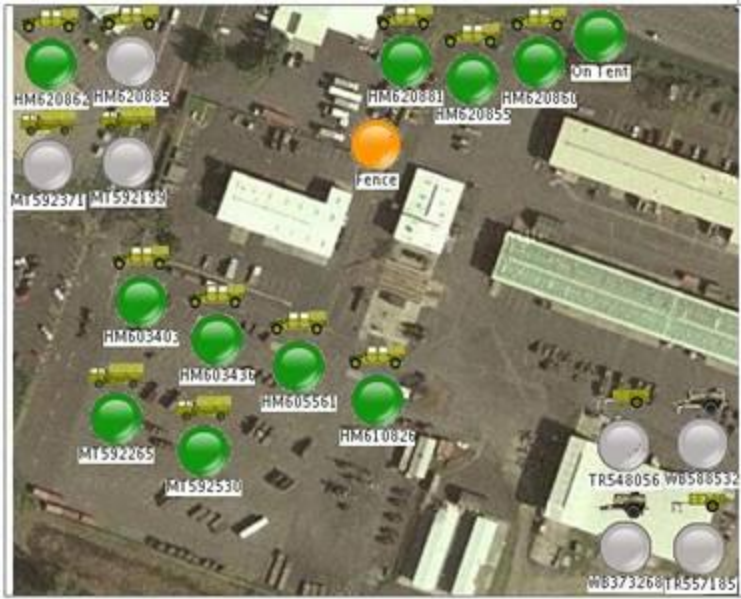
Web Portal

Location: Kaneohe Bay, HI
