The Use of Vitreous Enamel Coatings to Improve Bonding and Reduce Corrosion in Concrete Reinforcing Steel

1. Construction Engineering Research Laboratory,
2. Geotechnical and Structures Laboratory
USAE Research and Development Center

13. SUPPLEMENTARY NOTES 2009 U.S. Army Corrosion Summit, 3-5 Feb, Clearwater Beach, FL					
14. ABSTRACT					
15. SUBJECT TERMS					
16. SECURITY CLASSIFICATION OF:			17. LIMITATION OF ABSTRACT Same as Report (SAR)	18. NUMBER OF PAGES 30	19a. NAME OF RESPONSIBLE PERSON

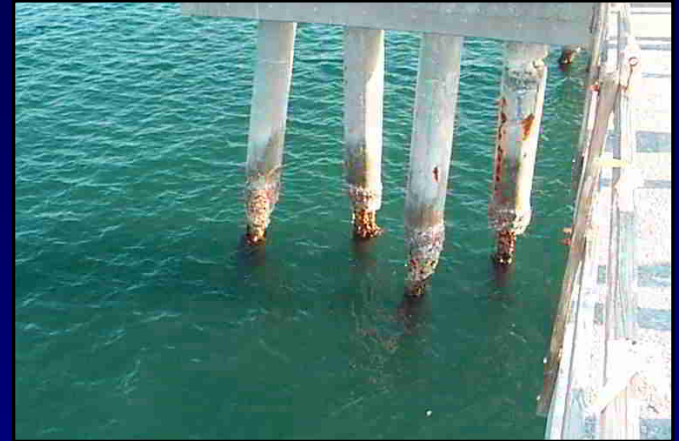
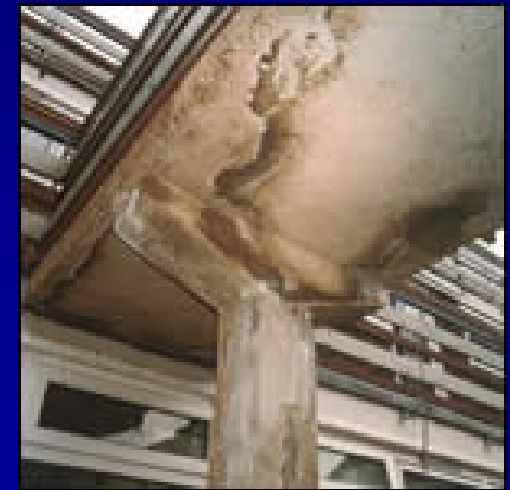
Failure of Concrete with Mild Steel Reinforcement is Due to Corrosion of the Steel

- The major cause of failure in reinforced concrete is the corrosion of the reinforcing steel whether it is rebar or steel fiber
- The rusting of iron embedded in the concrete increases the volume and cracks the concrete apart
- All normal reinforced concrete (cast-in-place and precast) may have a short service life due to corrosion

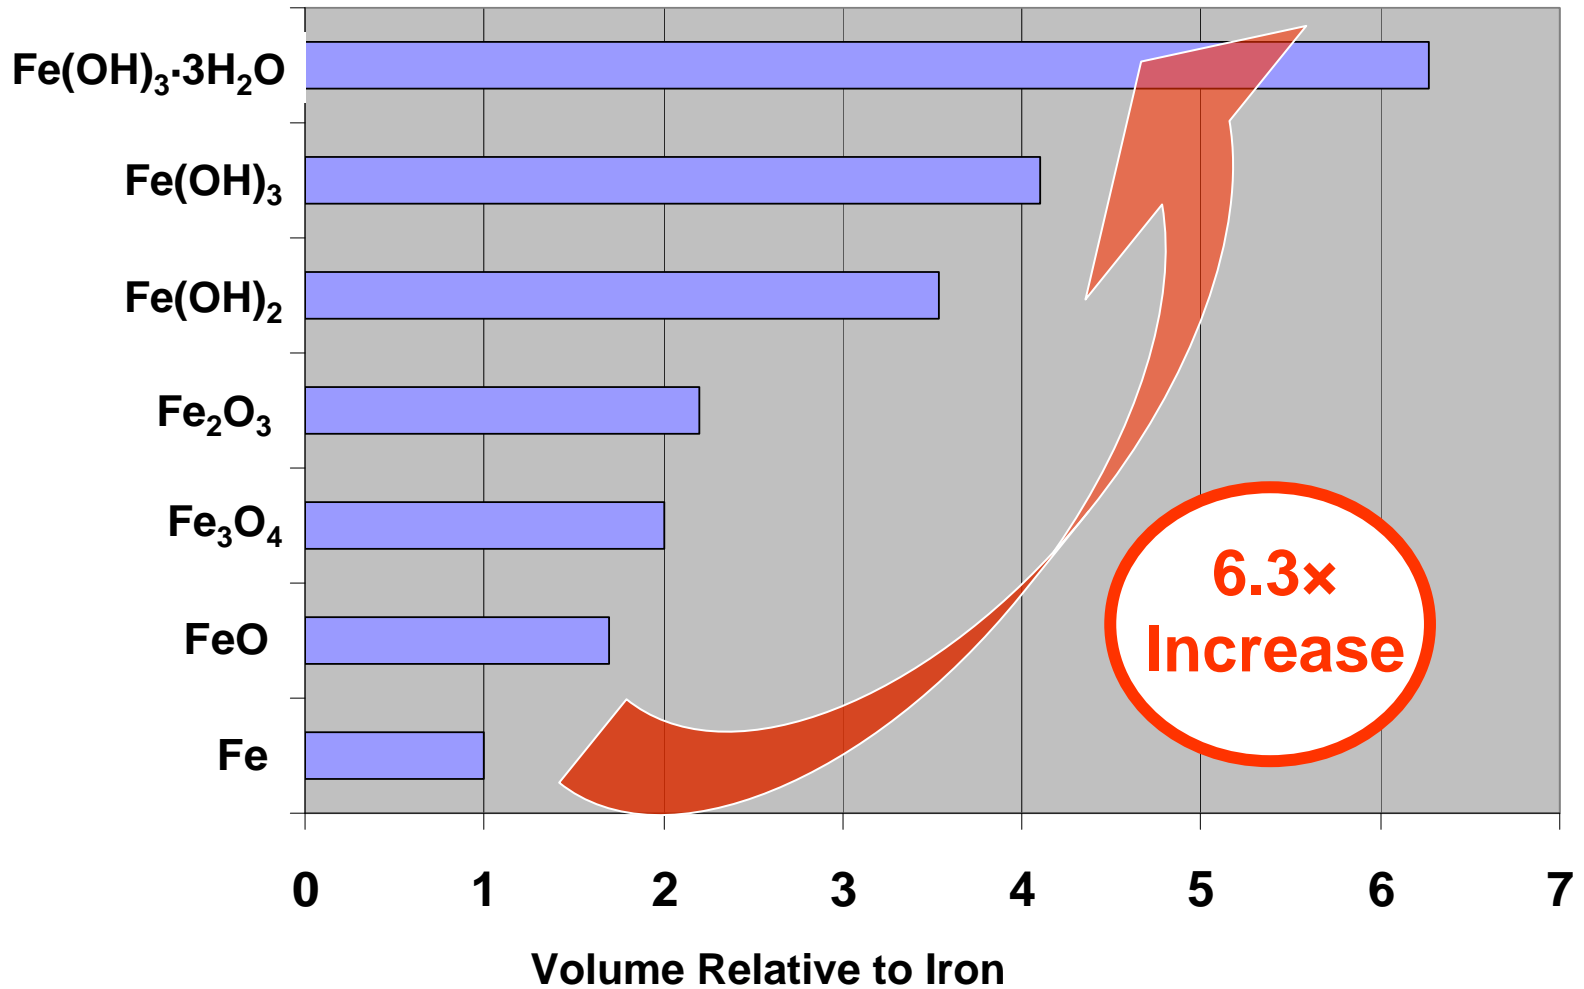
Volume Relative to Iron

Increasing the Volume of the Iron Oxide Layer Cracks the Concrete

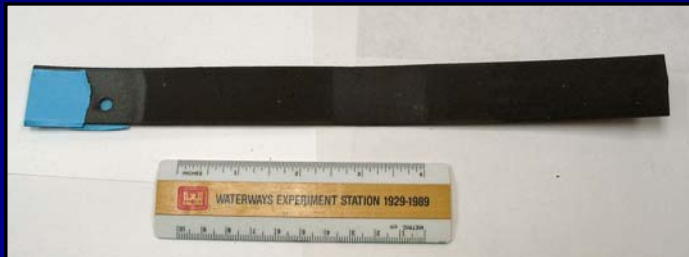
Bonding Enamel Has Serious Advantages!

- Enamel insulates the surface and prevents electrochemical effects that cause corrosion
- Enamel covers the surface to prevent chloride contact
- Provides a tight bond and dense cemented layer

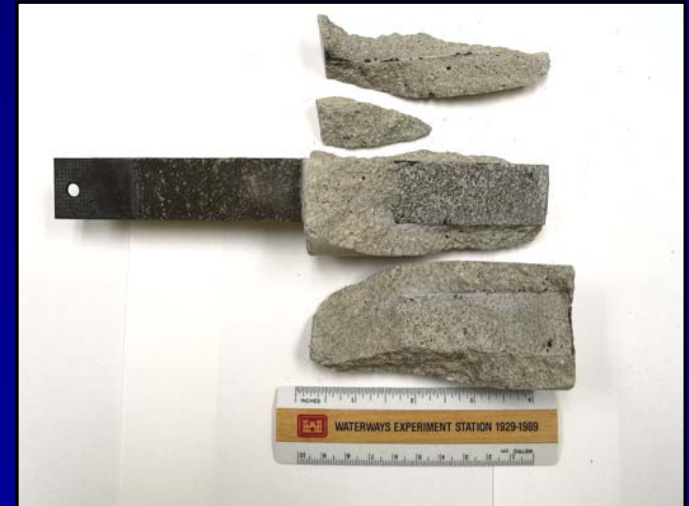
The cement-glass layer fused to the surface of the steel produces a bond strength that is significantly greater than that obtained with a bare steel surface (usually at least 2 to 4 times greater). All other coatings decrease bond strength.

- The cement-glass interface produces a bond strength to the steel that is at least 3 to 4 times greater compared to bare steel alone
- The cement-glass enamel hydrates in the same way as conventional cement. Morphological and chemical changes in the cement embedded in the glass is consistent with conventional hydration
- Enameling is very effective in preventing corrosion. In testing corrosion has not been observed on the steel when the enamel is not purposely removed
- Bonding enamel potentially can be very useful in creating reinforced concrete with an improved composite character and improved corrosion resistance
- Work at CCAD will demonstrate the technology on a much larger scale, yielding real world load bearing and corrosion performance data

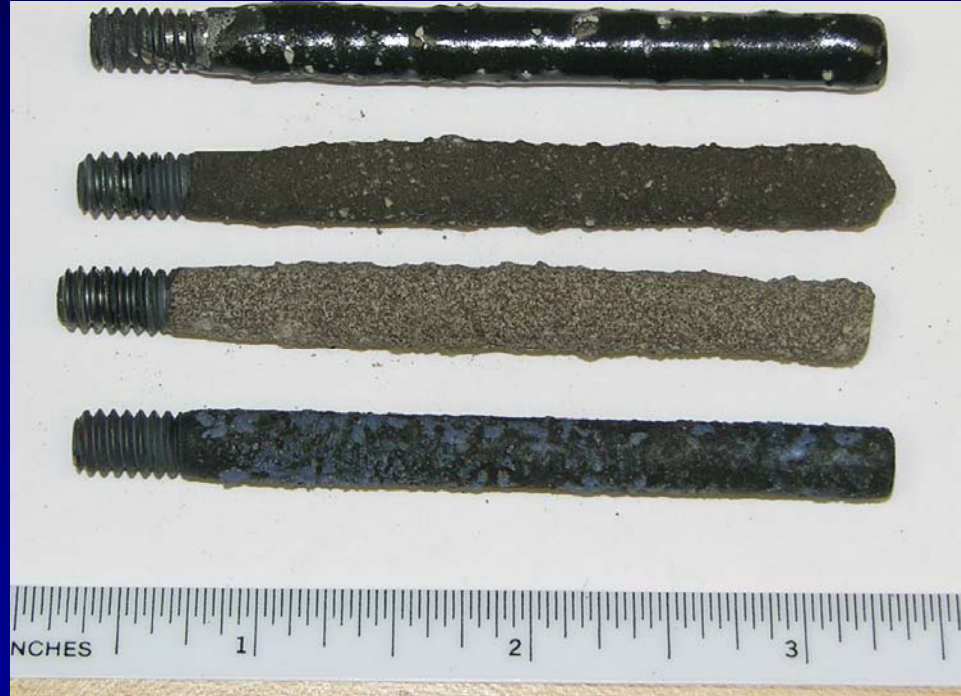
Enameled Test Rods

- Rods can be single-coated and fired once or double coated and fired twice
- Firing temperatures were in the 745 °C to 850 °C
- Firing times ranged from 2 minutes to 10 minutes

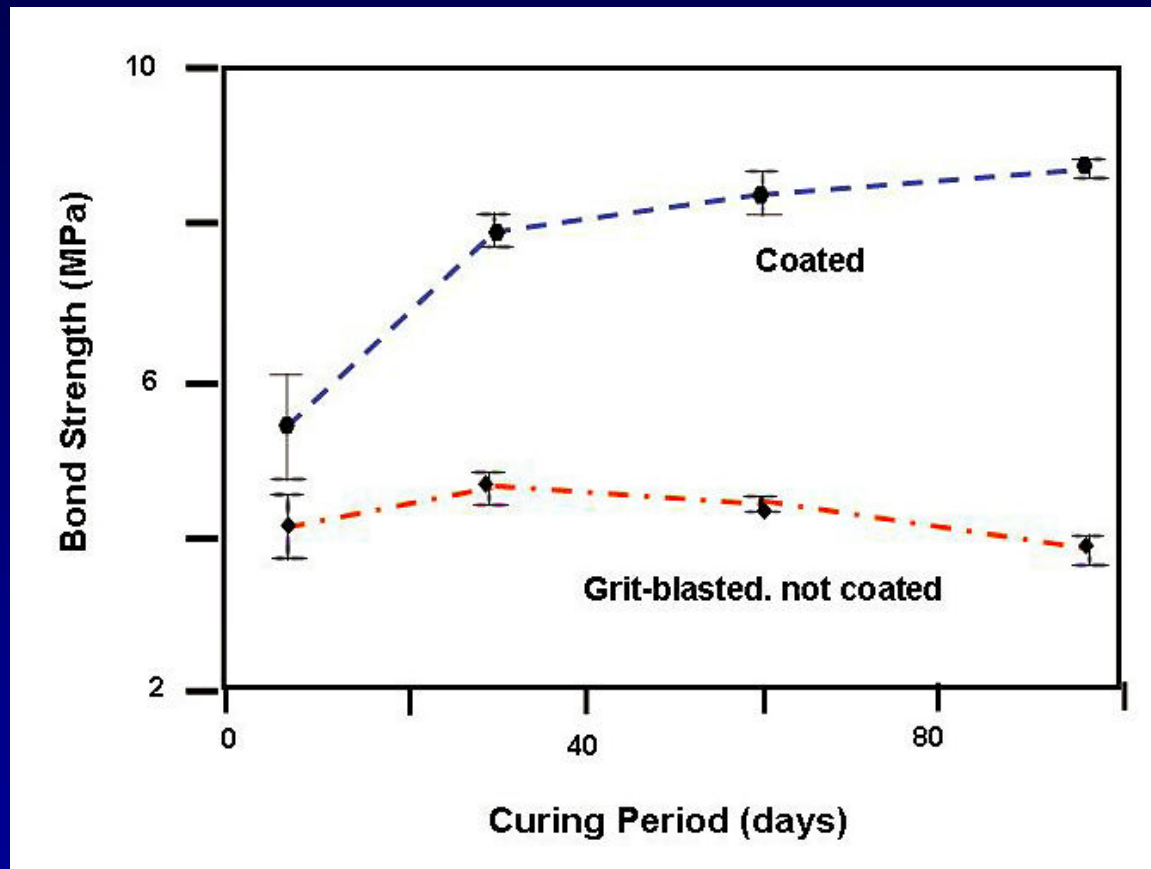
Reactive Enamel Increases Strength Over Time

- Bond strength of coated rebar increases over time
- Bond strength of non-coated rebar lower, and decreases over time

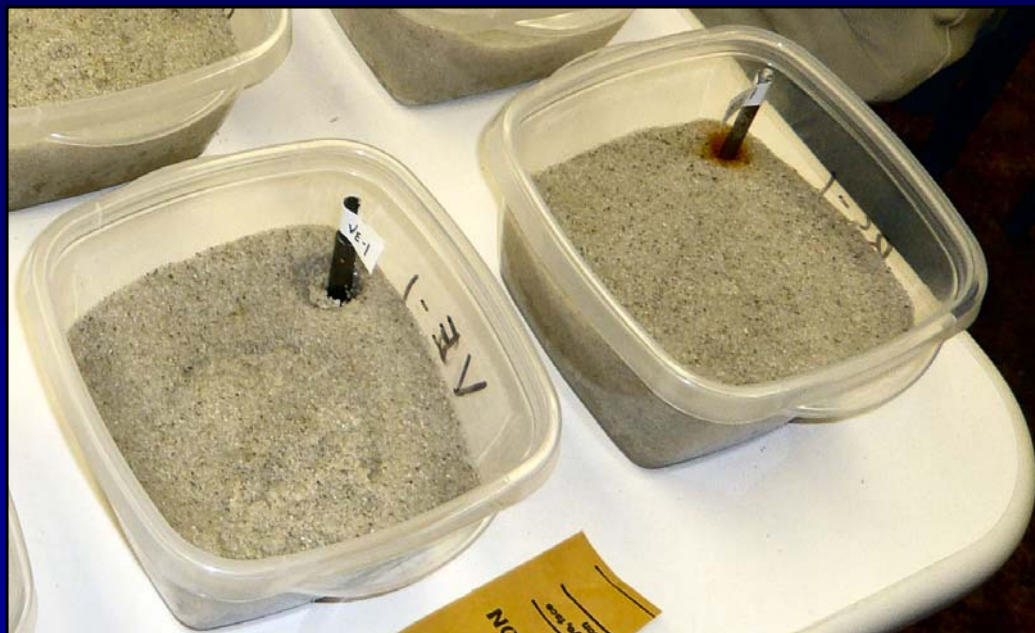
Salt Water Exposure Testing

Exposure in Partly Saturated Quartz Sand with 3.5% Sodium Chloride Solution at 20 °C

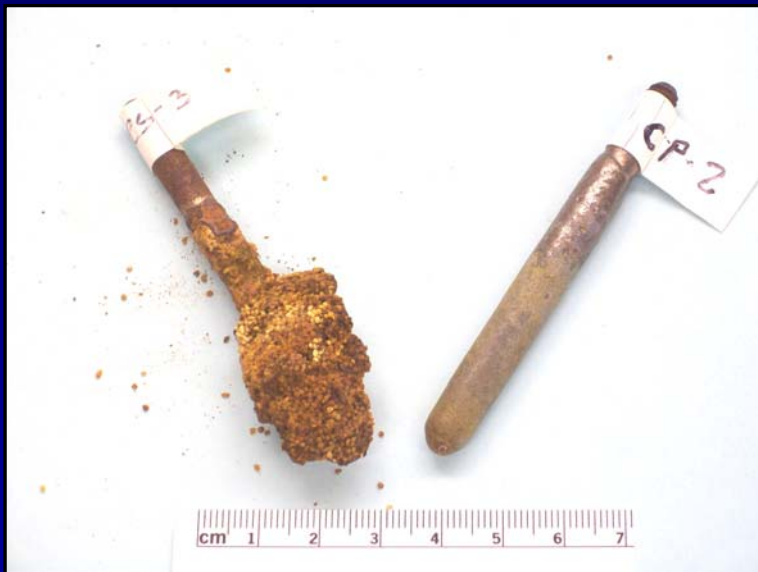
Results of 40-day exposure of mild steel test rods in 3.5% NaCl solution at 20 °C

Alkali-resistant ground coat enamel w/ portland cement

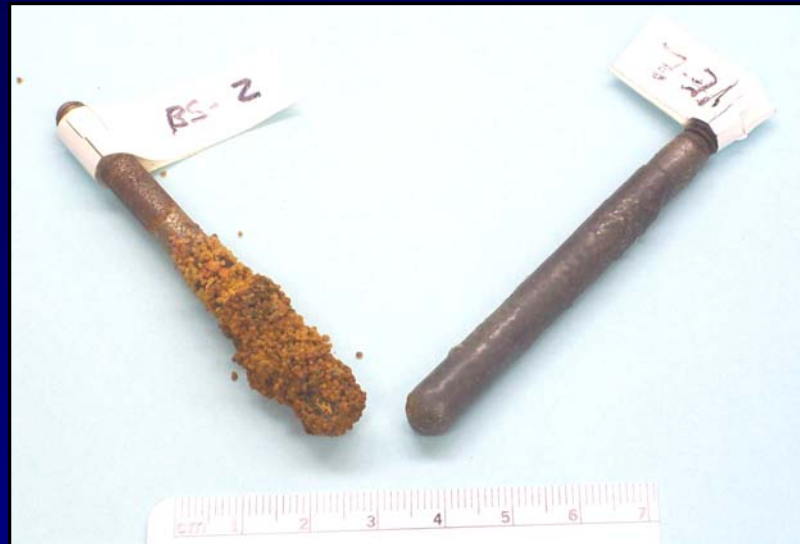
Alkali-resistant ground coat enamel

Cement on surface that contacted water hydrated

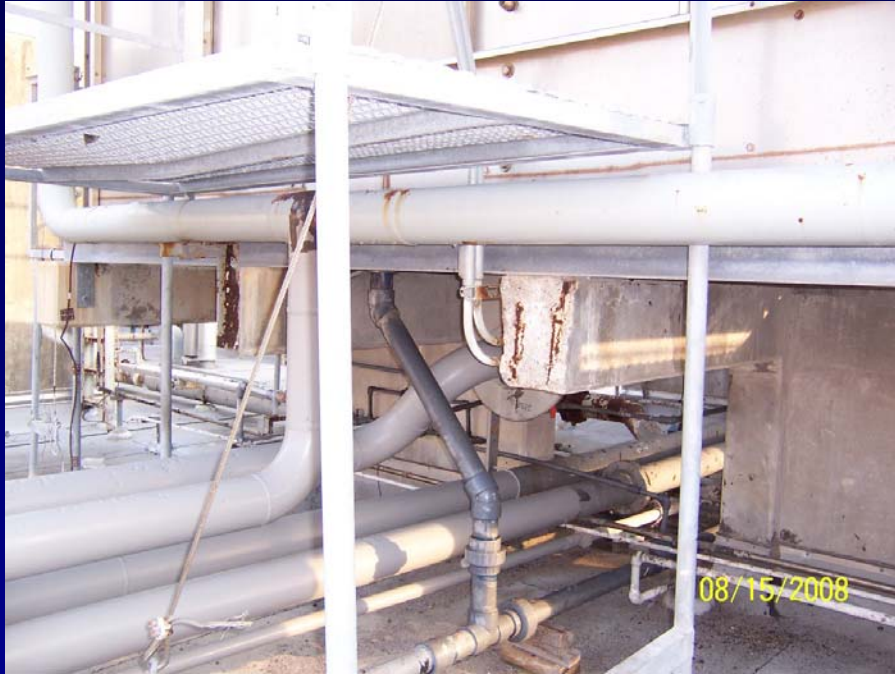
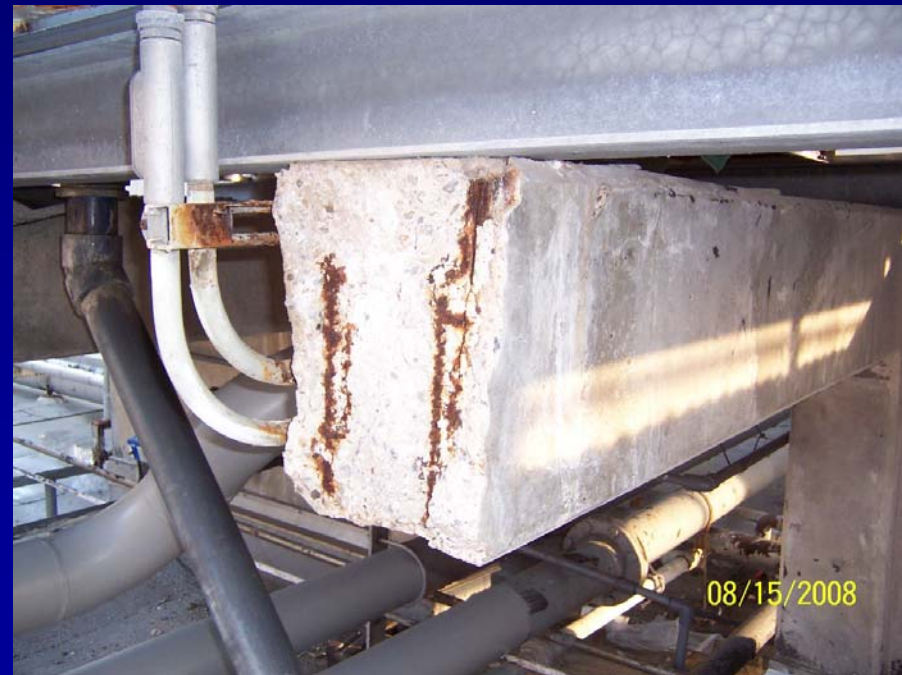
CCAD Cooling Tower Support

- Exposure to Atmospheric Chlorides from Gulf of Mexico
- Spalling concrete from corroding steel

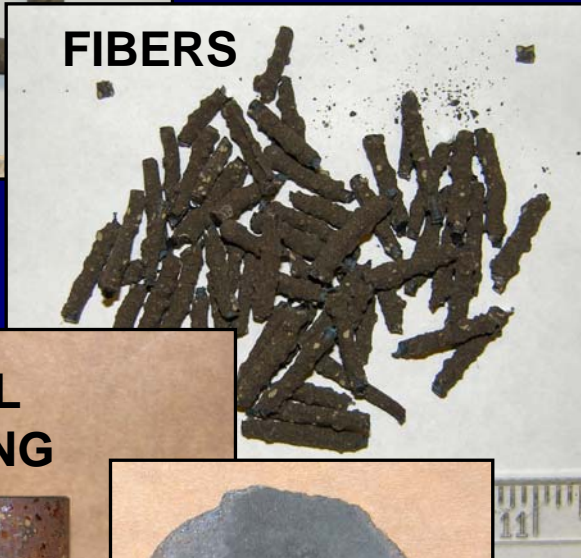
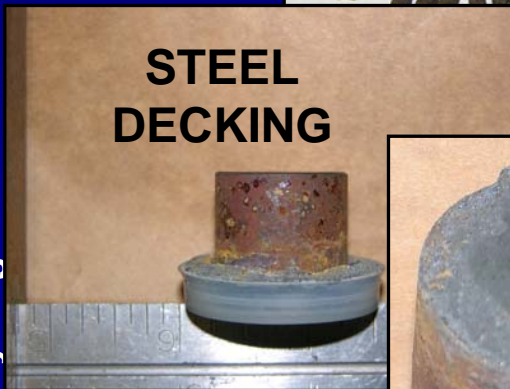
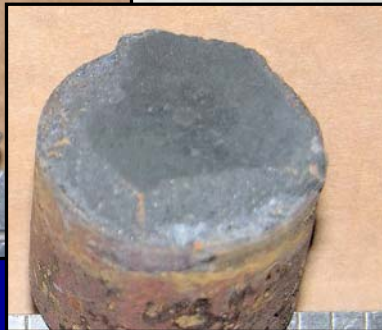
MASONRY ANCHORS AND FITTINGS

- It can go into pre-cast or cast-in-place concrete
- It can be go onto steel decking for concrete floor construction
- Masonry anchors and “appliances” that have to bond to mortar can be enameled
