Rotorcraft Downwash Flow Field Study to Understand the Aerodynamics of Helicopter Brownout

Presented at the American Helicopter Society Southwest Region Technical Specialists' Meeting, "Technologies for the Next Generation of Vertical Lift Aircraft," Dallas-Fort Worth, TX, October 15-17, 2008.

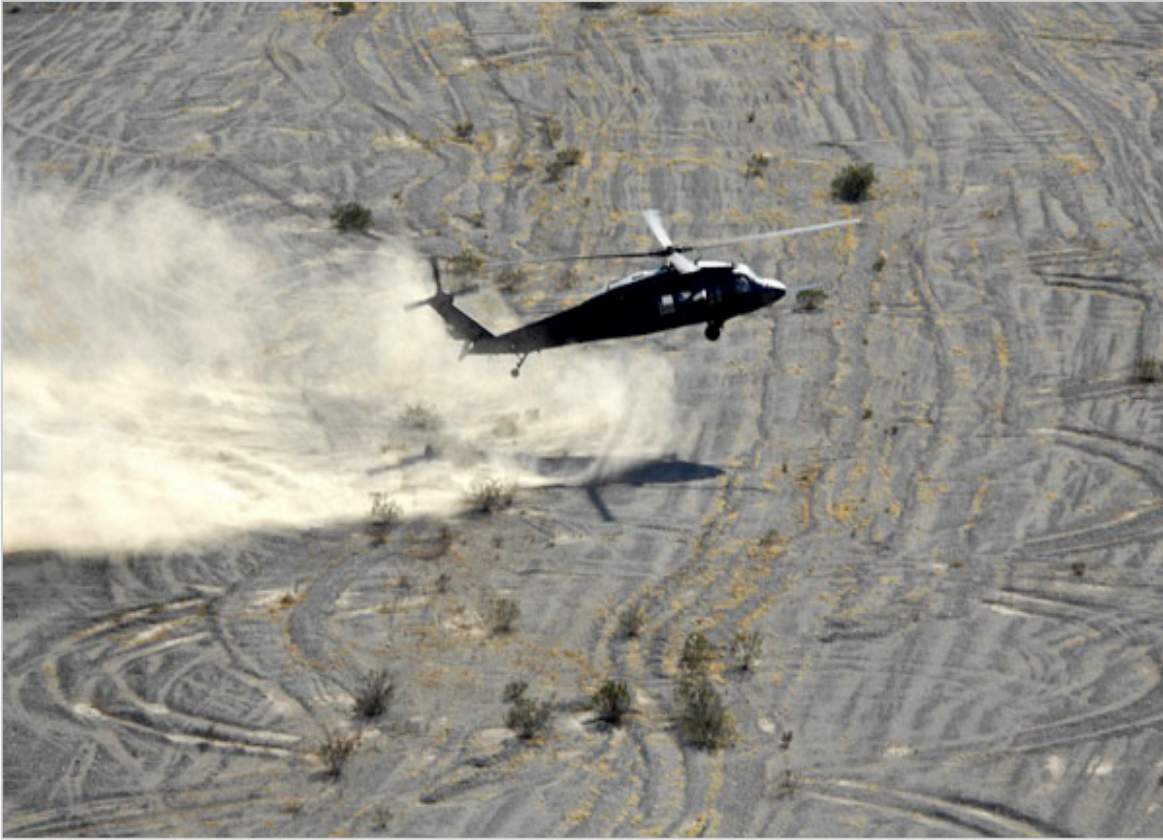
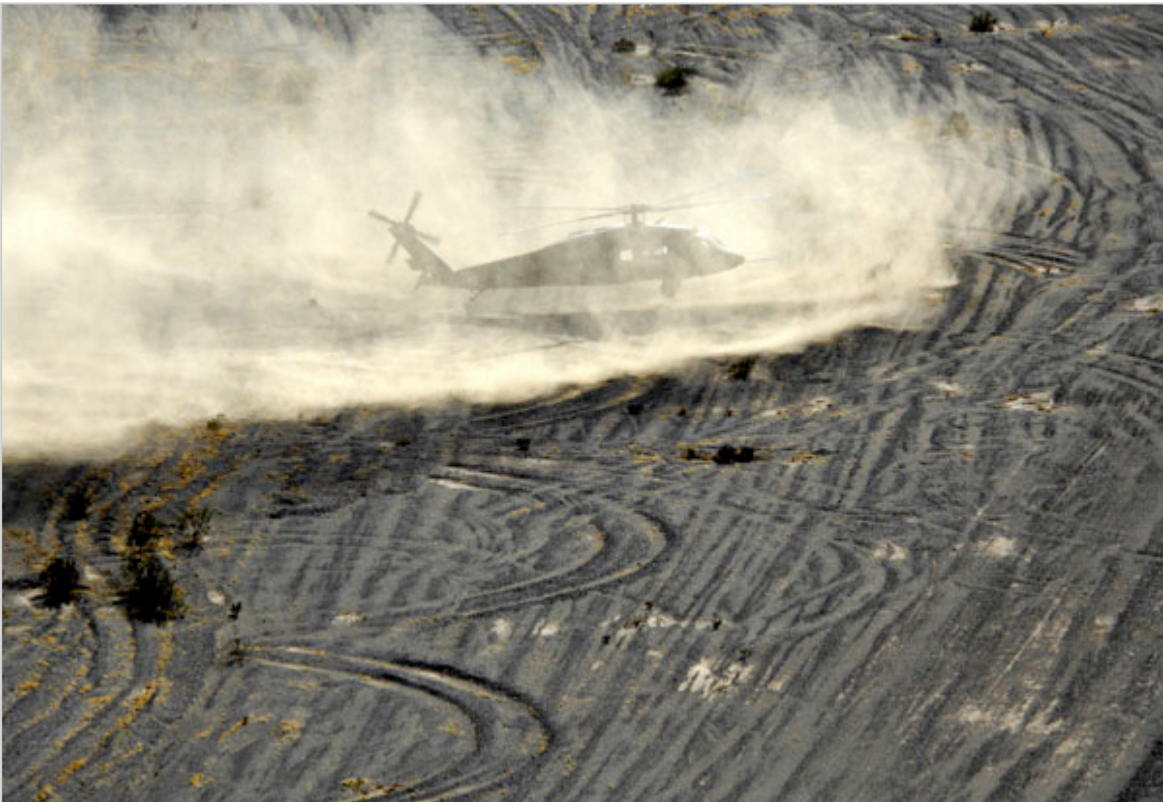
Figure 1. UH-60 Blackhawk performing test landing in brownout at Yuma Proving Grounds.

Rotorcraft brownout is a critical problem experienced by helicopters when landing in dry, sandy ground conditions. (Helicopters landing in powdery snow experience a similar problem referred to as whiteout). Brownout is caused by dust particles that get entrained in the rotor downwash while the helicopter is in ground effect. The dust can reduce or completely obscure the pilot's visibility of the ground and horizon, which are two important orientation cues used for landing (Figure 1). Due to recent military activity in desert environments, brownout

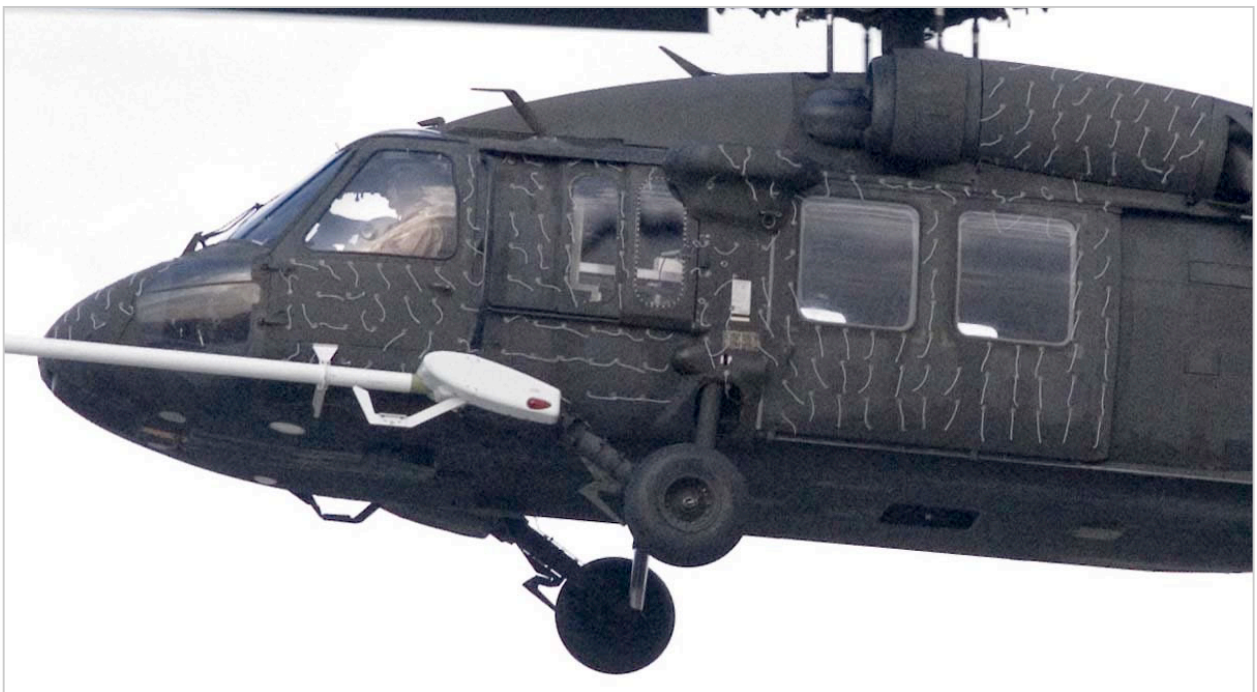
Figure 4(a). Single instantaneous airframe tuft pattern; Wheel height=50 ft.

Figure 4(b). Single instantaneous airframe tuft pattern; Wheel height=50 ft.

Figure 4(c). Single instantaneous airframe tuft pattern; Wheel height=50 ft.

Figure 4(d). Overlay of three instantaneous airframe tuft images; Wheel height=50 ft.

Figure 4. UH-60 airframe tufts in hover at 50-ft wheel height (OGE).

Figures 4(a) through 4(c) show single instantaneous photographs of airframe tufts on the UH-60L hovering out of ground effect (OGE) at 50-ft wheel height. Figure 4(d) represents an overlay of all 3 instantaneous images, providing information on average tuft direction and degree of flow steadiness (from degree of tuft coning) at this wheel height. The flow is clearly not steady. However, in general, tufts are seen to be pointing downwards on the side of the airframe (in the direction of the rotor downwash) indicating attached flow.

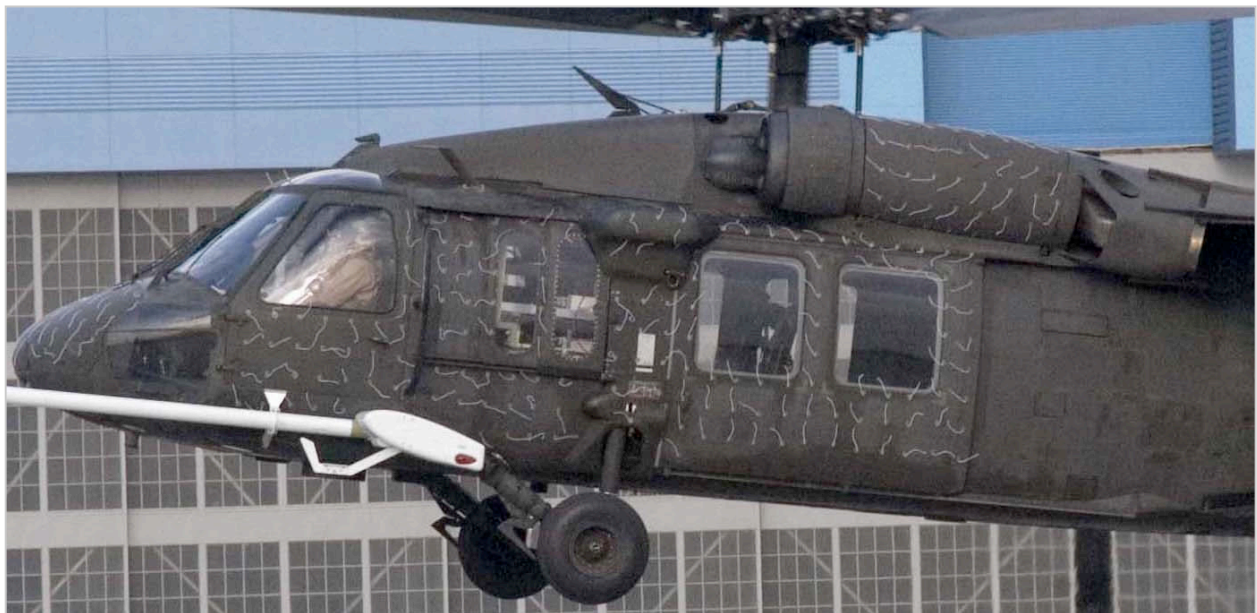
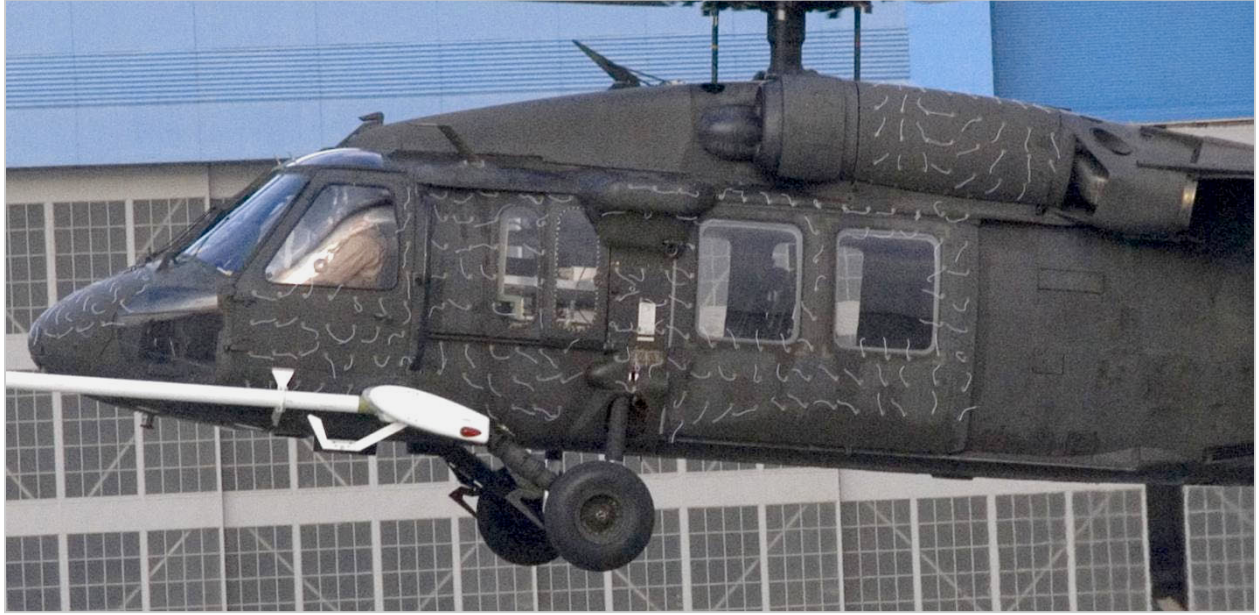
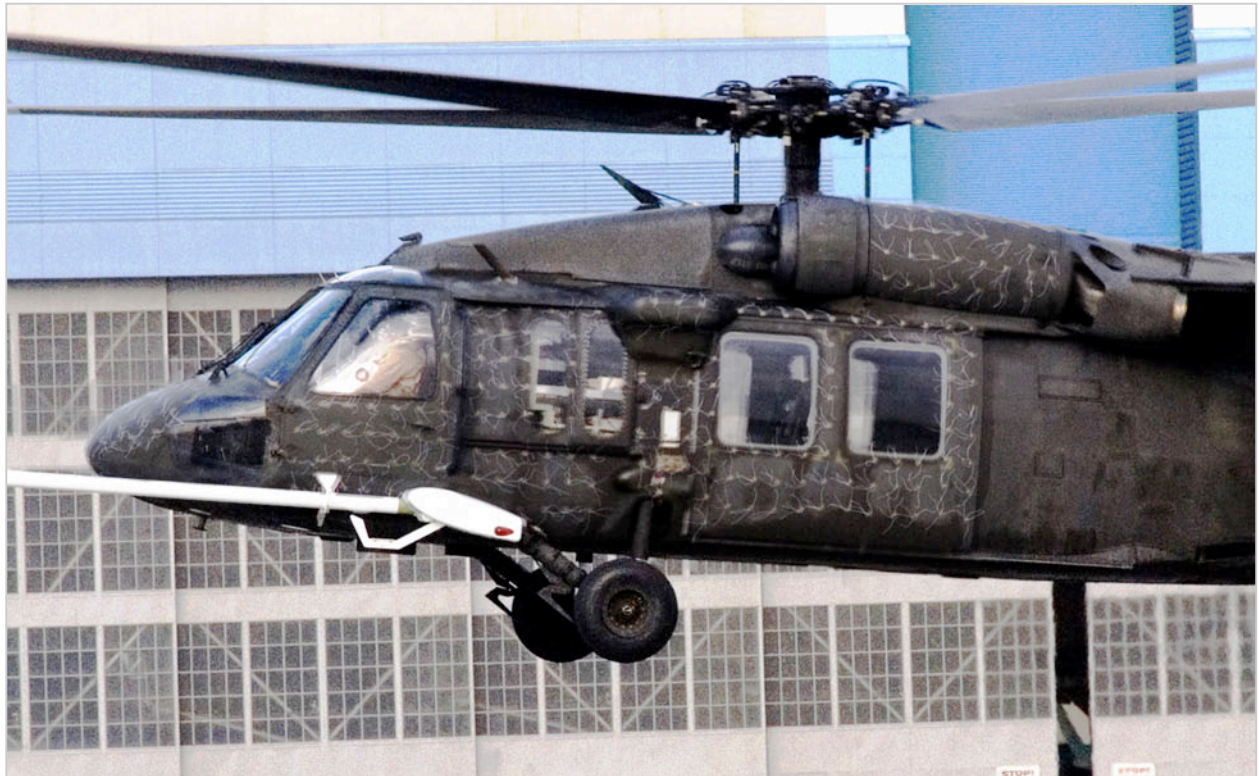
Figure 5(a). Single instantaneous airframe tuft pattern; Wheel height=5 ft.

Figure 5(b). Single instantaneous airframe tuft pattern; Wheel height=5 ft.

Figure 5(c). Single instantaneous airframe tuft pattern; Wheel height=5 ft.

Figure 5(d). Overlay of three instantaneous airframe images; Wheel height=5 ft.

Figure 5. UH-60 airframe tufts in hover at 5-ft wheel height (IGE).

Figures 5(a) through 5(c) show single instantaneous photographs of airframe tufts on the UH-60L hovering in ground effect (IGE) at 5-ft wheel height. Many tufts can be seen pointing upwards toward the rotor and away from the ground. Figure 5(d) represents an overlay of all 3 instantaneous images providing information on average tuft direction and degree of steadiness. In general, for the rotor in ground effect, the airframe tufts are very unsteady (the degree of unsteadiness increasing as the rotor approaches the ground). Many tufts show a large range of motion including complete reversal of flow direction. In general, tufts near the rotor hub tend to be pointing upwards.

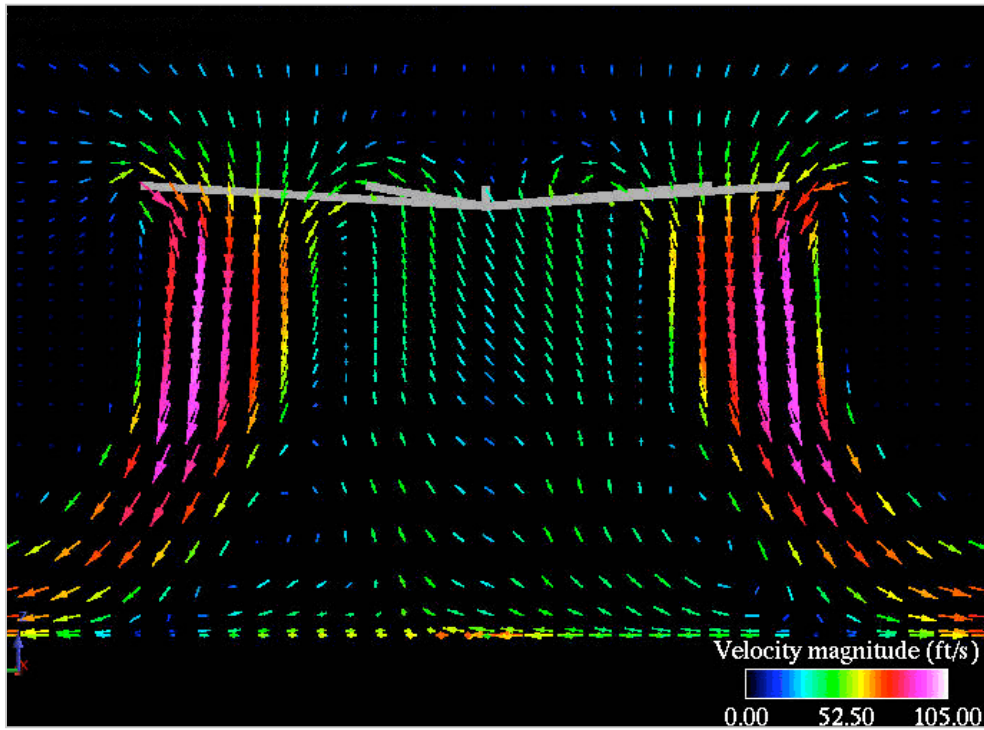
Figure 16. Velocity vectors in transverse plane for EH-101 (rotor without root cutout).

First, the isolated rotor with no root cutout was modeled. Figure 16 shows computed velocity vectors in the transverse plane through the rotor hub. The expected initial wake contraction is evident just below the rotor disk. Recirculation through the rotor disk is evident in the vicinity of the rotor hub. Upwash appears limited to $r/R < 34\%$. This is a surprisingly large area of upwash through the rotor disk considering that there is no root cutout modeled. Flow through the rotor disk is seen to stagnate on the ground plane close to $r/R = 90\%$. Large regions of recirculation are evident under the rotor disk.
