Travelogue and Phenomenology Report

UXO Detection and Characterization in the Marine Environment

ESTCP Project MM-0324

JULY 2009

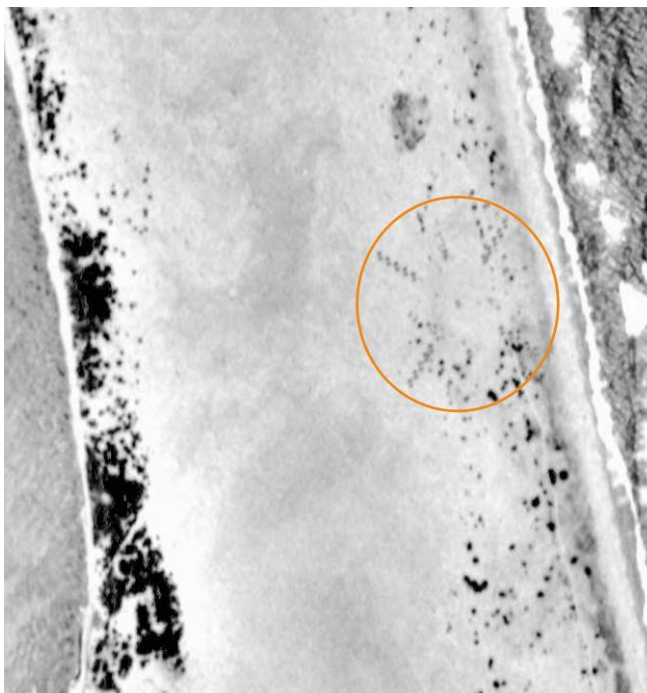
Figure 4-1. Portion of a 1961 aerial photo showing structures likely associated with the bull's eye for the Duck Target Range. The orange circle is super-imposed to highlight these structures.

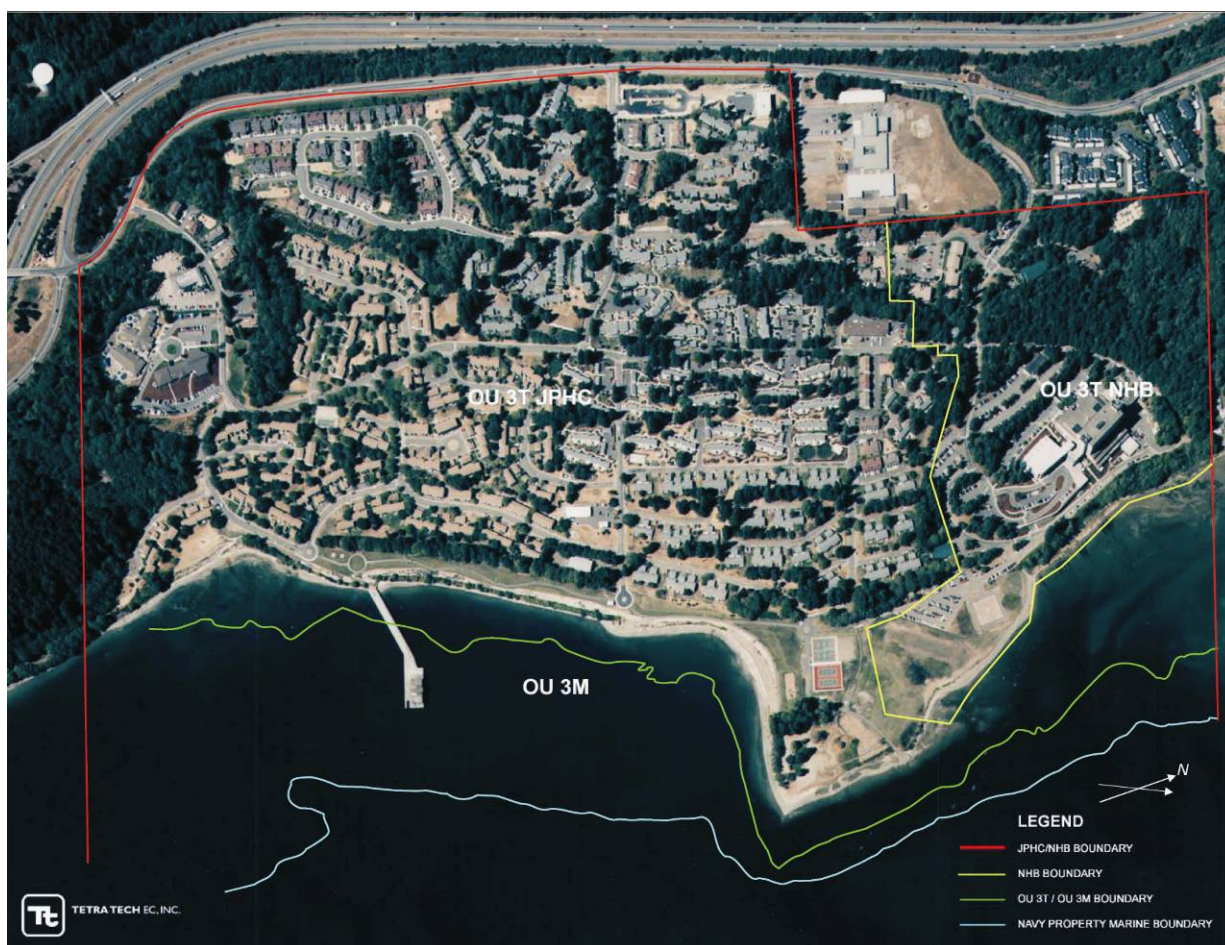
Figure 5-2. Modern aerial photograph of the JPHC and the NHB. The red line marks the Navy property boundary. The blue line marks the approximate marine Navy property boundary at 4 fathoms below MLLW.

The facility was decommissioned in 1959; subsequently 3 of the 4 piers have been removed. In the 1980s several thousand pounds of intact DMM were removed from the immediate vicinity of Pier II, which still remains standing. For the past 10 years DMM clean up operations have been ongoing, mostly on the land that originally composed the NAD.²² The NAD has subsequently been replaced with a high density Naval housing community and a hospital, the Naval Hospital–Bremerton. Figure 5-2 shows a modern aerial photograph of the same area shown in Figure 5-1 (from ~50 years earlier).

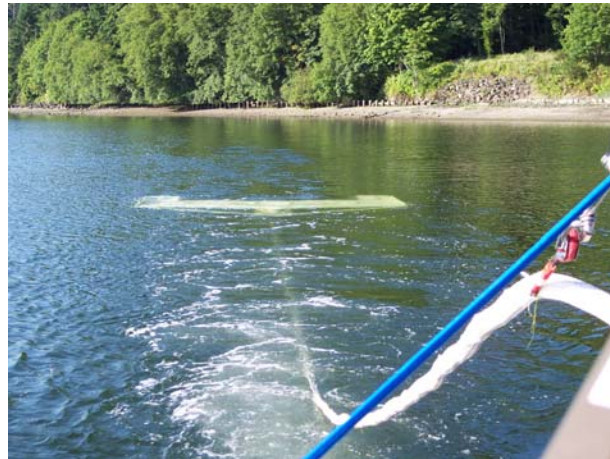
Figure 5-6. The MTA platform is shown surveying along the Ostrich Bay southwest shoreline in shallow water.

The weather in May is mild, with cool mornings and warm afternoons. There is typically very little rainfall at this time of the year and winds are usually light. During this survey, rough water was not a problem. Water visibility was typically four to six feet, Figure 5-6.

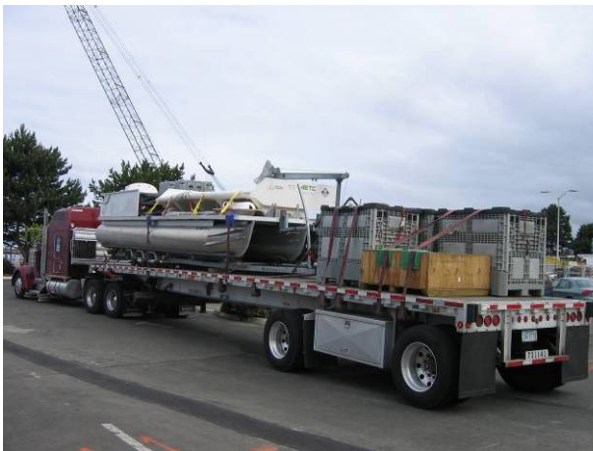
Figure 5-7. All of the MTA system components were shipped on the deck of a single 45 ft trailer. The sensor platform was transported on the boat deck.

The MTA equipment was transported from North Carolina to Seattle using a 45 ft flatbed trailer. With a standard height trailer, the wheels have to be removed from the MTA boat trailer to remain under the 13.5 ft overall height limit. The sensor platform was loaded onto the deck of the pontoon boat, Figure 5-7. The tow cables were shipped in a wooden palletized crate. The other equipment was packed into 4 X 4 ft plastic shipping containers. A few items such as the tow point assembly were Figure 5-7. secured directly to the deck of the trailer. There are no accessible loading docks or marinas with large strap lifts near Ostrich Bay; therefore the equipment was transported to the Shilshole Marina in downtown Seattle. Consequently, the initial staging took place at the marina in Seattle. See Figures 5-7 to 5-9. The boat trailer was

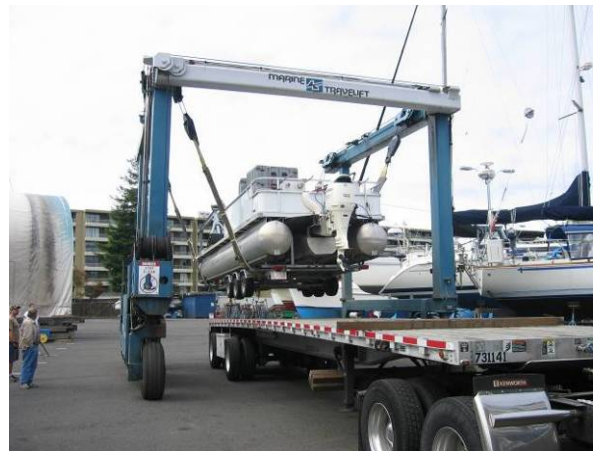
Figure 5-8. A marine hoist was used to unload the MTA vessel and the trailer together. It is difficult to lift the vessel alone without damaging the pontoons.

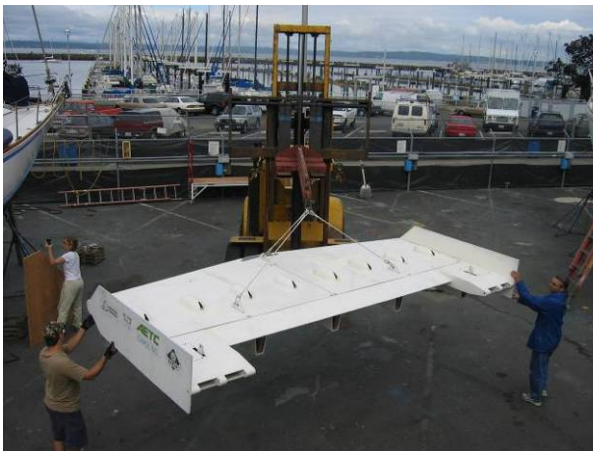
Figure 5-9. A large forklift was used to unload the sensor platform and later load it back onto the MTA vessel boat trailer.

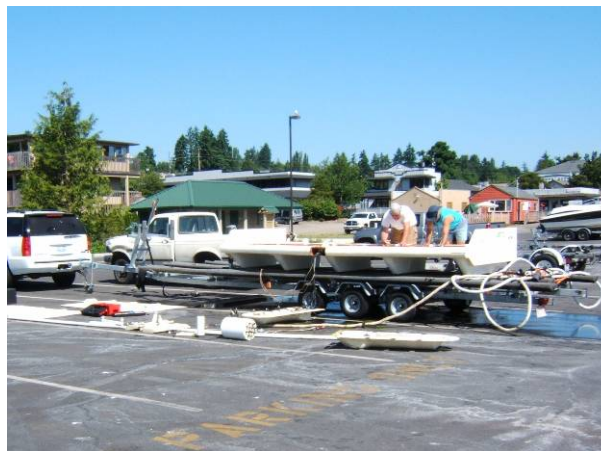
Figure 5-10. The sensor platform is being assembled in the parking lot at Silverdale Marina.

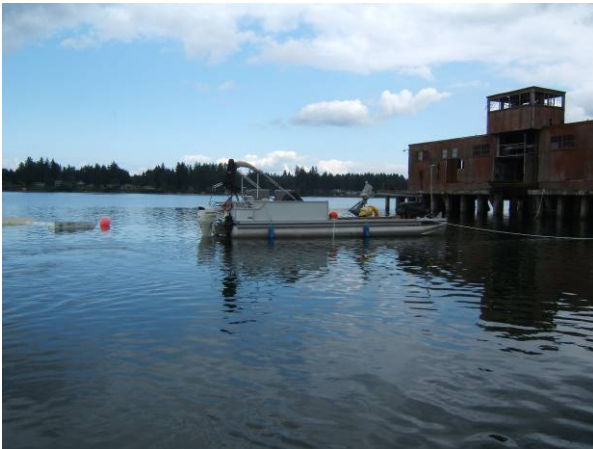
Figure 5-12. The MTA vessel and sensor platform are shown moored on the south side of Pier II.

Two moorings were set south of Pier 2 and were used to moor the pontoon boat and the sensor platform overnight during the survey operations. This mooring arrangement is shown in Figure 5-12. The chase boat was used morning and night to ferry the MTA crew to and from a

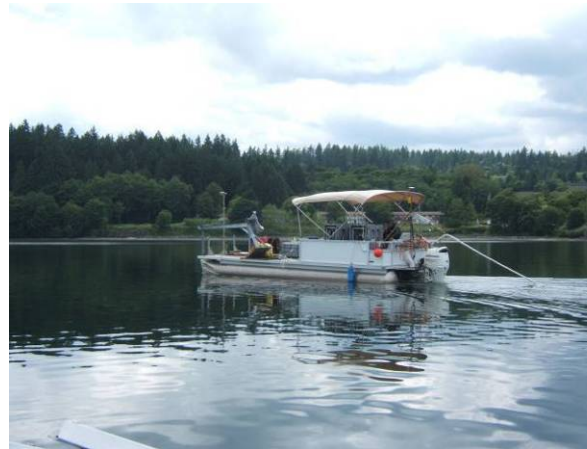
Figure 5-13. The Marine Towed Array is shown surveying on Ostrich Bay.

this period ~220 acres of the Bay, extending to the Navy property line in Dyes Inlet were surveyed, Figure 5-13. Based upon the survey files, about 65 hours of survey data were collected. Figure 5-14 shows a top level image of the anomaly image map for the magnetometry survey superimposed on a modern orthophotograph of Ostrich Bay.

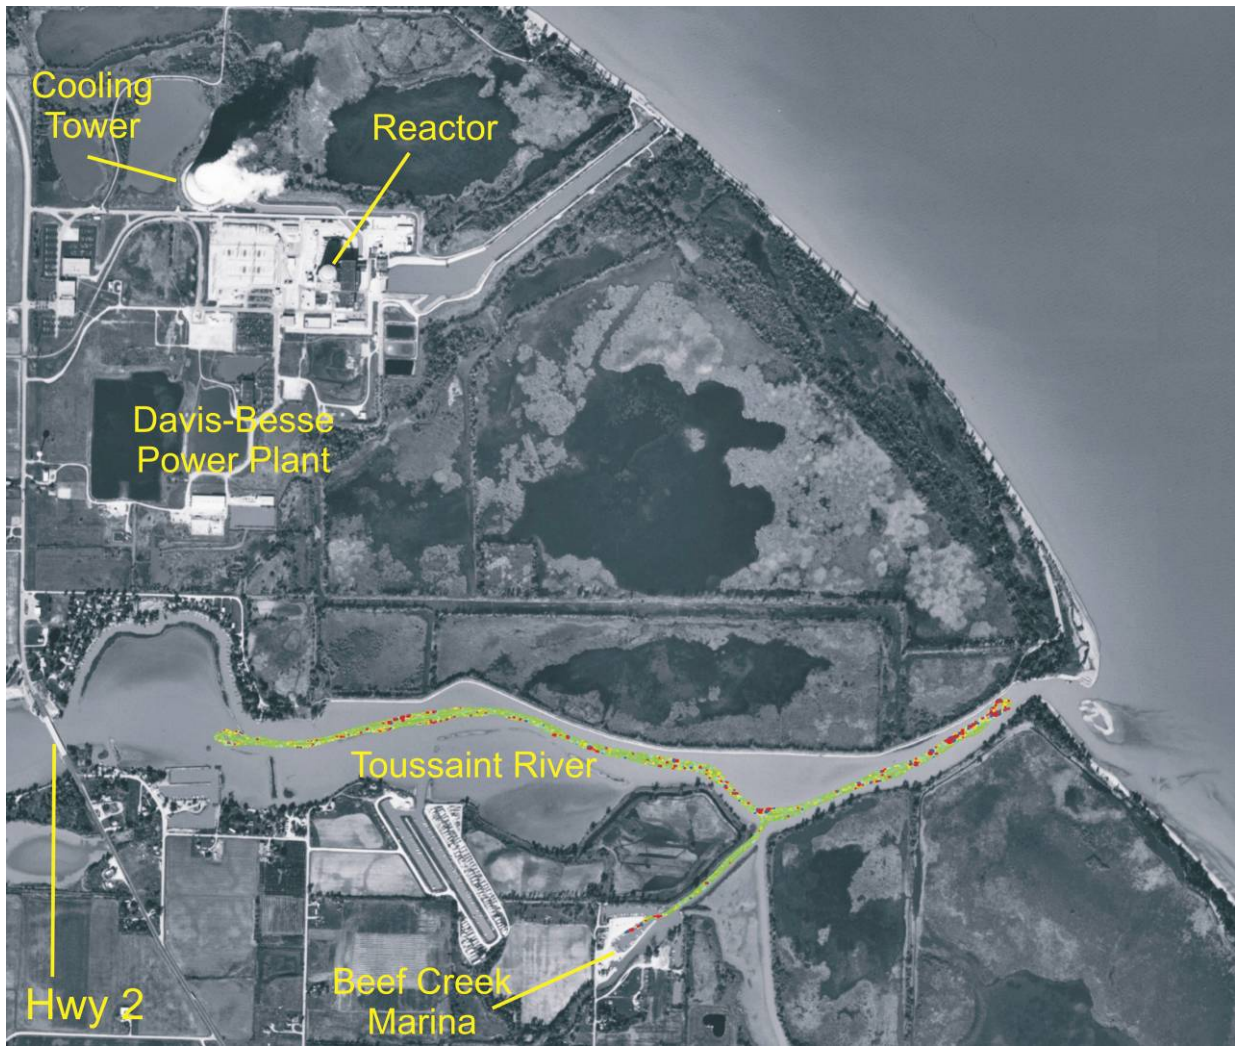
Figure 6-3. This 1996 aerial photograph shows the Toussaint River and the Davis Besse Power Plant. The magnetic anomaly image map of the MTA river survey is shown superimposed on the photograph.

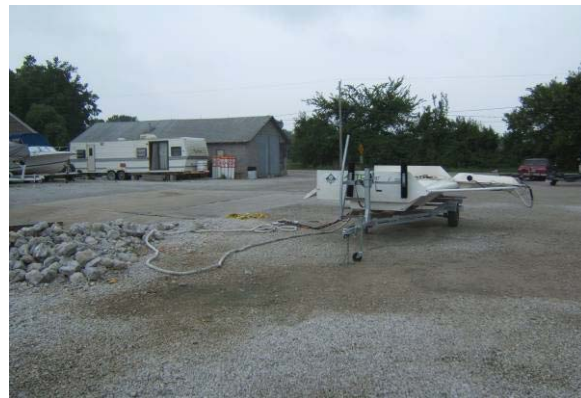
Figure 6-6. The sensor platform is assembled on its boat trailer, the tow cable is coiled up on top of the platform and it is launched beside the pontoon boat for mating.

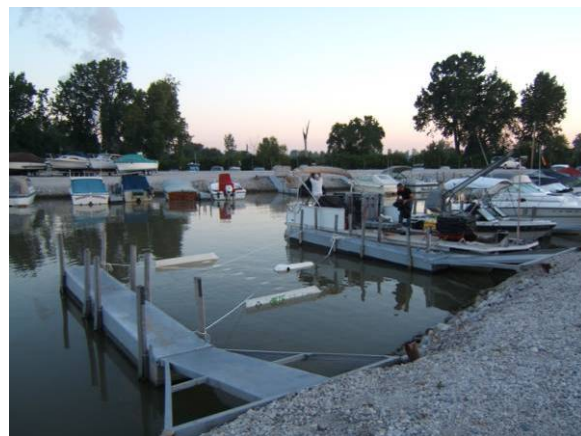
Figure 6-7. The sensor platform, the tow vessel, and the chase boat are moored in three adjacent slips.

The sensor platform, Figure 6-7, is shown lying very low in the water. This was because entering the channel into the Toussaint River (and from the Toussaint River into Beef Creek) the water was so shallow that the platform always bumped along the bottom and collected mud into its internal cavities. This mud, which typically washed out once we were underway in the Lake, often made it difficult to exit the very narrow and shallow channel from the Toussaint River into the Lake.

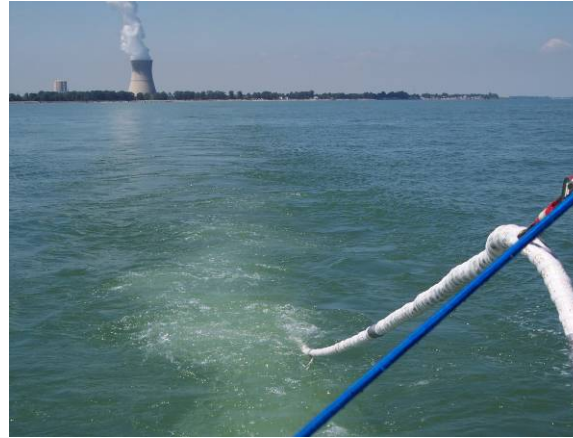
Figure 6-9. The MTA is shown surveying about 3 miles offshore from the Davis Besse Power Station.

During the first half of the survey period, the weather was, in general, benign. The lake surface was sometimes even glassy calm. See Figure 6-9. During this period the primary survey delays resulted from having to change marinas because of the lake height, or from time lost to ferrying the platform to and from distant off shore sites. During the month of September and into the beginning of October, the weather became increasingly more problematic. During the first half of September, we were on the Lake approximately half the days. After September 15

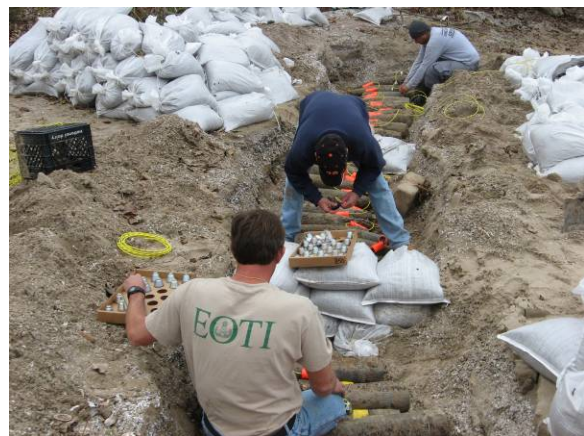
Figure 6-11. Recovered projectiles are being set up with shaped charges and sand bags for demolition.

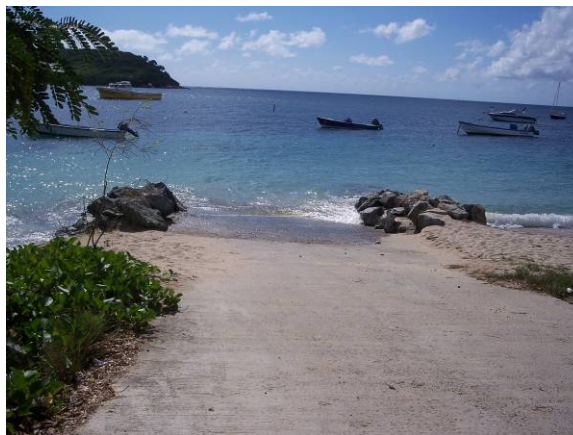
Figure 7-4. This image shows the launch ramp in Esperanza. The water was too shallow for Coral Queen access, which required us to launch the platform and tow it to the Queen with the skiff.

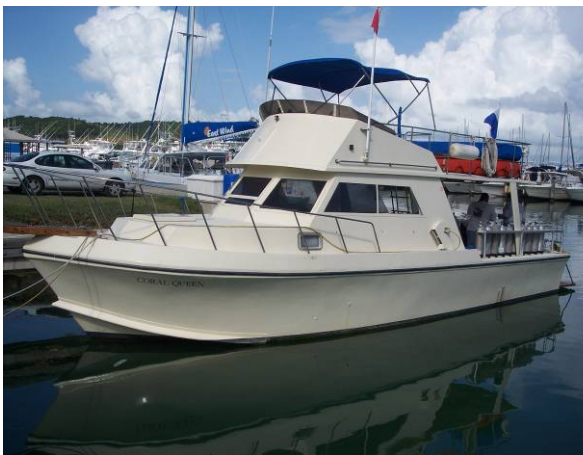
Figure 7-6. The Coral Queen is shown tied up at the marina in Fajardo. In this image it is outfitted as a recreational dive boat.

The primary survey vessel was a 42 ft fiberglass dive boat, the Coral Queen, see Figure 7-6. The Coral Queen was equipped to support 18 divers in exploration and pleasure dives on coral structures and wrecks. Working with Sea Ventures,³⁸ we spent two days outfitting the Coral Queen to support the MTA survey. All the dive support equipment was removed from the vessel. An aluminum plate was bolted down on the aft end of the deck. The tow point assembly was bolted to this plate. Forward of the plate, one inch plywood sheets were bolted to the deck.

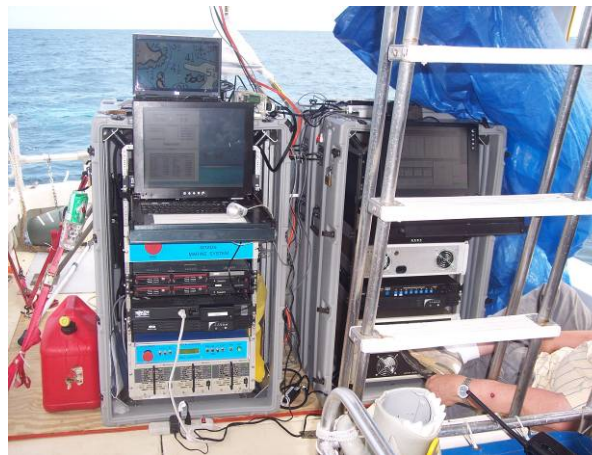
Figure 7-7. The MTA electronics racks are shown mounted on the Coral Queen. The ladder in the foreground leads up to the flying bridge.

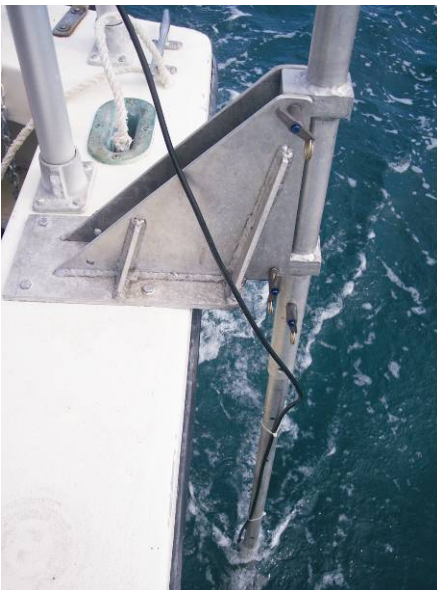
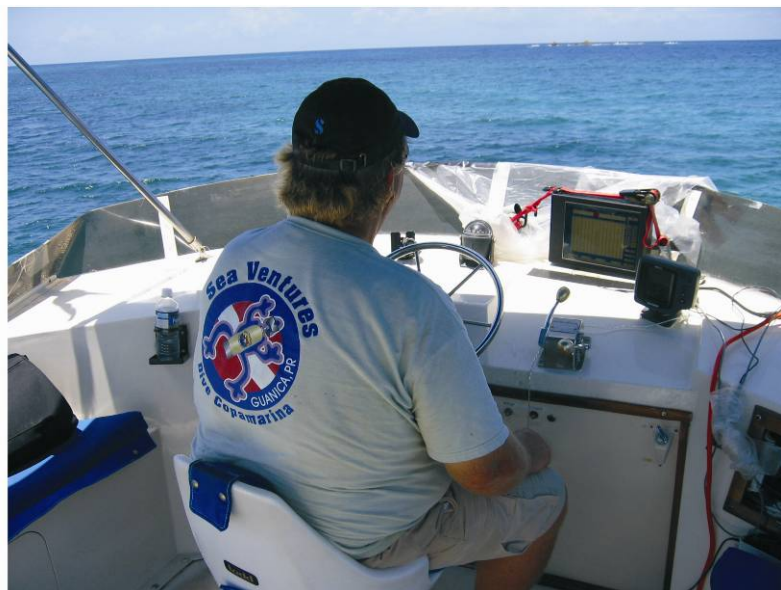
Figure 7-8. On the left the mount for the sonar altimeter is shown attached to the port rail. On the right the pilot guidance display is shown mounted on the bridge in front of the driver.

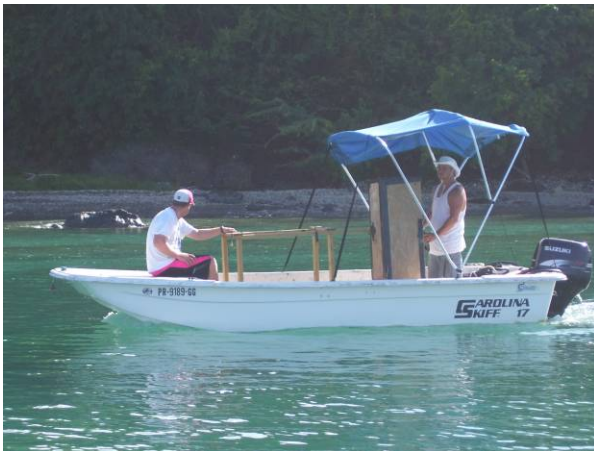
Figure 7-10. The Carolina Skiff is shown in the Bahia Salinas del Sur. During data collection, the skiff is operated by one person.

We knew that there were significant areas of the Bahía that were too shallow to survey with the MTA. We requested that Sea Ventures find a flat bottom fiberglass skiff for us to use for the shallow water surveys. They leased a 17 ft Carolina Skiff, which we used to support the shallow water surveys, Figure 7-10. The skiff was moved between Fajardo and Vieques (and Culebra) by towing the vessel behind the Coral Queen. We bought the lumber, plywood, foam, and hardware to build out the structures for mounting the magnetometers, the GPS antennas, and the pilot guidance and data acquisition computers in Fajardo and did the build out in Vieques. We were concerned that the structures might not survive the trip from Fajardo. The bimini was added to improve the computer visibility for the driver. Figure 7-11 shows all three vessels tied up side-by-side in the Bahía.

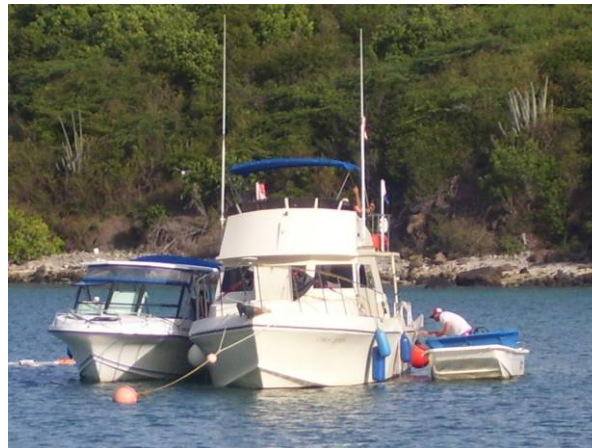
Figure 7-11. The Coral Queen, the Dusky, and the Carolina Skiff are moored together in the Bahia Salinas del Sur.

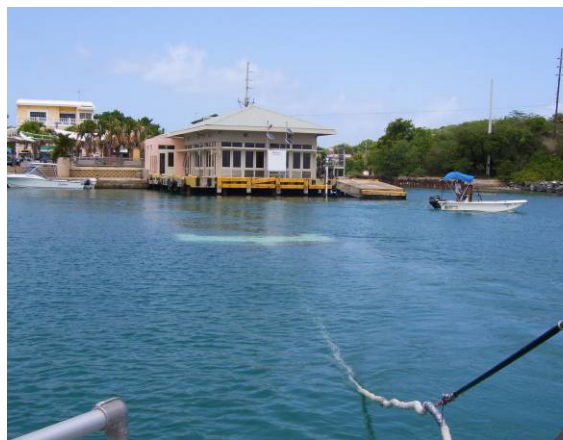
Figure 8-2. The Coral Queen is towing the sensor platform away from the Culebra public Ferry Dock.

There are dozens of moorings in the Bahia de Sardinias and constant boat traffic through the area because this is the location of the public Ferry Dock, Figure 8-2. It was also considered likely that there were many other abandoned moorings in the bay; therefore it was decided not to survey this bay. The two very small bays immediately adjacent to Bahia de Sardinias were too shallow to conveniently survey using the MTA; coral structures choked off the entrance to each bay. The bays east and north of Soldado Point were also deemed to be too shallow and too encircled by coral to be appropriate for survey using the MTA. In general, the shoreline around Culebra tends to be more rugged than that around Vieques. There are many more areas where rocky ridges appear to extend out into the sea. Following the Culebra surveys, it became apparent that there area many areas in the bays surrounding Culebra that have very high geologically-based magnetic signatures.

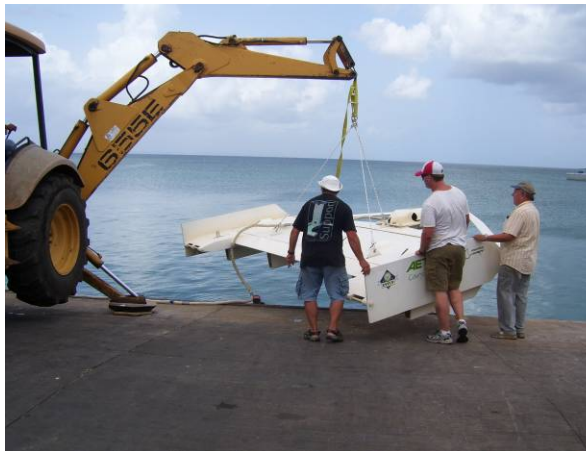
Figure 8-3. Because there was no boat launch facility, the MTA sensor platform is being launched from the Ferry Dock using a backhoe.

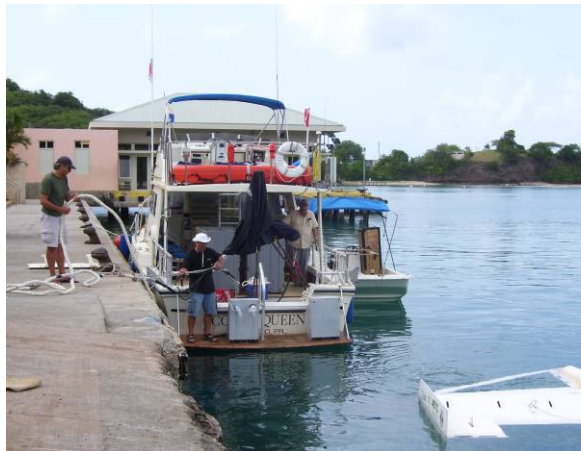
Figure 8-4. The MTA sensor platform is mated with the Coral Queen and hot tested before leaving the Ferry Dock.

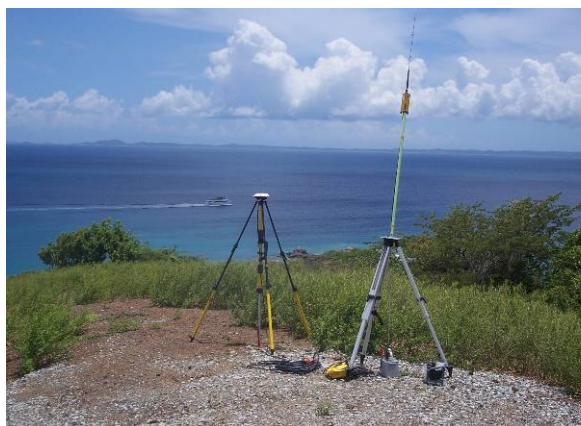
Figure 8-5. The base station was set up on a new GPS control point high above Bahia Tarja. The Fajardo passenger ferry is shown in the foreground, the island of Vieques is in the distance on the horizon.

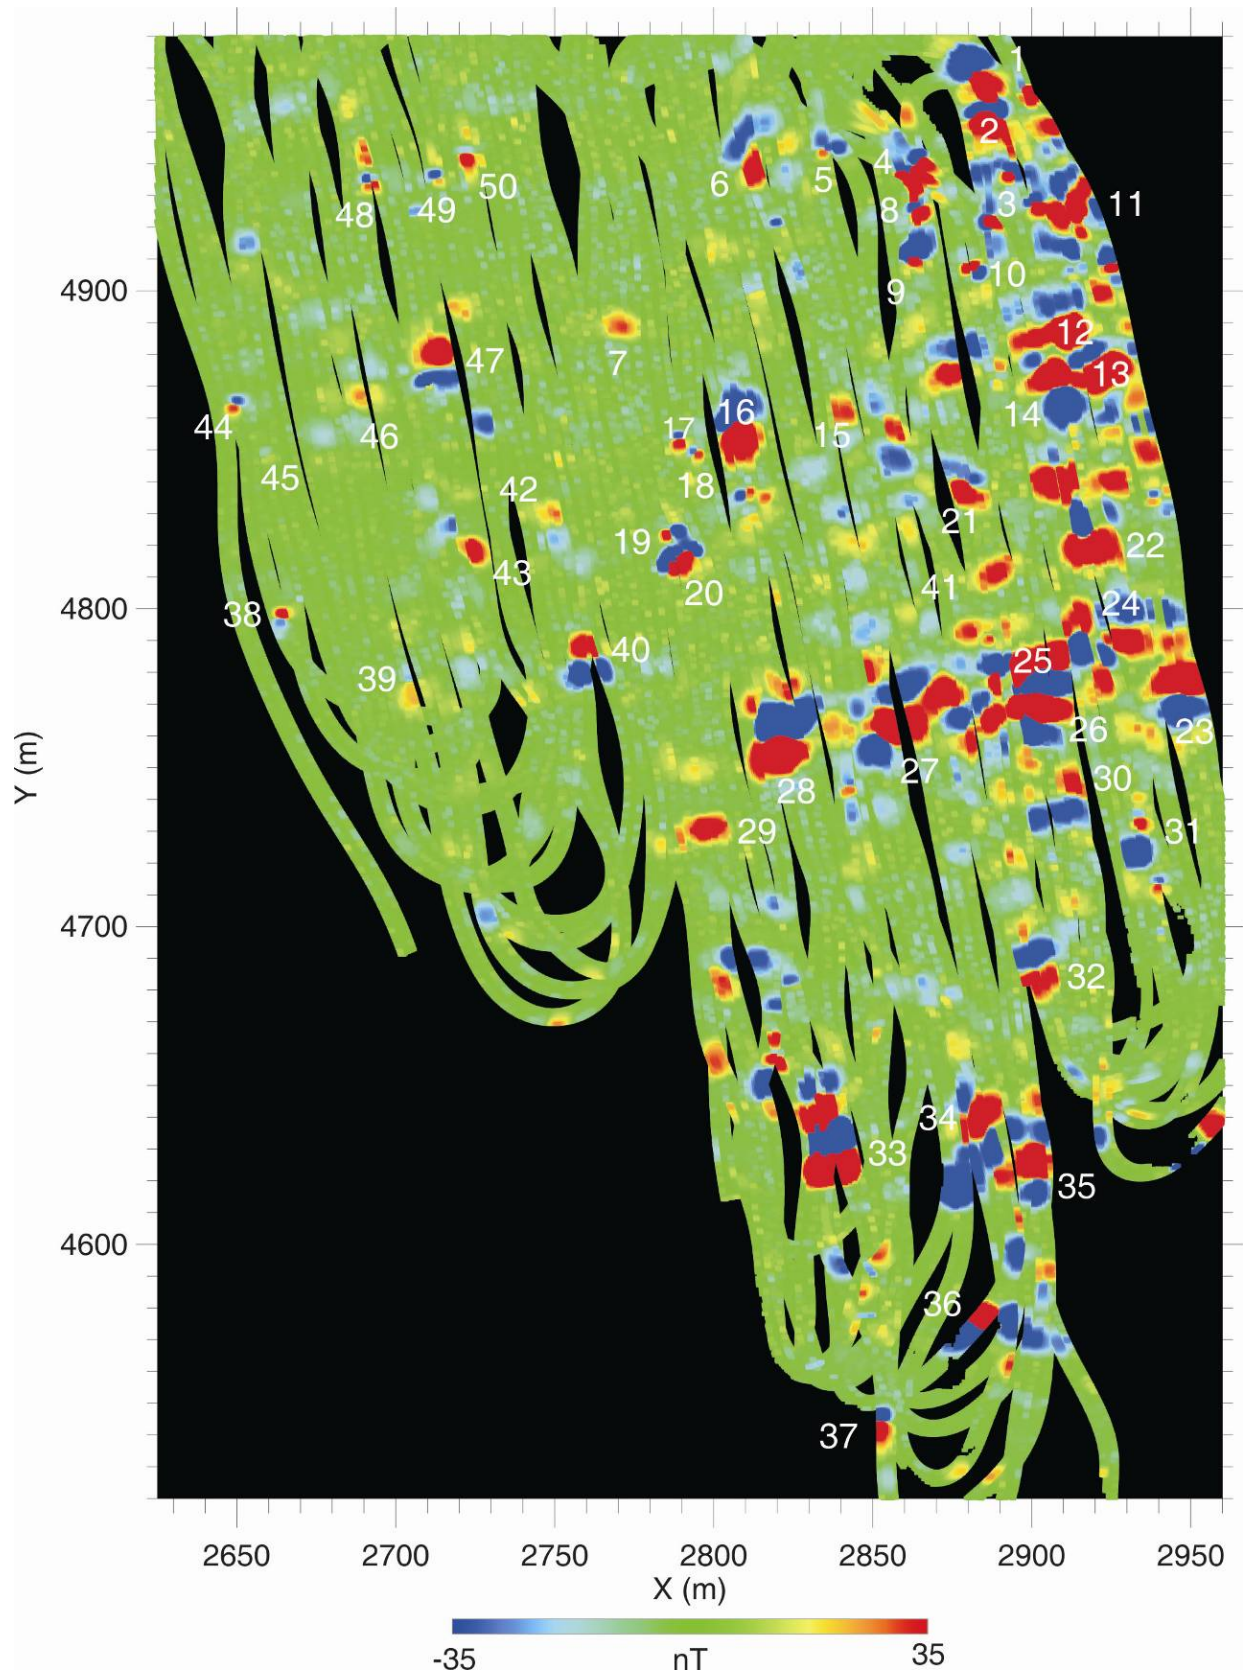
Figure 8-9. Magnetic anomaly image from the Bahia Tamarindo survey. Analyzed targets identifications are shown on the image.

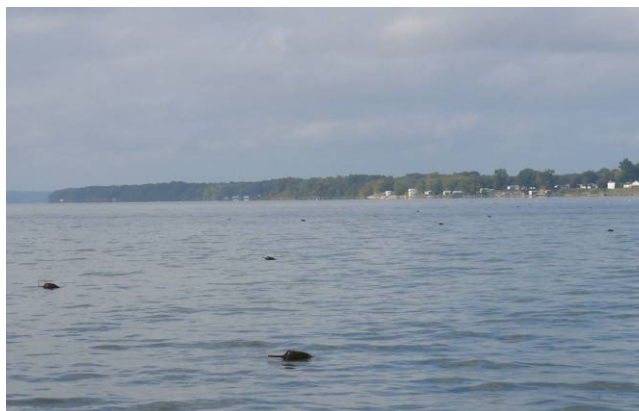
Figure 9-2. Floats from crab pots dominated the entire survey area except in the river channel.

Many commercial crab fishermen work all the Potomac River areas, except the channel where they are forbidden to operate. This survey took place near the end of the crab season, but there were still thousands of crab pots in the survey area, Figure 9-2. In the transect survey areas we just drove around them, in the blanket survey area they created small missed areas. In data analysis we learned to identify fully intact crab traps; however, pieces and parts of disintegrating traps were mistaken for possible ordnance.
