**THI QAR BEE FARM
THI QAR, IRAQ**

**SIGIR PA-09-188
APRIL 1, 2010**

SUBJECT: Report on the Thi Qar Bee Farm, Thi Qar, Iraq (SIGIR Report Number
PA-09-188)

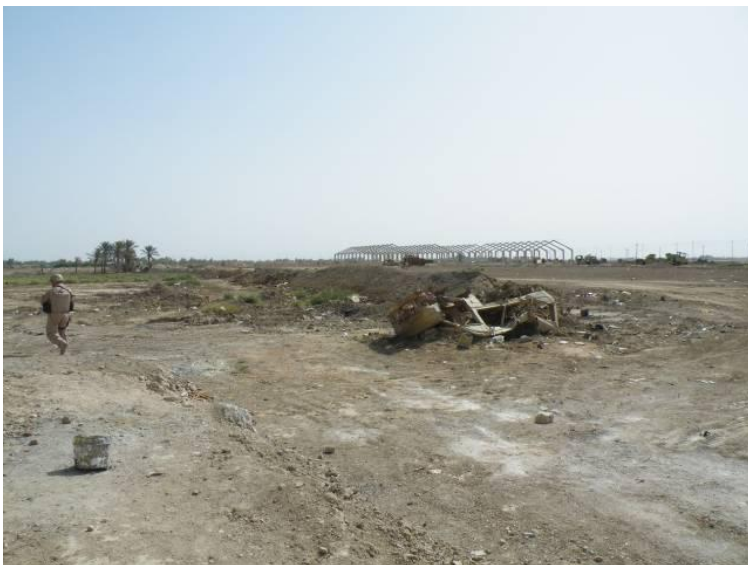
General topography of the area was flat with vacant or agricultural land extending for a significant distance from the site (Site Photo 2). Adjacent to the project was land currently used for agricultural research by the Ministry of Agriculture (Site Photo 3). A primary highway extended along the front of the project site; however, the facility was set back approximately 300 meters from the primary highway.

Site Photo 2. Surrounding vacant land

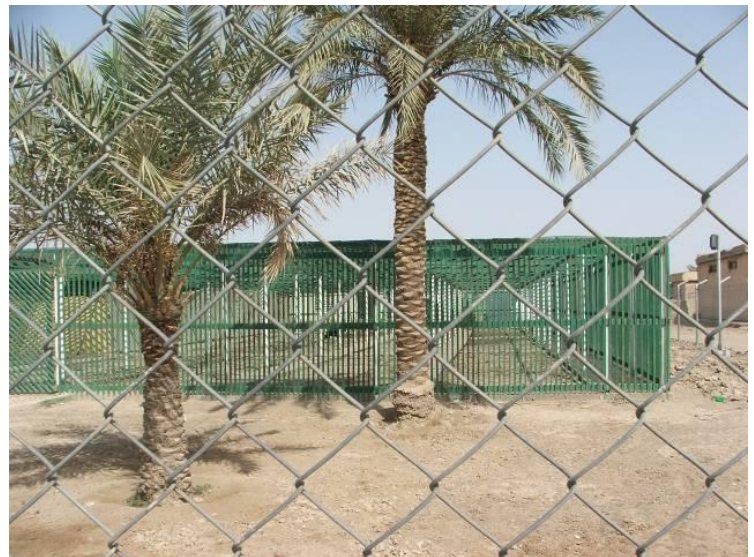
Site Photo 3. Agricultural use of land

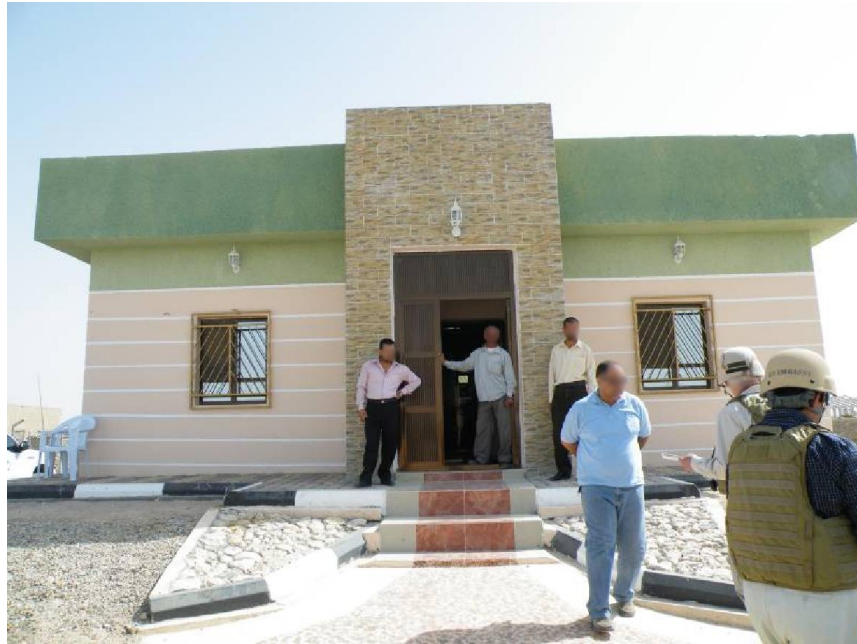
Site Photo 4. Building front exterior

The building was square in shape with a prominent entry. The exterior of the building was finished with plaster and painted in a decorative, horizontal-striped pattern. The horizontal stripes were inset into the plaster finish creating a permanent architectural feature on the exterior of the building. The entryway to the building was finished with ceramic tile to create a contrasting pattern to the building finish (Site Photo 4). The exterior walls were in good condition with no evidence of cracking or settlement. Corners appeared true and plumb and the overall structure appeared sound.

A continuous sidewalk was constructed adjacent to the building and along the exterior wall. Since the building was constructed on approximately one meter of fill material, steps and curbing were constructed at the entrance. Stone was laid behind the curbing and forms a protective surface that prevents erosion of the slopes adjacent to the steps.

Downspouts were constructed along the exterior walls to drain runoff from the roof. The downspouts were in good condition. The downspouts discharge directly onto the perimeter sidewalk adjacent to the building. With the discharge directly onto the sidewalk, the facility will require long-term maintenance.

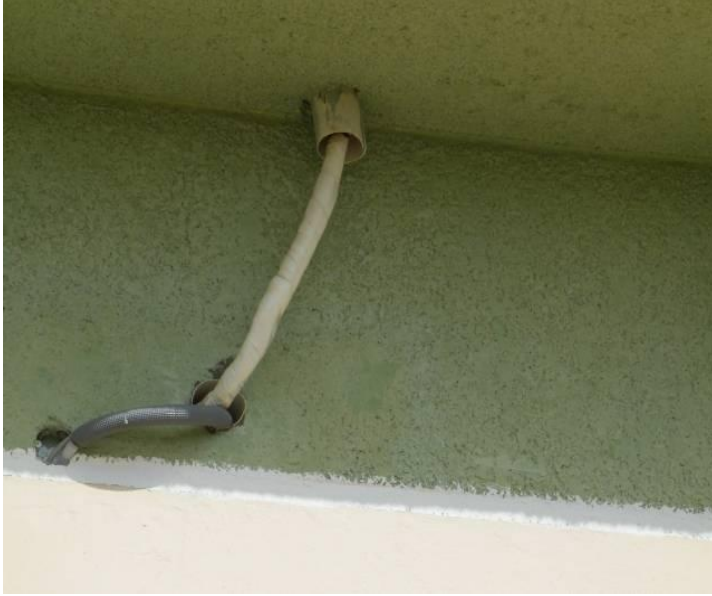
Site Photo 5. Coolant line penetrating roof and wall

The building was constructed with a flat roof. The roof held several of the utilities for the building—including the water storage tanks and the compressor units for the split unit air conditioners. Coolant lines for the air conditioning units were run through the roof overhang and through wall penetrations to the condensers on the interior of the building (Site Photo 5).

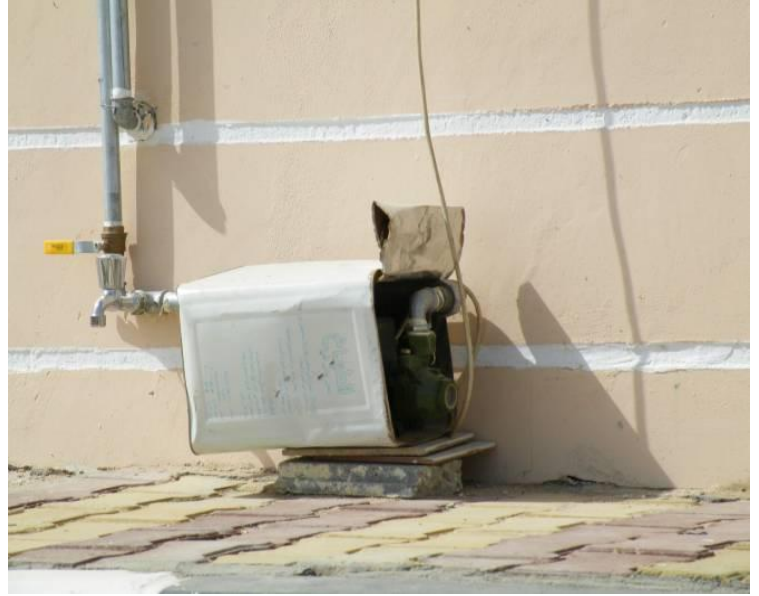
Site Photo 6. Water transfer pump

A transfer pump was located along the exterior wall of the building (Site Photo 6). Instead of connecting to the municipal system, as detailed on the design drawings, the contractor installed a transfer pump to convey water to the rooftop storage tanks. Based on this configuration, water can be supplied by tanker trucks. Due to the multiple connections and handling that must be performed to supply water to the facility, proper hygiene is critical to ensure that contamination is not introduced into the water supply at any point in the delivery cycle. This is especially important if the water is to be used to process honey.

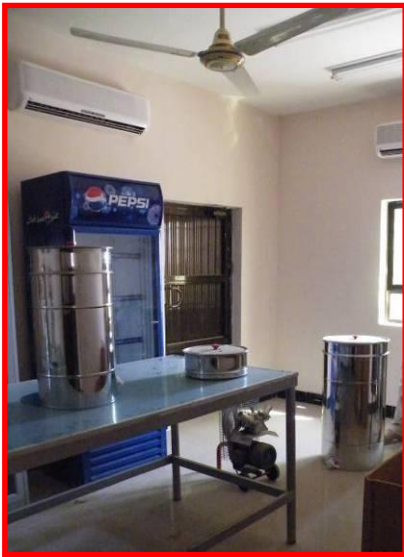
When entering the building through the foyer, the office and store are located on the left, the restroom is straight ahead, and the work room is on the right. The store area was equipped for processing honey and was well-maintained (Site Photo 7). Several tables were available for workers to perform the various tasks required for processing, and equipment was located in this area.

Site Photo 7. Store

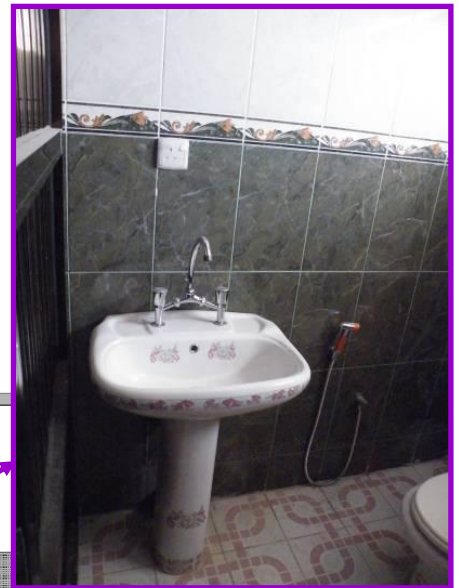
Site Photo 8. Restroom

The restroom was located immediately ahead of the front door to the facility. The restroom appeared functional at the time of the site assessment, and SIGIR observed no apparent defects with the construction (Site Photo 8). The restroom was clean and maintained by the current occupants.

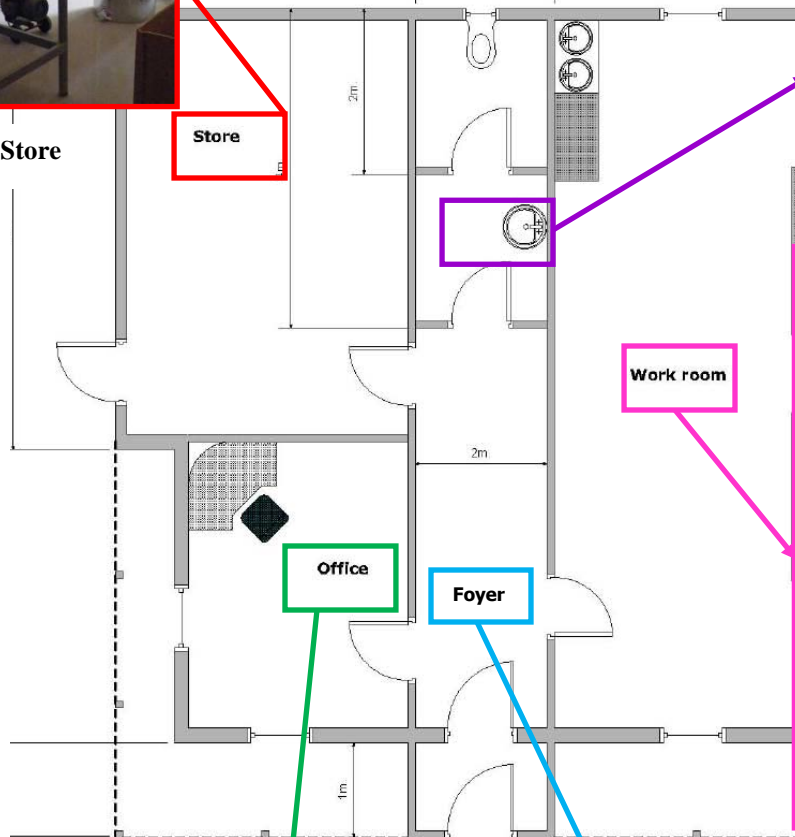
Figure 1. Conceptual design of honey processing facility (Courtesy of GRS)

The building was constructed with three primary rooms and one restroom (Figure 1). The finish in all of the rooms was similar—plaster and painted finish for the walls, and ceramic tiles for the flooring. The finishes appeared well applied and in good condition.

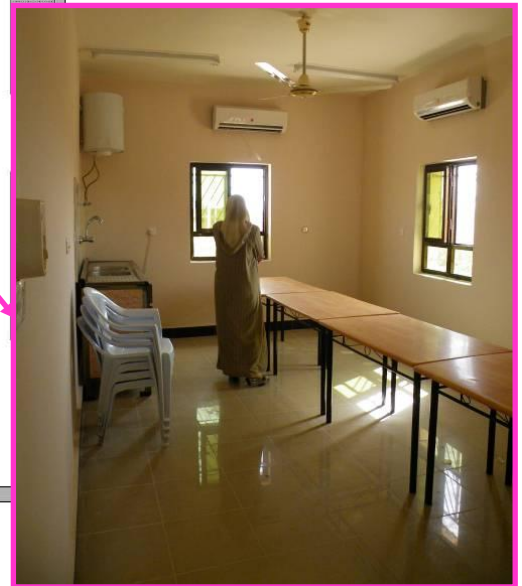
Site Photo 9. Work room

Also, a work room was located to the right of the front entrance. At the time of the site assessment, the work room contained materials and equipment for the facility (Site Photo 9).

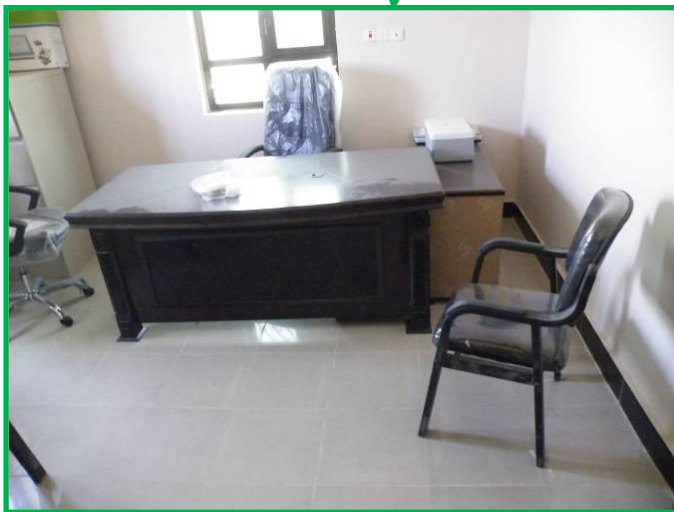
An office for the facility manager was located to the left of the front entrance. At the time of the site visit, the office was furnished (Site Photo 10) and the foyer was adequately sized for the building (Site Photo 11).

Site Photo 10. Office

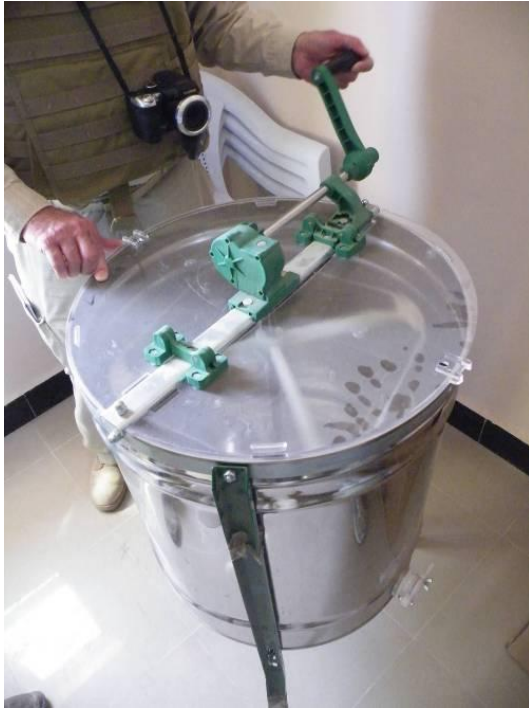
Site Photo 12. Extractor

SIGIR was able to verify that the equipment required by the contract was present. Specifically, SIGIR observed the extractors⁵ (Site Photo 12), stainless steel decanters⁶, transfer pump⁷ (Site Photo 13), filling machine⁸ (Site Photo 14), and a refrigerator to store the honey.

⁵ The extractor machine is used to separate combs from honey and uses centrifugal power through manual operation.

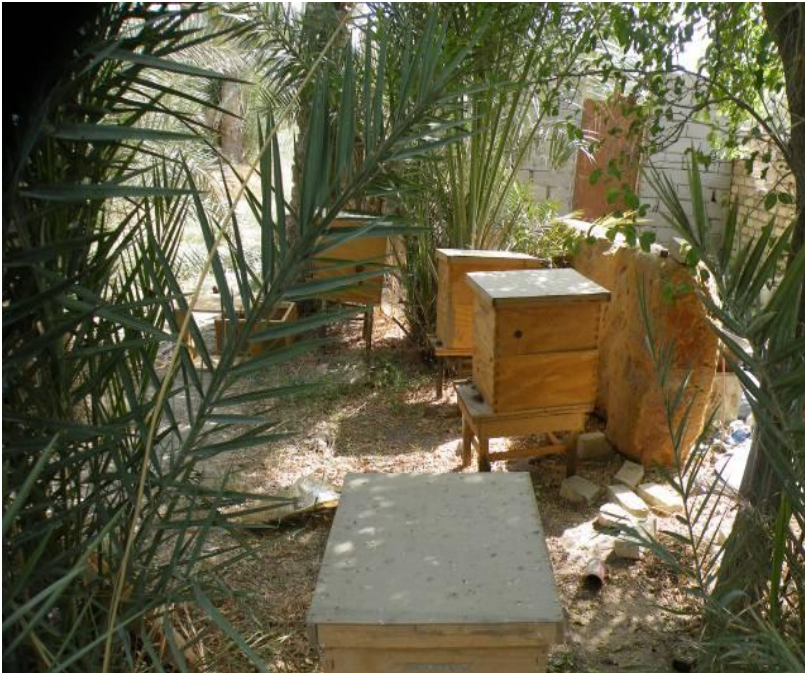
Site Photo 15. Bee hives

The GRS AAO representative and the security team accompanied SIGIR on a tour of a local apiary that received the queen and bees⁹, beehives¹⁰, and personal protective equipment¹¹ under this contract. SIGIR was able to identify the manufactured hives used to house the bees (Site Photo 15).

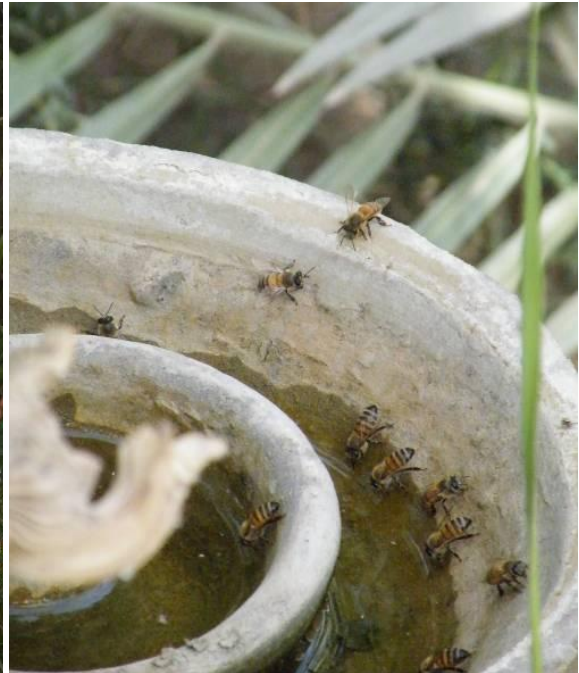
Site Photo 16. Sweetened water

Due to the current drought conditions in Iraq, there is not enough vegetation to sustain a high concentration of bee colonies. In order to maintain honey production, the beekeepers are providing the bee colonies with sweetened water (Site Photo 16).
