# FINAL REPORT

## Field Demonstration/Validation of Electrolytic Barriers for Energetic Compounds at Pueblo Chemical Depot

ESTCP Project ER-0519

Tom Sale  
Mitch Olson  
Dave Gilbert  
Matt Petersen  
**Colorado State University**

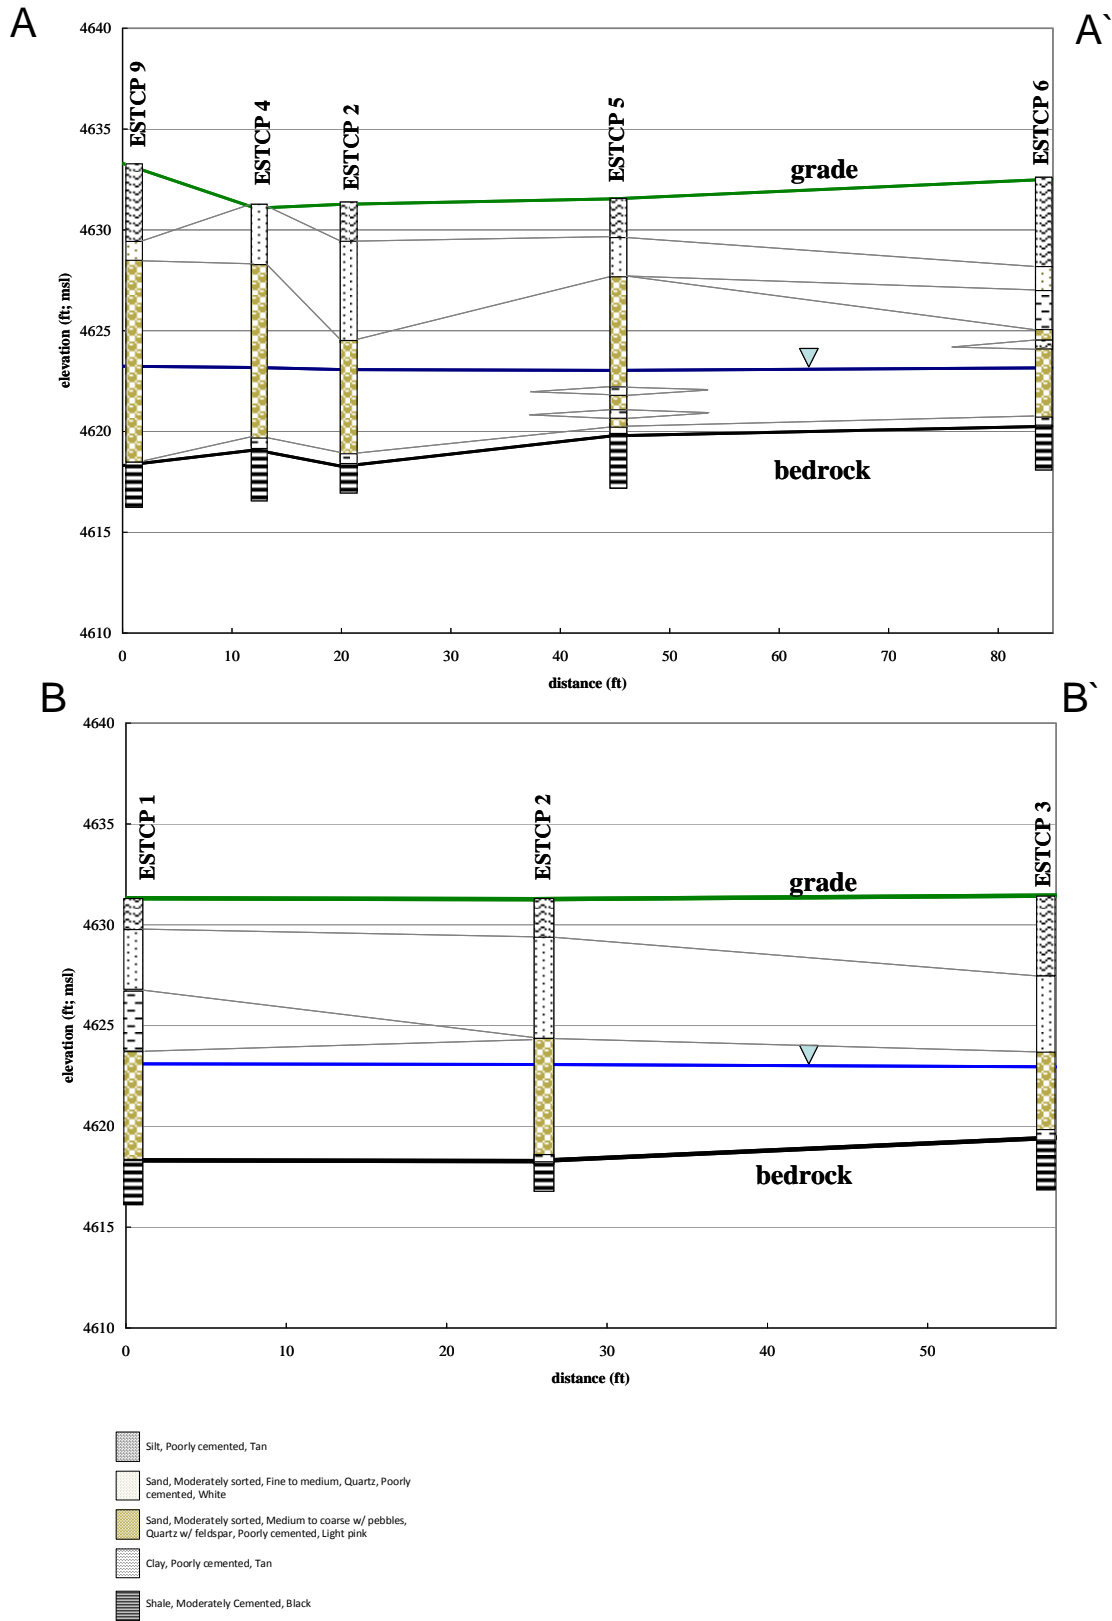
**Figure 10 - Geologic cross-sections through the demonstration location.**

Figure 10 presents geologic cross-sections through the demonstration location. The alignment of the cross-sections is presented in Figure 9. Sediment encountered consisted of a surficial silt layer ranging in depth from 1-2 feet. Underlying the surficial silt are well- and moderately-sorted coarse sands (Sand A and Sand B, respectively). The sands are unconsolidated and consist primarily of quartz and potassium feldspar. Within the sands, minor interbedded clay intervals were encountered in five of the eleven borings. The interbedded clays are unconsolidated and discontinuous. The Pierre Shale underlies the sediments at depths ranging from 12-15 feet bgs. Horizontal and vertical fractures are present in the shale. Fractures are attributed to near surface releases of overburden pressure. Figure 11 presents photographs of the primary geologic media encountered.

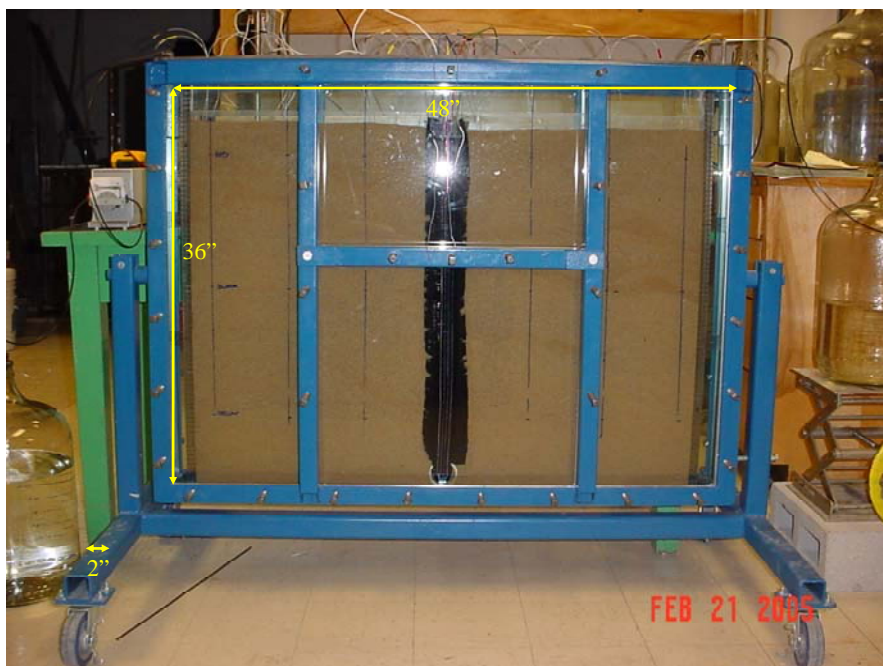
**Figure 20 - 2-D tank used in design testing studies.**

**Experimental Conditions** - The study was conducted in a glass-walled sand tank measuring 48 inches long, 36 inches tall, and 1 inch wide (inside thickness between glass panels). The tank was loaded with an ideal porous media (quartz feldspar sand) and an electrode pack that is an analog to the PCD demonstration e<sup>-</sup>barrier, consisting of four electrodes separated by biplanar geonet (Figure 20).

**Sampling and Analysis** - Performance evaluation consisted of monitoring aqueous concentrations of energetic compounds. The monitoring array included 27 monitoring points comprising nine bundles with sampling points at three depths. The sampling points consisted of 1/8-inch diameter Teflon™ tubing fitted with Nitex™ mesh to prevent sand infiltration. Water samples were collected using a glass syringe connected directly to the sample point tubing. Given the high contaminant concentrations used in the experiments, solid phase extraction and preconcentration was not necessary in the 2-D tank experiment.

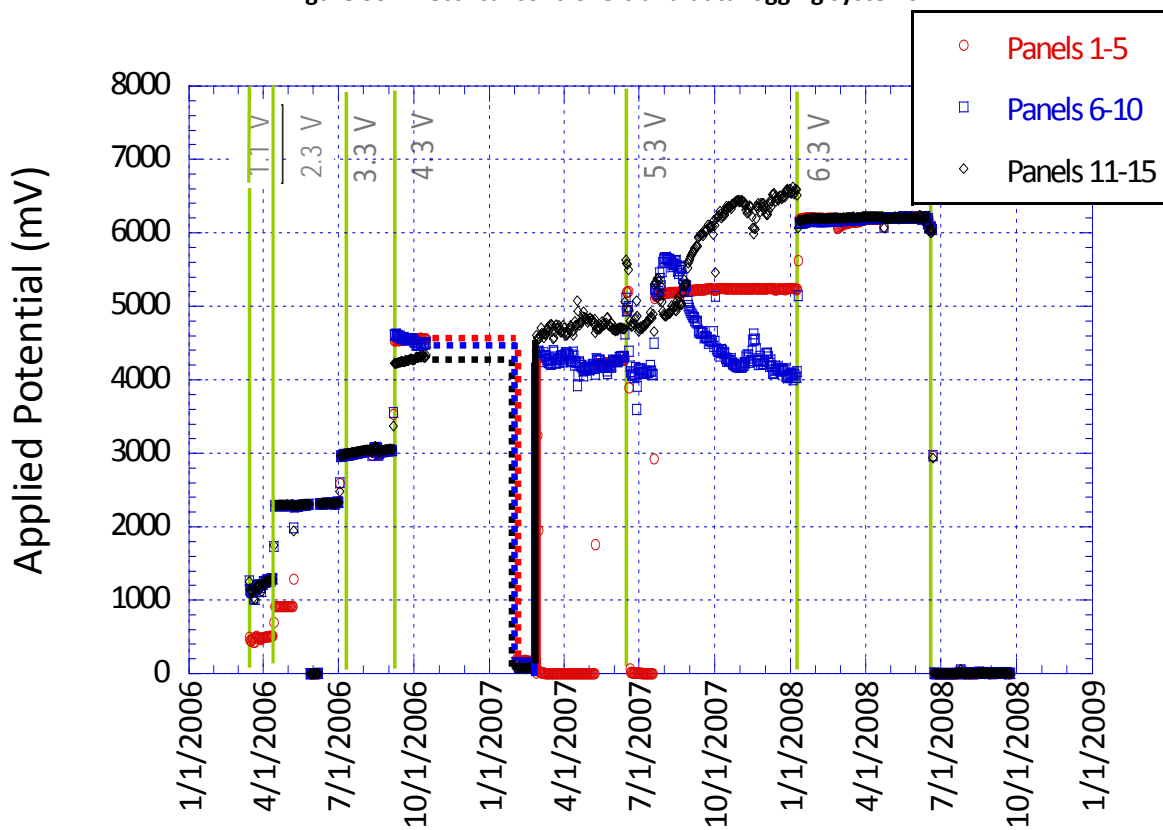
Figure 34 – Applied potential vs. time (dashed lines are estimated value from periods when the data logger was not working).

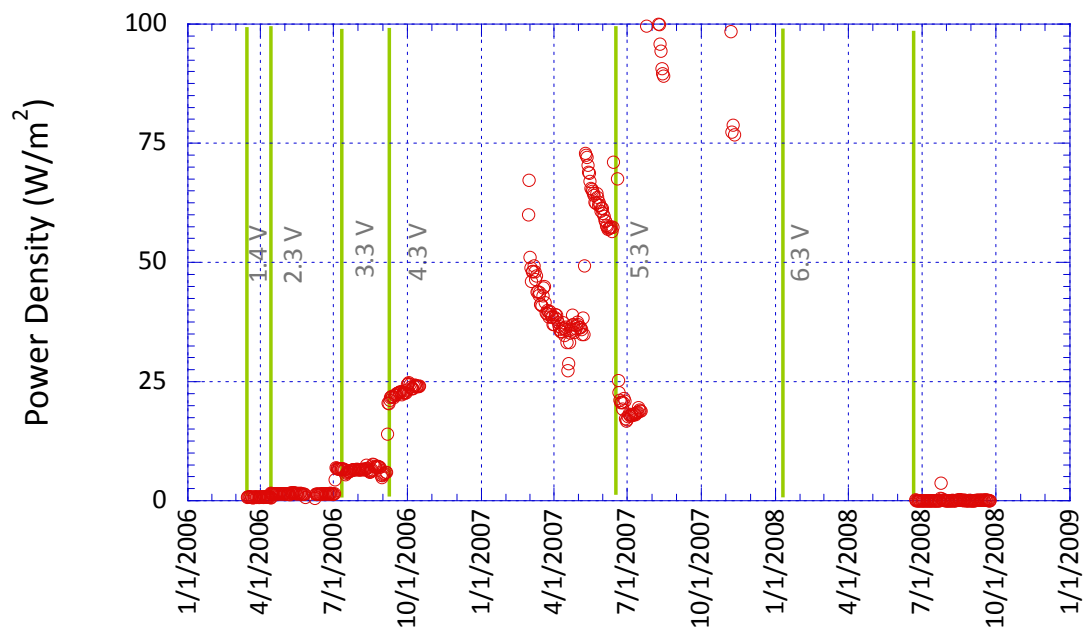
Figure 36. Power output in  $W/m^2$ .
