AATD TR10-D-93

US Coast Guard ASIST Probe Evaluation on a H-65 Dolphin

May 2010

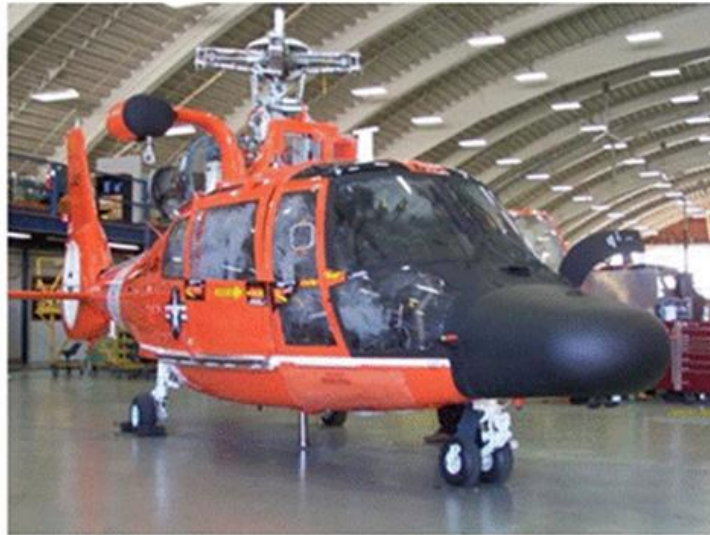
Figure 1 – Aircraft with Probe Installed

The aircraft used for both the GRT and the static testing was Coast Guard Aircraft #6583, an MH-65C with the ASIST Probe installed (Figure 1).

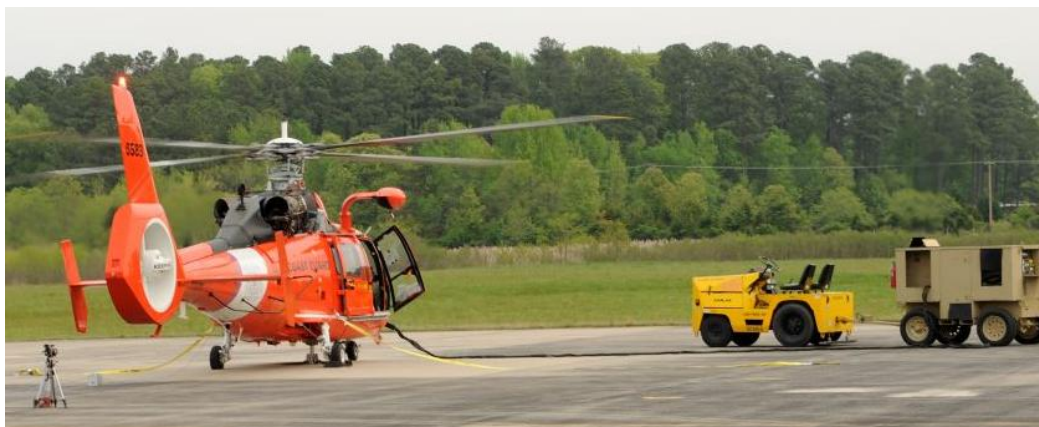
Figure 2 – Aircraft At Tethered Hover Pad

The aircraft was tested at the AATD tethered hover pad (Figure 2), facing a northwest direction (Figure 3). The Auxiliary Ground Power Unit (AGPU) was used to provide ground power because the aircraft onboard electrical generators tend to shut down at low rotor RPM. As a safety precaution, tie down straps (yellow straps visible in Figure 2) were attached from the aircraft to the ground, but remained slack so that they do not interfere with the resonance characteristics of the aircraft.

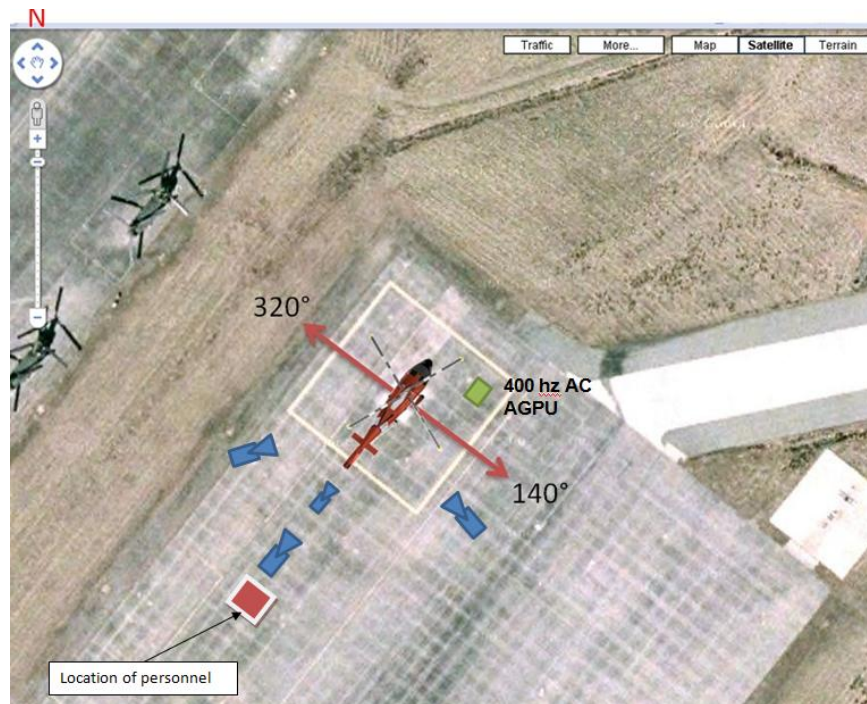
Figure 3—Test Setup and Camera Locations

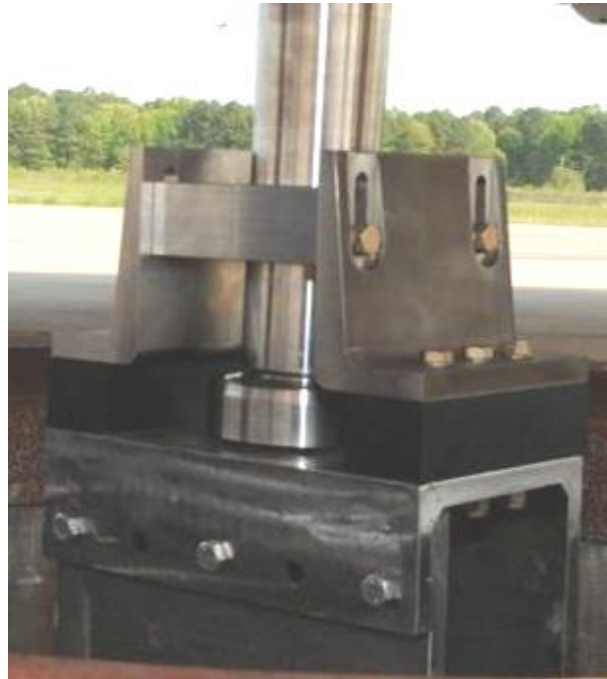
Figure 4—RSD Simulator Test Fixture

For the first GRT test sequence, the probe was installed on the aircraft, but was retracted into the airframe. For the tests with the ASIST probe attached to the RSD simulator, the probe was extended and attached to an AATD fabricated test fixture that simulated the geometry, and stiffness of the RSD capture device (Figure 4). The RSD capture claw that surrounds the probe was designed to approximate the lateral stiffness of the RSD simulator and fabricated from 17-4 stainless steel, 1025 heat treated as is the actual RSD.

The bottom of the probe did not contact the top of the test fixture (i.e. ground) when extended. An adjustable Turbomeca FADEC (Full Authority Digital Engine Controller) was used to adjust the rotor RPM to the desired value. Due to concerns of exciting resonance inside the engine, the FADEC controller is designed to not allow continuous operation between 300 and 320 RPM so this rotor RPM range was not tested.

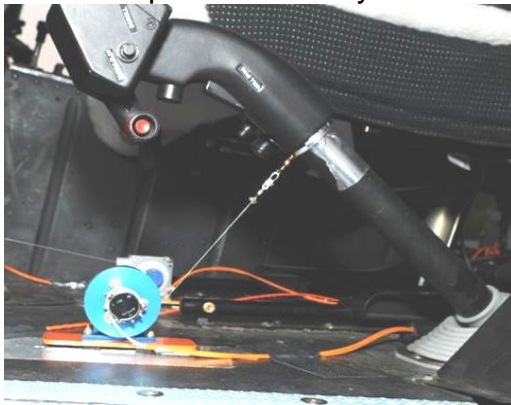
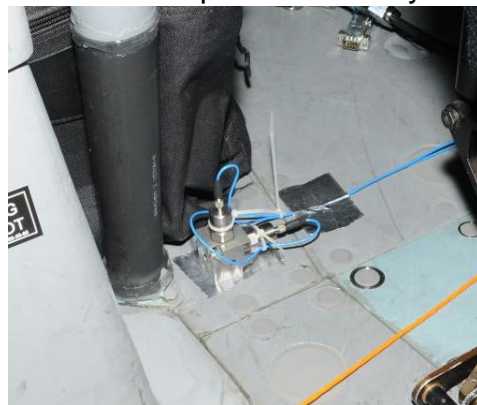
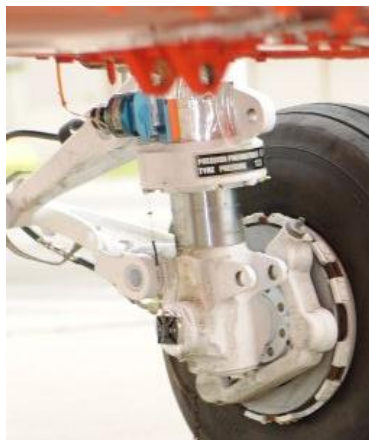
a. – lateral displacement of cyclic control

b.- fore/aft displacement of cyclic control

c. - displacement of collective

d. - acceleration in cabin

e.- displacement and acceleration of gears

Figure 5 – Instrumentation Locations On Aircraft

Acceleration and displacements on the aircraft were recorded by ALC personnel at various points on the aircraft (Figure 5), to include: nose and main landing gear accelerations, and displacements, cyclic control and collective control displacements, and acceleration inside the cabin. Data was collected at a 100 Hz sample rate with a 5 Hz low-pass filter .

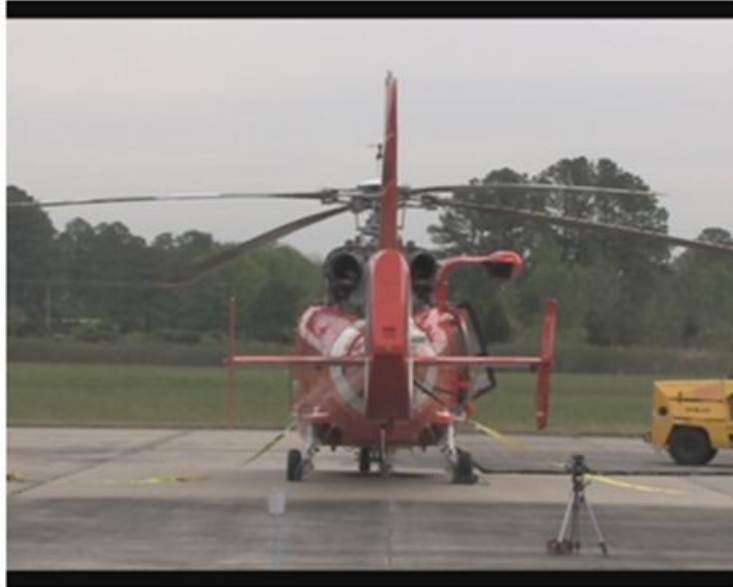
Figure 6 – Camera Locations, Overall Aircraft

Video was used to capture the test events. Real time video cameras were placed in strategic locations to capture motions of the aircraft due to ground resonance (Figure 6), as well as interactions at the probe / RSD simulator interface (Figure 7). All ground resonance testing was conducted on the hover pad (Table 1). For the static roll tests, the aircraft was rocked by personnel to obtain the airframe roll natural frequency. Once the aircraft was rocking on the two main landing gears, the number of cycles that occurred over a ten second interval were counted. This can be used to calculate the natural frequency of the airframe (without rotors spinning). For the dynamic tests, rotor RPM, excitation type and frequency, and engine torque were recorded by AATD test personnel prior to execution of each test sequence.

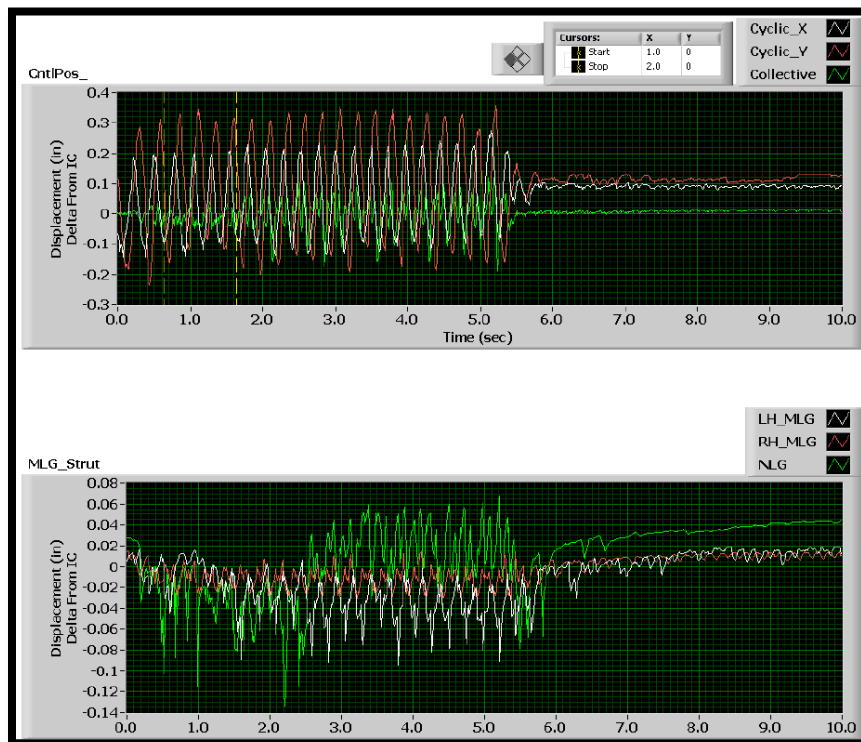
Figure 8 – Test 19 cyclic control input (top) and landing gear response (bottom)

For the dynamic tests (Table 2 & Table 3) rotor RPM was recorded, along with the frequency with which the pilot would excite the aircraft via the cyclic or collective. The type of excitation was also recorded. The Engine Torque (%) required at a given rotor RPM was also recorded when the pilot relayed it. Wind speed was monitored and recorded at various times, and is given as a direction and speed. Further explanation of test notes taken is provided as follows. When MAX STIR was initiated, the pilot noted issues with the hydraulic pressure lines actuating the correct response. If tests were repeated, it was noted. Vertical pitching indicates that the aircraft was rocking on its nose gear and one (or both) of its main gear. If the pilot felt contact between the probe and RSD simulator it was noted. Three cameras were used to record the test events and were run continuously. Video tape was changed in all cameras at the same time such that Tape 1 of each camera records events up to test 15, tape 2 records from event 16 to event 19, and tape 3 records events 21 through 44. Test event #20 was intentionally left blank. Data recorded by the ALC is provided in Reference (c). For the baseline tests, maximum deflection of the main landing gear occurred on Test #19 (Figure 8) in which the left side main landing gear oscillated over a range of 0 to -0.1 inches. For the tests with the probe attached to the RSD, maximum deflection of the main landing gear occurred on Test #36 (Figure 9) in which the left side main landing gear oscillated over a range of 0 to -.08 inches. Test #32 had the longest damping time, in which the nose landing gear experienced maximum deflection of 0.112 inches, which dissipated within 1.4 seconds of the pilot removing excitation.

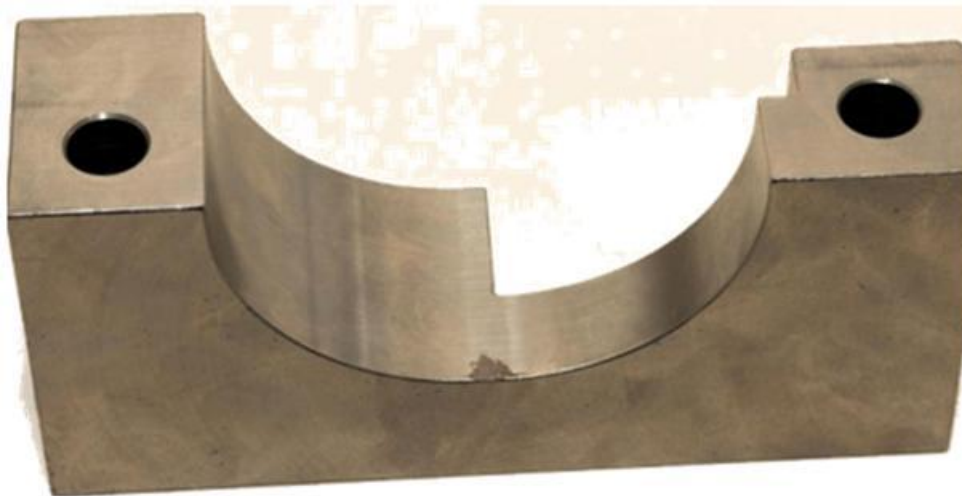
Figure 12 – Damage on RSD simulator fixture post test

After testing was complete the RSD simulator and the probe were inspected. At some time during the twenty three tests, the probe impacted the RSD simulator and caused marring on both the probe and RSD simulator. The RSD simulator was fabricated of the same material as the actual RSD: 17-4 Stainless Steel, 1025 heat treated.

There was minimal difference in the results of dynamic excitation tests of the baseline aircraft and the aircraft with the ASIST probe attached to the RSD simulator. Post test inspection found scratching and marring of the RSD simulator fixture and the ASIST probe due to vibratory contact between the two parts.

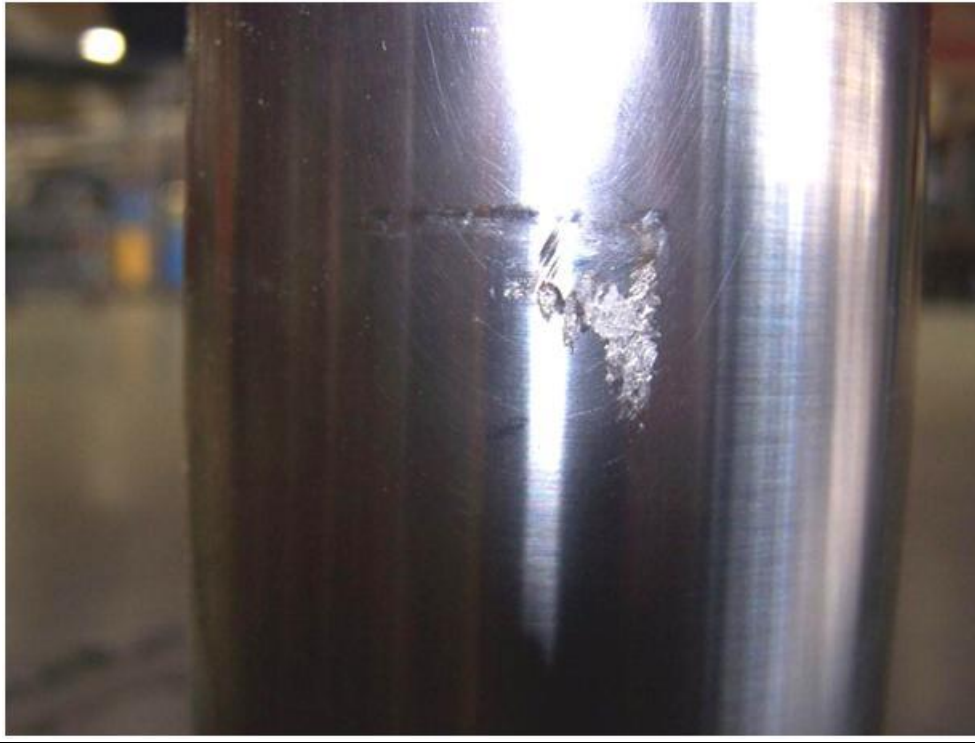
Figure 13 – Damage on probe post test.

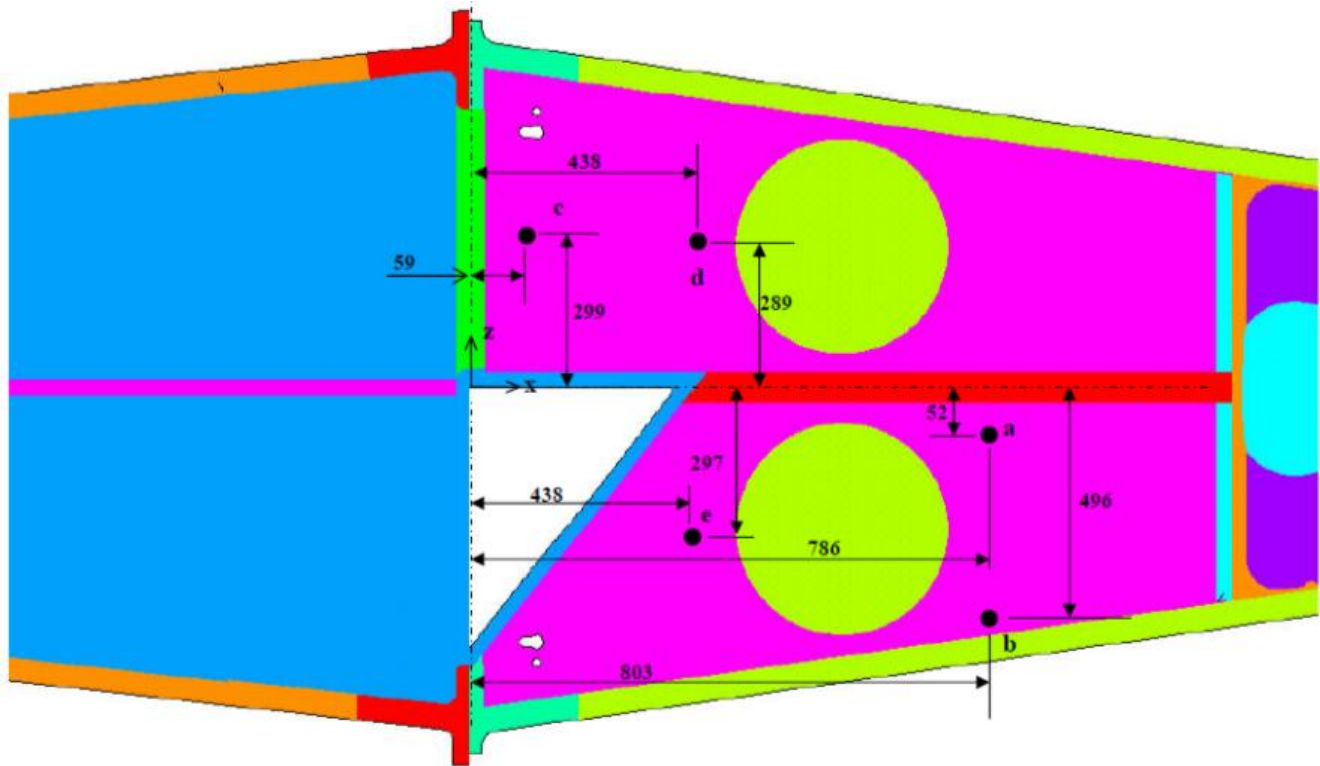
Figure 16 – External Strain Gauge General Locations, on Belly of Aircraft

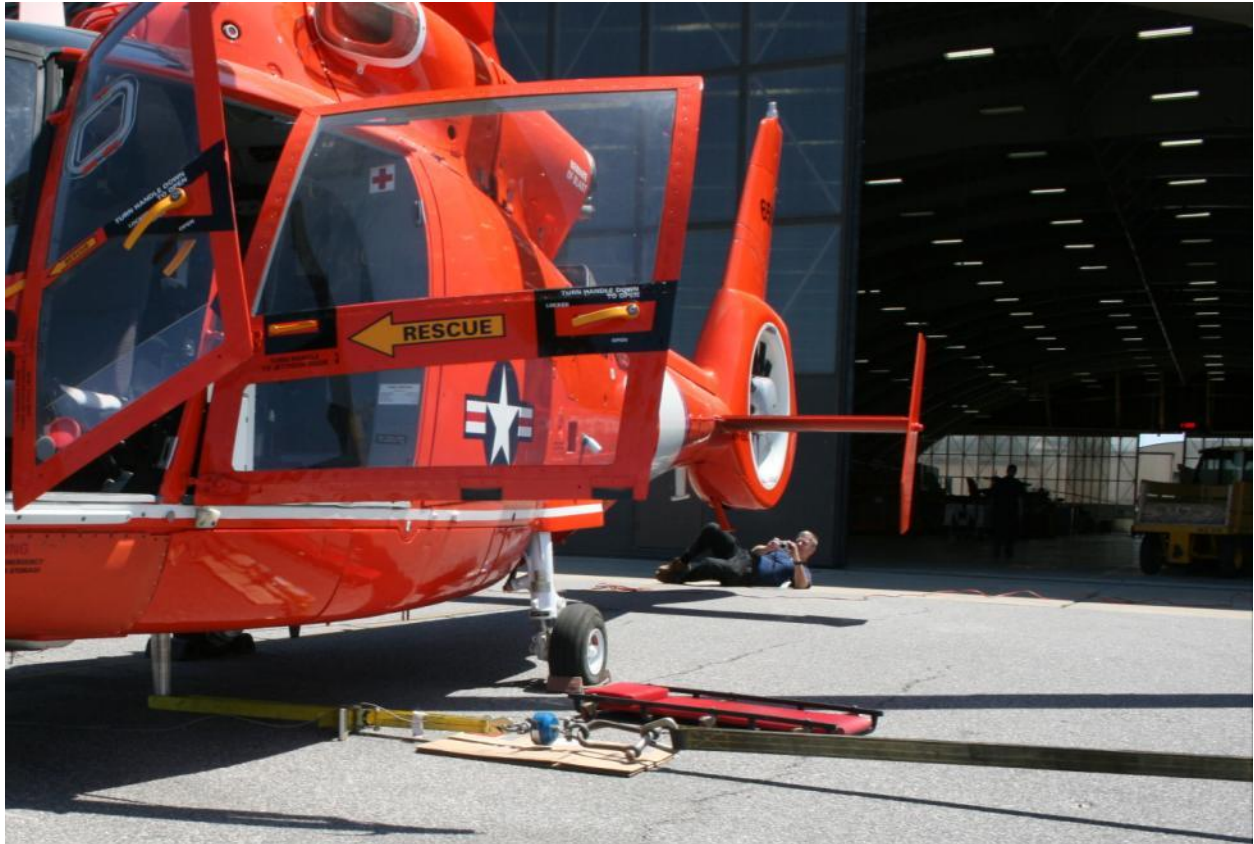
Figure 18 – Static Load Test Setup, 270 Deg. (Port) Load Case

A manual load actuator was attached to the probe via a cargo strap with a load cell in-line (Figure 18). Load was applied up to 2000 lbs in five directions (Table 6) and near parallel with the ground as practical. Five strain surveys were taken between 0-2000 lbs (e.g. 0lbs, 500lbs, 1000lbs, 1500lbs, 2000lbs). Strain gauges were zeroed prior to testing. Resistance calibration was conducted on the data acquisition system pre-test and post test. The aircraft did not move during the conduction of the testing.

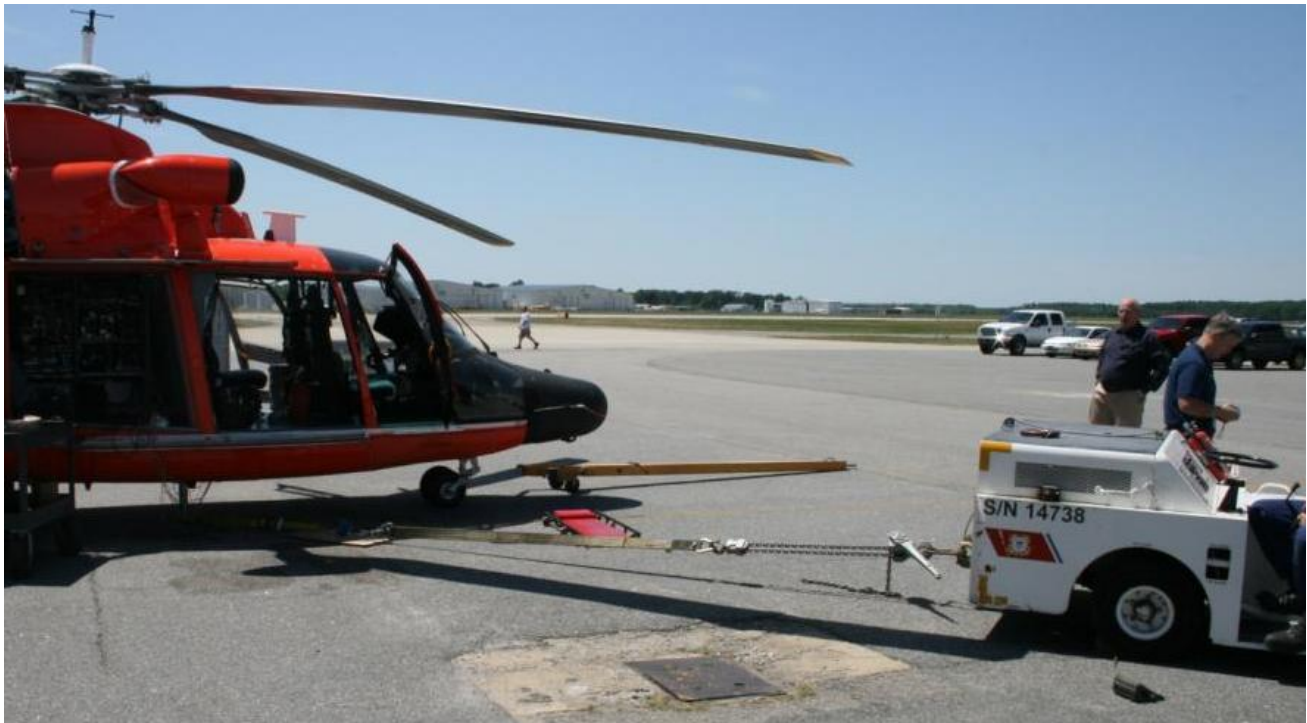
Figure B4 – 45 deg. Load Case

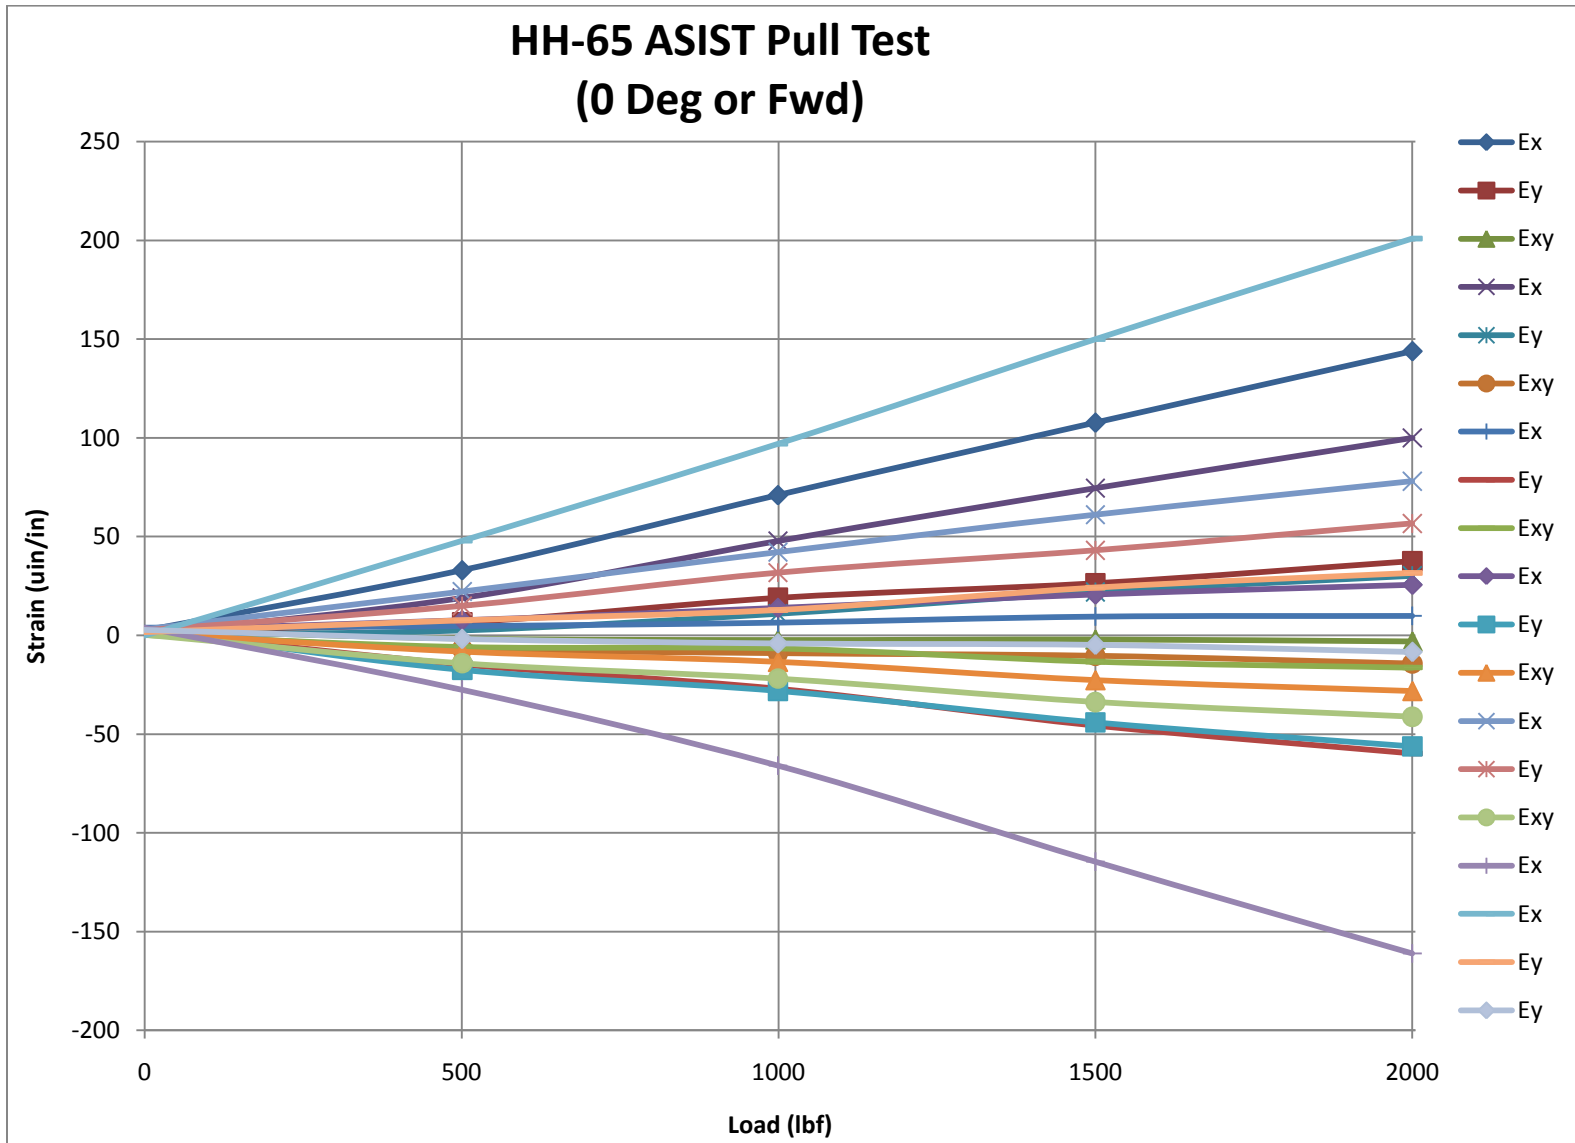
Figure B5 - Load Versus Strain Plot 0 deg. Load Case

Static load test results are provided in Appendix A. Load versus strain was primarily linear. Strain trended to increase in the direction of loading (i.e. lateral strain gauges increased with lateral load) with minimal orthogonal effect. A fifth test was also conducted at 45 degrees center on the starboard side (See Appendix). This test case was conducted in order to provide loading data off axis from the aircraft main axis.

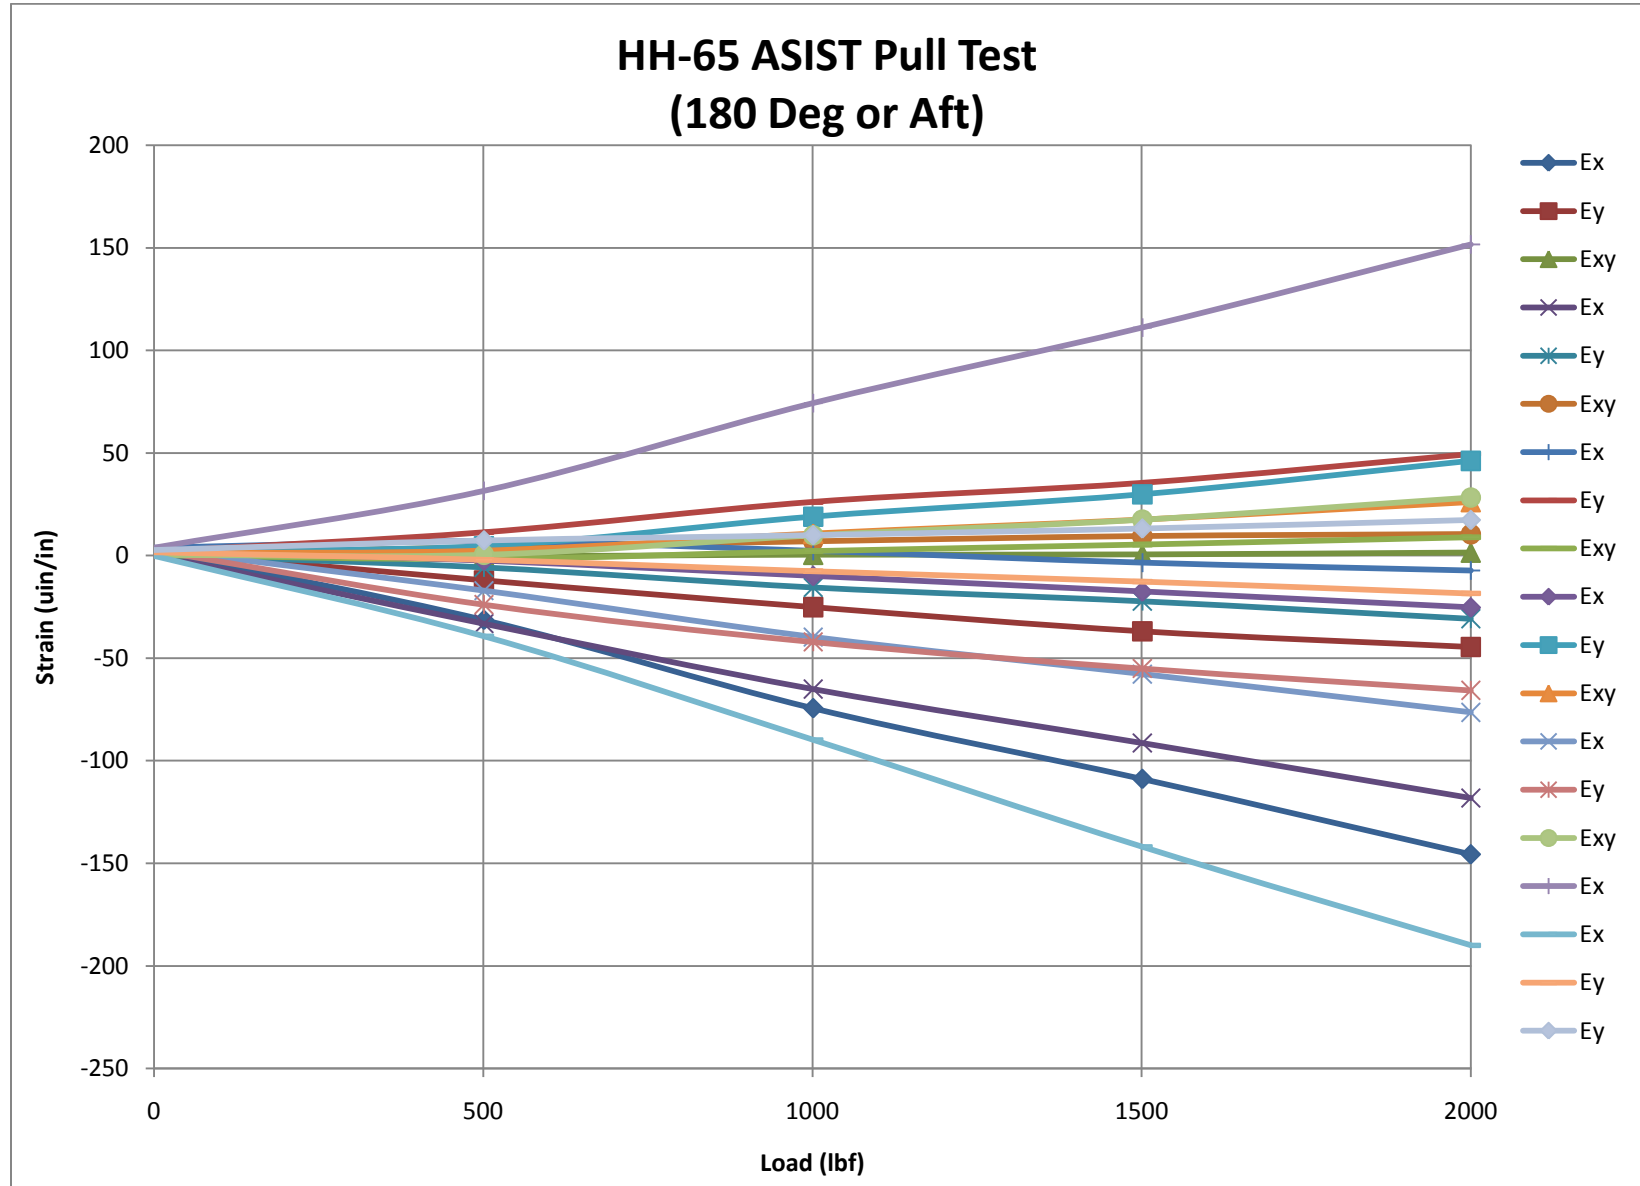
Figure B7 - Load Versus Strain Plot 180 deg. Load Case
