# **Investigation and Site Restoration following a Major Accident Involving Hazard Classification 1.2 Ammunition**

**Dr Irmeli Tuukkanen**  
**Army Materiel Command**  
**Tampere, Finland**  
**and**  
**MSc (Eng) Kari Mäkinen**  
**Ministry of Defence**  
**Helsinki, Finland**

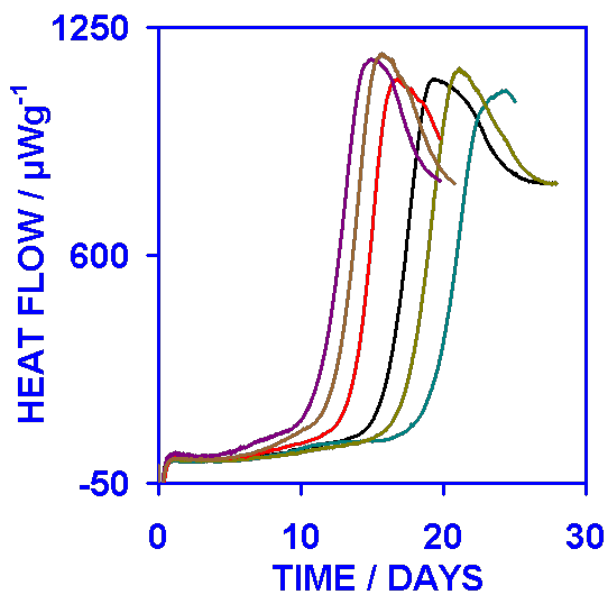
Preliminary studies on a 50% magnesium-50% strontium nitrate composition at 50 °C and 65 % RH showed an initial induction period where a very low heat flow was observed, after 15 days the reaction rate increased rapidly and it continued at a significant rate following the peak heat flow. Repeat experiments showed that the onset time of main reaction was variable but the curves observed had similar peak sizes and shapes (Figure 1).

Figure 1: Heat flow for a binary mix of 50% magnesium-50% strontium nitrate at 50 °C and 65 % RH.

- Initial induction period – very low heat flow
- Reaction rate increased rapidly after 15 days
- Reaction continued at a significant rate following the peak heat flow

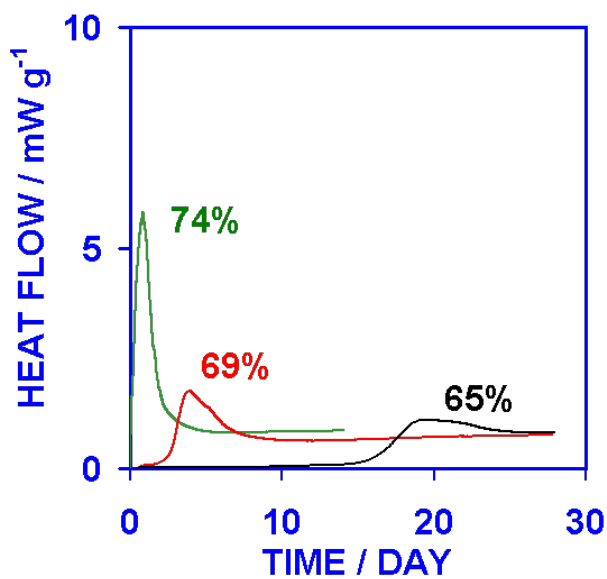
Increasing the relative humidity from 65% to 69% RH resulted in a reduced induction period and an increase in the maximum heat flow (Figure 3). A further increase to 74% RH caused the induction period to be eliminated and a further increase in the maximum heat flow was observed.

Figure 3: Heat flow for 50% magnesium-50% strontium nitrate at 50 °C and different relative humidities.

- Increasing the relative humidity from 65% to 69% RH
  - Reduced induction period
  - Increase in the maximum heat flow
- Increasing it further to 74% RH
  - The induction period was eliminated
  - Further increase in the maximum heat flow was observed

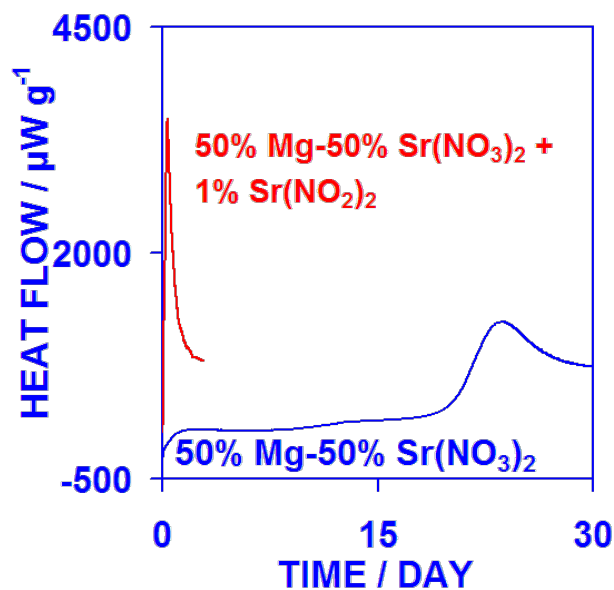
The role of nitrite formation in rate of ageing was studied (Figure 4), the addition of 1% nitrite eliminated the induction period and a more rapid heat flow was observed after just 8.7 hrs.

Figure 4: Heat flow curves showing the influence of adding 1% strontium nitrite.

- Addition of 1% strontium nitrite
  - Eliminates the induction reaction
  - Maximum heat flow observed after 9 hrs

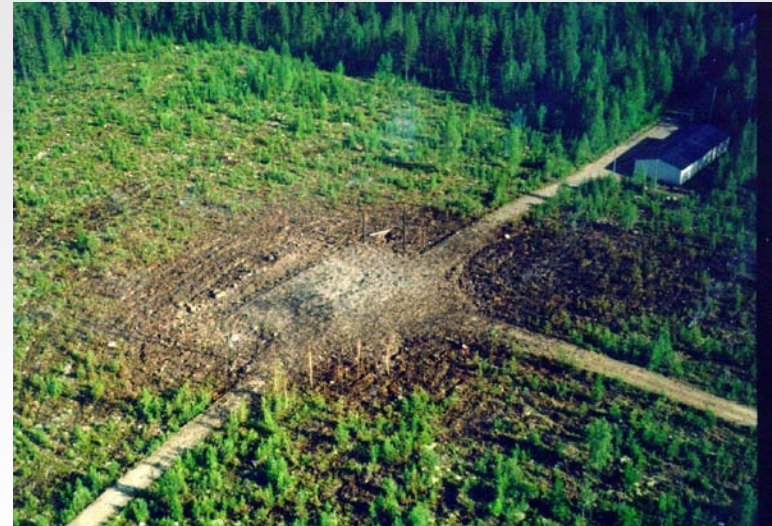
- In July 1999 a storage magazine at an ammunition depot was completely destroyed by an explosion
- 1.2 ammunition (40 mm) awaiting disposal
  - High explosives
  - Fuzes
  - Double and single based propellants
  - Pyrotechnic tracers
- Unheated and unventilated magazine
  - Clad timber frame with sheet metal roof
  - Ambient temperatures up to 30 ° C
  - Magazine interior temperature up to 60 ° C

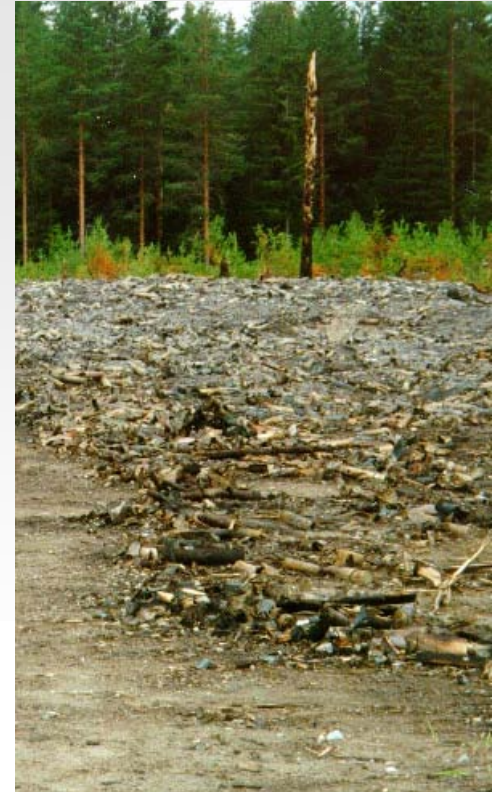
- No personnel were injured by or directly involved in the accident
- Helicopters and planes took more than 4 days to extinguish the fire
- Ordnance and energetic materials were spread over a wide area
- Debris was ejected onto the roof of a nearby magazine and through the wall of a second
  - Fire inside both buildings
    - Propellant in an ammunition container
    - Wooden pallet
  - Both self-extinguished

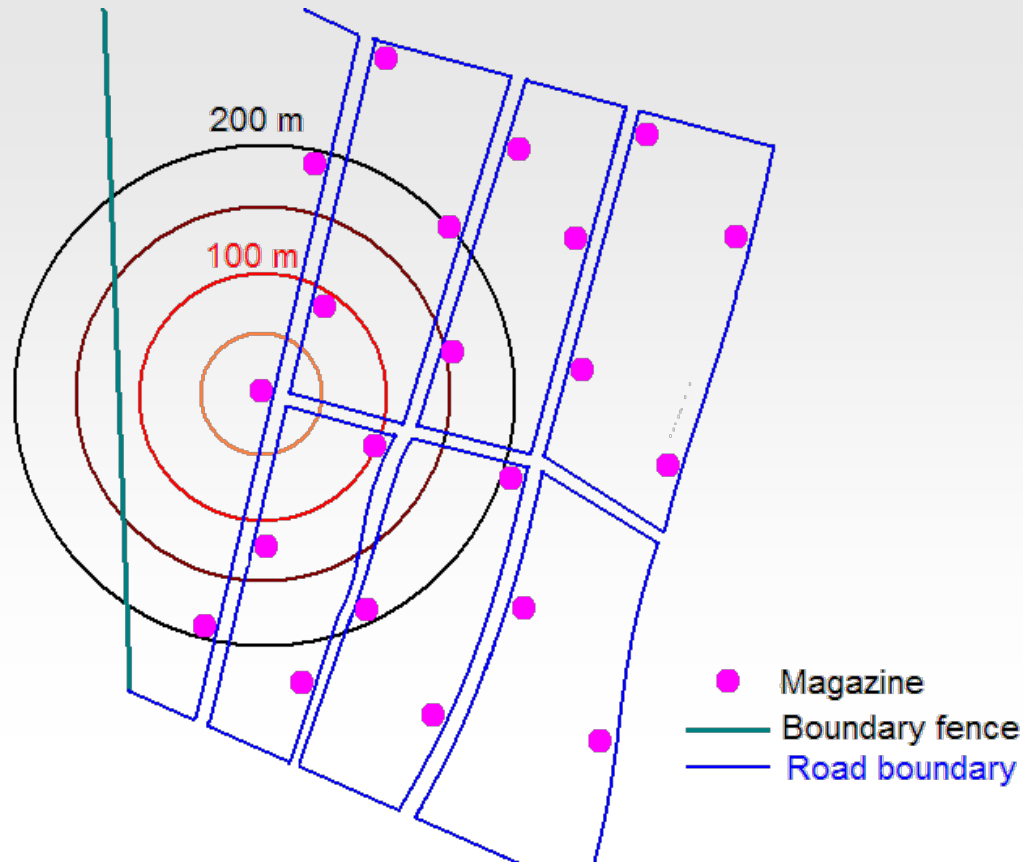
- Fixed ammunition - 1000 items
- Projectiles - 700 items
  - fuzes and tracers - 4000 items
  - with fuzes - 1000 items
  - with tracer - 750 items
- Fuzes - 200 items
- Tracers - 4000 items
- Cartridge cases with primers and/or propellant - 600 items

The positions of more than twelve thousand items of ordnance were recorded during the operation to restore the site. A summary is presented in Table 1. Approximately 75% of the items were recovered from an area within 50 m of the magazine and more than 99% were found within 100 m distance. The majority of the 55 ordnance found more than 100 m from the magazine were tracers, but there were 23 other larger items; one fuze and one tracer were projected over 400 m.

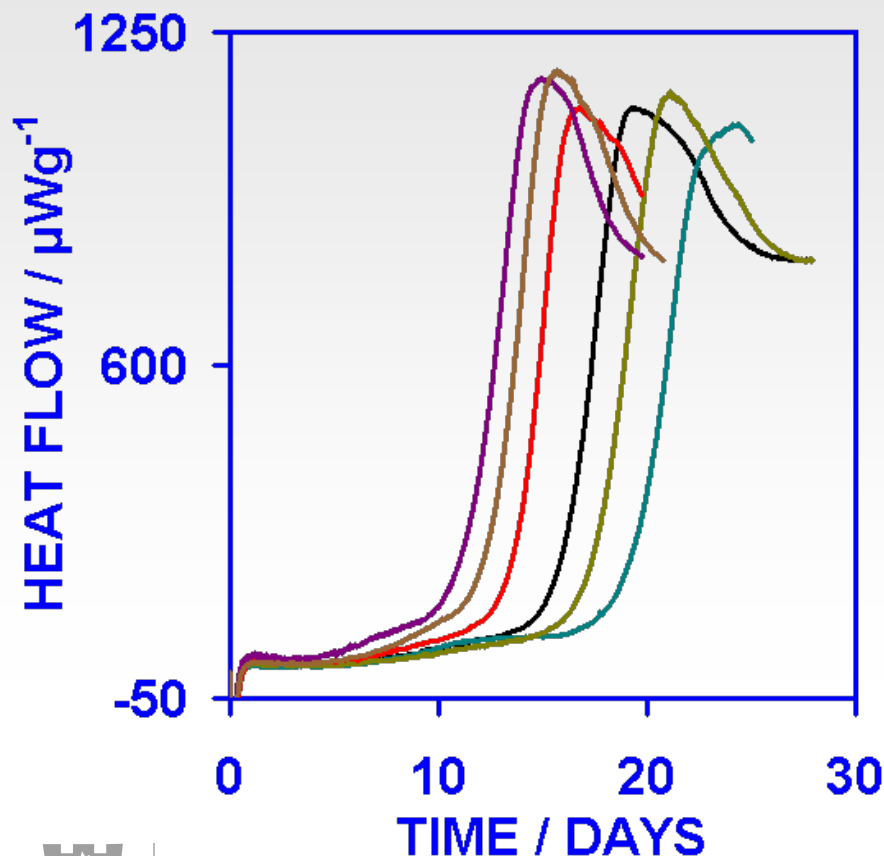
50% Mg-50% Strontium Nitrate 50 ° C and 65% RH

- Initial induction period – very low heat flow
- Reaction rate increased rapidly after 15 days
- Reaction continued at a significant rate following the peak heat flow
- Onset time of main reaction was variable
- Similar peak size and shape
