Radiology Corner, Case #14

The Deep Lateral Femoral Notch: A Sign of Anterior Cruciate Ligament Disruption

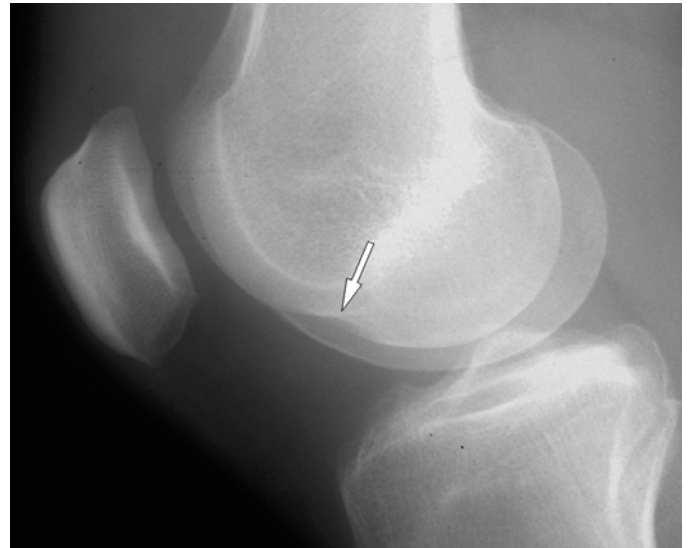
Fig 1. Lateral view of the knee demonstrates a deep lateral femoral sulcus (arrow) with irregularity and asymmetry of the notch.

Lateral radiograph of the knee demonstrates a deep, irregular appearing lateral femoral sulcus, and a small joint effusion, but is otherwise normal (Fig 1). Follow up MR imaging demonstrates marrow edema in the lateral femoral condyle and in the posterior tibial plateau. The lateral femoral sulcus appears deepened and irregular in contour. T2-weighted sagittal image through the region of the intercondylar notch demonstrates complete disruption of the anterior cruciate ligament (Fig 2).

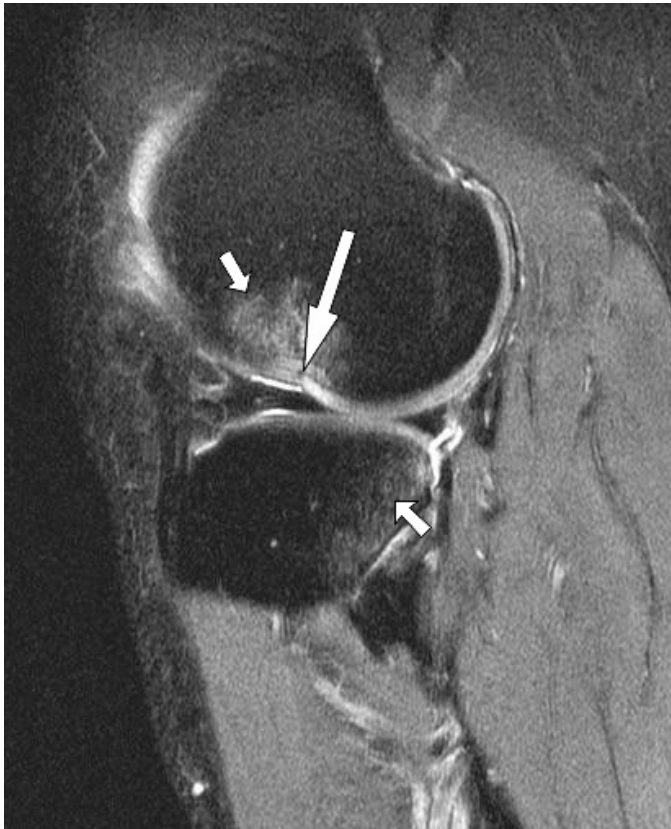
Fig 2. Sagittal STIR image through the lateral femoral condyle demonstrate a deep irregular appearing lateral femoral sulcus (long arrow). Marrow edema is also noted in the lateral femoral condyle and lateral tibial plateau (short arrows).

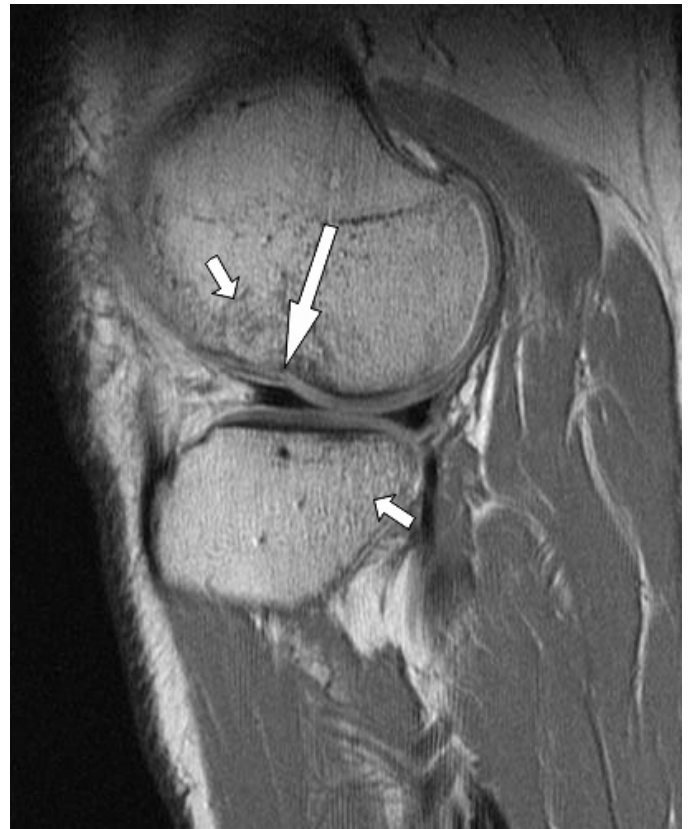
Fig 3. T2-weighted image through the lateral femoral condyle demonstrate a deep irregular appearing lateral femoral sulcus (long arrow). Marrow edema is also noted in the lateral femoral condyle and lateral tibial plateau (short arrows).

MR imaging also demonstrates an irregular appearing deep lateral femoral sulcus and in addition it will demonstrate marrow edema within the lateral femoral condyle and the posterior tibial plateau secondary to the impaction injury (6). This pattern of marrow edema has been referred to as the “pivot shift” marrow edema pattern and is also highly specific for ACL injury. See figures 2, 3 and 4 for examples in our case. MR imaging will demonstrate the ACL disruption along with associated injuries of internal derangement to include meniscal tear, chondral injury and collateral ligament tear.

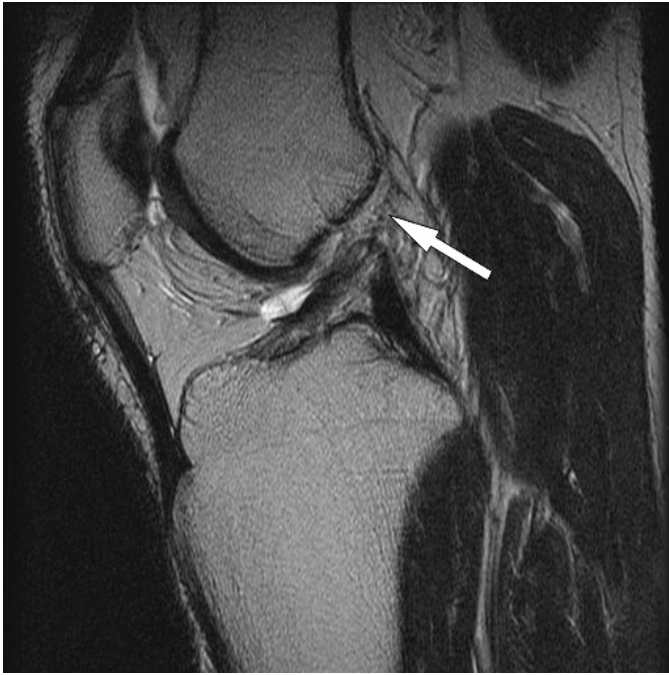
Fig 4. Sagittal T2-weighted image through the level of the intercondylar notch demonstrates disruption (arrow) of the proximal fibers of the ACL.

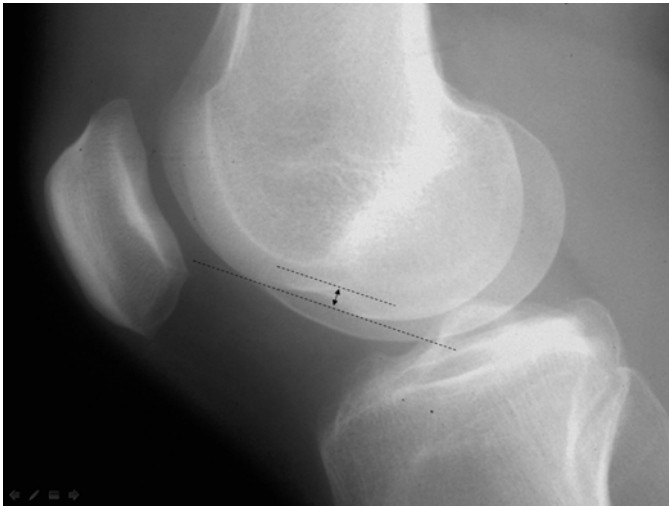
Fig 5. This figure demonstrates how to measure the lateral condylopatellar sulcus to see if it is less than 2 mm. The depth of the notch is measured by drawing a line tangential to the sulcus along the articular surface of the lateral femoral condyle and then by measuring the distance from the line to the depth of the sulcus. When this measurement is greater than 2 mm it is referred to as the “deep lateral femoral sulcus” sign.

The radiograph will demonstrate an irregular asymmetric appearing notch that is greater than 2 mm in depth. This is referred to as the “deep lateral femoral sulcus” sign. The depth of the notch is measured by drawing a line tangential to the sulcus along the articular surface of the lateral femoral condyle and then by measuring the distance from the line to the depth of the sulcus (Fig 5). The presence of a deep lateral femoral sulcus is nearly always associated with ACL disruption but lacks sensitivity; the absence of the sign therefore does not exclude the presence of an ACL tear (5).
