Excerpts from AMSAA's M109A6 Paladin Starter Motor Corrosion Analysis

For the 2010
U.S. Army Corrosion Summit
February 9-11, 2010

Brian E. Frymiare
U.S. Army Materiel
Systems Analysis Activity

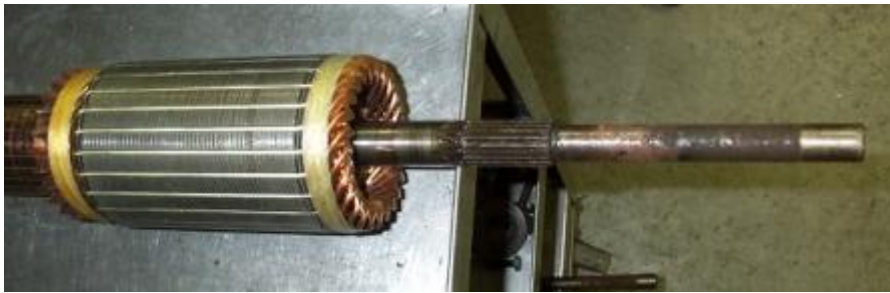
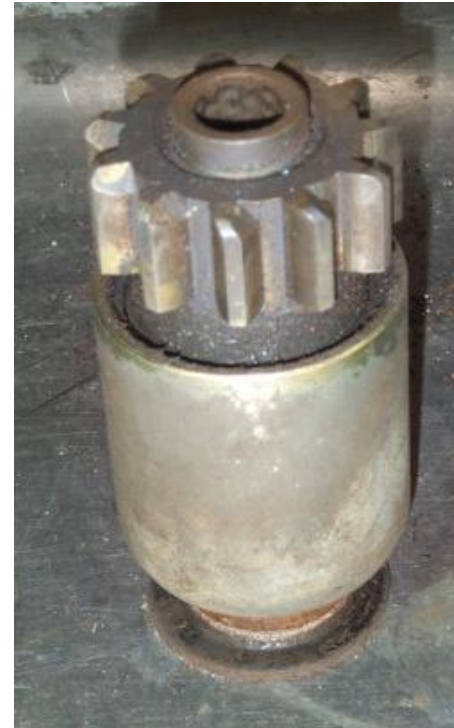
Two Starter Motors (One from Each Manufacturer) were Analyzed.

A **Thorough** Material Analysis was Conducted on the Starters

Despite the New Manufacturer stating that their Starter Motor Shaft's Utilized a Protective Zinc Plating, **NO** Zinc was Found on the Armature Shaft Analyzed.

Lack of a Protective Coating Undoubtedly Led to the High Rate of Starter Motor Failures

The Corrosion Problem **WAS NOT** Revealed Under the Required 96 Hour Salt Spray Test

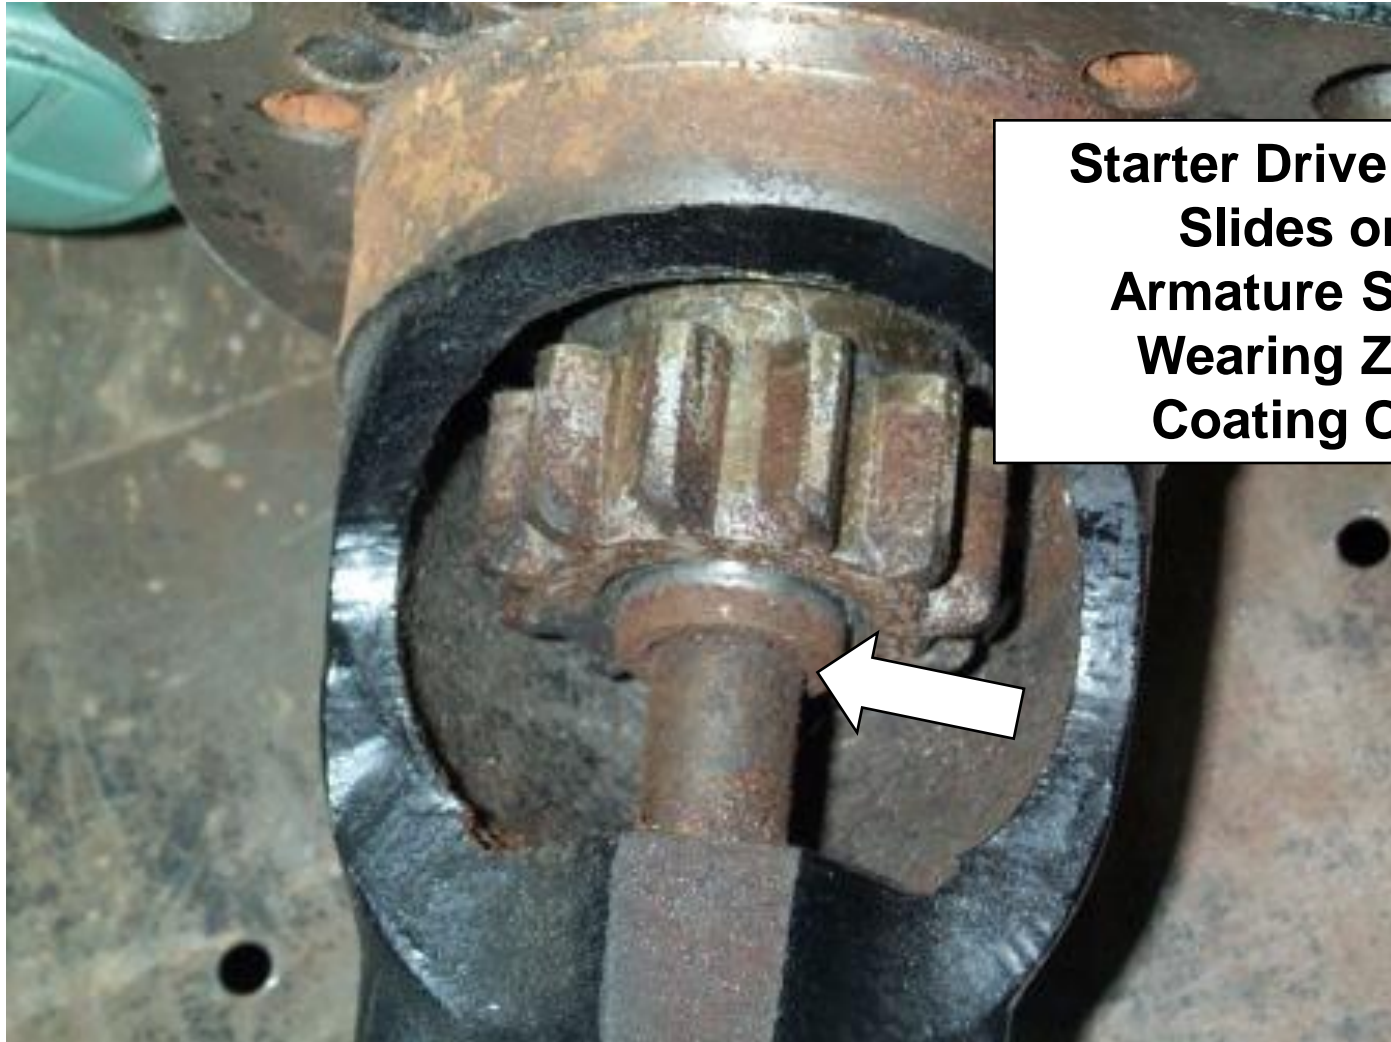
Failed M109A6 Starter

Corrosion was Starting on the Original Starter, Where the Starter Drive Gear Slides on the Armature Shaft – Wearing the Protective Zinc Coating Off

**Starter Drive Gear
Slides on
Armature Shaft
Wearing Zinc
Coating Off**

It was Recommended that all Starter Motors be Exercised During Salt Water Spray Corrosion Testing, and the Test Procedure be Changed so that any Similar Items be Exercised During Salt Water Spray Corrosion Testing
