Producing Durable Continuously Reinforced Concrete Pavement using Glass-ceramic Coated Reinforcing Steel

Principal Investigator:	Sean W. Morefield	CERL
Co-Investigators:	Brett A. Williams	GSL
	Charles A. Weiss, Jr.	GSL
	Philip G. Malone	GSL
	Mike Koenigstein	PPEC

Presentation

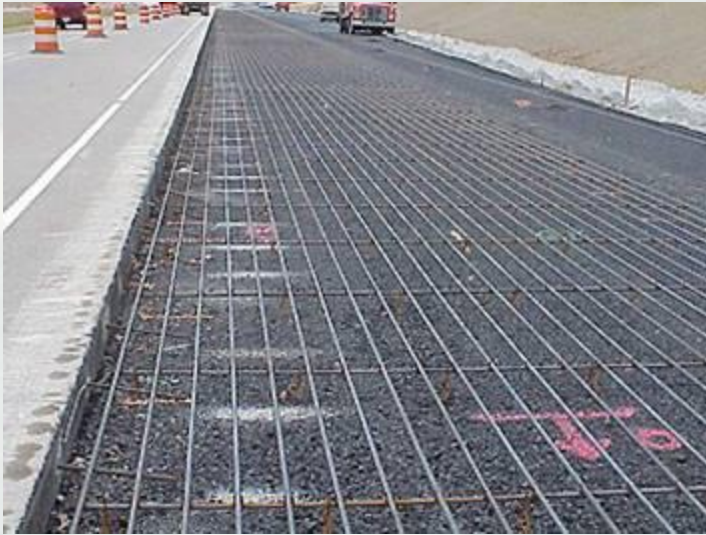
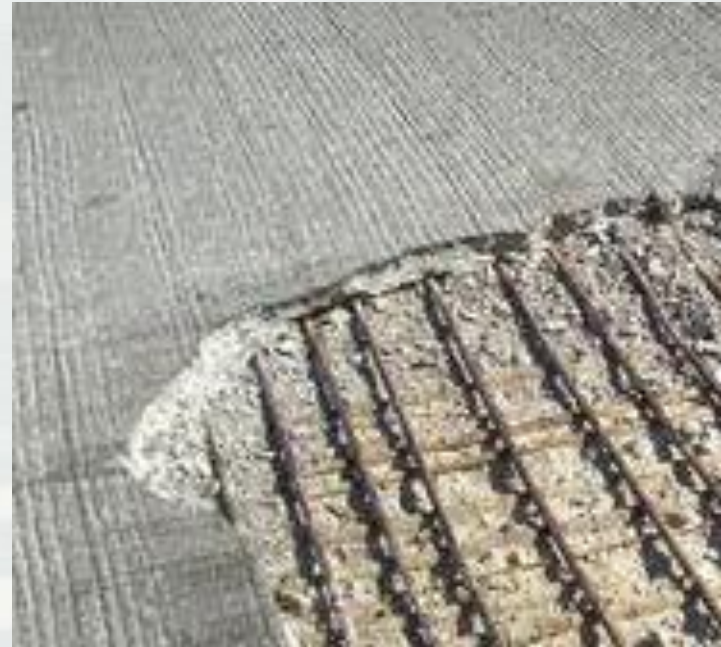
Corroding Steel Reinforcement is a Major Problem in Continuously Reinforced Concrete Pavement

The 600% volume change in the iron to iron oxide formation put the concrete in tension and it cracks and spalls

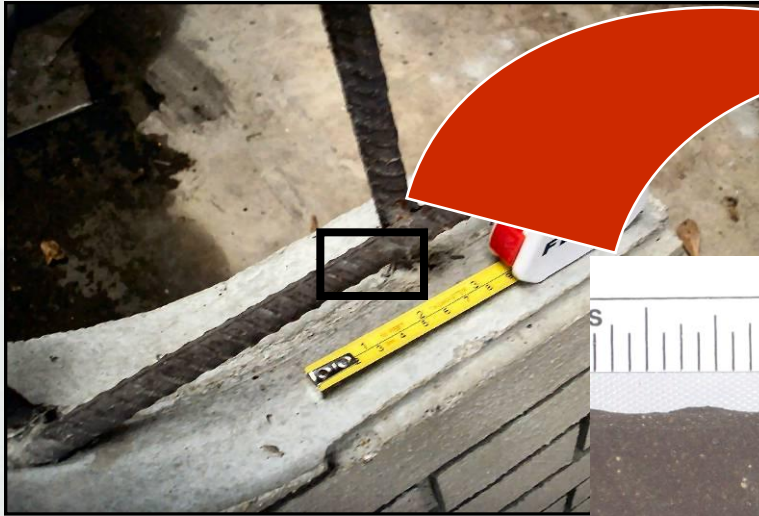
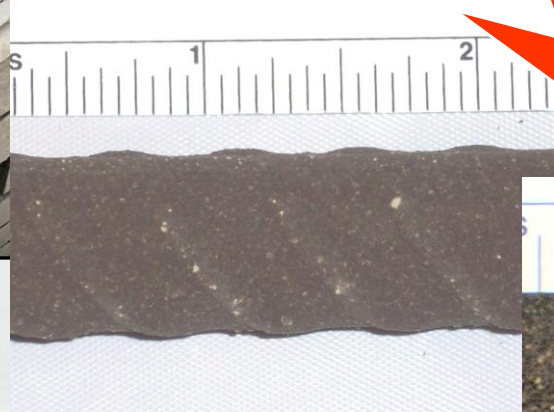
Vitreous-Ceramic Coating On Rebar

Mild steels used in reinforcement enamel well

Enamel application produces no changes

After firing cement grains are embedded in glass enamel

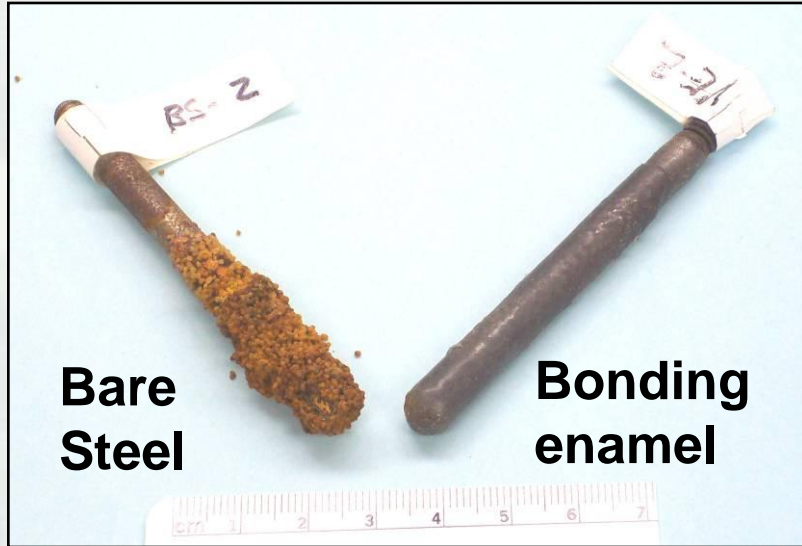
Enameling Provides Excellent Corrosion Resistance

Results of 40-day exposure of mild steel test rods with and without enamel in 3.5% NaCl solution at 20 °C

Coated rods would only corrode if the enamel was intentionally removed.

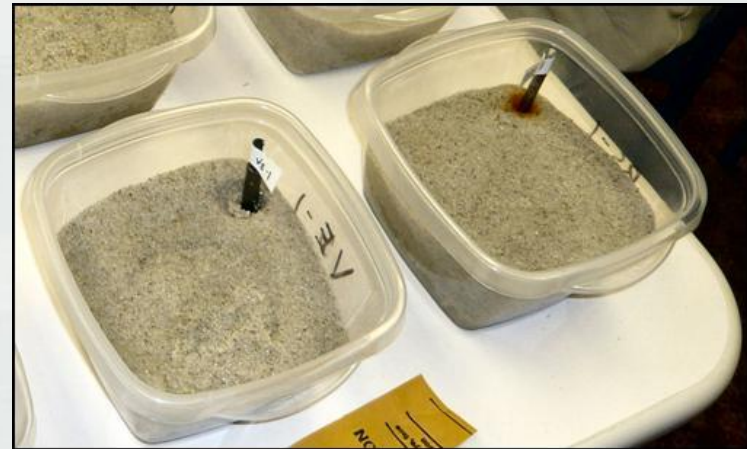
Quartz sand saturated with 3.5% NaCl solution was test bed

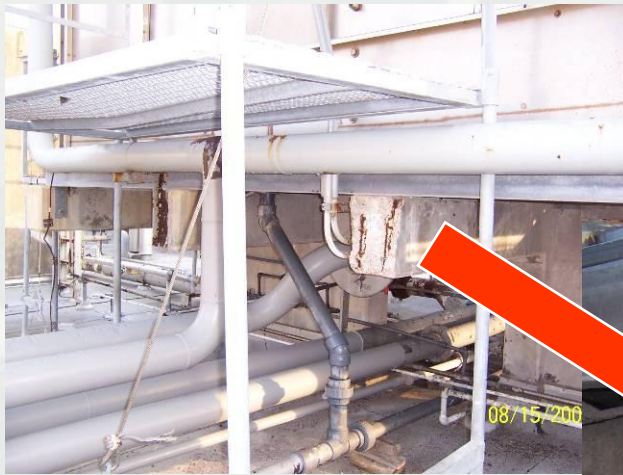
Corrosion of stirrup rebar in support beam caused end of the beam to fall off

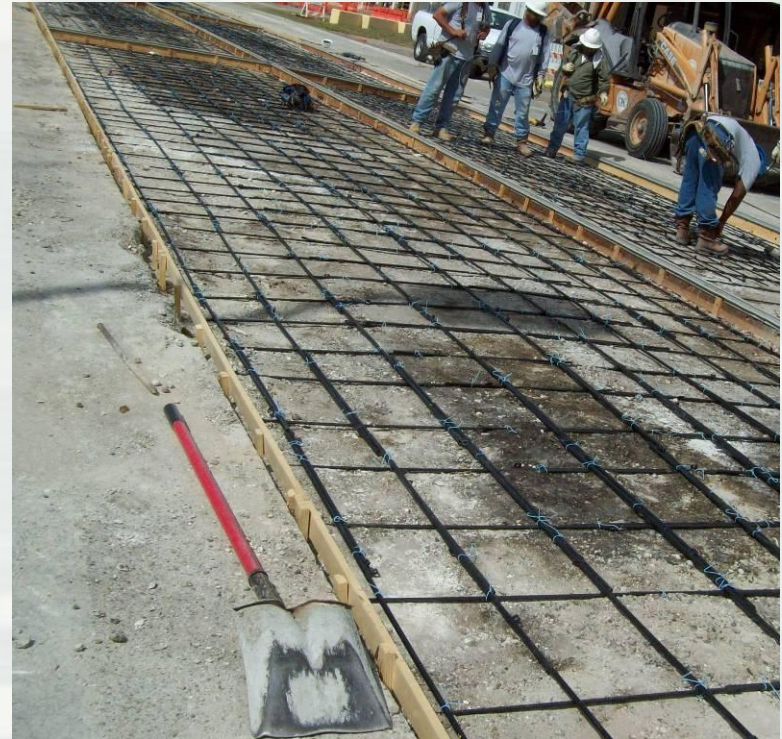
Crecy Street Test Site at CCAD (2)

- Pavement is 6-in. thick
- Bars are positioned at mid-depth
- Bars were overlapped to form splices
- The overlaps vary from 12 in. to 20 in.
