Performance of FRP Connectors for Seismic Rehab of Michie Stadium

The objective of this project order was to inspect two hundred and fifty (250) FRP composites patches used for service life extension of Michie Stadium at the USAMA, West Point, NY, using Acoustic Guide Wave technology

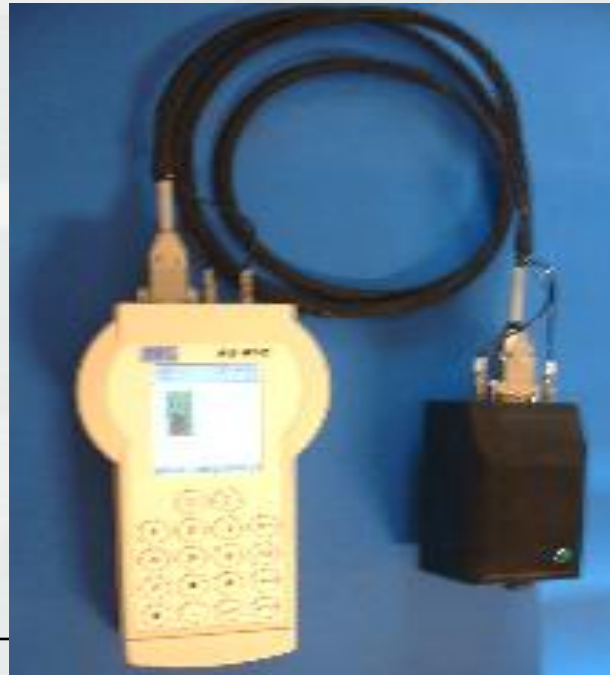
- Acousto-Ultrasonic (AU) technology developed Physical Acoustic Corporation (PAC) as an inspection technique for nondestructive evaluation of structures such as FRP composite and graphite epoxy

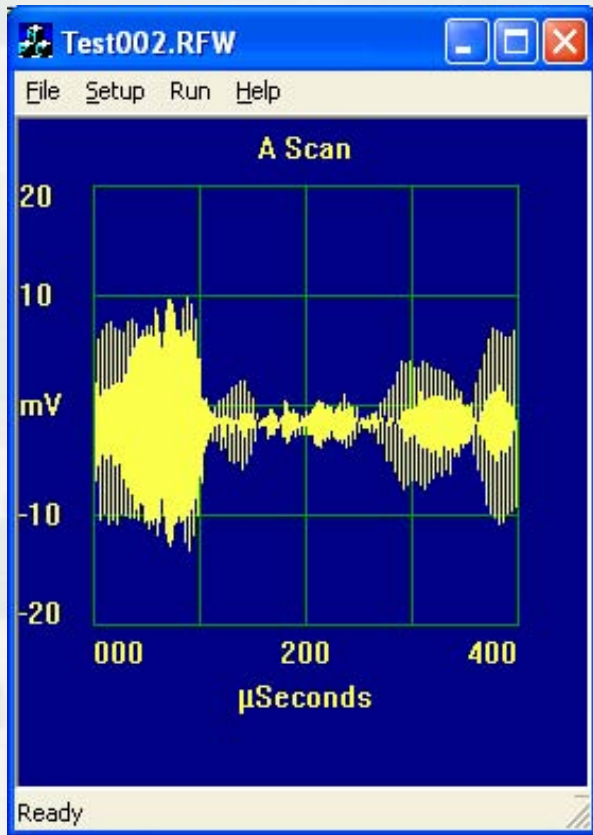
Example A-Scan

- System based on AU technology
- acoustic waveform bursts (100-500 kHz) directed into the material being inspected
- AU receiver recognizes these waveforms and AGW device processes the results and displays them as A-Scan waveforms and C-Scan image maps.
 - ▶ The acoustic signal features include gated Amplitude and Time of Flight parameters,
 - change when the acoustic bursts travel through the material and encounter defects and discontinuities, cracks, material property changes, delamination and debonding.
